Interim Action and Data Gap Investigation Report

**Whitney's Chevrolet, Inc.
123 Pioneer Avenue
Montesano, Washington 98563**

February 23, 2012

Environmental Partners, Inc.
295 NE Gilman Blvd., Suite 201
Issaquah, Washington 98027
(425) 395-0010

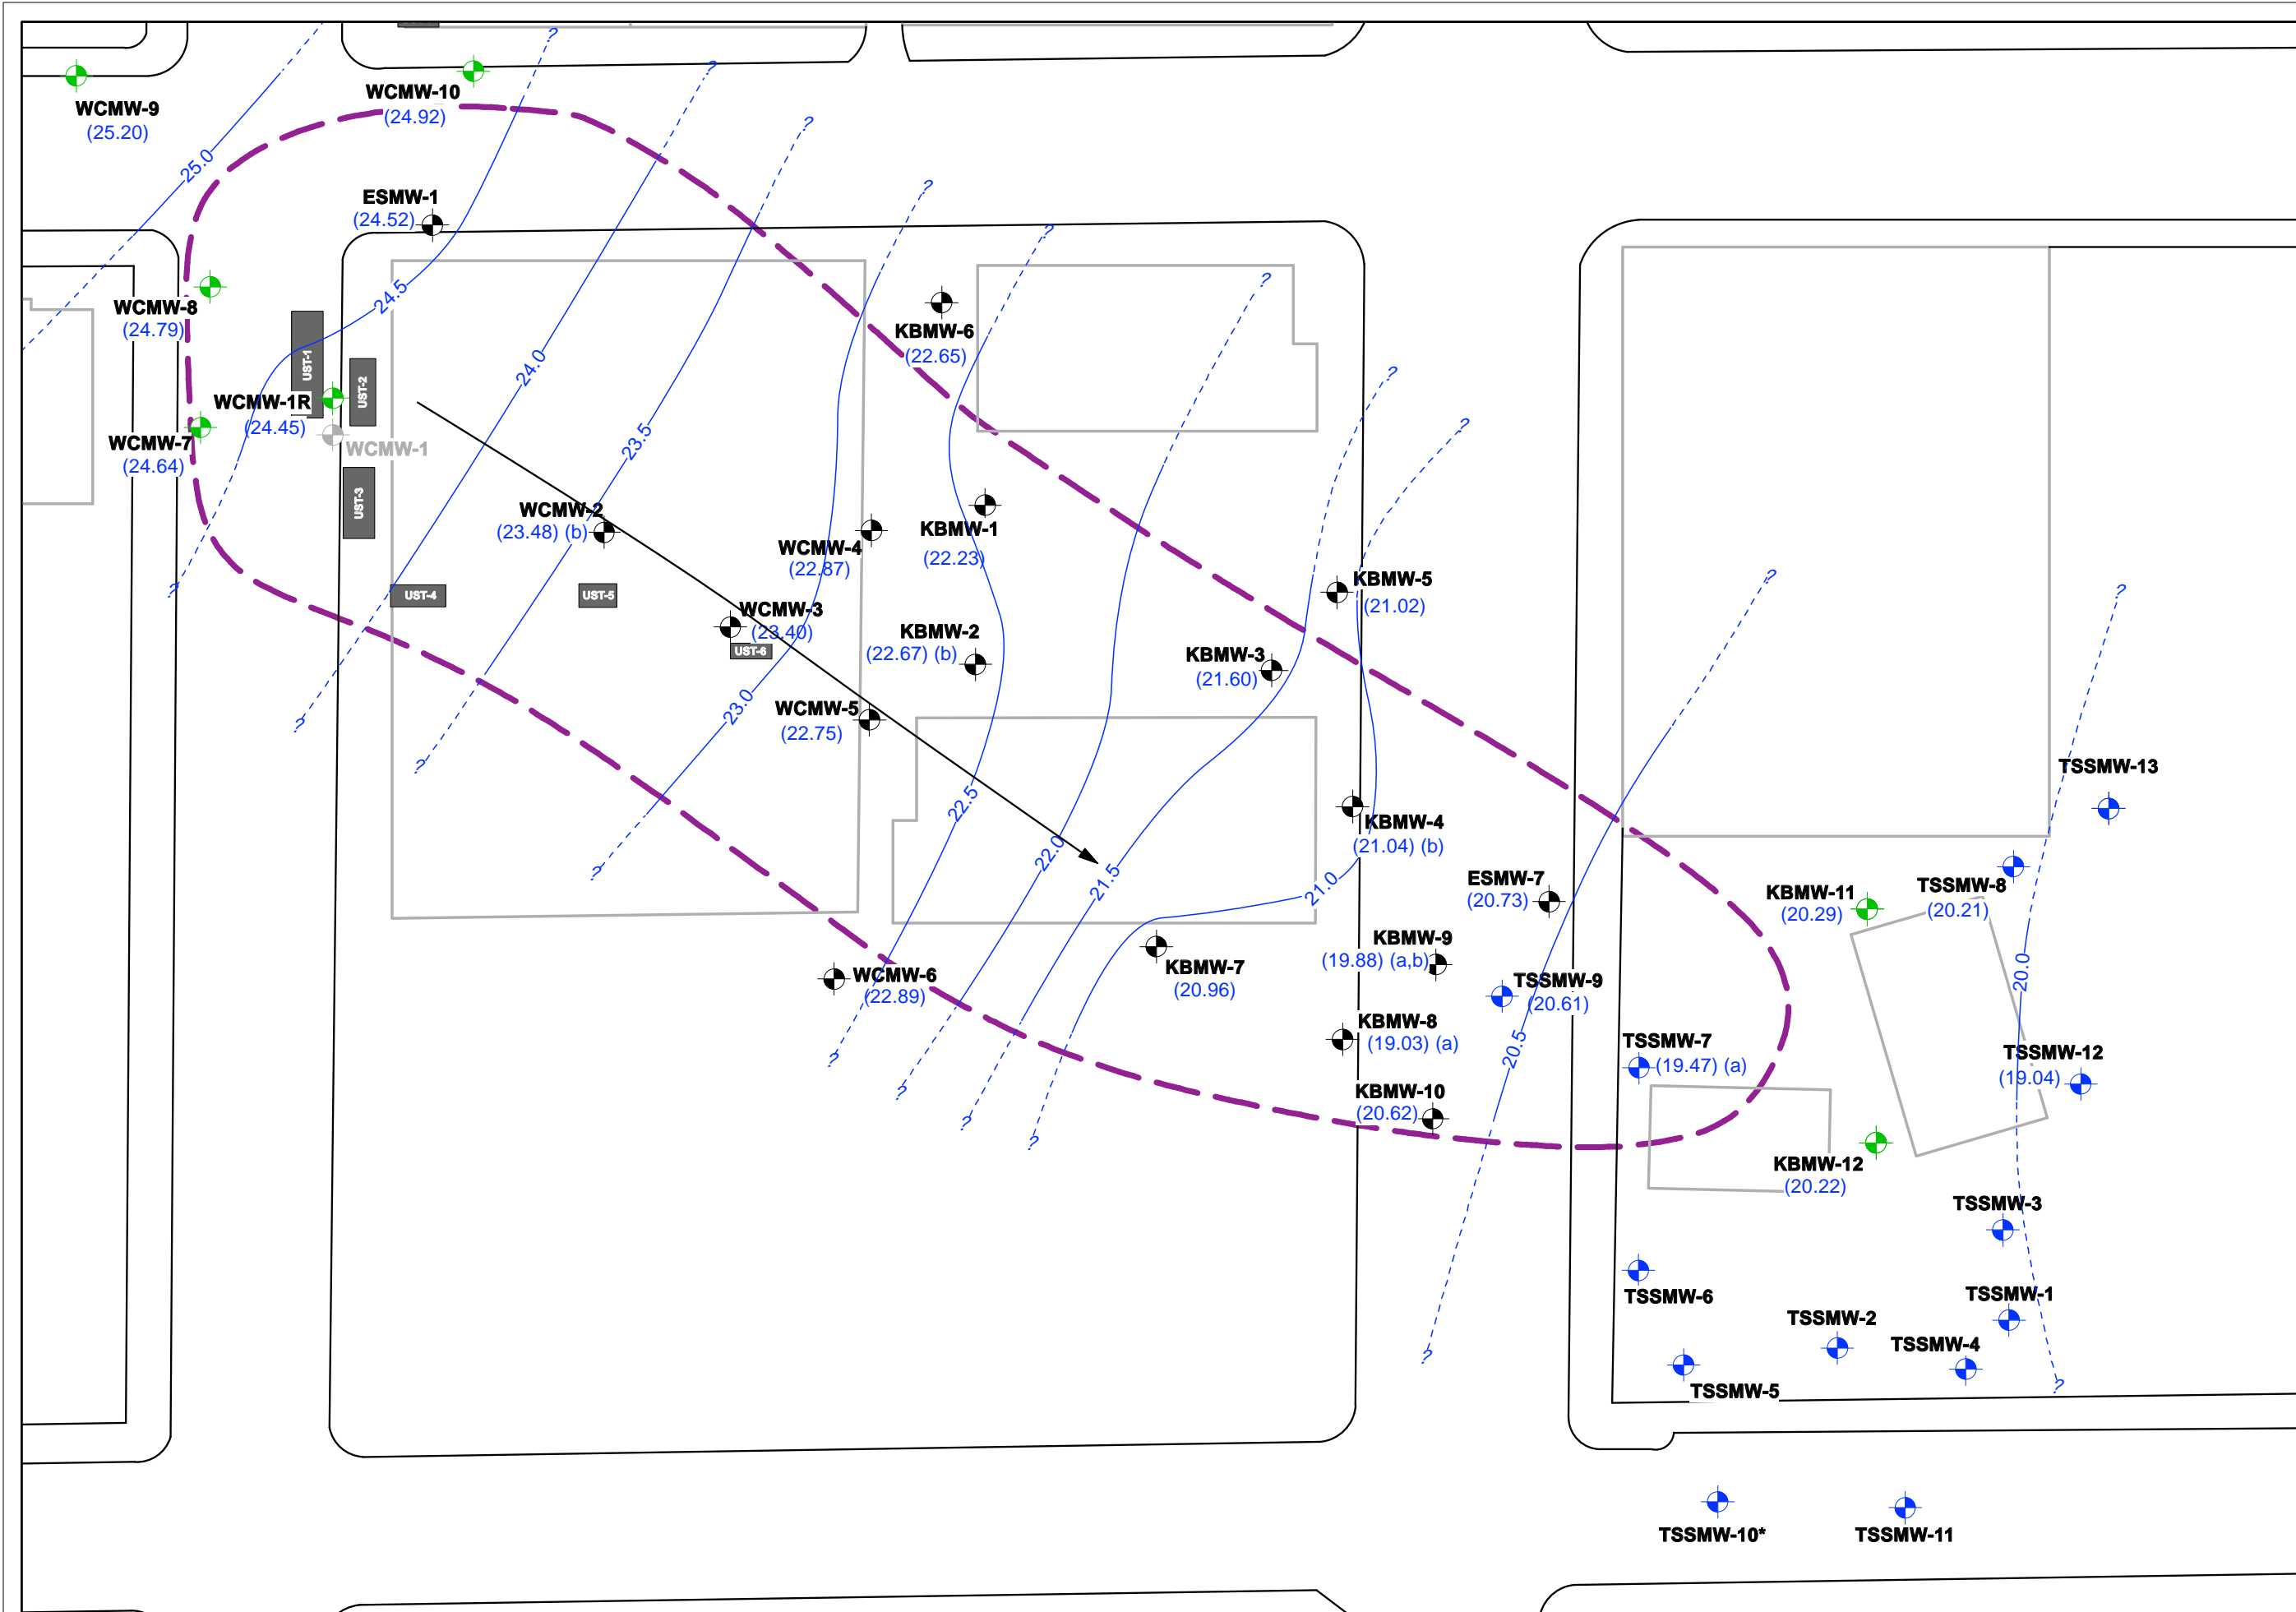
ENVIRONMENTAL PARTNERS INC. 295 NE Gilman Boulevard, Suite 201 Issaquah, Washington 98027	PROJECT 51201.8	PREPARED FOR WHITNEY'S CHEVROLET, INC.	LOCATION MONTESANO, WASHINGTON	DATE 01/06/12
	SHEET 1 of 1	DRAWN BY M/M/M	REVIEWED BY E/LC	DATE 01/06/12
FIGURE 12 WATER TABLE PIEZOMETRIC CONTOURS FOR OCTOBER/NOVEMBER 2011

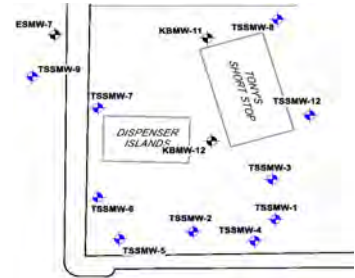
Site Representation:

Depth	SUBSURFACE PROFILE			SAMPLE			PID (ppm)	Sheen	Well Data	Comments
	Log	USCS Code	DESCRIPTION	Interval Recovery	Blows per 6"	Sample				
0			Ground Surface							
0-1			Asphalt							Traffic rated flush-mount vault
1-2			Fill							Cement grout
2-12		SM	Silty Sand Brown; damp; mostly fine to medium sand with silt; and clay-rich bands							2" Schedule 40 blank PVC
3-6					3-3-4	KBMW-11:5	0			Hydrated bentonite chips
6-9							0			No petroleum odor
9-10					4-7-10	KBMW-11:9				
10-13		SP	Poorly-graded Sand Brown; damp; mostly medium sand		9-10-10	KBMW-11:12.5	0			2" 0.010" slot screen schedule 40 PVC
13-15		SP	Poorly-graded Sand with Gravel Brown to red-brown; wet; mostly medium sand		50-6	KBMW-11:14	0			#2/12 Silica sand pack
15-19										
19-20					12-20-21					Slight petroleum odor at 19'
20-24		GW	Well-graded Sand with Gravel Saturated; mostly fine to coarse sand with few gravel				0			No petroleum odor

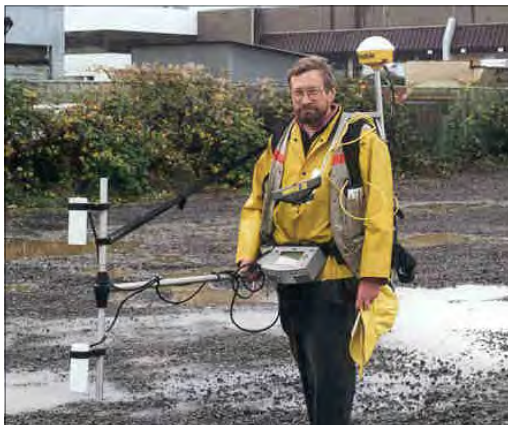
Photo 3-Magnetometer

The photo 3 on the cover shows a magnetometer/gradiometer. This instrument can also cover wide areas quickly, providing complementary data to the EM. Figure 2 includes total magnetic

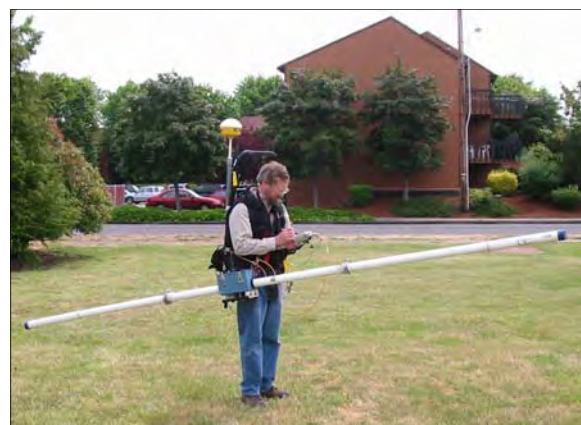
Photo 4-EM31

The Geonics EM31 is a common frequency domain EM instrument, often used for buried object detection. The cover photo 4 shows the EM31 in a field situation. Figure 1 is a schematic showing the principles of operation. A transmitter coil is in one end of the boom and a receiver coil in the other end. Depth of investigation for the EM-31 is generally 10-15 feet, but it may detect large metal objects at a somewhat greater distance. The instrument can quickly cover a wide area, mapping anomalous areas (metallic object locations) as well as changes in the soil character.

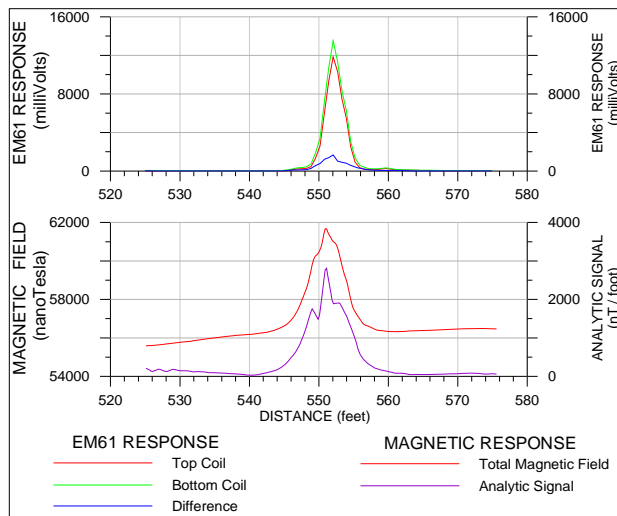
FIGURE 3
EM61 & MAGNETIC PROFILES OVER
PARTIALLY BURIED 55 GALLON DRUM

Magnetic methods measure disturbances in the earth's natural magnetic field. These disturbances are caused by magnetic materials, either magnetic rocks, or man made objects containing iron or steel. This is shown schematically in Figure 4. Most soils have negligible magnetization (both induced and remanent). Thus, most magnetic disturbances from shallow sources can be attributed to iron or steel objects which have been placed there by man's activities.

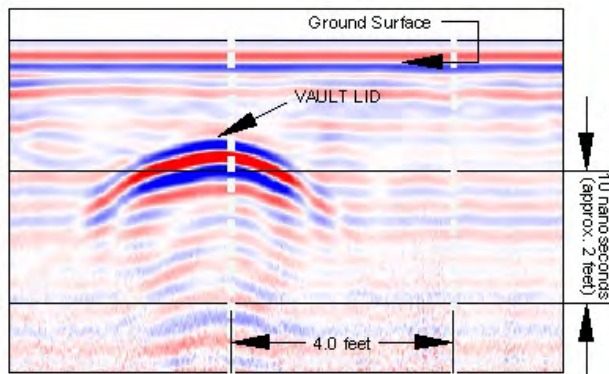
FIGURE 5
SAMPLE GPR PROFILE

As we have stressed, EM and magnetics are effective in screening large areas quickly to identify areas where buried objects may be present. Often these techniques can provide a rough estimate of the size and depth of the object causing the anomalous readings.

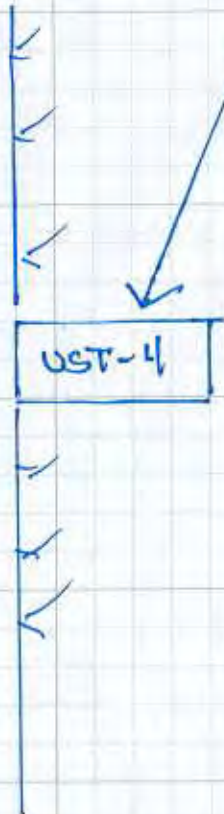
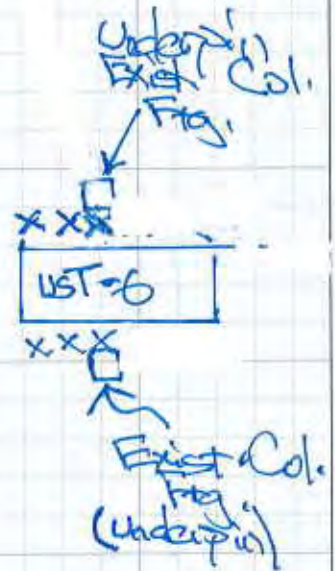
UST-4

Geotechnical Engr. To Observe Excavation
 And Stability - Additional Shoring Or
 Underpinning May Be Required

Driven 4" ϕ Pipe
 3ft. o.c.
 20ft. lengths

Shoring
