TECHNICAL MEMORANDUM

To: Jim Carsner, U.S. Army Corps of Engineers Date: November 20, 2017
From: Phil Wiescher, PhD, Maul Foster & Alongi, Inc. Project: NWS-2013-1209

RE: Port of Ridgefield Carty Lake Remedial Action (NWS-2013-1209) Year 2 (2017)
Vegetation Monitoring

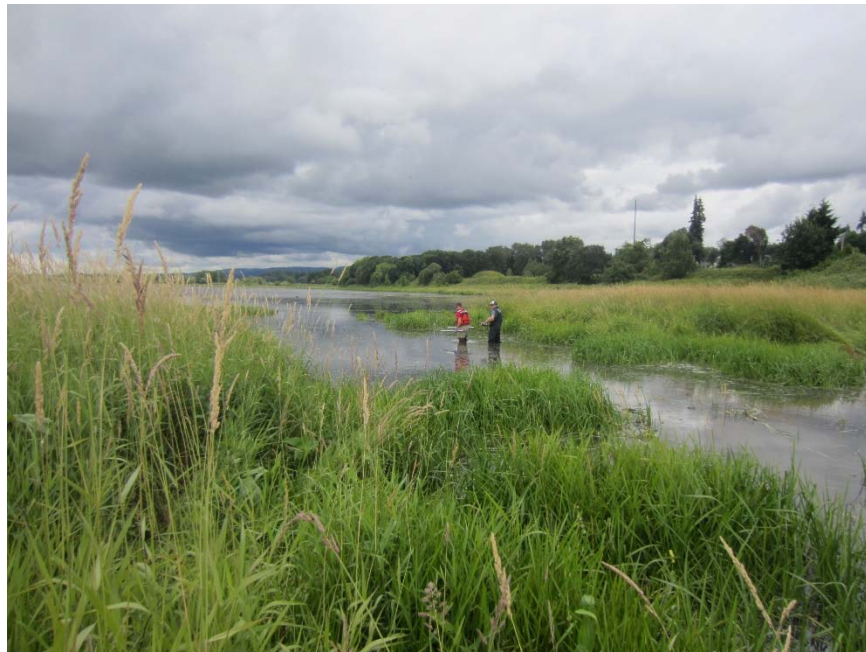
Photo No. 1

Fall 2013.
Mitigation area
before remediation.
Reed canary grass
is dominant
vegetation.
Looking northeast.

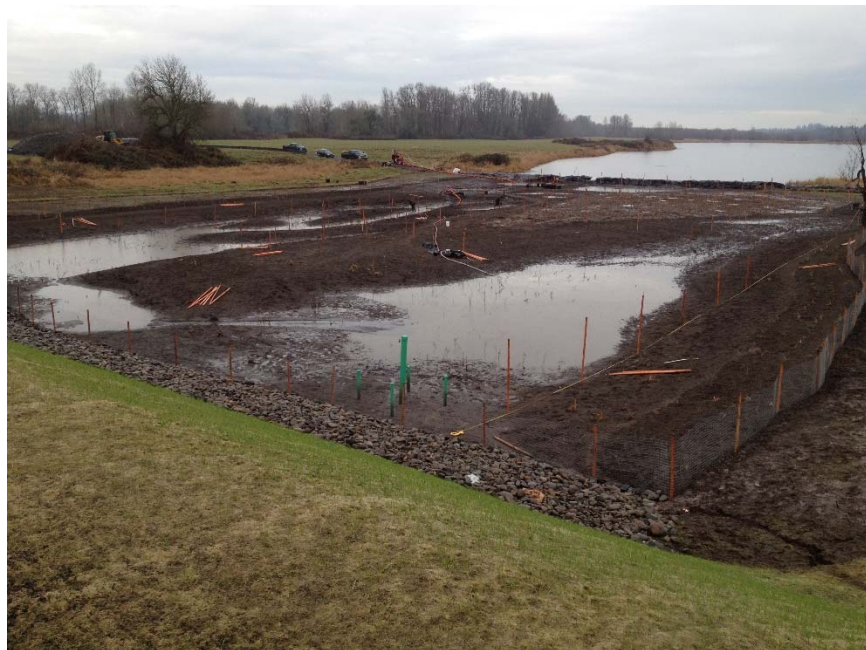
Photo No. 2

Winter 2014/15.
Remediation area
prior to plantings
and temporary dam
removal. Wildlife
fencing installed.
Looking northwest.

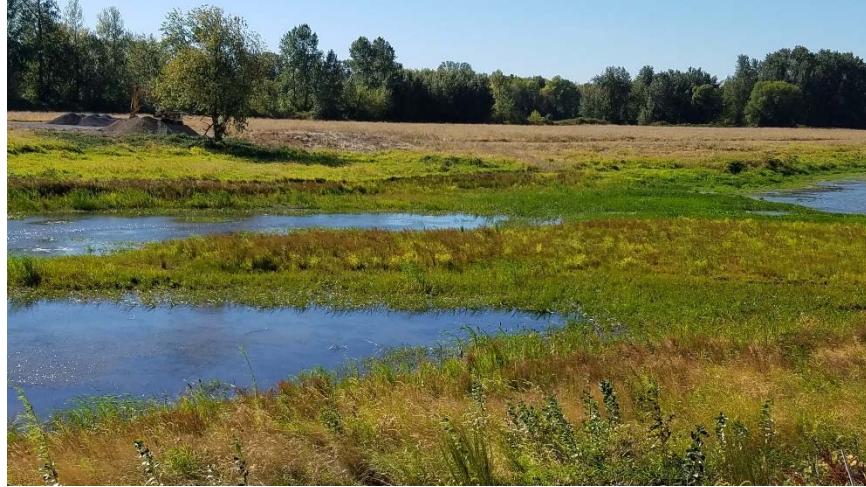
Photo No. 3

August 2016.
Mitigation area.
Looking west.

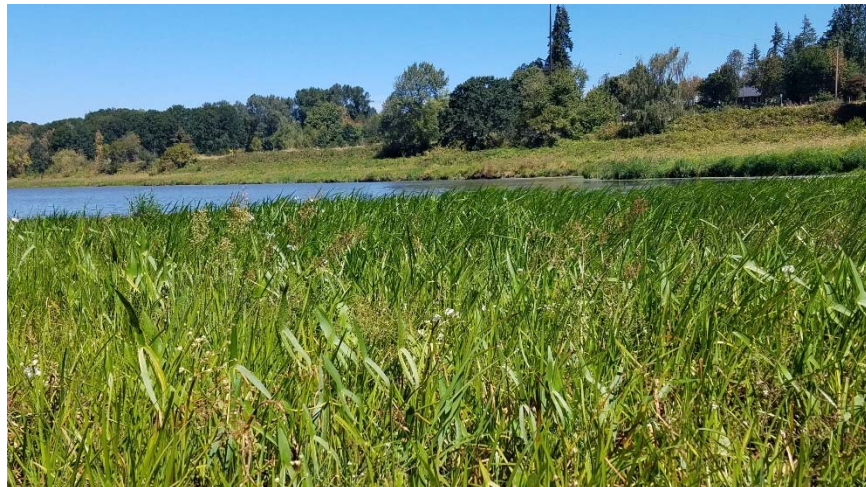
Photo No. 4

August 2016.
Mitigation area.
Flowering wapato
and bur-reed.
Looking northeast.

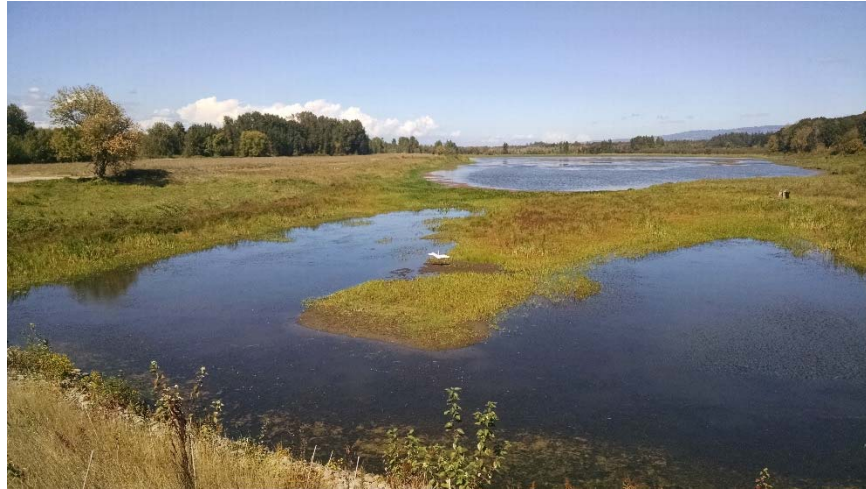
Photo No. 5

August 2016.
South end of
mitigation area.
Looking north.

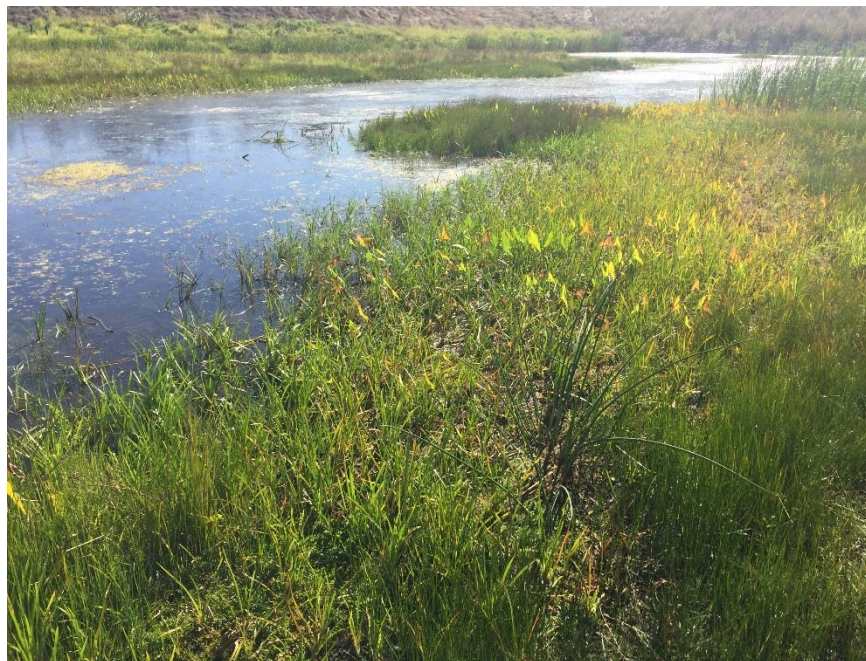
Photo No. 6

September 2017.
North end of
mitigation area.
Looking
southeast.

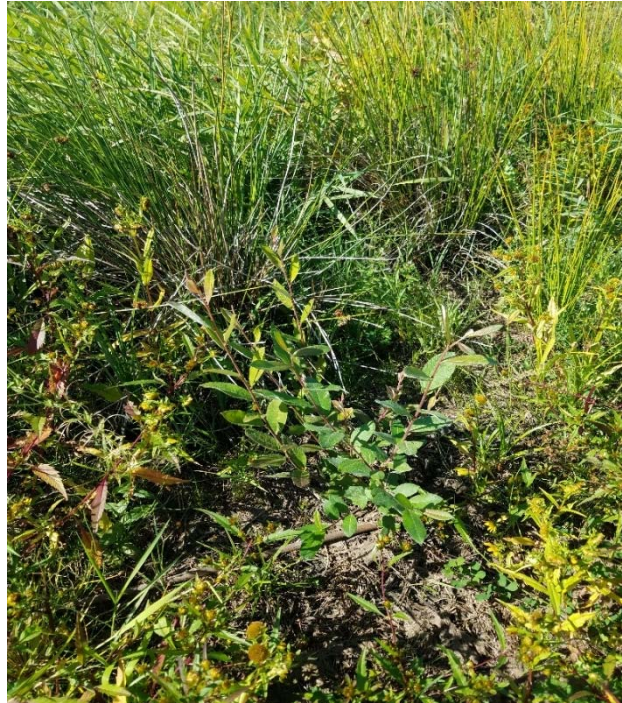
Photo No. 7

September 2017.
Photo point C1.
Marginal zone. Salix
species, spikerush,
Juncus, nodding
beggartick, and reed
canary grass
observed in vicinity.

To meet performance standards, PBI will manually remove invasives such as reed canary grass in the marginal zone as part of ongoing control measures. Isolated plants and small patches of reed canary grass will be removed by digging out and removing the entire root mass by hand. Care will be taken to remove all rhizomes and roots to reduce resprouting. MFA recommends not removing milfoil, as this would, at best, result in temporary, short-term improvement at significant effort and cost. Further removal may result in additional spreading of milfoil. Long-term control of milfoil would best be achieved if milfoil were treated throughout Carty Lake; however, existing USFWS budgets and staffing levels do not allow treatment of enough acreage to control spreading in the lake (USFWS, 2010).

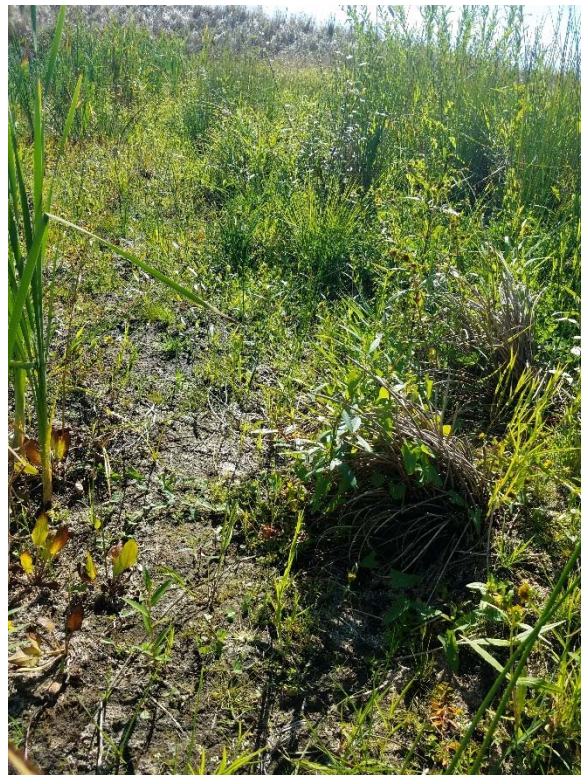
Photo No. 8

September 2017. Photo
point B1. Marginal
zone. American water
plantain, spikerush,
Salix species, Juncus,
sedges, wapato, cattail,
nodding beggartick, and
reed canary grass
observed in vicinity.

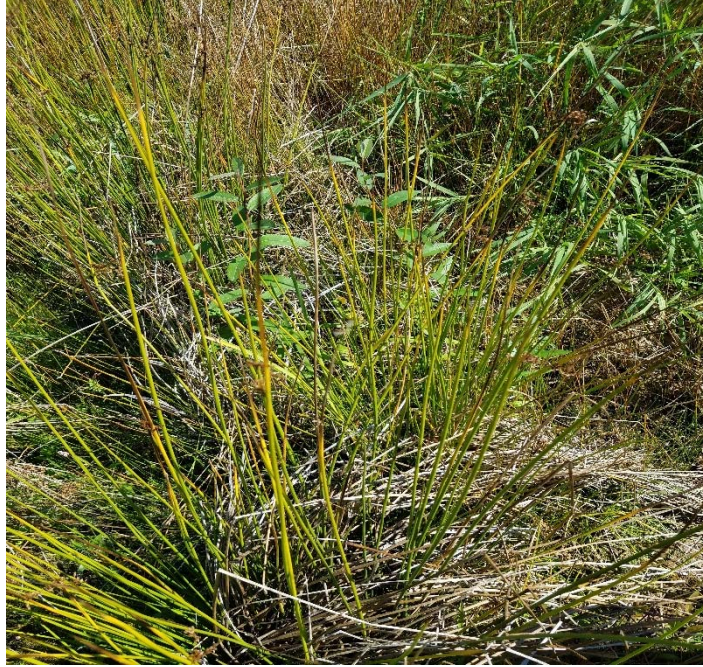
Photo No. 9

September 2017.
Photo point B18.
Marginal zone.
American water
plantain, spikerush,
Juncus, Salix species,
cattail, nodding
beggartick, and reed
canary grass
observed in vicinity.

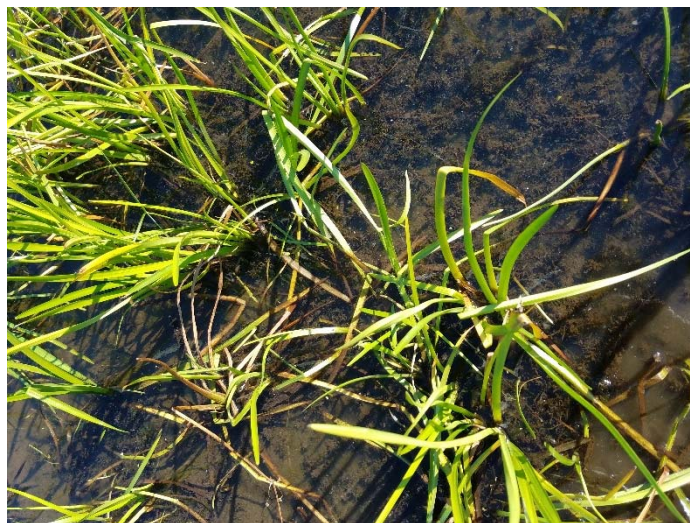
Photo No. 10

Areal cover for transects A (100 percent), B (94 percent), and C (90 percent) are above 20 percent for invasive species, and the performance standard is not met at this time. This is due primarily to the presence of the pond weed Eurasian milfoil, which has encroached from Carty Lake to the north of the mitigation area. Eurasian milfoil is a common invasive present in much of the RNWR and was observed in Carty Lake immediately north of the mitigation area; existing USFWS budgets and staffing levels do not allow treatment of enough acreage to control spreading of invasives such as milfoil (USFWS, 2010). Eurasian milfoil can be controlled by raking or seining it from the water, but it can reestablish from any remaining fragments and roots, and these activities can lead to further spreading. Chemical controls can be effective but their use would require coordination with the USFWS and evaluation of the potential for associated impacts (e.g., oxygen depletion after decomposition of the dead plant material). In both cases, it is likely that milfoil would reestablish quickly because of its presence throughout the RNWR and in Carty Lake.

September 2017.
Photo point C5.
Emergent zone.
Bur-reed, wapato,
Canadian
waterweed, cattail,
and Eurasian
watermilfoil
observed in vicinity.

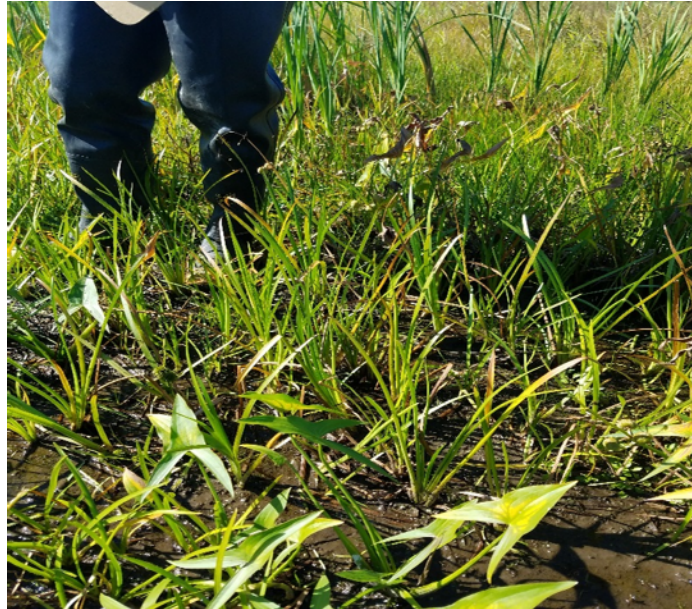
Photo No. 11

September 2017.
Photo point C15.
Emergent zone.
American water
plantain, spikerush,
bur-reed, wapato,
cattail, and reed
canary grass
observed in
vicinity.

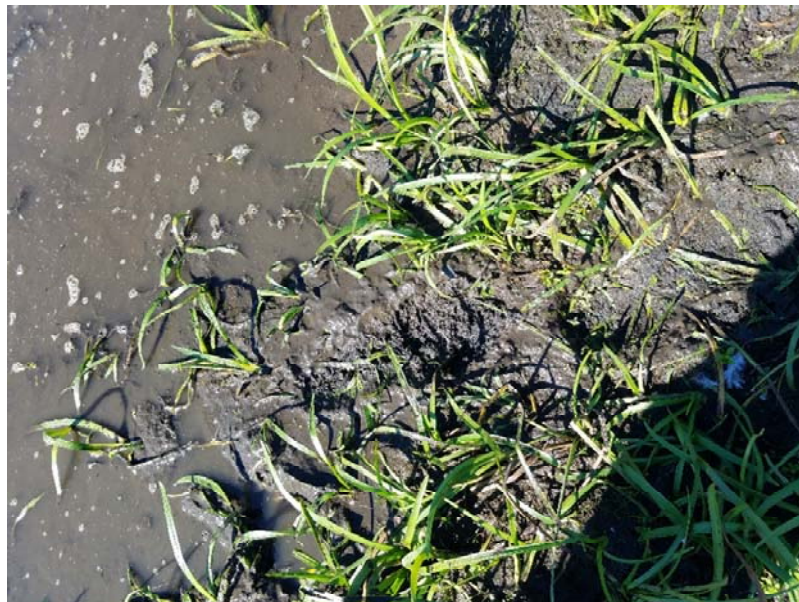
Photo No. 12

September 2017.
Photo point B11.
Emergent zone.
Spikerush, bur-reed,
curly dock, and reed
canary grass
observed in vicinity.

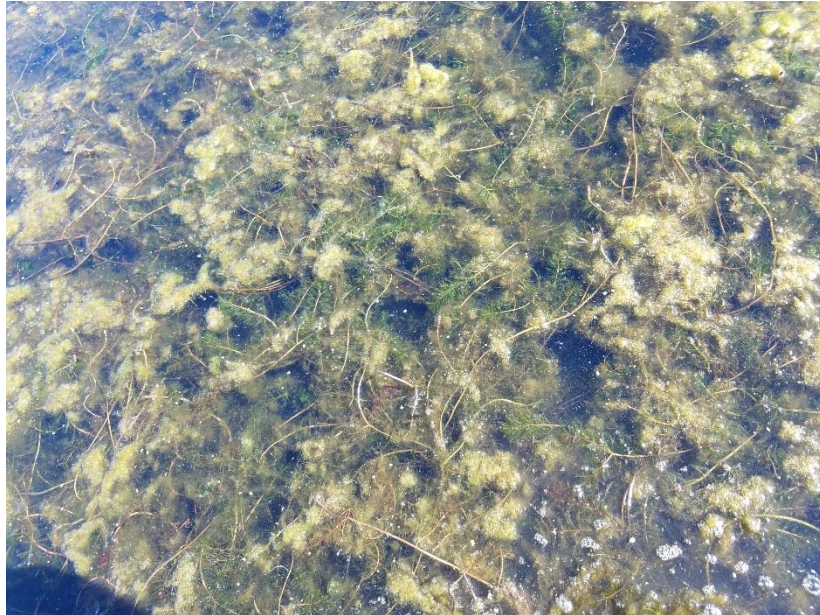
Photo No. 13

September 2017.
Photo point B5.
Submergent zone.
Canadian
waterweed,
hornwort,
duckweed, native
algae, and
Eurasian
watermilfoil.

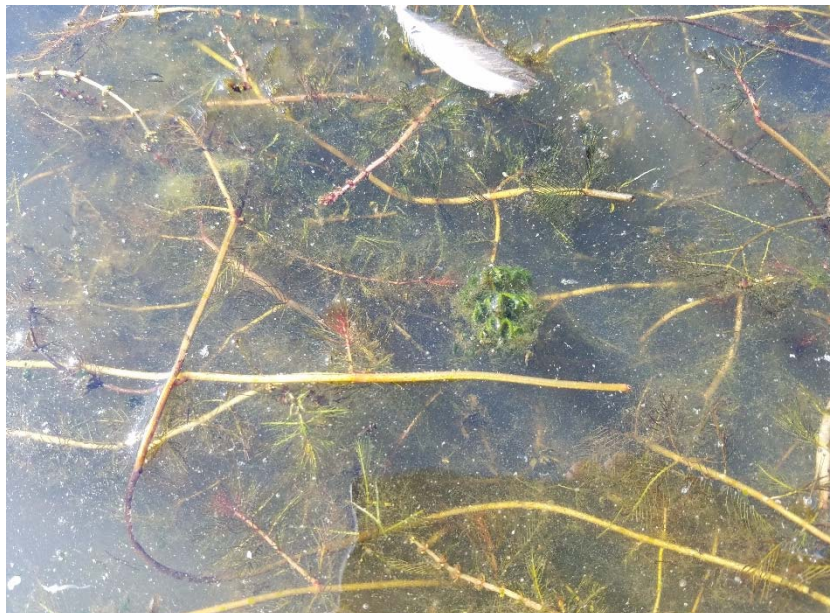
Photo No. 14

September 2017.
Photo point B16.
Submergent zone.
Canadian
waterweed,
hornwort,
duckweed, native
algae, and Eurasian
watermilfoil.

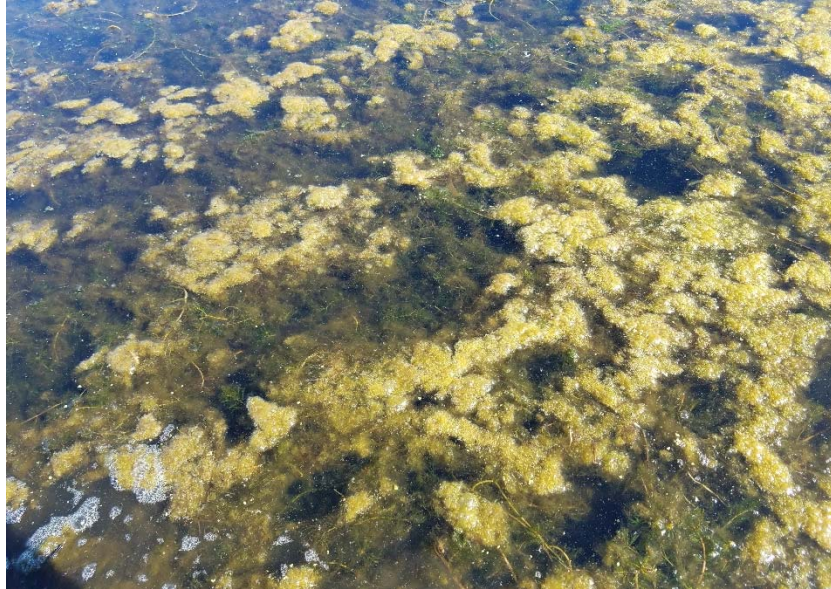
Photo No. 15

September 2017.
Photo point A5.
Submergent
zone. Hornwort,
Canadian
waterweed,
duckweed, native
algae, and
Eurasian
watermilfoil.
