**Re: Olympic View Sanitary Landfill – Flare Station Modifications and Utility Flare Installation
As-built Report**

2010 FLARE STATION MODIFICATIONS

PREPARED FOR OLYMPIC VIEW SANITARY LANDFILL

OLYMPIC VIEW SANITARY LANDFILL
 PORT ORCHARD, WASHINGTON
FLARE STATION IMPROVEMENTS
AS-BUILT FLARE STATION SITE PLAN

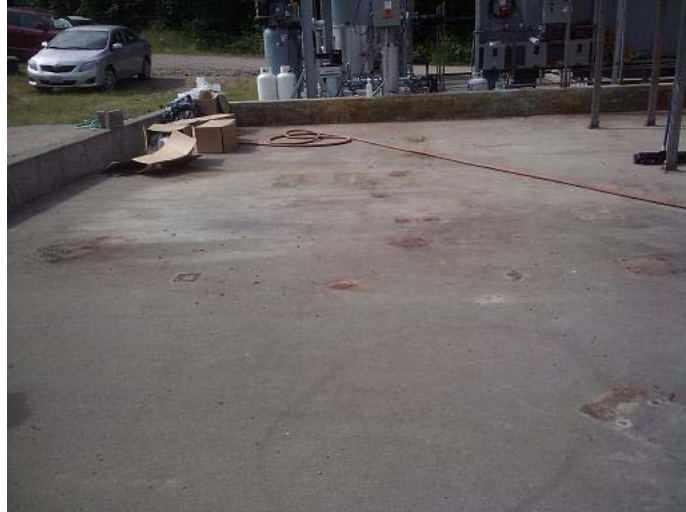
Removed leachate evaporator unit, skid, and associated vessels and anchors.

Glacier mobilized to OVSL during the week of May 5, 2010 to decommission and remove the LEU, its LFG combustion and injection skid, and associated vessels and piping. Upon removal of all the LEU equipment, Glacier cut and grinded anchor bolts flush with the existing concrete. Glacier also blinded off the inlet from the LEU to the existing enclosed flare stack and the inlet from the wellfield to the LFG combustion and injection skid.

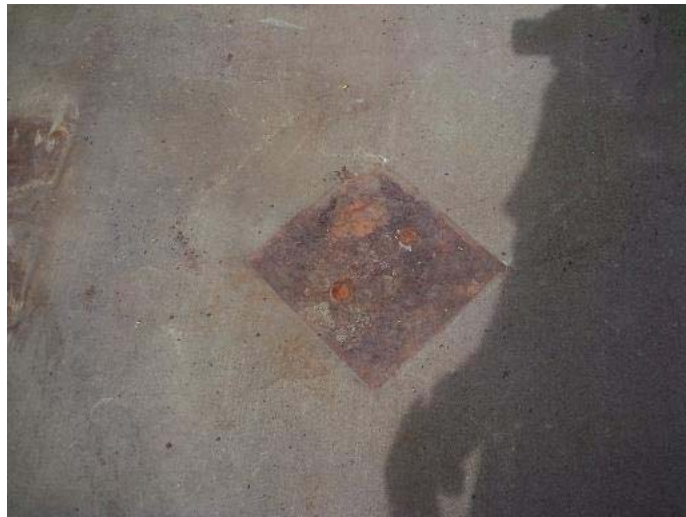
Removed leachate evaporator unit and associated vessels and anchors.

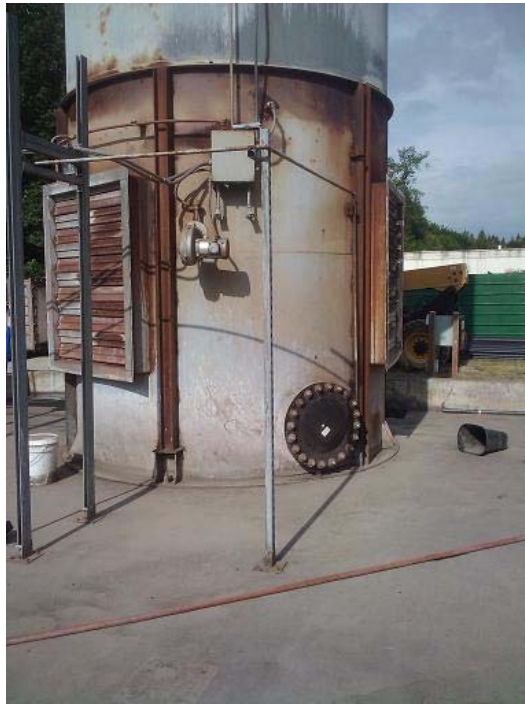
Blind flange installed on inlet to flare from former leachate evaporator unit.

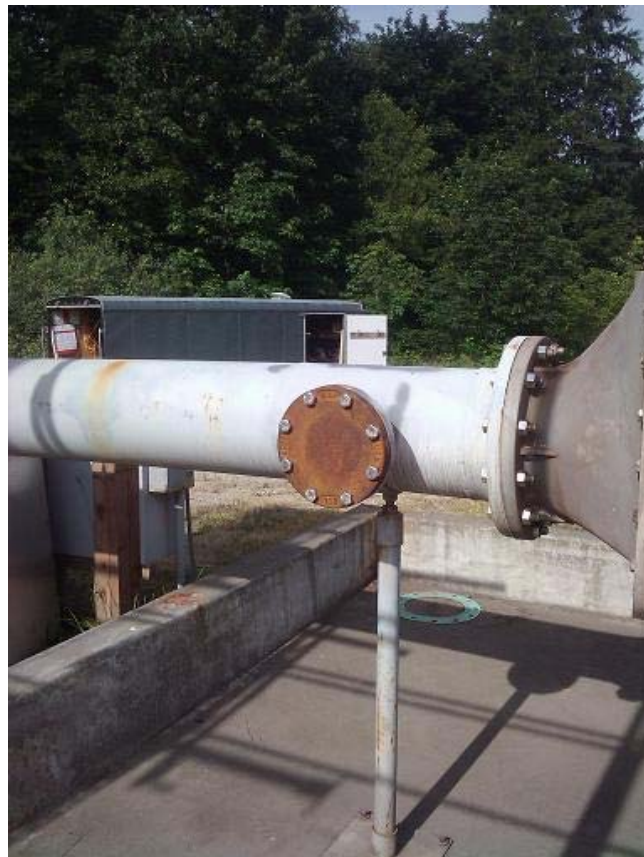
Blind flange installed on inlet to old enclosed flare.

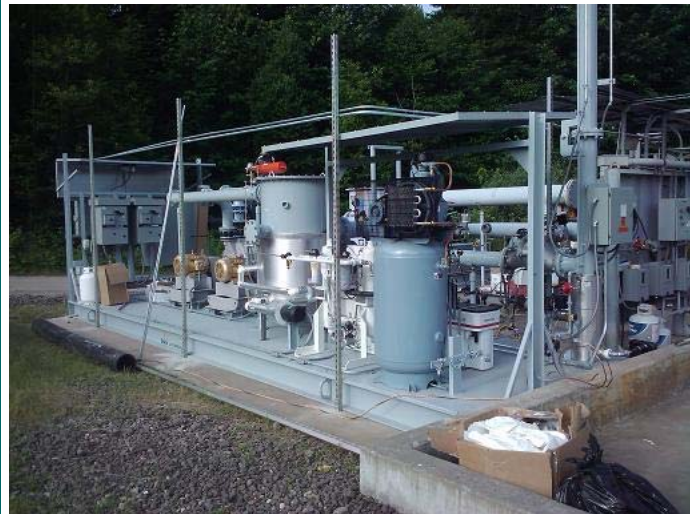
Utility flare skid.

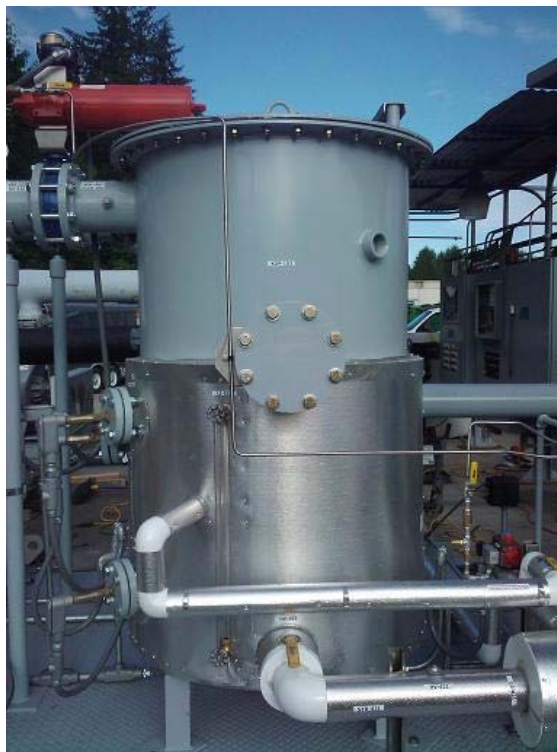
Utility flare skid knockout pot (KOP).

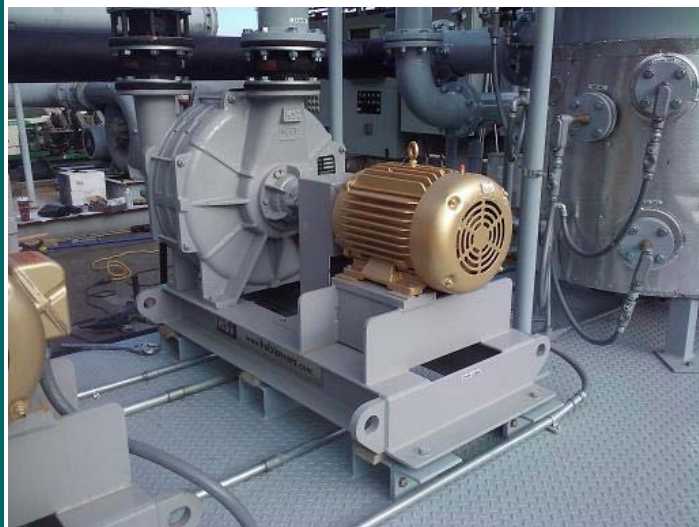
Blower and motor.

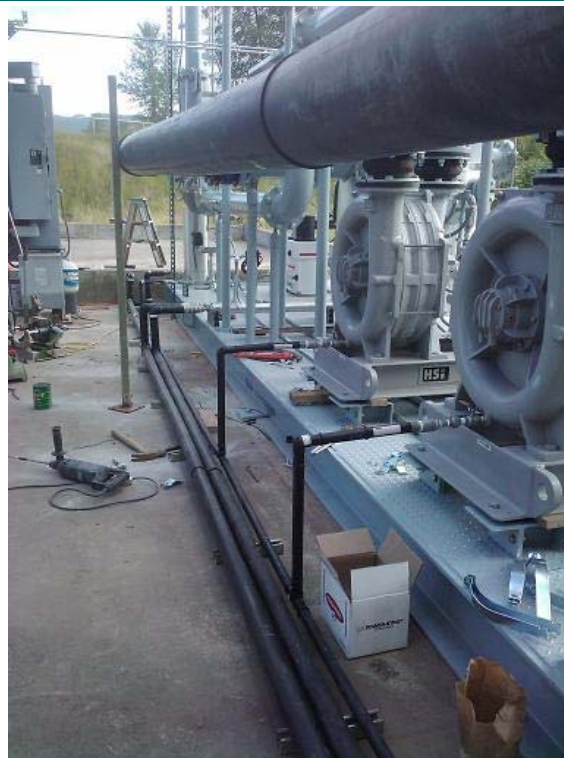
Installation of pipe supports.

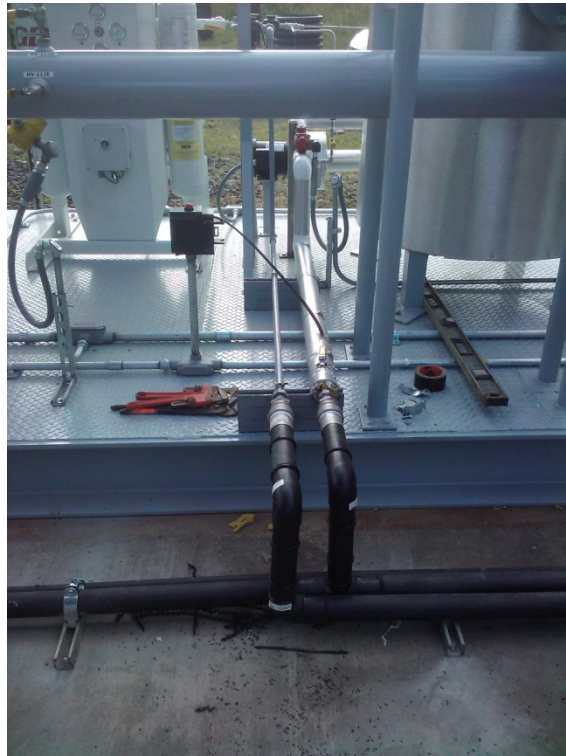
Condensate force main and air supply piping anchored to concrete pad.

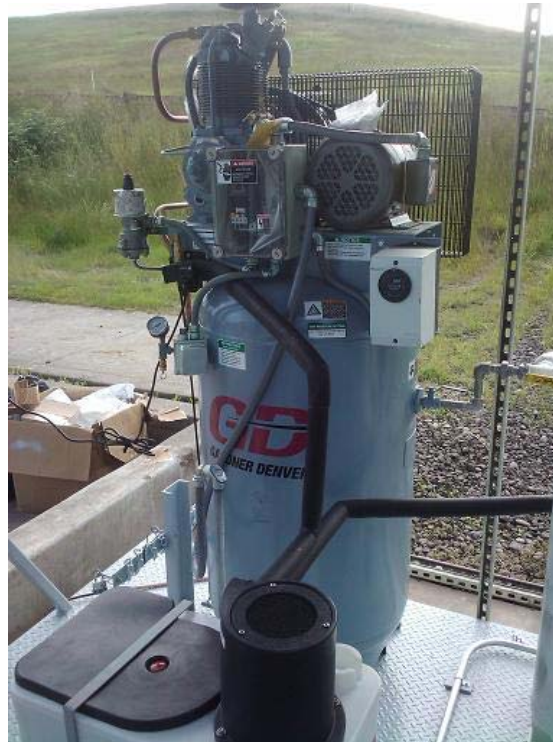
Air compressor.

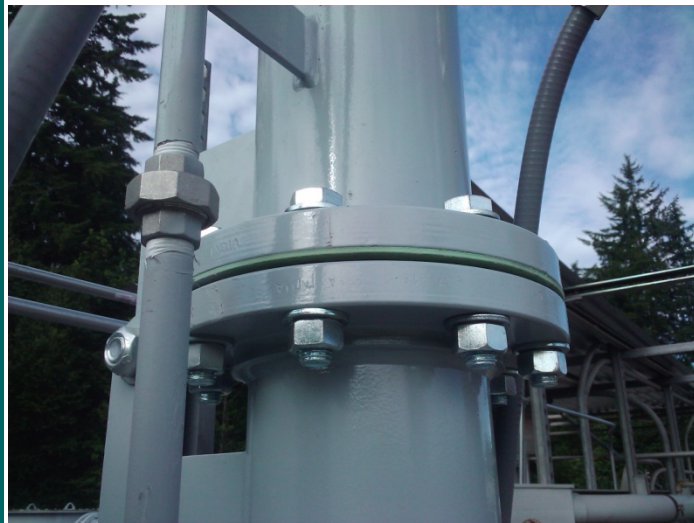
Flare stack hinge point with gasket and union for electrical.

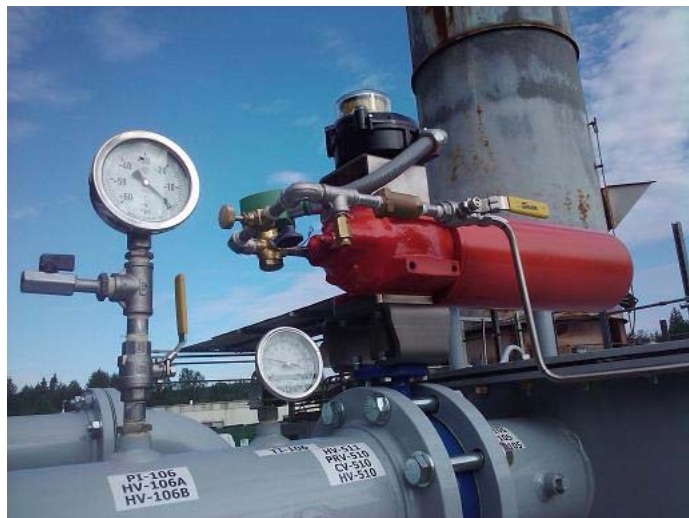
Pneumatic fail close valve.

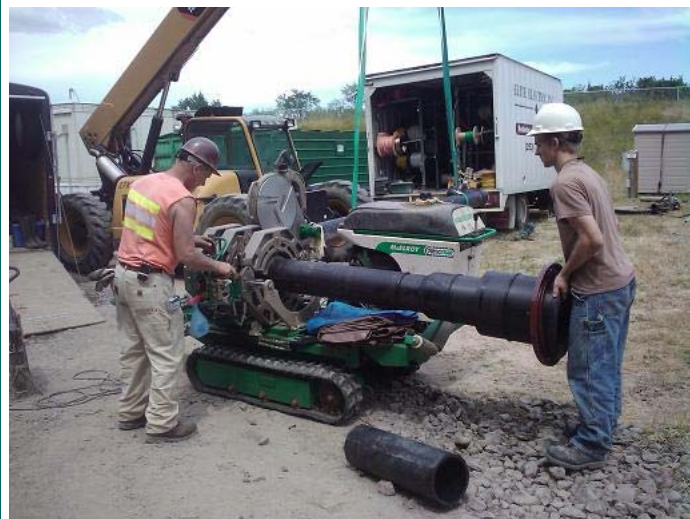
Pipe fusion.

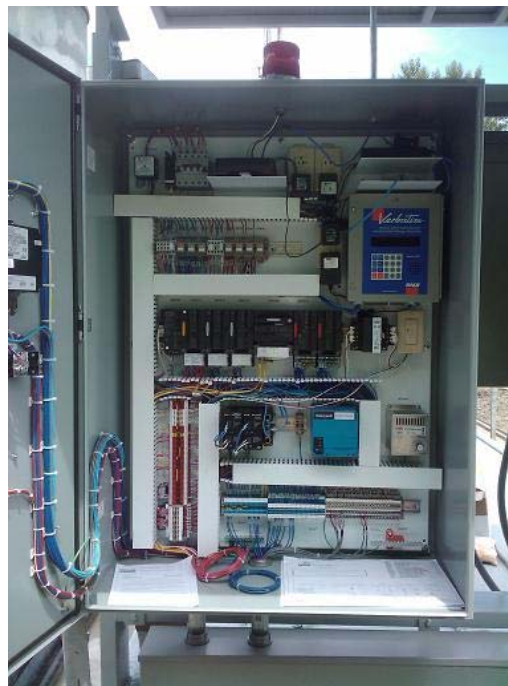
Interior of main control panel.

- The surface of the window on the main control panel is not clear. The glass is etched or oxidized. The window pane needs to be replaced. LFG Specialties is aware and is sending a replacement window to the site. The GCCS operator offered to replace the window upon receipt. The glass was received early July and installed.

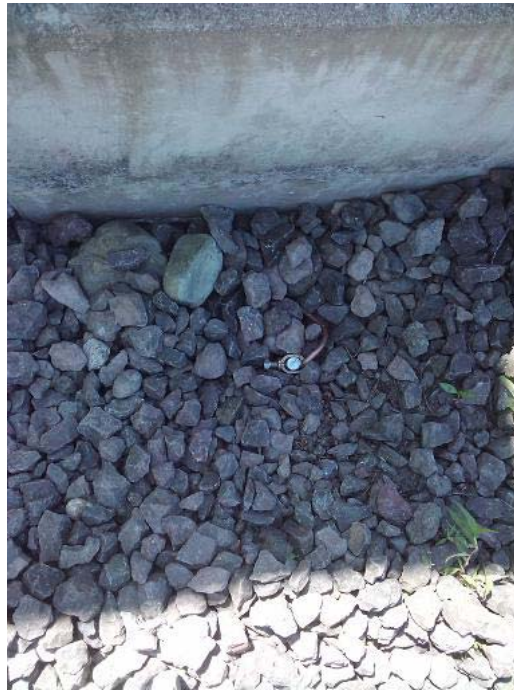
- Two ground rods are required spaced at least six (6) feet from each other. Only one had been installed at the time of the inspection;
- The ground wire must be routed in PVC conduit instead of galvanized steel conduit unless the conduit is also grounded by a separate system;
- The flare skid transformer must be grounded to the skid; and
- Where dual voltages exist within panels, each panel must have color-coded labels indicating the presence of dual voltages and the type of voltage in each panel by color must be properly displayed/labeled.

Ground rod and ground wire installed.

The electrical contractor returned to the site on June 24, 2010 and corrected the deficiencies identified by the inspector with the exception of the labels for the control panels. LFG Specialties arranged to have the labels sent to the site for placement on the panels. On June 30, 2010, the electrical inspector returned and found all completed items acceptable and signed off on the work.

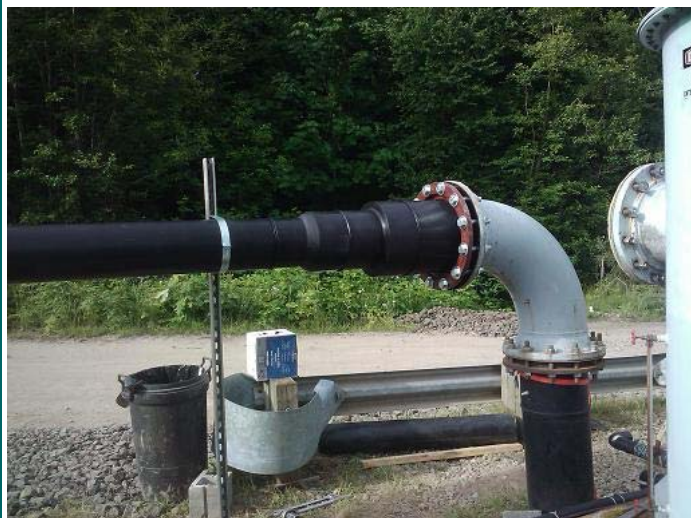
Completed connection to field header.

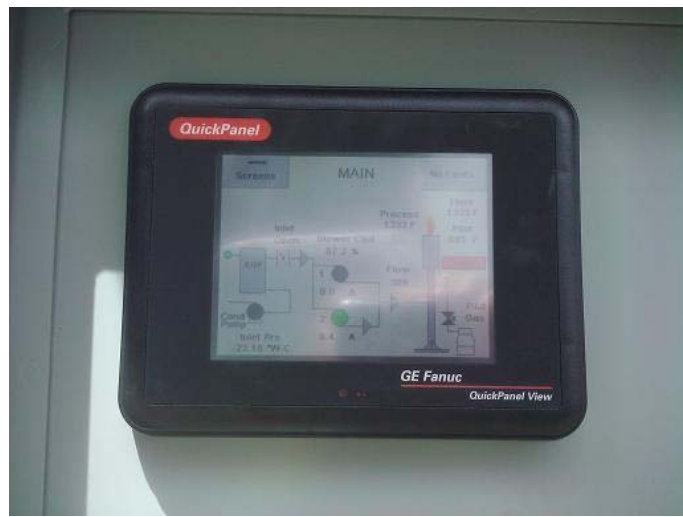
GE touch screen / PLC interface.

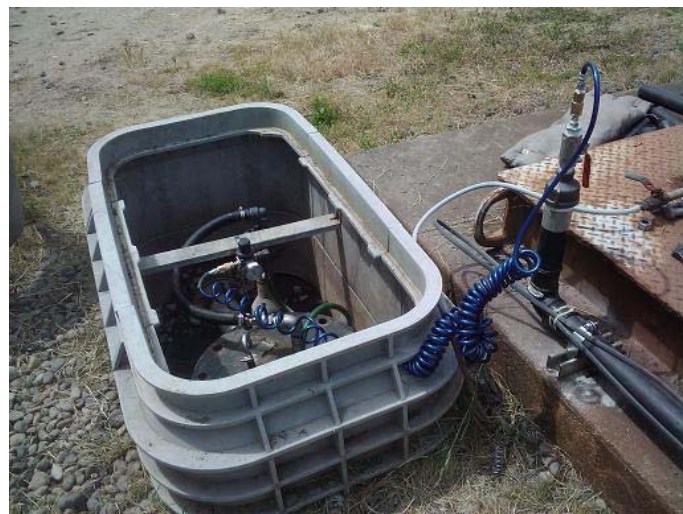
New air supply stub and hose to inlet header sump.

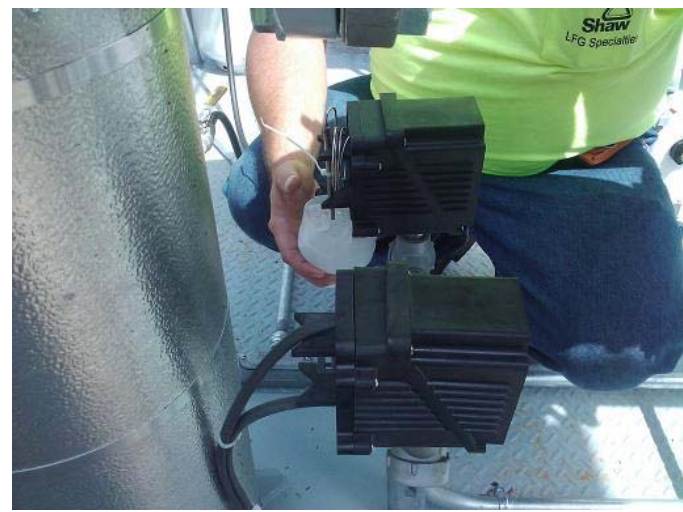
Testing of heat trace auto-on.

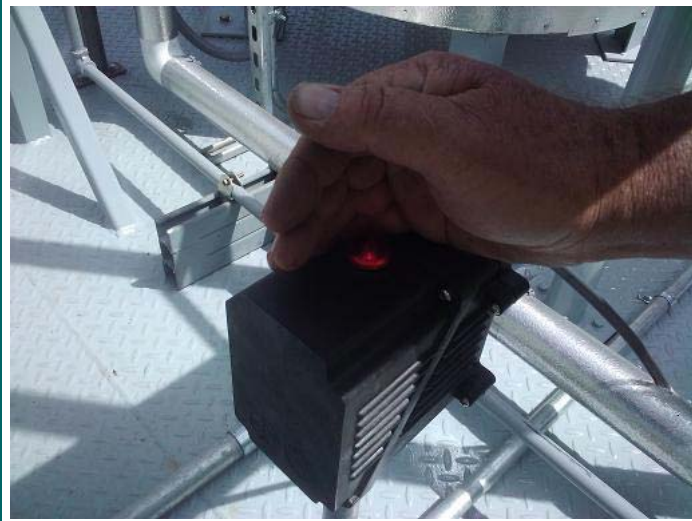
Heat trace on prove light.

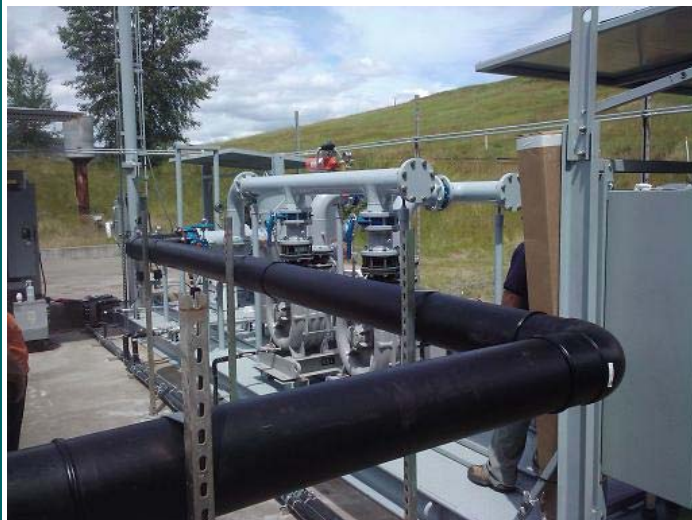
Completed inlet header and pipe supports to new KOP.

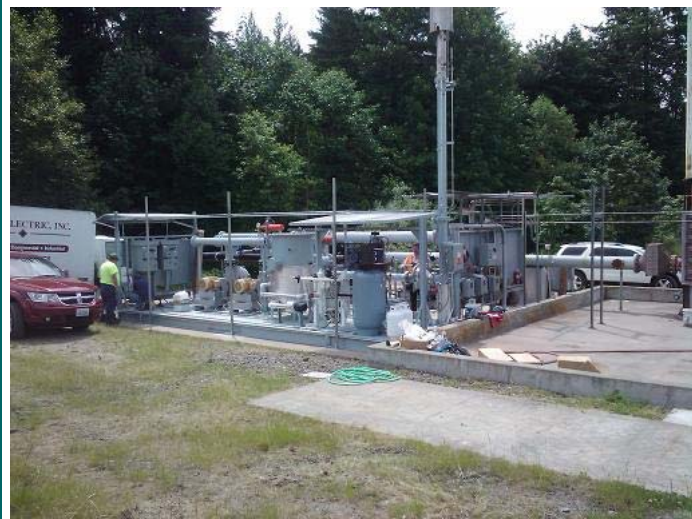
Completed utility flare skid showing electrical and telephone conduits run overhead on pipe supports.
