UNDERGROUND STORAGE TANK CLOSURE & SITE ASSESSMENT REPORT

RGI PROJECT NO. 2015-019D

**SILVER BAY LOGGING
7814 8TH AVENUE SOUTH
SEATTLE, WASHINGTON 98108**

AUGUST 8, 2017

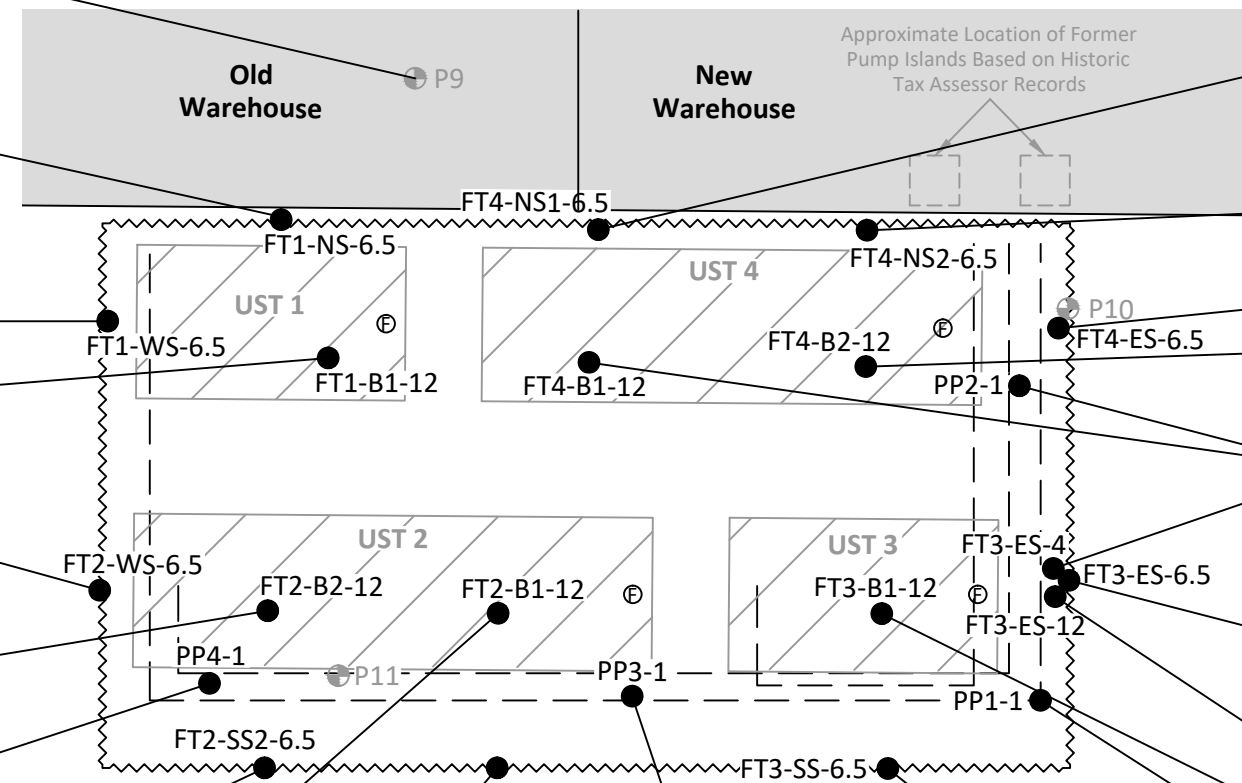
Product piping suspected to be associated with the former garage was observed in the South Yard above UST1 through UST4 in the approximate locations displayed on Figure 3. Soils beneath the former product piping locations were field screened in several locations and no evidence of contamination was observed. RGI collected four soil samples (PP1-1, PP2-1, PP3-1, and PP4-1) from locations beneath the product piping at approximately 1 foot bgs prior to the removal of the USTs.

This product piping was associated with the former pump islands, which were previously located under the southern extent of the existing warehouse building in the locations displayed on Figure 3. The product piping was observed to continue underneath the current warehouse. Product piping situated above UST1 through UST4 was decommissioned (cut and capped) by IO prior to UST decommissioning.

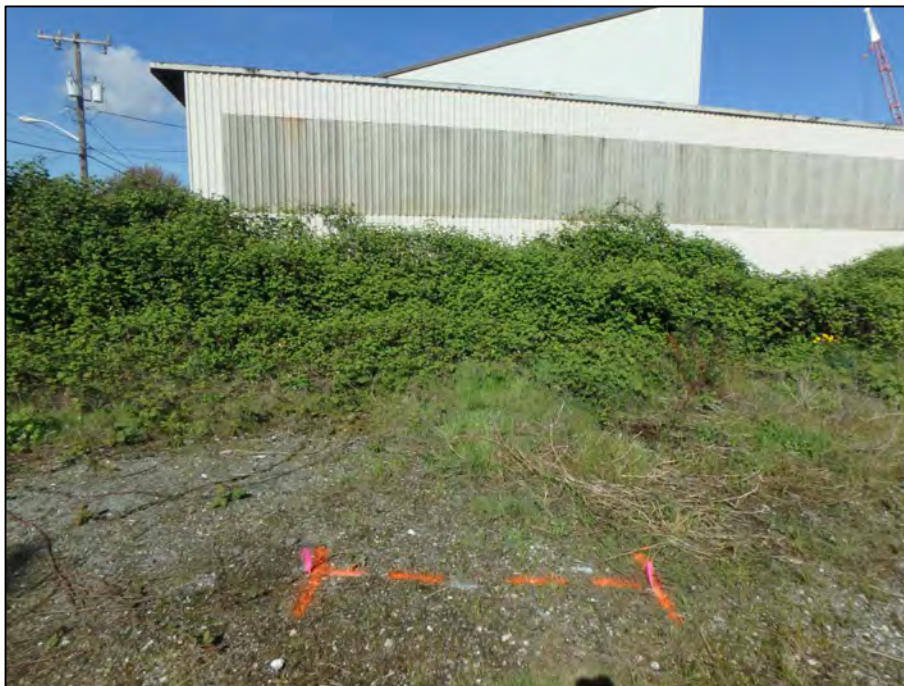
Photograph 2: View looking west at the residential heating oil tank (RT) excavation, which was situated approximately 35 feet from the eastern edge of the warehouse.

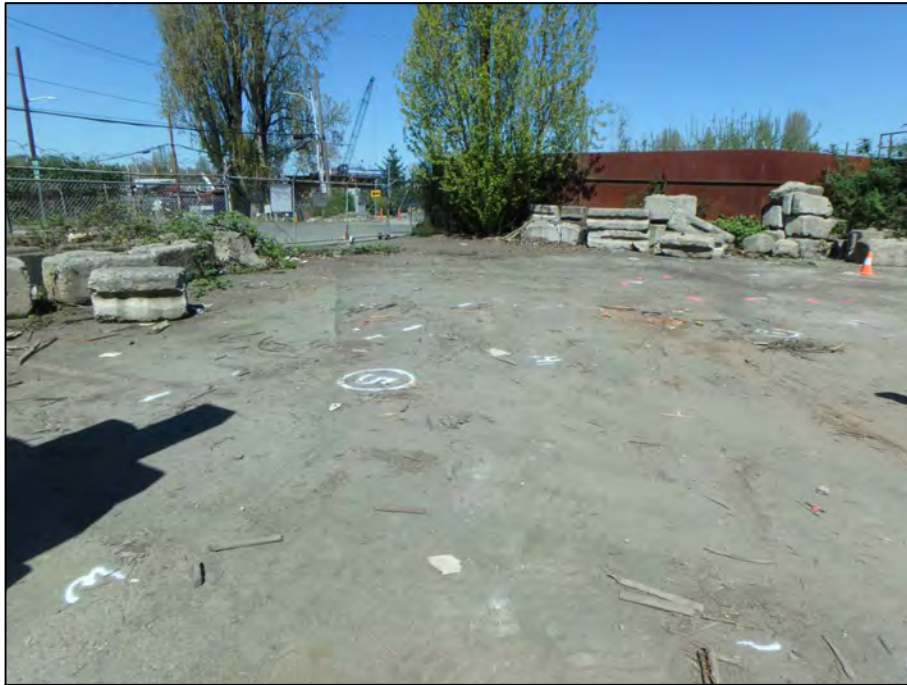
Photograph 3: View looking northwest at the northern portion of the Property and suspected location of USTs. The white markings depict suspected UST locations identified during a geophysical survey.

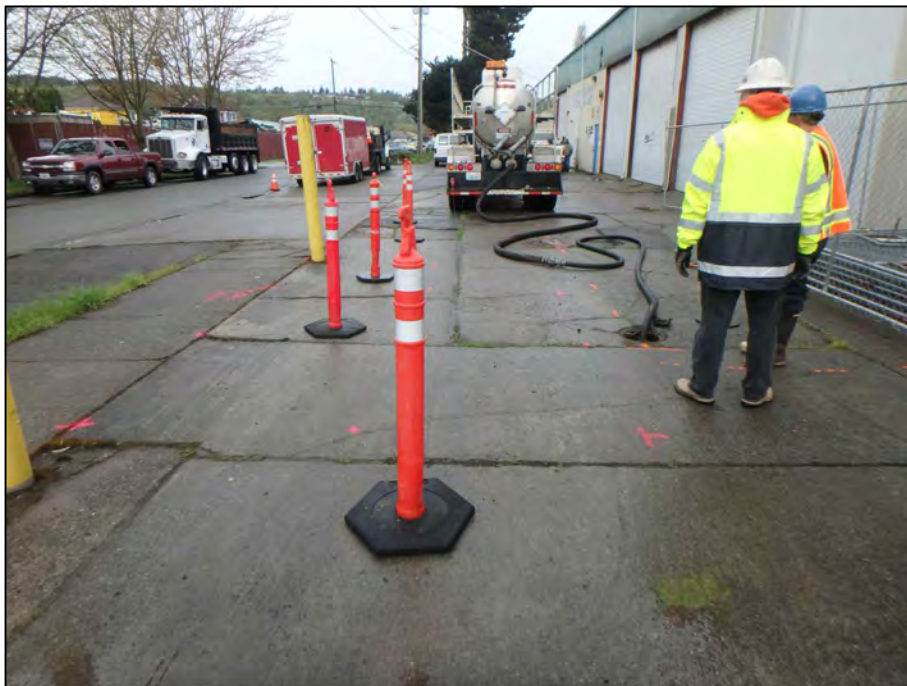
Photograph 4: View looking west at the South Yard excavation location while the USTs were being pumped of fluid in preparation for their removal.

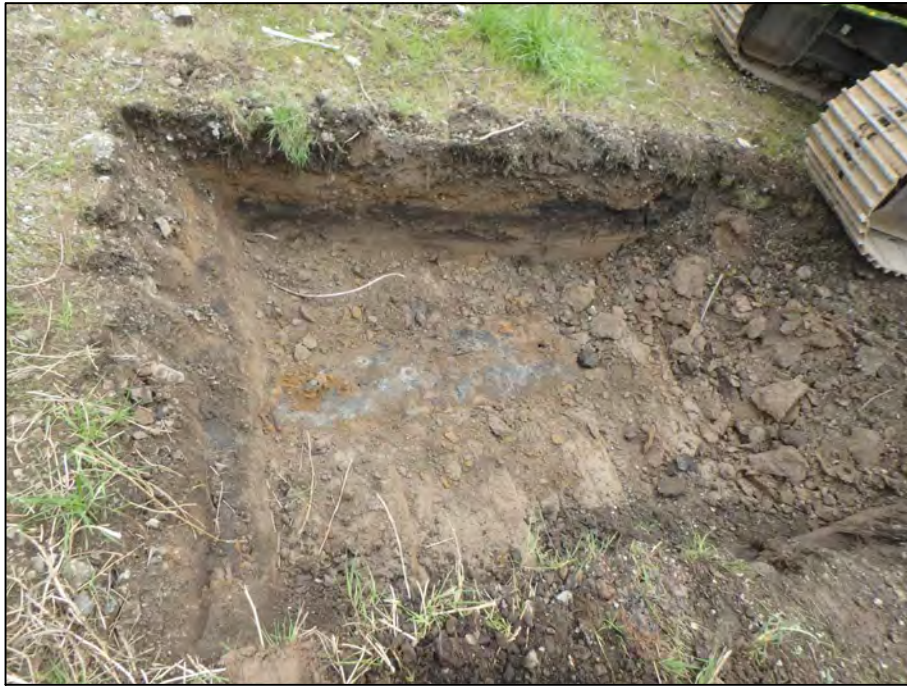
Photograph 5: Top of the residential heating oil tank located on the eastern portion of the Site. The top of the tank was approximately 2 feet below ground surface.

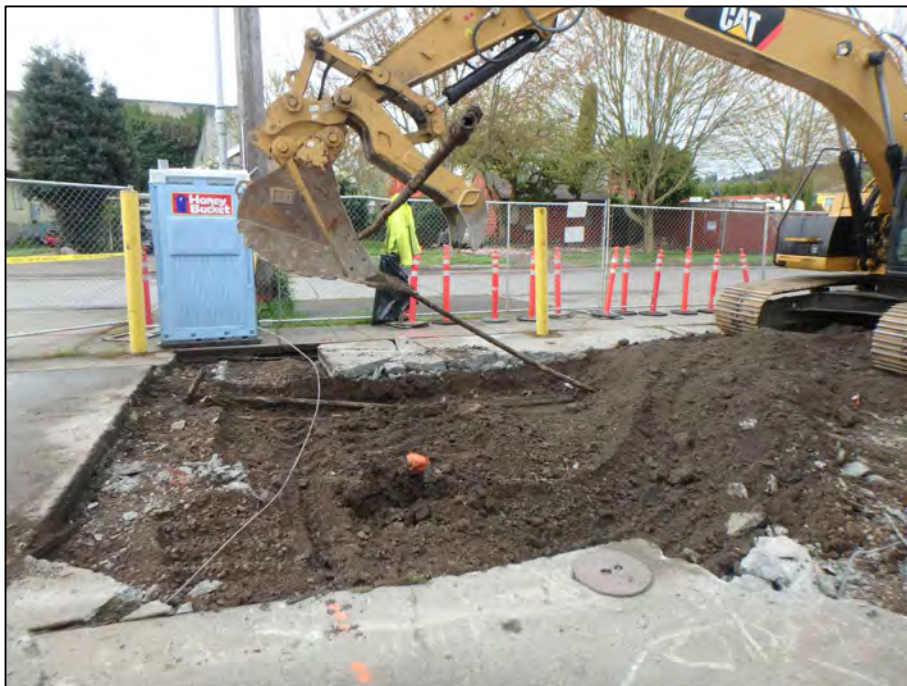
Photograph 6: Uncovering and removal of three former product lines between the USTs and the former pump island in the South Yard.

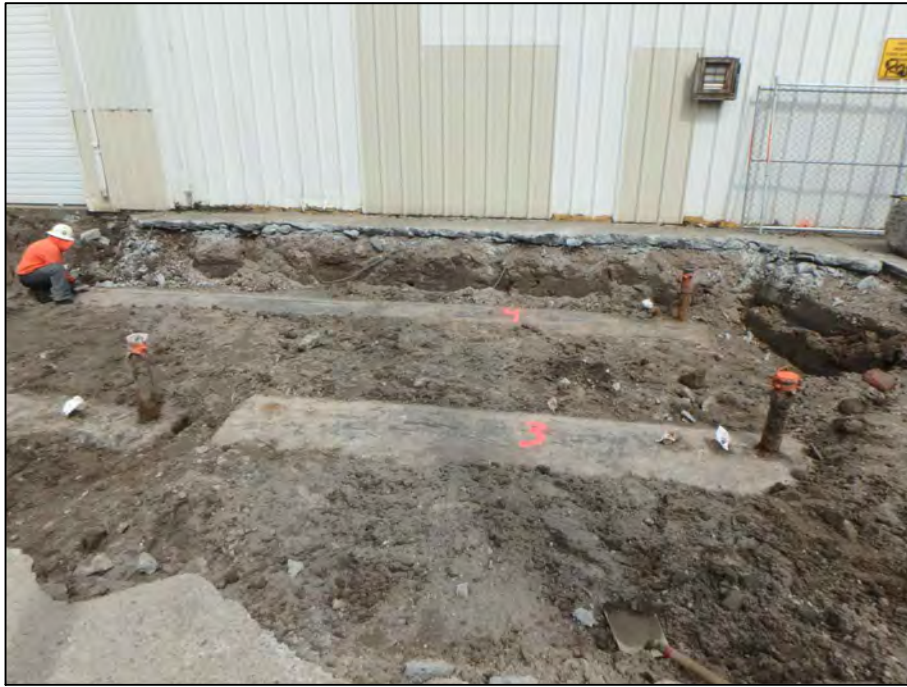
Photograph 7: View of UST3 and UST4's fill ports which were covered by concrete and uncovered during excavation. UST4 is north of UST3 and south of the current warehouse building.

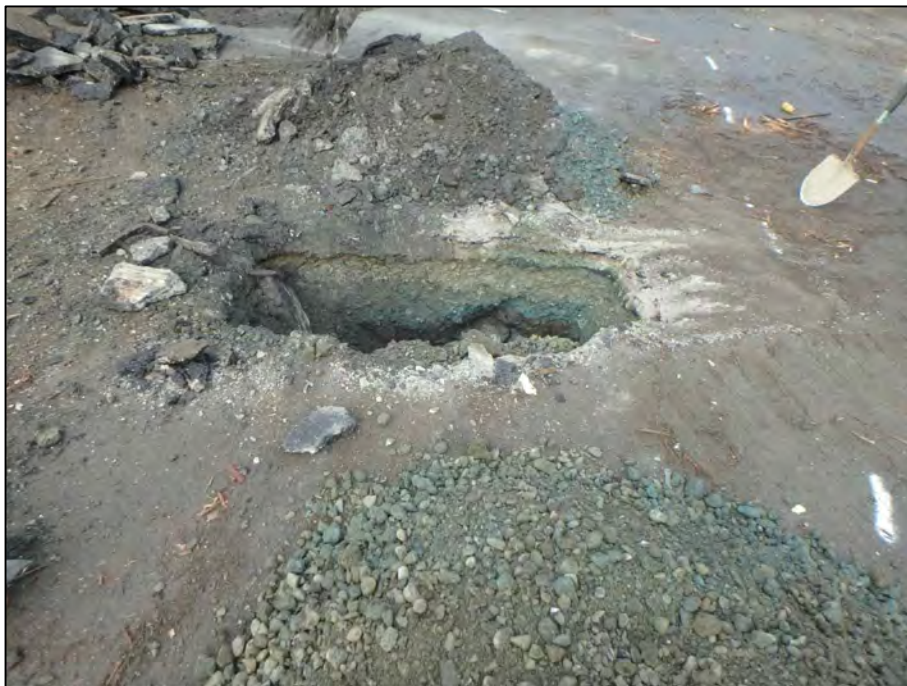
Between approximately 2 and 7 feet bgs, fill was encountered and consisted of wood, sheet metal, concrete and brick debris with loose, mottled black, white and brown silty sands with gravel. No water seepage was observed in either test pit.

Photograph 8: Location of TP2 in the North Yard where contaminated soil with metal and wood debris was encountered.

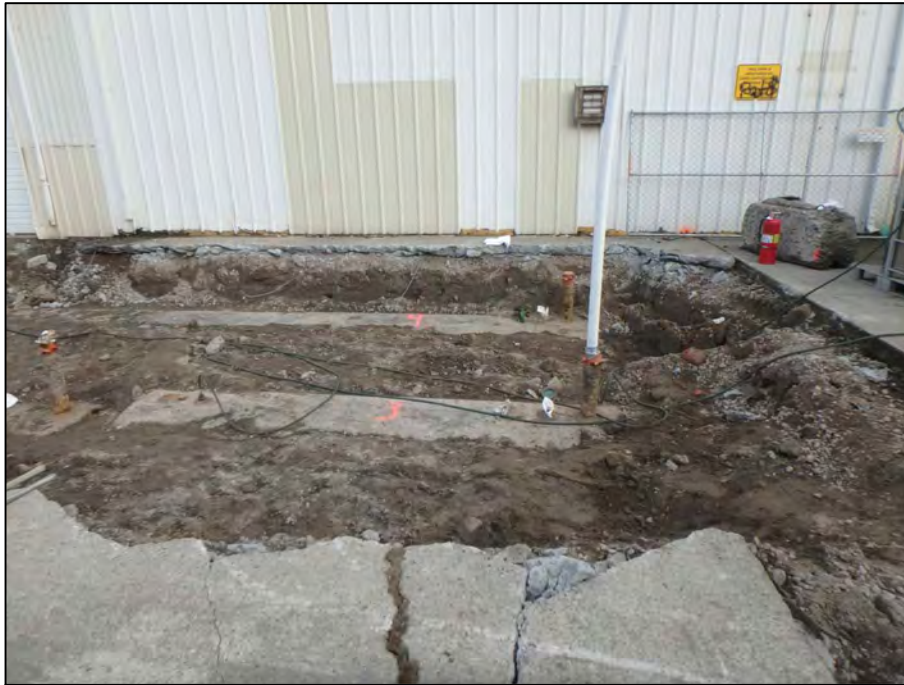
Photograph 9: Photograph of the interting of UST3 in the South Yard with carbon dioxide. CO₂ tanks were located east of the excavation.

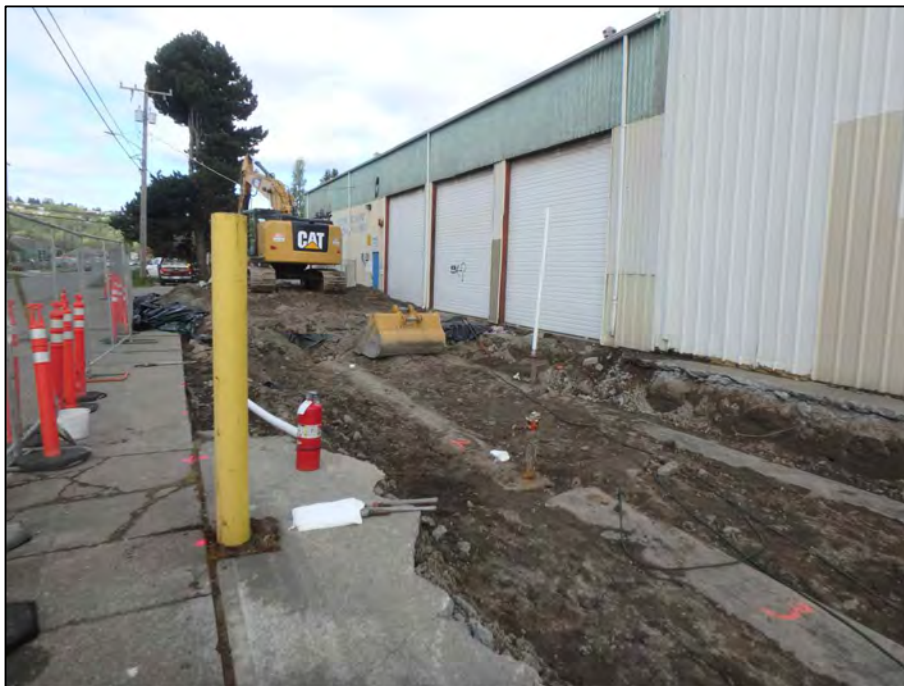
Photograph 10: Photograph showing the interting of UST1 in the South Yard with carbon dioxide. CO₂ tanks were located east of the excavation.

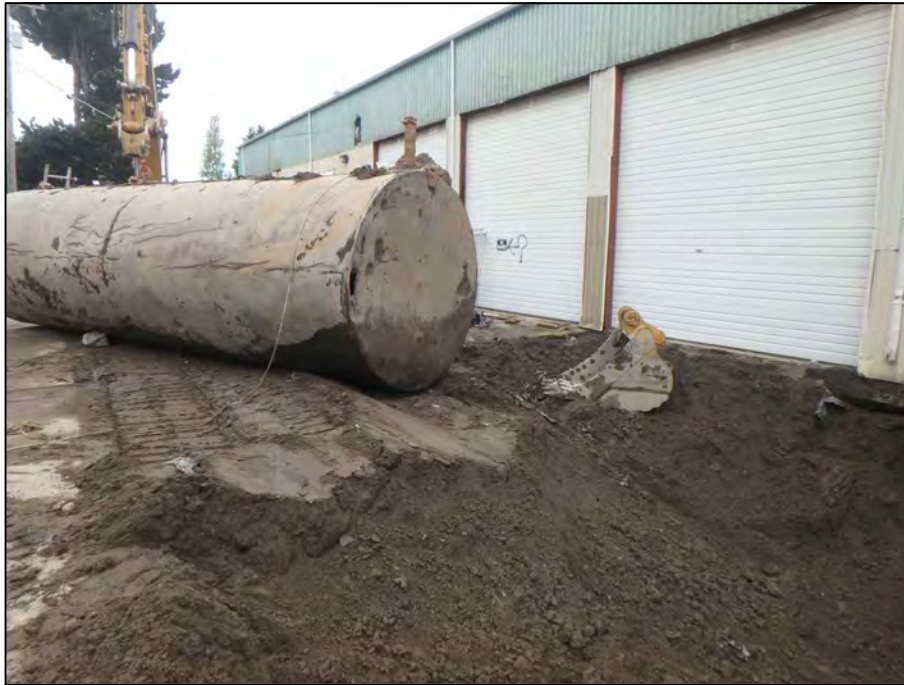
Photograph 11: View of a hole observed in the eastern sidewall of UST4 caused by the excavator during removal. No release of fluids was observed.

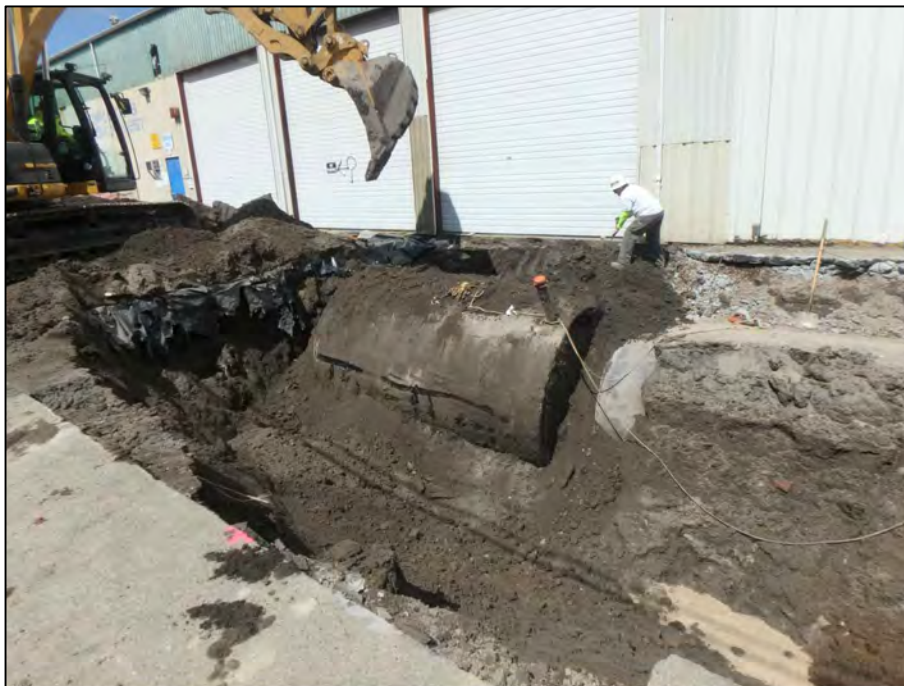
UST1 was an approximately 5,000-gallon capacity, single-walled steel UST (Photographs 12 and 13) that was identified during previous geophysical surveys. The top of UST1 was encountered at approximately 2.5 feet below the concrete surface in this location. UST1 measured approximately 13.8 feet in length and 8.0 feet in diameter and contained approximately 33 inches of water with no observable free product (LNAPL). The water within UST1 had a slight petroleum odor, no noticeable sheen was observed.

Photograph 12: Location of UST1 in the fuel tank nest located in the South Yard on the Property.

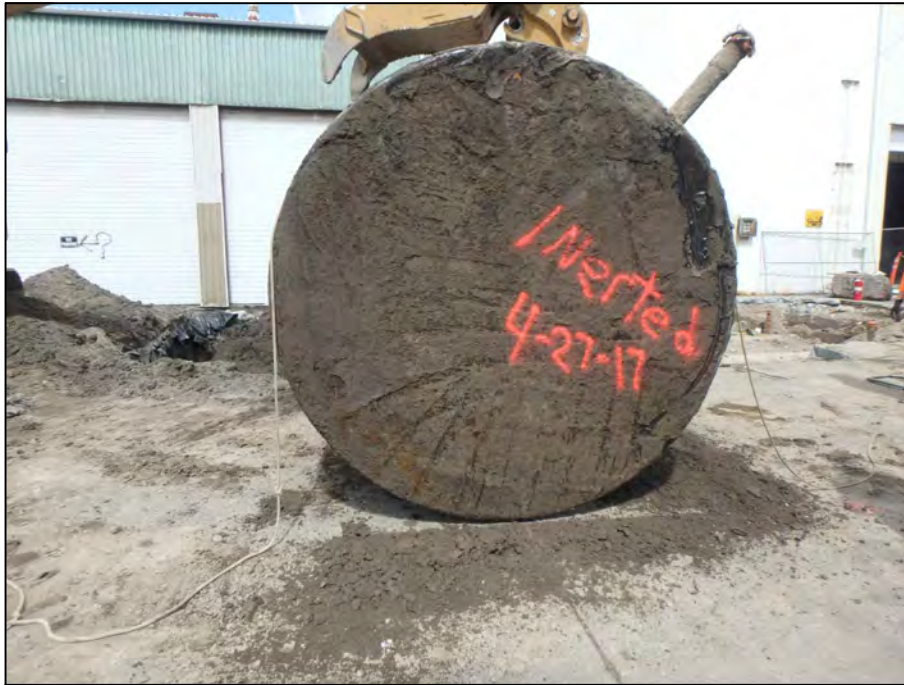
Photograph 13: Side view of UST1 after being removed from the excavation.

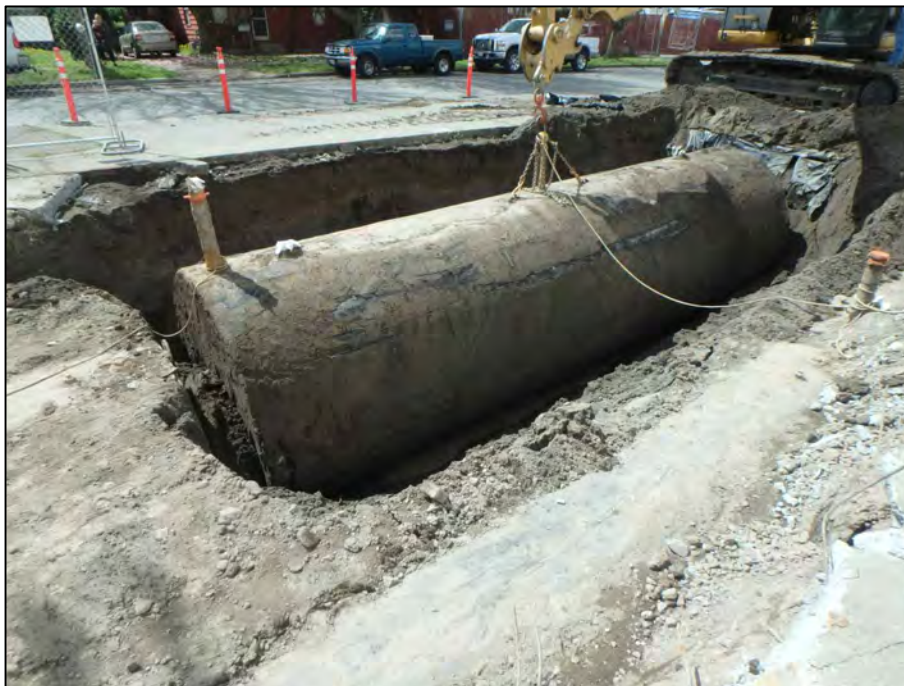
Photograph 14: View of UST2 as it was being removed from the excavation.

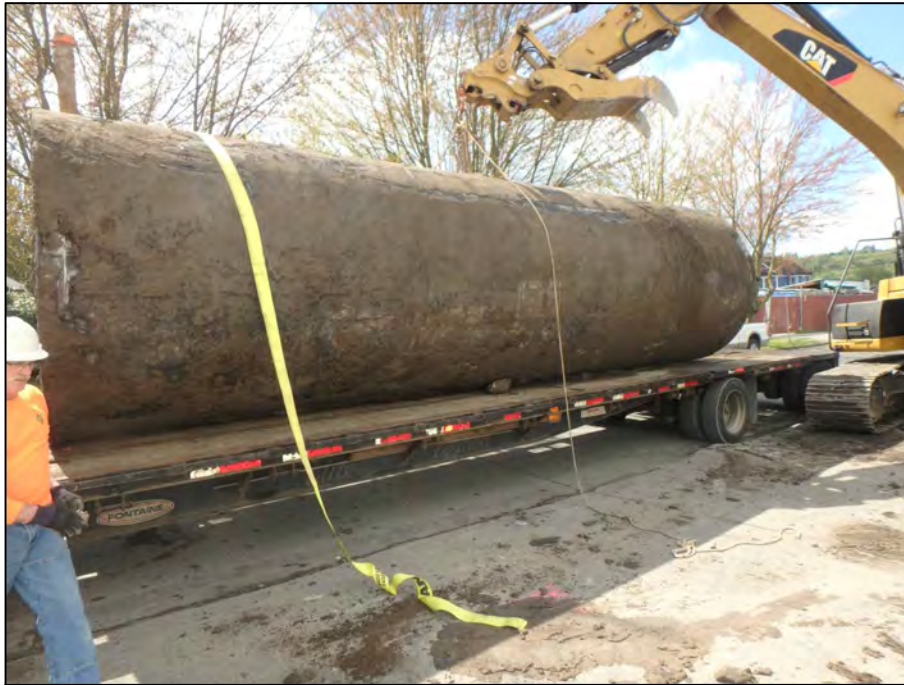
Photograph 15: Side view of UST2 on the truck prior to being transported off-Property. No obvious signs of holes or other evidence of release from UST2 was observed.

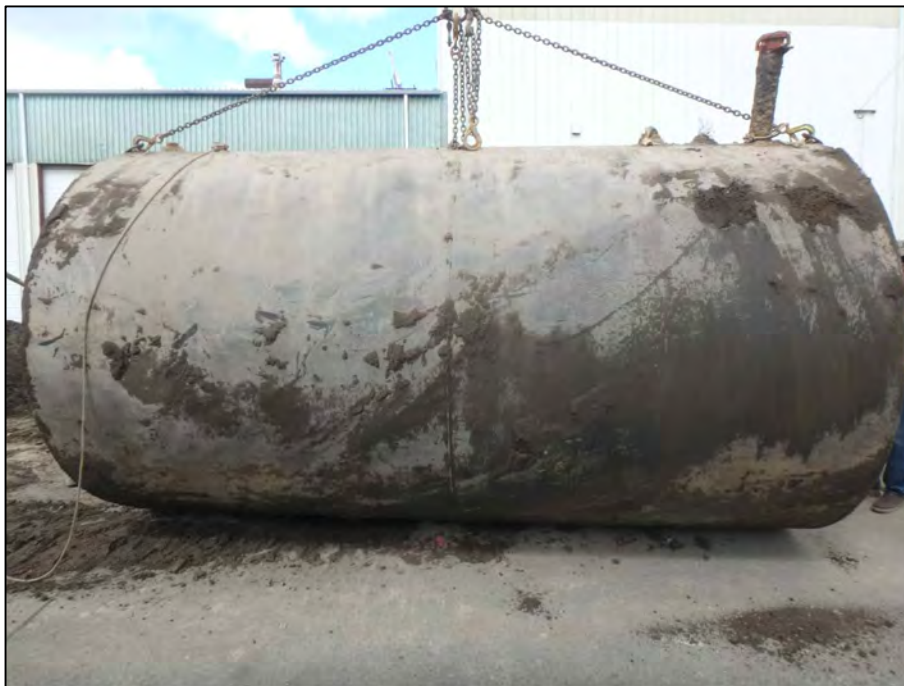
Photograph 16: View of UST3 after being removed from the excavation. No obvious signs of punctures or other evidence of a release from UST3 was observed.

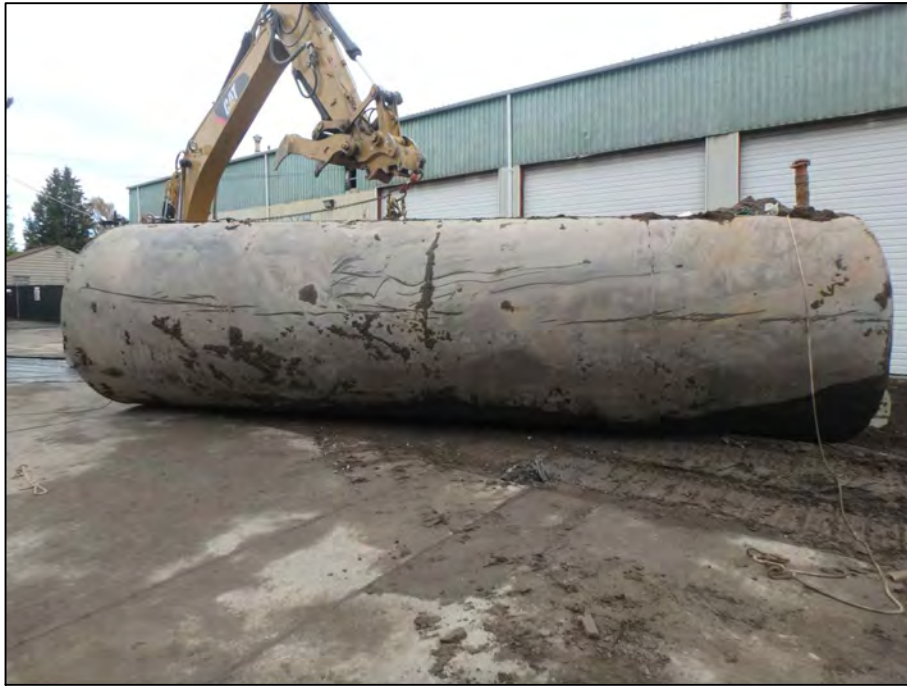
Photograph 17: Side view of UST4 after being removed from the excavation.

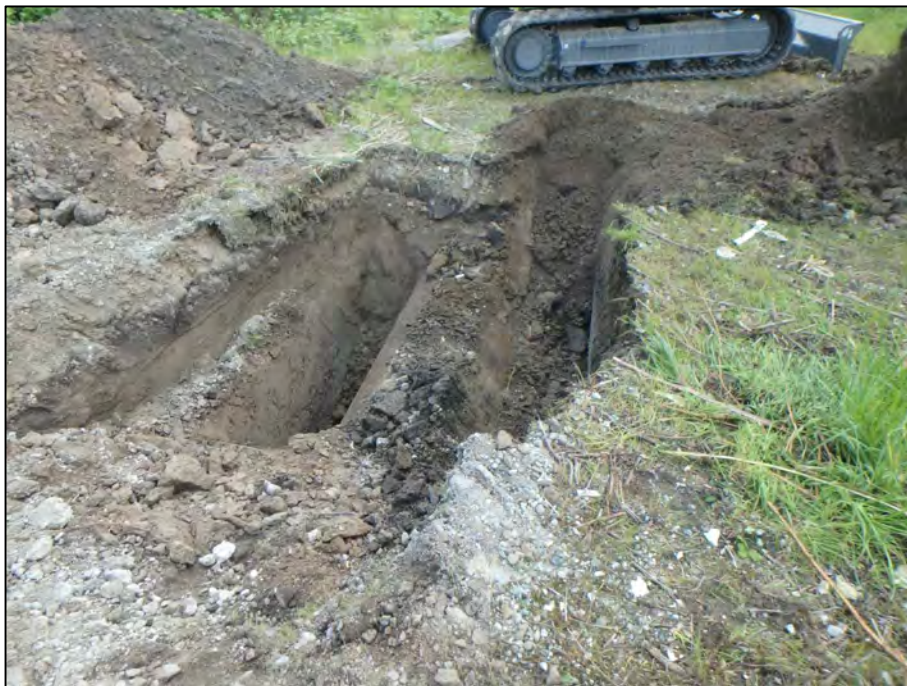
Photograph 18: View of the surface above UST5 (residential heating oil tank) during the excavation.

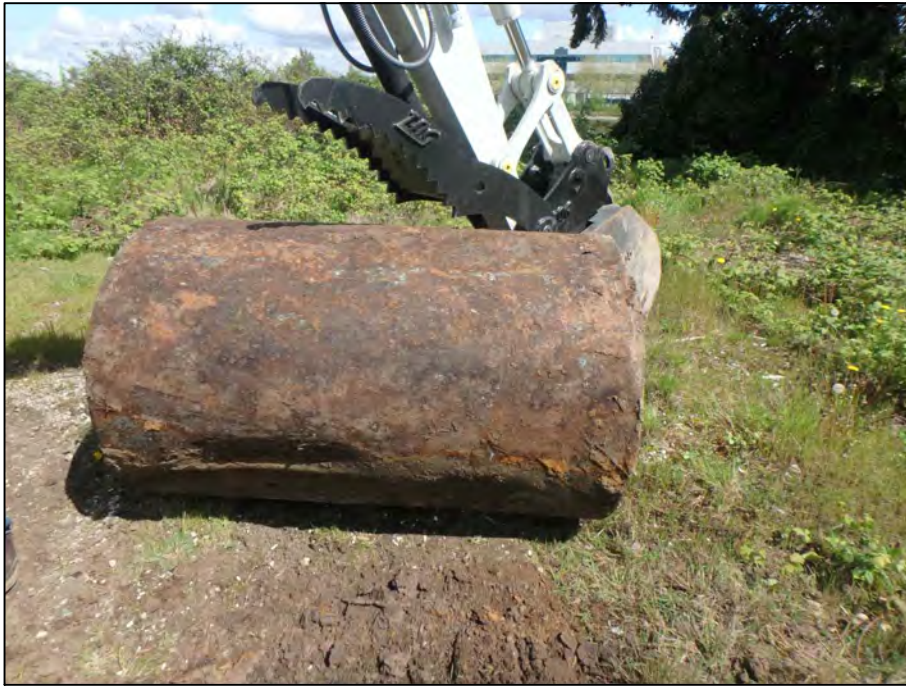
UST5 was decommissioned and removed by IO Environmental on April 27, 2017 using the methodology in Section 5.1. Approximately 100 gallons of rinse wastewater (generated during cleaning of UST5) was pumped into a vacuum truck and disposed of off-Property. UST5 appeared to be in poor condition and heavily corroded with several small holes (<1/2 inch to 4 inch) in diameter located on the sides and bottom.

Photograph 19: View of UST5 after being removed from the excavation.

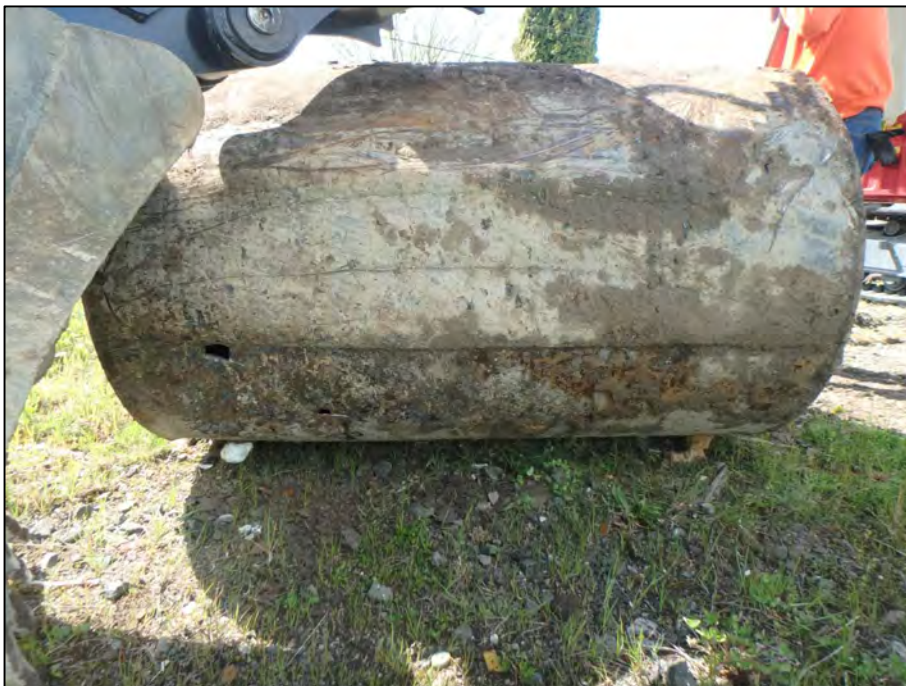
- The results of the UST Site Assessment indicate that a release has occurred at UST5 in the East Yard. This heating oil UST was heavily corroded and visible holes were observed in the UST. Analytical data obtained from soil samples collected from within the UST5 excavation, north and beneath the UST, indicated that diesel-range TPH is present in soil at concentrations exceeding MTCA Method A Soil Cleanup Levels for Unrestricted Land Uses. Soil analytical data obtained during the 2016 ASI from test probes P18 and P19, which were in close proximity to UST5, appear to indicate that the extent of soil impacts in this location is limited.

Photograph 20: View of pin holes and visible corrosion on the bottom of UST5 after its removal from the excavation.

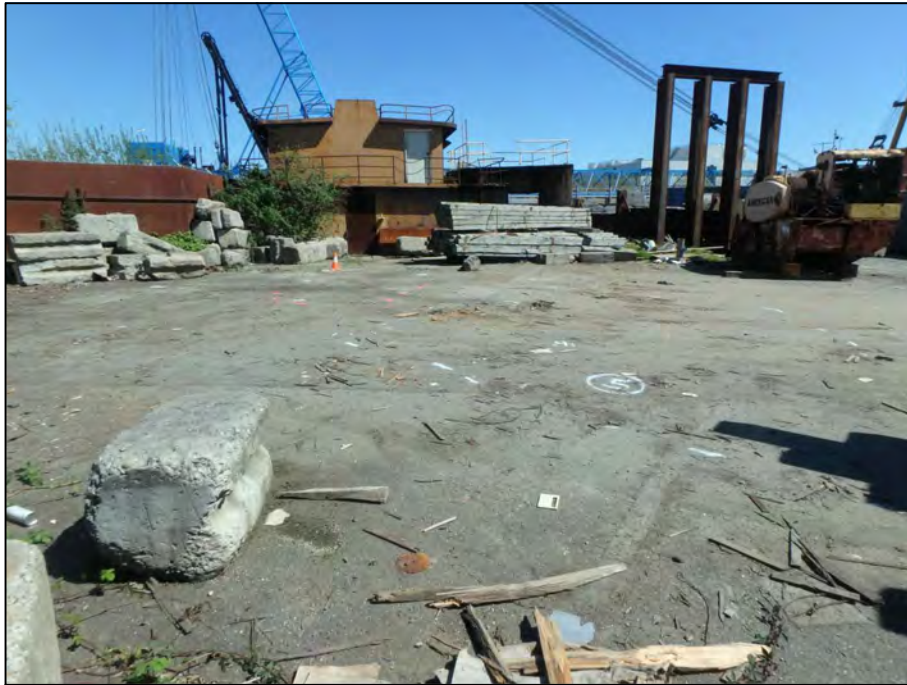
Photograph 21: Location of TP1 at the white mark labeled 5.

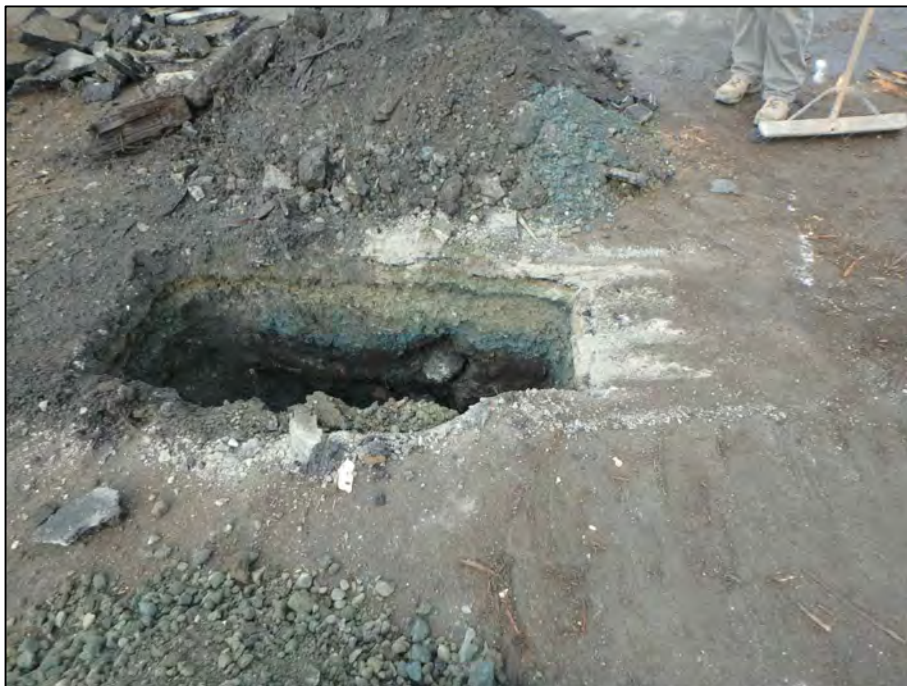
Photograph 22: Cross-section of TP1 showing the blueish-green layer beneath the pea gravel and asphalt. The mottled subsurface soils are also visible. Wood and metal fill was removed from TP1.

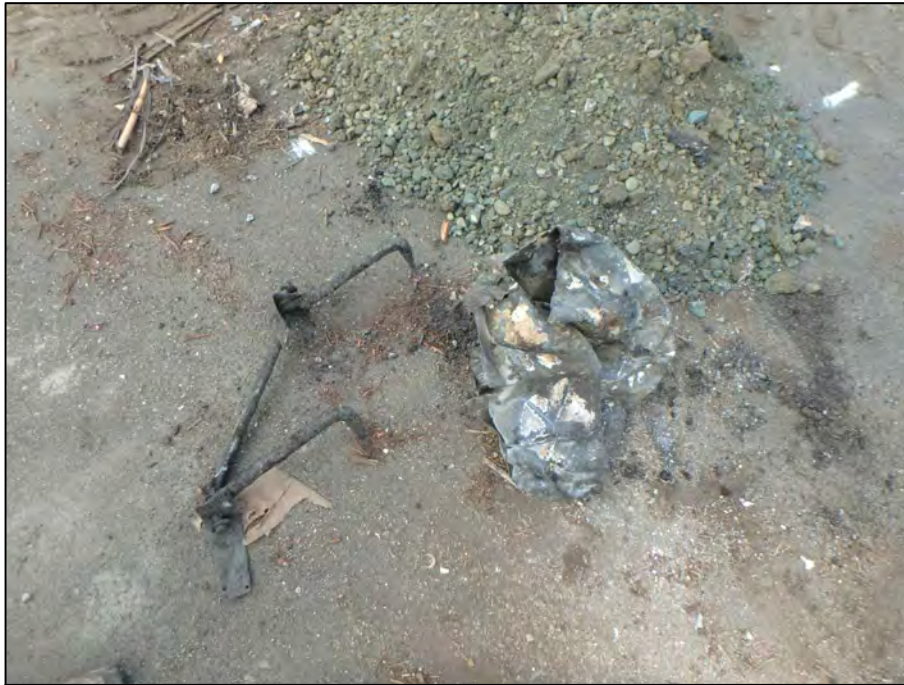
Photograph 23: Metal debris removed from TP1 and TP2, most likely the result of elevated metal detector readings during the geophysical survey.
