RE: Warning Letter - Noncompliance with NPDES Industrial Stormwater General Permit No. WAR 125002, terms and conditions and RCW 90.48.

State of Washington Department of Ecology  
Northwest Regional Office  
**STORMWATER COMPLIANCE INSPECTION  
REPORT**

Seattle Iron & Metals Annex, Seattle  
January 5, 2012

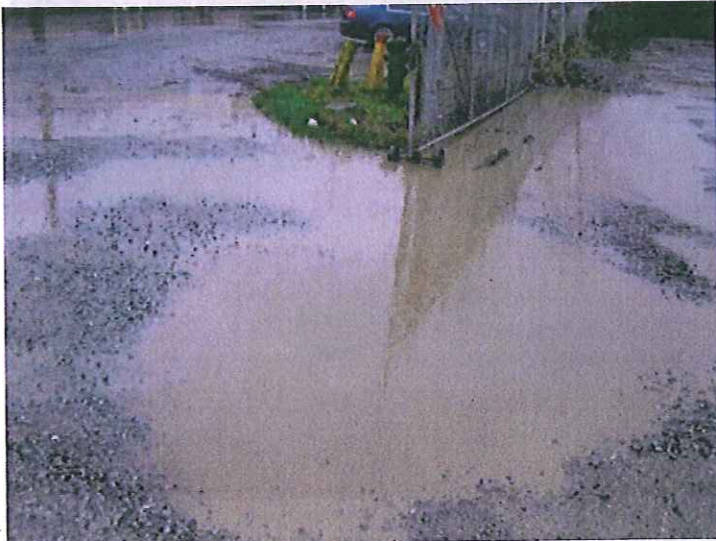
#1. **DESCRIPTION:** Seattle Iron & Metals Truck Parking (Annex) has coverage under the Industrial Stormwater General Permit. The site is a little over 3 acres and is divided into 3 sections. This gate is located on S. Myrtle Street. The turbid stormwater has a visible sheen on it.

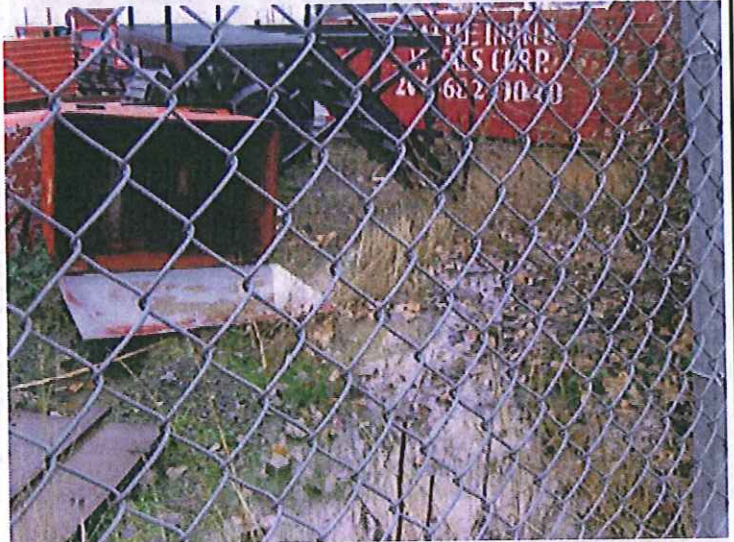
#2. **DESCRIPTION:** There are no catch basins or storm drain systems on the site. Stormwater run-off sheet flows to a low point and then through the chain link fence and onto the unpaved shoulder of S. Myrtle Street.

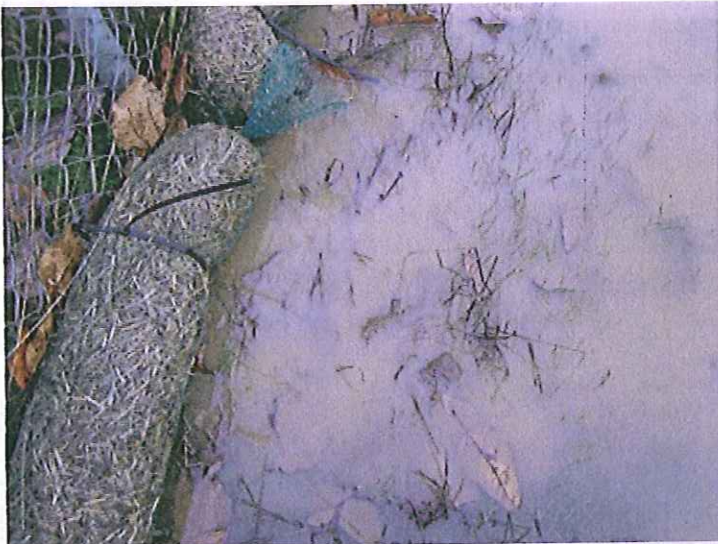
#3. **DESCRIPTION:** These straw wattles are on the outside (downstream) side of the fence. The wattles do not appear to improve the turbidity of the stormwater run-off.

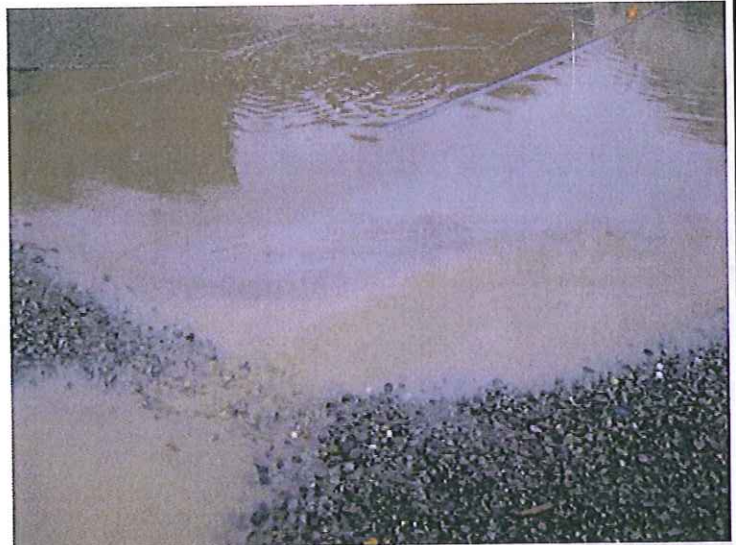
Stormwater discharges from the SIM Annex facility and flows across the unpaved shoulder of S. Myrtle Street (see photos # 1, 4, 5, 6, & 7). The stormwater likely picks up petroleum and turbidity as it flows across this unpaved shoulder. Stormwater from the SIM Annex flows into several storm drain catch basins on S. Myrtle Street.

#4. **DESCRIPTION:** The stormwater leaving the fenced area of the SIM Annex is oily and turbid. The stormwater then flows across the unpaved shoulder of S. Myrtle Street and towards the catch basins on Myrtle.

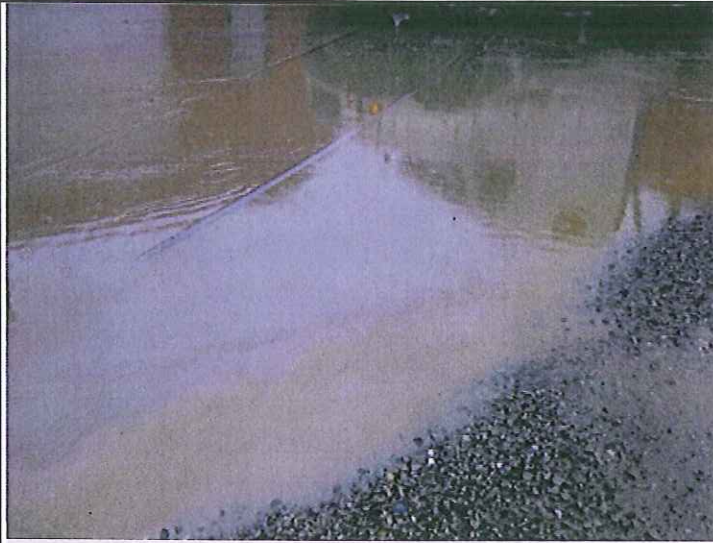
#5. **DESCRIPTION:** All of the stormwater on Myrtle Street between the SIM Annex chain link fence and the paved portion of Myrtle St was very turbid and oily.

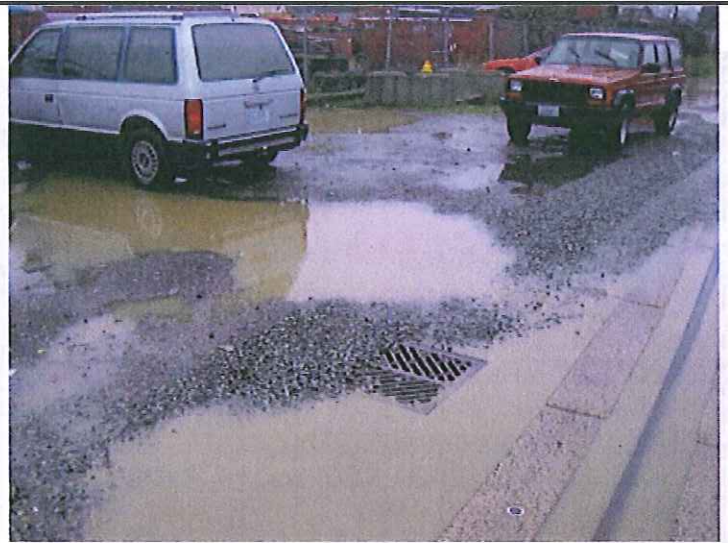
#6. **DESCRIPTION:** The stormwater from SIM Annex flows into several storm drain catch basins on Myrtle. This one is located on the north side of S. Myrtle just east of where 7<sup>th</sup> Avenue comes in from the south.

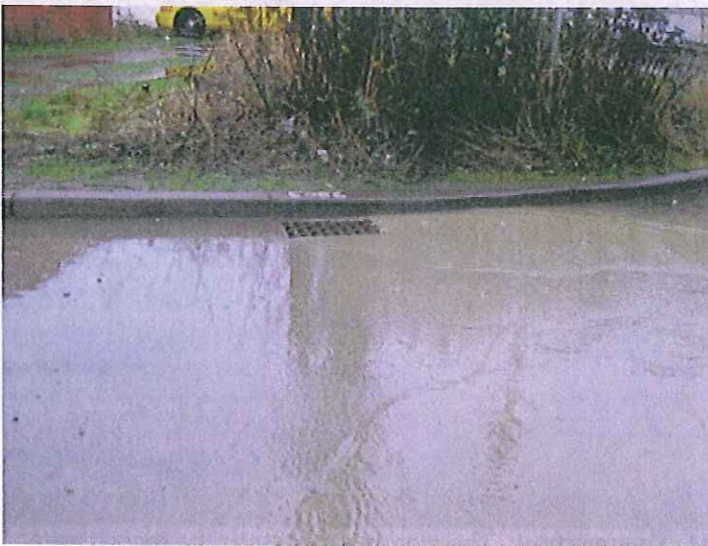
#7. **DESCRIPTION:** This storm drain catch basin is located at the southeast corner of S. Myrtle and 7<sup>th</sup> Ave. The stormwater was extremely turbid. Some could be traced to SIM Annex but a large contribution was also coming from other sources and the unpaved shoulder of S. Myrtle Street itself.

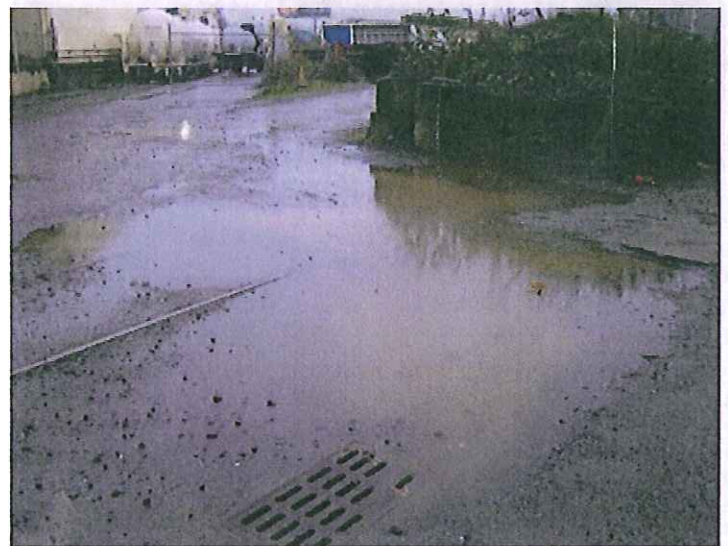
#8. **DESCRIPTION:** This storm drain catch basin is located on Fox Avenue at the northwest corner of the SIM Annex.

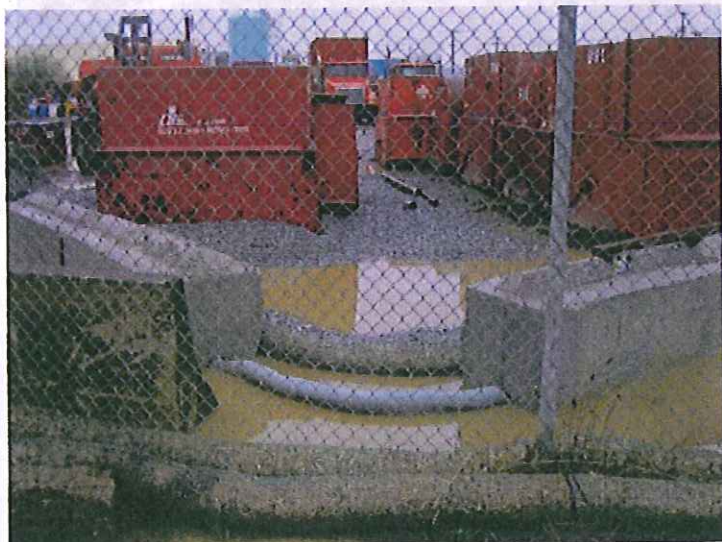
#9. **DESCRIPTION:** After a brief discussion between Ecology and SIM on January 26, SIM officials installed the ecology blocks to enhance their ability to collect stormwater run-off samples. The sausage booms and straw wattles were not providing adequate treatment of the oily turbid stormwater run-off.

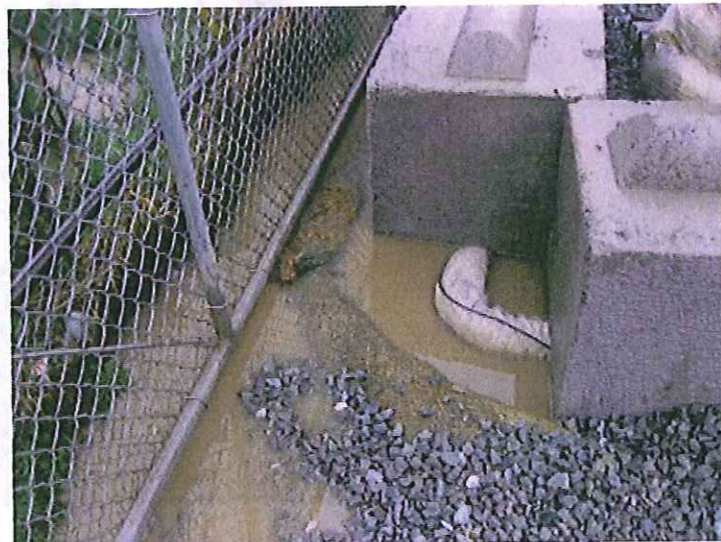
#10. **DESCRIPTION:** The stormwater flows from the ecology blocks to the chain link fence and then onto Myrtle Street. The quality of the stormwater was not noticeably improved on the discharge side of the fence.

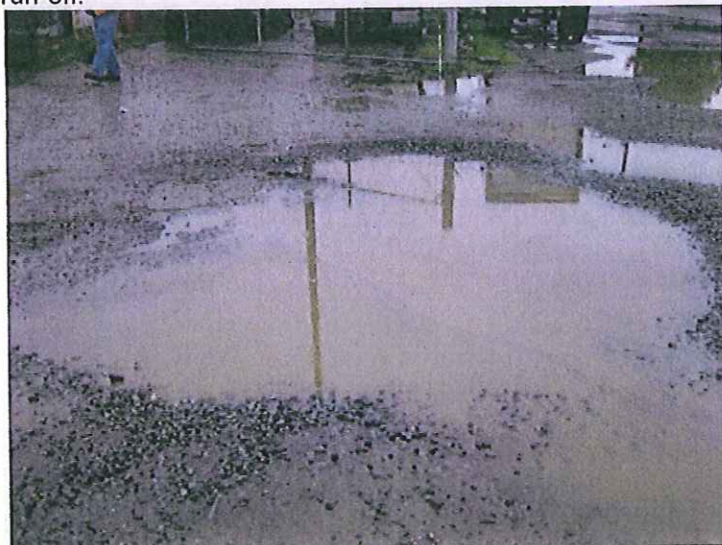
Most of the stormwater within the facility had a significant sheen on it (see Photos # 11, 12, 15 & 16). The permit requires them to immediately clean up spills and leaks to prevent the discharge of pollutants. The permit also requires "empty" scrap metal bins and dumpsters (unless they are clean) to be stored under cover or be provided with a lid that remains closed when not in use (see Photos # 13, 14).

#11. **DESCRIPTION:** Most of the stormwater puddles on the facility were turbid and a petroleum sheen present.

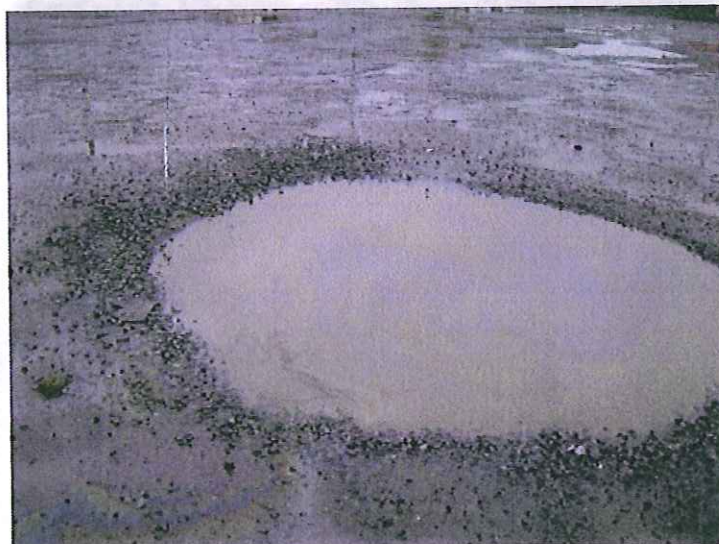
#12. **DESCRIPTION:** The petroleum leak or spill (lower left of photo) was enough to cause a black layer on the nearby puddle. The permit requires leaks and/or spills to be cleaned up immediately.

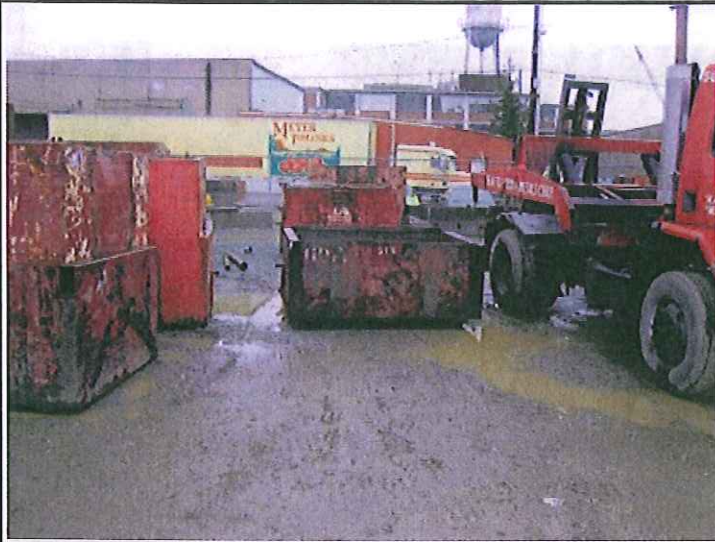
**#13. DESCRIPTION:** These scrap metal bins are "empty". But contain varying amounts of residue. The ground may have pavement under the dirt layer. Stormwater is very turbid.

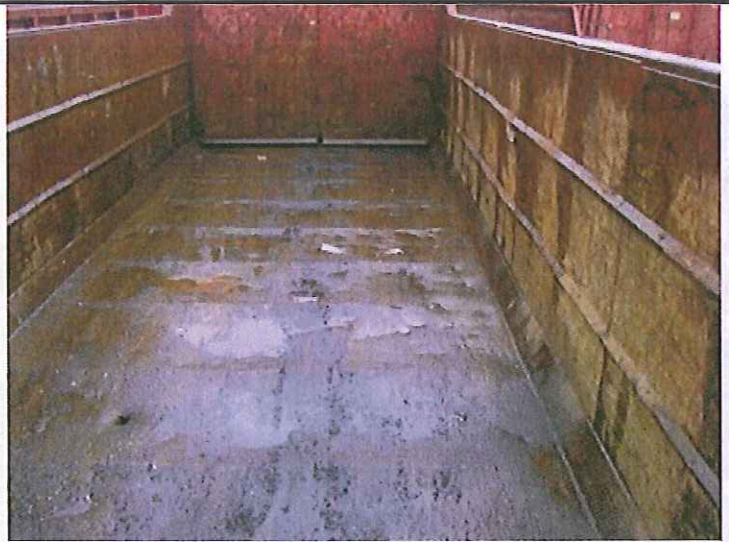
**#14. DESCRIPTION:** This scrap metal dumpster (drop box) is "empty" but unless it is clean, it must be stored under cover or be fitted with a lid that remains closed when not in use. Stormwater falling into this bin will flush pollutants out of the holes and unsealed ends and onto the ground.

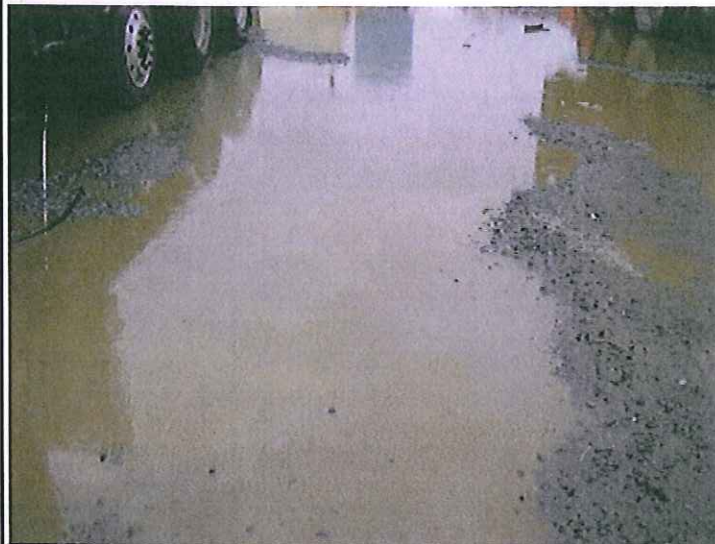
**#15. DESCRIPTION:** The petroleum sheen observed on the stormwater here was traced to an area where drums were stored (see Photo # 16).

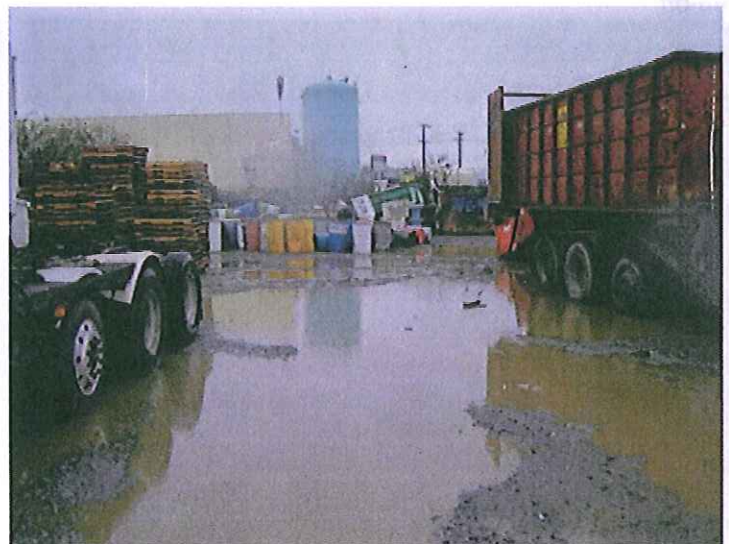
The facility was also storing "empty" drums that were damaged and waiting for repair or scrapping. These drums all had residual metals and fluids in them. The permit requires that all scrap metals bins (or drums) be stored under cover or be fitted with a tight fitting lid. The permit also requires that scrap metal chips, grindings and/or turnings not be allowed to remain on the ground and exposed to stormwater. It is a permit violation to store drums with liquid chemical or petroleum products or wastes without proper cover and containment (see Photos # 17-21). Formal enforcement is being considered for permit noncompliance.

**#16. DESCRIPTION:** The drums stored here are damaged and are waiting for repair or to be scrapped. Stormwater flows from the drums towards the photographer. The permit requires these drums to be stored under cover or be provided with a tight fitting lid.

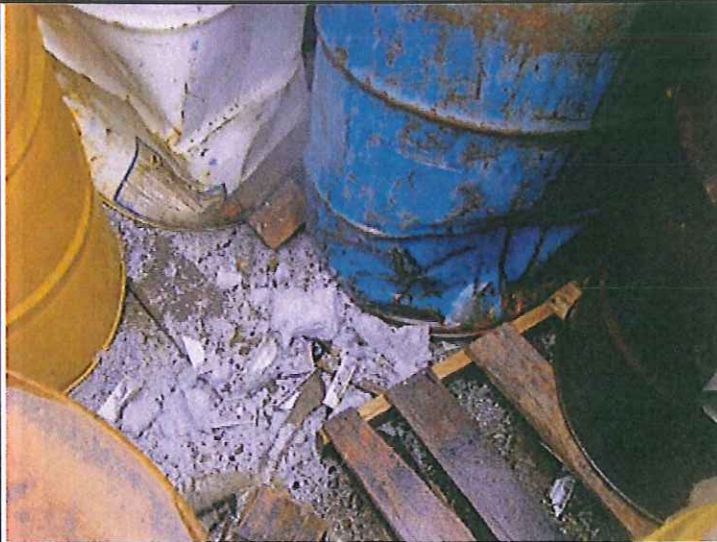
**#17. DESCRIPTION:** This scrap metal cannot be allowed to remain on the ground and exposed to stormwater. The ground in this area was covered with scrap metal chips, turnings and/or grindings. Dirt surface makes it difficult to pick up spilled or leaked metals.

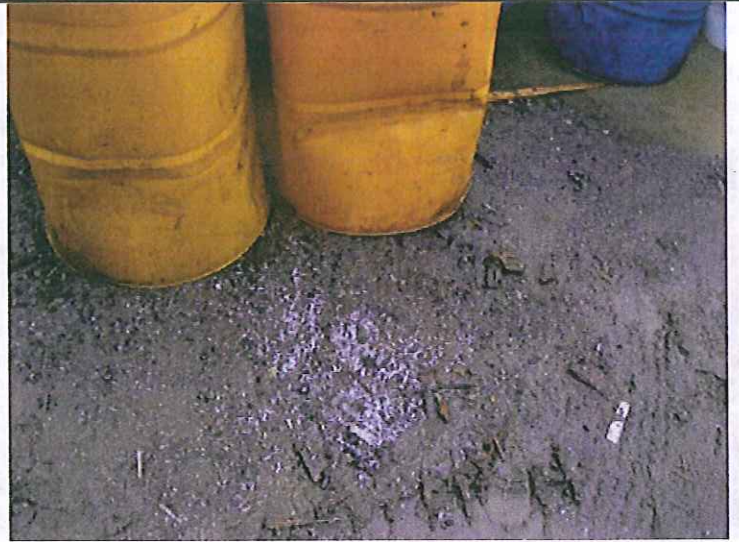
**#18. DESCRIPTION:** The spilled scrap metal fines must be picked up in some manner and not be allowed to remain on the ground.

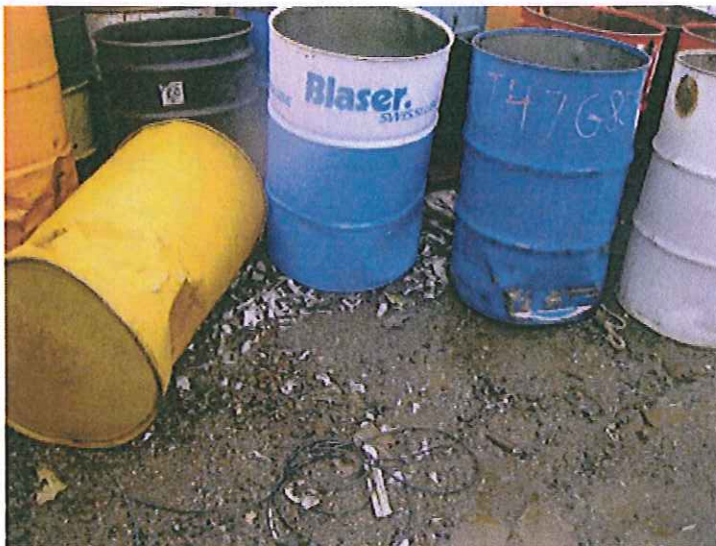
**#19. DESCRIPTION:** Most of these drums were "empty" but all contained residual scrap metals and cutting fluids. Some of the drums in this area contained cutting fluids and/or coolants. Liquid products or wastes stored outside must be provided with proper cover and containment.

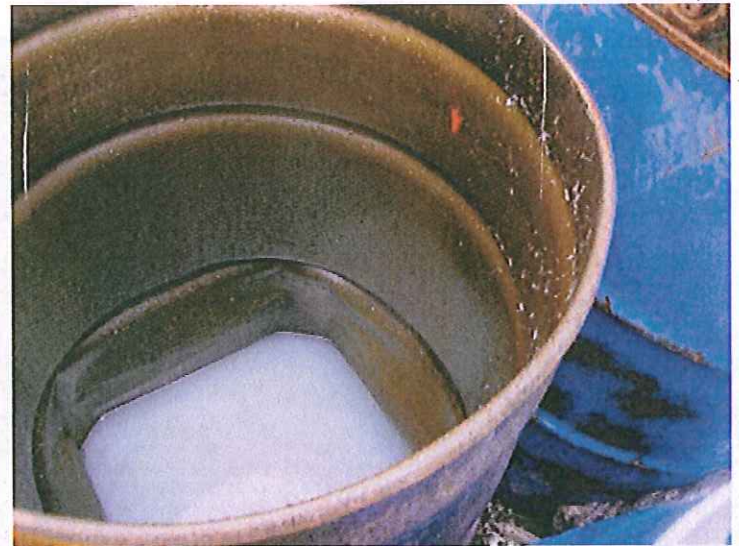
**#20. DESCRIPTION:** The white fluid is a coolant or cutting fluid. The storage of this fluid in an uncovered drum out in the open is a violation of the permit.

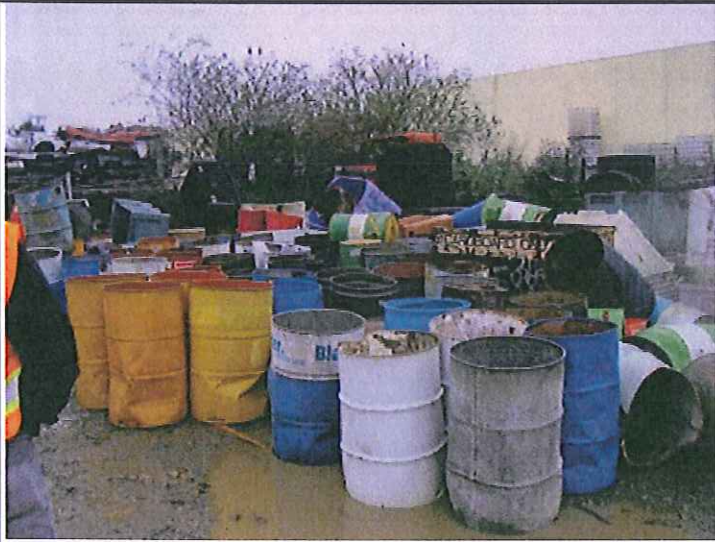
**#21. DESCRIPTION:** This entire area is a major source of stormwater pollution. All scrap metal debris must be cleaned up off the ground and all drums stored under cover or removed from the facility. All liquid chemical and petroleum products and/or wastes must be stored with proper cover and containment.

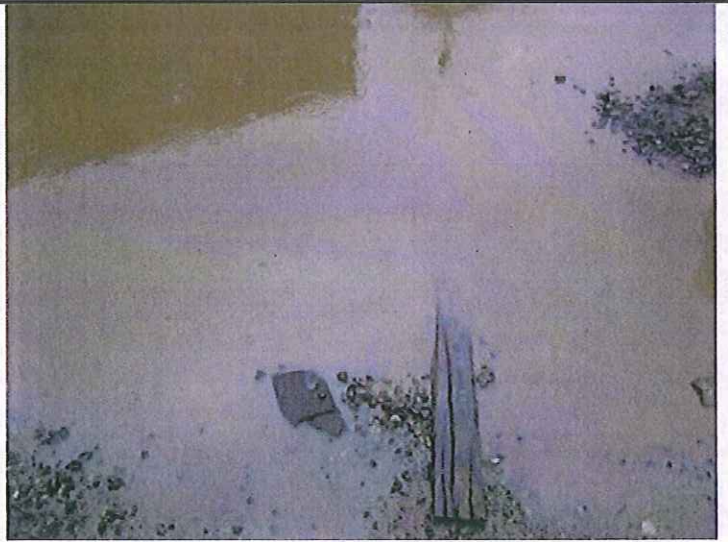
**#22. DESCRIPTION:** A petroleum sheen was observed on nearly all of the stormwater on site. A more aggressive source control effort for control and cleaning up petroleum leaks and spills is necessary.

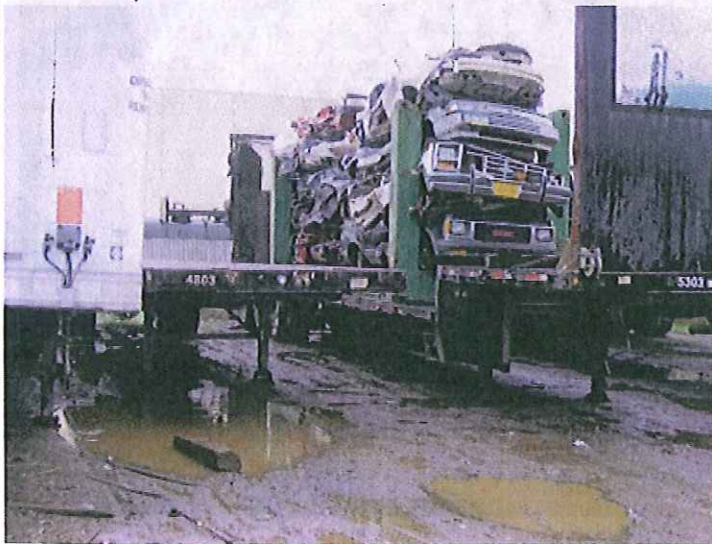
**#23. DESCRIPTION:** The western most third of the 3-section facility is sometimes used to stored flat bed trailers and containers. This area may also be paved but is covered with a hard layer of dirt. The periodic storage of crushed cars, and the container and equipment repair and maintenance at this facility demonstrates that this operation is more than just truck parking.

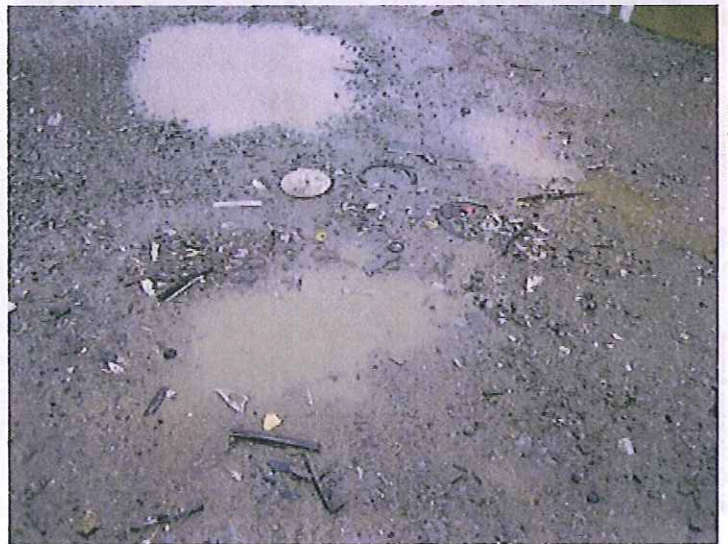
**#24. DESCRIPTION:** The facility must make a better effort to prevent scrap metals from getting onto the dirt and picking it up when it does.
