January 27, 2016
G-Logics Project Number 01-1039-A

Subject: Groundwater-Sampling Report, January 2016
Facility/Site No. 28995469
VCP Project No. CE0411
Cleanup Site ID No. 12353
Horse Heaven Hills Travel Plaza
101 Merlot Dr.
Prosser, WA 99350

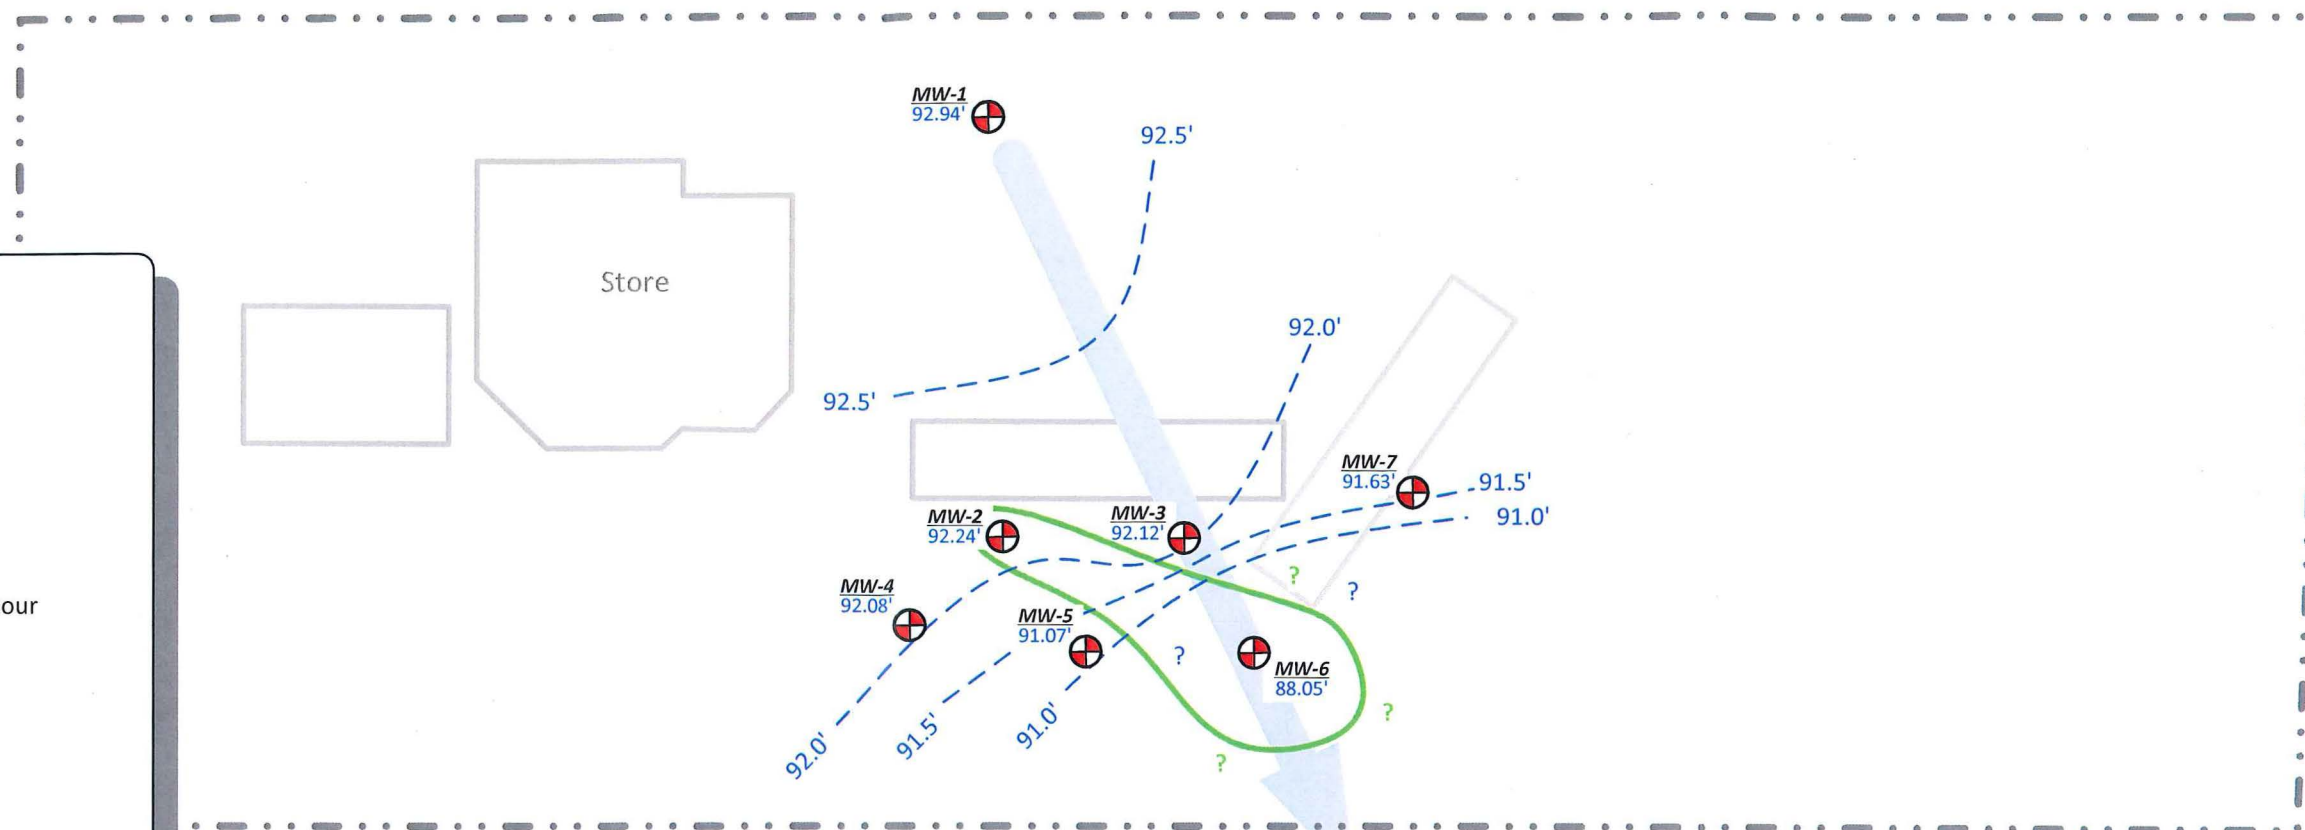
Figure
3b

Well	DRO
MW-1	nd
MW-2	570
MW-3	400
MW-4	nd
MW-5	410
MW-6	920
MW-7	nd

Groundwater Elevation and DRO Concentrations (11/24/2014)
Horse Heaven Hills Travel Plaza
101 Merlot Drive
Prosser, Washington

The analytical and groundwater-elevation information from the five previous groundwater-sampling events (conducted by Blue Mountain) and the current event conducted by G-Logics are tabulated in Tables 1 and 2, respectively. G-Logics interpretations of this data (DRO concentrations and groundwater-flow directions) are presented on Figures 3a through 3f.

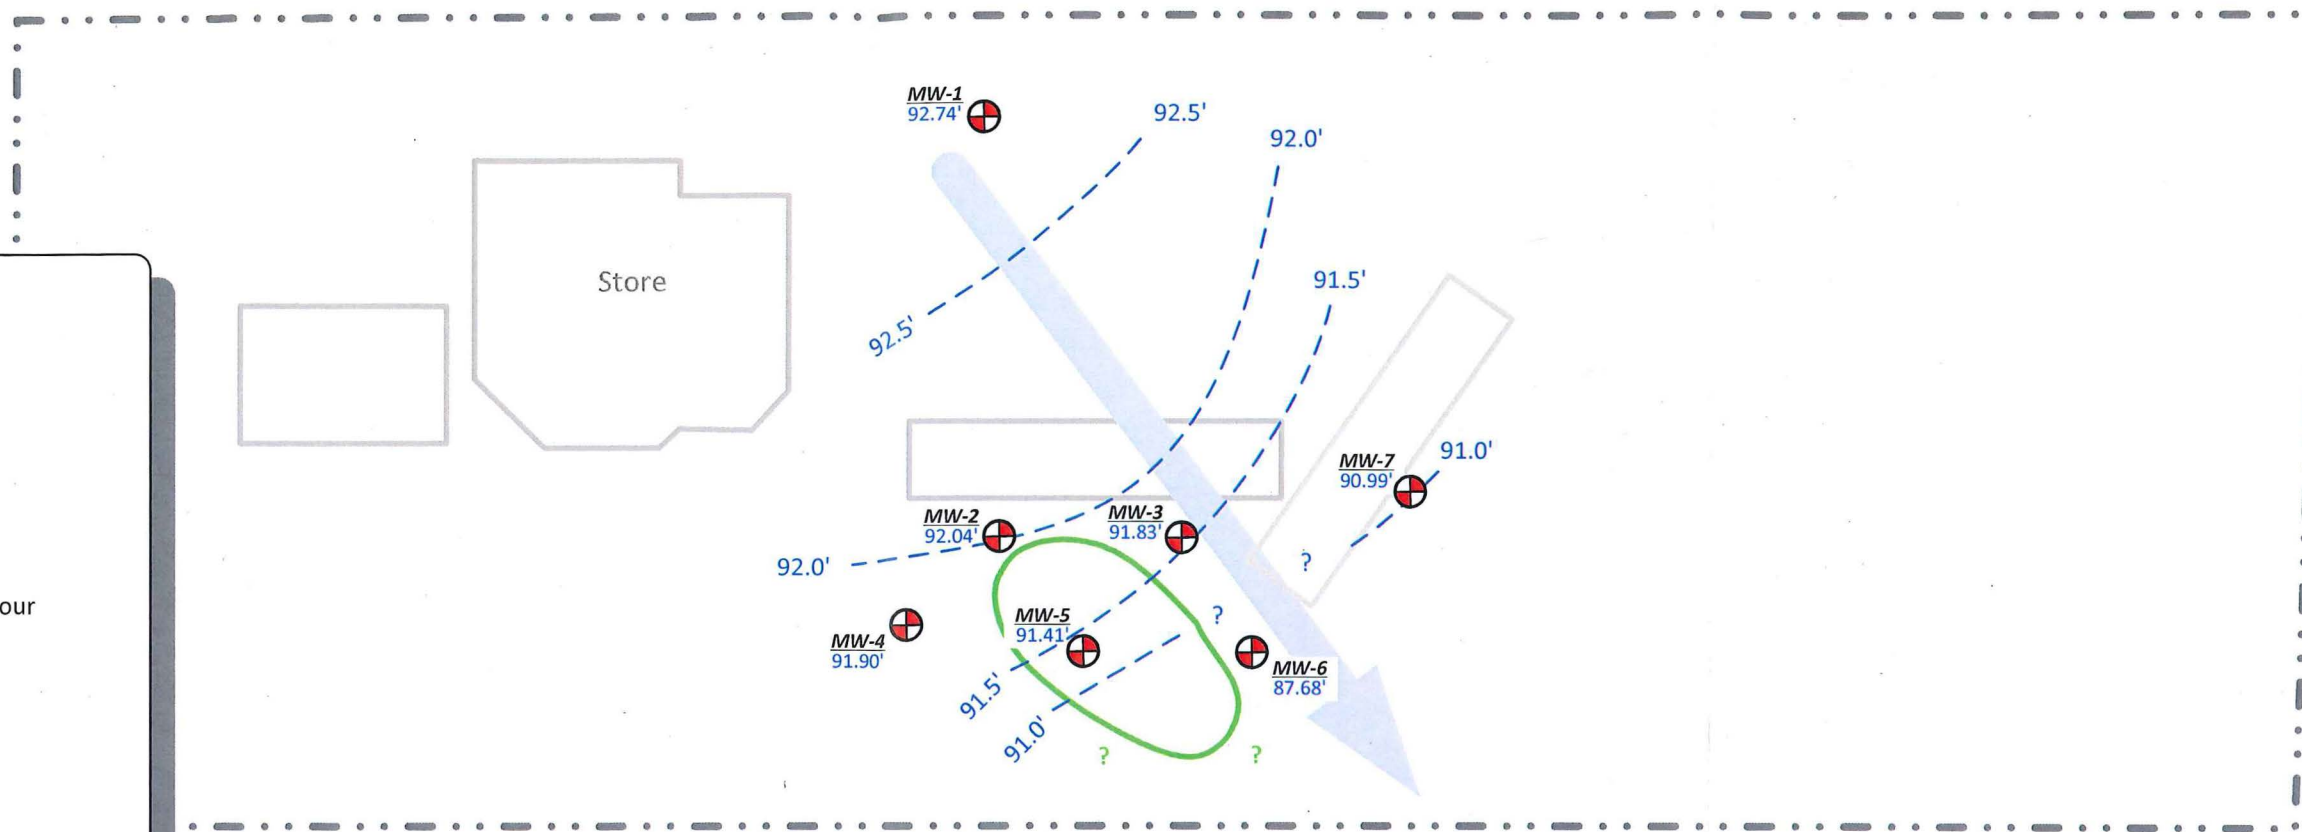
Figure
3c

Well	DRO
MW-1	nd
MW-2	400
MW-3	340
MW-4	nd
MW-5	730
MW-6	370
MW-7	nd

Groundwater Elevation and DRO Concentrations (2/11/2015)
Horse Heaven Hills Travel Plaza
101 Merlot Drive
Prosser, Washington

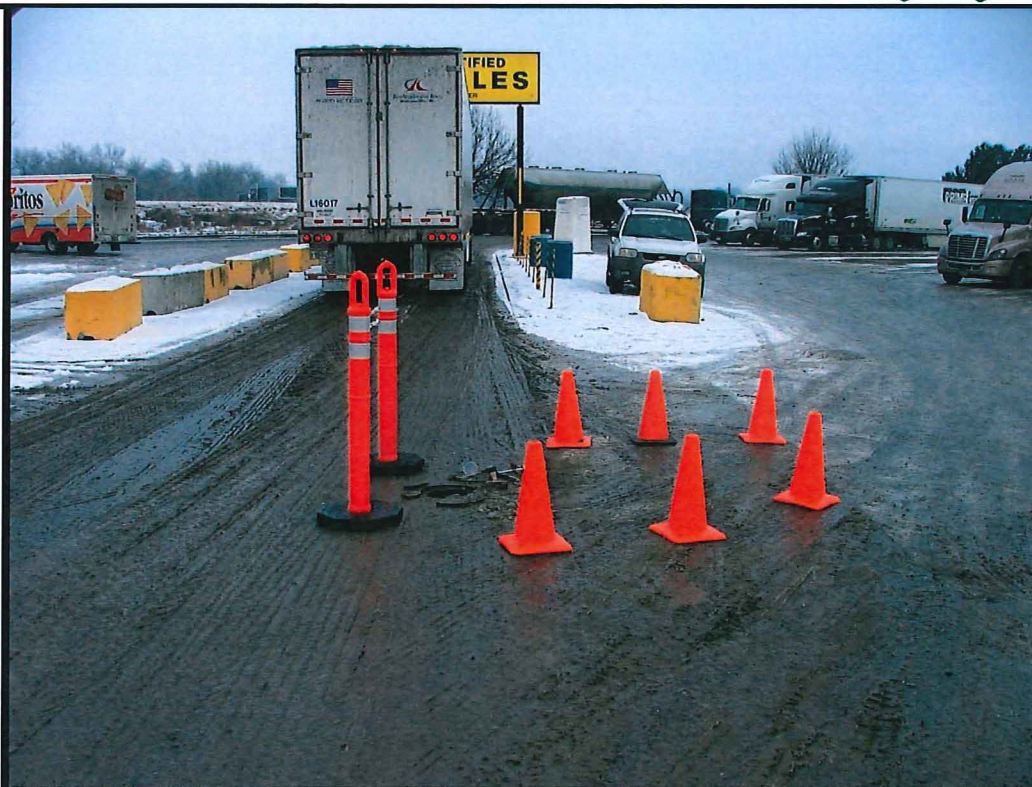
Seven groundwater-monitoring wells (MW-1 through MW-7, Figure 2) were resampled on January 5/6, 2016 to obtain updated information regarding groundwater contaminants. During sampling, six wells were found to have broken or missing monument lids (Photos 1 through 4). Several of the monuments were also found to contain ice, which needed to be removed prior to sampling (Photo 2).

Description: MW-6: Looking north toward truck scale.

Comments: Six of the seven monuments, in high traffic areas, sustained damage to the lids and seals.

- Analyze groundwater samples for DRO and BTEX.
- Conduct an elevation survey of the new and existing wells.
- Replace up to six 12-inch monument lids, seals, and bolts as needed.
- Remove and manage the generated IDW (purge water).

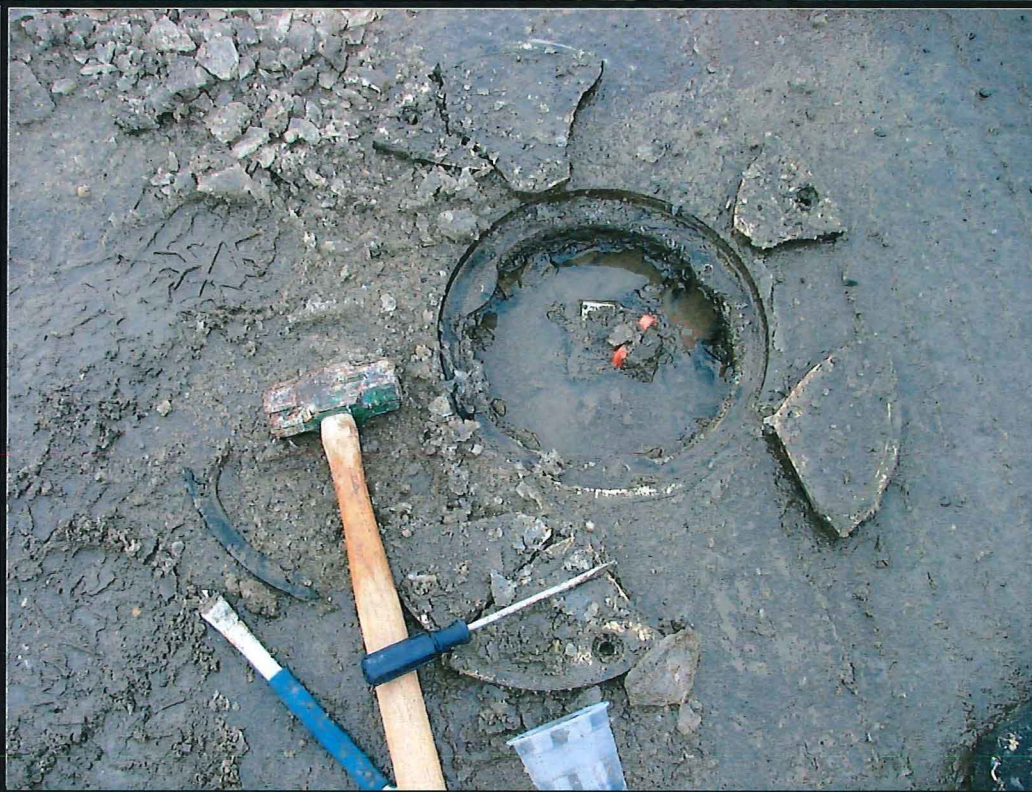
2

Description: MW-6: 12" Monument

Comments: Several monuments were full of ice that needed to be chipped out prior to sampling.

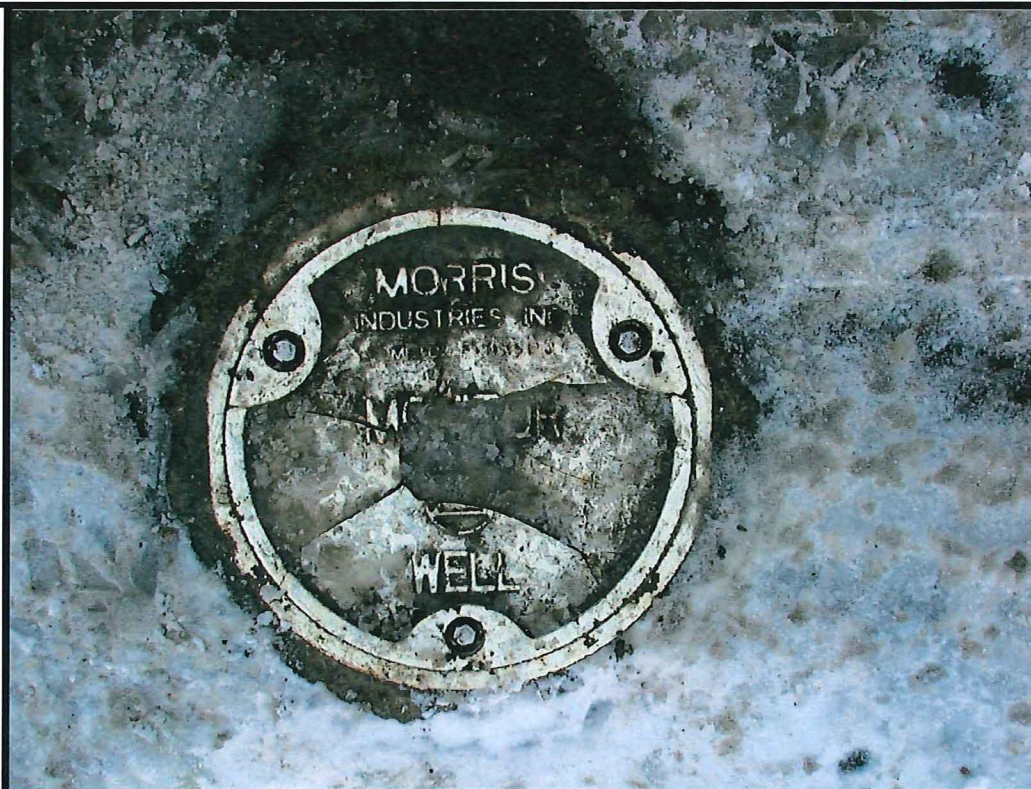
3

Description: MW-1: 12" Monument.

Comments: Five wells were found to have broken lids.

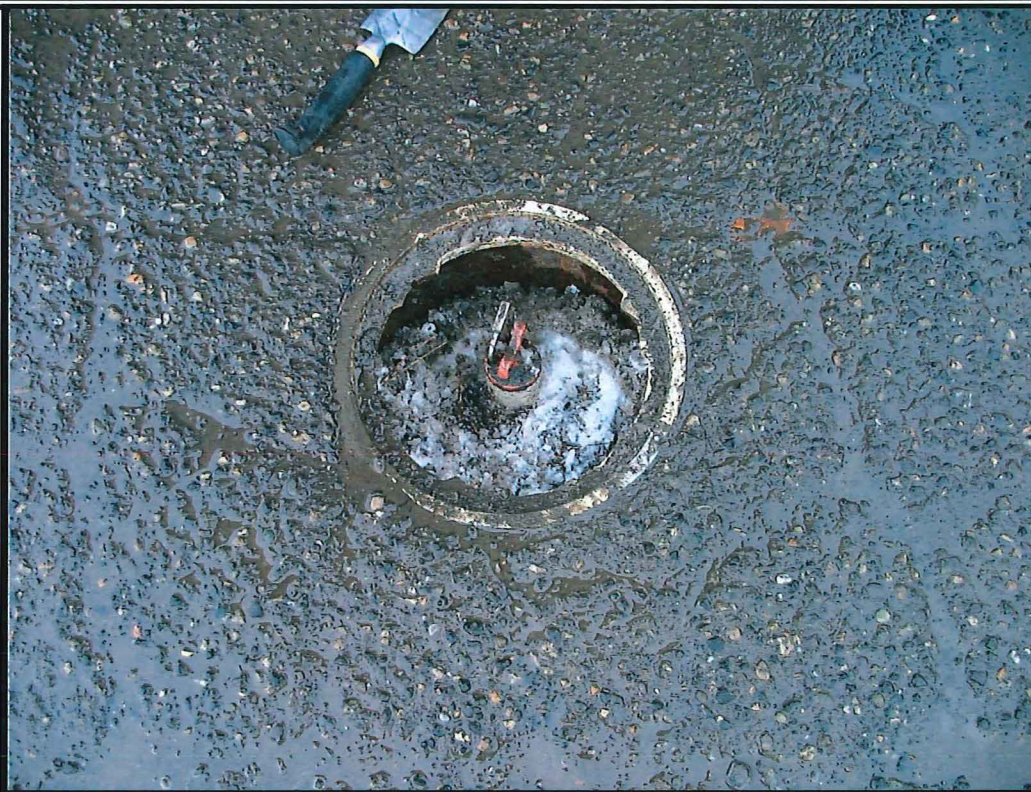
4

Description: MW-4: 12" Monument.

Comments: This well was missing a lid.

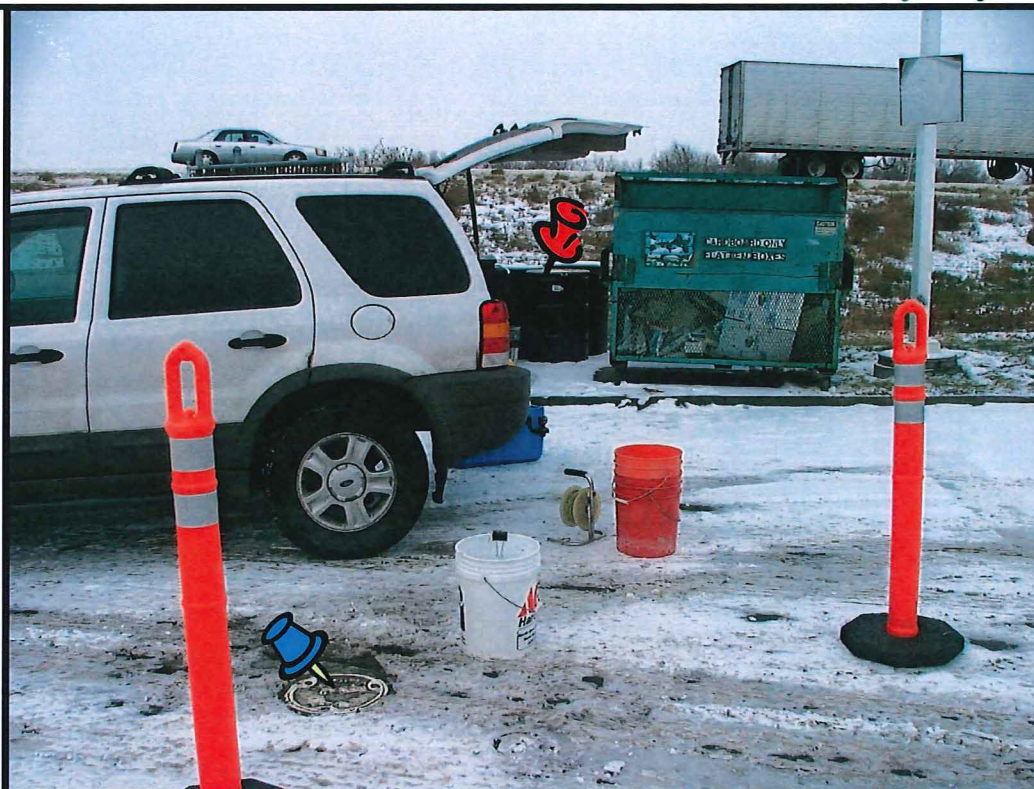
Seven 55-gallon drums (six from previous sampling events) of well-purge water are stored on the property see (Photos 5 and 6, location shown on Figure 2). Following the January 2016 sampling event, Oil Re-Refining Company, Inc. (ORRCA) was retained by G-Logics to test, pump, and treat this Investigation Derived Waste (IDW) water. Documentation regarding the disposal of this IDW will be presented in the next quarterly report.

Description: Drum storage area looking north.

Comments: MW-1 in the foreground (blue pin). 55 gallon drums of well purge water in the background (red pin).

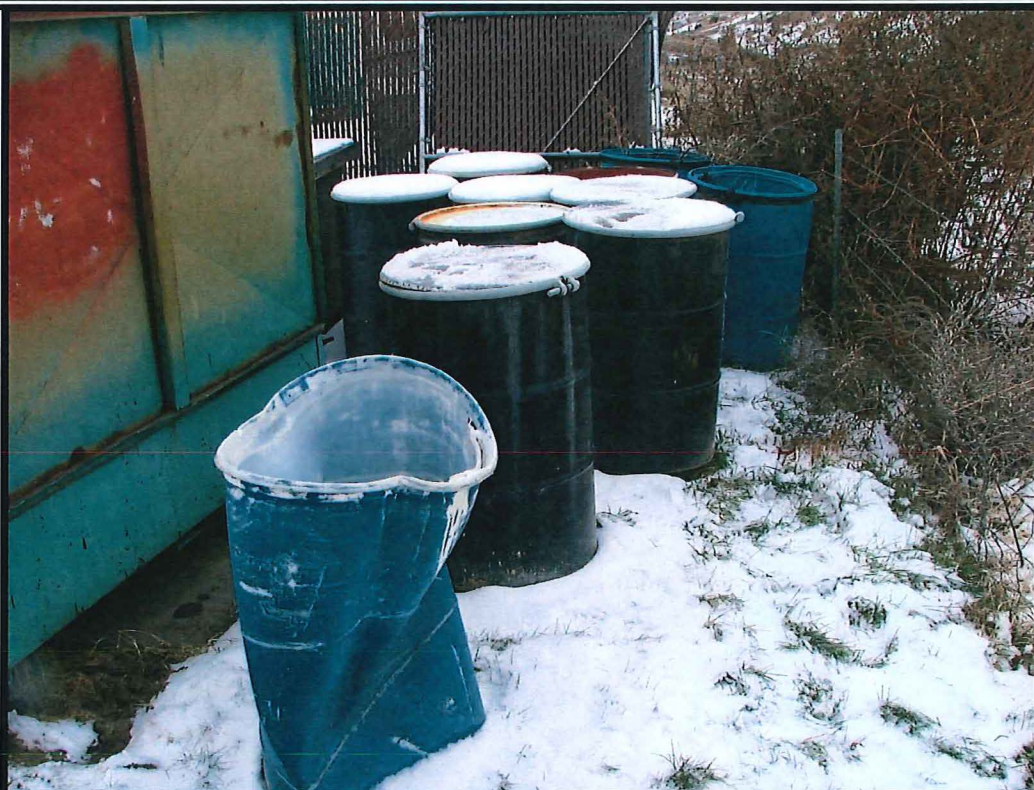
6

Description: Drum storage area looking west.

Comments: Seven drums of well purge water from past and present sampling events.
