REMEDIAL INVESTIGATION AND CLEANUP ACTION REPORT

Modera Jackson Site
1803–1905 South Jackson Street
Seattle, Washington

Remedial Investigation and Cleanup Action Report

Project No.: 0811-005

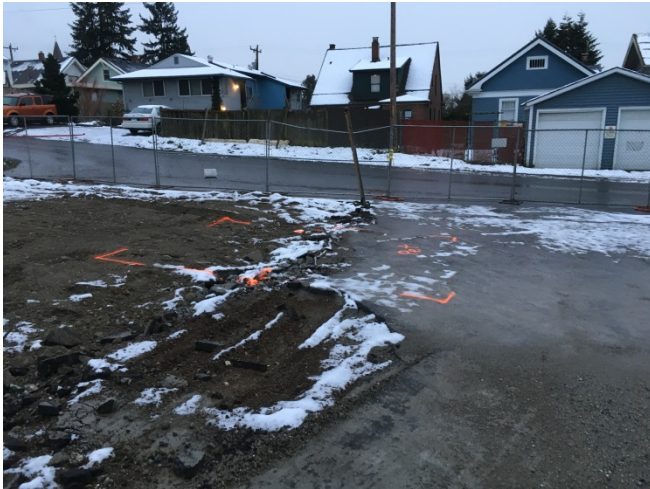
Photograph 3. Looking south. Location of remedial excavation area EX03 near former leaking press machine.

- **Area 3.** During a Phase I Environmental Audit conducted in 2000 by EAI, oil-staining was observed on the wall and ground surface on the southwestern portion of Building 2. The staining was due to a leaking press machine. A remedial excavation of impacted soil was conducted by EAI outside the building, adjacent to the leak. However, approximately 0.2 cubic yards of PCS were estimated by EAI to remain beneath Building 2. This material was not removed due to concerns regarding the structural stability of the building foundation.

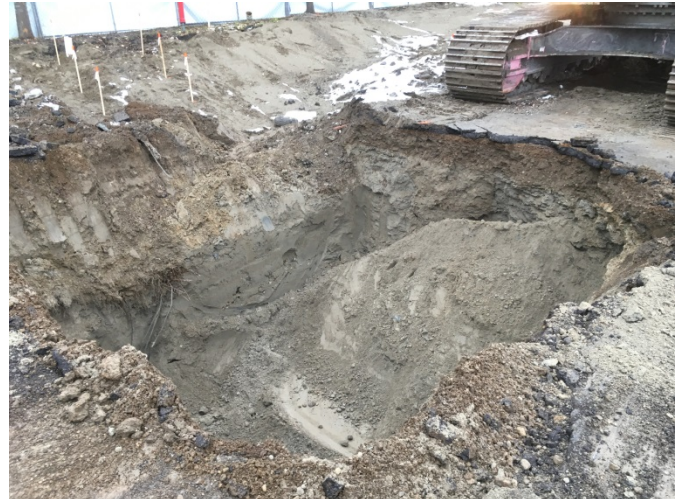
Photograph 4. Looking northeast. Final extent of remedial excavation area EX01. No PCS observed.

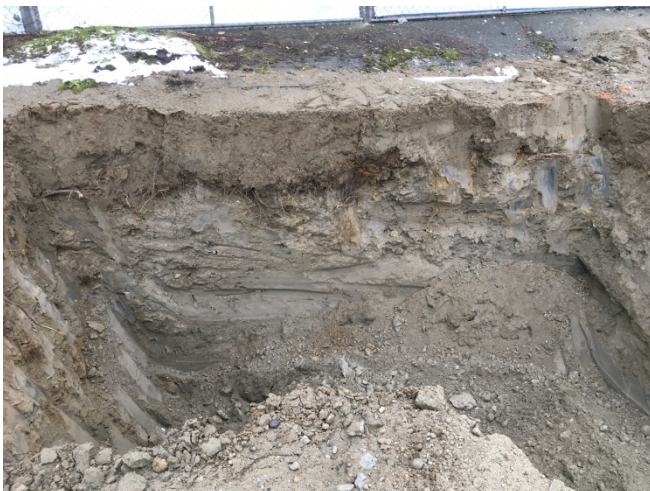
Photograph 5. Looking north. Northern portion of remedial excavation area EX02. No PCS observed.

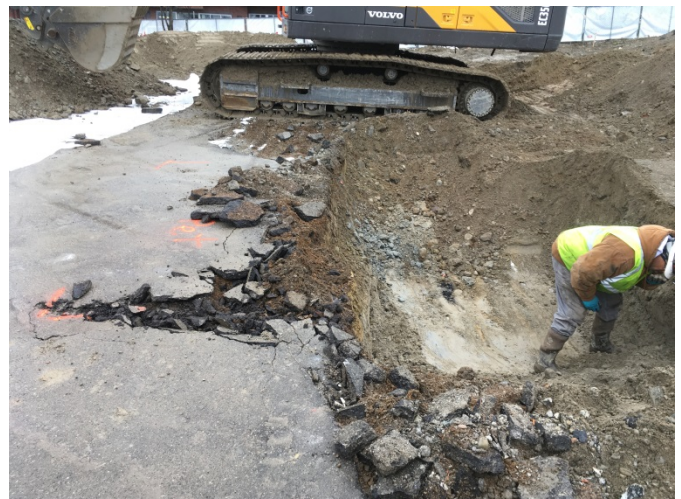
Photograph 6. Looking north. Gray-stained PCS visible on northwestern sidewall of remedial excavation area EX03.

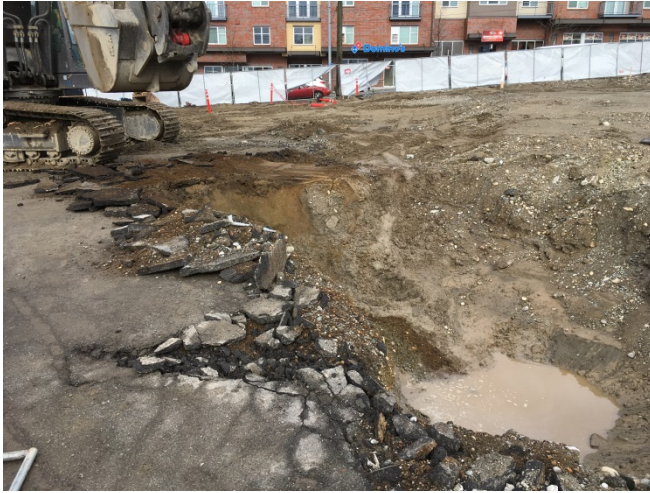
Photograph 7. Looking north. Final extent of remedial excavation area EX03.

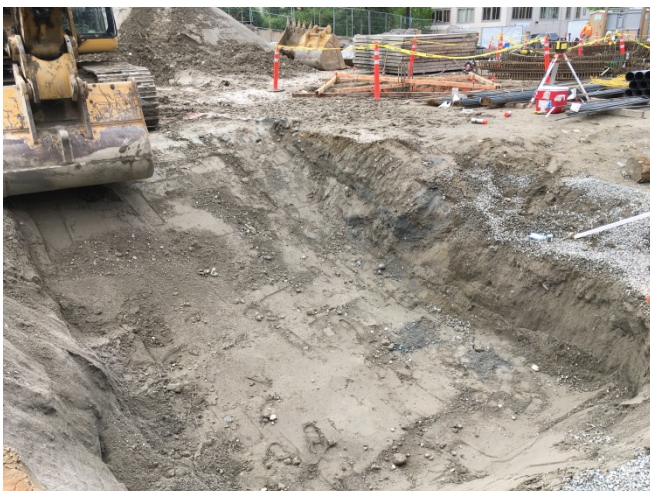
Photograph 11. Looking southwest. Gray-stained PCS visible on bottom and west sidewall of elevator pit area.

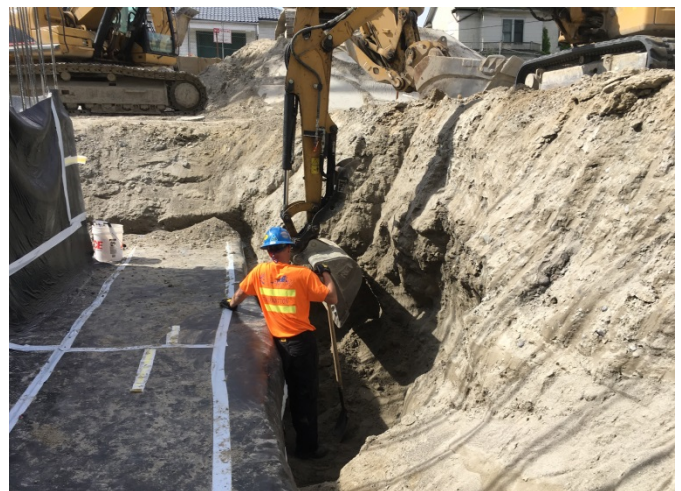
Photograph 12. Looking south. Removal of remaining PCS on west sidewall of elevator pit once elevator footing is in place.
