INITIAL INVESTIGATION FIELD REPORT

<u>Site Name (Name over door):</u> Block 47 Property	<u>Site Address (including City, State and Zip):</u> 910 John St (& 200-216 9th Ave N) Seattle, WA 98109	<u>Phone</u> <u>Email</u>
<u>Site Contact, Title, Business:</u> Joe Rounds Farallon Consulting	<u>Site Contact Address (including City, State and Zip):</u> 1809 7th Avenue, Suite 1111 Seattle, WA 98101	<u>Phone</u> 425-295-0800 <u>Email</u> jrounds@farallonconsulting.com
<u>Site Owner, Title, Business:</u> City Investors XXVI, LLC	<u>Site Owner Address (including City, State and Zip):</u> 505 5th Avenue South, Suite 900 Seattle, WA 98104	<u>Phone</u> <u>Email</u>
<u>Site Owner Contact, Title, Business:</u> Deb Willard City Investors XXVI, LLC	<u>Site Owner Contact Address (including City, State and Zip):</u>	<u>Phone</u> <u>Email</u>
<u>Previous Site Owner(s):</u>	<u>Additional Info (for any Site Information Item):</u>	
<u>Alternate Site Name(s):</u>	Historical property addresses: 200 & 216 9th Ave N, Seattle, WA 98109

Following remedial activities at the site, Joe Rounds (Farallon) reported the contamination and submitted the Independent Cleanup Action Report on behalf of City Investors XX

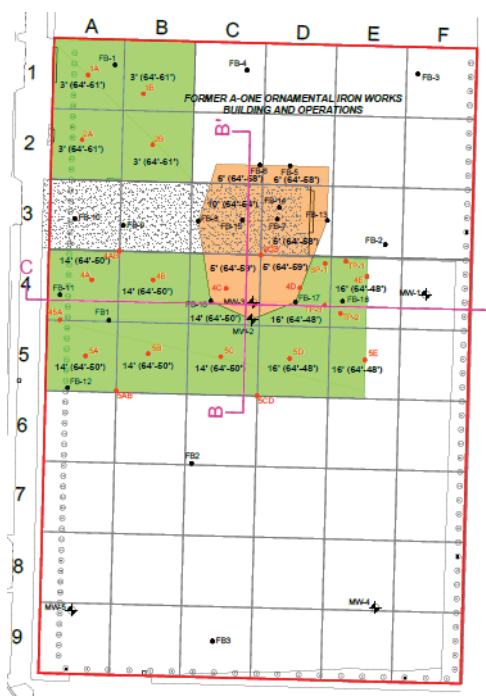
The site is comprised of two parcels. The north (rows 1-3 on the figure below) formerly housed A-One Ornamental Iron Works and the south (rows 4-9 on the figure below) has been used as a parking lot since at least the 1960s. The site is currently undergoing redevelopment to become a mixed-use building with two levels of subsurface parking.

2014 and 2016 sampling events indicated two potential areas of petroleum contamination. The northwest corner of the site contained oil-range organics below MTCA Method A cleanup levels. The central portion of the site, just south of where the previous boundary between the two parcels was, contained the only soil sample above MTCA Method A cleanup levels (at location FB-17; oil-range organics 2300 mg/kg, 15' bgs), as well as multiple other samples with oil-range organics below MTCA Method A cleanup levels. A region of shallow groundwater was also encountered in this area (MW-3, approx. 4' bgs), with samples indicating oil-range organics above MTCA Method A cleanup levels.

Sampling also indicated a region of HVOC contamination overlapping with the central petroleum contamination area. PCE, TCE, and cis-1,2,-DCE were quantified in soil and groundwater below MTCA Method A cleanup levels.

Areas of excavation for petroleum (green) and HVOC (orange) contaminated soil are indicated on the figure to the left. Shading in regions 3 A-D indicates a gravel driveway. (See page 6)

Petroleum contaminated soil was excavated and sent to CEMEX for disposal. Remedial excavation extended to approximately 6' bgs in the northwest corner of the site and 16' bgs in the central region of the site. 14 base and 5 sidewall confirmation samples were collected following the remedial excavation, and none contained concentrations of petroleum hydrocarbons above laboratory quantitation limits. HVOC contaminated soil received a contained out designation from Ecology, and was disposed of by Republic Services at the Subtitle D Landfill in Roosevelt, WA. Previously collected samples without quantifiable concentrations of HVOCs were used to determine the contained-out soil area and were used as confirmation of successful remedial activities. Following remedial excavation, construction excavation continued across the site to a final depth of approximately 28' bgs.

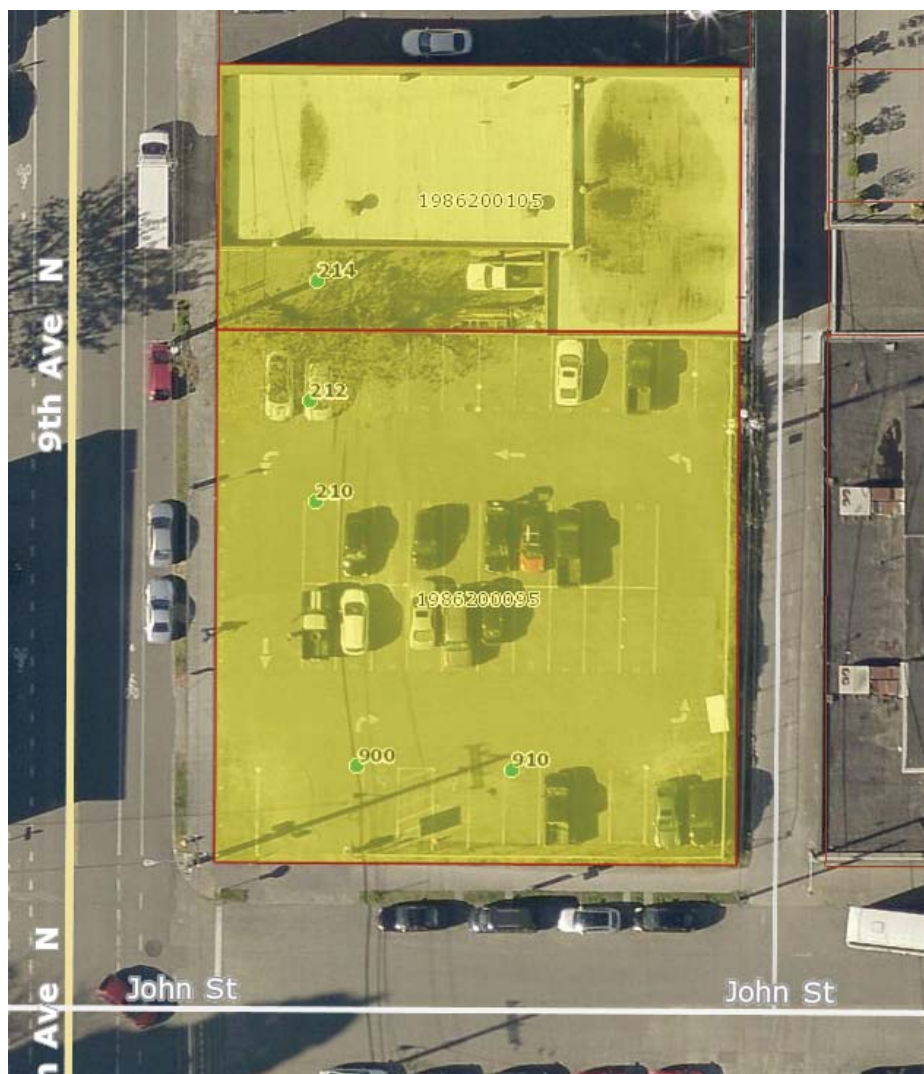
Figure below shows two addresses: 900-910 John St AND 210-214 9th Ave N.
