**Cleanup Action Report  
PSE Bothell TSCA Spill**

Glen Grove Apartments  
10295 Northeast 189th Street  
Bothell, Washington

March 31, 2011

**File No. 0186-853-00**

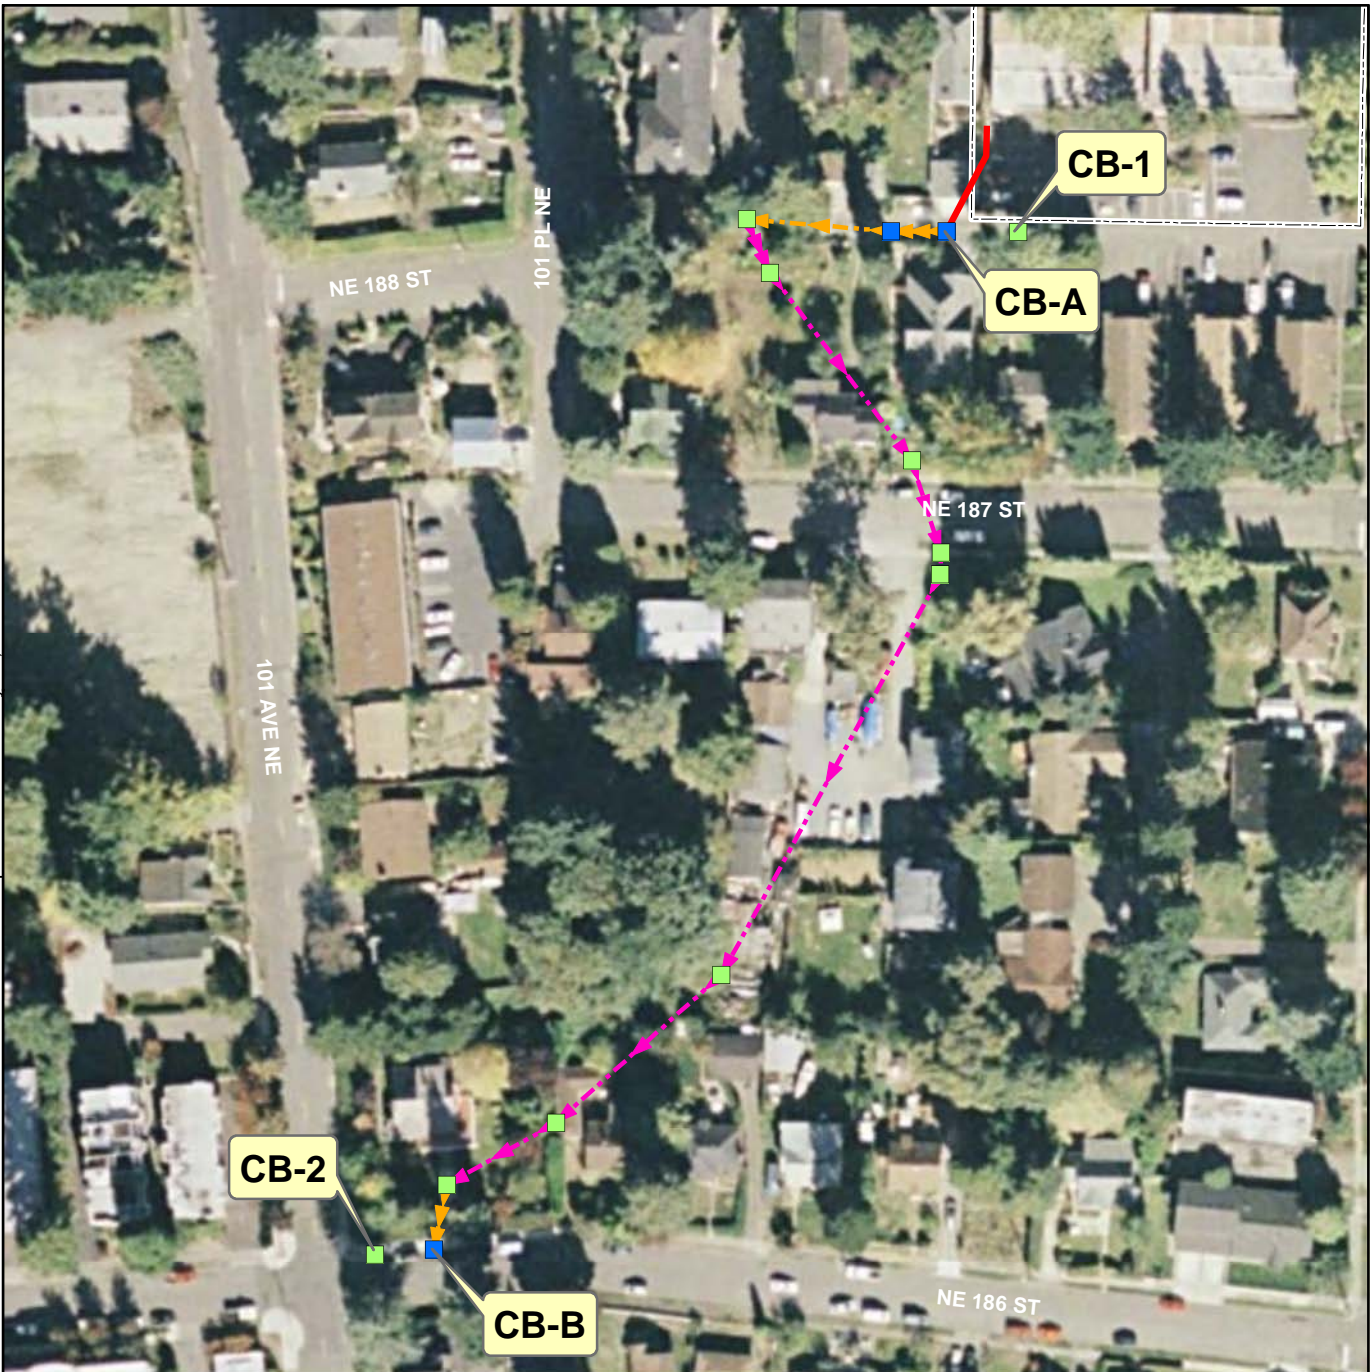
<b>City of Bothell Stormwater Drainage System</b>	
PSE Bothell TSCA Spill Bothell, Washington	
	<b>Figure 4</b>

The City's stormwater system was temporarily impacted by this release until the release was contained. Specifically, between the August 30, 2010 rainfall event and August 31, 2010, mineral oil and PCBs had entered the City of Bothell's stormwater drainage system. These fluids were immediately contained after GeoEngineers initiated spill response containment/cleanup activities on August 31, 2010.

The oil entered the stormwater system with stormwater that accumulated in the release area and either flowed by gravity through subsurface piping or entered a sump pump on the north side of the building and was discharged through a hose into the stormwater system. A heavy sheen that appeared to be mineral oil (based on our observations and experience with other similar mineral oil releases) was observed in two catch basins in an alley to the south of the apartment complex. Power to the sump pump was disconnected by GeoEngineers on August 31, 2010 immediately after the sheen was discovered. Additionally, piping leading into the stormwater drainage system was plugged with oil-sorbent pads on August 31, 2010 to help prevent the further migration of oily water outside of the immediate release area. After its discovery, oily water in the release area was controlled, collected and removed from the site for permitted disposal by representatives of PSE until cleanup activities at the site had been completed.

Portions of the City of Bothell's stormwater drainage system impacted by the release were cleaned on August 31, 2010. Oil sorbent booms were placed in the alley catch basins soon after the sheen was discovered and a vac-truck was later utilized to clean the catch basins and underground piping connected to the basins.

- Two sludge samples were obtained for cleanup verification purposes; one from upstream and one from downstream of the impacted portion of the City of Bothell's stormwater drainage system. Based on our observations and chemical analysis of sludge samples obtained from the City of Bothell's stormwater drainage system, it is our opinion that oil and sheen observed in the system were removed and residual sludge in the system located immediately downstream of the cleaned portion of the system was not impacted by PCBs.

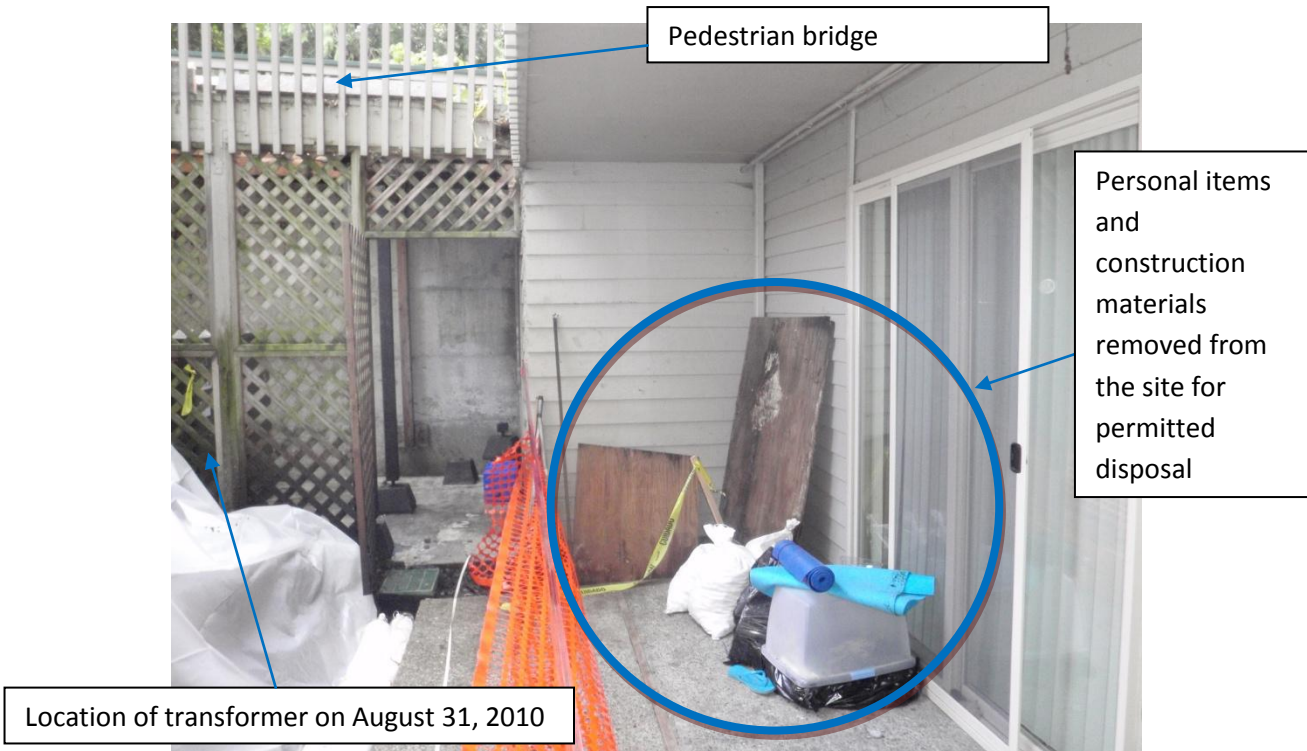
Original transformer location on September 1, 2010; after initial spill cleanup activities.

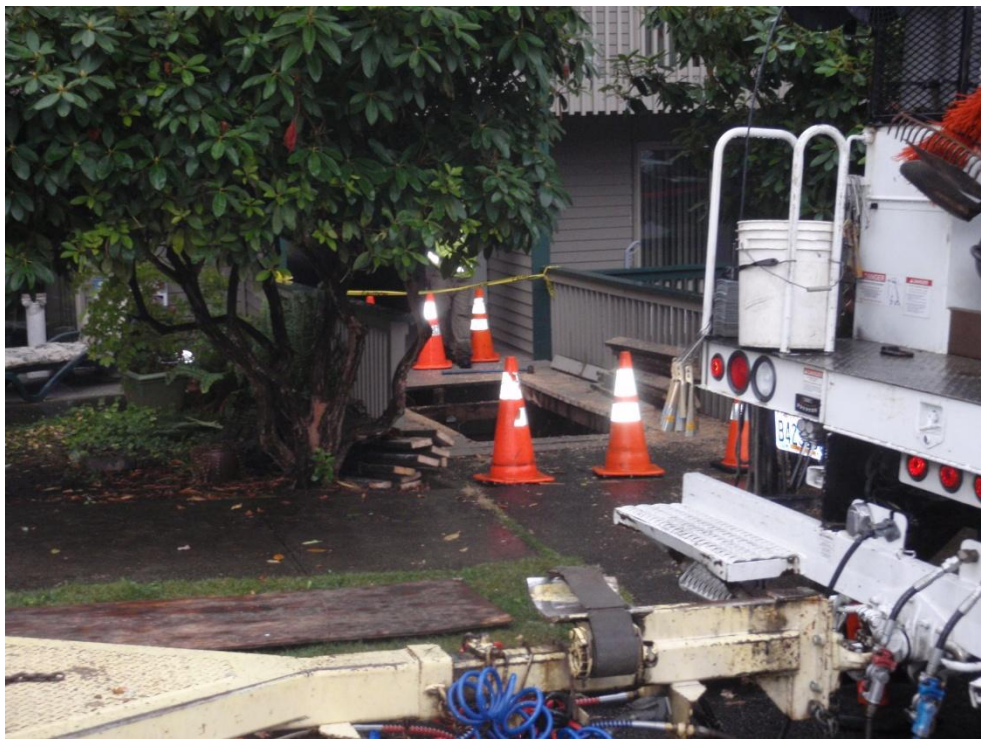
Cones mark access hole cut in top of pedestrian bridge to remove damaged transformer on August 31, 2010.

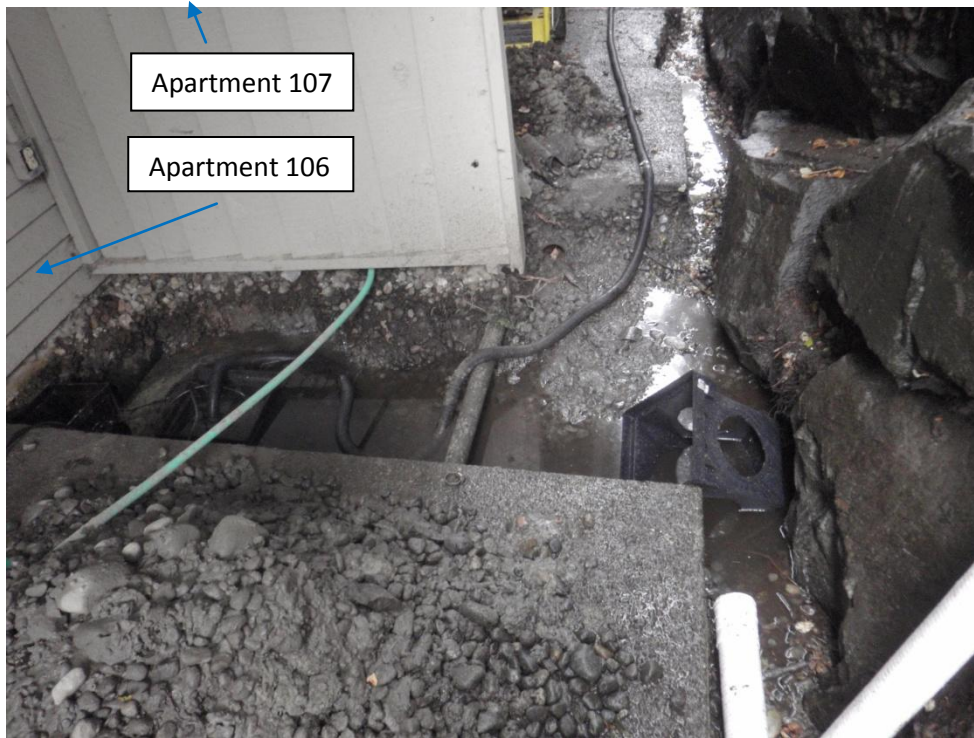
Sump pump used on north side of building for construction dewatering prior to initial spill response activities on August 31, 2010.

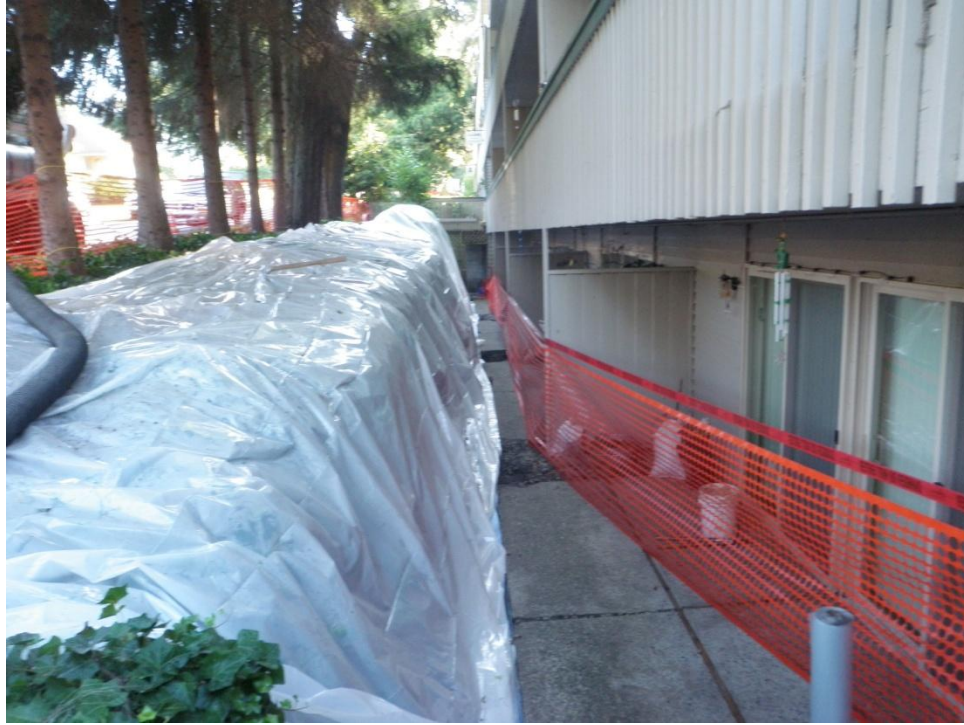
Exclusion zone to help isolate casual contact with potentially contaminated materials at the site; September 1, 2010.

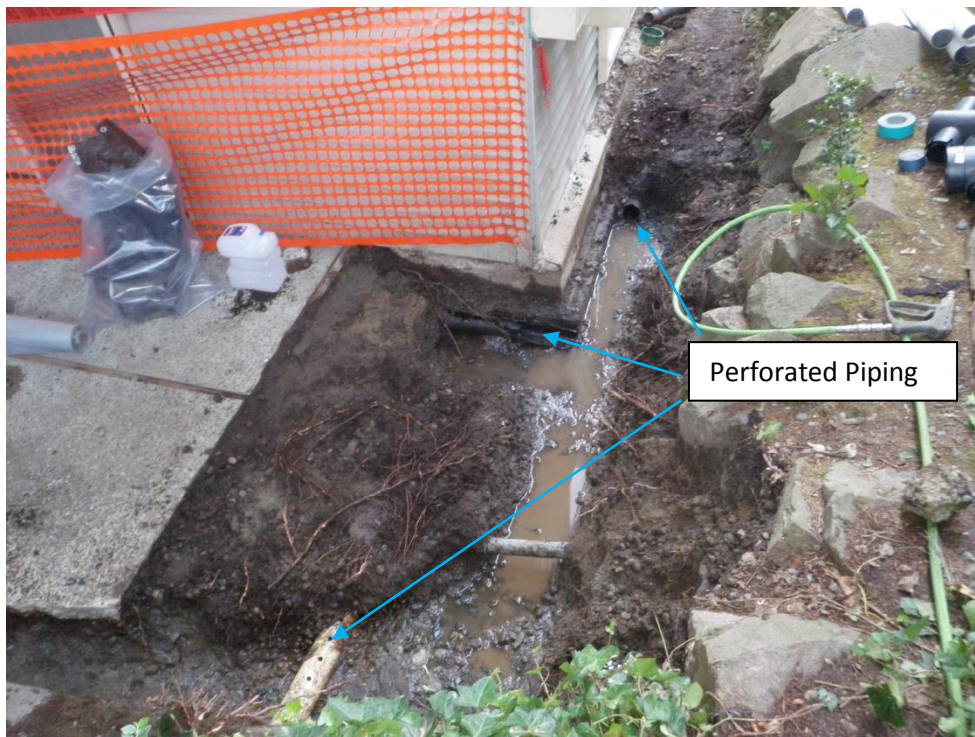
Northwest corner of the building exposing subsurface perforated piping on September 1, 2010.

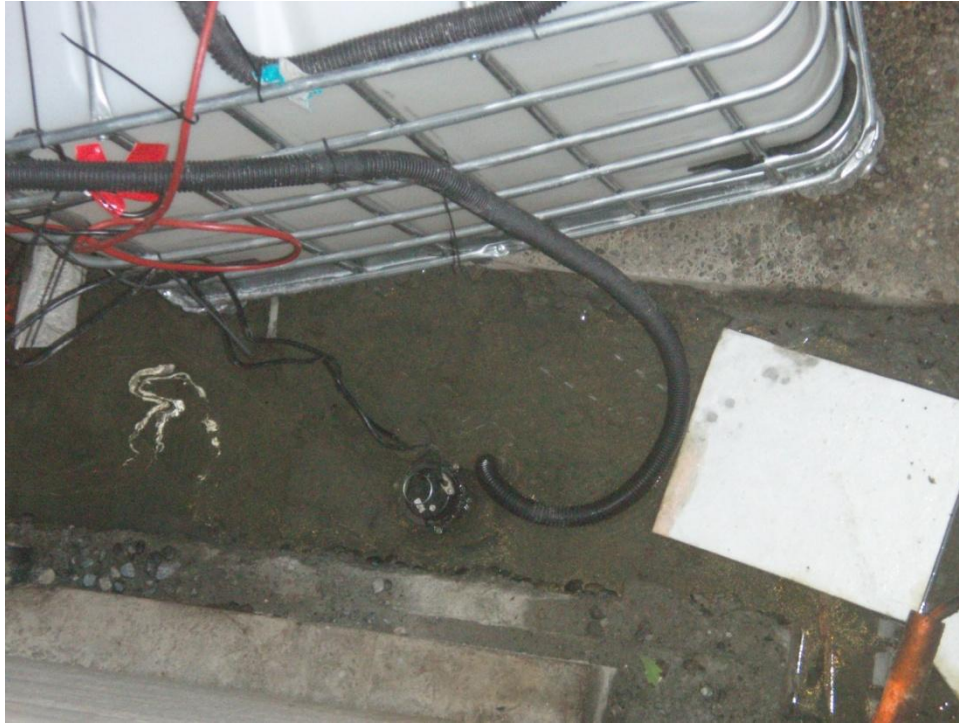
Containment of potentially impacted surface water by pumping to poly totes between September 1 and 18, 2010.

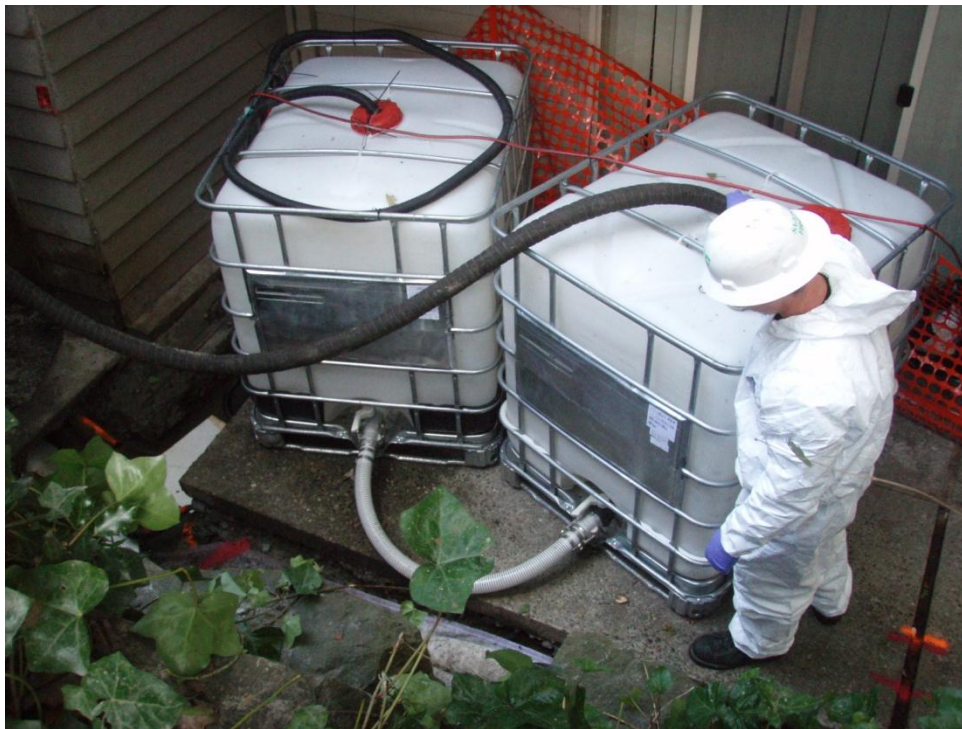
Temporary water storage in poly totes. Totes were emptied using a vacuum truck every two days and the fluids transferred off-site for permitted treatment and disposal between September 1 and 18, 2010.

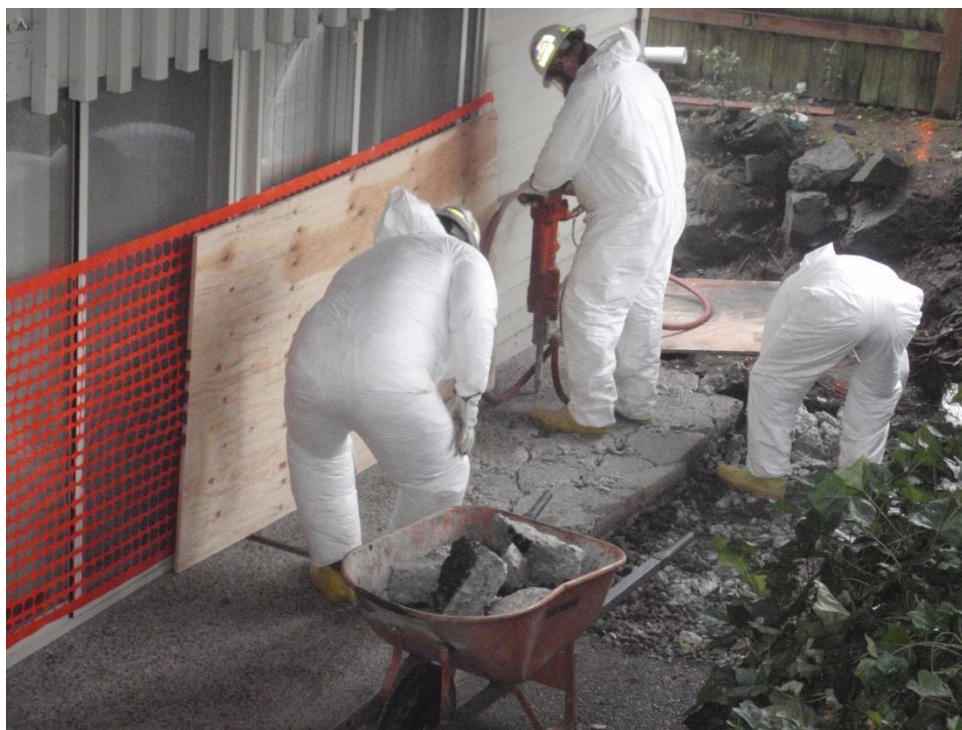
Concrete removal at patio decks during remedial activities; September 16, 2010.

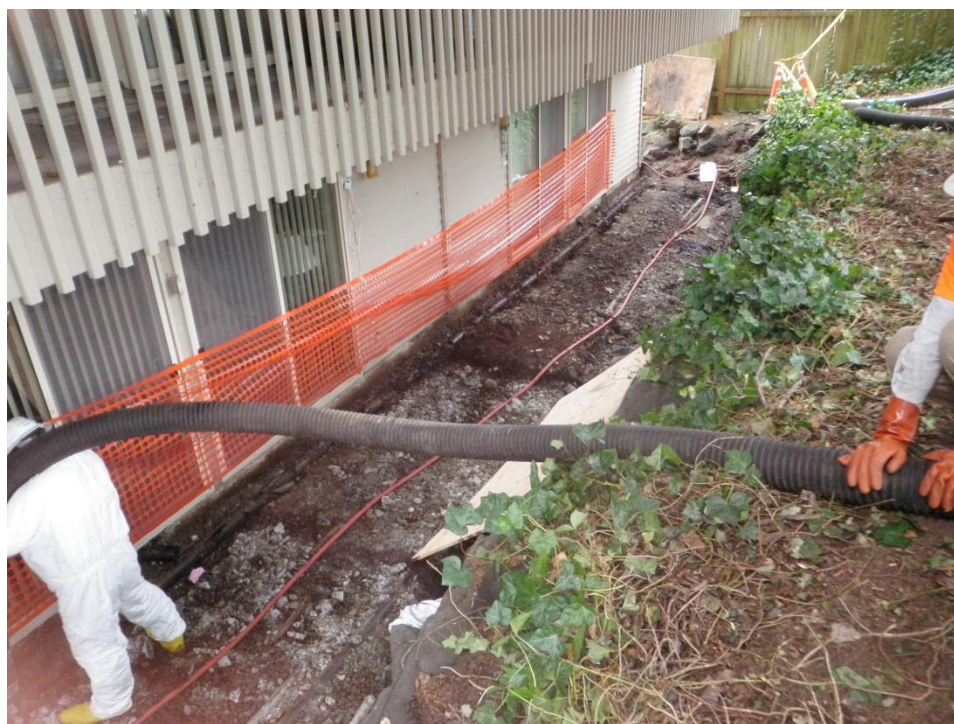
Soil removal using vac-trucks on September 16, 2010  
at perforated pipes beneath concrete patio decks.
