J-3149-02

March 3, 1992

Re: Soil Cleanup Report  
Snohomish County PUD Headquarters  
Everett, Washington

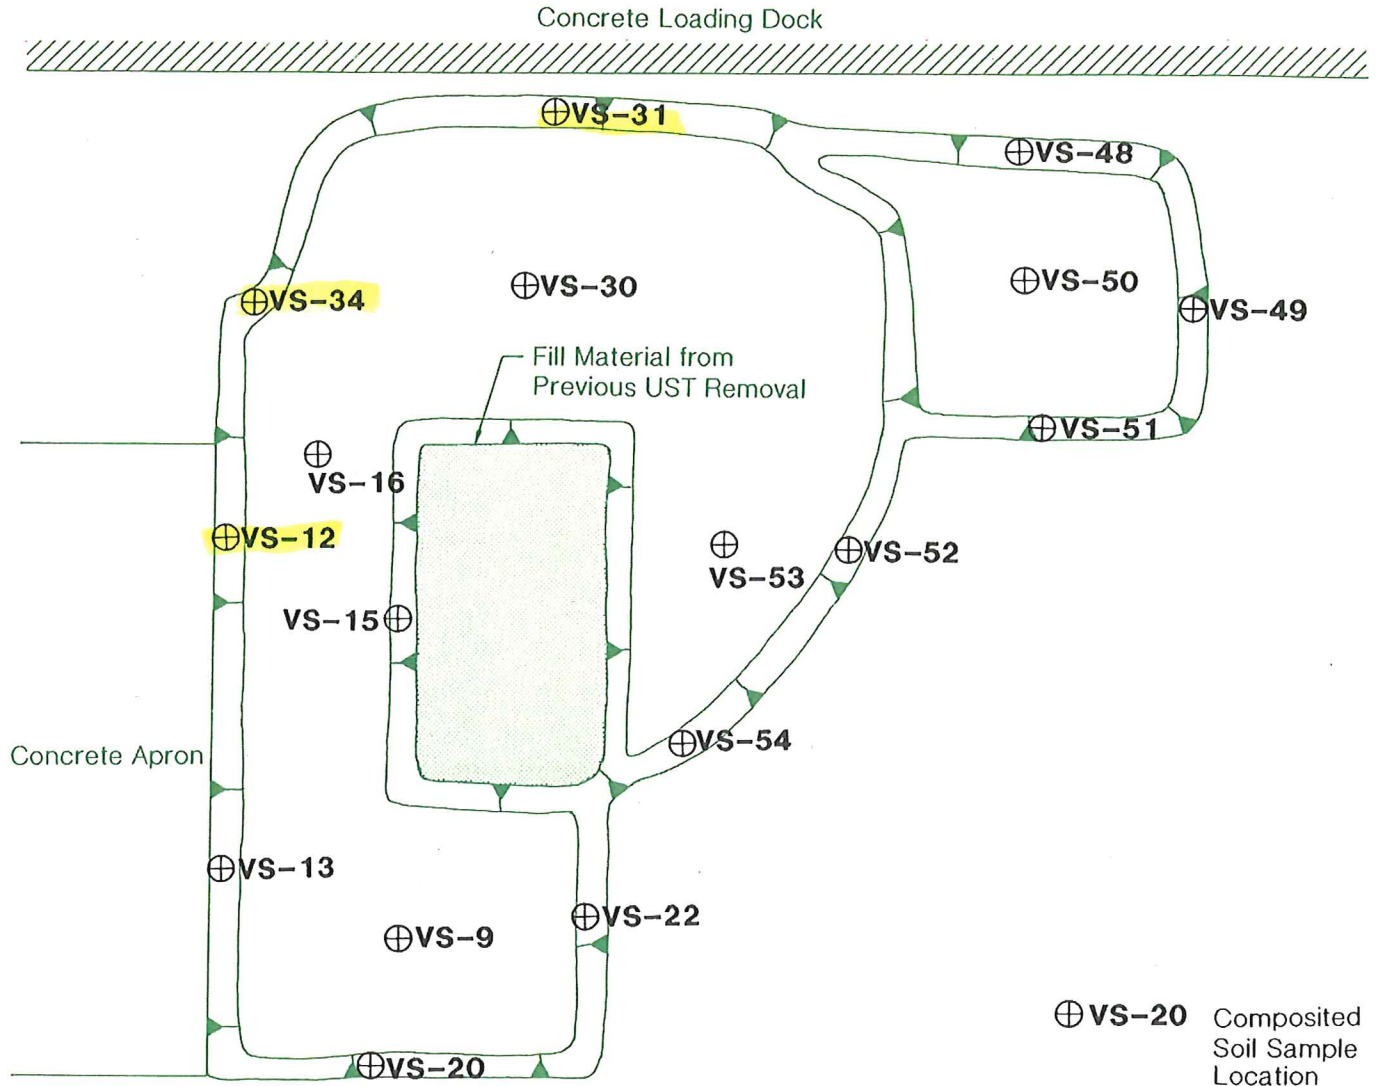
# Parking Garage Area Verification Sampling Location Plan

Excavation and restoration of the Parking Garage Area was performed between January 6 and 21, 1992. The final configuration of the excavation is shown on Figure 3, and the quantities of soil excavated and backfilled are listed in Table 2.

Composite verification soil samples were collected from the excavation side walls and bottom at the locations shown on Figure 3. The results of the chemical analyses are listed in Table 5. The verification analyses were limited to fuel hydrocarbons (Method 8015 modified) and total lead, because the detailed soil boring survey that was performed earlier demonstrated that no other contaminants were present at concentrations exceeding regulatory limits.
