REVISED REMEDIAL INVESTIGATION/FEASIBILITY STUDY AND REMEDIAL ACTION REPORT

BMC ISSAQUAH FACILITY
5210 EAST LAKE SAMMAMISH PARKWAY SOUTHEAST
ISSAQUAH, KING COUNTY, WASHINGTON
Facility Site ID #8428648
Cleanup Site ID #7791

Project No. 1099.25
February 26, 2018

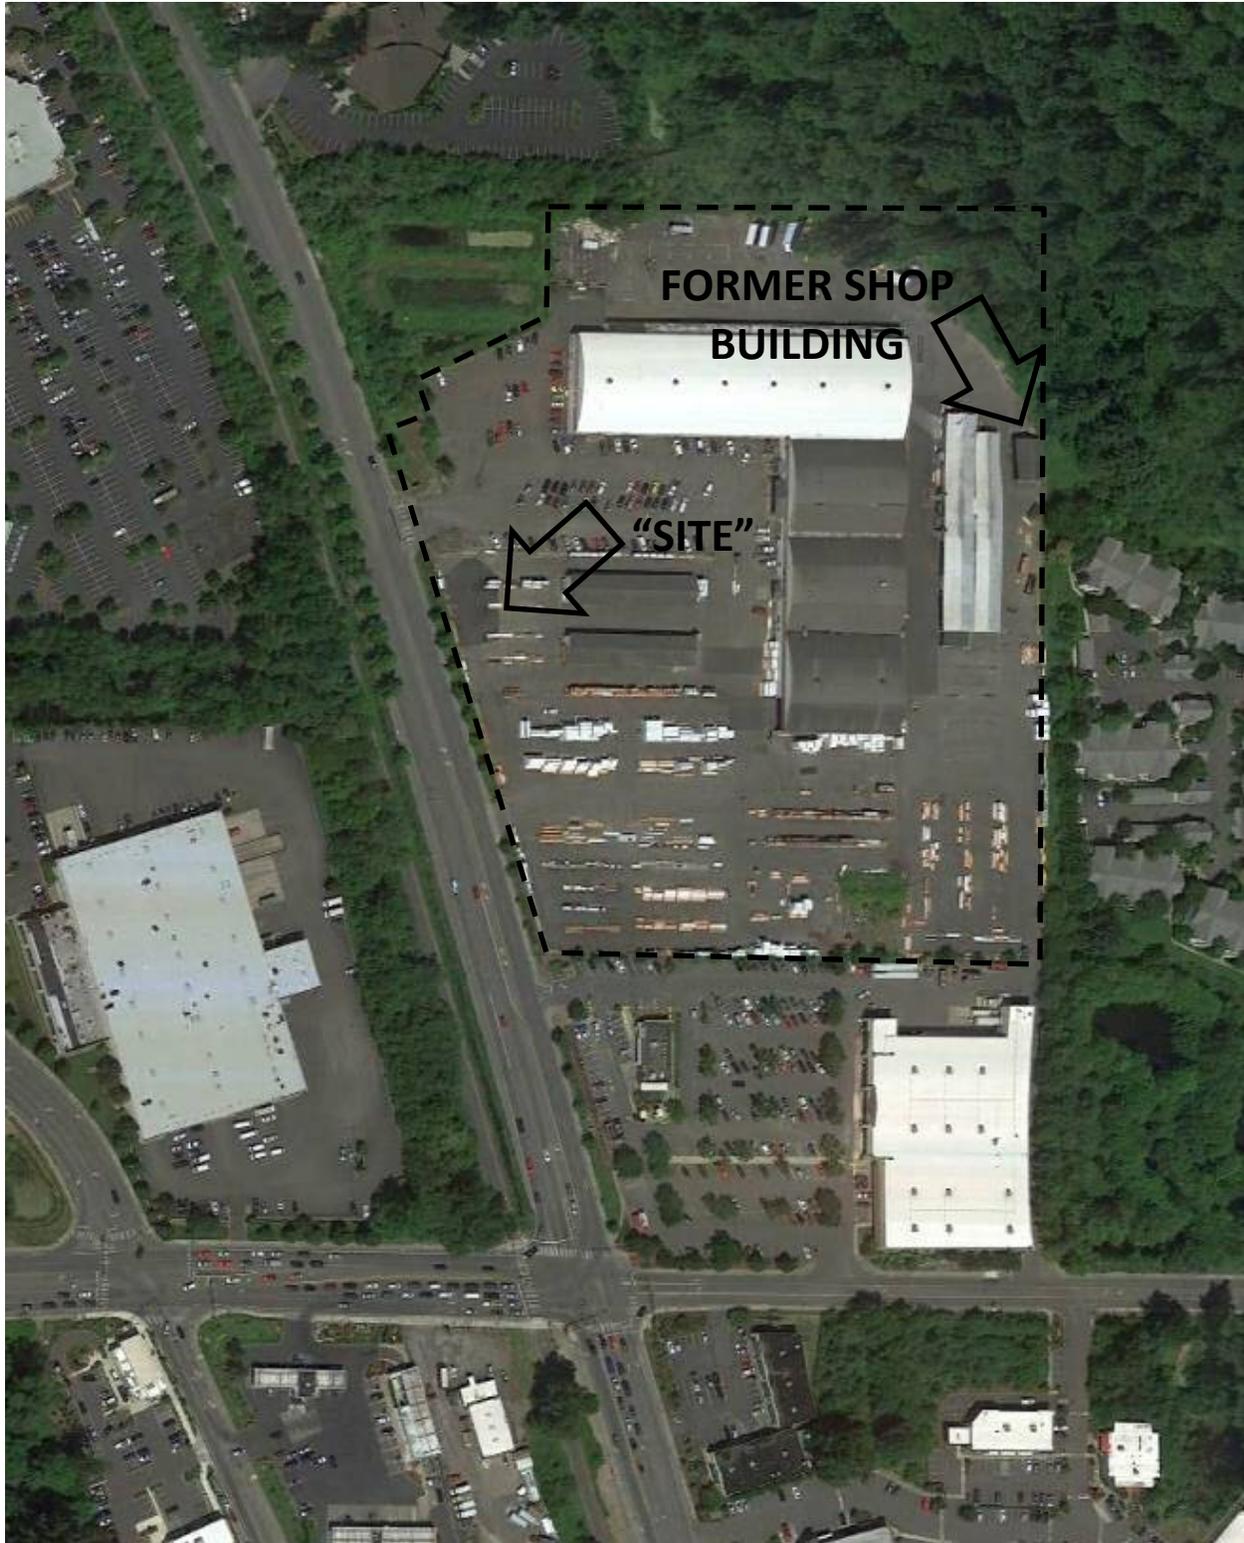
Figure 2 – 2016 Aerial Photograph (Google Earth). The property boundary is indicated by the black dashed line. The Site as defined by WAC 173-340-200 can be seen as the trapezoidal-shaped patch of fresh asphalt.

WAC 173-340-200 defines the Site as “any building, structure, installation, equipment, pipe or pipeline (including any pipe into a sewer or publicly owned treatment works), well, pit, pond, lagoon, impoundment, ditch, landfill, storage container, motor vehicle, rolling stock, vessel, or aircraft; or any site or area where a hazardous substance, other than a consumer product in consumer use, has been deposited, stored, disposed of, or placed, or otherwise come to be located”. In accordance with this definition, the Site is located within the west central part of King County tax parcel #009500-0030. The approximate location of the Site as defined by WAC 173-340-200 is indicated on Figure 2.

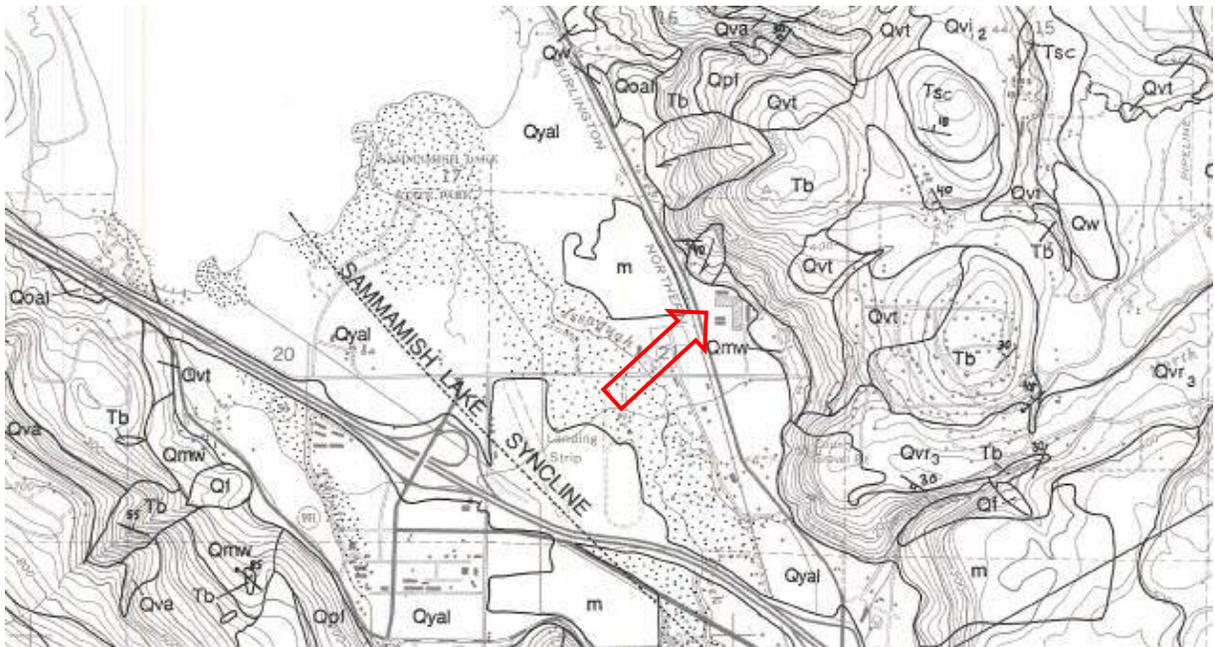
Figure 5. A portion of the Geologic Map of the Issaquah Quadrangle (Booth and Minard, 1992). The approximate location of the Site is indicated by the red arrow.

Geologic conditions in the vicinity of the Property have been mapped by Booth and Minard (1992). According to this geologic map, the Property is underlain by young Quaternary alluvial sediments (unit Qyal, Figure 5), which extend south and west to Interstate 90 and northwest to Lake Sammamish. These soils consist of beach and lacustrine (lake) deposits.

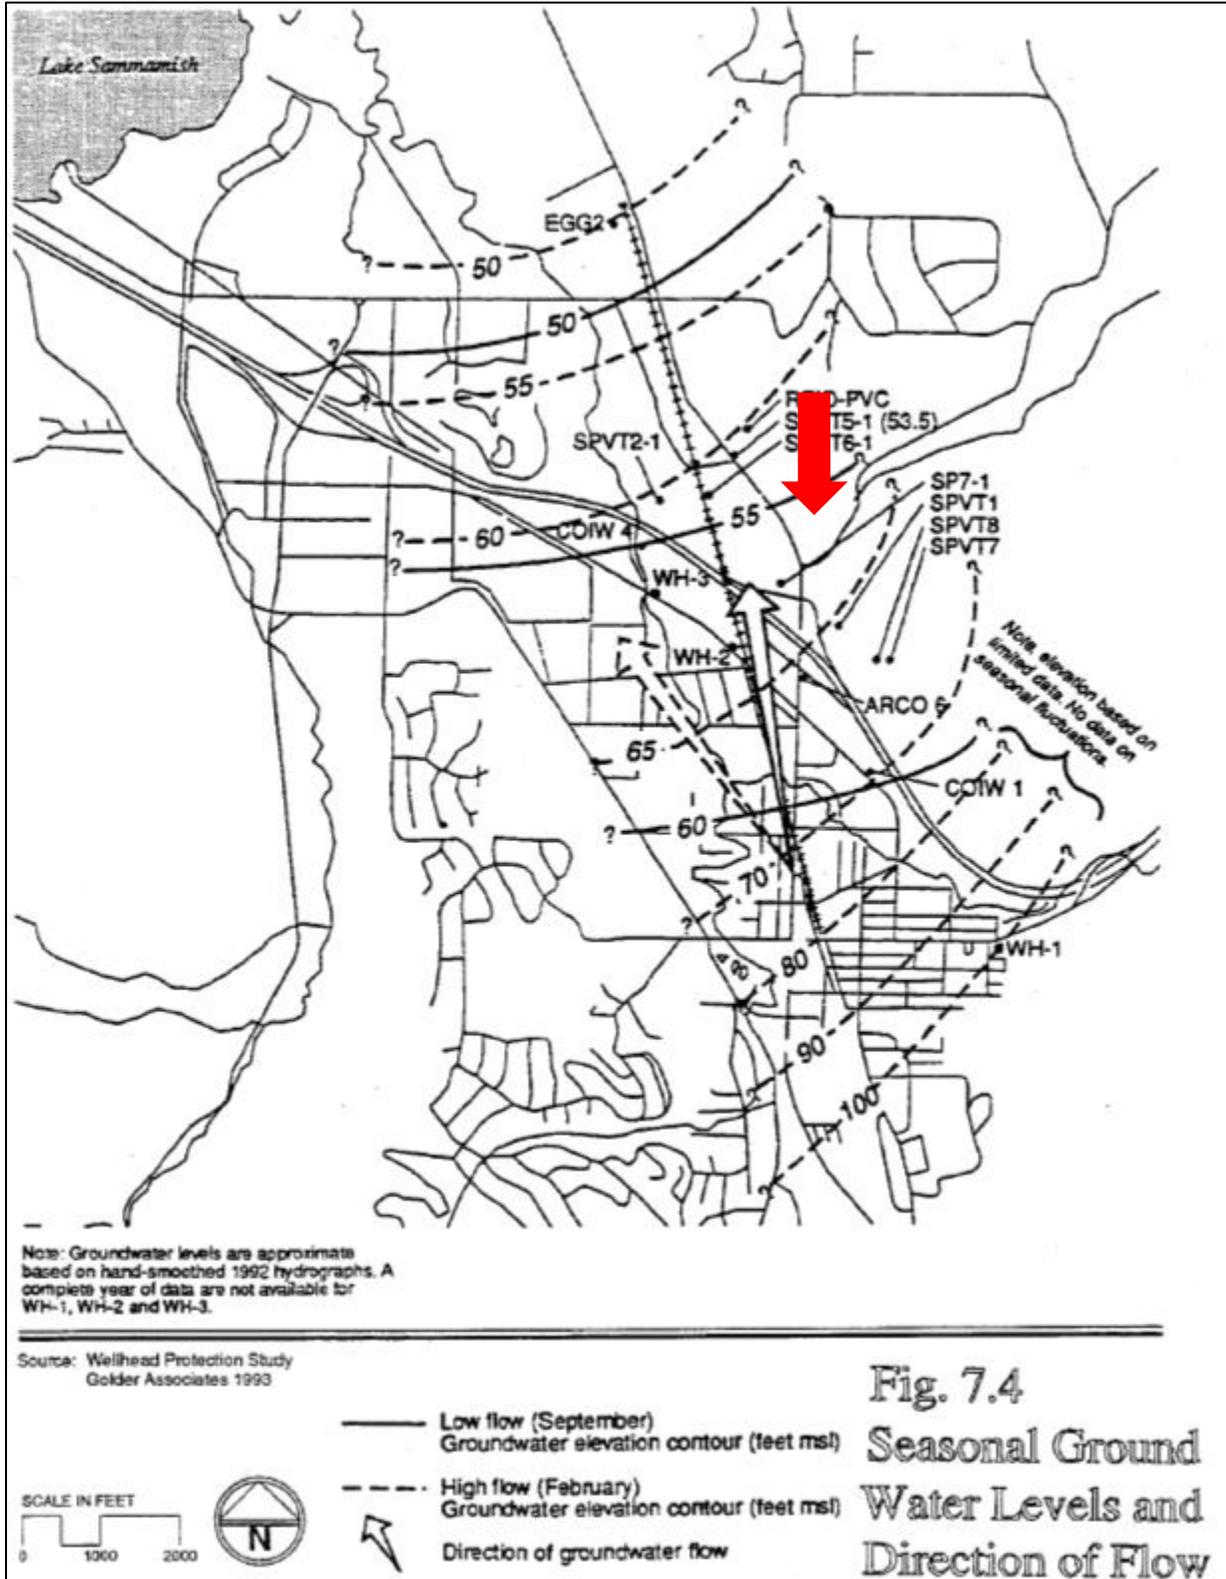
Figure 6. Groundwater contours. The approximate location of the property is indicated by the red arrow.

Based on a groundwater contour map on the King County Water and Land Services web site, produced by Golder Associates in 1993, shallow groundwater in the vicinity of the Site flows in a north-northwesterly direction (Figure 6). Groundwater was observed between about 2 to 3 feet below the ground surface during our post-remedial action groundwater sampling (see Section 5 of this report). Depth to groundwater and groundwater flow directions will likely vary seasonally.

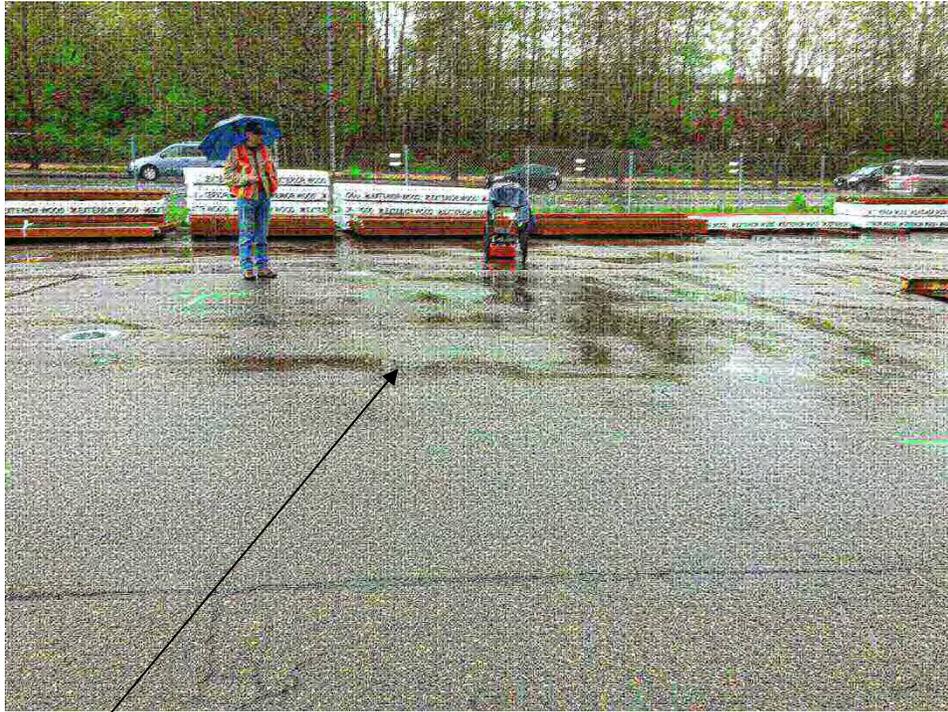
Possible UST pit

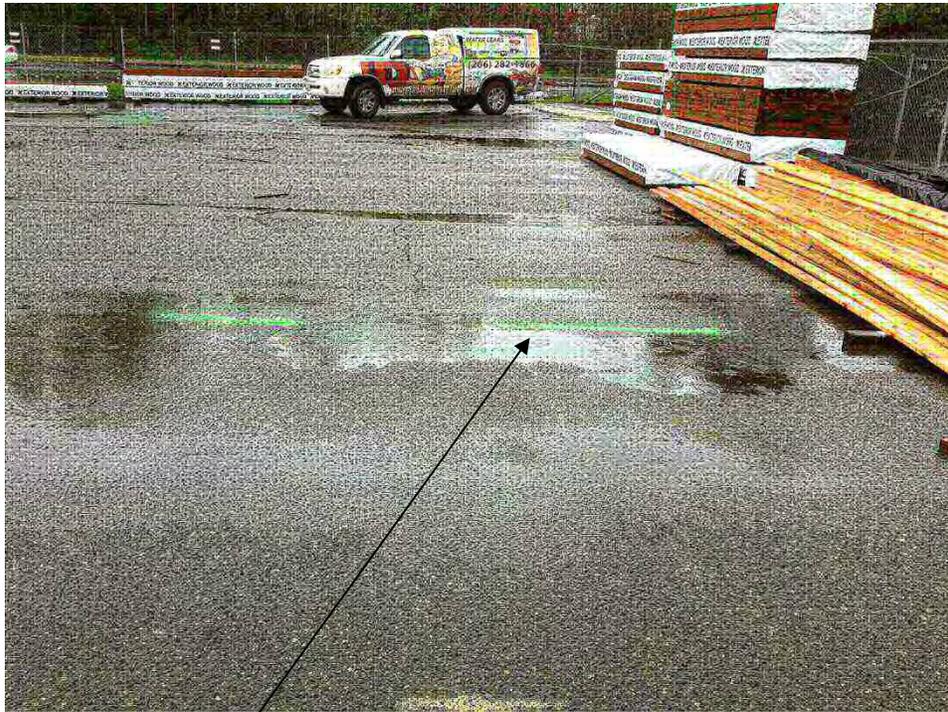
Unknown anomaly north of UST pit

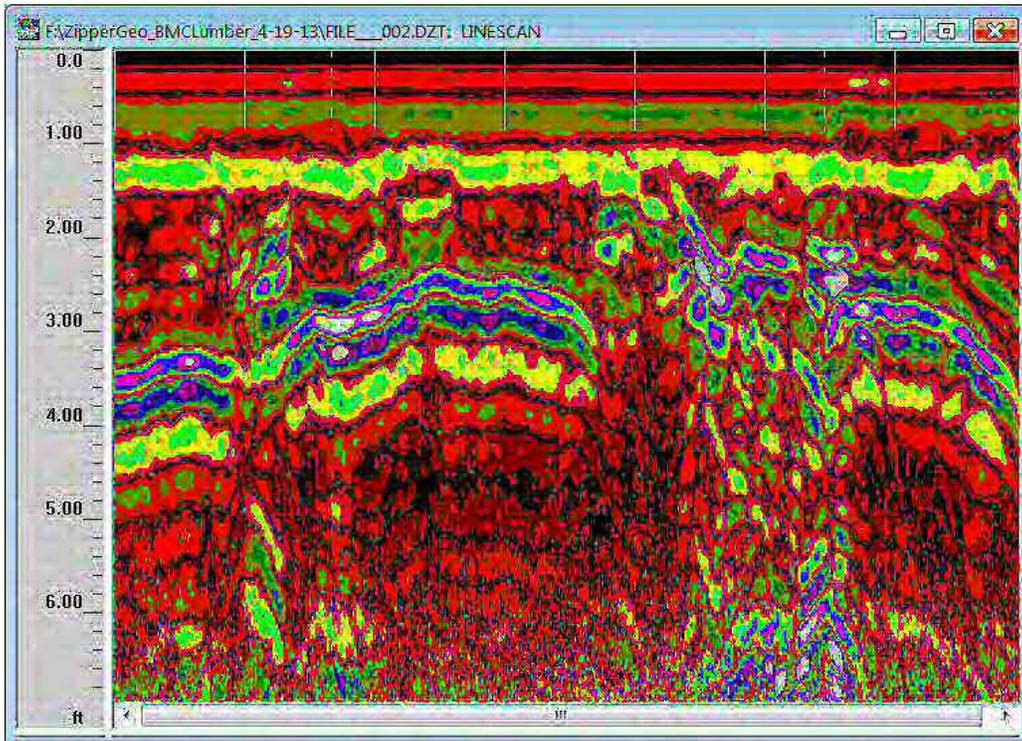
GPR Data; UST oit, East to West

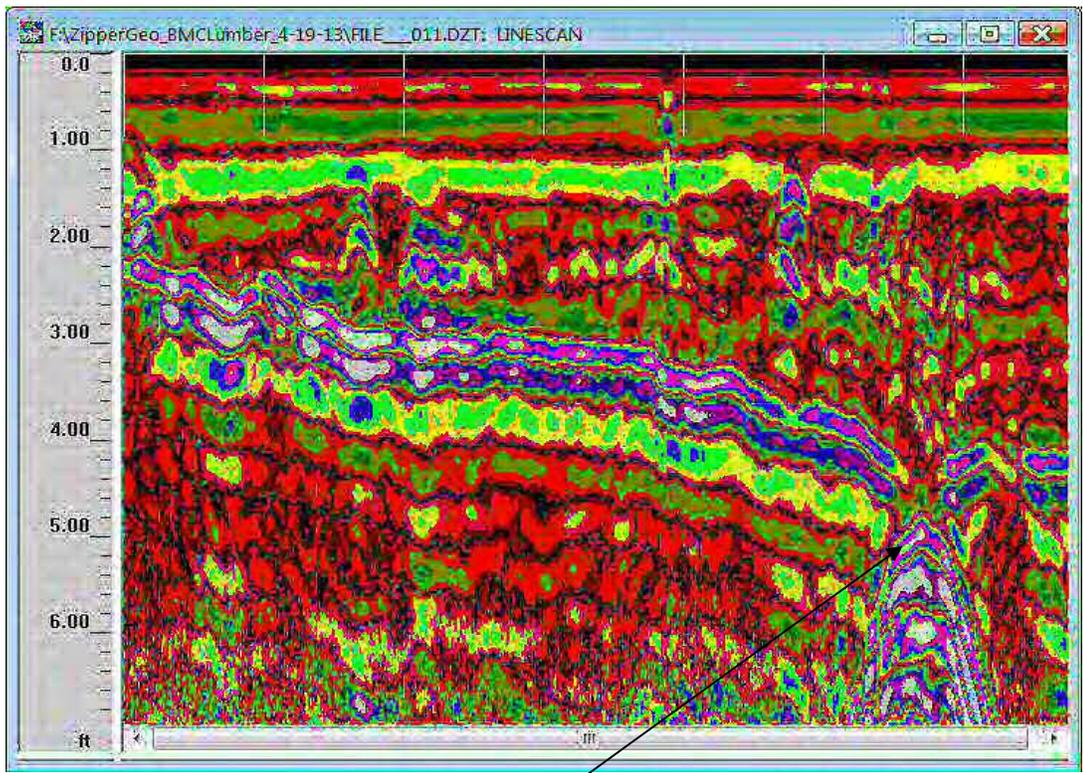
GPR Data; North of UST pit, W-E, unknown anomaly

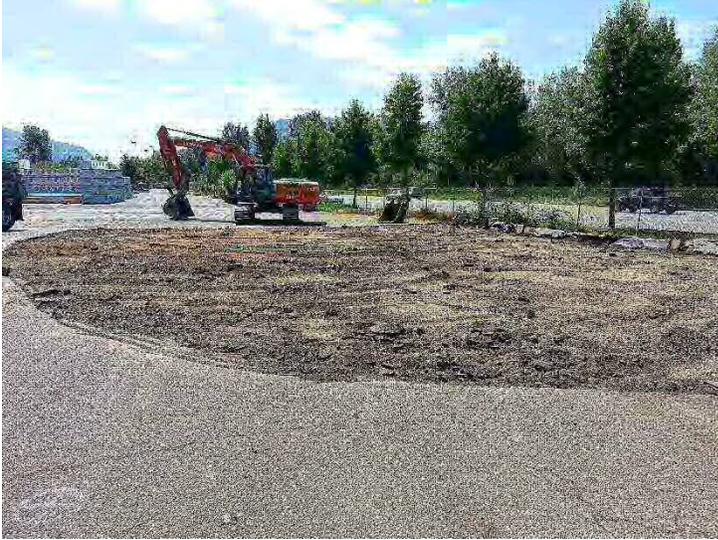
Photo #1. Asphalt removed and preparing to excavate contaminated soil.

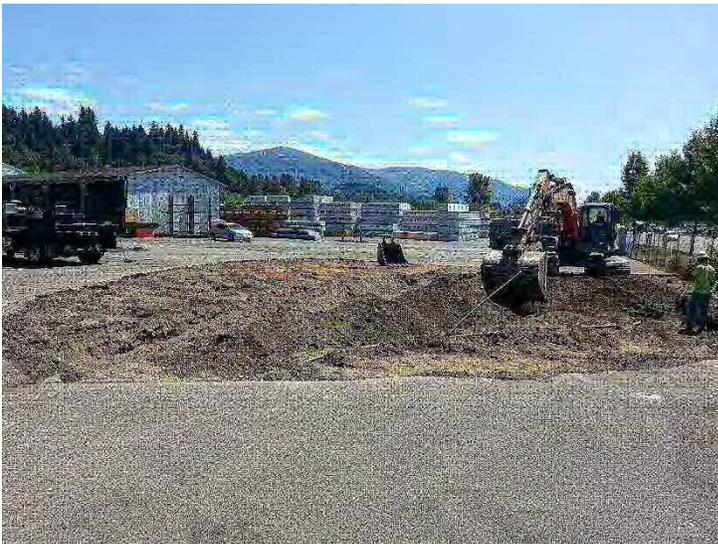
Photo #2. Removal of clean overburden fill soils.

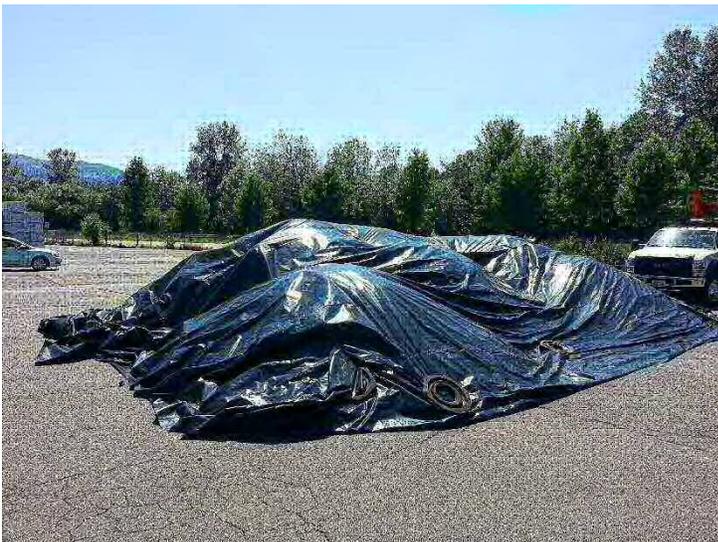
Photo #3. The stockpiled clean overburden soil was returned to the excavation following the remedial action.

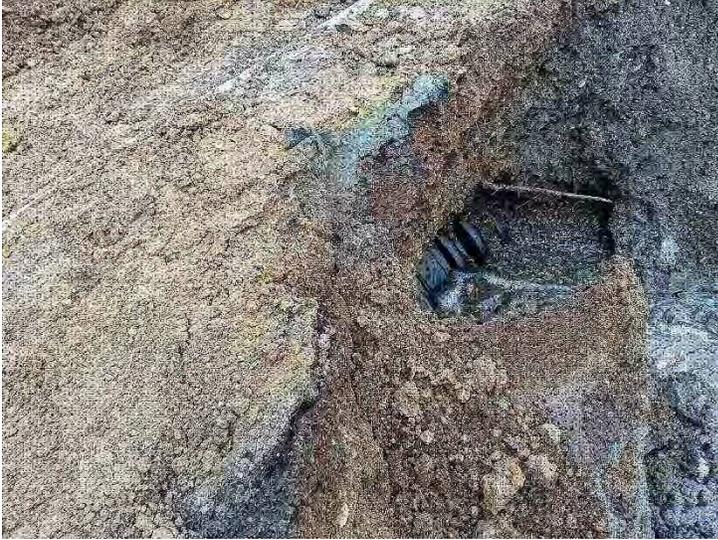
Photo #4. A 24-inch PVC storm water pipe was encountered along the west side of the remedial excavation. The pipe was not damaged by the excavator, instead water appeared to be leaking from a faulty pipe join.

A 24-inch PVC storm water pipe was encountered along the west side of the remedial excavation on July 21, 2015. Although the pipe was not damaged by the excavator, water leaked into the remedial excavation from what appeared to be a faulty pipe join (see photos in Appendix G). We determined that the storm

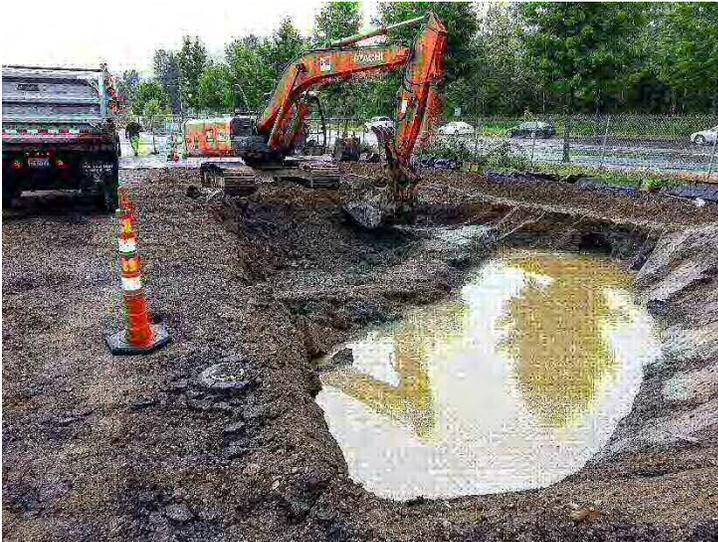
Photo #5. The leaking storm water pipe flooded the remedial excavation.

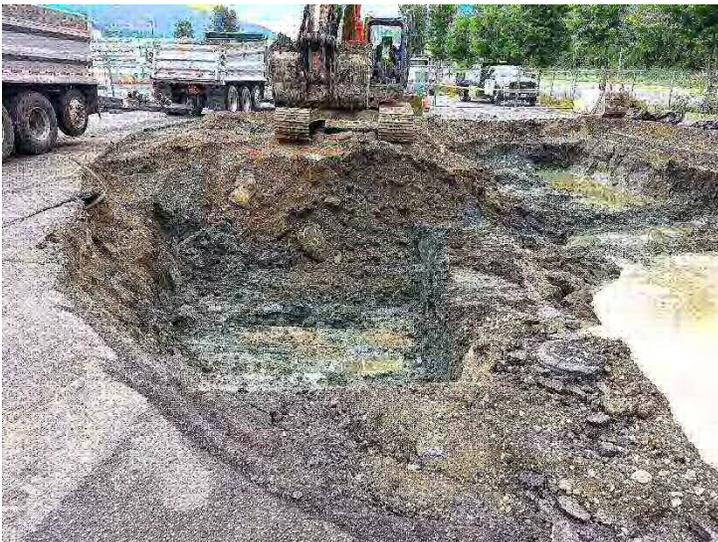
Photo #6. Impacted soil continued to be removed using temporary soil berms to retain the storm water pipe water.

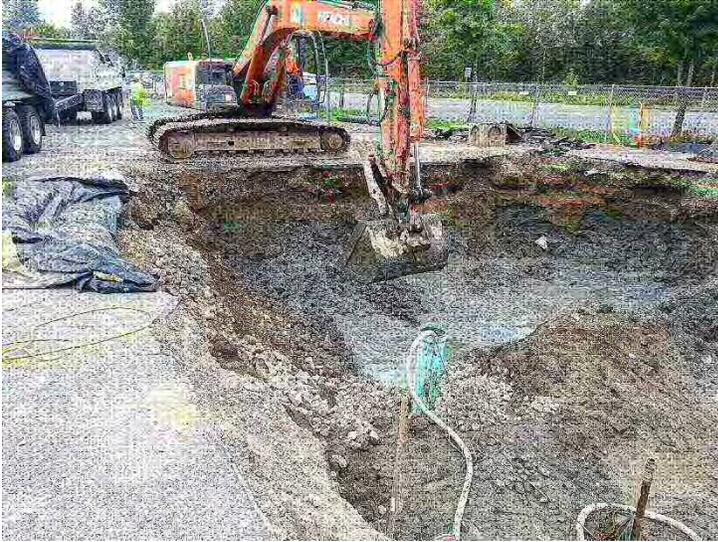
Photo #7. A sump was installed in the remedial excavation to extract water for treatment and subsequent permitted disposal to the King County sanitary sewer system.

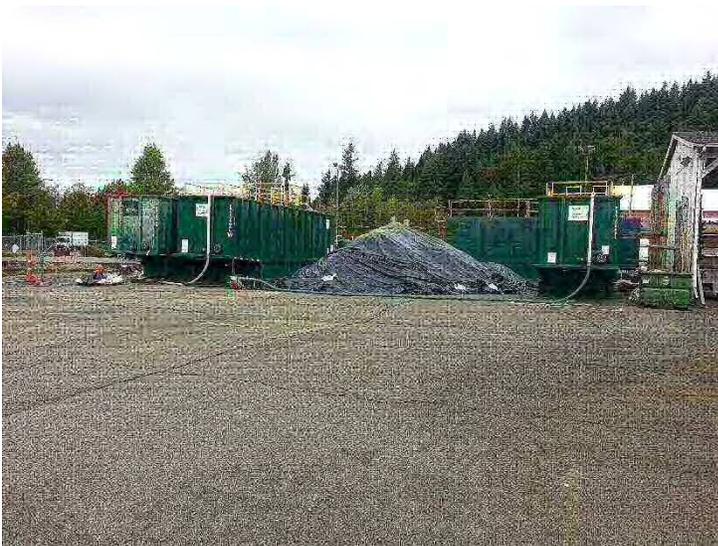
Photo #8. Dewatering effluent was stored in a series of four Baker tanks.

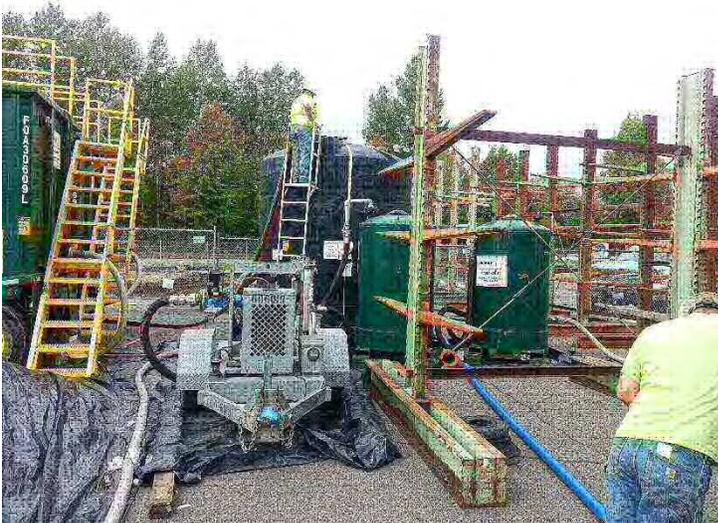
Photo #9. Dewatering effluent was treated with a sand filter and activated carbon, sampled and analyzed for TPH and BTEX, and discharged to the sanitary sewer under a King County permit.

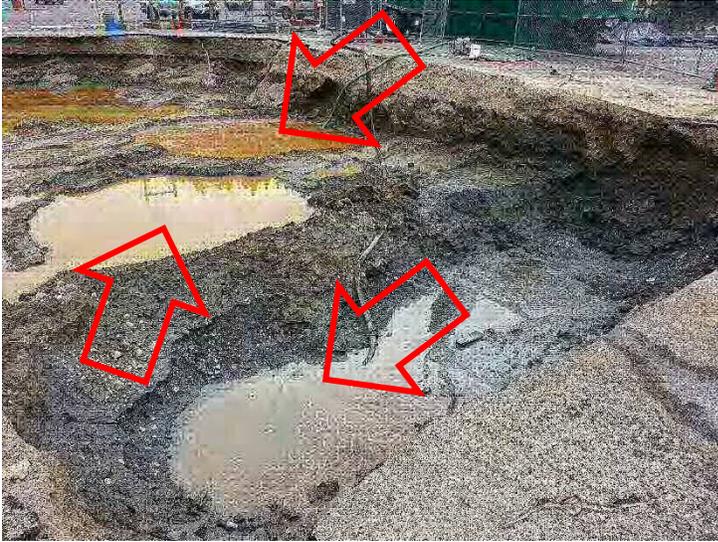
Photo #10. Rectangular-shaped areas that had been backfilled with pea gravel are assumed to be the former location of the three USTs removed in 1989.

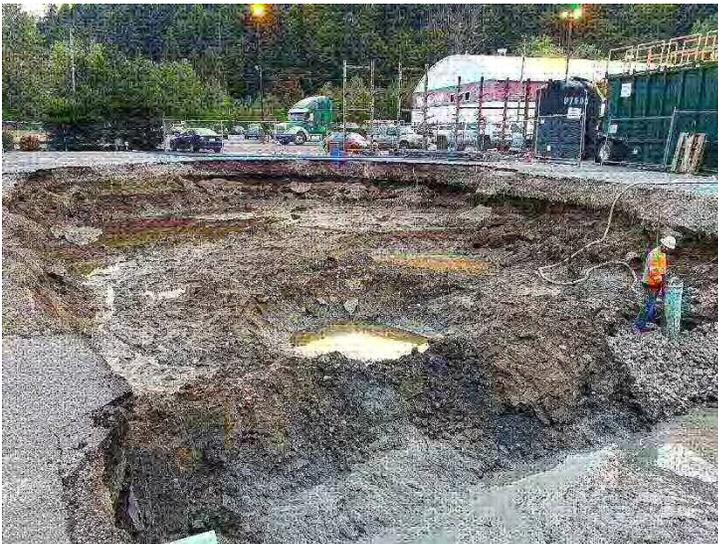
Photo #11. The final extent of excavation.

Excavated soil was field screened using the sheen test, a photo-ionization detector, and/or odor. Gasoline impacted soils were identified at depths ranging from about 2 feet to 6 feet below grade, except for on the south part of the excavation where three likely historical UST cavities were found. The cavities were identified by the presence of rectangular areas that contained several feet of pea gravel. Gasoline impacted soil in these areas extended to depths ranging from about 8 to 11 feet.

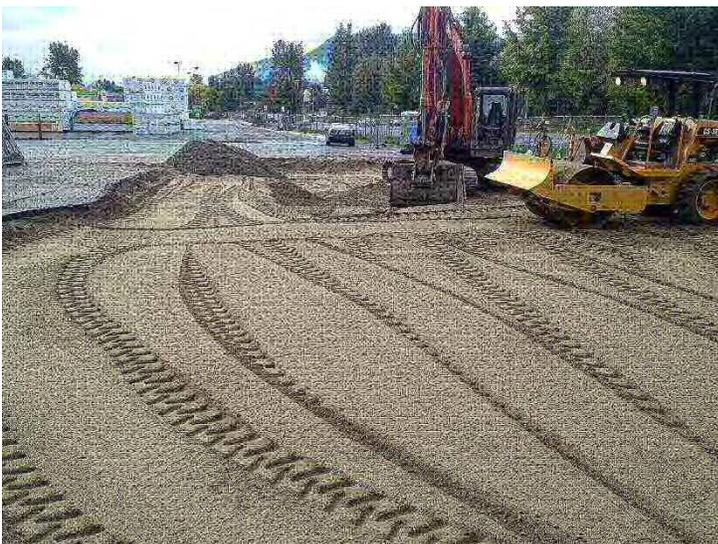
Photo #12. Backfilled excavation.

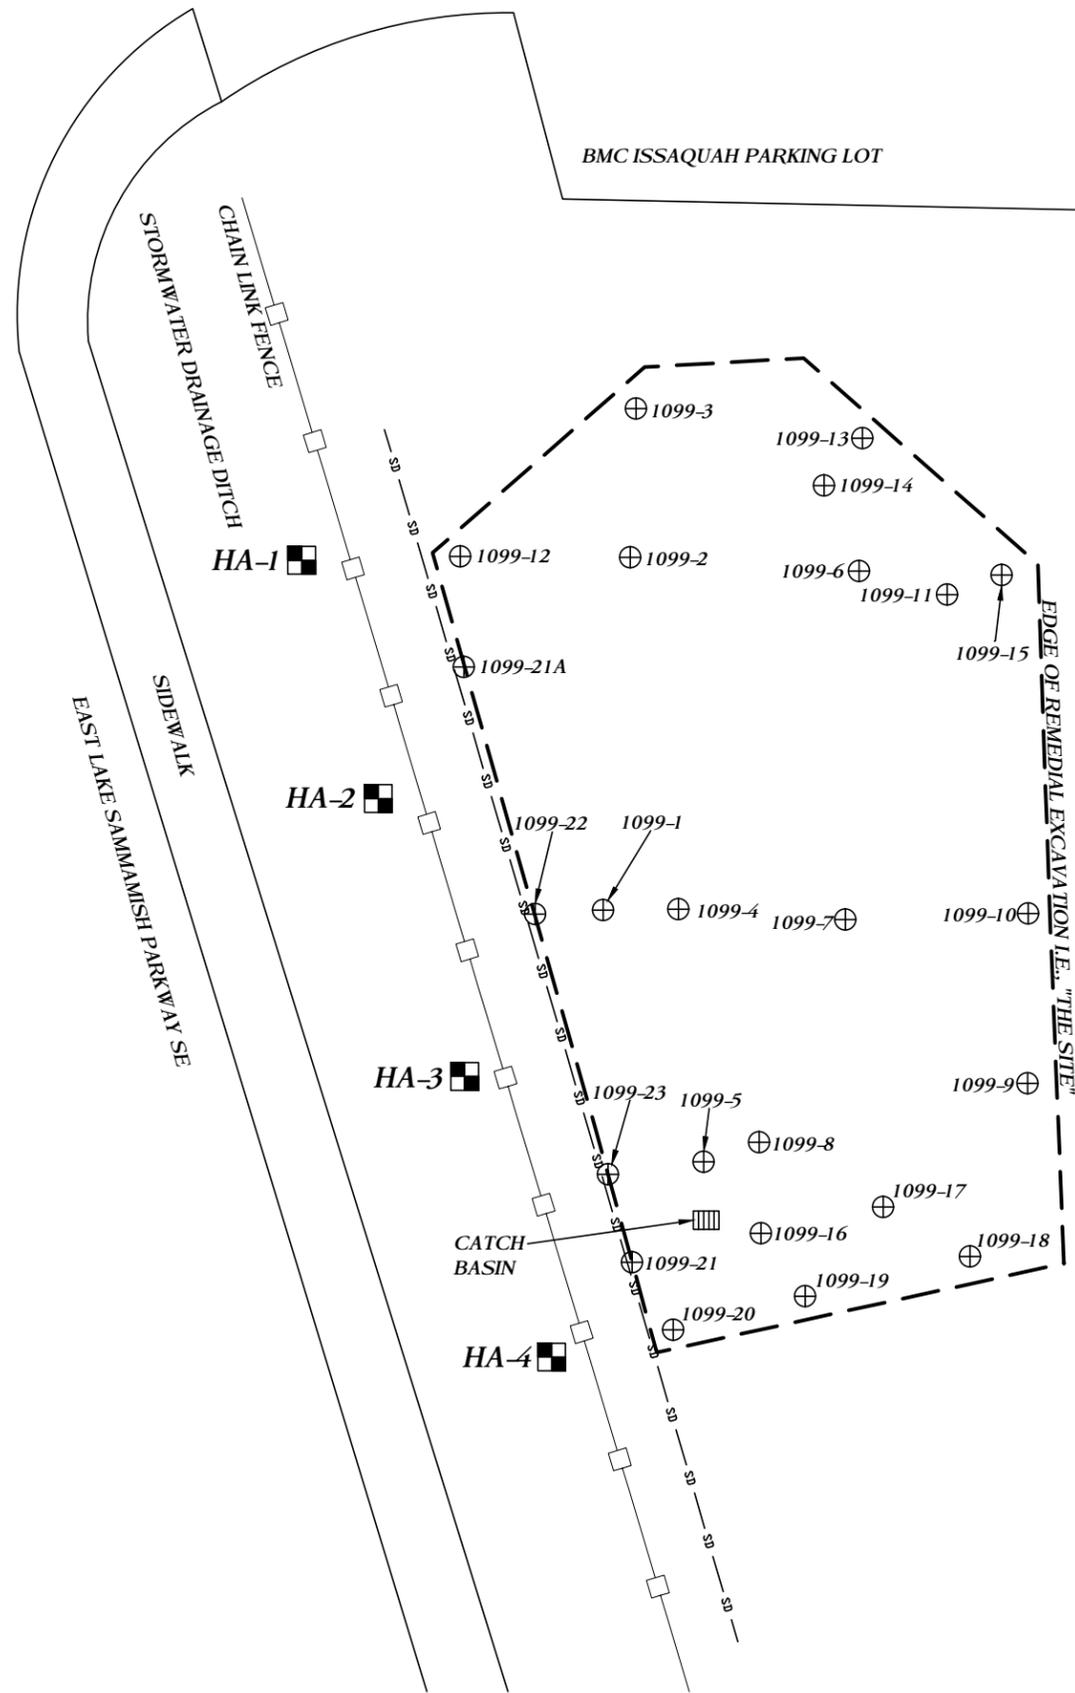
BMC ISSAQUAH 5210 East Lake Sammamish Parkway SE Issaquah, Washington		
REMEDIAL EXCAVATION SOIL SAMPLE LOCATIONS		
DATE: JANUARY 2017	Job No.	1099.25
Zipper Geo Associates, LLC 19023 36th Ave. W., Suite D Lynnwood, WA	FIGURE	7
		SHT. 1 of 1

- HA-1 APPROXIMATE LOCATION OF HAND AUGER EXPLORATION WITH ID
- 1099-1 APPROXIMATE LOCATION OF REMEDIAL EXCAVATION SOIL SAMPLE WITH ID
- SD — SD — APPROXIMATE LOCATION OF STORM DRAIN OBSERVED DURING REMEDIAL EXCAVATION
- — — "THE SITE" PER WAC 173-340-200
