INTERIM ACTION REPORT

Mercury Soil Treatment and Disposal Project,
Chlor-Alkali RAU, Georgia-Pacific West Site,
Bellingham, Washington

Prepared for: Port of Bellingham

Project No. 070188-001-28 • March 8, 2018 Final

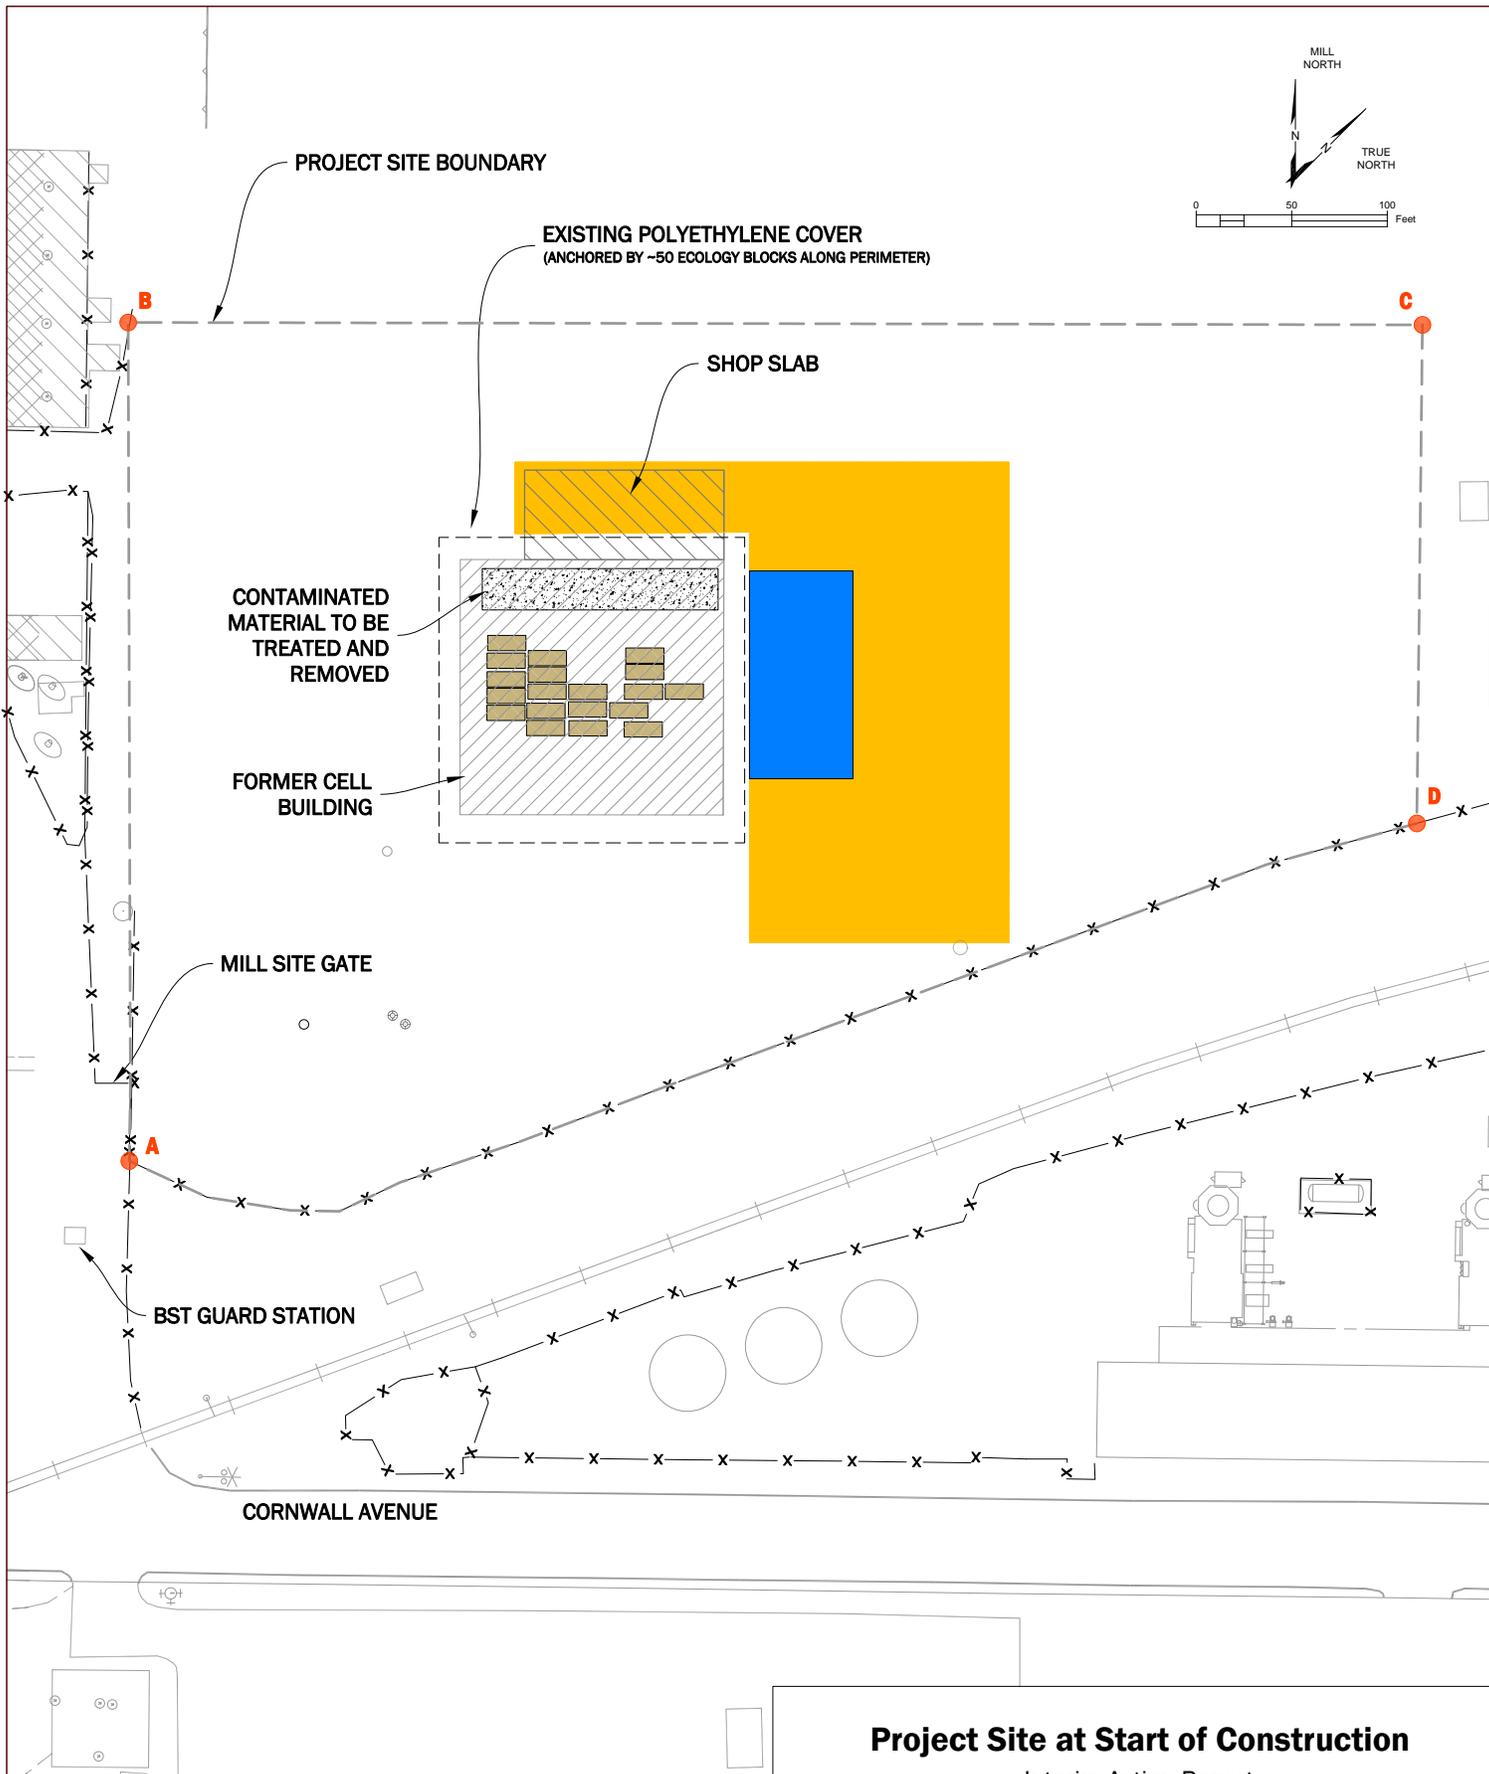
Jan-2018	BY: SJG/SCC	FIGURE NO. 2
	PROJECT NO. 070188	REVISED BY: SCC

The Interim Action area (Project Site) at the start of construction is depicted on Figure 2. When the floor slab of the Cell Building was removed in a previous (2013-2014) interim action (Aspect, 2014), extensive mercury contamination was unexpectedly observed in the subgrade, and underlying impacted soils and building foundation components were removed in selected areas. Due to the unexpected conditions, approximately 430 cubic yards of soil and debris were left in the northern¹ portion of the Cell Building footprint at the end of that interim action, and 19 steel road plates (generally 20 feet by 8 feet and 1 inch thick) were placed across grade beams that remained in place to cover open excavation areas. Crushed brick generated from demolition of the former pulp mill was placed and graded to generally level the area. The entire Cell Building footprint, including the soil/debris pile, was then covered with a 12-mil-thick polyethylene cover, which was anchored around its perimeter with approximately 50 ecology blocks.

As depicted on Figure 2, the Contractor established a waste storage area and erected a treatment enclosure (tent) over the area where contaminated soil was to be treated. In addition to protection from the weather, the treatment enclosure provided containment of mercury vapor generated during the soil treatment process. Air from inside the enclosure

Project Site at Start of Construction

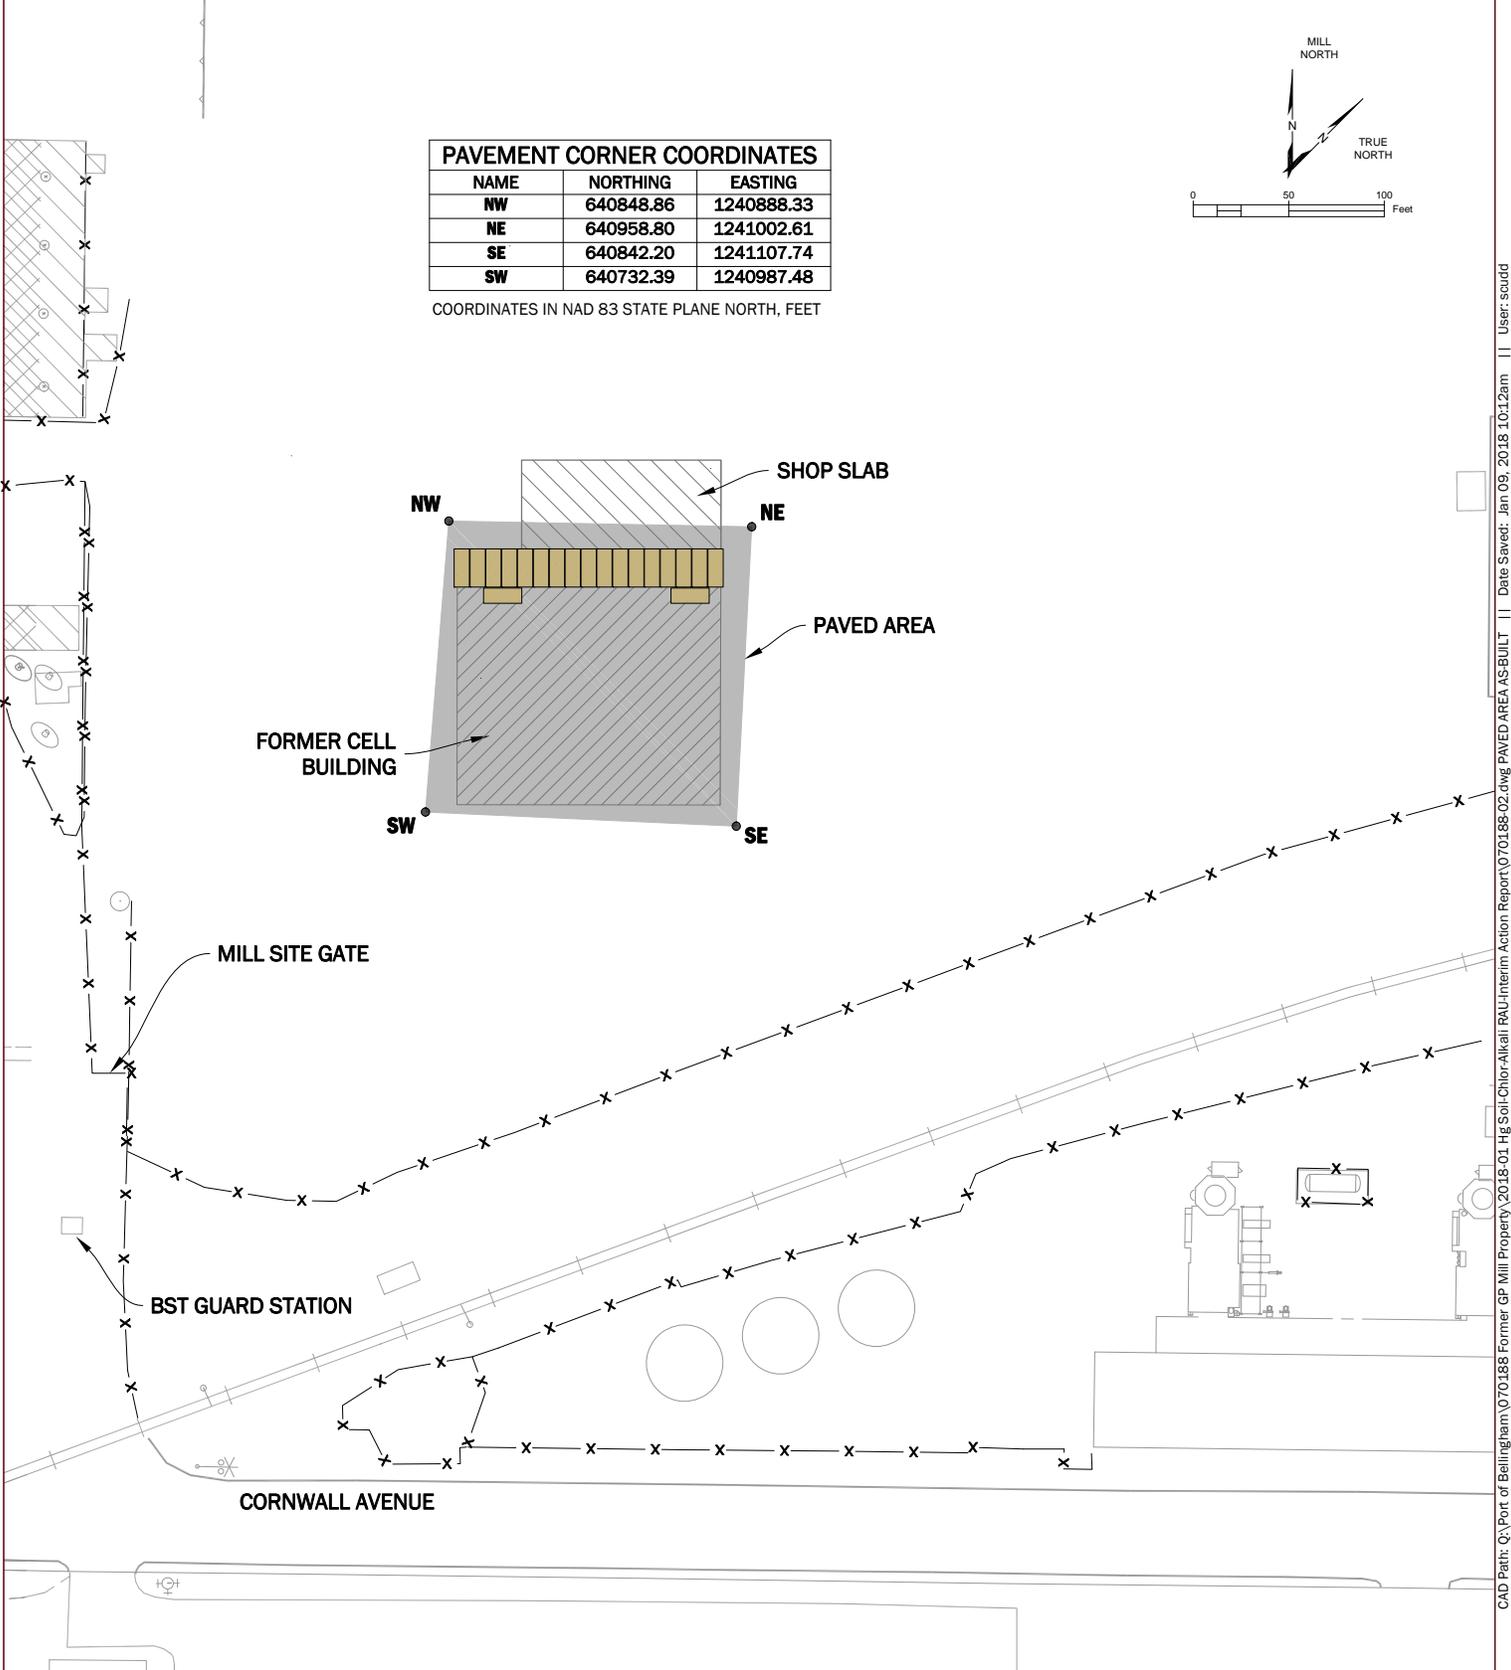
FIGURE NO.
3

Figure 3 depicts in plan view the as-built pavement covering the former Cell Building footprint. Approximate locations of the steel road plates beneath the pavement are shown for future reference. Figure 4 is a schematic cross section depicting a generalized vertical sequence of subgrade materials beneath the new pavement, recognizing that the distribution and thickness of subgrade materials are variable across the paved area (see notes on Figure 4). During the final cleanup action currently planned for the RAU, all materials beneath the separation geotextile will be considered contaminated and thus will be remediated, whereas the materials above the separation geotextile will be considered uncontaminated.

Paved Area As-Built
Interim Action Report
Mercury Soil Treatment and Disposal Project
Chlor-Alkali RAU, GP West Site, Bellingham, Washington

With approval from the Port, the actual work differed from the above in several respects. These are described below, along with reasons for the changes:

1. The crushed brick material within the Cell Building footprint and soils generated during the Bellingham Shipping Terminal (BST) Phase 1 stormwater improvements project were used in lieu of imported gravel borrow to fill the void spaces. Beneficially reusing the on-Site stockpiled soils was done primarily to reduce project costs, as well as to reduce off-Site impacts from mining and importing native aggregate for the same purpose. Prior to making this change, the Port provided BST soil sampling results to Ecology in a letter proposing that a portion of the stockpiled BST soils be used for this purpose (Port, 2017); Ecology approved the change. Soils from the “TW,” “LP,” and “MFD” stockpiles referenced in Port (2017) were used to fill voids beneath the pavement.

2. The steel road plates were placed on the ground surface in the northern portion of the Cell Building footprint (beneath the geotextile) instead of staging them elsewhere. This was done to help stabilize the ground surface in that area prior to paving, as the dredge fill soils there were extremely soft and thus incapable of supporting equipment loads during subsequent pavement construction.

3. Additional thickness of CSBC was placed on the geotextile in lieu of imported gravel borrow. This was also done to help stabilize the ground surface across the entire area prior to paving. While the northern portion of the Cell Building footprint exhibited the worst conditions, the ground surface throughout the area to be paved was observed to be soft and lacking in load-bearing capacity. The total volume of CSBC placed was equivalent to roughly a 12-inch thickness over the entire Cell Building footprint; however, the CSBC layer was thicker in the center and tapered at the edges to promote drainage from the final paved surface.

4. Slope orientation was adjusted so that drainage of precipitation from the paved surface would be primarily to the northeast and southwest rather than to the north and south. This was done so that stormwater would be more efficiently directed to existing catch basins with demonstrated drainage capacity.

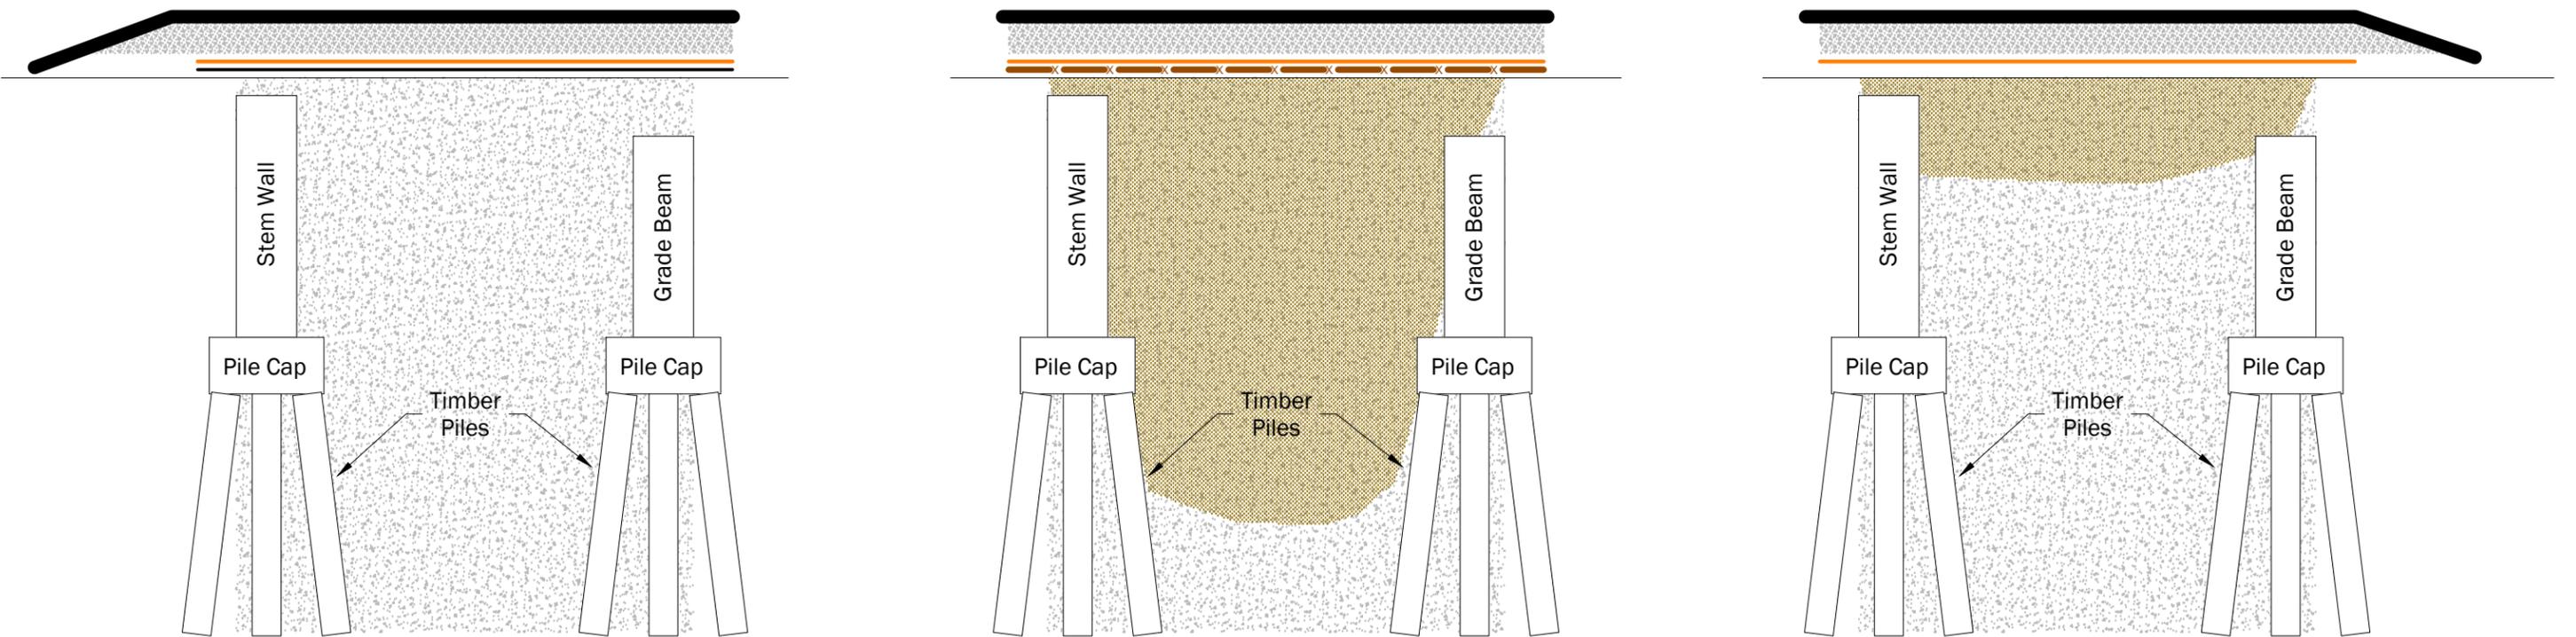
FIGURE NO.
4

Placed (not compacted) during Interim Actions

Placed during 2017 Interim Action

Soft, wet, silty, dredge-spoils fill

Crushed Brick

Sandy, gravelly fill

Hot Mix Asphalt (HMA) 3" Thickness

Crushed Surfacing Base Course (CSBC) Variable Thickness

Separation Geotextile

8' x 20' Steel Road Plate

1. This figure is a schematic representation of subgrade conditions for the mill-northern, mill-central, and mill-southern portions of the Cell Building footprint. Subgrade conditions will vary from those shown, depending on location.
2. Subgrade conditions across the former Cell Building footprint are variable because, during the 2013-2014 interim action, some foundation elements (grade beams, pile caps) were removed and some contaminated dredge-spoils fill was excavated to variable depths. Some of the excavations were backfilled with imported gravel borrow and some were left open (voids) until backfilled with onsite stockpiled soil during the 2017 interim action. Also, note that the nature of the dredge-spoils fill is variable.

Schematic Cross Section of As-Built Pavement and Subgrade Conditions
