**RE: REQUEST FOR WRITTEN OPINION
FOCUSED FEASIBILITY STUDY AND DISPROPORTIONATE COST ANALYSIS
OLD STONEWAY RENTON PROPERTY
1915 SOUTHEAST MAPLE VALLEY HIGHWAY, RENTON, WASHINGTON
VCP PROJECT NO. NW1702
FARALLON PN: 266-008**

**Old Stoneway Renton Property
1915 Southeast Maple Valley Highway
Renton, Washington**

Farallon PN: 266-008

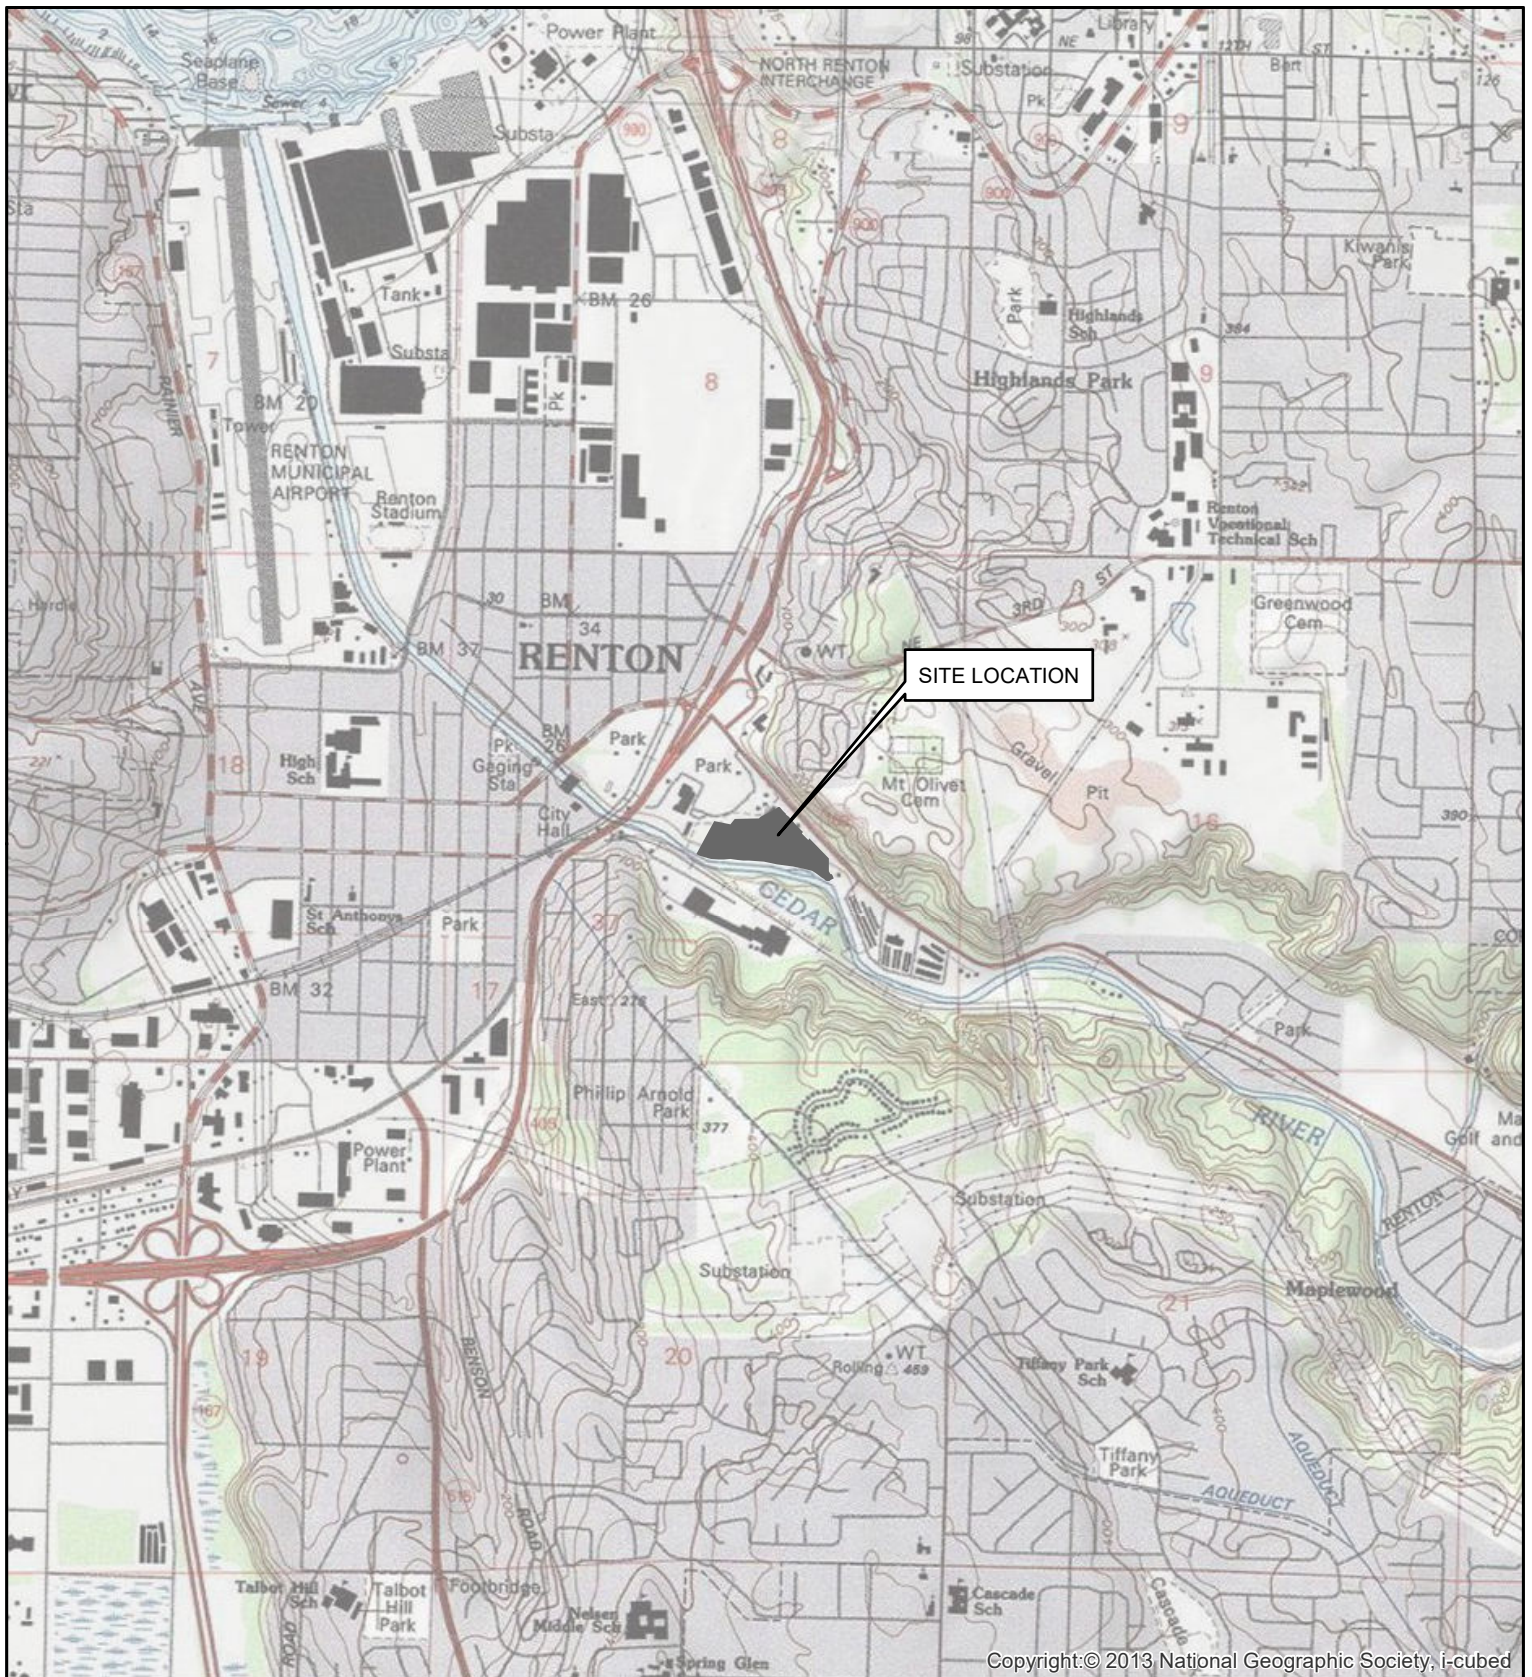
REFERENCE: 7.5 MINUTE USGS QUADRANGLE RENTON, WASHINGTON, DATED 2011

The Site is located between the Cedar River and the Maple Valley Highway, just east of Interstate 405 (Figure 1). The Site comprises King County Parcel No. 172305-9026 totaling 12.54 acres of land. According to the City of Renton (2015) *Zoning* map, the Site is zoned as Resource Conservation. The Site is located within the City of Renton Aquifer Protection Zone, which precludes industrial activities that use, handle, or store hazardous substances on the Site.
