12 JANUARY 2018

# **ANNUAL AIR SPARGE AND SOIL VAPOR EXTRACTION SYSTEM PERFORMANCE MONITORING REPORT – 2017**

Joint Base Lewis-McChord Area of Concern 9-2  
Lewis North Credit Union

**Joint Base Lewis-McChord**  
Pierce County, Washington

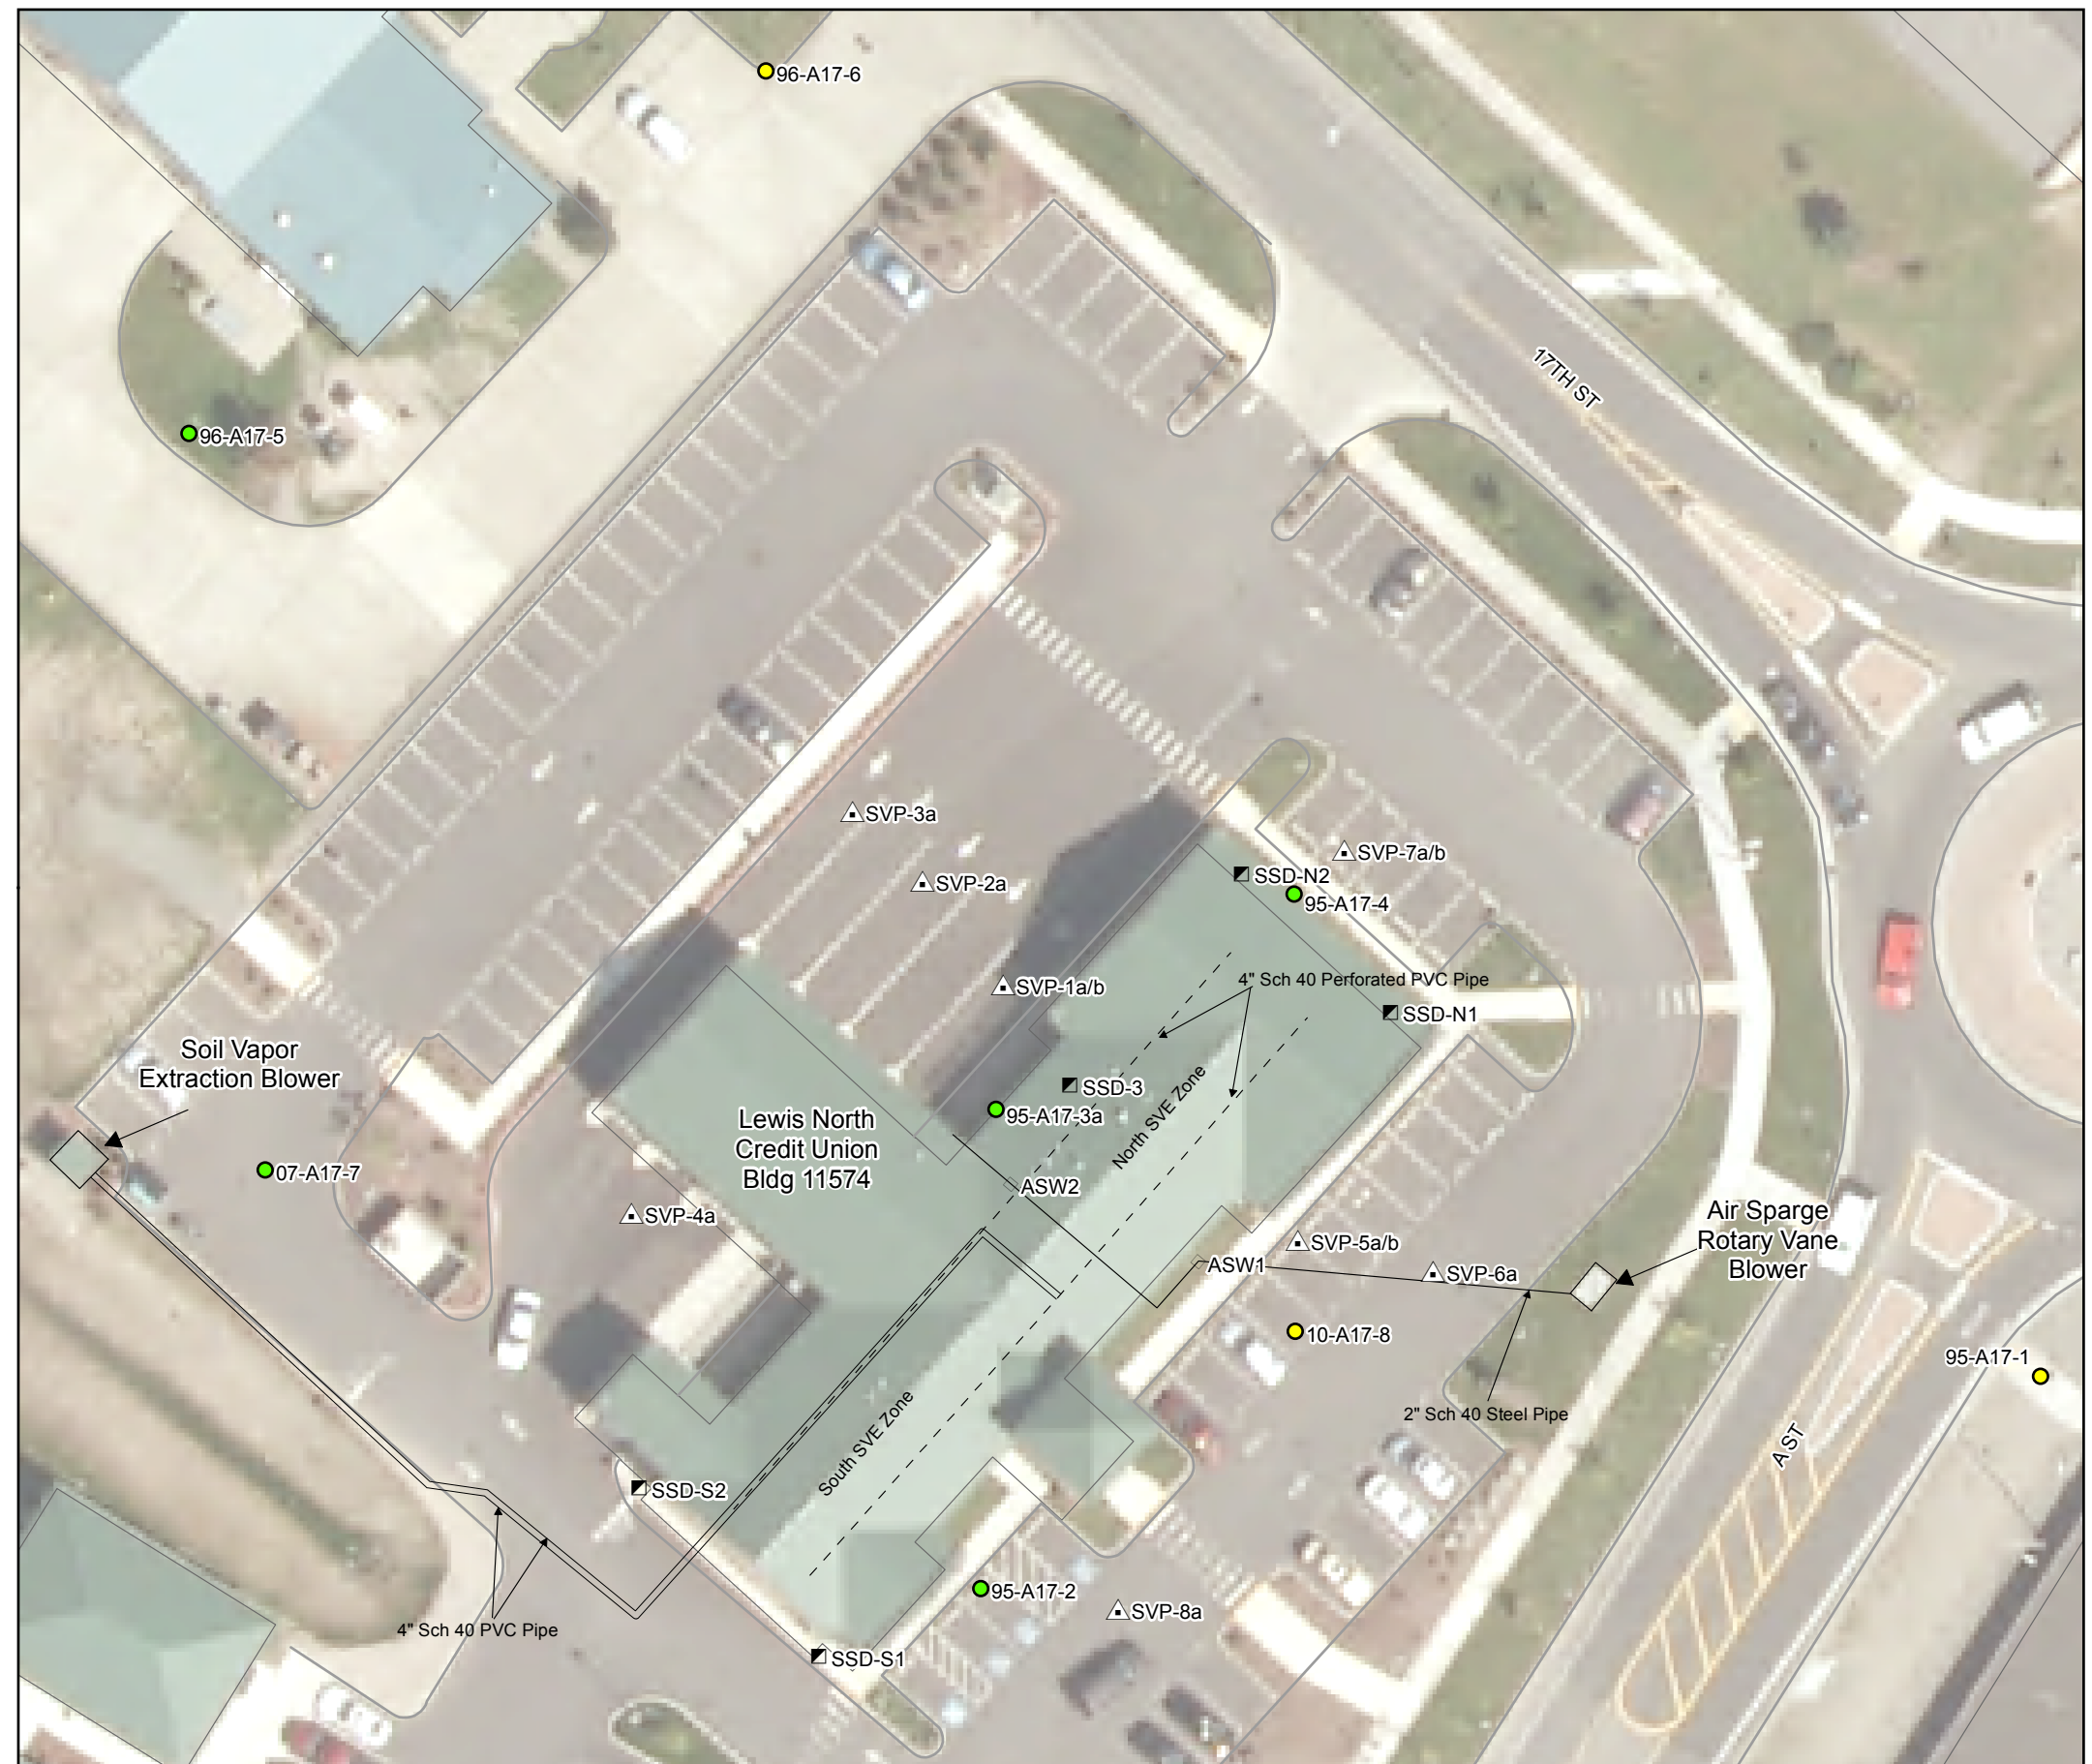
19 The SVE system consists of a vacuum blower housed in a small shed on a concrete pad  
20 located near the southwest corner of the site adjacent to the stormwater pond (see  
21 Figure 2-1). The SVE system maintains a negative pressure under the slab and vapor barrier.  
22 In addition, the building heating, ventilation, and air conditioning (HVAC) system maintains  
23 a positive pressure in the building interior. By maintaining this pressure differential over the  
24 slab and sub-slab system, soil vapors are drawn into the underlying extraction laterals, and  
25 away from the building.

19    Eight groundwater monitoring wells are installed at AOC 9-2. The locations of the wells are  
20    identified on Figure 2-1. Sampling of groundwater monitoring wells is used to assess the  
21    progress of remedial action and overall groundwater quality at AOC 9-2.

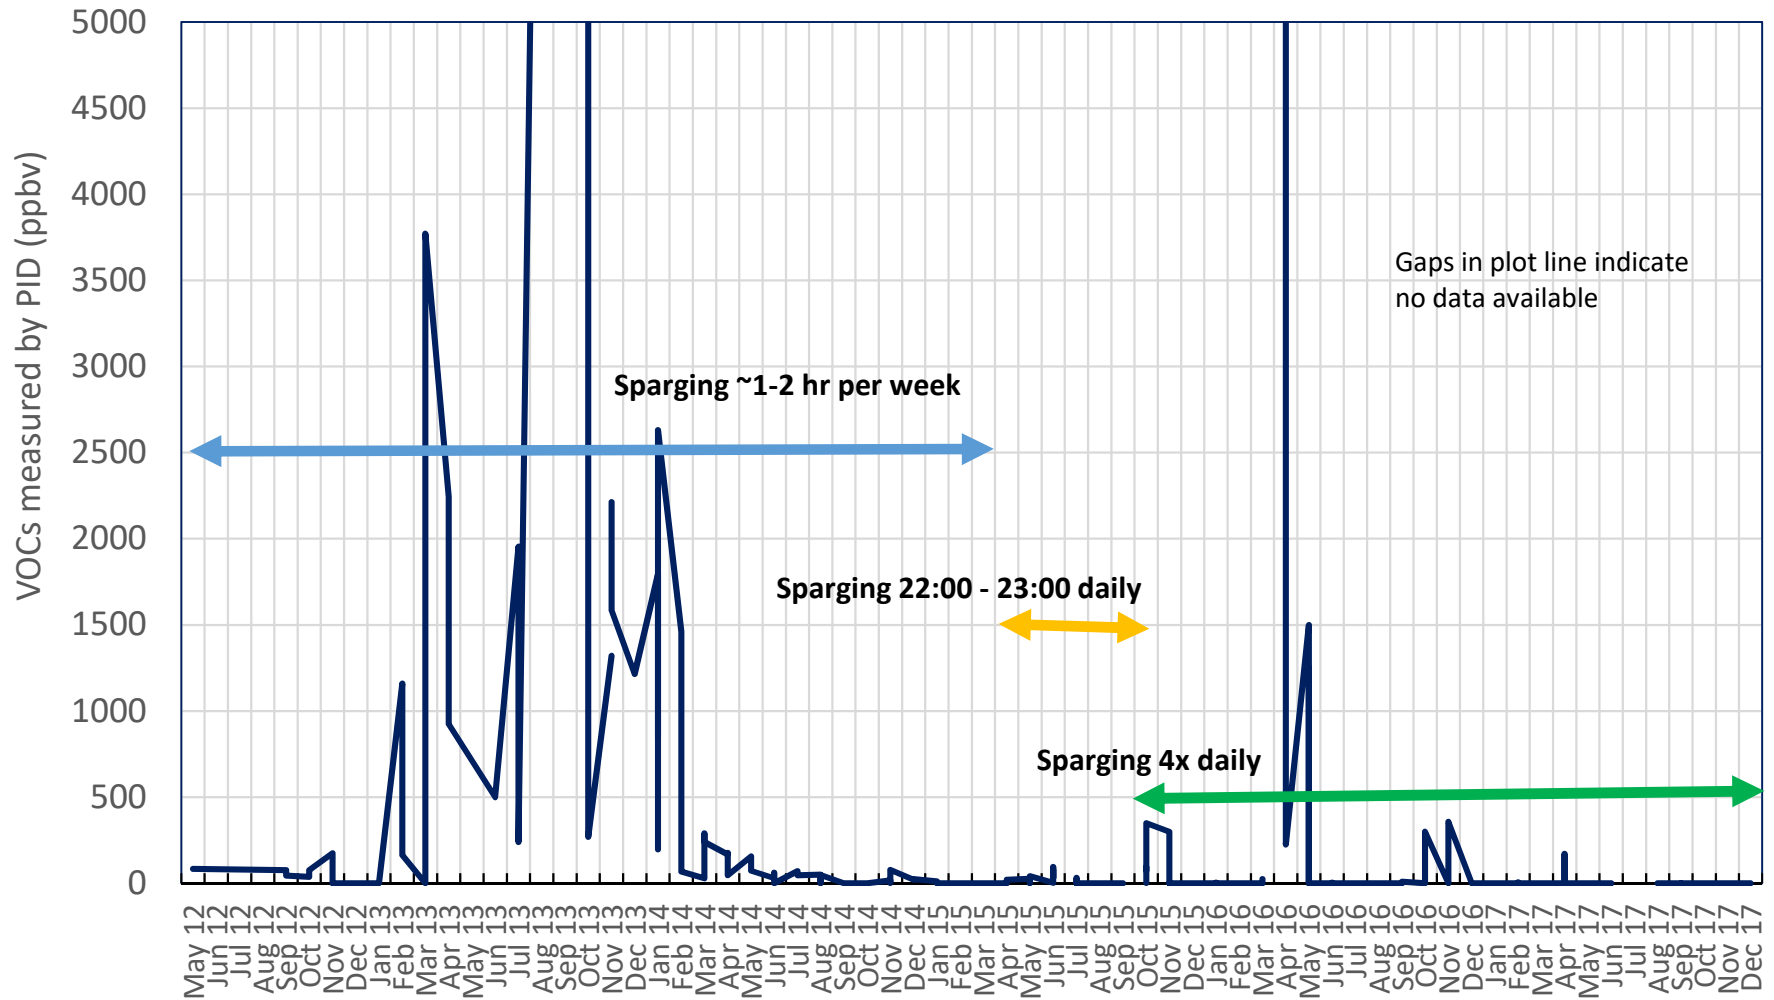
**Figure 3-1**  
**Weekly VOC Concentrations at SVE Blower Exhaust**  
**May 2012 through November 2017**

4 Appendix B, Table B-1 contains a table of field data including results of weekly PID  
5 measurements of VOC concentrations at the SVE exhaust. Figure 3-1 shows results of  
6 weekly screening of SVE exhaust by PID. The plot of PID readings shows a significant  
7 downward trend in VOC concentrations since startup of the AS compressor in 2012. In  
8 general, PID screening in 2017 yielded concentrations of VOCs similar to 2016. Brief spikes  
9 in VOC concentrations observed in SVE exhaust in April and May 2016, and April 2017 may  
10 be associated with exposure of a petroleum hydrocarbon smear zone after a seasonal drop in  
11 groundwater levels. No increase in VOCs was observed after the AS compressor was  
12 restarted following the extended outage between March 1 through August 24, 2017 (see  
13 Section 3-1).

8 As noted previously, weekly monitoring of SVE exhaust was performed using a PID.  
9 Figure 3-1 shows a plot of the weekly PID values versus time. The PID monitoring has  
10 indicated a general downward trend in VOC concentrations.

11 VOC concentrations in soil vapor vary depending on the time since the last AS event. As a  
12 result, PID readings may vary weekly. However, a general decline in VOC concentrations in  
13 SVE exhaust has been observed since AS startup, with brief increases after shutdown and  
14 restart of the AS compressor.

22 Continuation of weekly screening of SVE exhaust using a PID and quarterly Tedlar bag  
23 sampling of the SVE system exhaust are recommended to observe for evidence of  
24 fluctuations in VOC associated with plume contaminant rebound after shutting down and  
25 restarting the AS compressor.

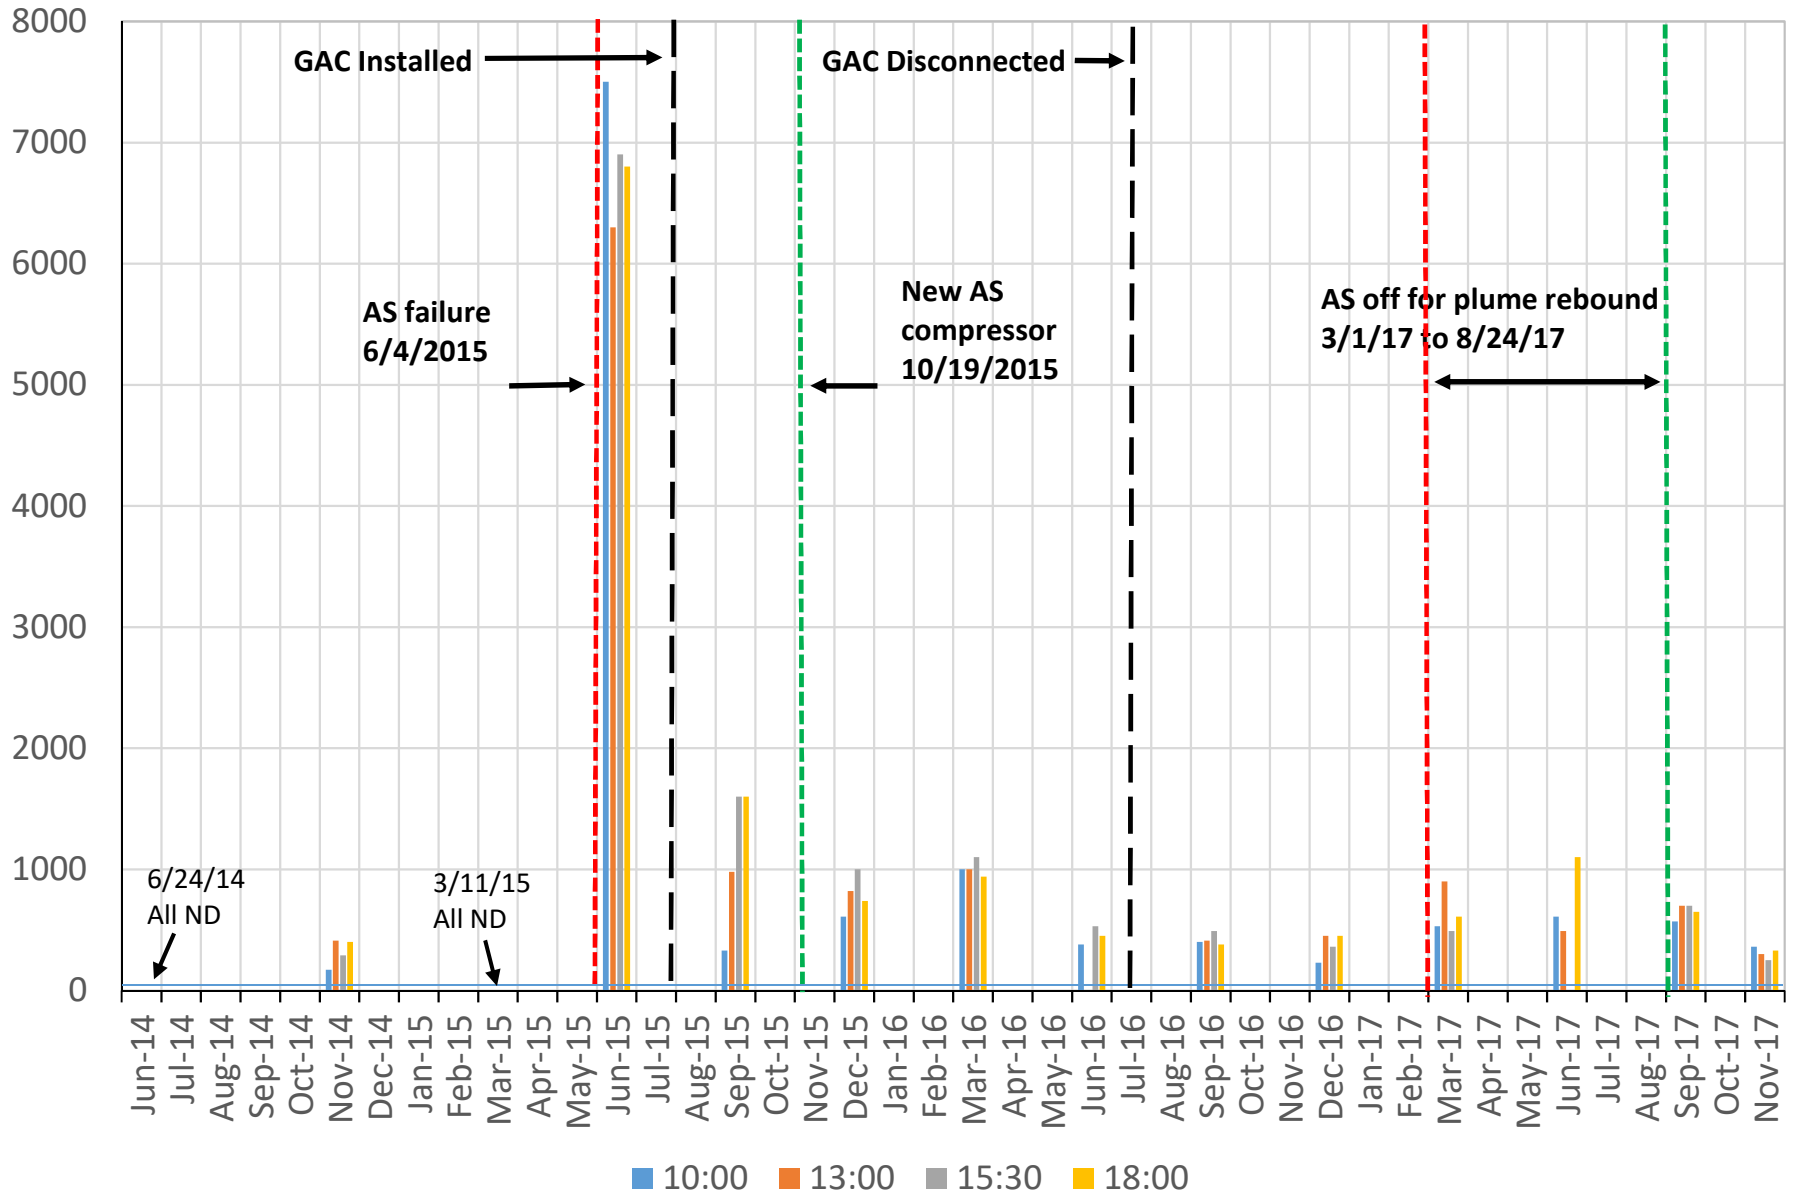
**Figure 3-2. SVE Exhaust - Tedlar Bag Samples: TPH-G ( $\mu\text{g}/\text{m}^3$ )**

27 The AS system was offline from March 1 through August 24 to assess plume contaminant  
28 rebound and repair a failed motor-compressor coupling. SVE exhaust sampling completed during  
29 the period the AS was offline did not show the increase in TPH-G or benzene concentrations that  
30 were observed when the AS system was offline in 2015. Instead, a sharp increase in BTEX was  
31 observed in November, approximately 2.5 months after AS system restart (Table 3-2). TPH-G  
32 showed a concentration decrease in November when compared to the other 2017 sampling events.  
33 The correlation between AS system operation and contaminant concentration in the SVE exhaust  
34 is unclear.

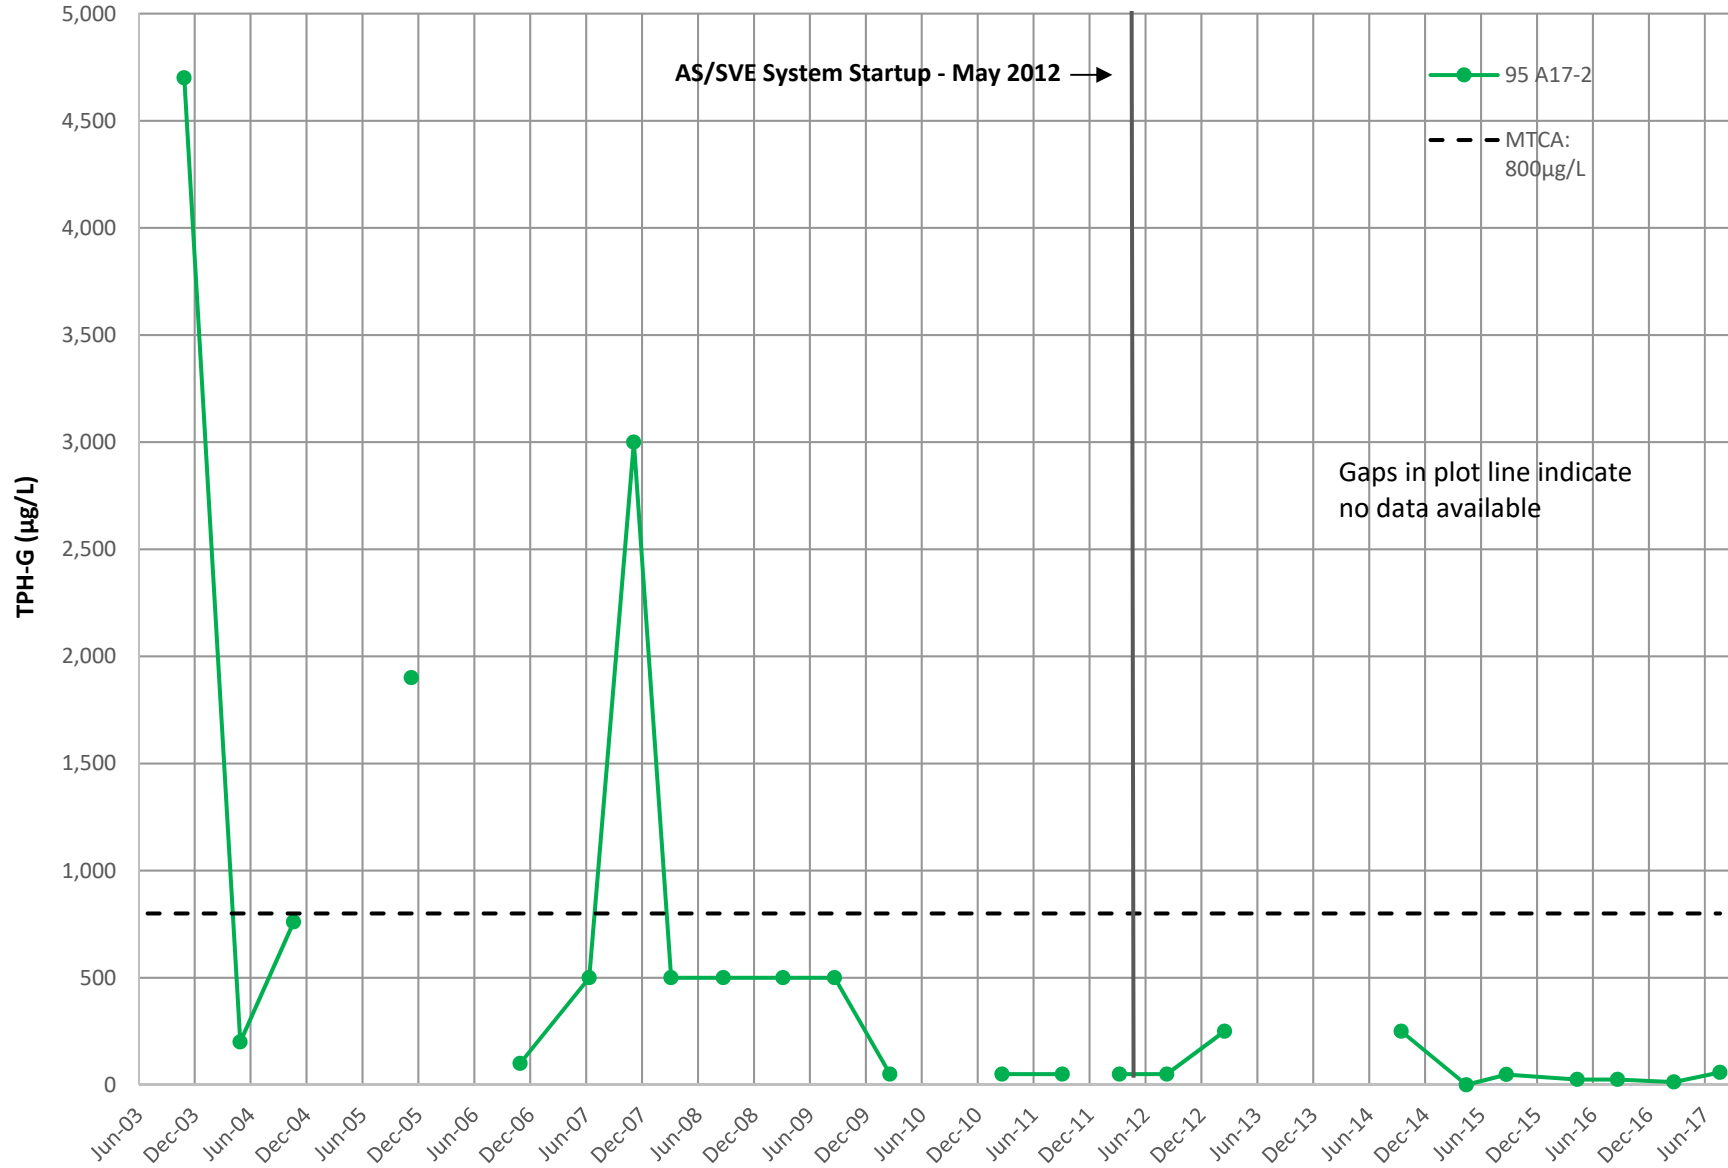
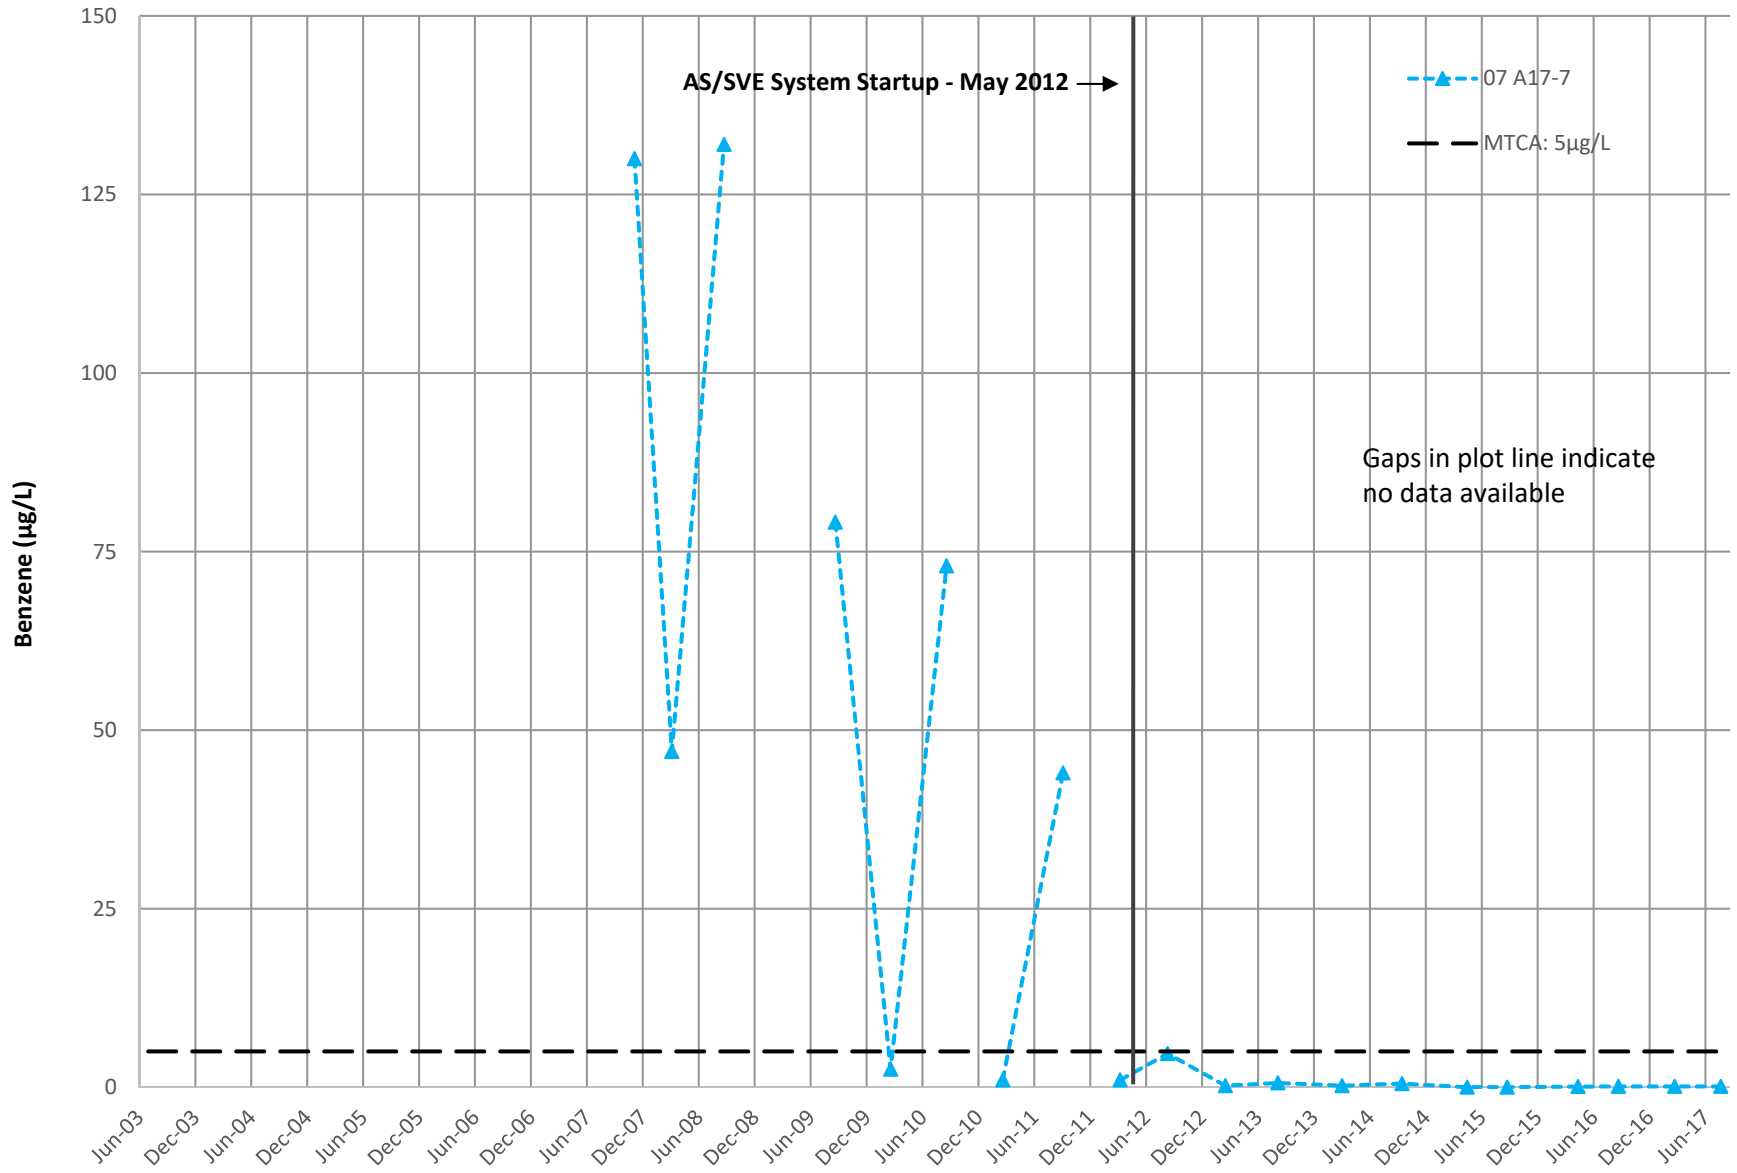
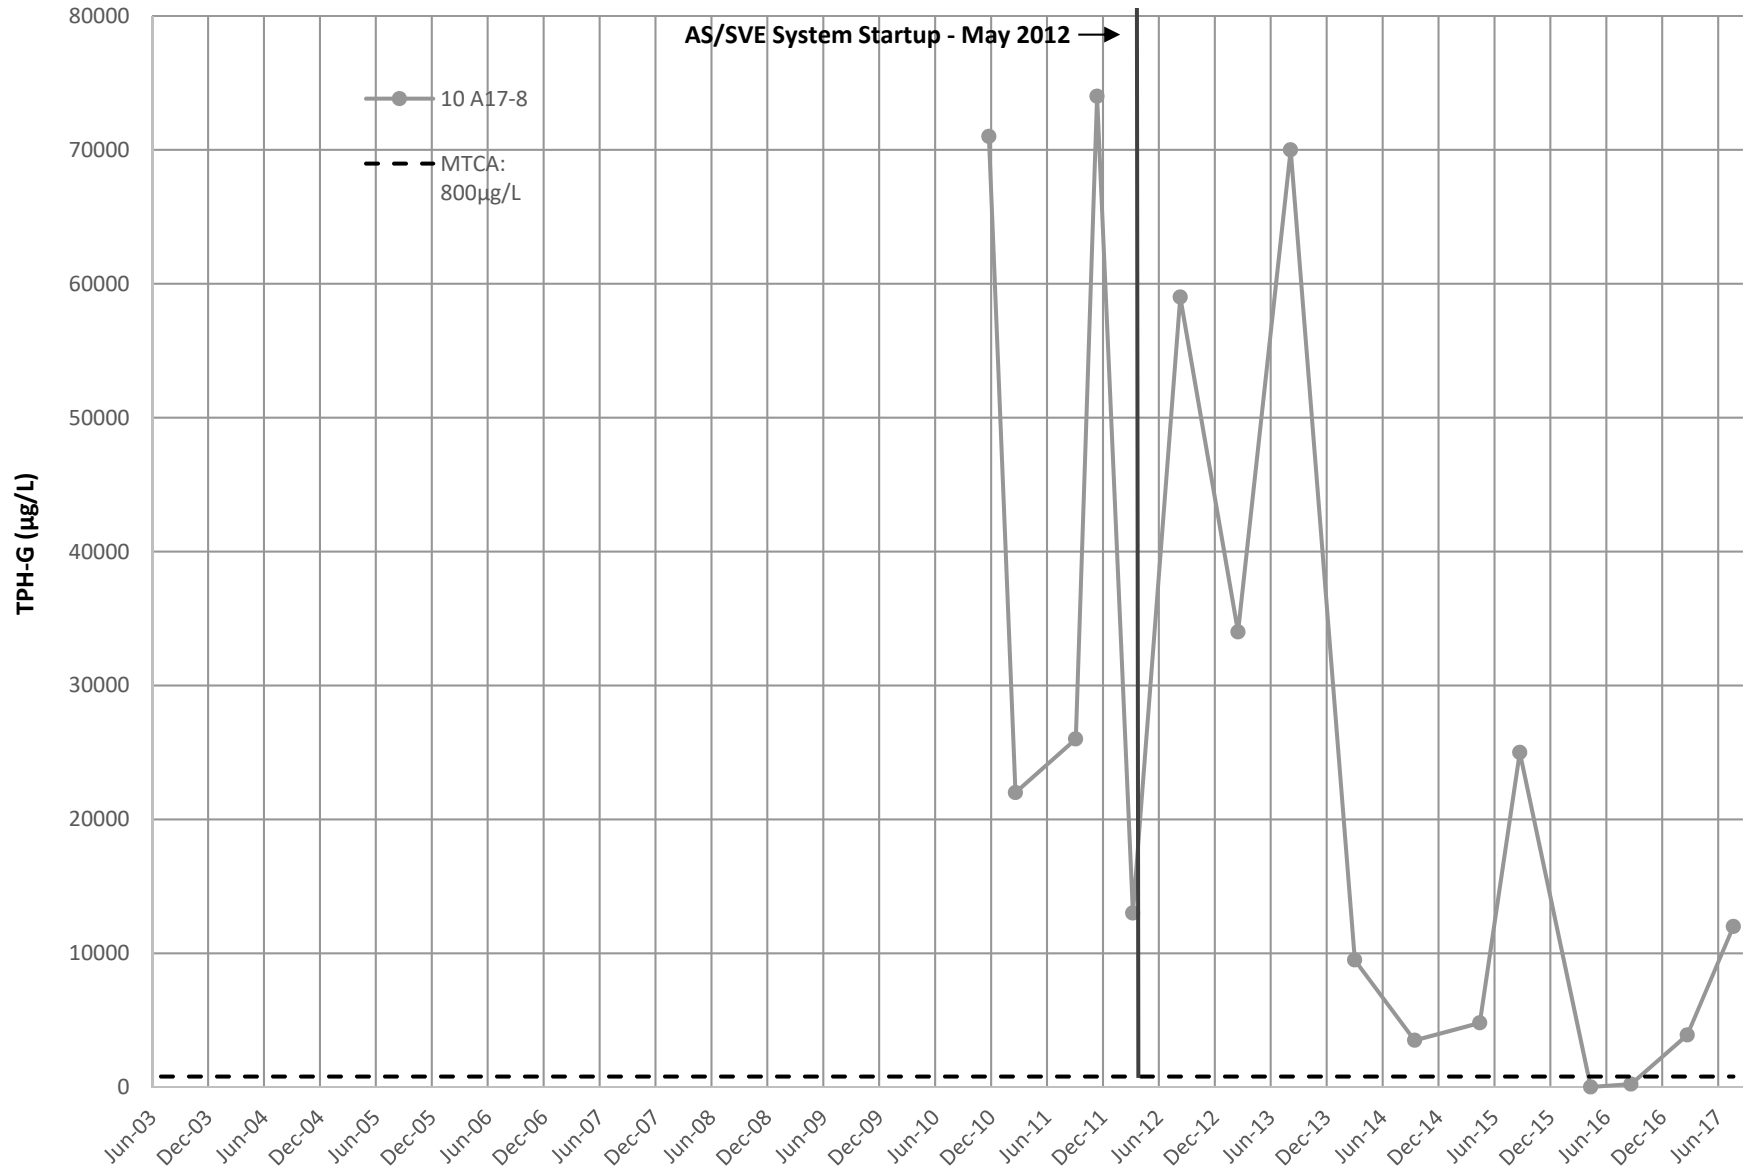
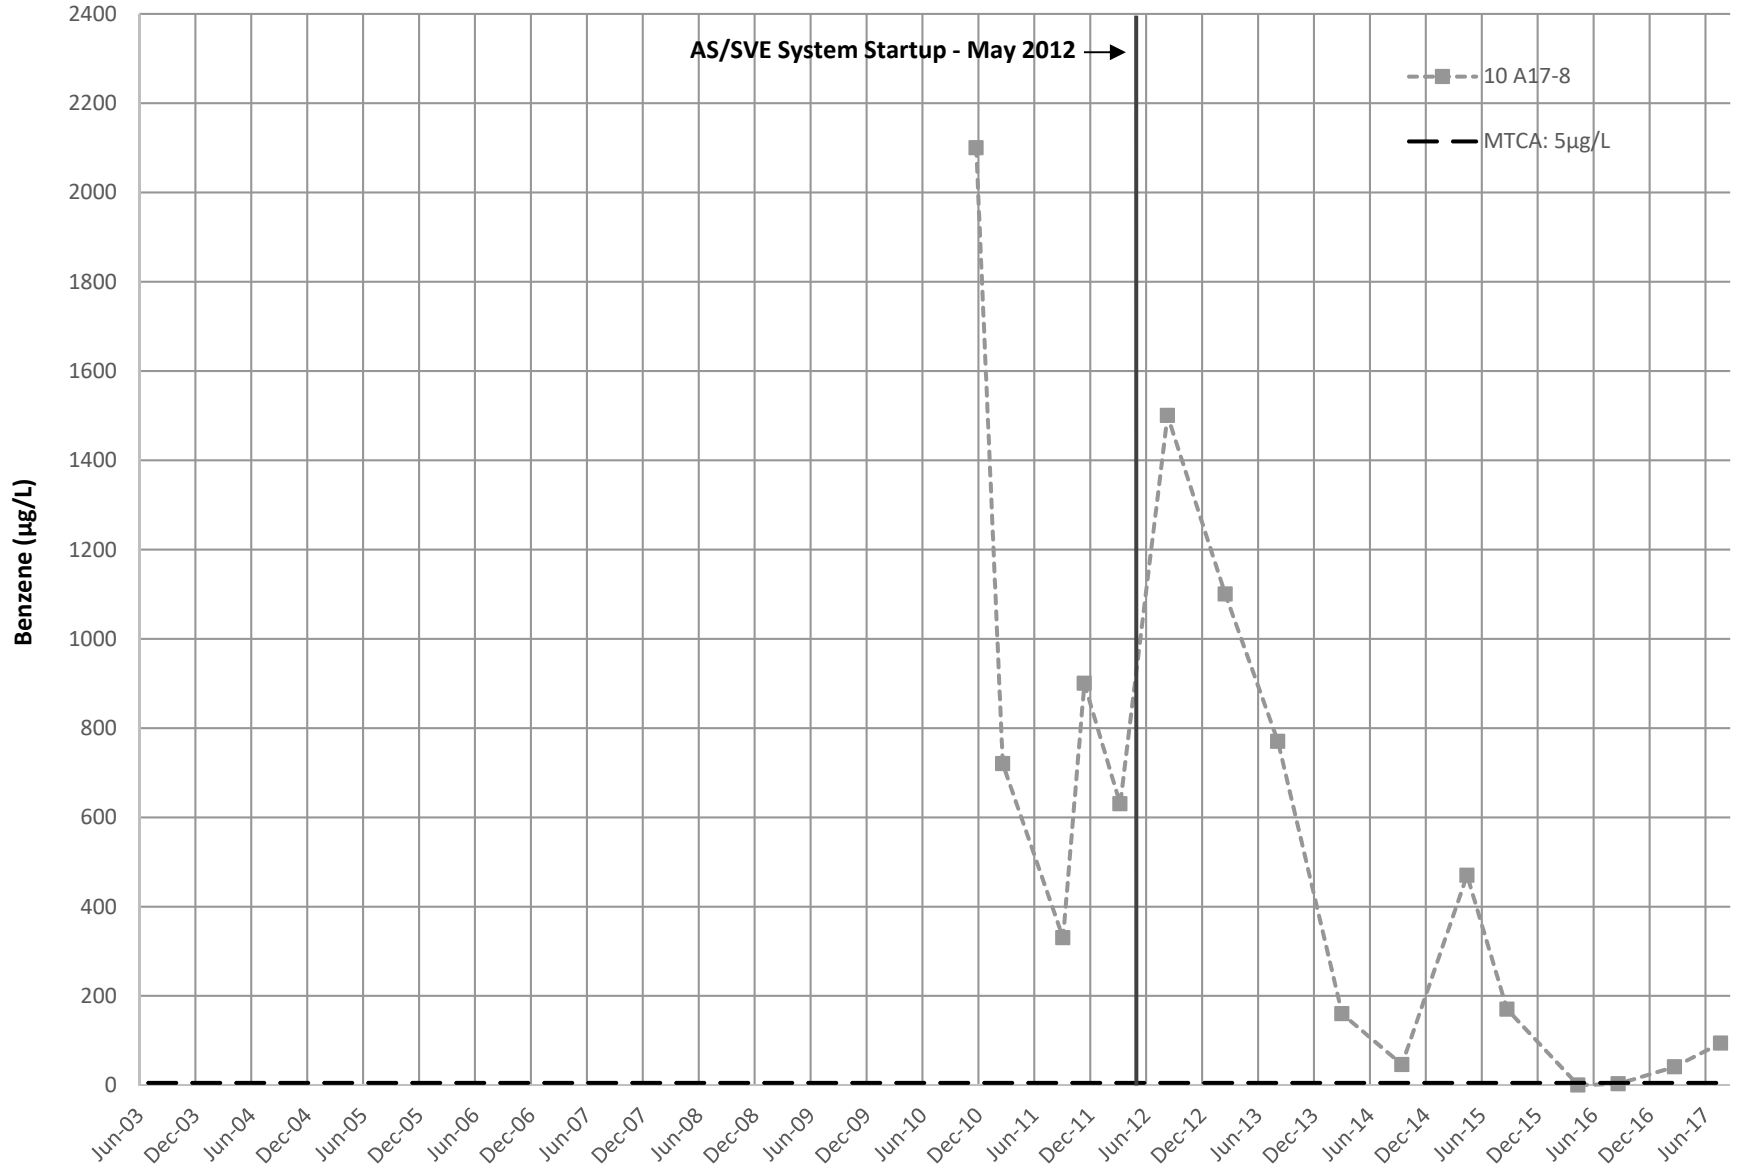
12 The AS compressor failed in mid-2015 and was replaced in September 2015. Groundwater  
13 samples collected in early September 2015 (prior to the AS compressor replacement) had the  
14 highest TPH-G concentrations in over 2 years and BTEX components also showed an  
15 increase during the time the AS system was offline. After replacement of the AS compressor  
16 and restoration of daily sparge cycling, concentrations decreased at all monitoring wells  
17 based on 2016 groundwater sampling results.

18 The late 2015 and early 2016 groundwater results suggested contaminant rebound while the  
19 AS system was offline. With this observation, the AS system was offline from March 1  
20 through August 24, 2017 to assess for plume contaminant rebound and repair of a failed  
21 motor-compressor coupling. Groundwater monitoring was performed on March 2 and July  
22 31, 2017. March 2017 groundwater sampling results indicated TPH-G in source area wells  
23 95-A17-3a and 10-A17-8 at 1,500 µg/L and 3,900 µg/L, respectively. Samples collected in  
24 July 2017 indicated TPH-G in source area wells 95-A17-3a and 10-A17-8 at 1,300 µg/L and  
25 12,000 µg/L, respectively.

26 By comparison, in 2016 benzene concentrations detected in samples collected from well  
27 95-A17-3a were non-detect (April 2016) and 1.9 µg/L (August 2016), both below the  
28 MTCA Method A cleanup level for groundwater of 5 µg/L. Benzene was detected in  
29 samples collected from well 10-A17-8 at an estimated concentration of 0.14 µg/L (April  
30 2016) and 3 µg/L (August 2016). Increases in TPH-G and benzene in 2017 are attributed, in  
31 part, to plume contaminant rebound while the AS system was offline.

2 Based on evidence of plume contaminant rebound after two extended periods of the AS  
3 system being offline, continuing aggressive management of AS operation is recommended  
4 to allow for plume contaminant rebound.

14 The current AS operation appears to be producing a “donut hole” of clean groundwater  
15 around the AS wells with the possibility of a ring of hydrocarbons beyond the ZOI.  
16 Continued intermittent operation of the AS system is recommended to allow for plume  
17 contaminant rebound for removal of VOCs. An extended period of taking the AS system  
18 offline, appears to be effective in allowing plume contaminant rebound. In addition, to allow  
19 for the collection of groundwater samples more representative of actual groundwater  
20 conditions, the AS system should be shut down at least 48 hours to allow for plume  
21 contaminant rebound.
