RE: Carpinito Farms, LLC (formerly Smith Brothers Farm)
F/S 37576215
2017 Groundwater Sample Results

Groundwater samples were obtained from the four monitoring wells at Carpinito Farms in Kent in the four quarters of 2017. Samples were analyzed for diesel by Ecology Method NWTPH-Dx as specified in Washington Department of Ecology MTCA regulations.

CARPINITO FARMS, LLC
(FORMER SMITH BROTHERS FARM)
27441 68th Ave. S
KENT, WA 98032

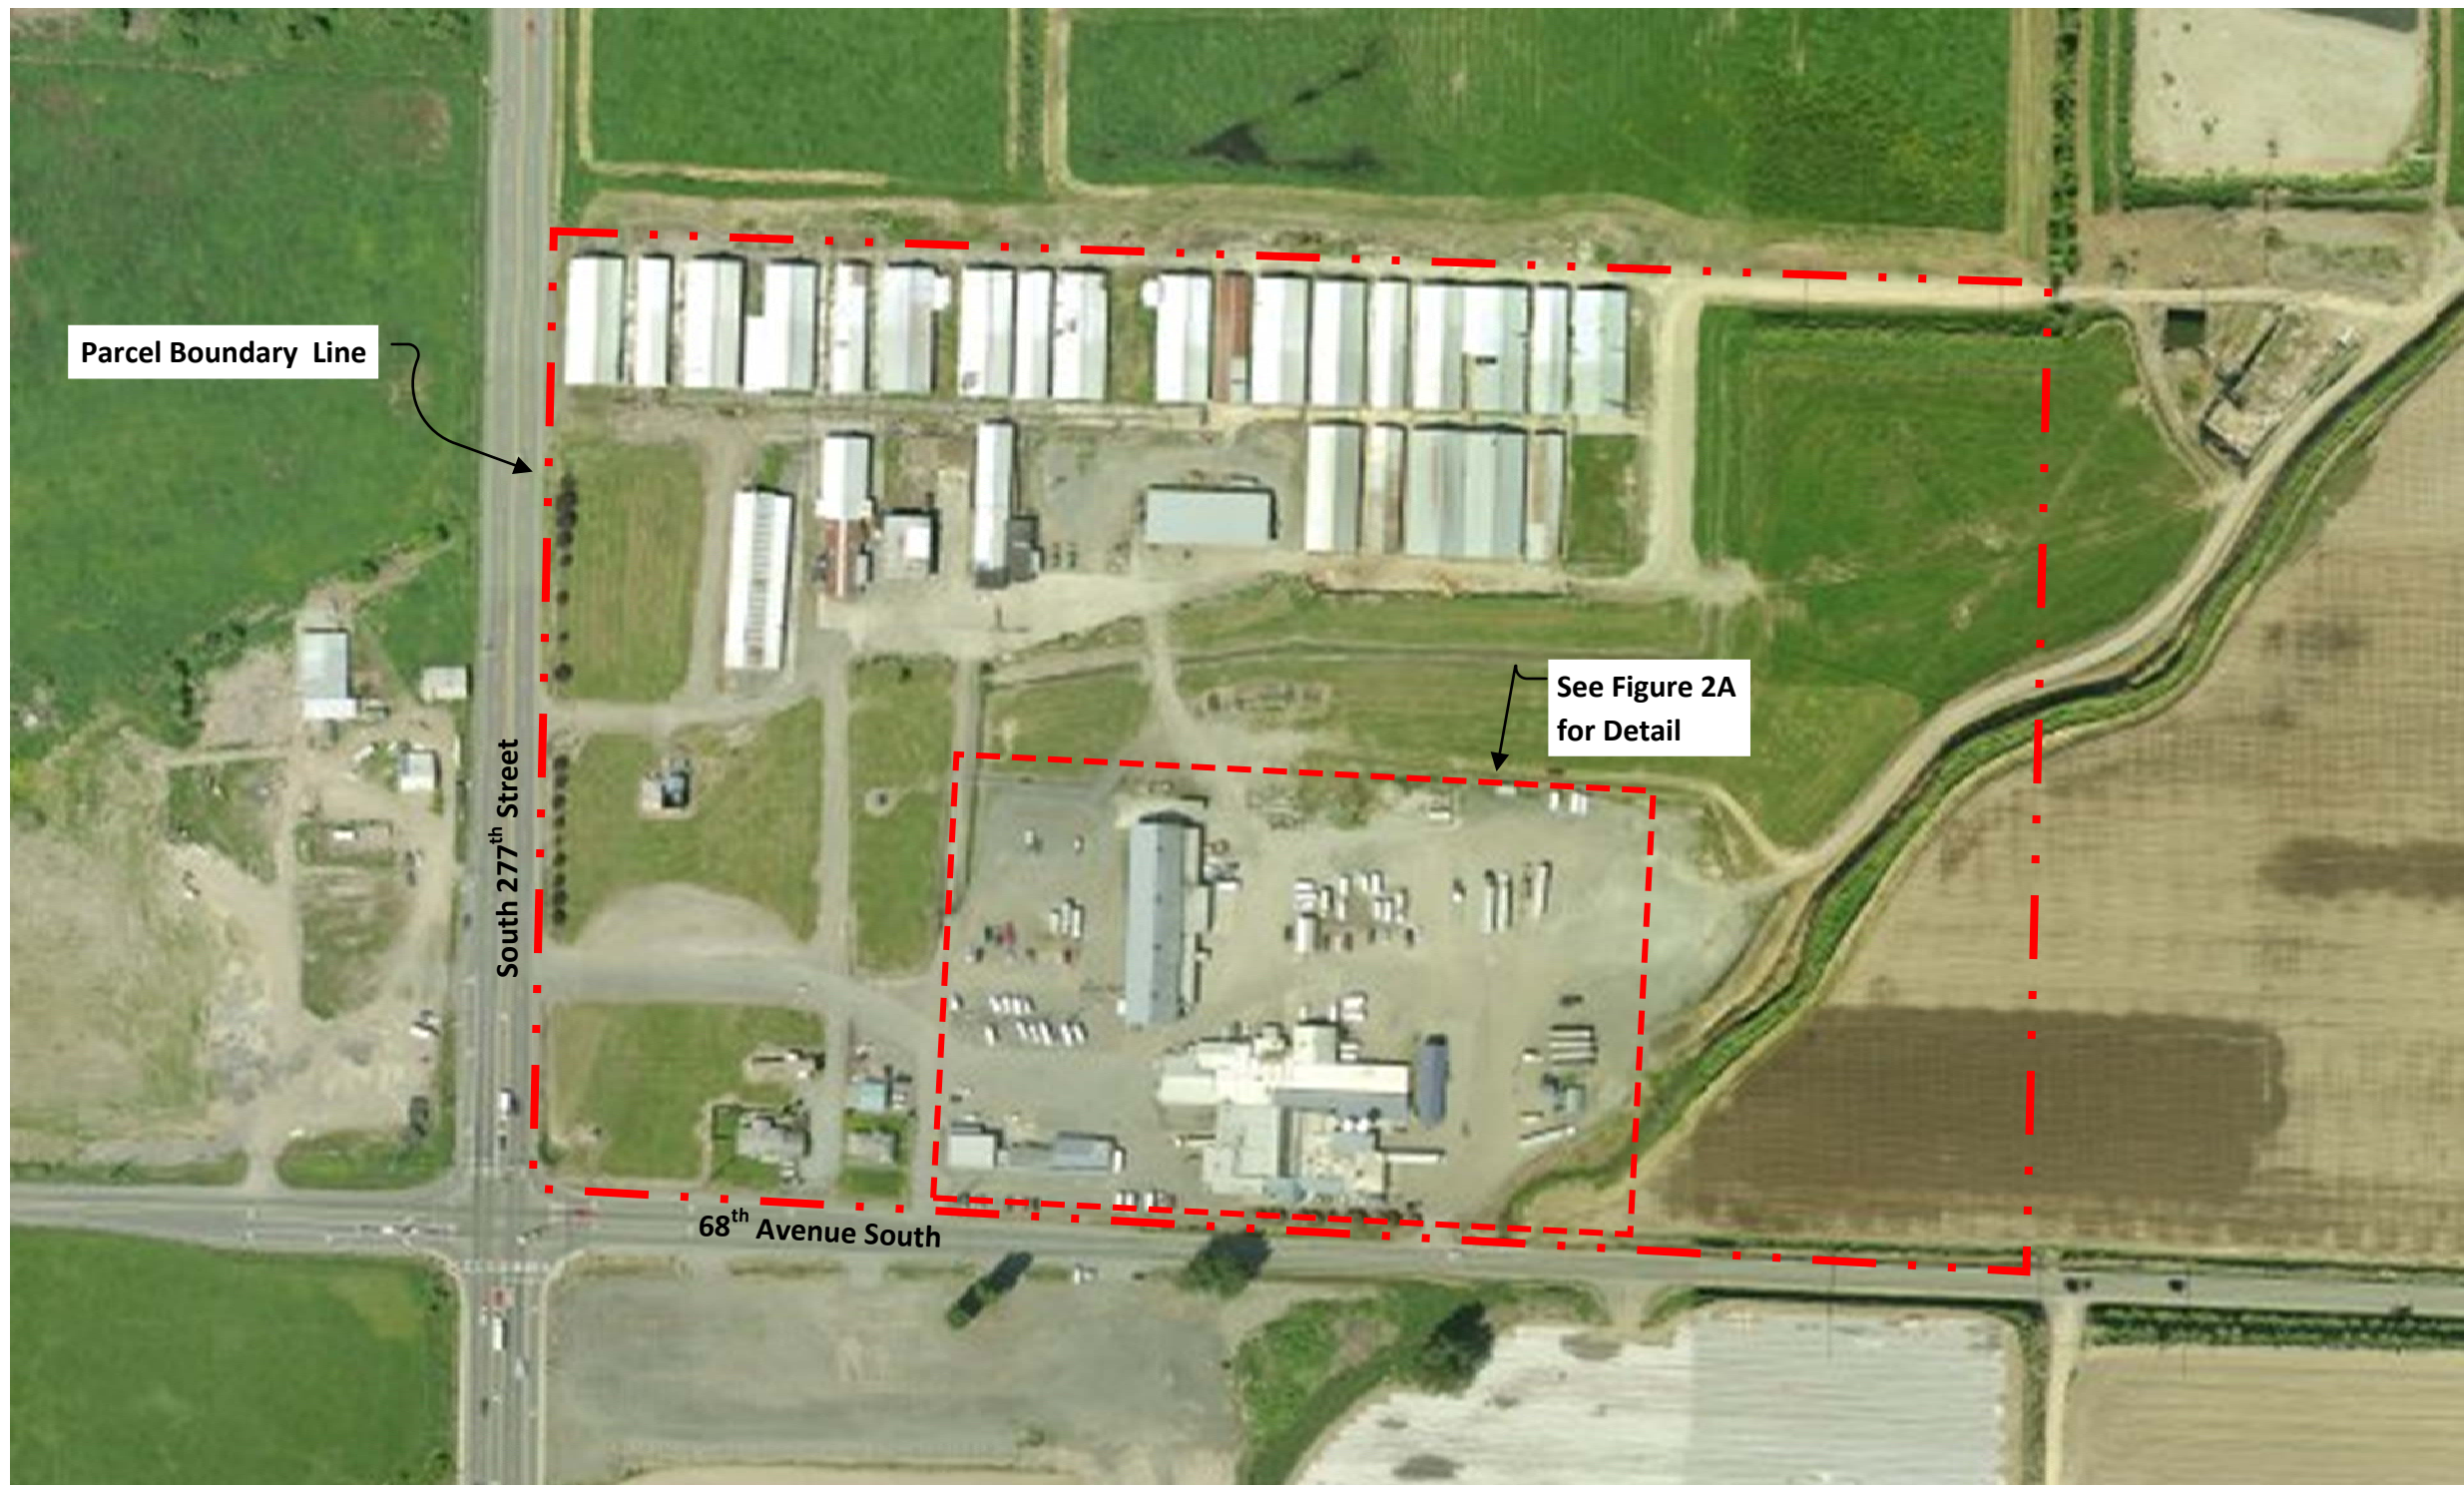
**Figure
2**

**Site Overview
Smith Brothers Farms
27441 68th Avenue South
Kent, WA 98032**

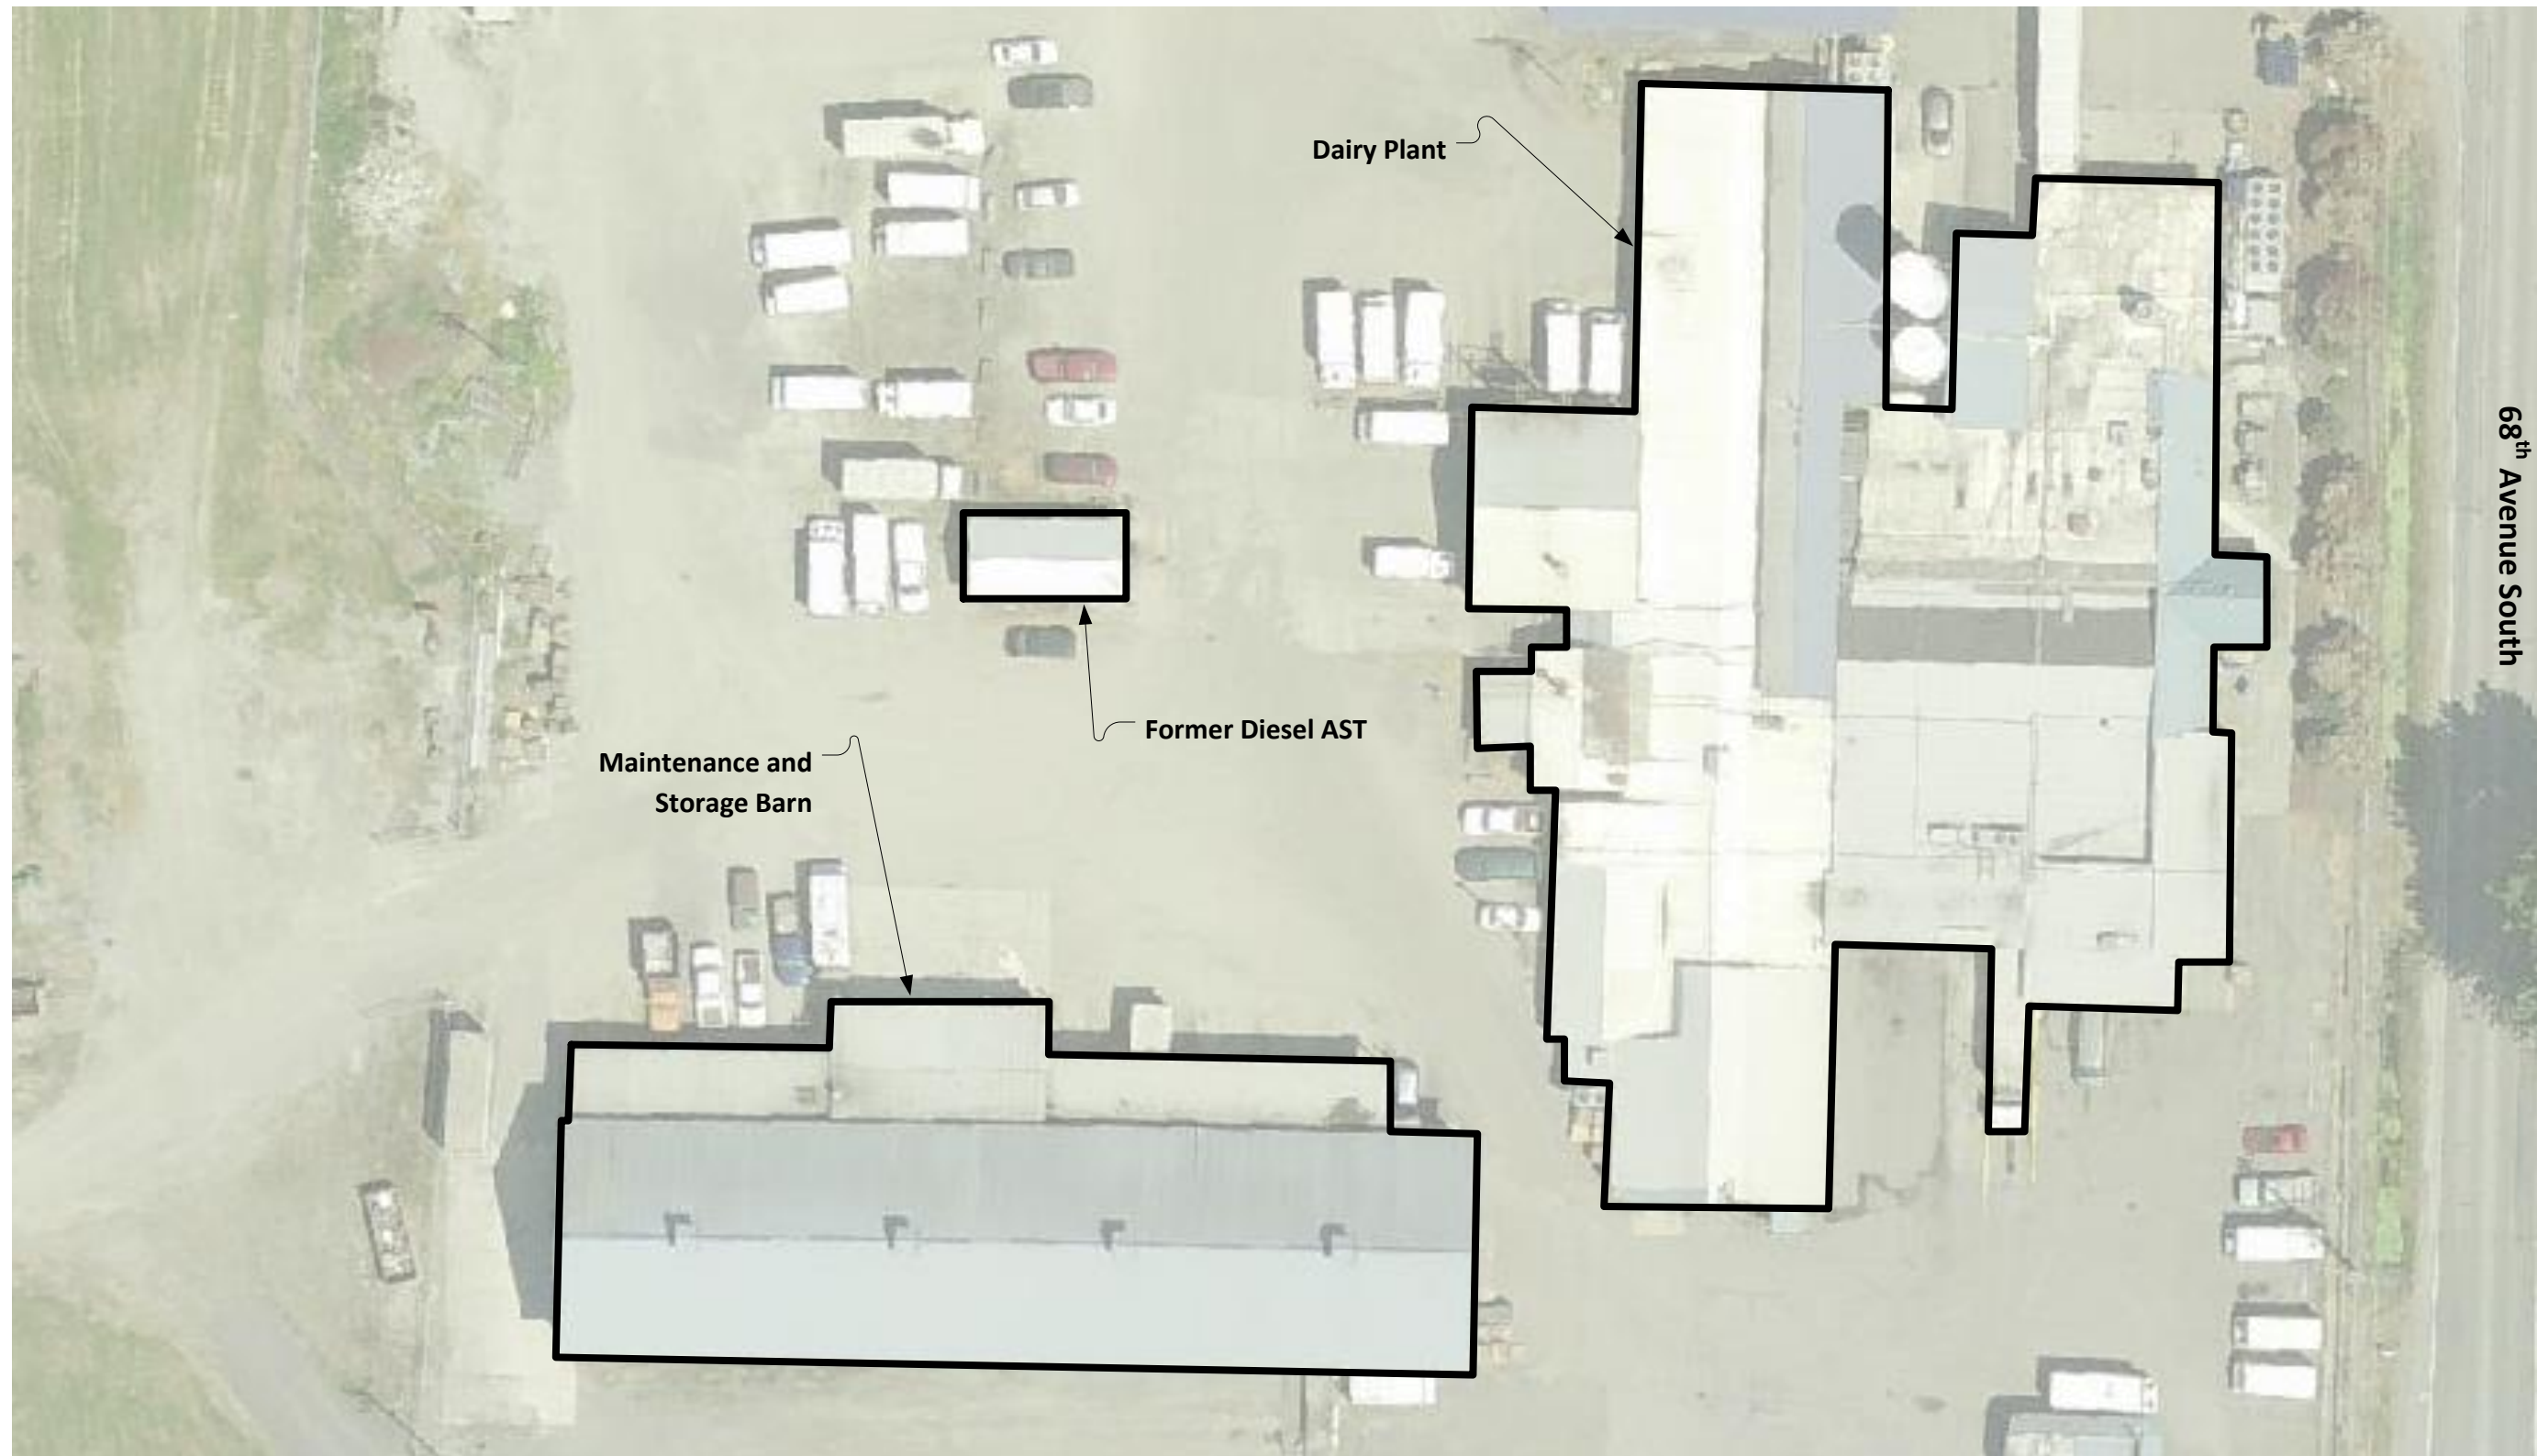
**Figure
2A**

**Site Diagram
Smith Brothers Farms
27441 68th Avenue South
Kent, WA 98032**

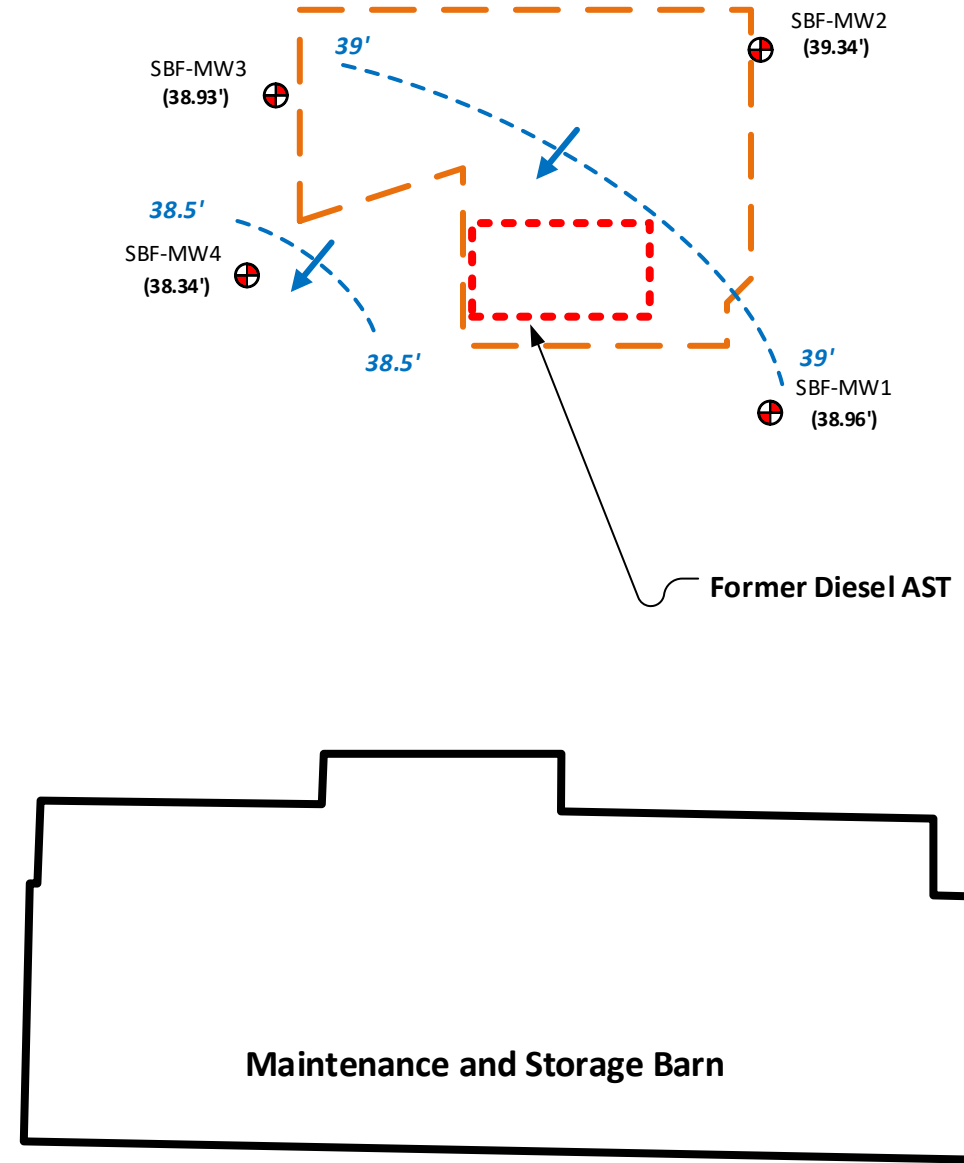
Figure 5L

The contours represent an interpretation of available data, for the indicated date. Site groundwater contours may change with additional measurements and/or data points, weather changes, construction activities, and/or other influences.

Site Diagram, Groundwater Contours 06/14/17
Smith Brothers Farms
27441 68th Avenue South
Kent, WA 98032
