Feasibility Study
Maury Island Open Space Property
Maury Island, Washington

King County Parks and Recreation
Division
King Street Station
201 South Jackson Street,
M.S. KSC-NR-700
Seattle, Washington 98104-3855

April 17, 2017

**DRAFT FINAL
FEASIBILITY STUDY
MAURY ISLAND OPEN SPACE PROPERTY
MAURY ISLAND, WASHINGTON**

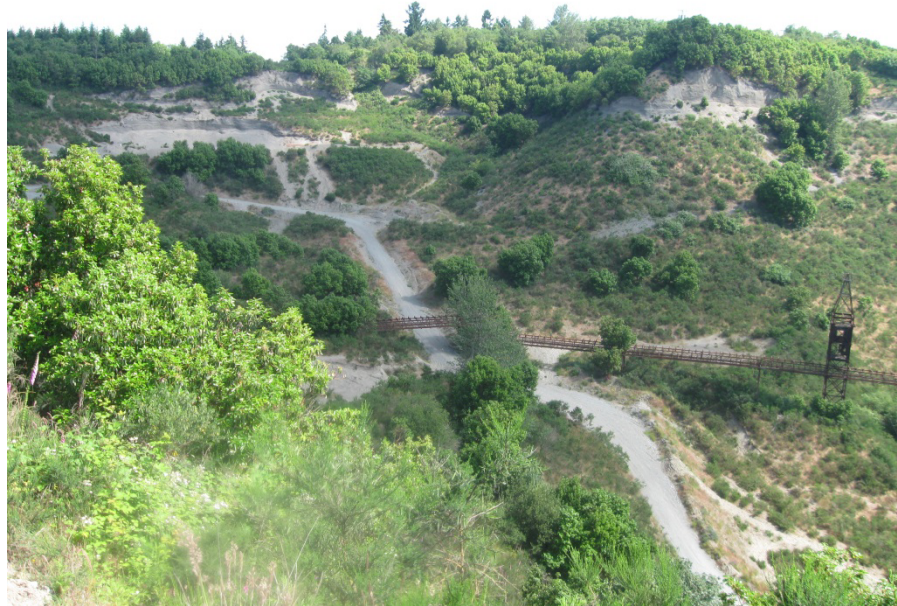
Description:
View of Unit 2a (South Pit) from the beach. Remnant of mining conveyor structures and the road down to the beach shown.

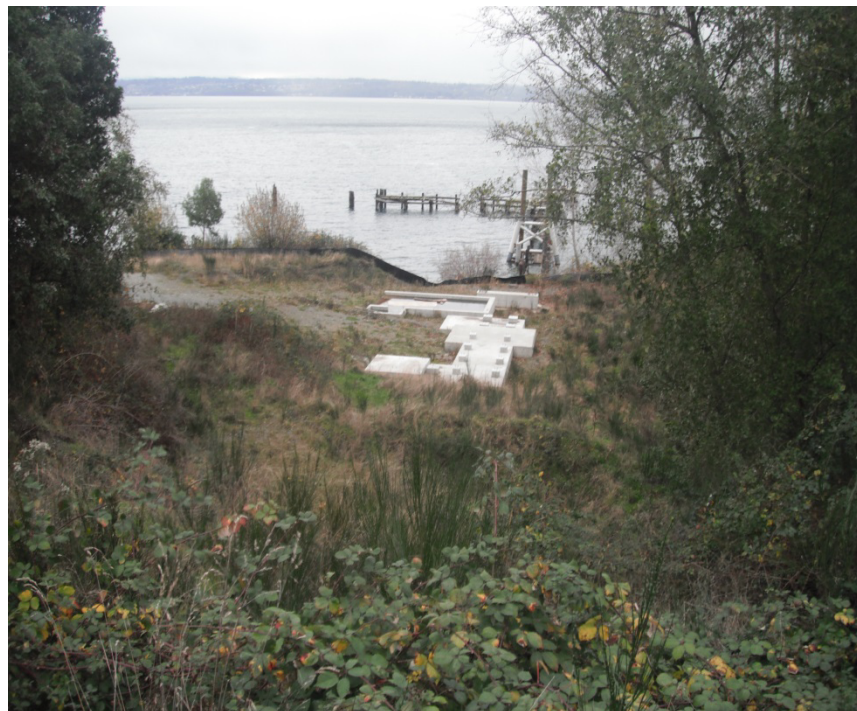
Photograph No. 2

Description:
Partially reconstructed dock at the base of the South Pit.

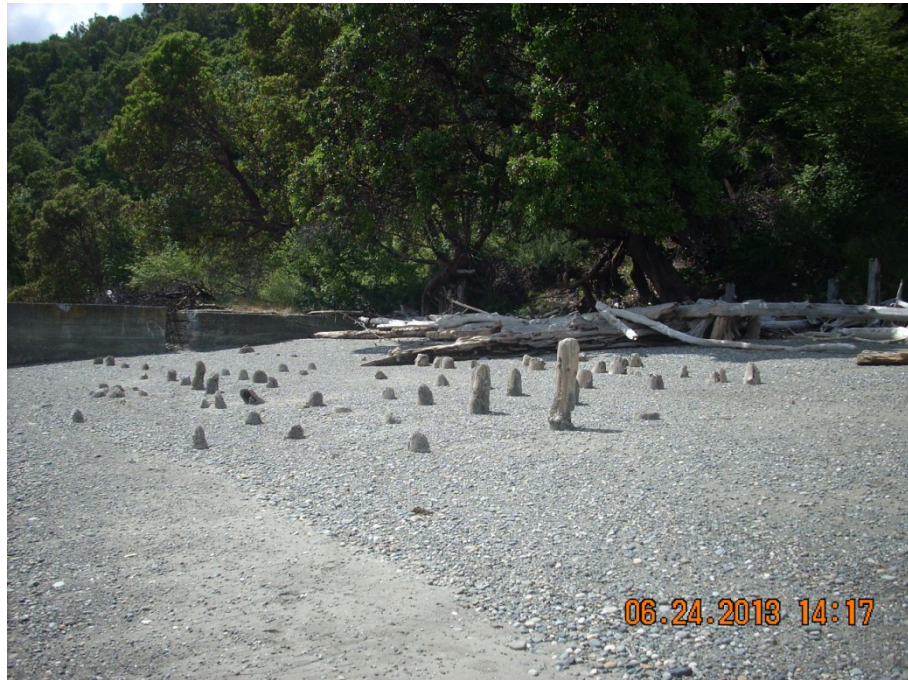
Description:
Remnant pilings near the old
North Pit concrete pier.

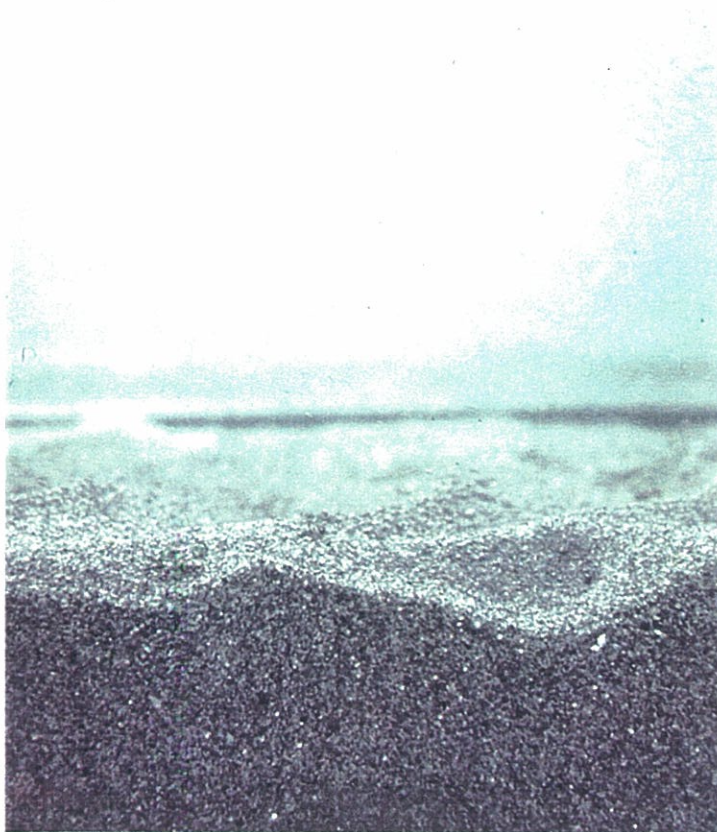
Figure 2-7. Sediment profile image from Station 5; note the well-sorted, medium sand with surface ripples and evidence of emerging eelgrass fronds at the sediment-water interface. Width of image = 15 cm

Habitat conditions were typical of a nearshore, sandy bottom; there was no evidence of an accumulation of fine-grained sediments or organic loading at any of the locations sampled. A wide variety of fauna and flora were detected in the images, from worm tubes and eelgrass projecting above the sediment-water interface to starfish, mussels, hermit crabs, and invertebrate egg clusters found on both the sand and gravel bottoms (Figure 2-17). The community in this area and in the shallower depths is obviously adapted to high-energy regimes and frequent disturbances.

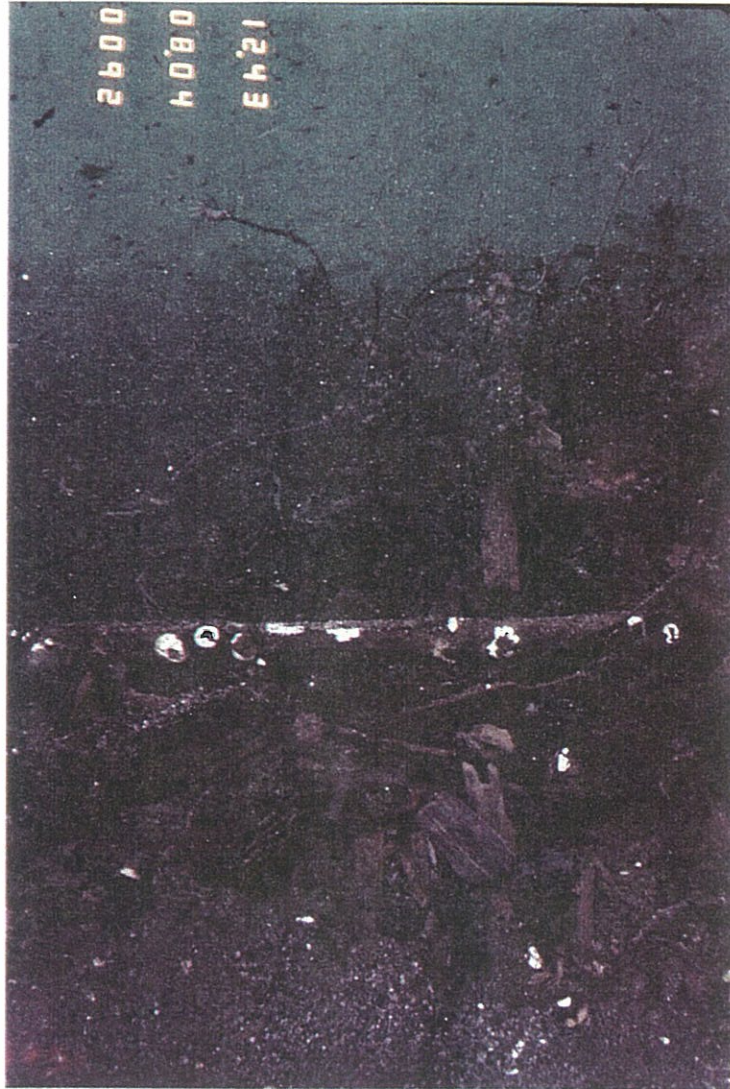
Figure 2-8. Sediment profile image from Station 6; wood twigs and leaf litter are very common in nearshore areas. Width of image = 15 cm

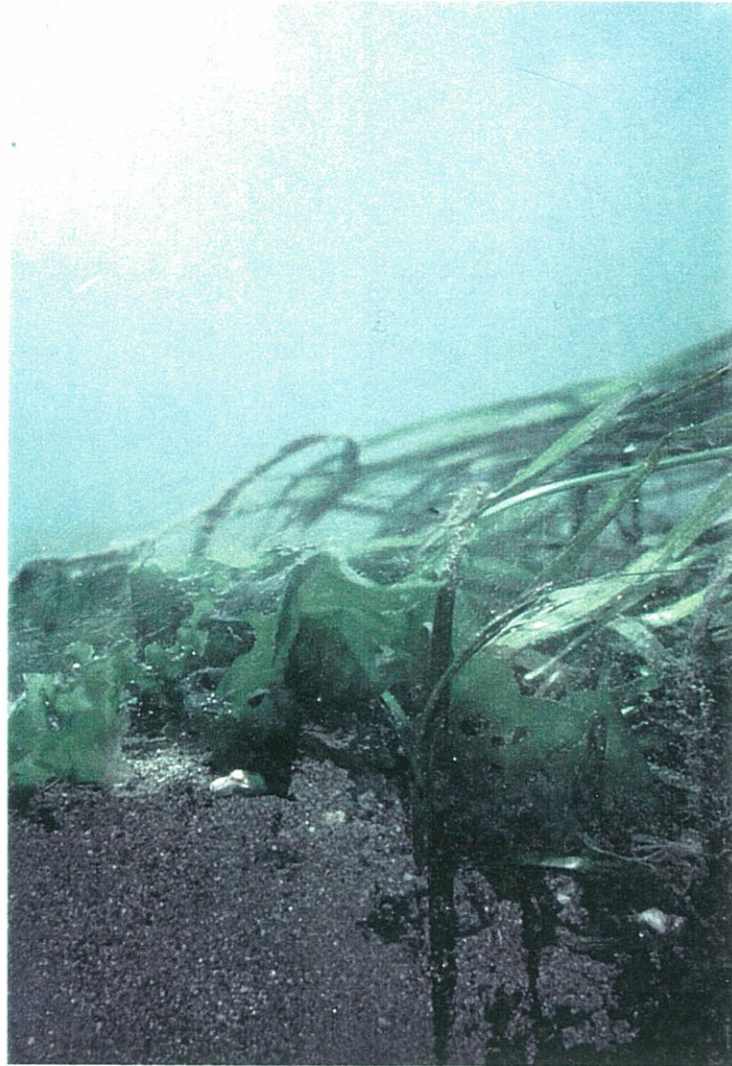
Figure 2-10. Sediment profile image from Station 11; both eelgrass and sea lettuce (*Ulva sp.*) can be seen bent over from the current at this shallow station (5 ft water depth). Width of image = 15 cm

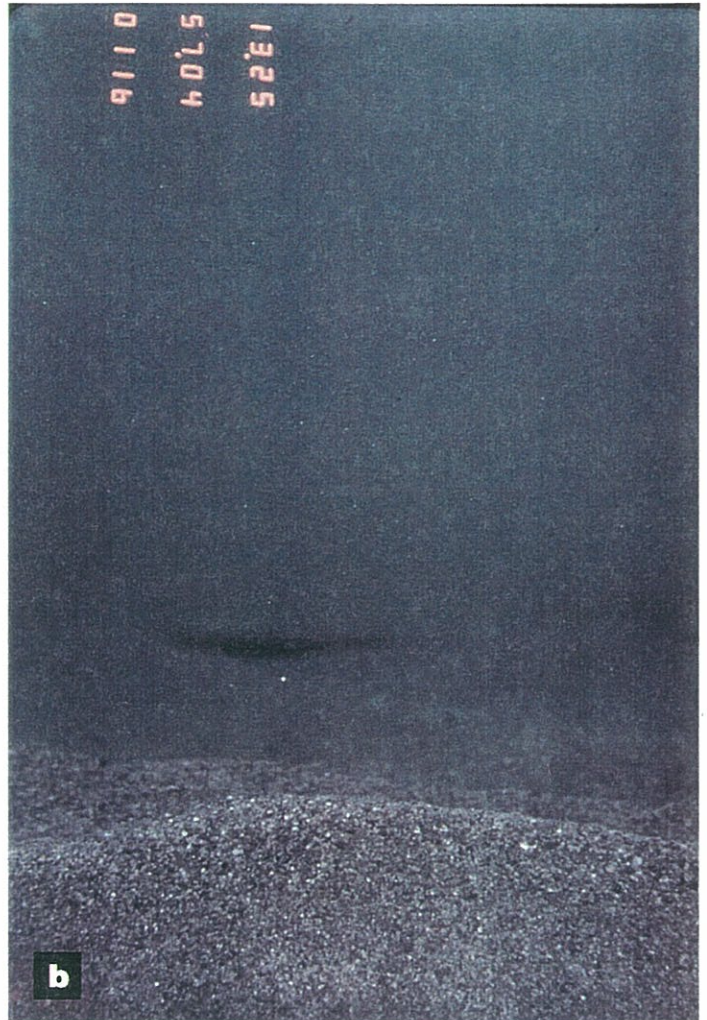
Figure 2-11. Sediment profile images from Station 18 (a) and Station 4 (b). Note the uniform cross section of well-sorted sand in each image; the greater SPI prism penetration at Station 18 is likely due to increased bioturbation activity. Width of image = 15 cm

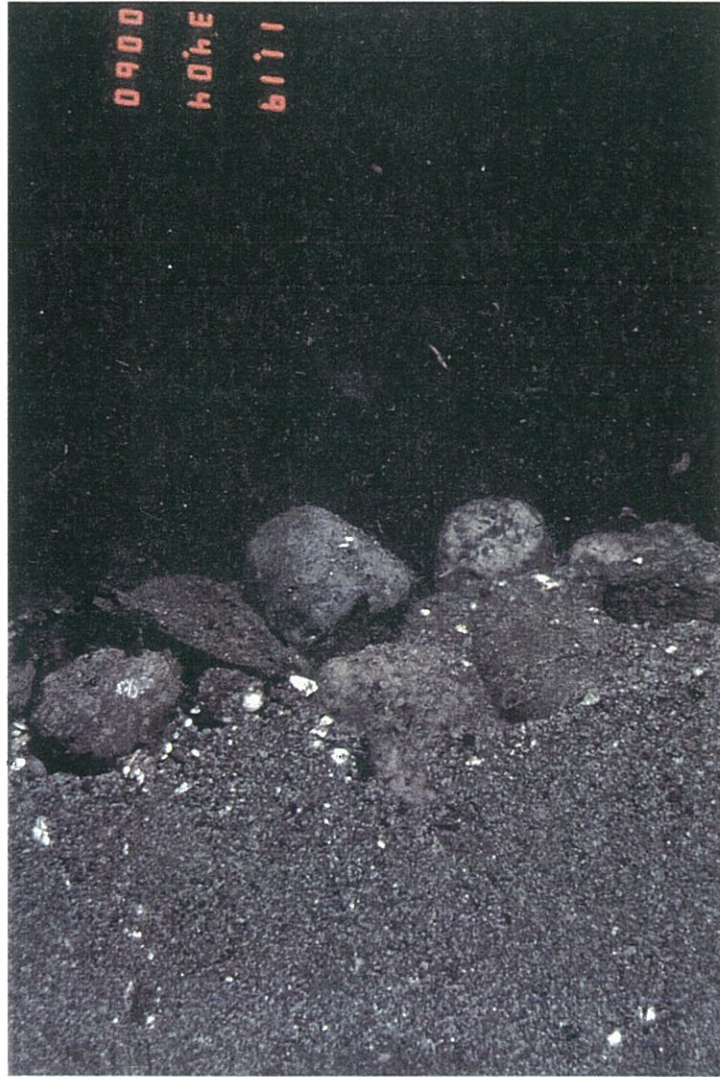
Figure 2-12. Sediment profile image from Station 39; note the uniform surface layer of gravel that was most likely deposited due to natural physical transport mechanisms. Width of image = 15 cm

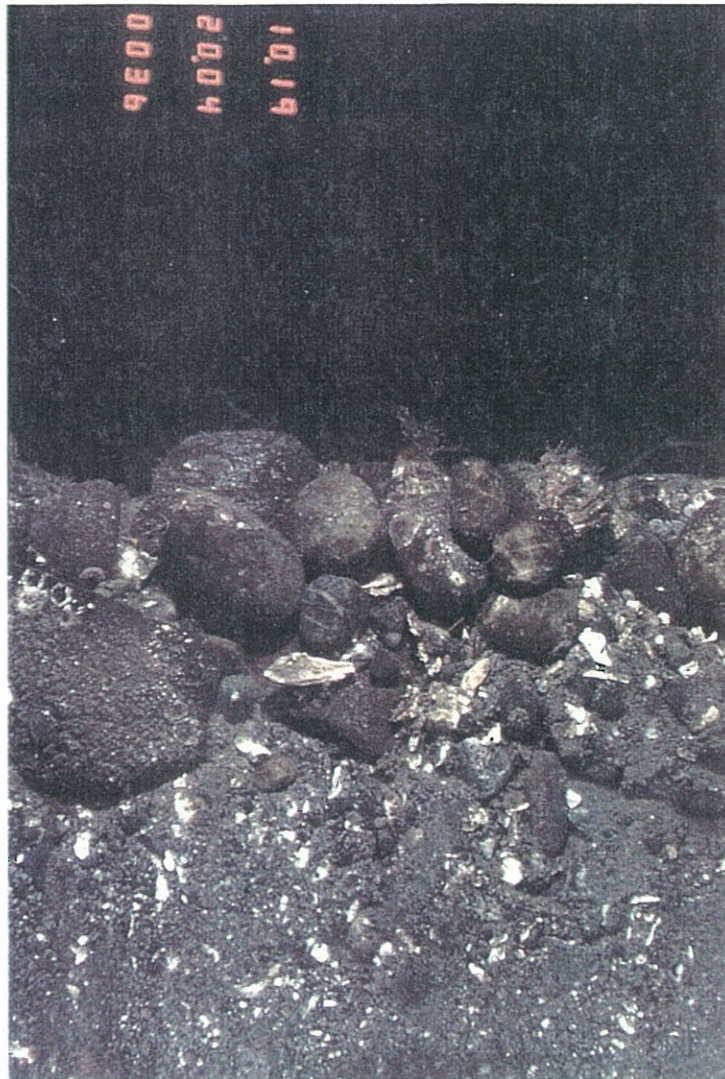
Figure 2-13. Sediment profile image from Station 19 showing a layer of gravel on the sand surface; note the colonial epifauna growing on the surface of the gravel. Width of image = 15 cm

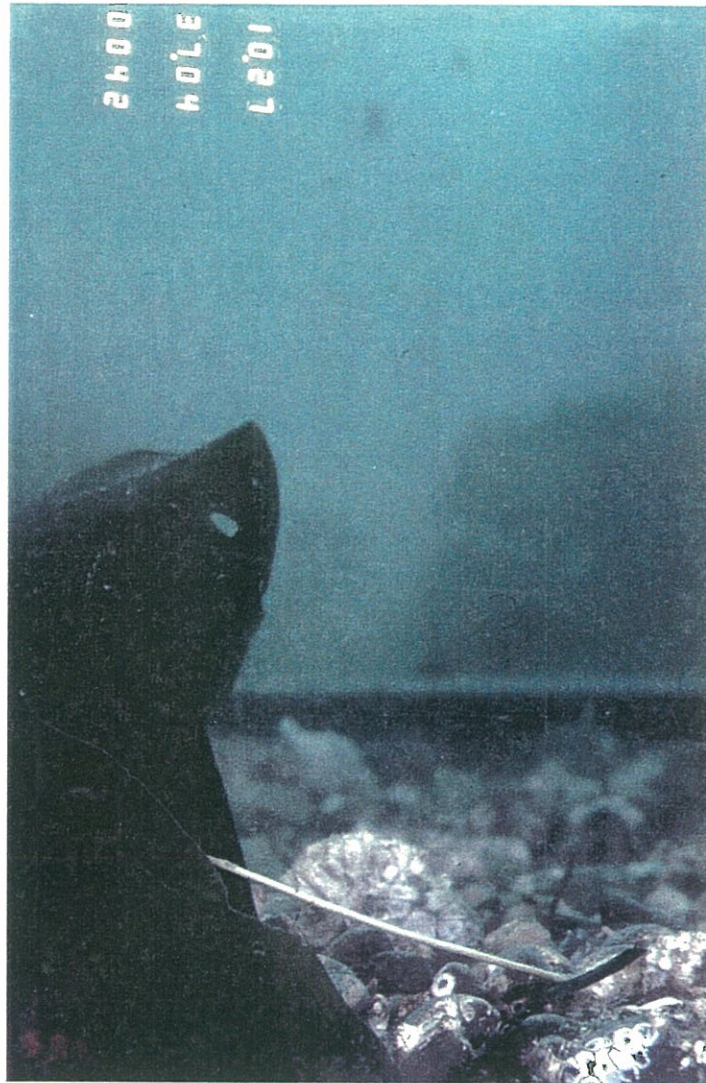
Figure 2-14. Sediment profile image from Station 17; both barnacles and kelp are utilizing the surface gravel layer as a substratum for growth. Width of image = 15 cm

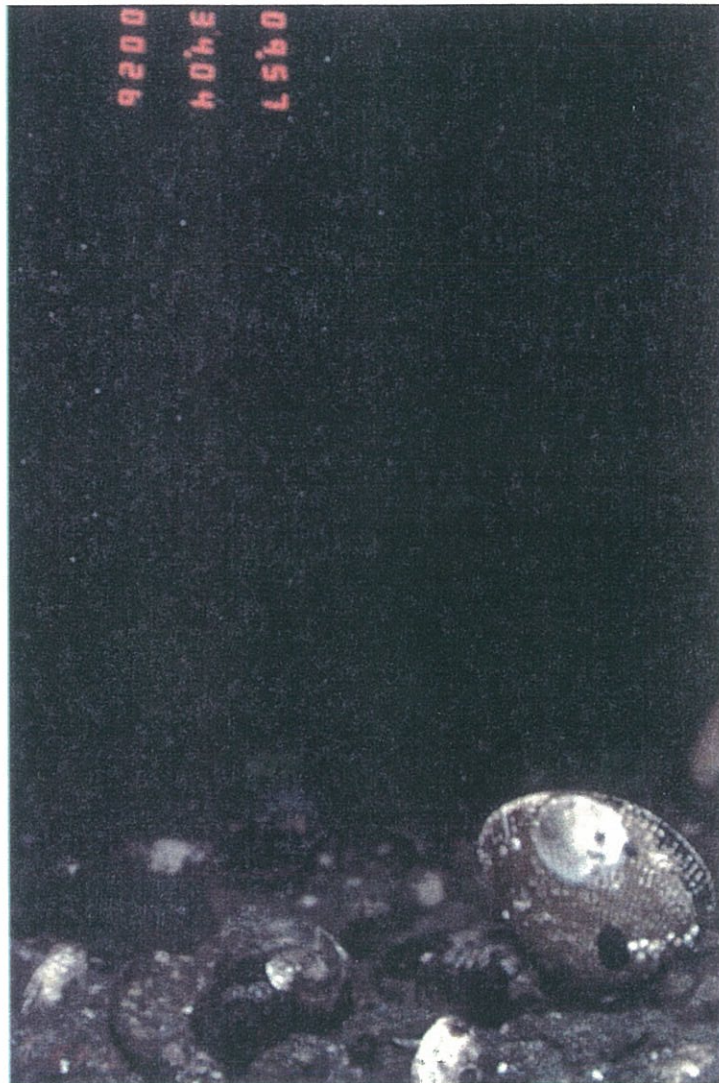
**Figure 2-15. Sediment profile image from Station 21; the mussels on the gravel surface provide a food source for larger foraging predators. Note the tip of a starfish arm at the right edge of the image.
Width of image = 15 cm**

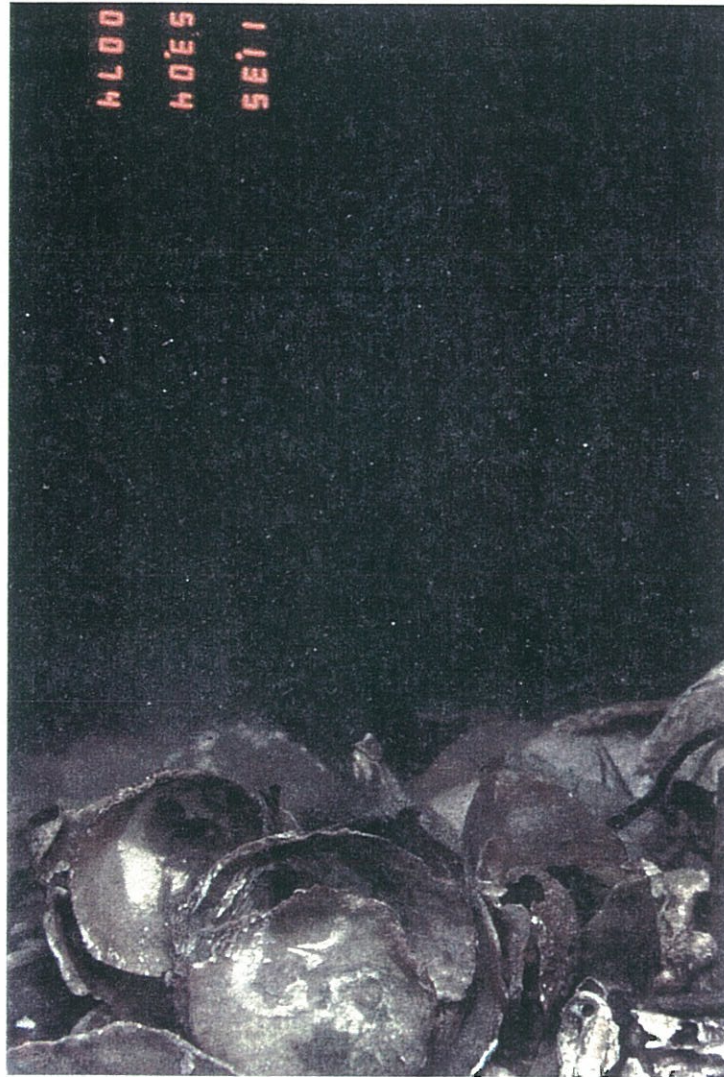
Figure 2-16. Sediment profile image from Station 25; the thick layer of shells from dead bivalves prevented any substantial penetration by the sediment profile camera prism. Width of image = 15 cm

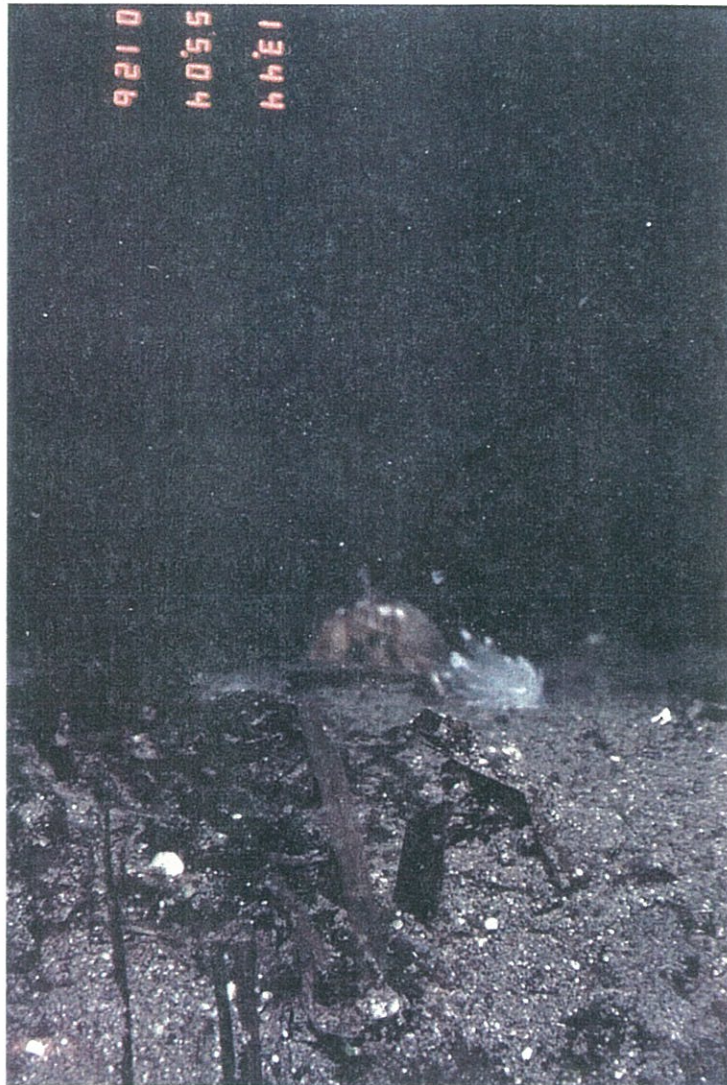
Figure 2-17. Sediment profile image from Station 23; note the hermit crab and the cluster of what are most likely squid eggs on the sediment surface. Width of image = 15 cm
