Kennedy/Jenks Consultants

Subject: Response to Ecology Comments
Forensic Evaluation of Hydrocarbons
Former Tacoma Metals Facility
K/J 996098.00

SECTION 1 – INTRODUCTION AND PURPOSE

SECTION 2 – PAST USES AND CONTAMINANT SOURCES

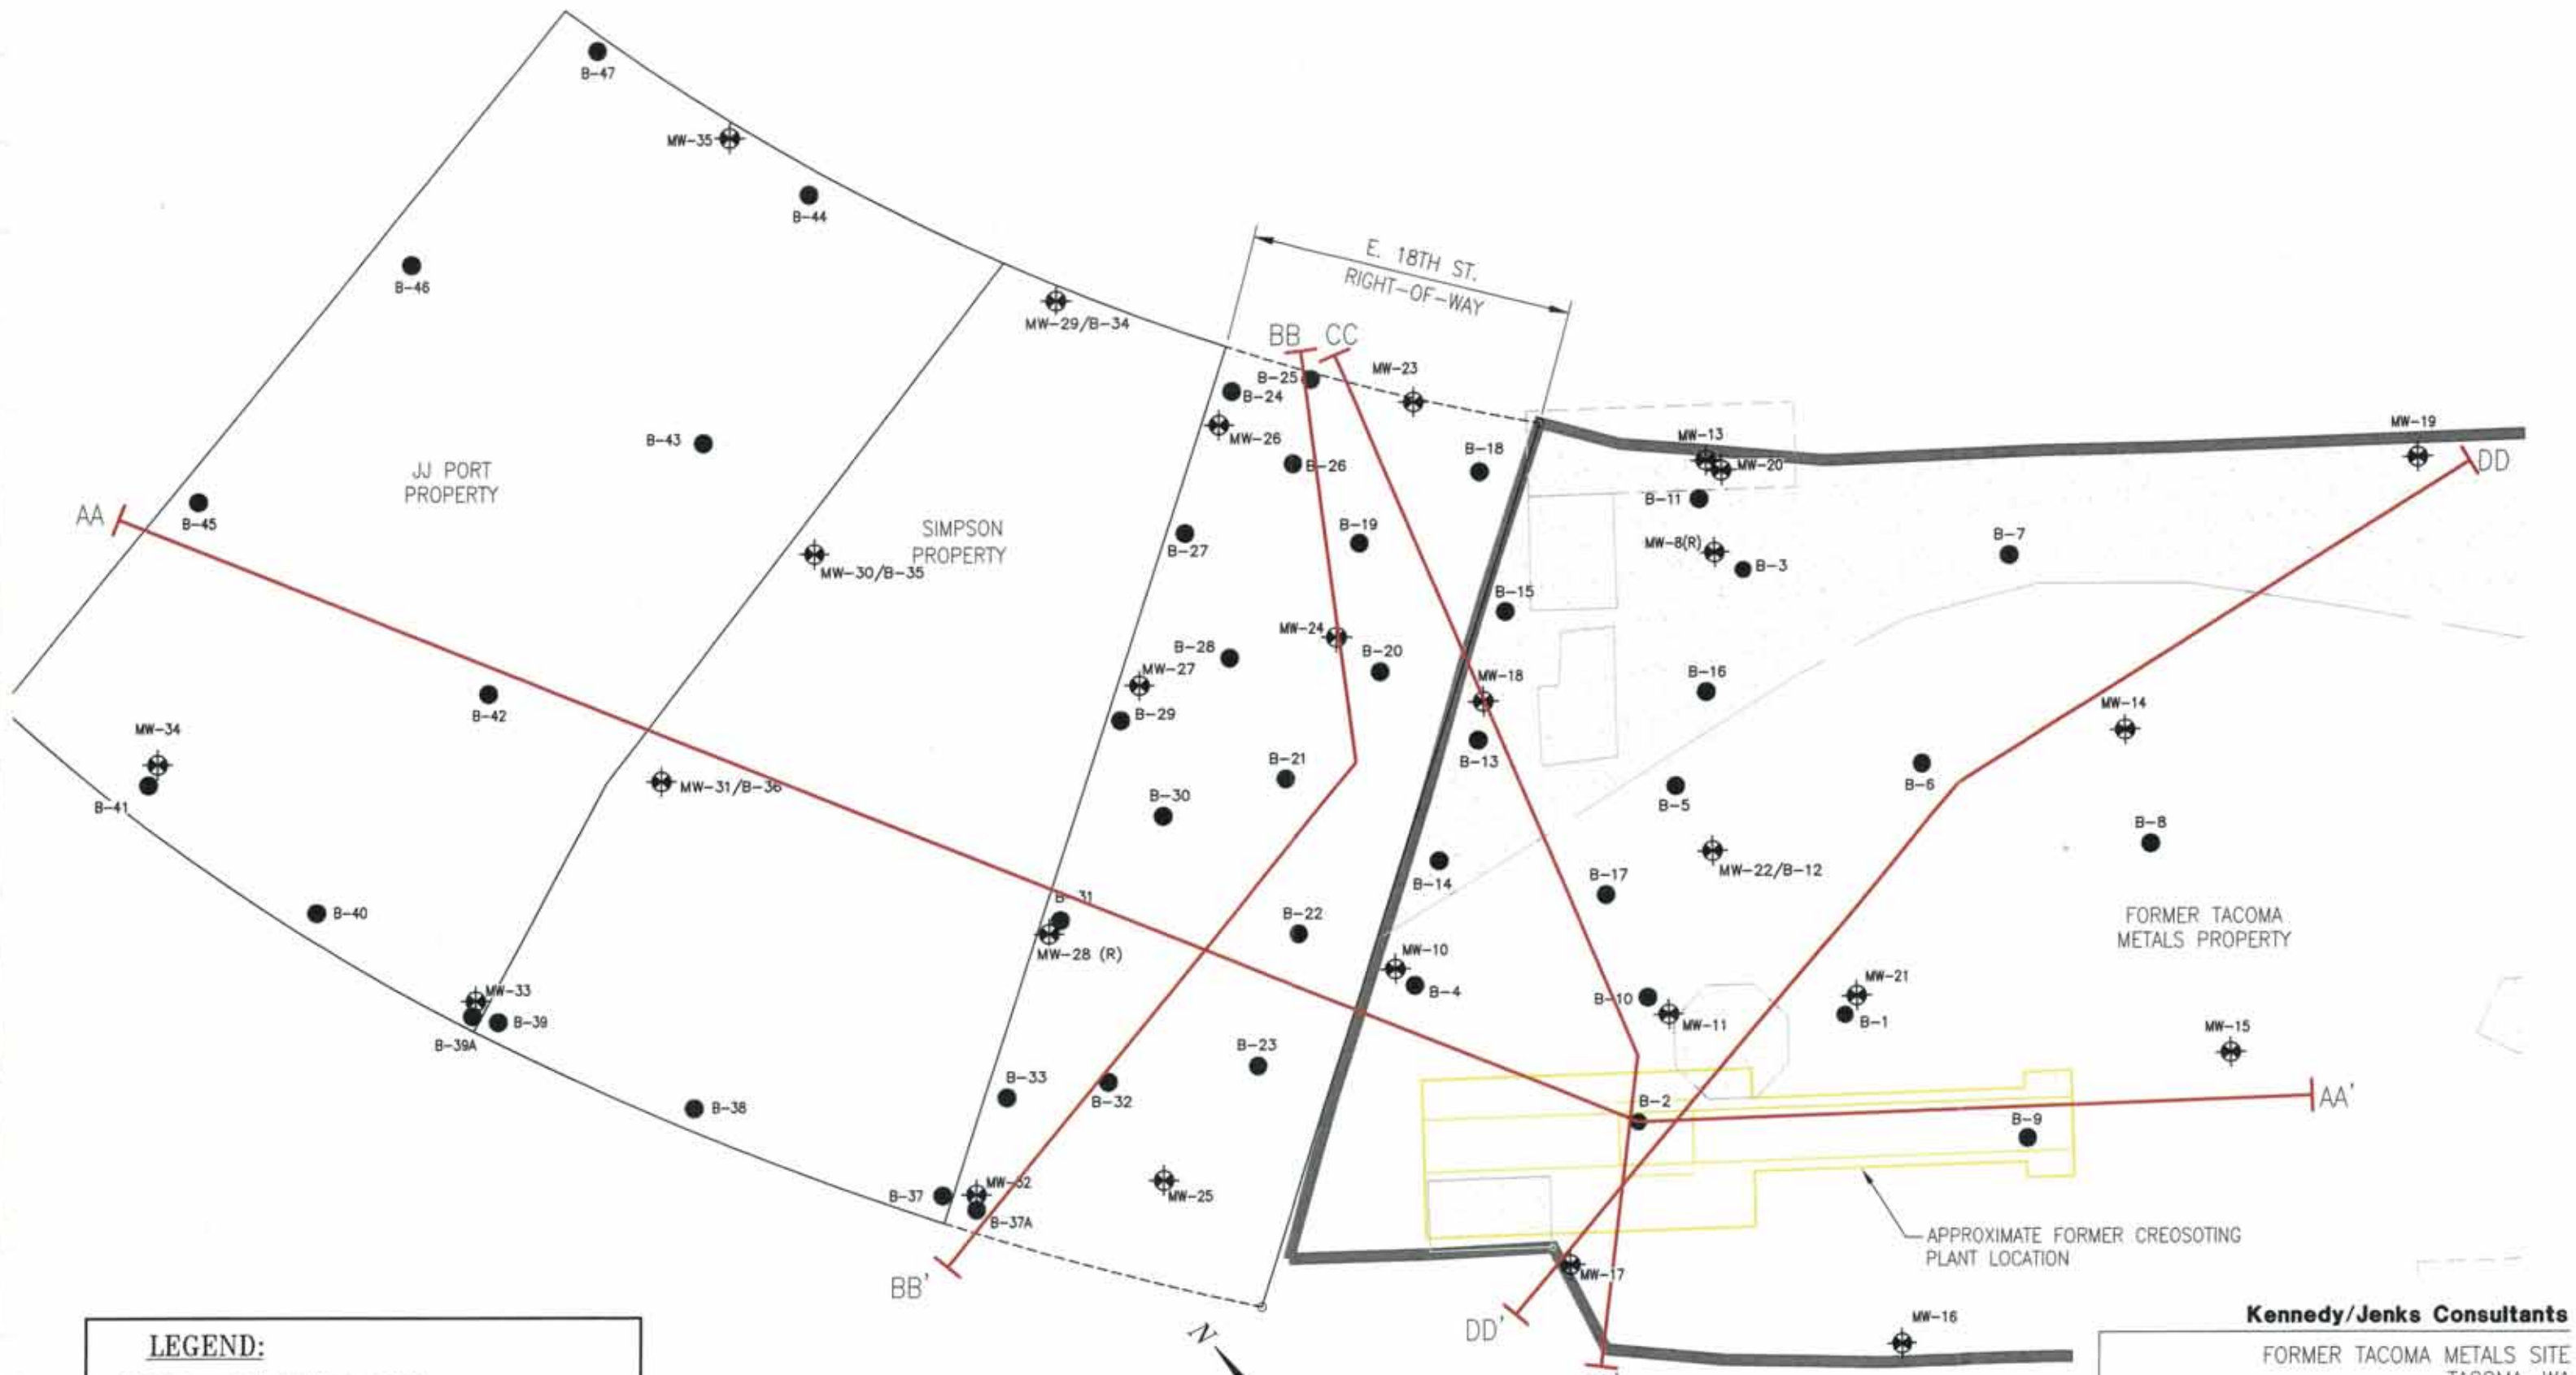
**FORMER CREOSOTING PLANT
 SITE AND SAMPLE LOCATION MAP**

- B-18 SOIL BORING LOCATION
- ⊕ MW-12 MONITORING WELL LOCATION
- BB' | BB GENERALIZED CROSS SECTION LOCATION

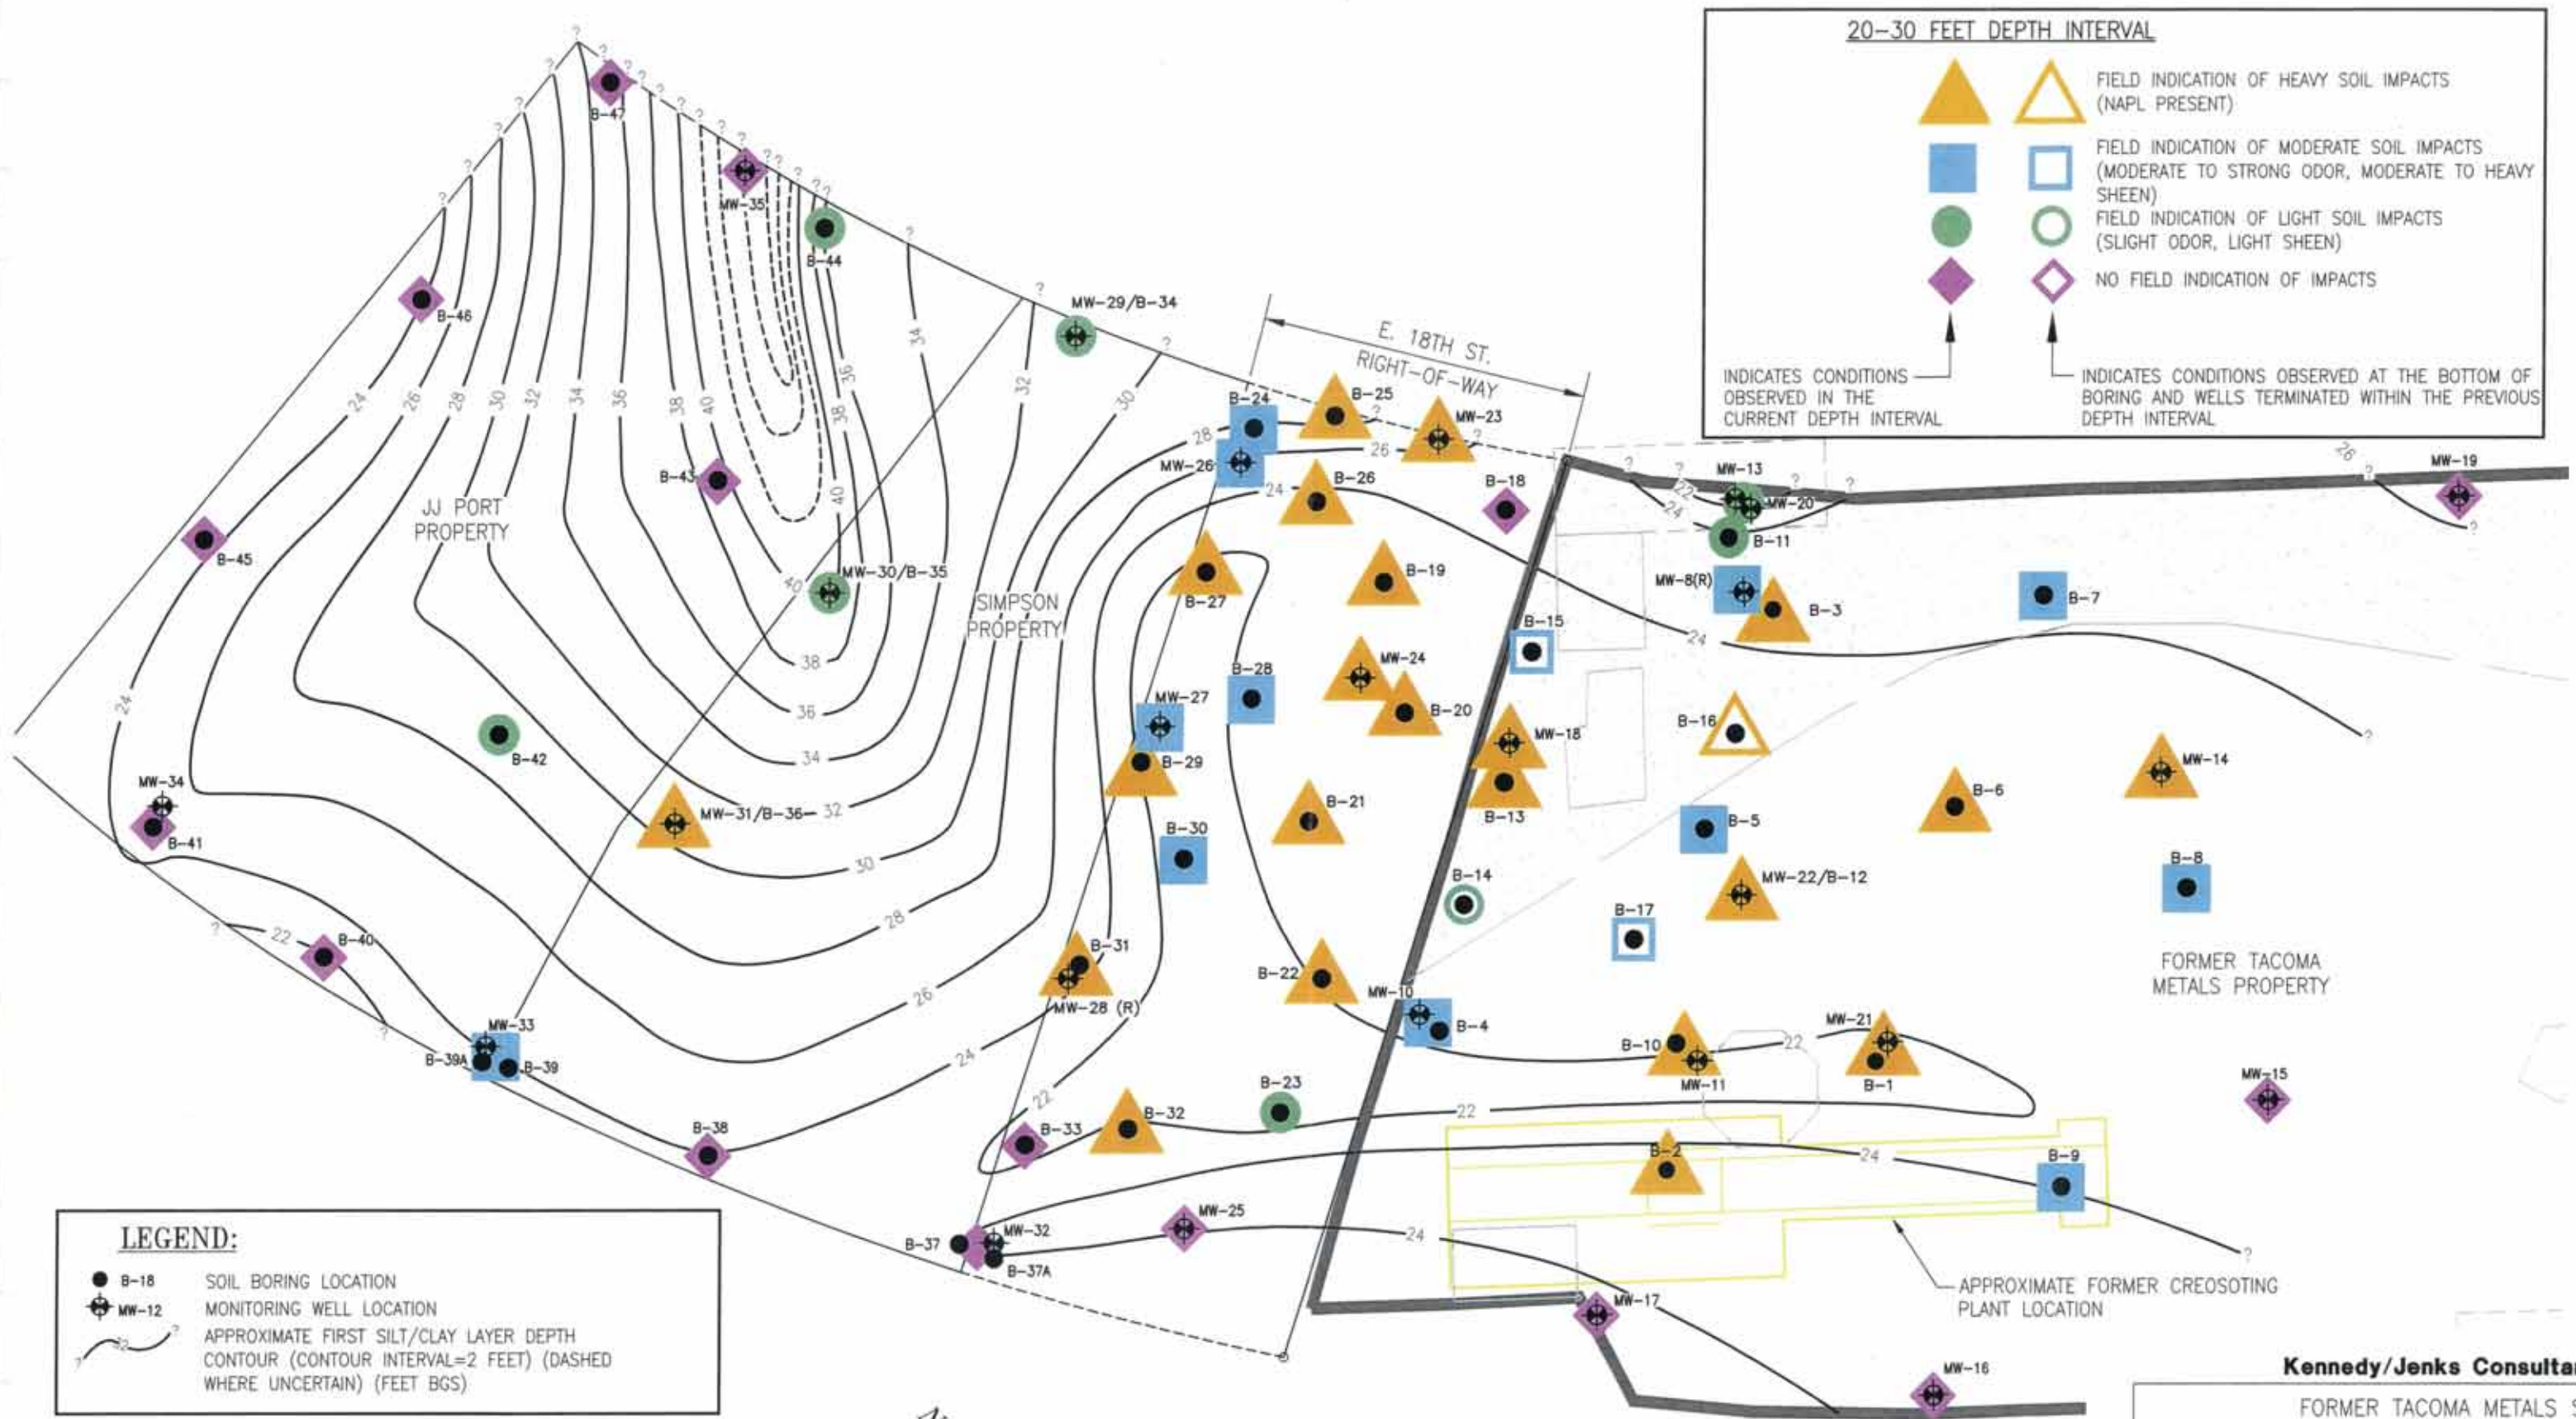
FIGURE 2C

20-30 FEET DEPTH INTERVAL

1. ALL LOCATIONS ARE APPROXIMATE.
2. BGS = BELOW GROUND SURFACE.
3. THIS MAP SHOWS THE HIGHEST LEVEL OF SOIL IMPACTS OBSERVED WITHIN THE INDICATED DEPTH INTERVAL. THESE CONDITIONS ARE NOT NECESSARILY REPRESENTATIVE OF THE ENTIRE DEPTH INTERVAL.
4. DEPTHS ARE IN FEET BGS NORMALIZED TO AN ELEVATION DATUM OF 10 FEET (THE APPROXIMATE EXISTING SURFACE ELEVATION AT THE FORMER CREOSOTING PLANT STRUCTURE).
5. NAPL = NON-AQUEOUS PHASE LIQUID.

Figures 2A, 2B, 2C, and 2D illustrate the degree of soil impacts observed at various depth intervals (0 to 10 feet, 10 to 20 feet, 20 to 30 feet, and 30 to 40 feet). The depths are normalized to the approximate existing surface elevation (10 feet above mean sea level) at the former location of the creosoting plant. The most heavily impacted soil (NAPL evident) at shallow (0 to 10 feet) depths is encountered beneath the former creosoting plant. At intermediate depths (10 to 20 feet and 20 to 30 feet), heavily impacted soil is encountered both beneath and laterally away from the former creosoting plant to the northeast/northwest. The lateral extent of heavily impacted soil is greatest in the 20- to 30-foot depth interval. Heavily impacted soil was observed at only one location distal to the former creosoting plant location in the 30- to 40-foot depth interval. Impacted soil was not observed below 40 feet bgs. This indicates a creosote source at the former creosoting plant location and creosote migration vertically and laterally away from the facility. The degree and magnitude of impacted soils are clearly greatest directly beneath the former location of the creosoting plant (the only documented source at the site).

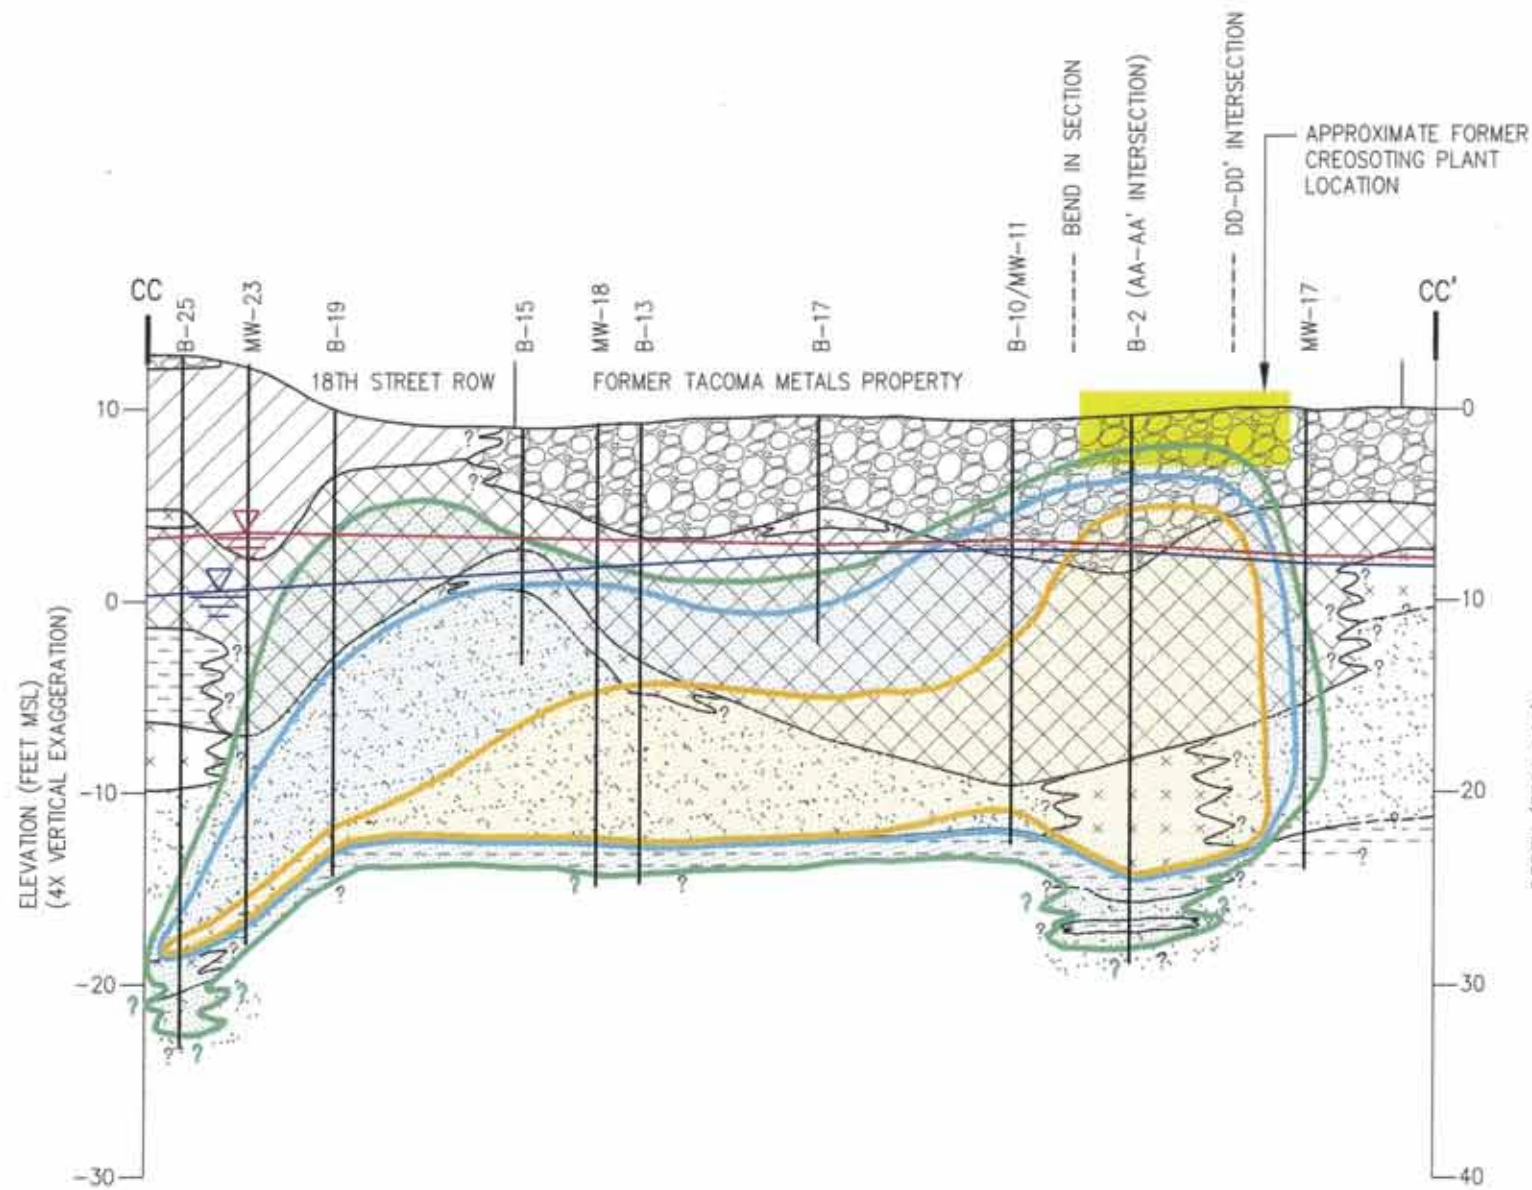
FIGURE 3C

**FORMER CREOSOTING PLANT SITE
 GENERALIZED CROSS SECTION CC-CC'**

Figures 3A, 3B, 3C, and 3D provide generalized geologic cross-sections of the former creosoting plant site area, illustrating the vertical and lateral distribution of the degree of observed soil impacts (cross-section locations are shown on Figure 1). Stratigraphic units observed at the former creosoting plant site, and shown on the cross-sections, are similar to those observed on other parts of the former Tacoma Metals Property (refer to Table 1).

The cross-sections clearly show that the former creosoting plant is the source of contaminants in the former creosoting plant site area. The vertical and lateral distribution of heavily impacted soil is consistent only with a source at the former location of the creosoting plant. Furthermore, our field observations indicate that visible creosote impacts are initially encountered beneath, or at the base of, the 3 to 5 feet of fill material placed at the former creosoting plant site prior to construction of the coke plant. This indicates that the creosote impacts observed at the former creosoting plant site resulted from a release that occurred before the fill material was placed (prior to approximately 1940 to 1943).

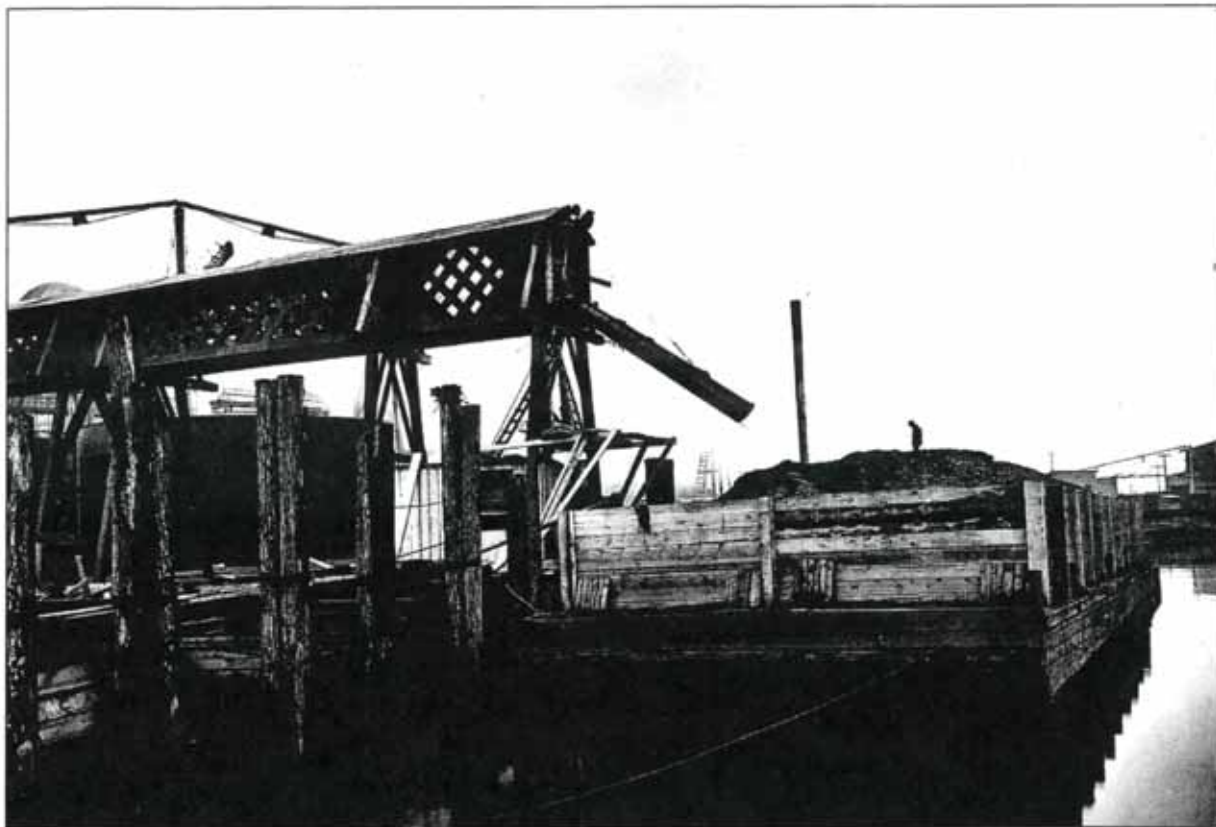
Photo 1920A. Storage tank (left half of photo) at the former creosoting plant site.

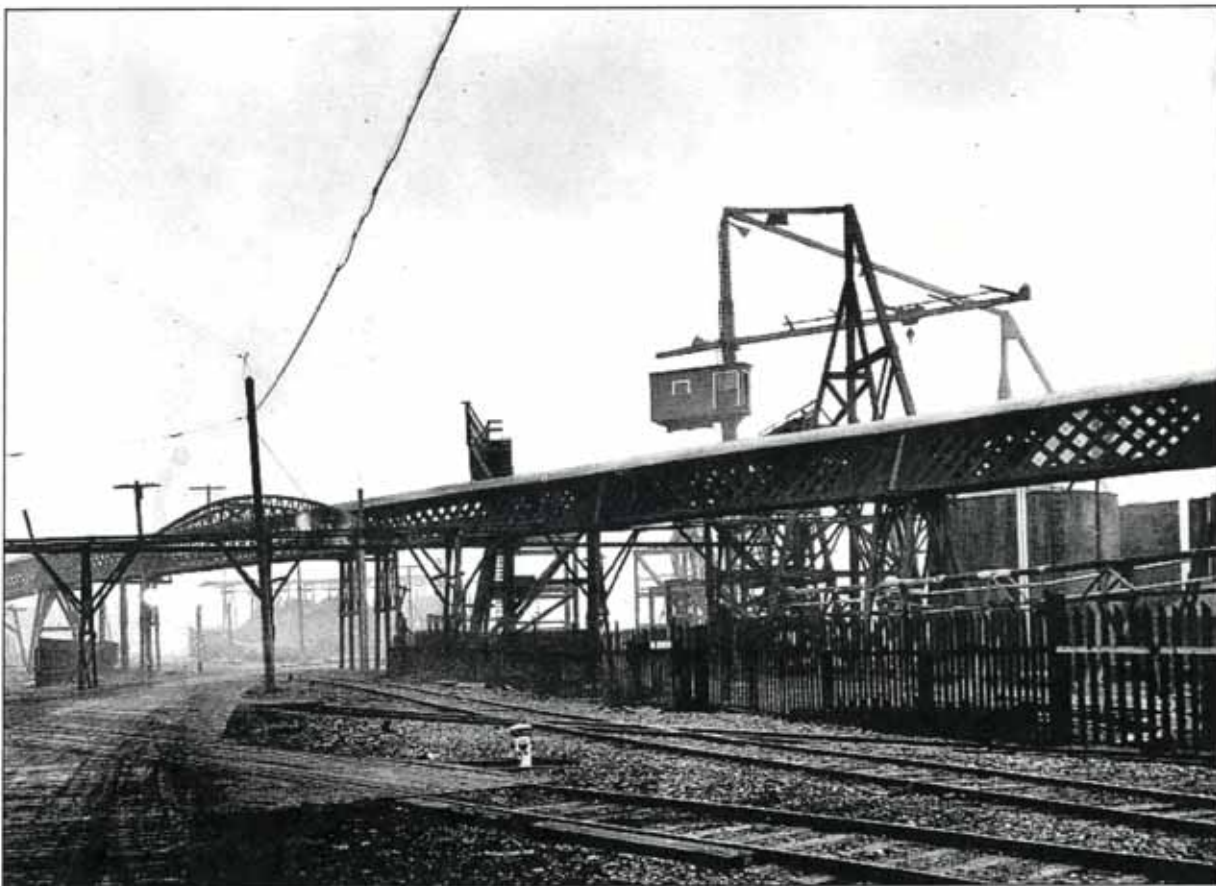
Photo 1920B. Former creosoting plant site tanks and structures (right half of photo)

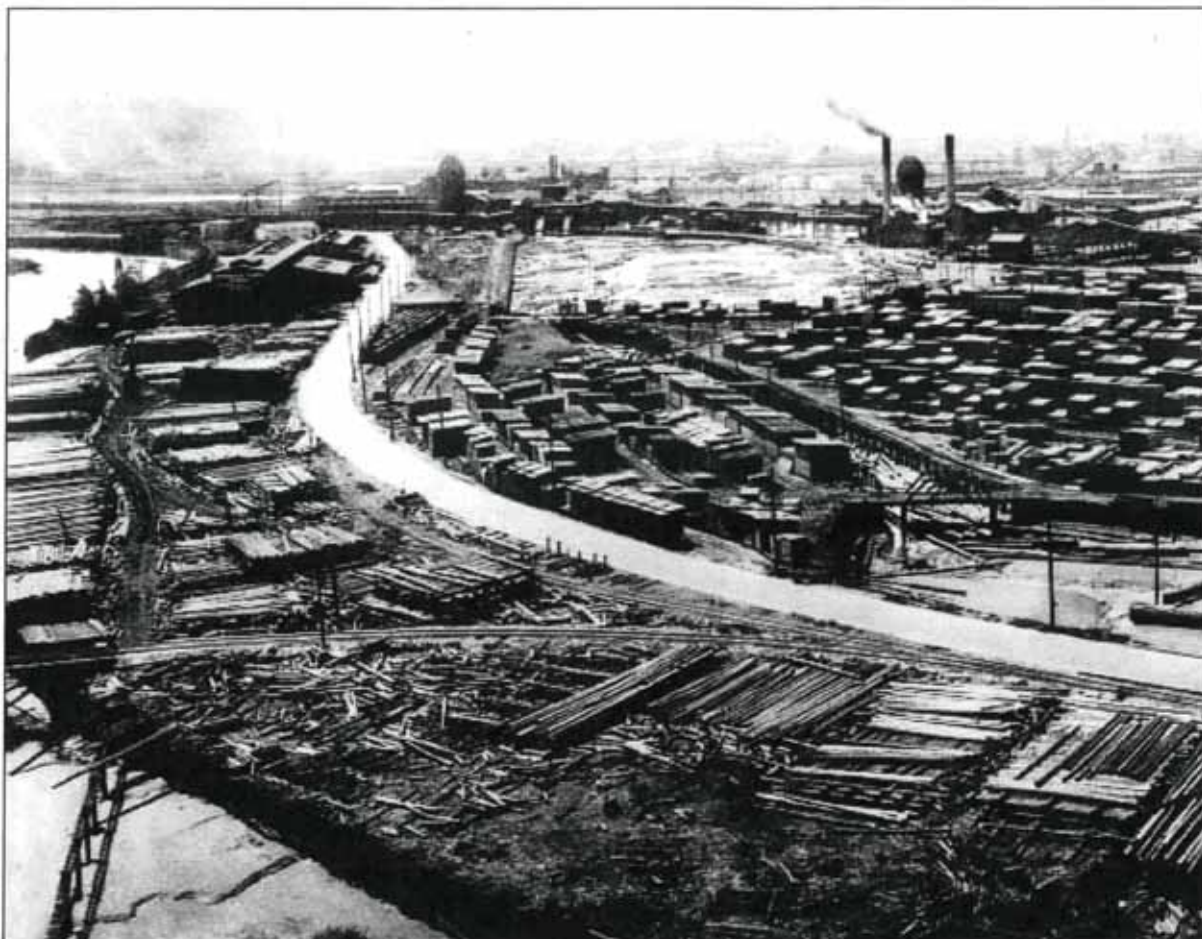
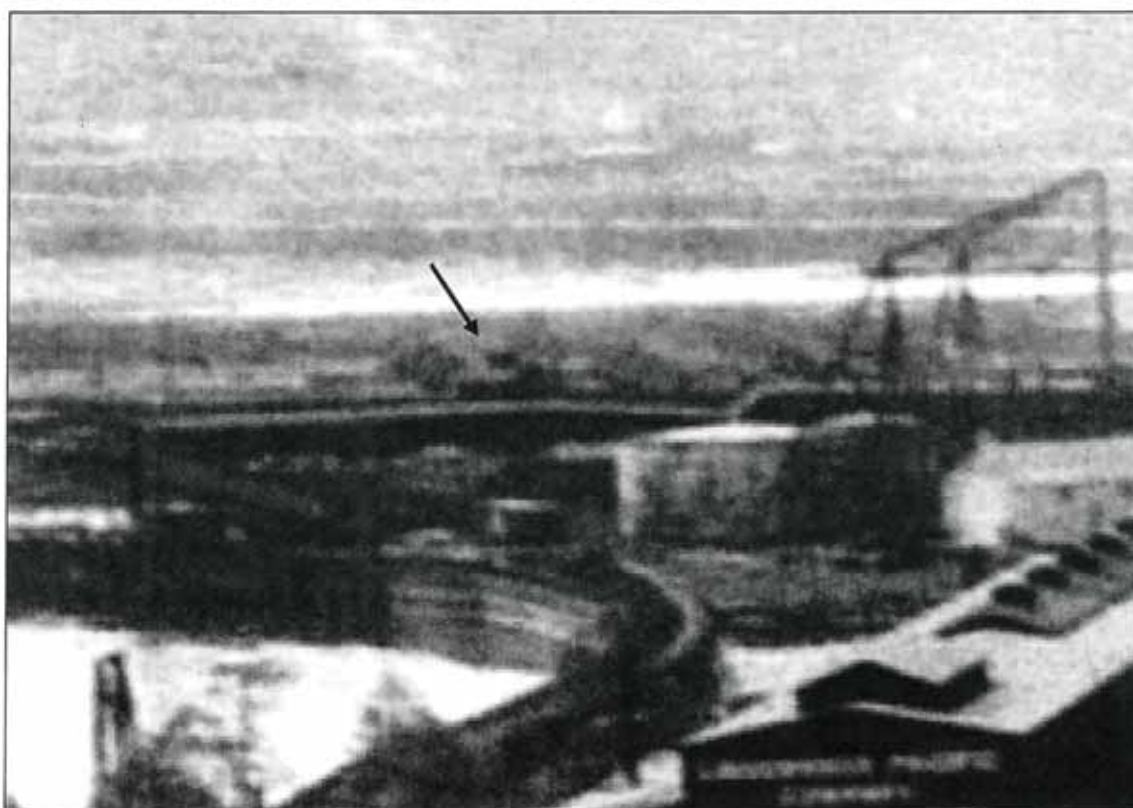
1927 Photo. Upper--Oblique view of the former creosoting plant site (upper left of photo, tanks and crane visible) and surrounding area. **Lower--**Former creosoting plant site, zoomed in from upper photo (arrow points to top of the main site structure that houses the retort).

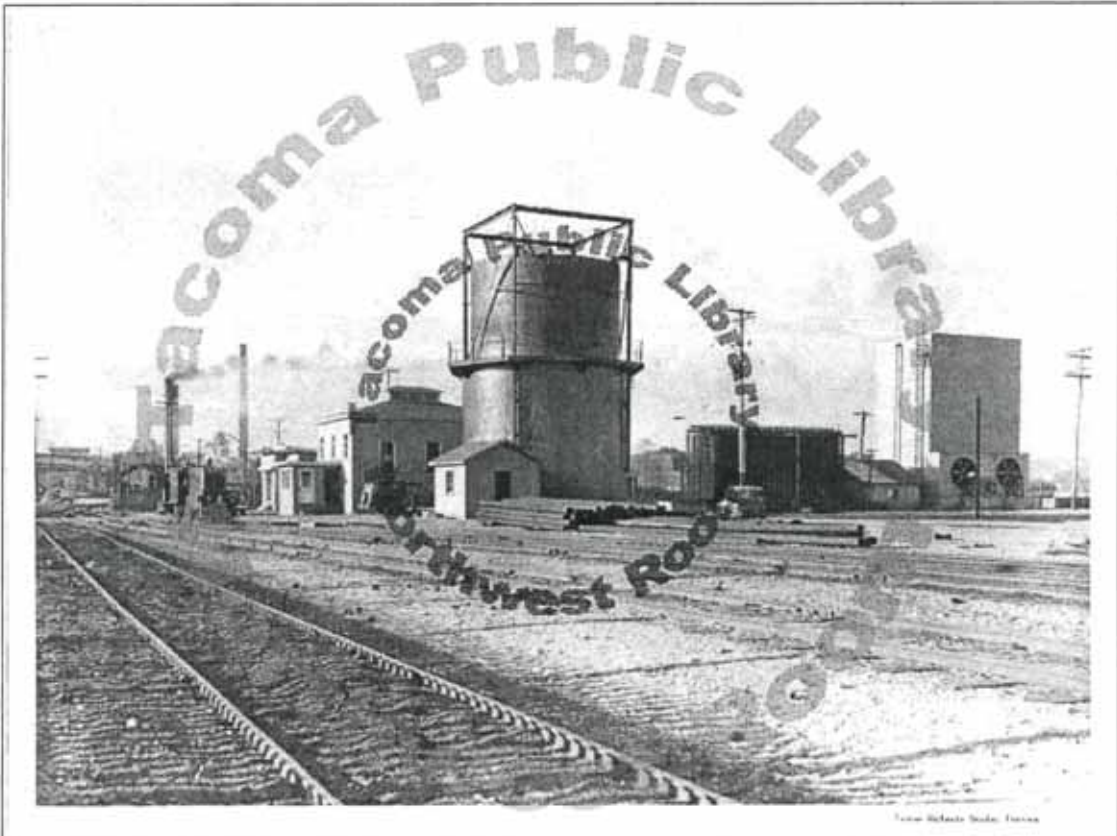
Photo 1944B. Likely coal gas storage and distribution structures located at the former coke plant site and associated with the former creosoting plant site, view to the west.

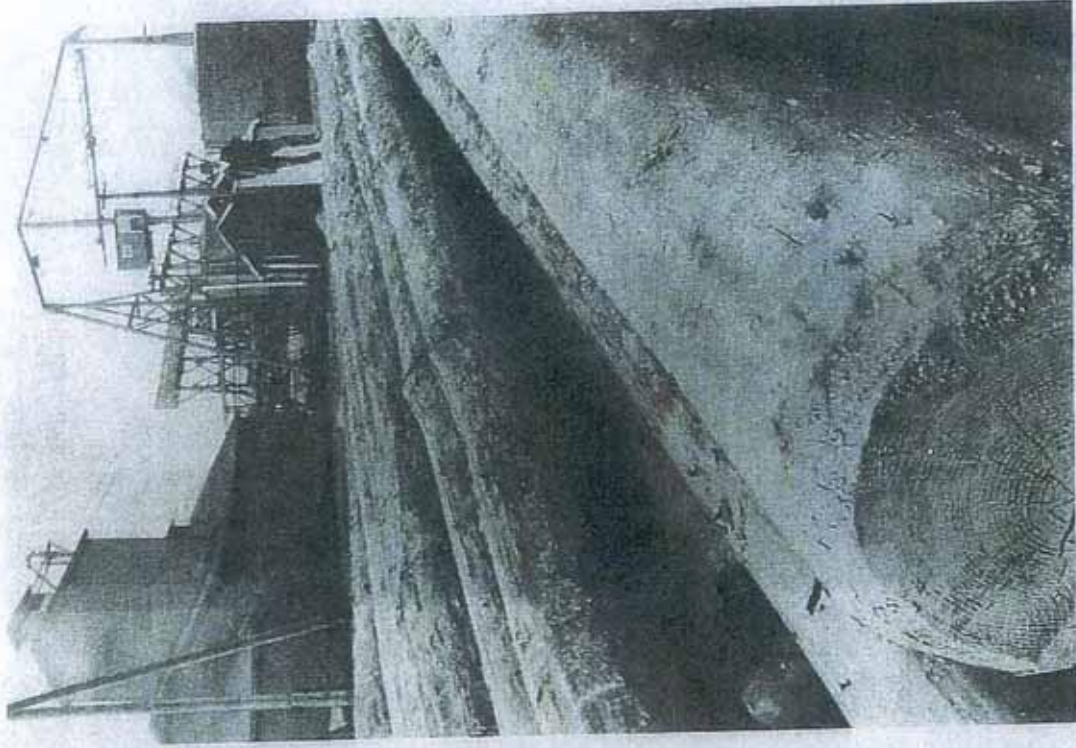
The creosoting plant with an array of treated piling in the foreground. The plant supplied some of the material for Tacoma's Eleventh Street bridge, which was originally paved with creosoted wood blocks (from American Lumberman, May 21, 1921)
