# THEA FOSS AND WHEELER-OSGOOD WATERWAYS REMEDIATION PROJECT

## REMEDIAL ACTION CONSTRUCTION REPORT

SEPTEMBER 2006

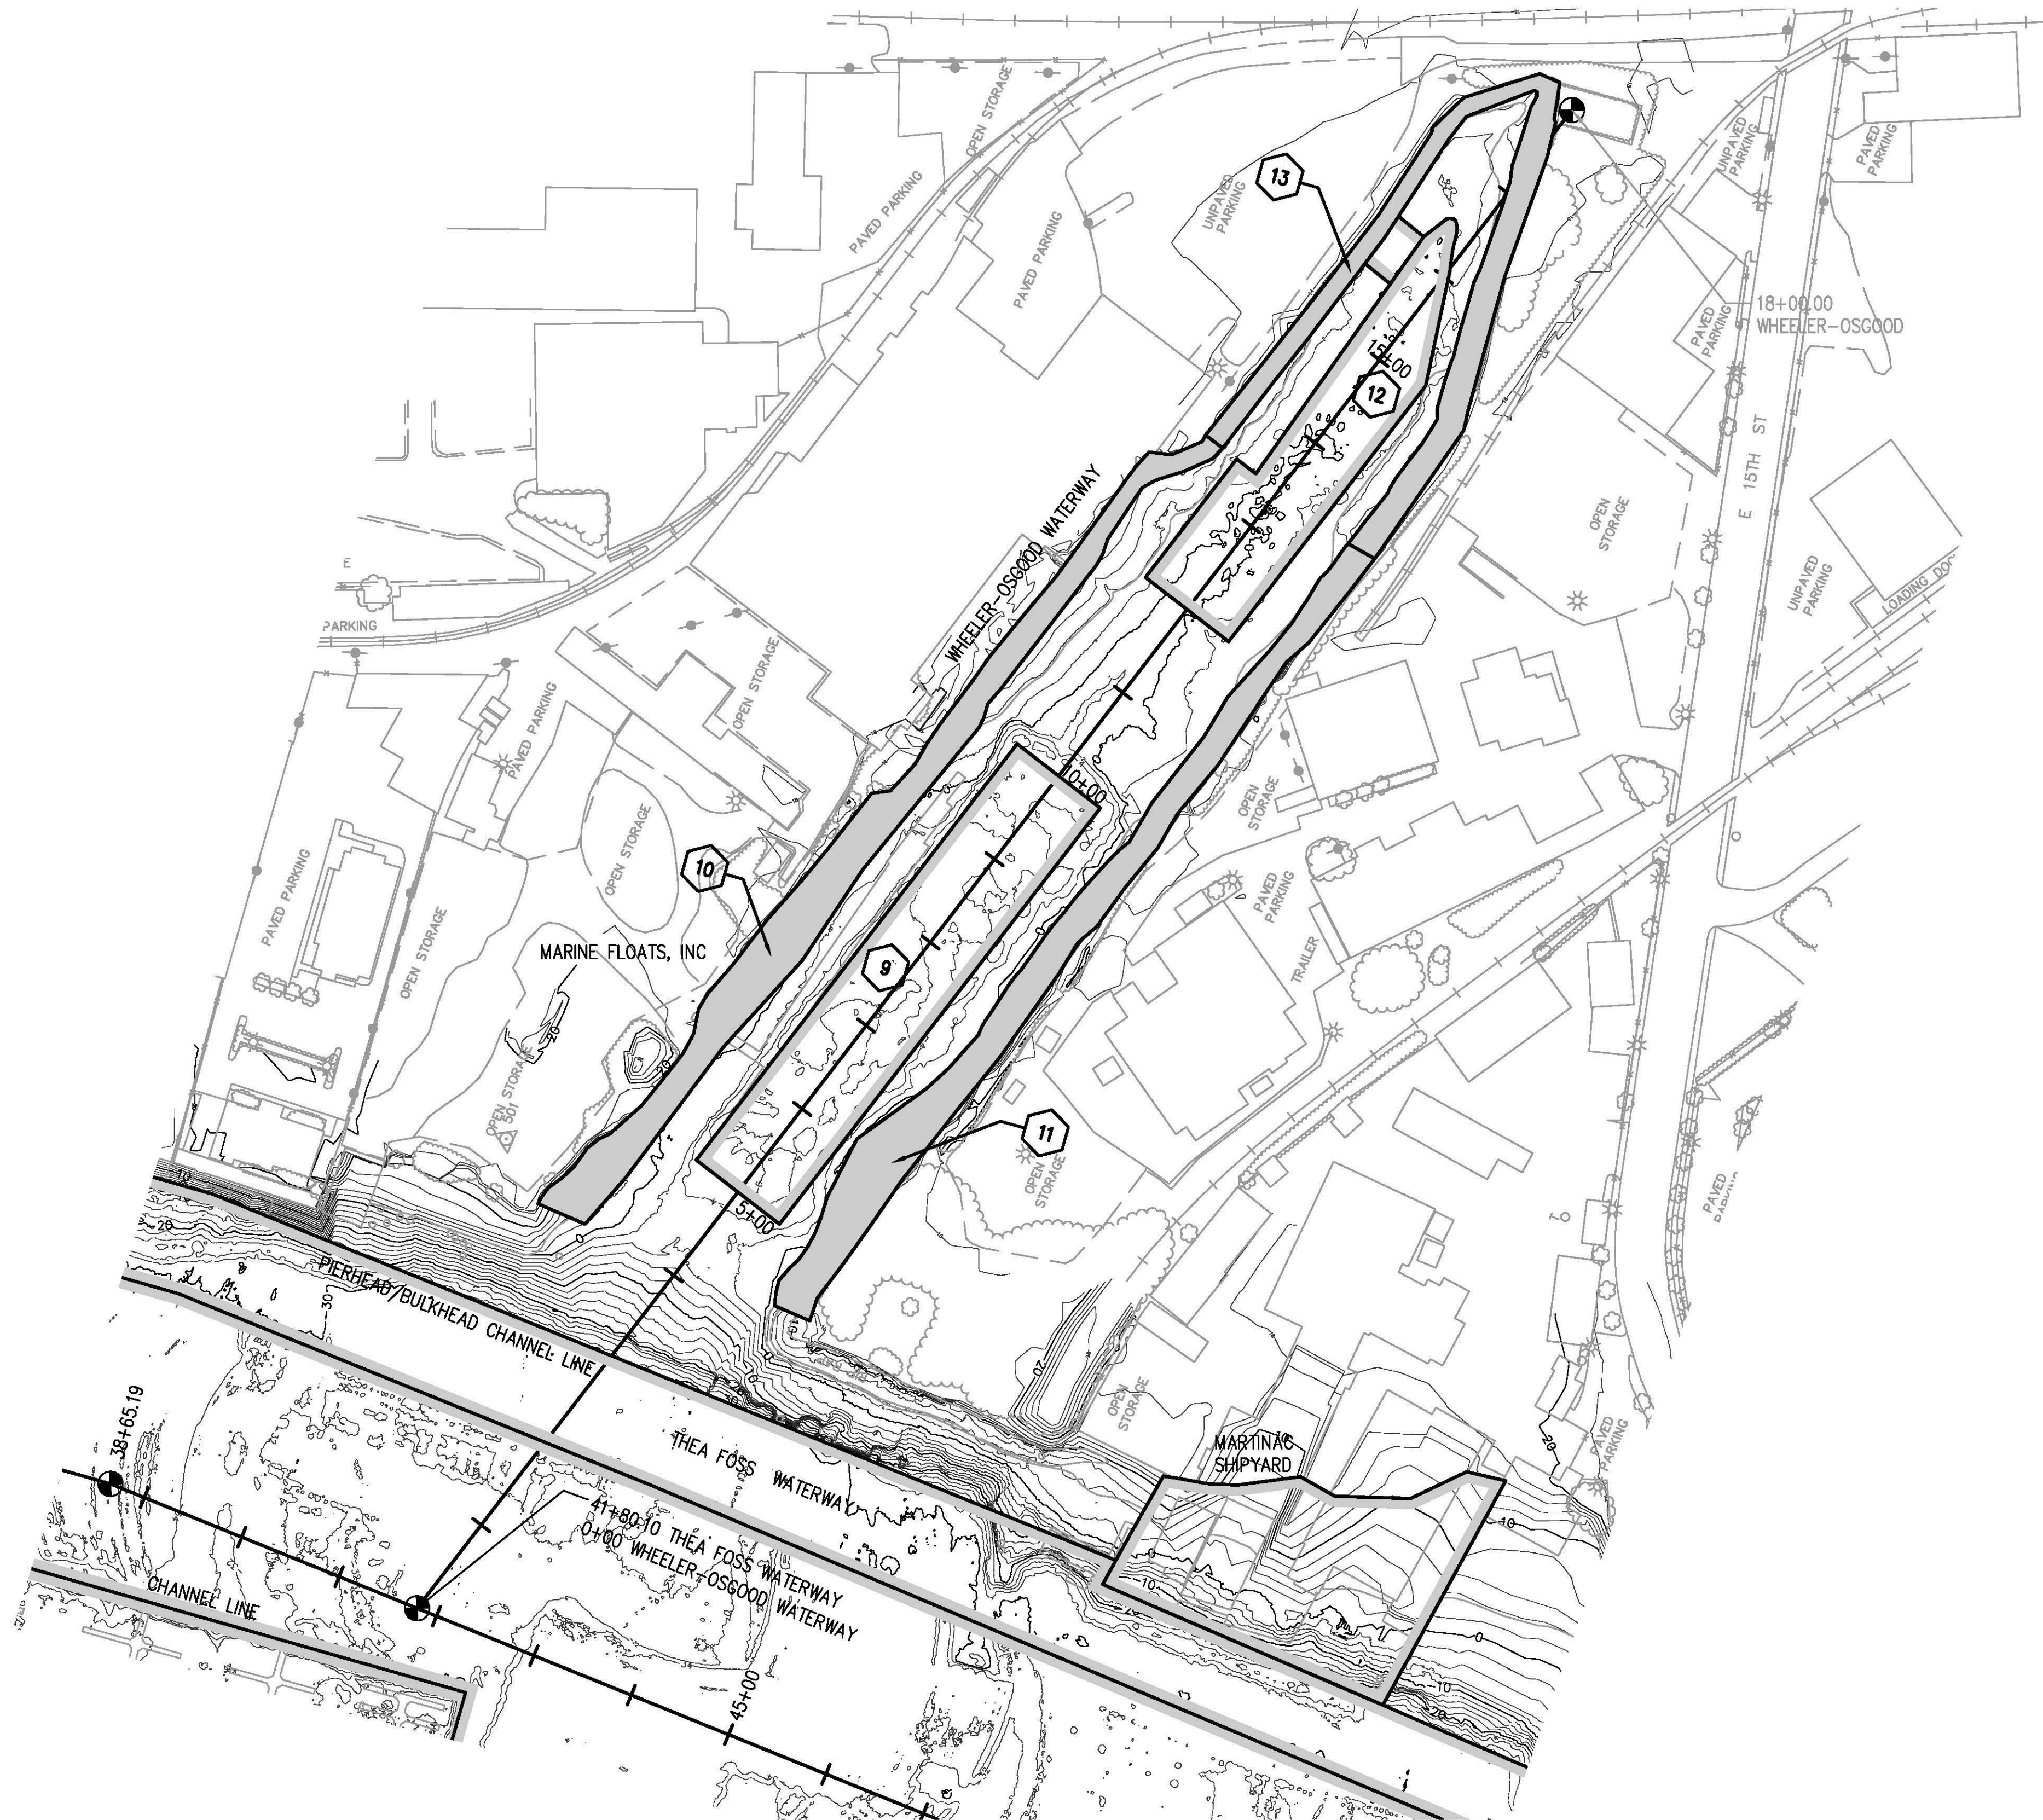
Hydrographic surveys were conducted to confirm dredge depths and limits as well as cap thickness. Dredge surveys were reviewed and approved by the CM Team prior to commencing capping operations. Cap surveys were reviewed by the Corps at the time of the Pre-Final Inspection with no issues noted. Figure 6 presents the post-construction conditions in RA 9.

Pre and post-dredge hydrographic surveys were performed. The post-dredge surveys were reviewed and approved prior to backfilling RA 12 and capping of the sheen source removal area. Post backfill and cap surveys were taken and were reviewed by the Corps during the Pre-Final Inspection with no issues noted. Figure 6 presents the post-construction conditions in RA 12.

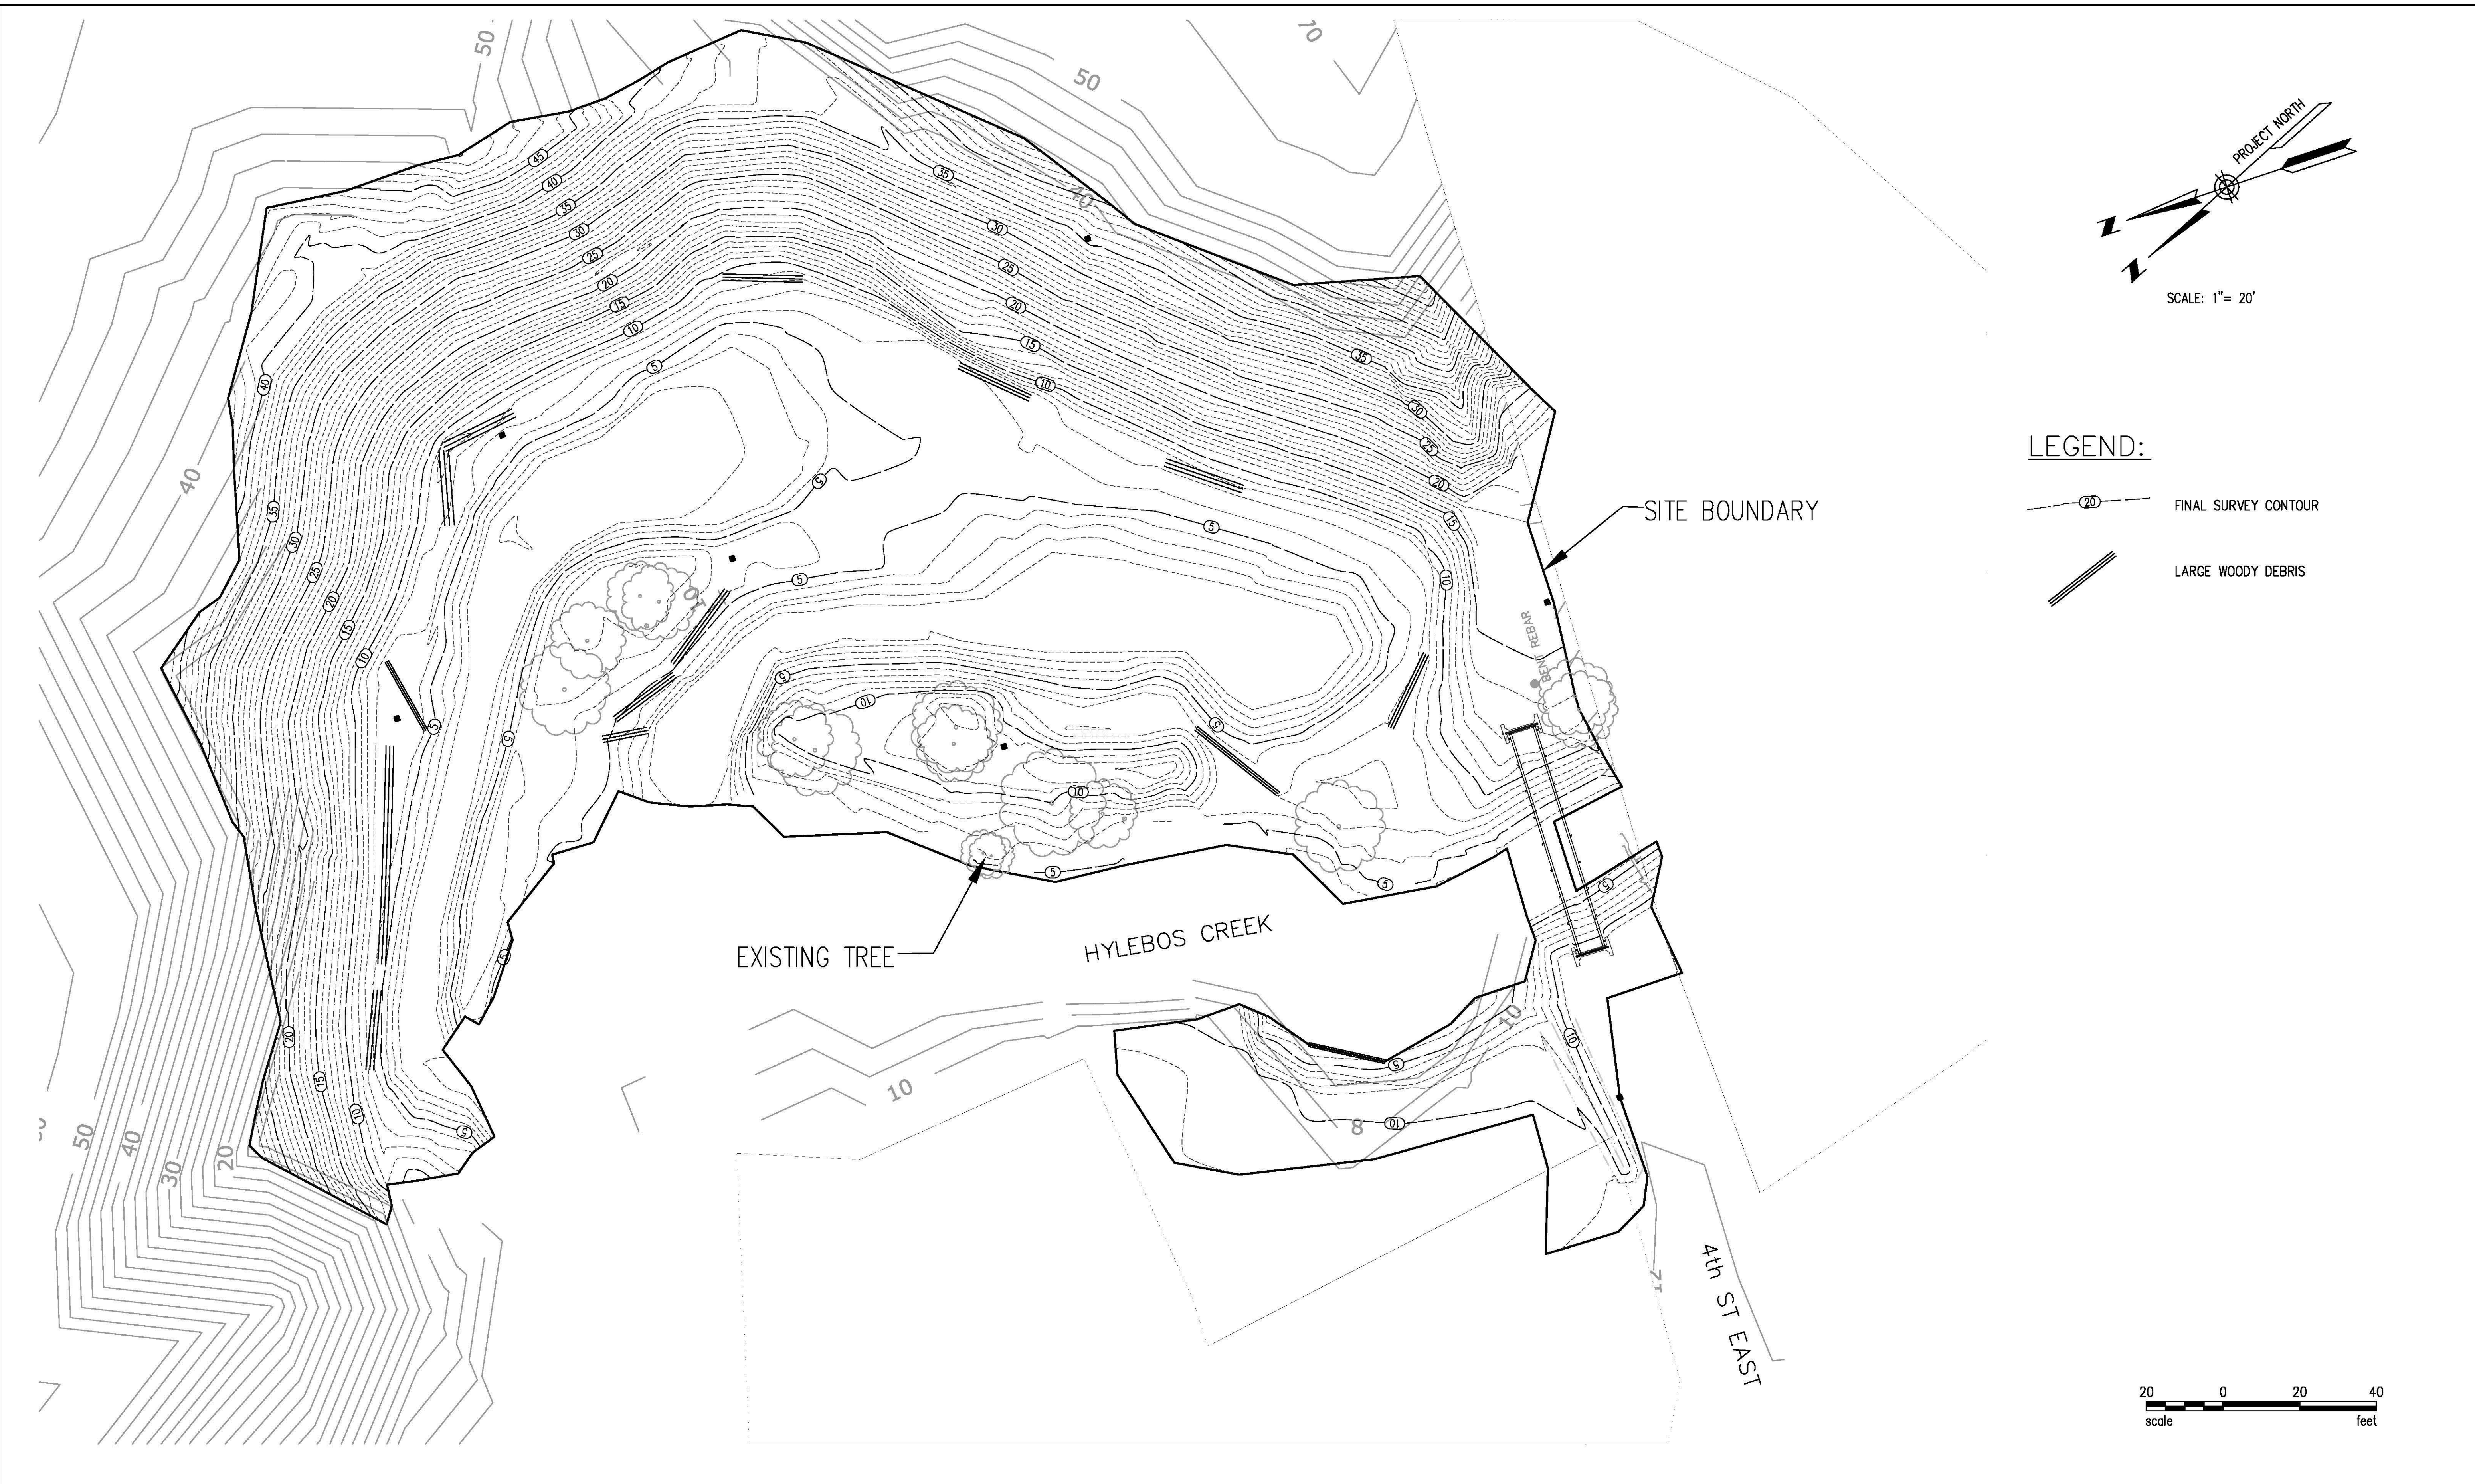
Figure 14  
Puyallup River Side Channel Sample Stations

At seven of the 10 pre-construction characterization sample stations within the PRSC, the detected chemical concentrations were below the SQOs in samples collected at the habitat surface. Detected chemical concentrations were less than the SQOs in samples at and below the habitat surface at Stations HC-MW-1, HC-MW-2, PR002, PR004, PR005, PR007, and PR008 (Figure 14). At three of 10 pre-construction characterization sample stations (PR001, PR003, and PR006), chemical concentrations in samples collected from the habitat surface were greater than the SQOs for one or more compounds.
