REMEDIAL INVESTIGATION REPORT

KELLOGGS KORNER MIDVALE AND EMERALD ROADS SUNNYSIDE, WASHINGTON

Farallon PN: 1432-001

April 2018

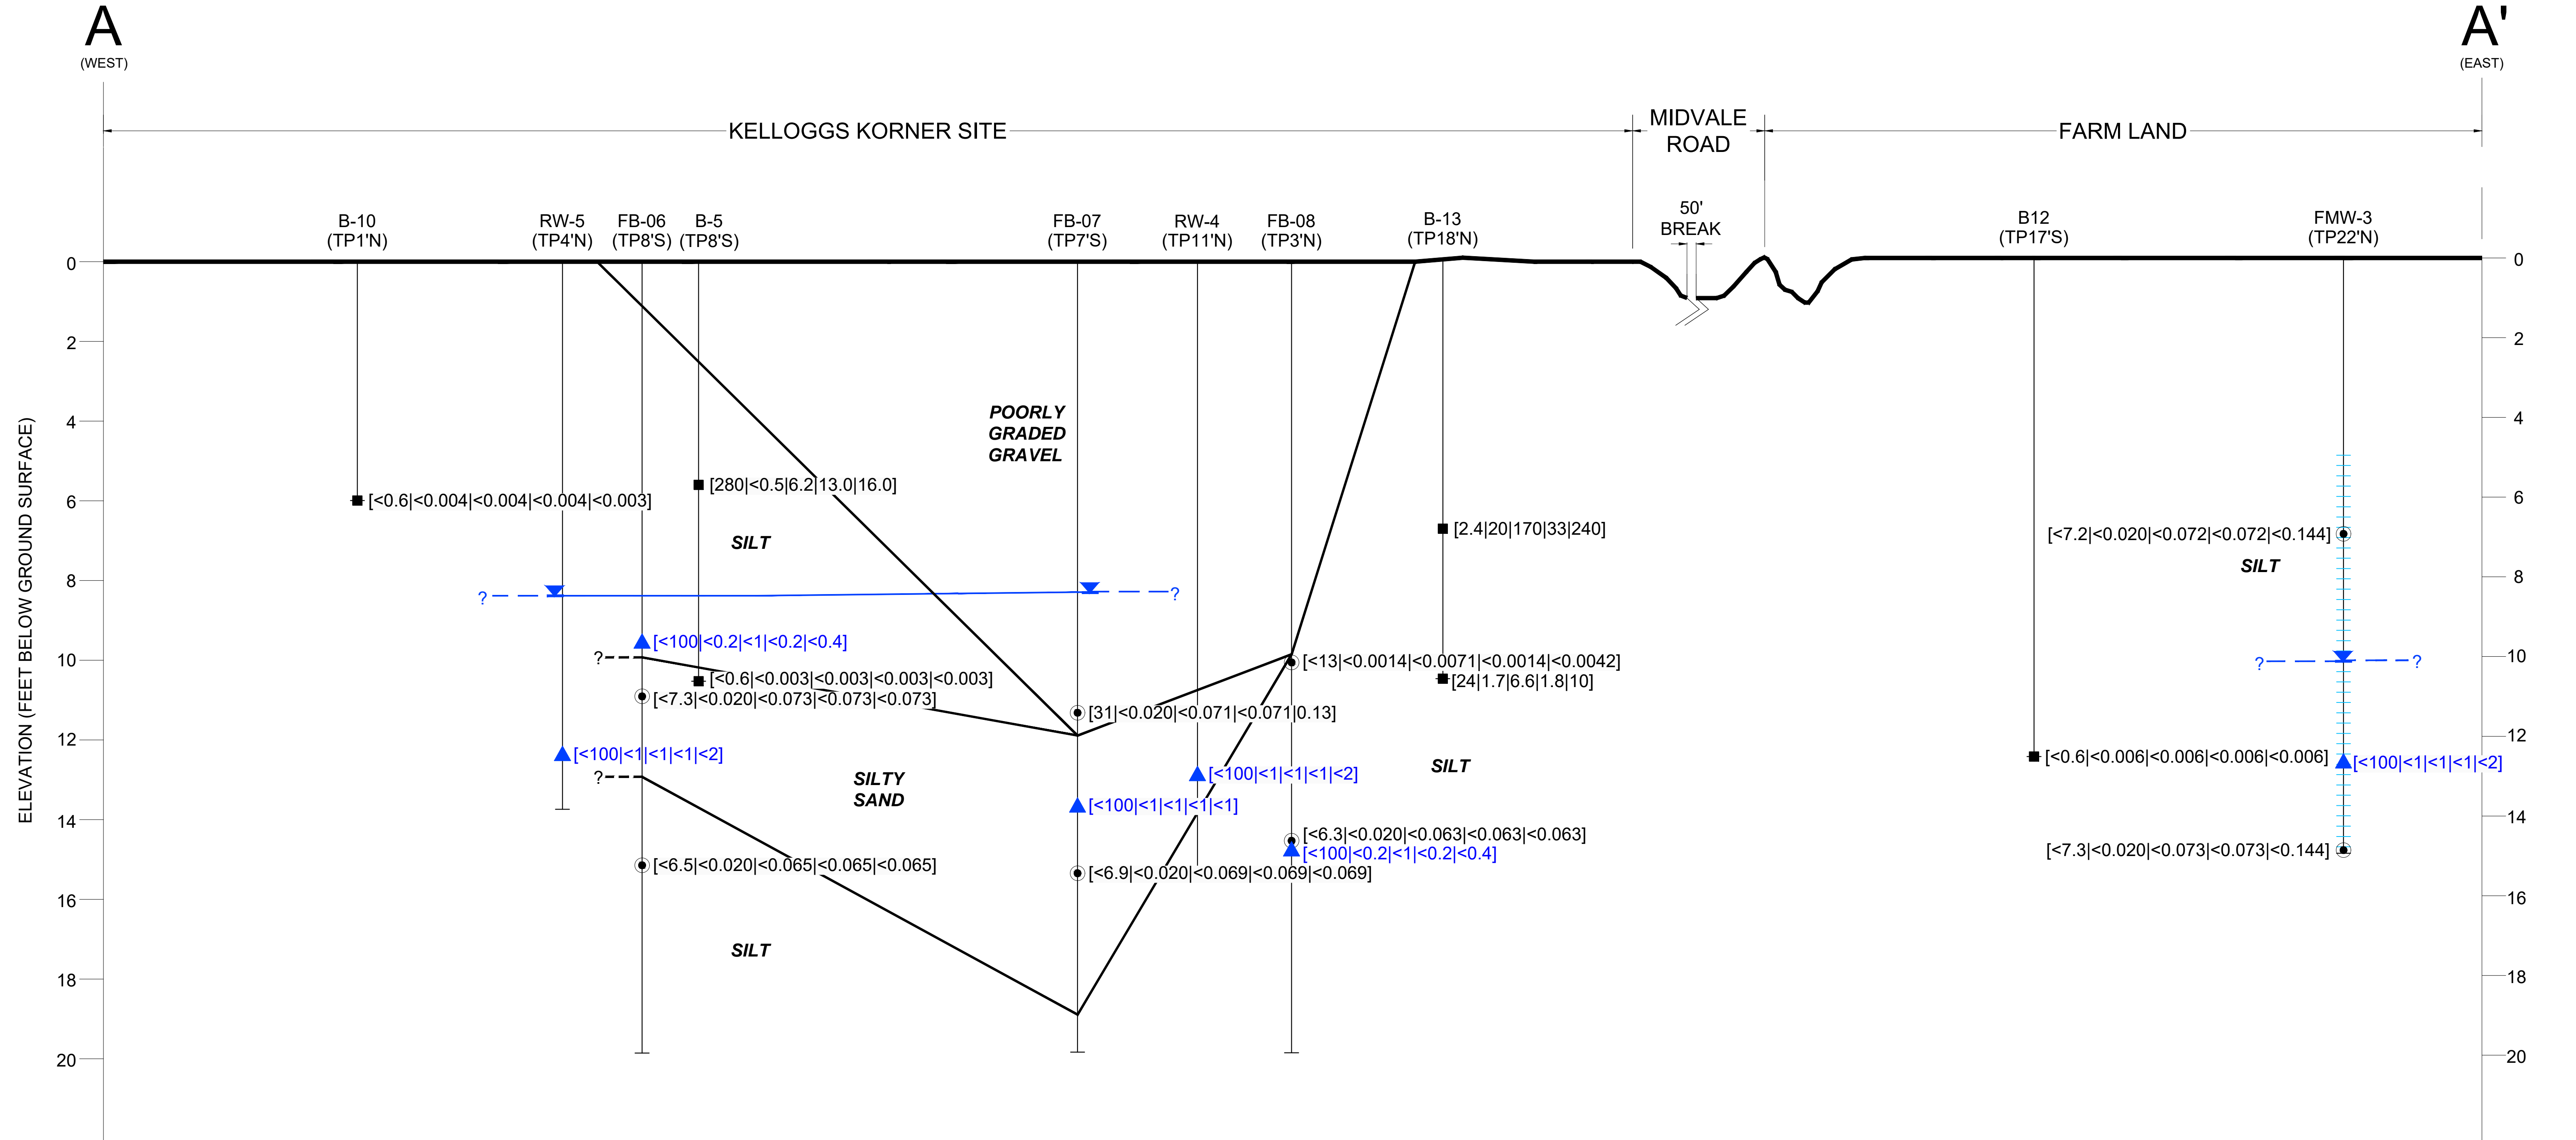
- B-10 (TP1'N) BORING/MONITORING WELL ID
- BORING TRANSPOSED (TP) IN FEET NORTH (N) OR SOUTH (S) OF CROSS-SECTION LINE.
- STRATIGRAPHIC CONTACT] DASHED WHERE APPROXIMATE
- CHEN-NORTHERN INC. SOIL SAMPLE (1994)
- FARALLON SOIL SAMPLE (2015 AND 2017)
- FARALLON GROUNDWATER SAMPLE (2015 AND 2017)
- GROUNDWATER ELEVATION
- WELL SCREEN INTERVALS

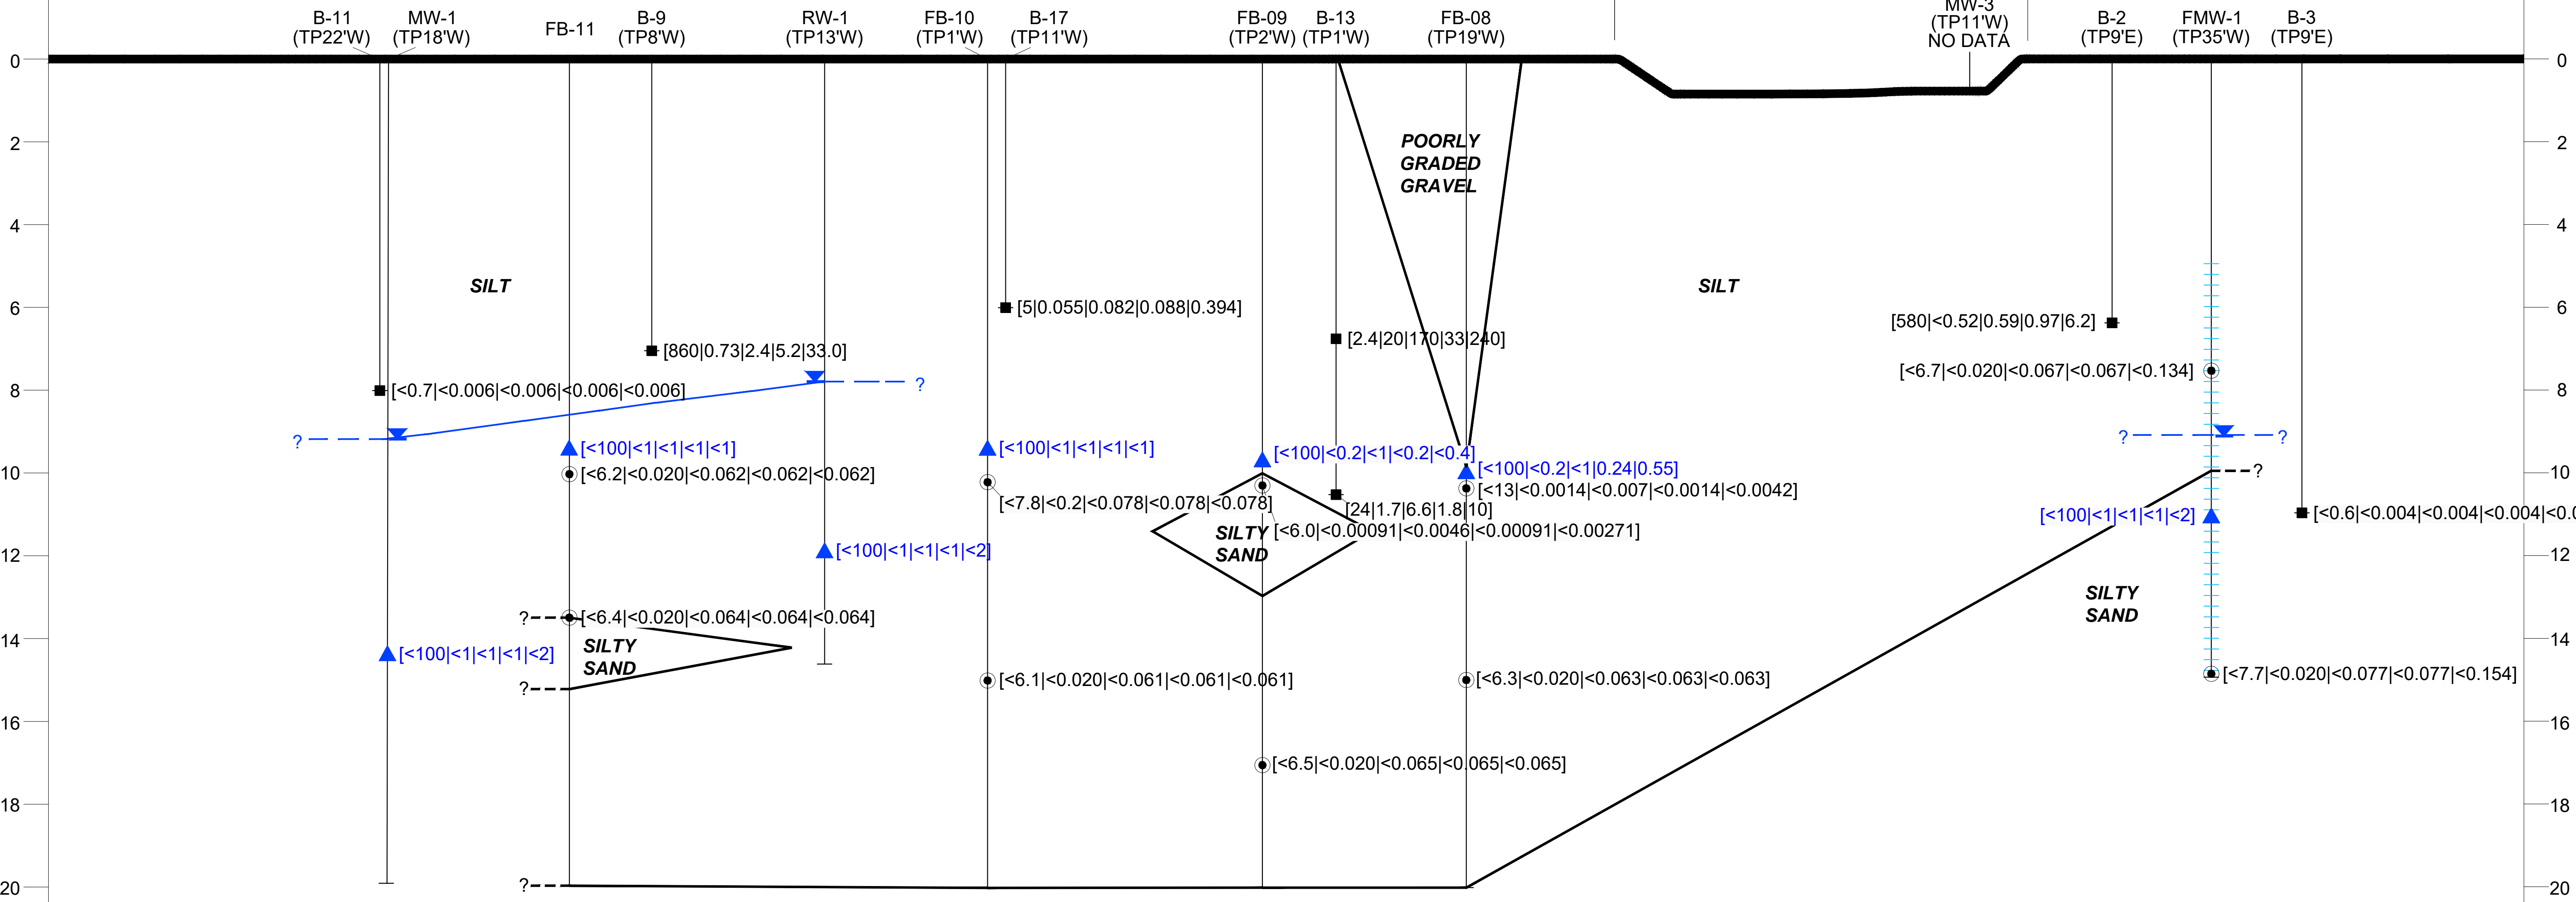
FIGURE 5
CROSS-SECTION B-B'
KELLOGGS KORNER
EMERALD AND MIDVALE ROADS
SUNNYSIDE, WASHINGTON

- B-11 (TP22'W) BORING/MONITORING WELL ID
BORING TRANSPOSED (TP)
IN FEET EAST (E) OR WEST (W) OF
CROSS-SECTION LINE.
- STRATIGRAPHIC CONTACT
DASHED WHERE APPROXIMATE
- CHEN-NORTHERN INC. SOIL SAMPLE (1994)
- FARALLON SOIL SAMPLE (2015 AND 2017)
- FARALLON GROUNDWATER SAMPLE (2015 AND 2017)
- GROUNDWATER ELEVATION
- WELL SCREEN INTERVALS
