**PHASE I ENVIRONMENTAL  
SITE ASSESSMENT**

**HERS INDUSTRIAL PARK  
4403 RUSSELL ROAD  
MUKILTEO, WASHINGTON 98275**

**June 20, 2005**

**Project No. 2005-087**

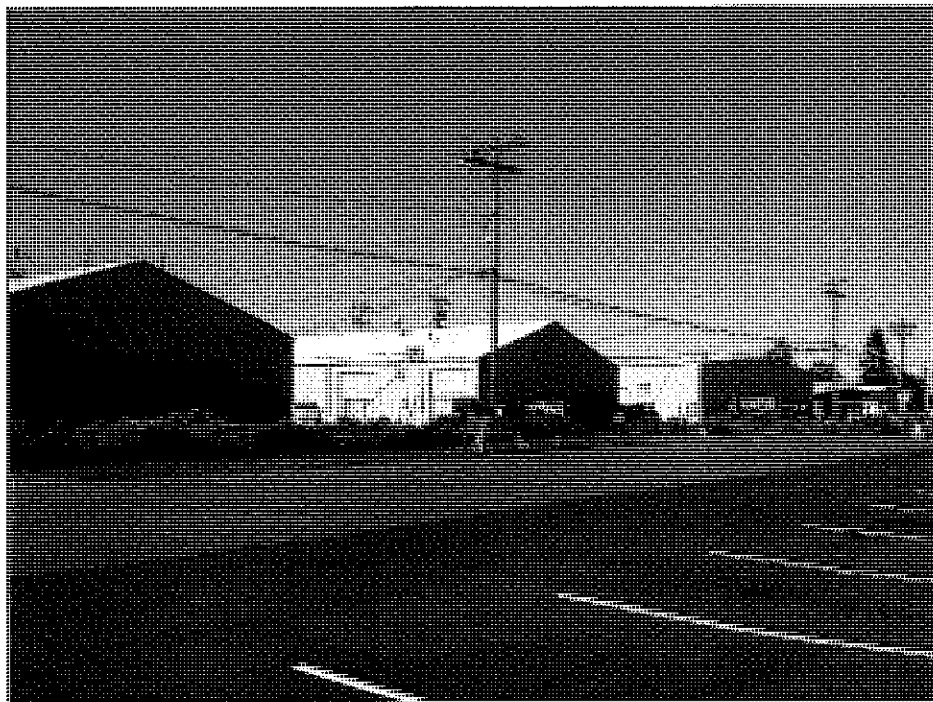
Photograph 1. View of the Site facing northeast from across Russell Road.

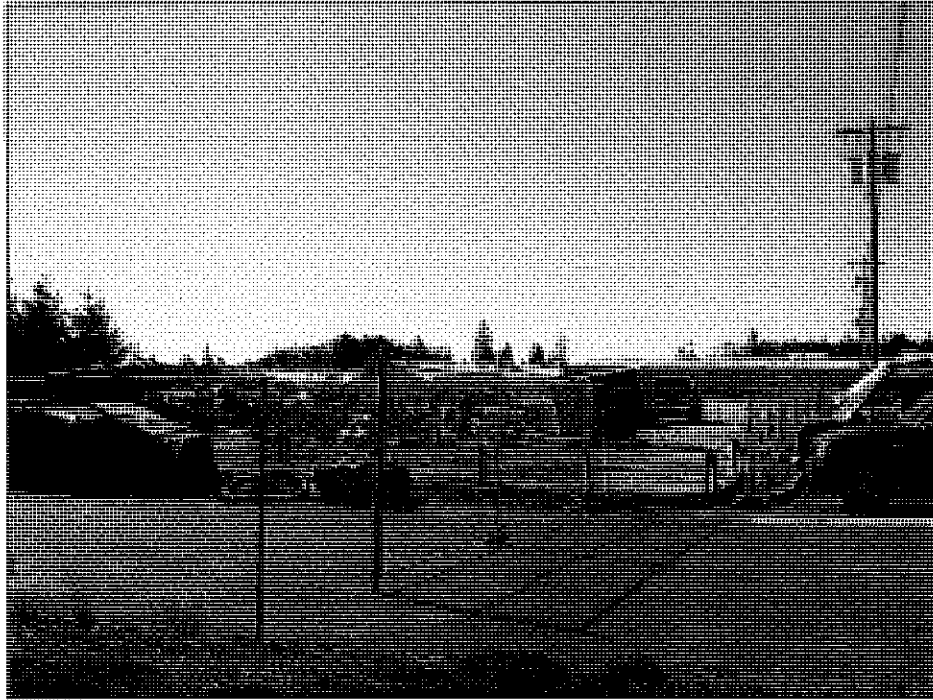
Photograph 3. View of the demised 4493 Building pad, facing northwest.

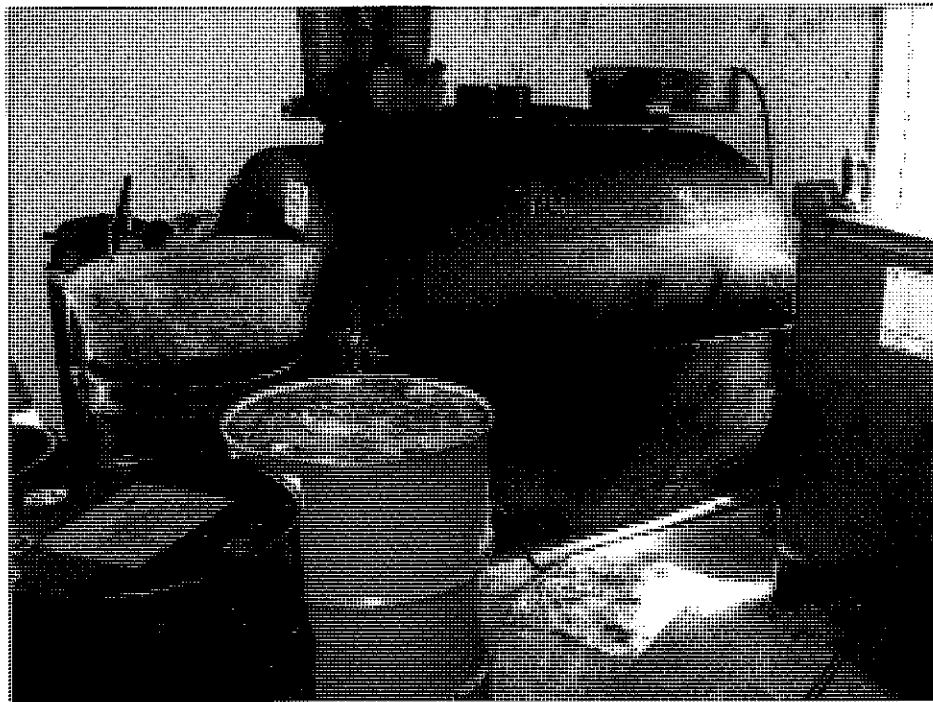
- The Fiber International tenant space, in the 4440 Building, is currently being utilized for service and repair of fleet vehicles. Automotive wastes (e.g. oil, filters, coolant) were being stored in 55-gallon drums and a waste oil AST, discussed below (Photo #5, Appendix A). Evidence of minor spills were noted in the shop. Recent spills were being addressed with absorbent pads and granular absorbent. A parts cleaning unit within the space was labeled for mineral spirits and "naphtha" (Photo 6, Appendix A). The occupants indicated that wastes are picked up by Emerald Petroleum approximately twice a year. A floor drain and concrete-filled trench drain were noted on the northeast corner of the space. The occupants stated that the drain is not used. No staining was noted around the drain.

Photograph 5. View of the waste collection area in the Fiber International truck shop (4440 Building).

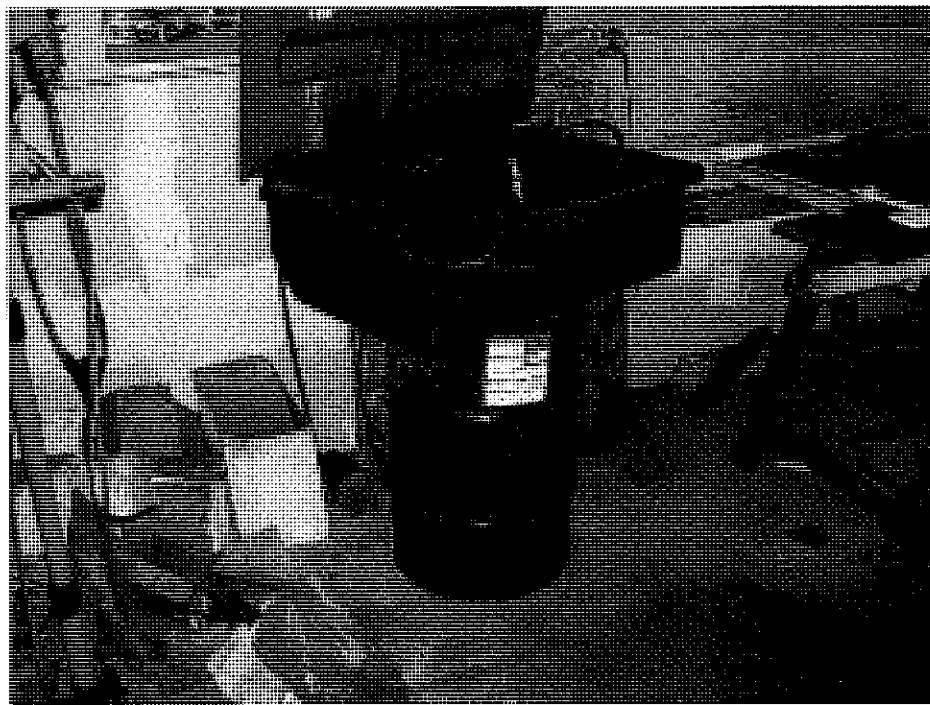
Photograph 6. View of the parts cleaning unit in the Fiber International truck shop (4440 Building).
