2015 AS-BUILT COMPLETION REPORT
BNSF Former Maintenance and Fueling Facility
Skykomish, Washington
Consent Decree No. 07-2-33672-9 SEA

SITE PHOTOGRAPHS
2015 As-Built Completion Report
BNSF Former Maintenance and Fueling Facility
Skykomish, Washington
Farallon PN: 683-057

Project Name: Skykomish Hot Water Flushing Remediation
 Project Location: Skykomish, Washington
 Project No.: 683-057
 Prepared By: Beth Padgett
 Report Period: June 14 – 20, 2015

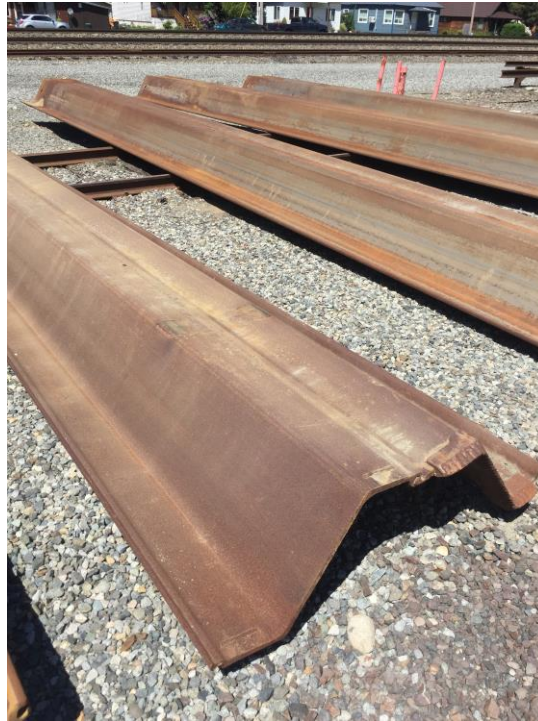
Photograph 1: Sheet piles sitting in rail yard prior to installation, facing north.

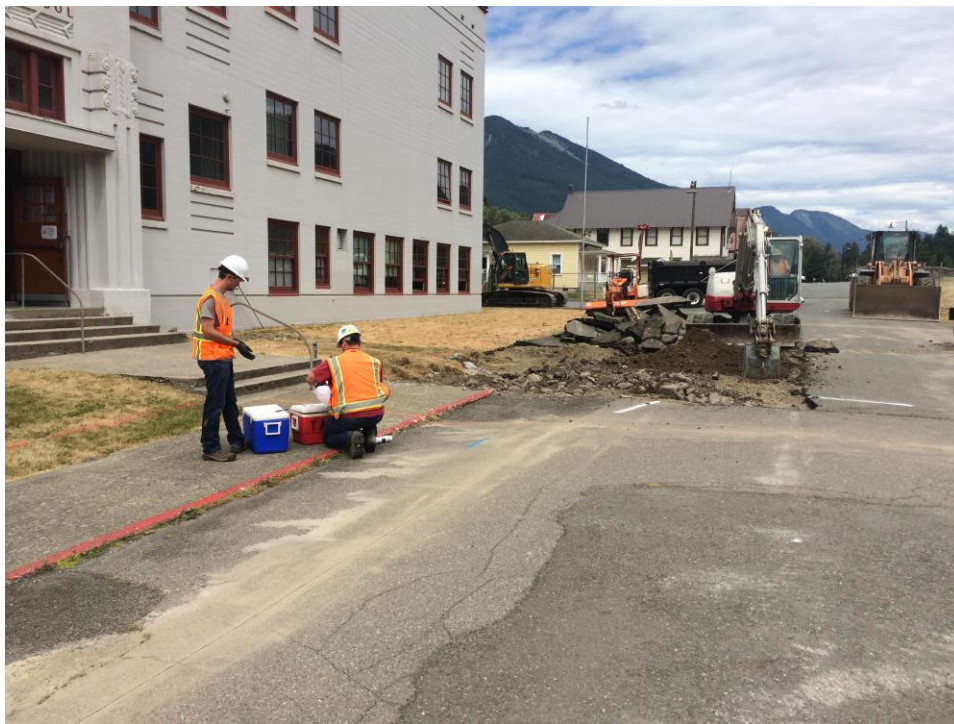
Photograph 2: Farallon Consulting, L.L.C. collects soil samples on southern side of school, facing east.

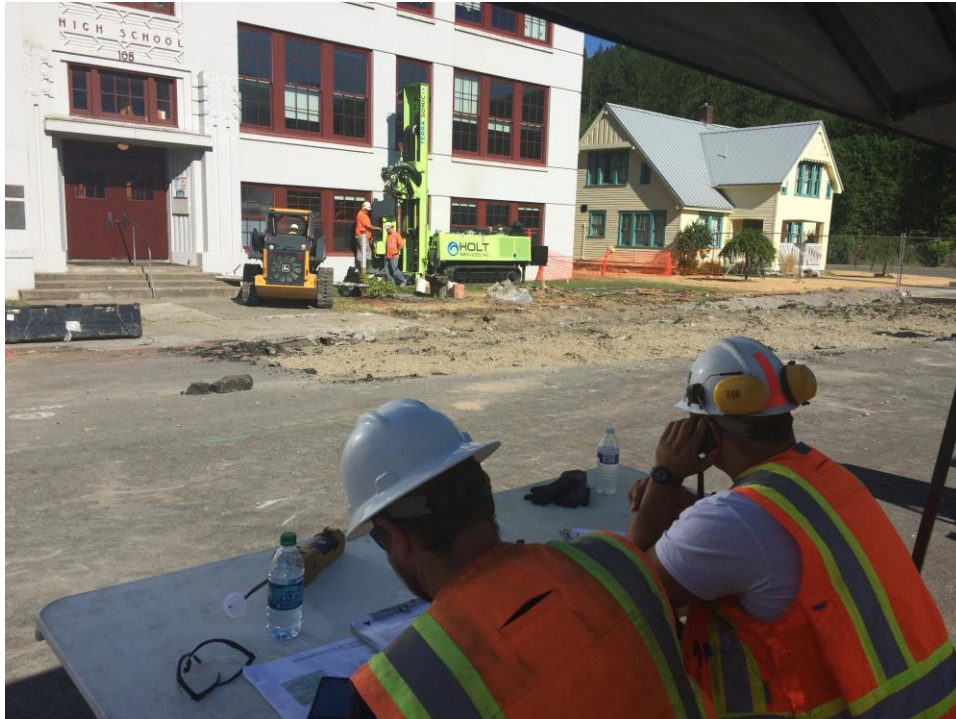
Photograph 3: Holt Services installing a hot water flushing system well, facing west.

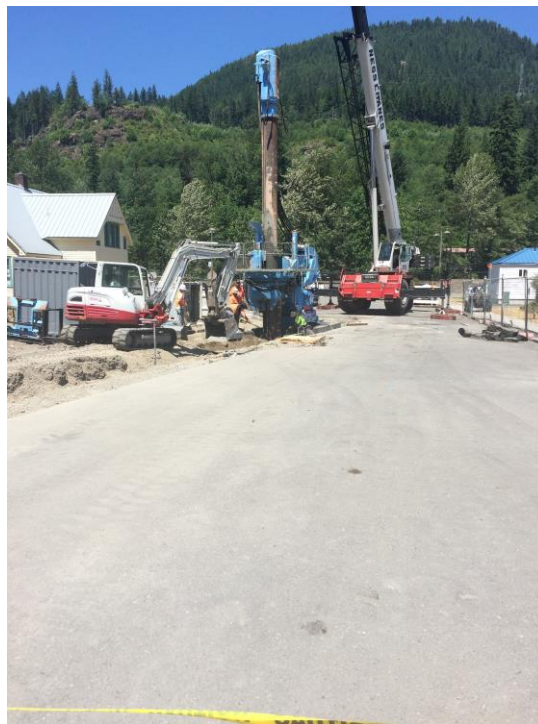
Photograph 4: Blue Iron installing sheet piles on eastern side of school, facing north.

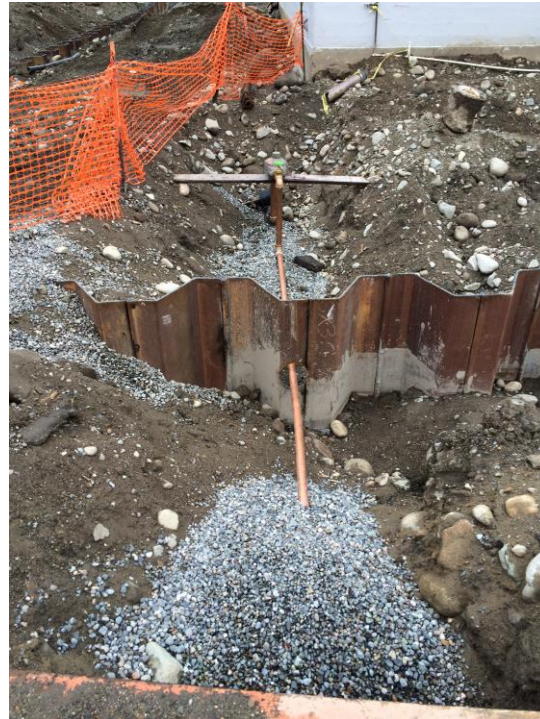
Photograph 5: Water main installation through sheet pile on southern side of school, facing north.

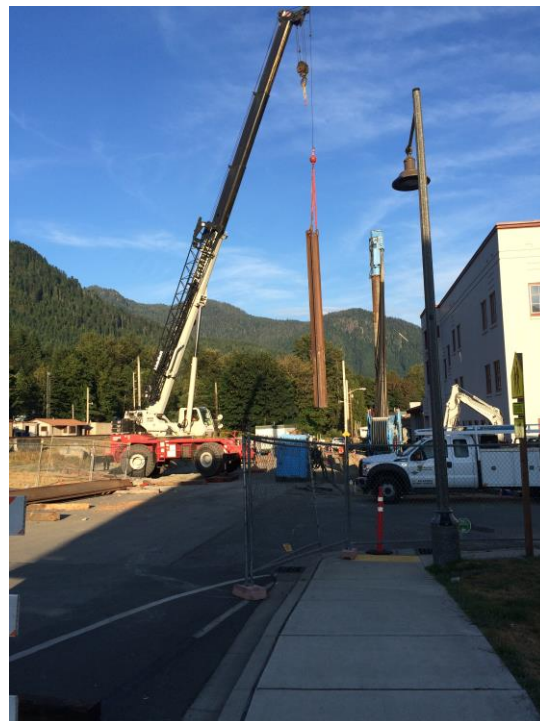
Photograph 6: Blue Iron installing sheet piles on southern side of school, facing west.

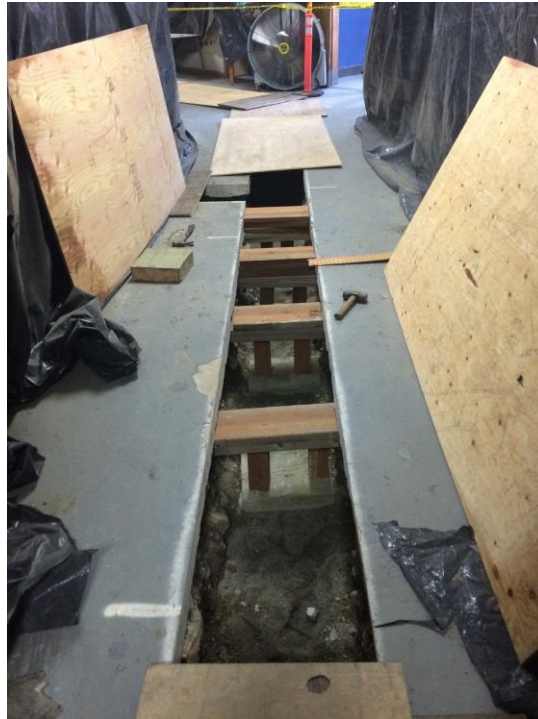
Photograph 7: School interior showing sinking interior floor slab and preventative measures.

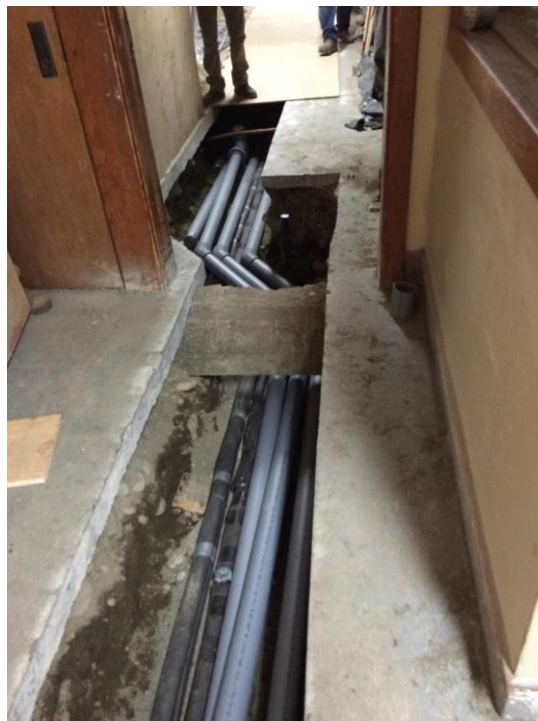
Photograph 8: School interior showing interior hot water flushing system piping, facing east.

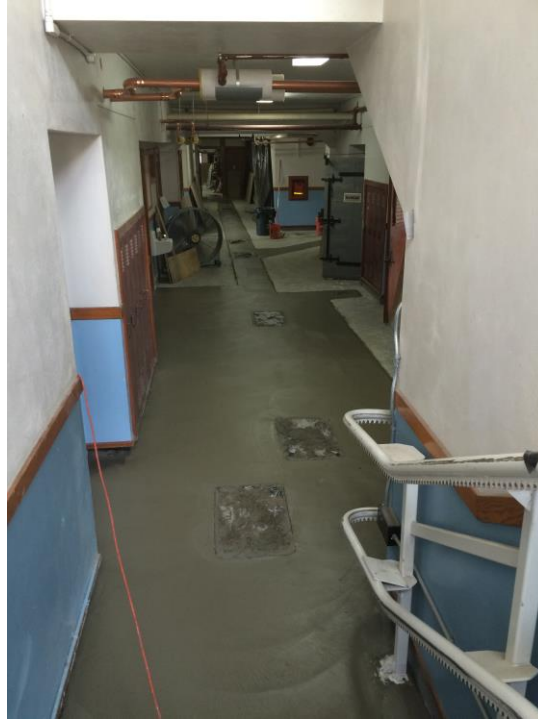
Photograph 9: School interior showing recently poured concrete, facing south.

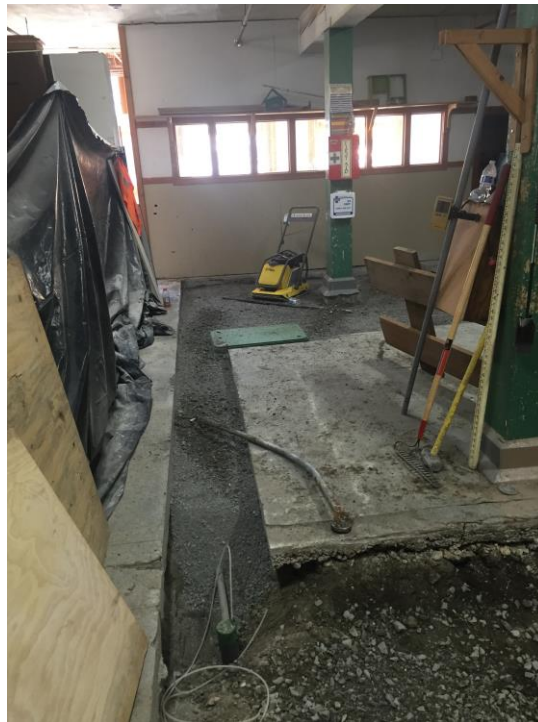
Photograph 10: School interior showing backfill and compaction, facing south.

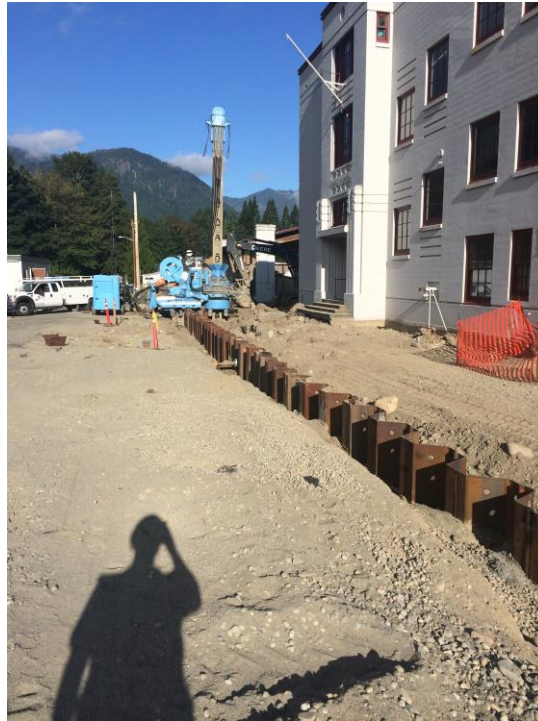
Photograph 11: Blue Iron installing sheet piles on southern side of school, facing west.

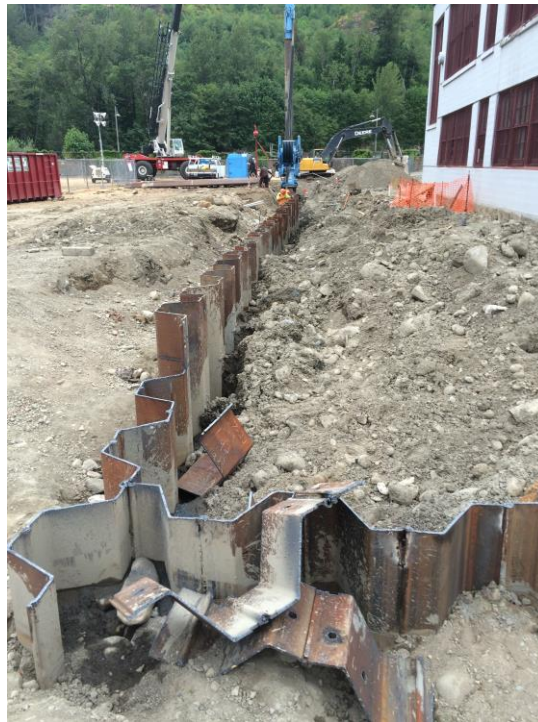
Photograph 12: Blue Iron installing sheet piles northwest of school, facing north.

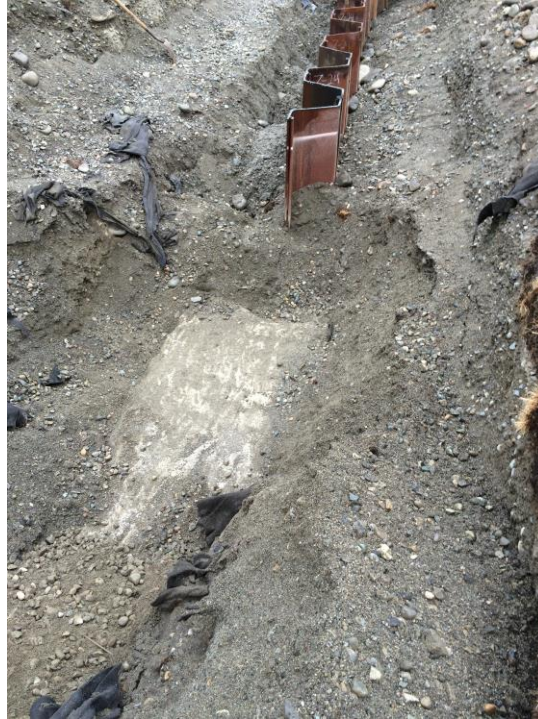
Photograph 13: End of sheet pile installation on northern side of school, facing east. Sheet piles are tied into ecology blocks.

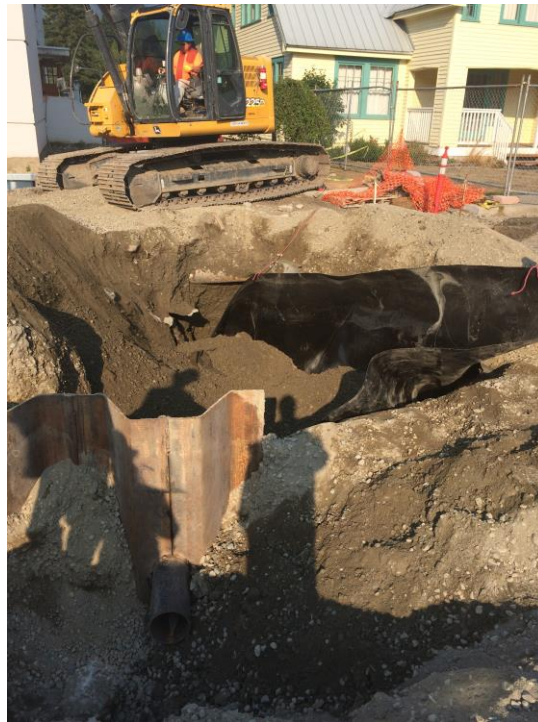
Photograph 14: Geomembrane liner near northeastern corner of Site, facing west.

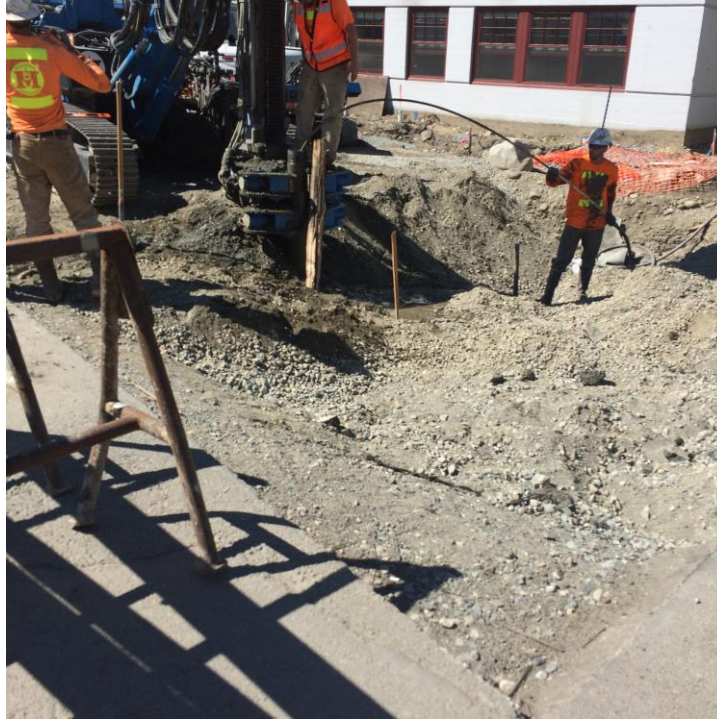
Photograph 15: Malcolm Drilling conducting permeation grouting, facing southwest.

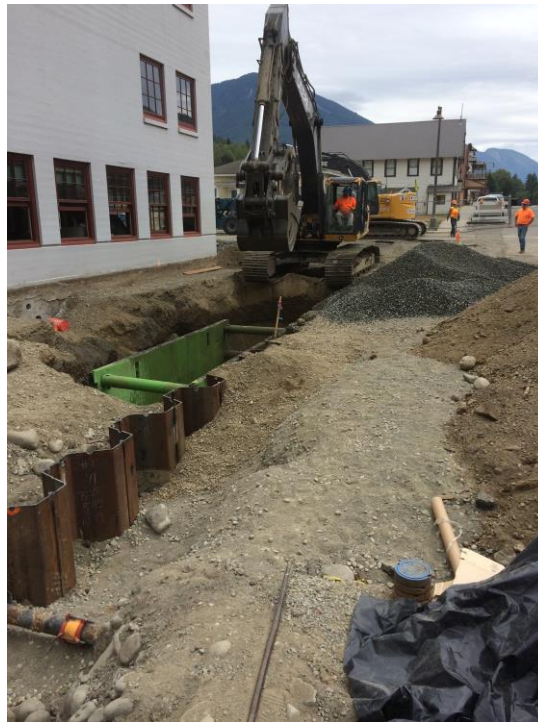
Photograph 16: Glacier Environmental excavating recovery trench on southern side of school, facing east.

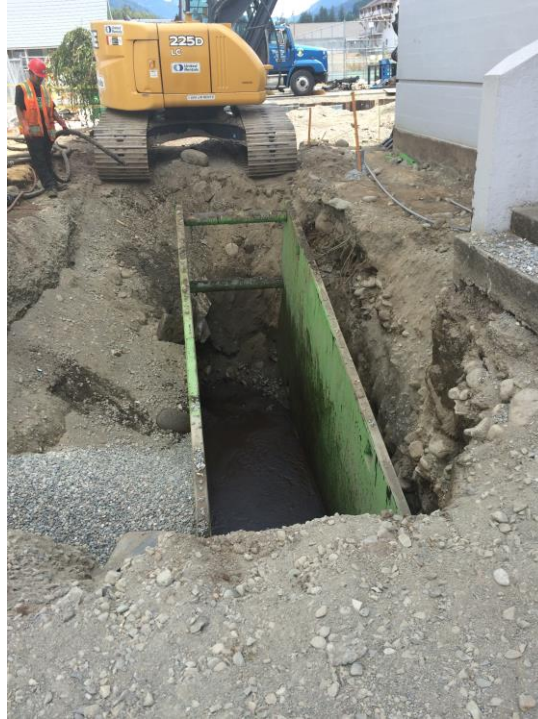
Photograph 17: Northern side of school showing trench box used for recovery well trenching, facing east.

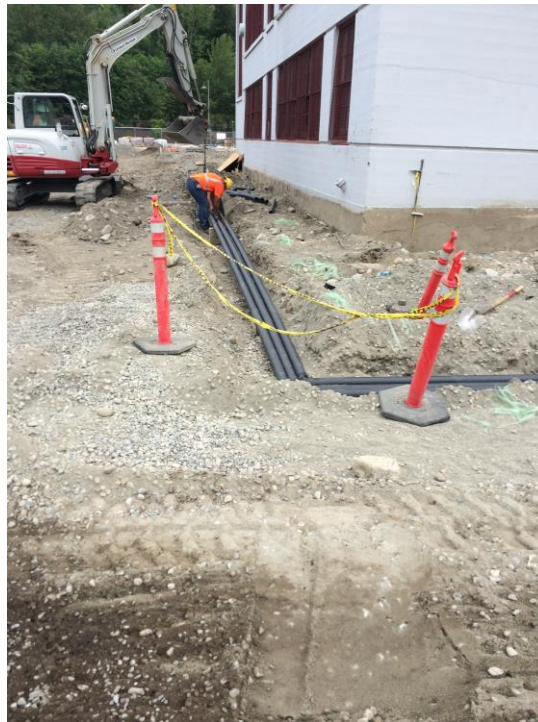
Photograph 18: Glacier Environmental installing hot water flushing system pipe insulation, facing north.

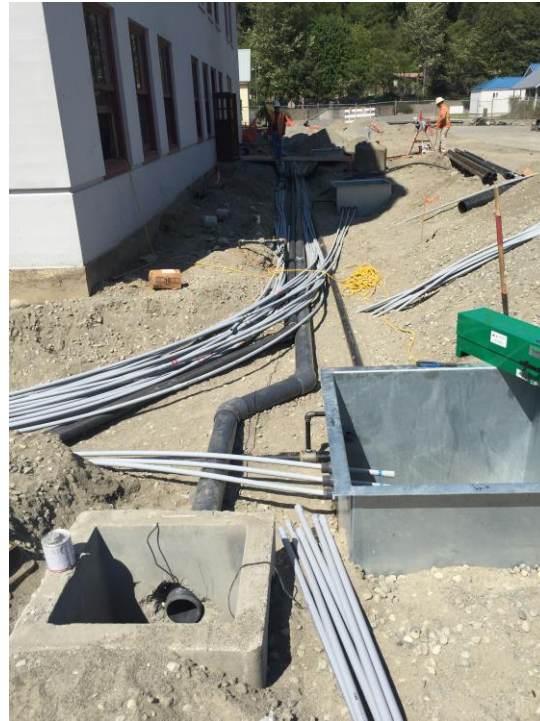
Photograph 19: Glacier Environmental installing hot water flushing piping on eastern side of school, facing north.

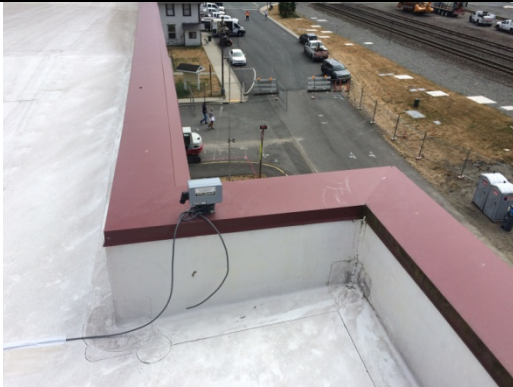
Description: Protection monitoring on south side of school - tiltmeters.

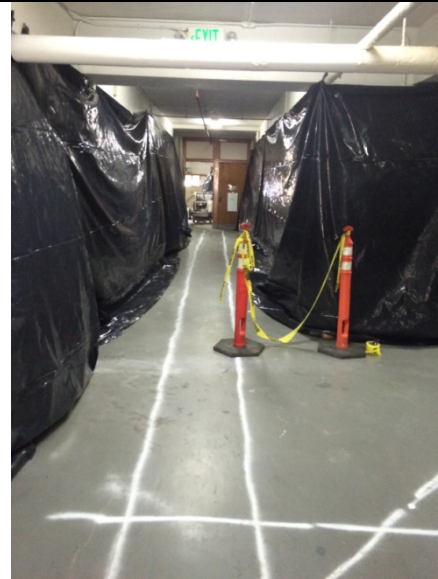
Description: Preparing interior for saw cutting and well installation.

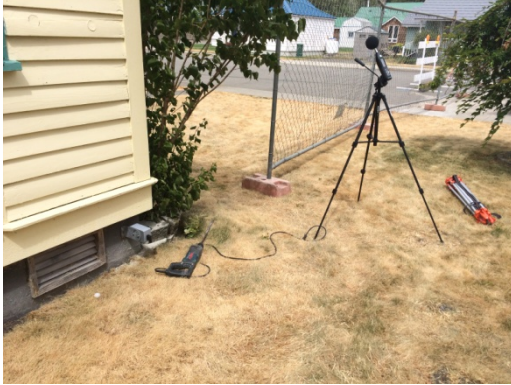
Description: Protection monitoring near southeast corner of teacherage - tiltmeters and sound meters.

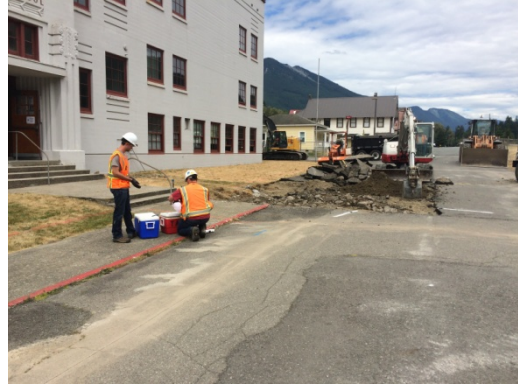
Description: Sampling overburden soil from the supplemental excavation area.

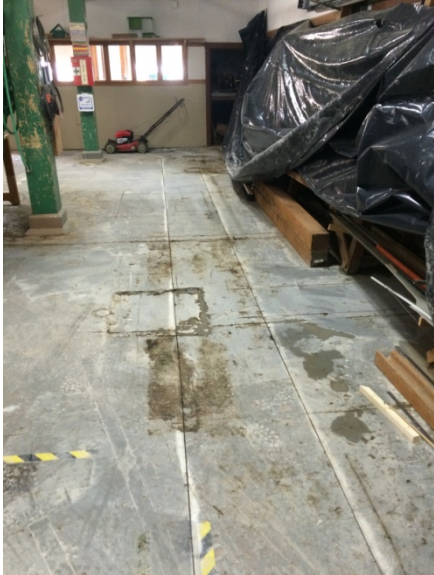
Description: Saw cuts in shop for interior trenching.

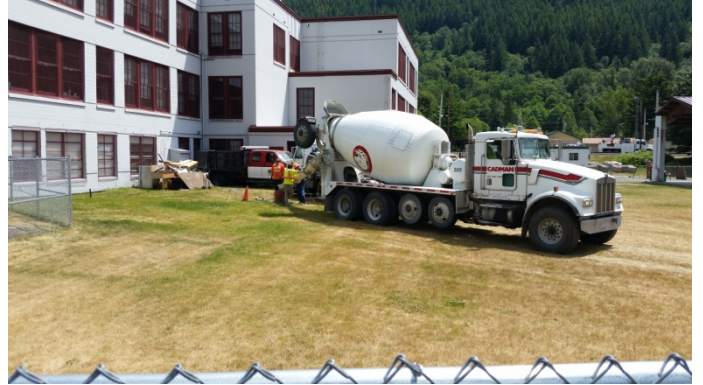
Description: School contractor filling heating oil underground storage tank with grout.

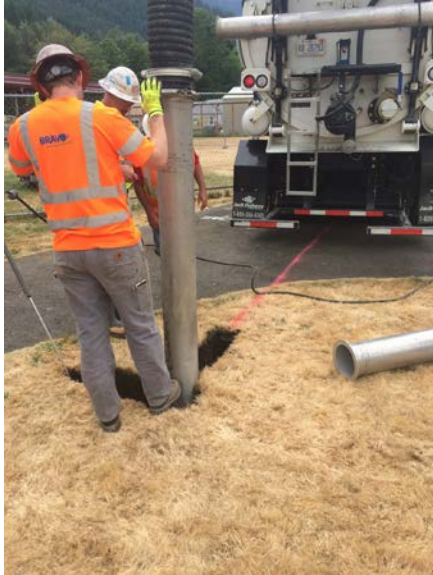
Description: Bravo Environmental locating MSE wall adjacent to sheet pile intersection.

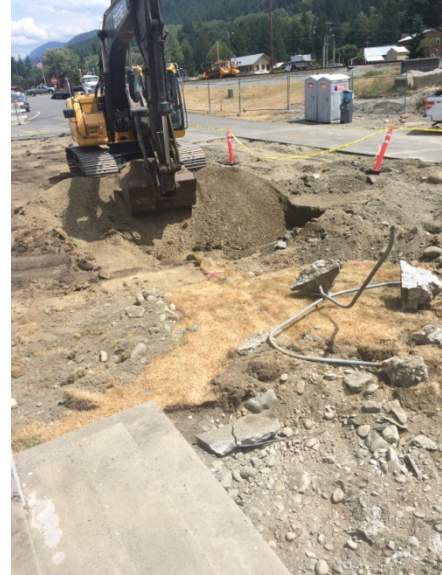
Description: Glacier excavator removing overburden soil from supplemental excavation area.

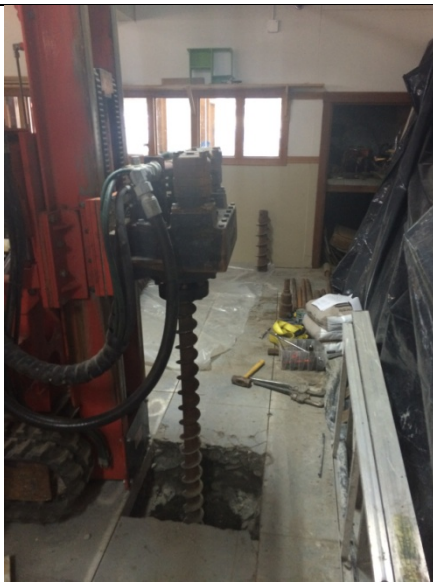
Description: Holt drilling installing system groundwater monitoring wells inside school shop.

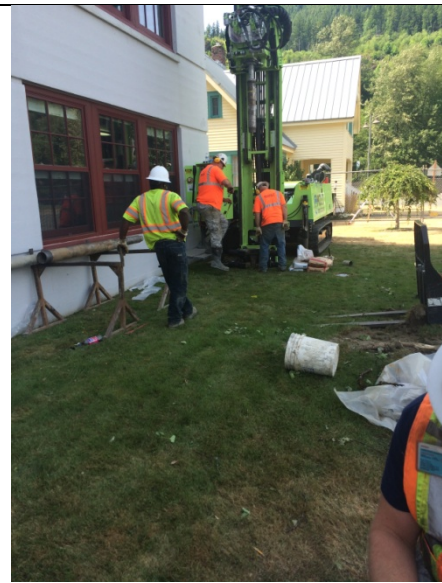
Description: Holt drilling installing system injections wells east of school.

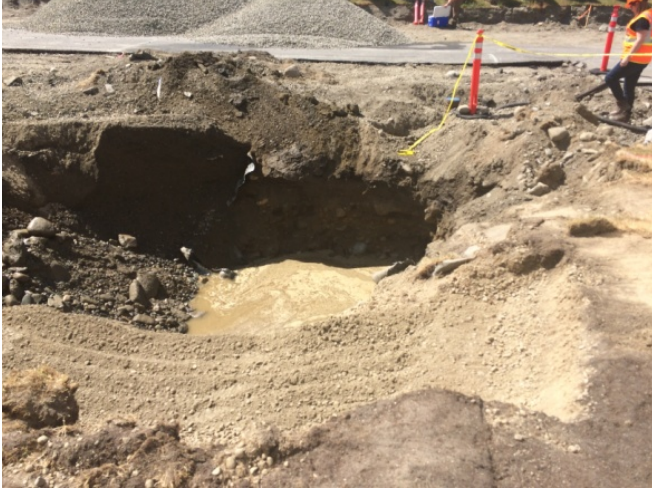
Description: Supplemental excavation, looking south.

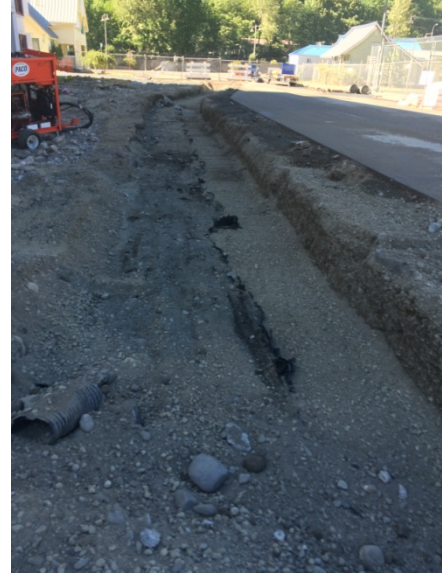
Description: Trenching for sheet pile installation.

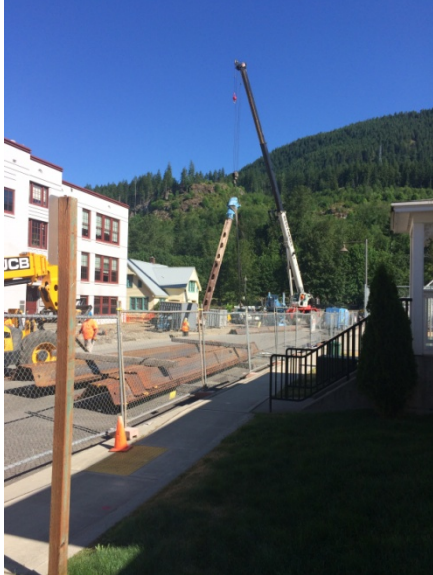
Description: Blue Iron assembles Giken auger crush equipment.

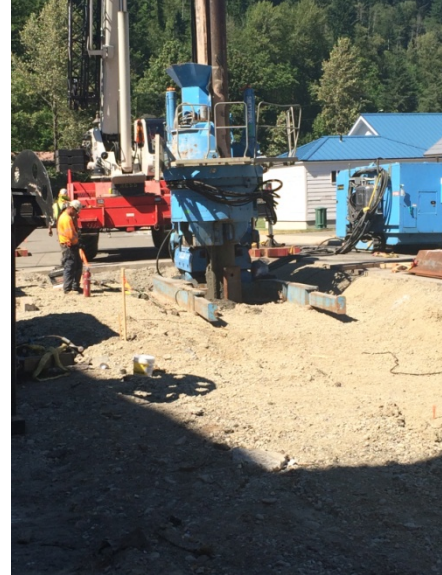
Description: Blue Iron installing sheet pile east of school.

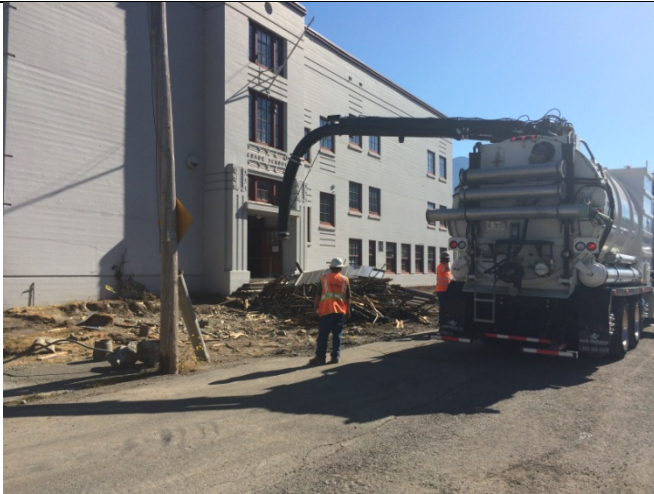
Description: Bravo Environmental air knifing for water service line south of school.

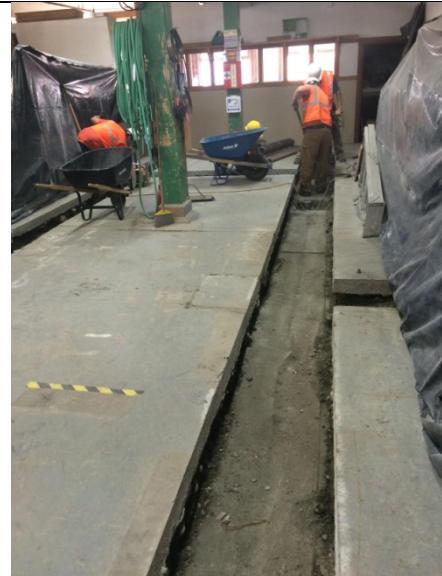
Description: Glacier demolishing concrete for trench inside school shop.

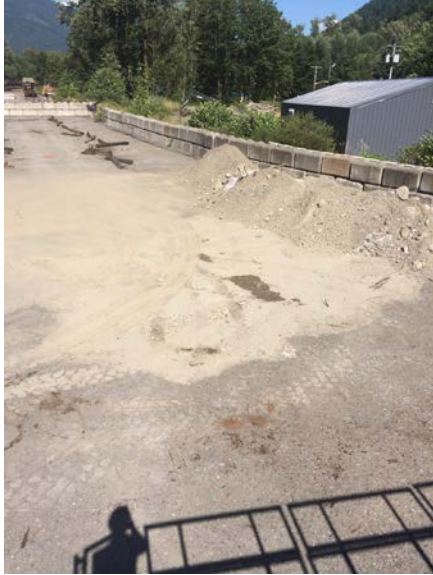
Description: Contaminated soil temporarily stockpiled in soil handling facility.

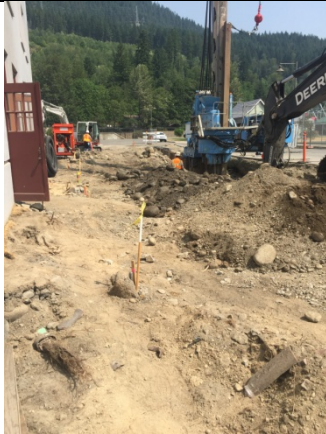
Description: Blue Iron installing sheet pile along 6th Avenue, looking north.

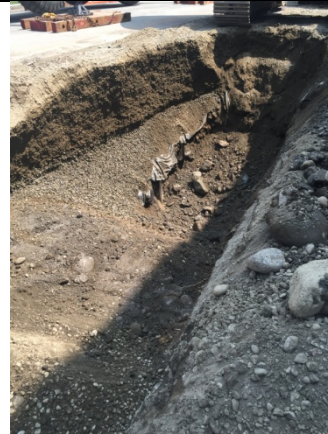
Description: Glacier pre-excavating trench for sheet pile rig.

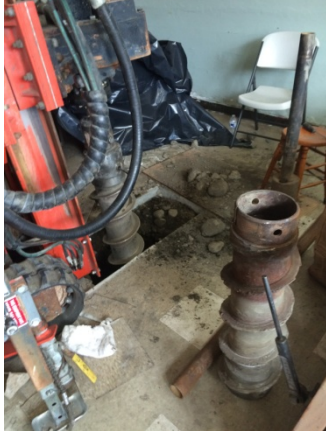
Description: Holt installing soil vapor extraction well SVE-1 in cafeteria.

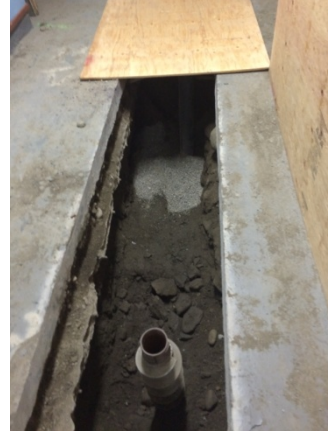
Description: Installation of injection well INJ-12 in hallway.

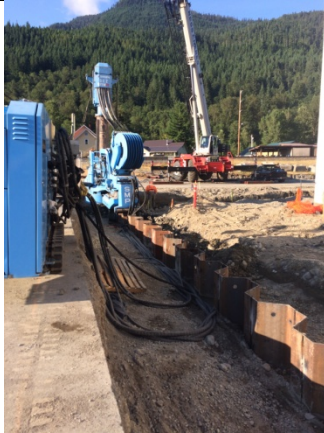
Description: Blue Iron installing sheet pile along 6th Avenue.

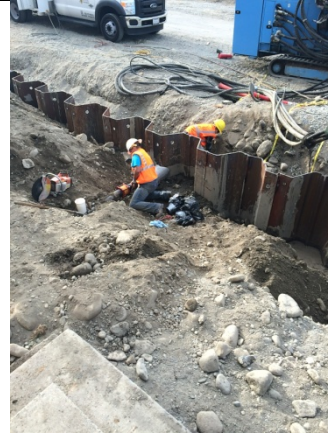
Description: Glacier installing FDC along Railroad Avenue.

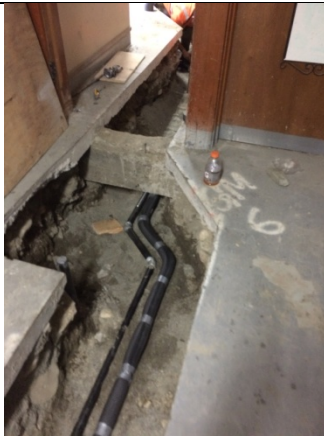
Description: Injection pipe installation in basement hallway.

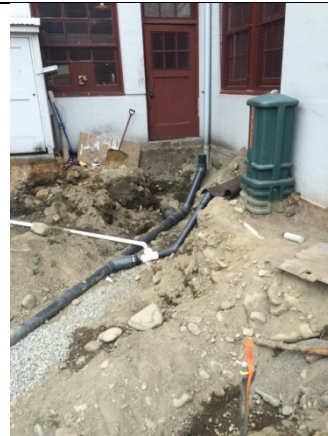
Description: Sewer drain pipe installation west of school.

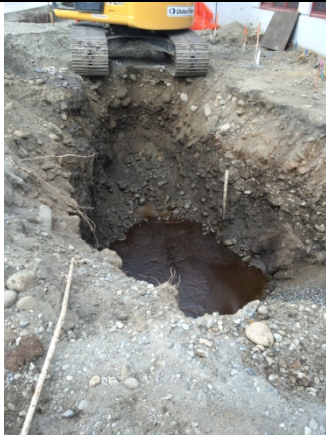
Description: Glacier excavating recovery trench northeast of school.

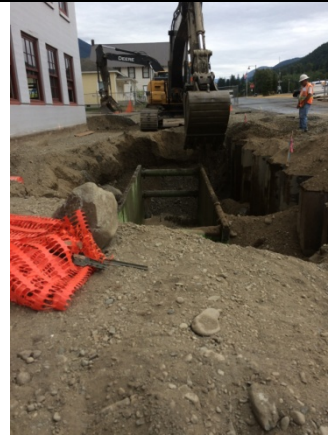
Description: Glacier excavating recovery trench southeast of school.

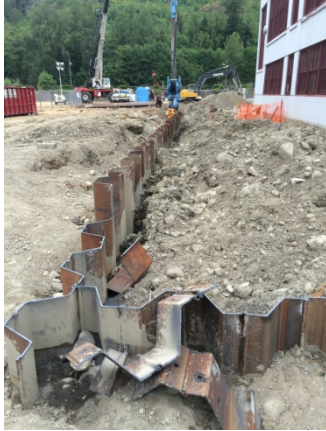
Description: Trimming sheet pile to design grade west of school.

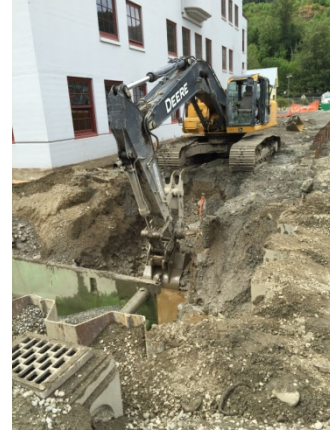
Description: Glacier excavating recovery trench east of school.

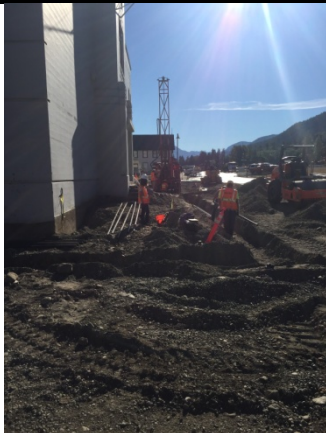
Description: Glacier installs HWF injection piping along south side of the school.

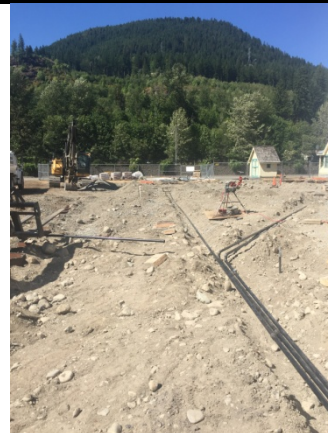
Description: Glacier installs HWF injection piping along west side of the school.

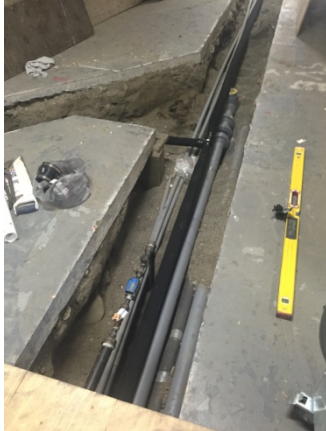
Description: Glacier installs HWF controls inside the basement of the school.

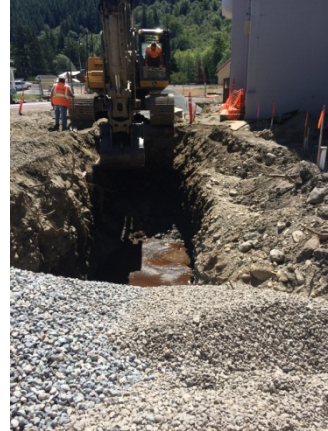
Description: Glacier installs recovery trench east of school.

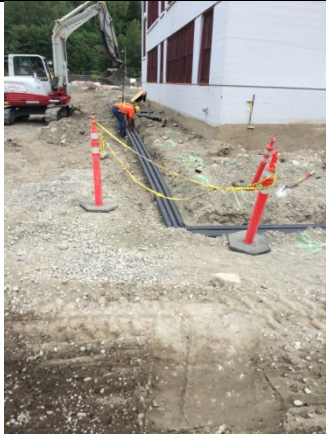
Description: Glacier installs HWF pipe insulation.

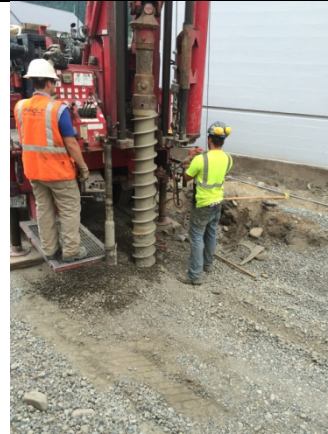
Description: Holt installs recovery wells.

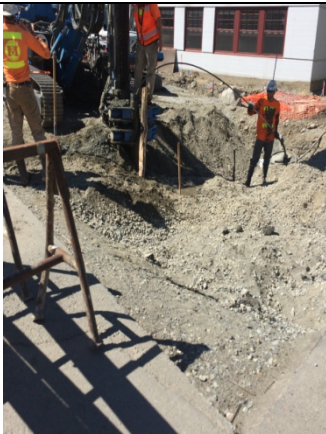
Description: Malcolm performs permeation grouting.

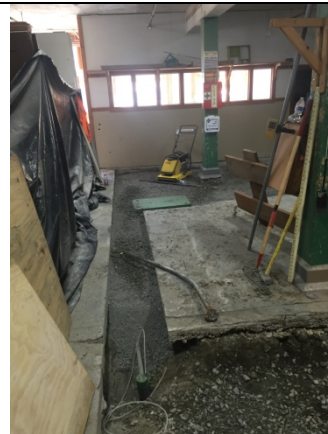
Description: Interior backfill and compaction in the basement of the school, as part of preparing the interior trench for restoration.

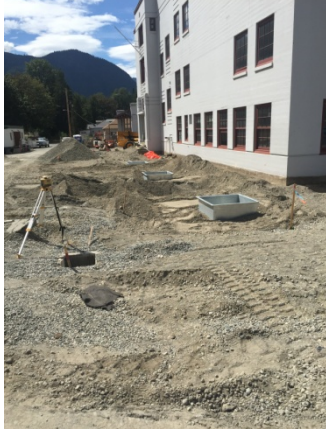
Description: Glacier installs recovery well vaults.

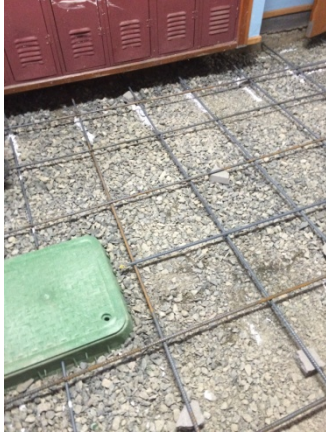
Description: Glacier installs rebar.

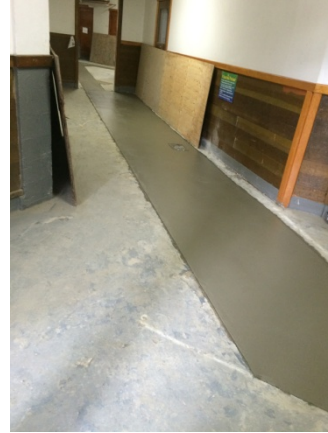
Description: Concrete slab interior of the school.

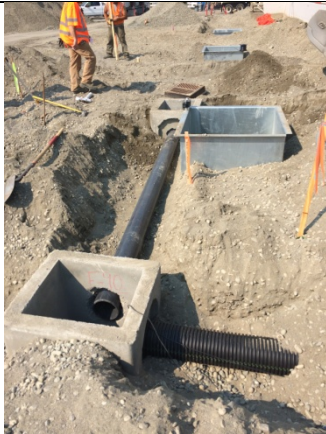
Description: Glacier installs storm drain system east of the school.

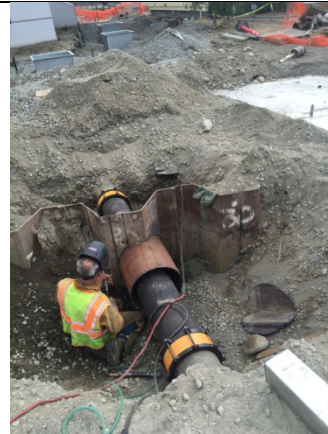
Description: Glacier installs sheet pile penetration.

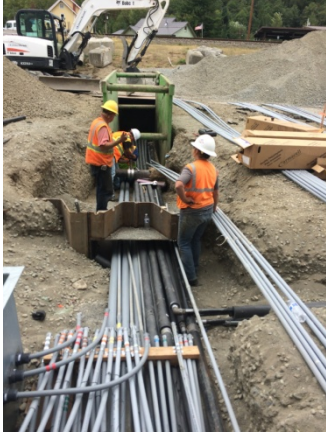
Description: Glacier and Town of Skykomish installing water service pipe on Railroad Avenue.

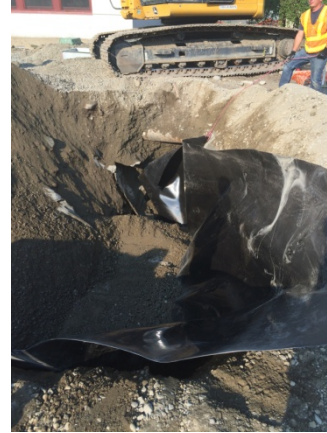
Description: Glacier installing liner for Change Order 12.

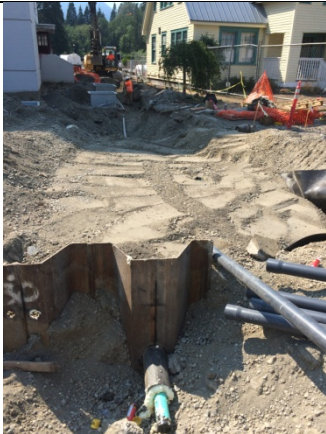
Description: Glacier installing sewer pipe to teacherage.

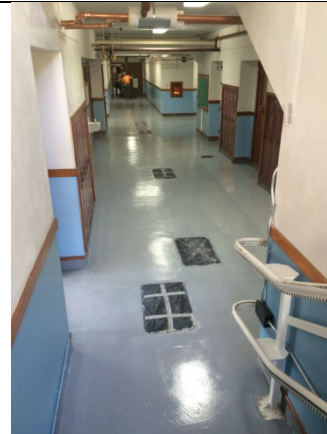
Description: Glacier painters painting basement hallway floor.

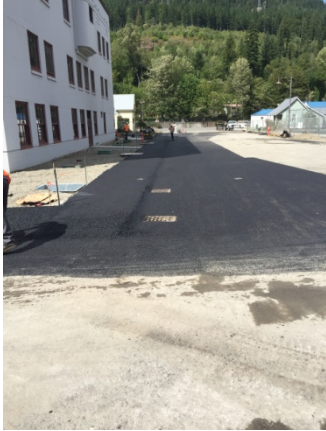
Description: Lakeridge Paving placing asphalt along 6th Avenue.

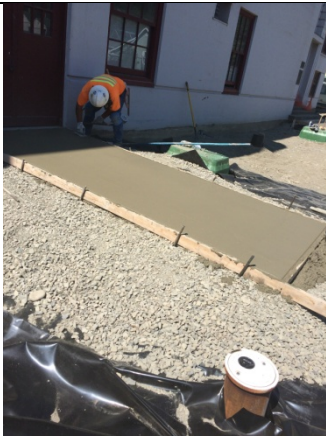
Description: Salinas Concrete placing concrete sidewalk east of school.

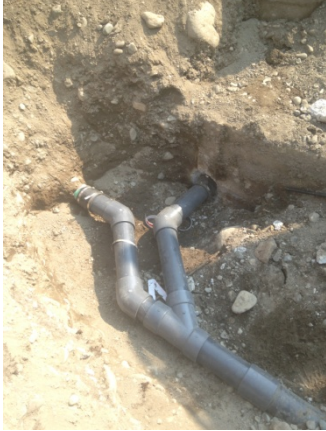
Description: Glacier removing distribution box and temporary sewer connection.
