Stratum Group
PO Box 2546, Bellingham, Washington 98227
Phone (360) 714-9409

Re: **Underground Storage Tank Removal and Hazardous Waste Generator Identification**
Cascade Laundry
205 Prospect Street
Whatcom County Parcel 380330111249
Bellingham, Washington 98225
Ecology FS ID: 21786898

Former Cascade Laundry, WA
UST Removal & HWG Status

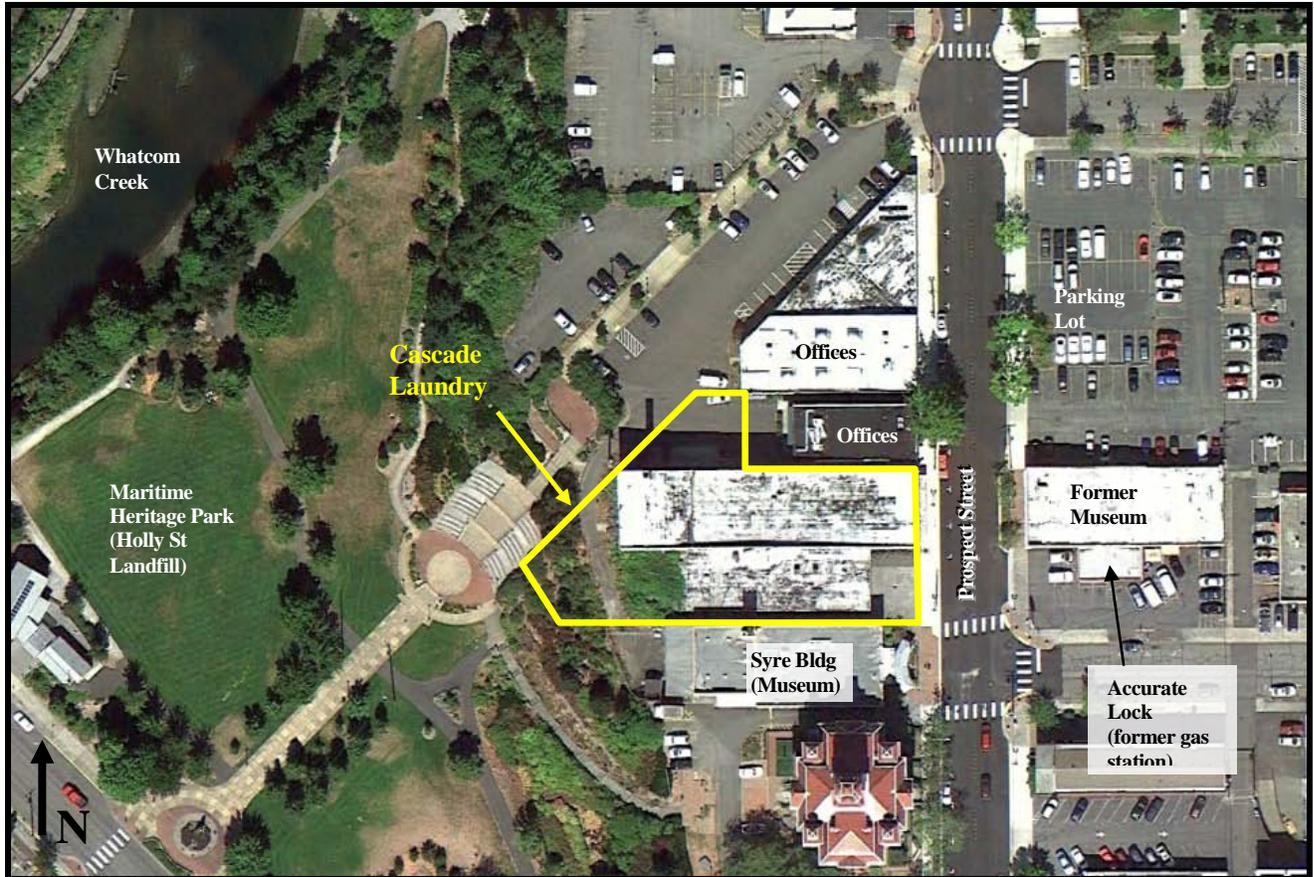
The Cascade Laundry site was developed as a dry cleaning and laundry facility by at least 1932, which included clothes dyeing and leather tanning. The site conducted dry cleaning activities through 1971. Commercial laundry continued at the site through the early 2000s. The site has undergone a significant interior renovation and has been utilized as an art/furniture gallery since approximately 2015 and a hard cider press and restaurant since 2018. The remainder of the building is under renovation for construction of a theater. Properties in the vicinity of the Cascade Laundry site are in commercial use along Prospect Street, with Maritime Heritage Park (former landfill) to the west. An aerial photograph of the site and vicinity is provided in Figure 2.

Figure 1. Aerial photo of site and surrounding land uses

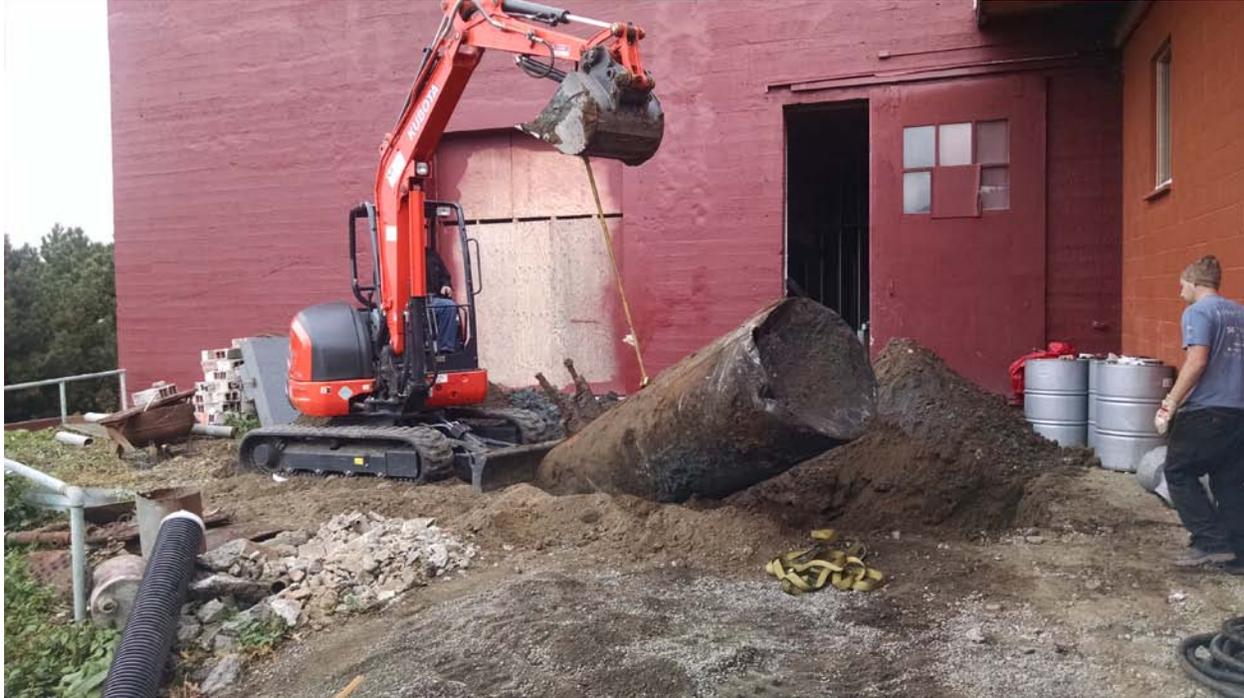
Figure 3. View of the UST removal

The tank was constructed single-walled steel and no piping was identified. The tank was approximately 9' long and 3'2" in diameter. The tank was in poor condition with obvious holes in the tank bottom. A photograph of the tank being removed from the site is provided in Figure 3.

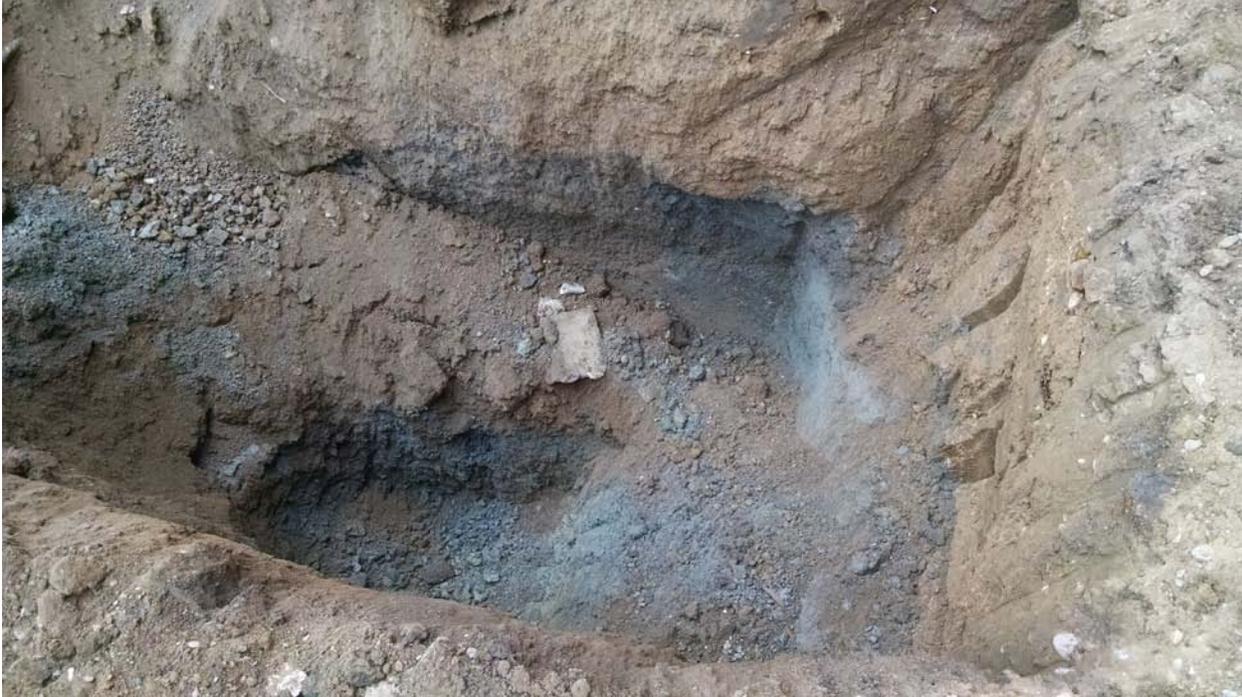
Shallow gravel fill was underlain by brown clay to approximately four (4) foot depth. A distinct color change from brown to bluish-grey was noted from approximately four foot depth to the depth of the excavation pit at approximately nine (9) foot depth. The color change corresponded with a strong petroleum odor.

Figure 4. View of the excavation and soil around the former UST. Blue colored soil had odors indicative of release.

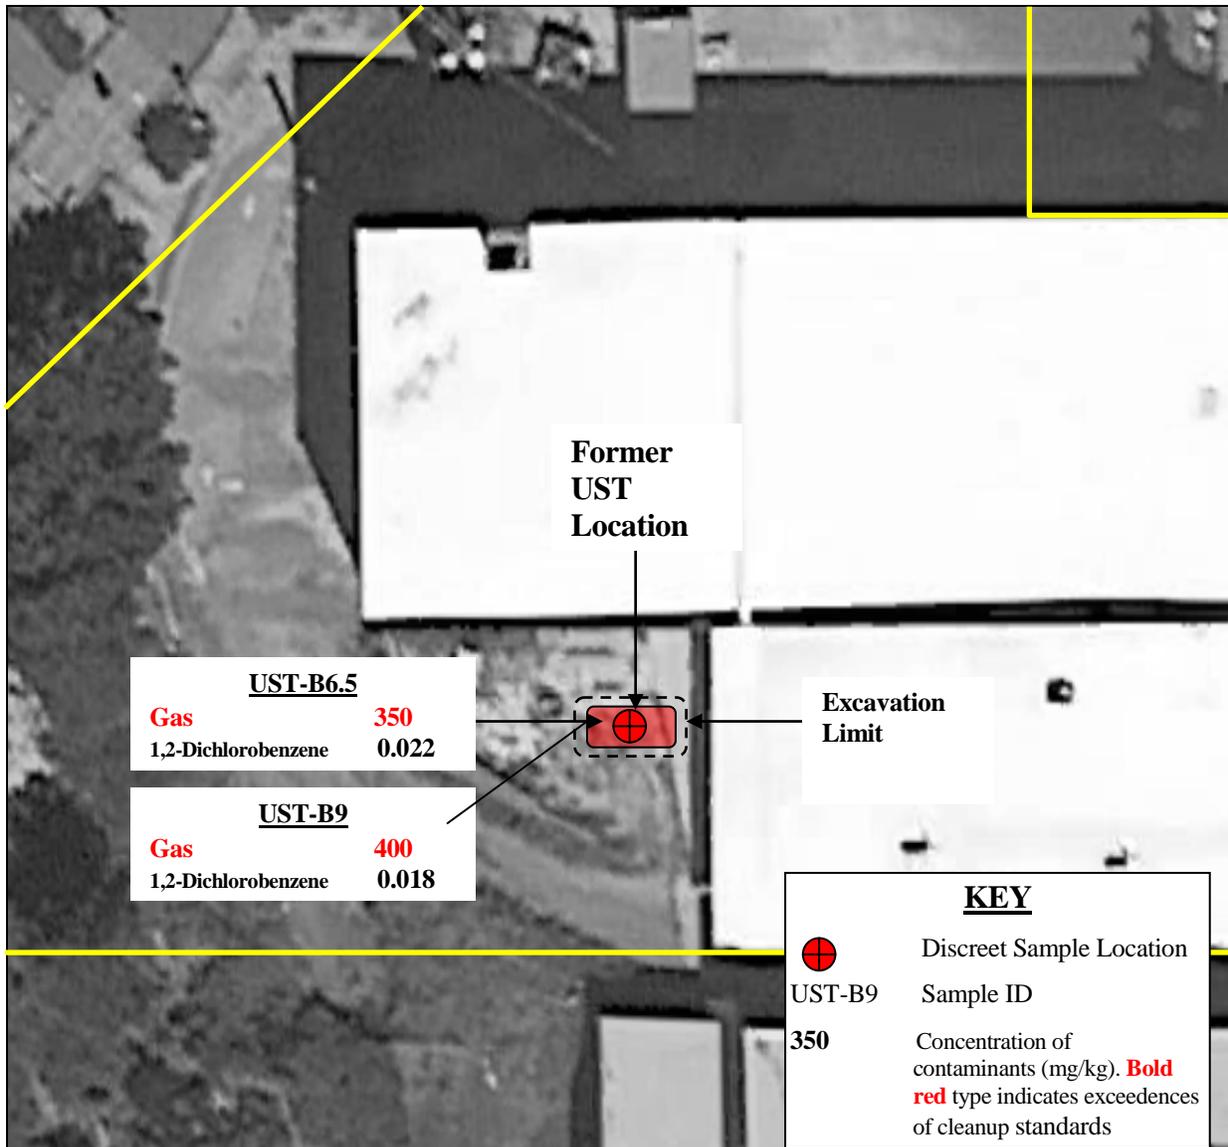
Figure 5. Soil Sample Locations

Two samples were collected from directly below the UST, at different depths. Sample UST-B6.5 was collected from approximately one foot below the UST. The soil consisted of moist grey clay with a strong odor and heavy sheen. Sample UST-B9 was collected from nine foot depth below the former UST. The soil consisted of moist light grey clay. The soil at nine foot depth had a minor odor and a slight sheen.
