UST REMOVALS
10816 18TH AVENUE E
TACOMA, WASHINGTON
STS PROJECT #ST5693

UST REMOVALS
10816 18TH AVENUE E
TACOMA, WASHINGTON
STS Project ST5693 – October 11, 2011

1.0 Background

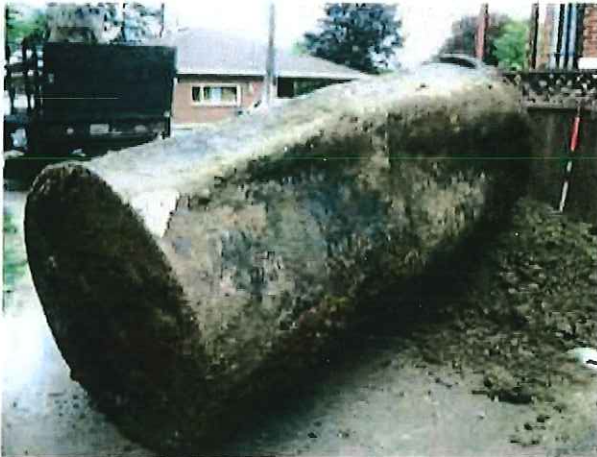
Photograph 1. Removed UST #1

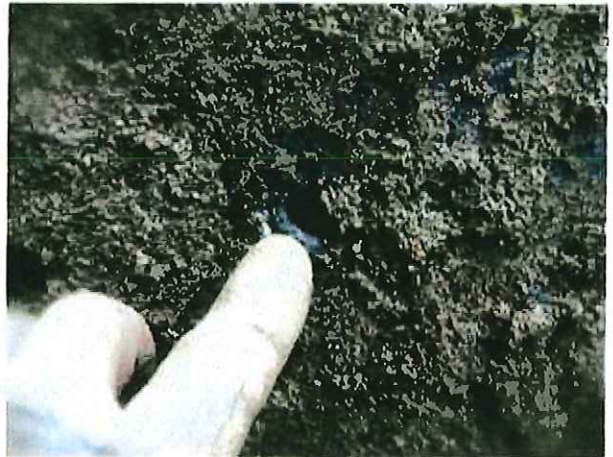
Photograph 2. Corrosion Hole in UST #1

Soils in the UST #1 removal pit were primarily sandy clays and gravel, much of which had a gray discoloration and "diesel" odor characteristic of material having prolonged contact with petroleum substances. An STS ICC-Certified UST Site Assessor collected three representative soil samples from the UST removal pit, and an additional three samples from

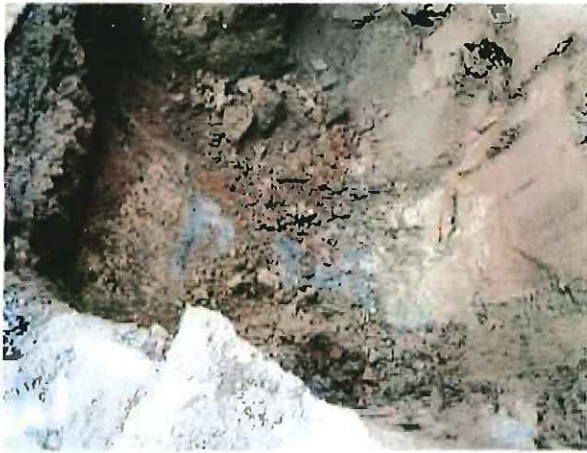
Photograph 3. UST #1 Removal Pit

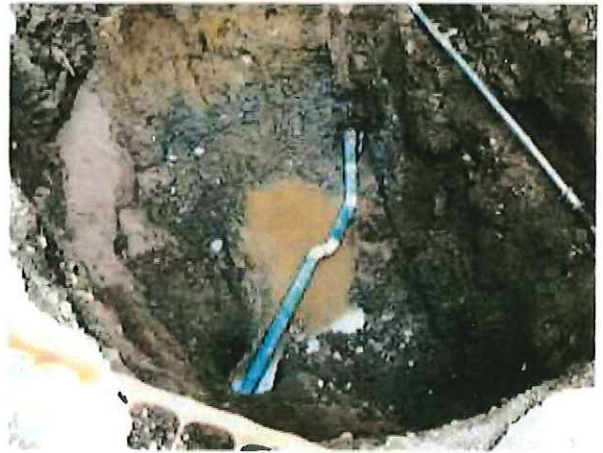
Photograph 4. UST #1 Final Excavation

Based on the analytical results for the soil samples collected from the final UST #1 excavation, along with the results of the EPH analysis and risk calculation, no additional remedial actions were required related to the release of petroleum product from the UST. The excavation was backfilled with clean imported pit run, over which was placed topsoil to match the surrounding grade.

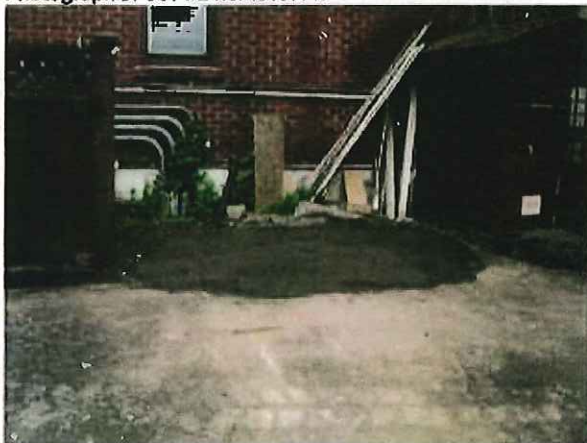
Photograph 5. Backfilled UST #1 Excavation

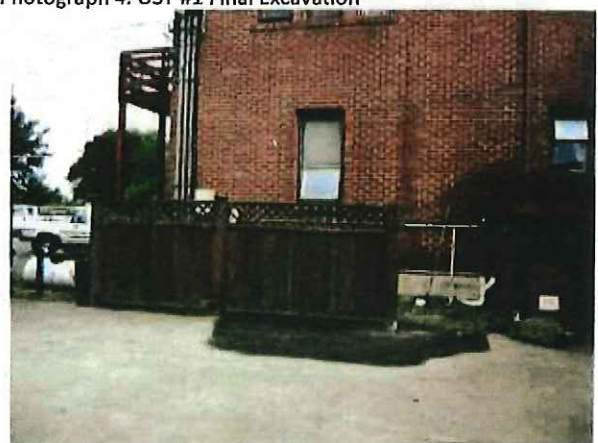
Photograph 6. Restored Former UST# 1 Location

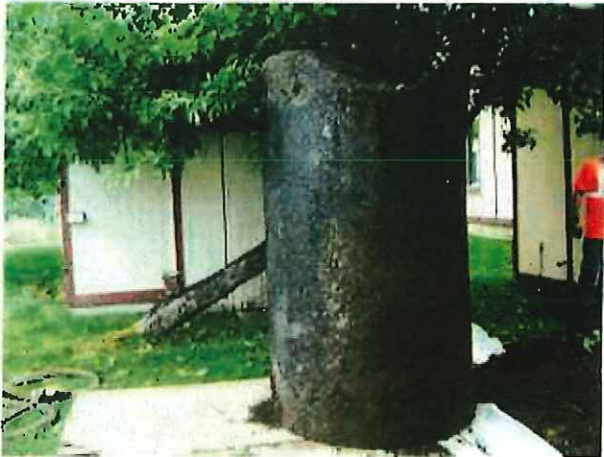
Photograph 7. Removed UST #2

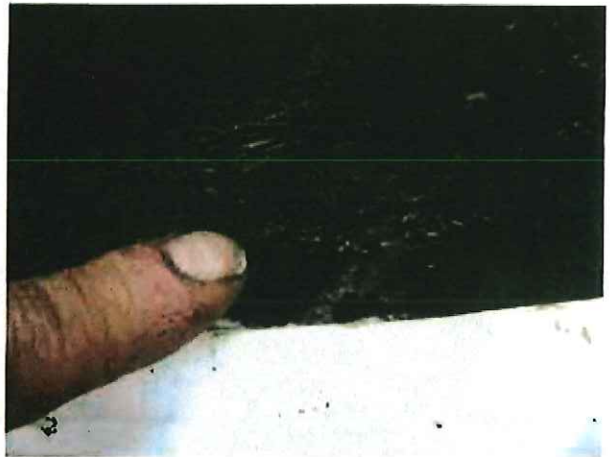
Photograph 8. Corrosion Hole in UST #2

Soils in the UST #2 removal pit were primarily sands, some of which had a gray discoloration and "diesel" odor characteristic of material having prolonged contact with petroleum substances. An STS ICC-Certified UST Site Assessor collected three representative soil samples from the UST removal pit, and an additional three samples from the stockpile of excavated overburden soils. The samples were handled in the same manner as those collected for UST #1 and submitted to Friedman & Bruya. The locations of the samples collected from the UST #2 removal pit are shown as B, D and E on the diagram for UST #2.

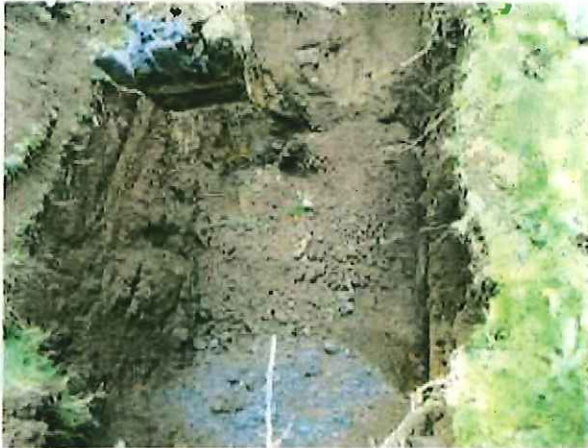
Photograph 9. UST #2 Removal Pit

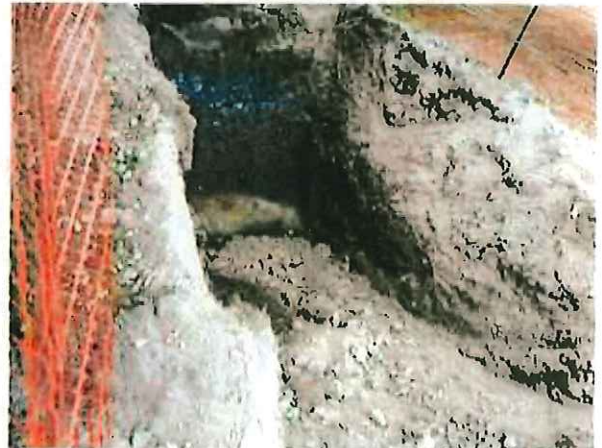
Photograph 10. UST #2 Final Excavation

No more material could be safely removed from the east wall without risking damage to the structure of the outbuilding. The STS assessor used a hand auger to collect two soil samples from points one foot and two feet into the east wall. The sample collection locations are shown as S and T on the site diagram. The samples were handled in the same manner as those collected previously and submitted to Friedman & Bruya.

As all other sampled locations of the excavation met the cleanup standard, and no additional material could be safely removed from the east wall, STS backfilled the excavation with the confirmed clean stockpiled soils along with clean imported pit run, over which was placed clean topsoil.

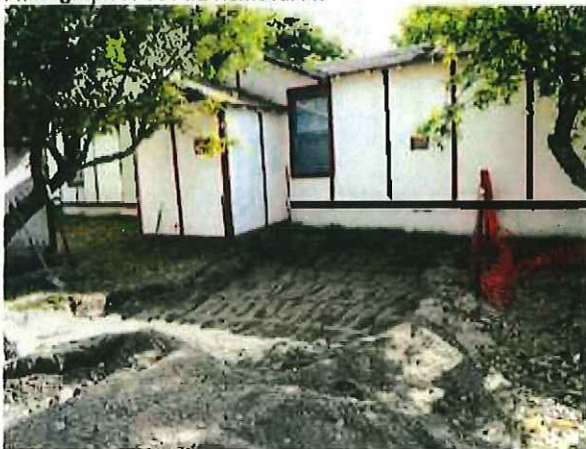
Photograph 11. Partially Backfilled UST #2 Excavation

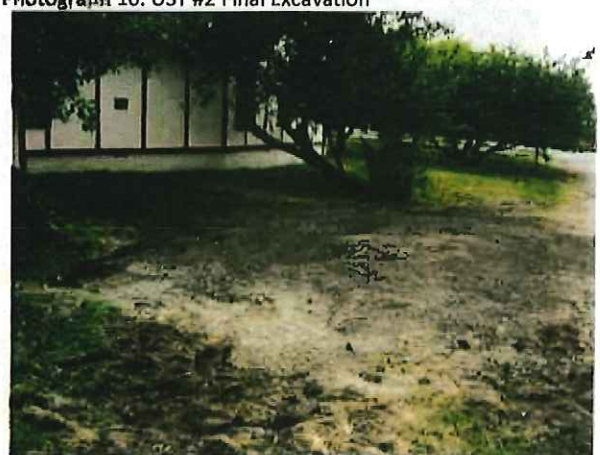
Photograph 12. Restored Former UST #2 Location

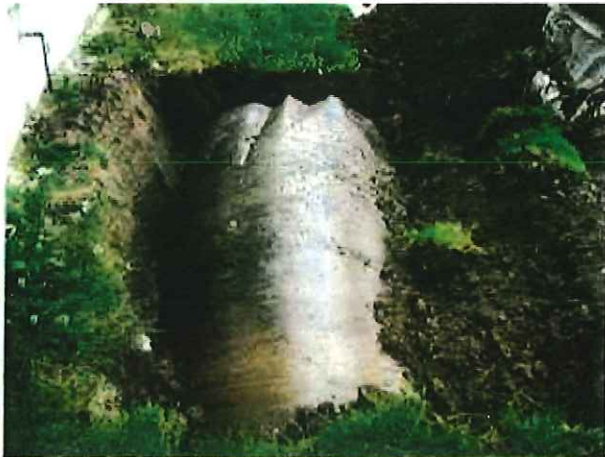
Photograph 13. Removing UST #3

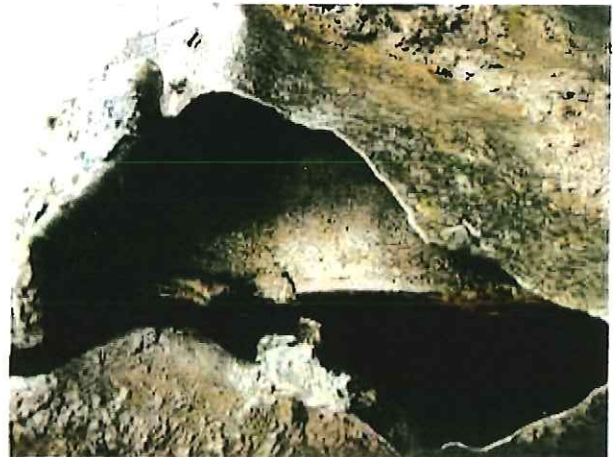
Photograph 14. Corrosion Hole in UST #3

Soils in the UST #3 removal pit were primarily sands, much of which had a gray discoloration and "diesel" odor characteristic of material having prolonged contact with petroleum substances. An STS ICC-Certified UST Site Assessor collected three representative soil samples from the UST removal pit, and an additional three samples from the stockpile of excavated overburden soils. The samples were handled in the same manner as those collected from the other UST removal pits and submitted to Friedman & Bruya.

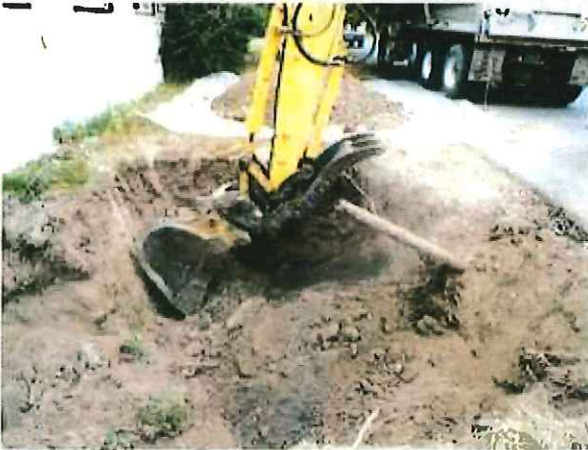
Photograph 15. UST #3 Excavating Petroleum-Impacted Soils

Based on the analytical result for the soil sample collected following UST removal, STS used a tracked excavator to remove 153.60 tons of petroleum-impacted soils from the UST removal pit. The soils were transported to LRI.

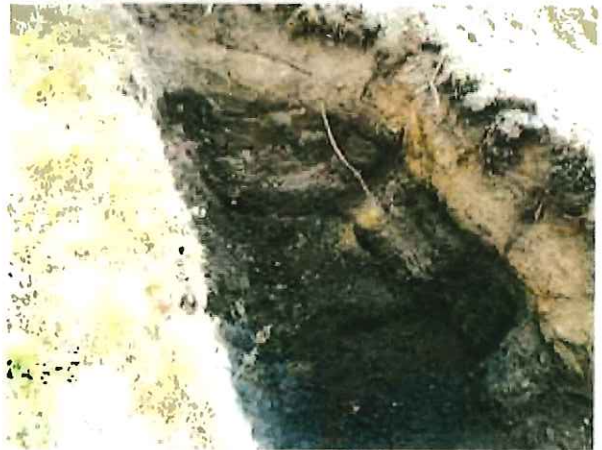
Photograph 16. UST #3 Final Excavation

Based on the analytical results for all the soil samples, and the inability to safely remove remaining impacted material from the north and south walls, the excavation was backfilled with the confirmed clean overburden soils along with clean imported pit run, over which was placed clean topsoil.

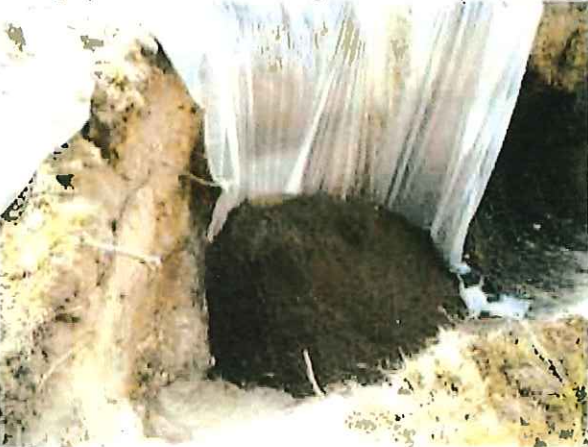
Photograph 17. Backfilling UST #3 Excavation

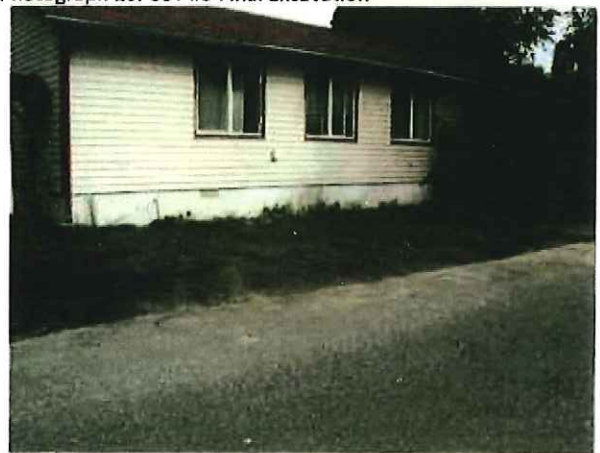
Photograph 18. Restored Former UST# 3 Location
