DEPARTMENT OF
ECOLOGY
State of Washington

**CLEANUP ACTION PLAN
R.G. HALEY INTERNATIONAL CORPORATION SITE
BELLINGHAM, WASHINGTON**

April, 2018

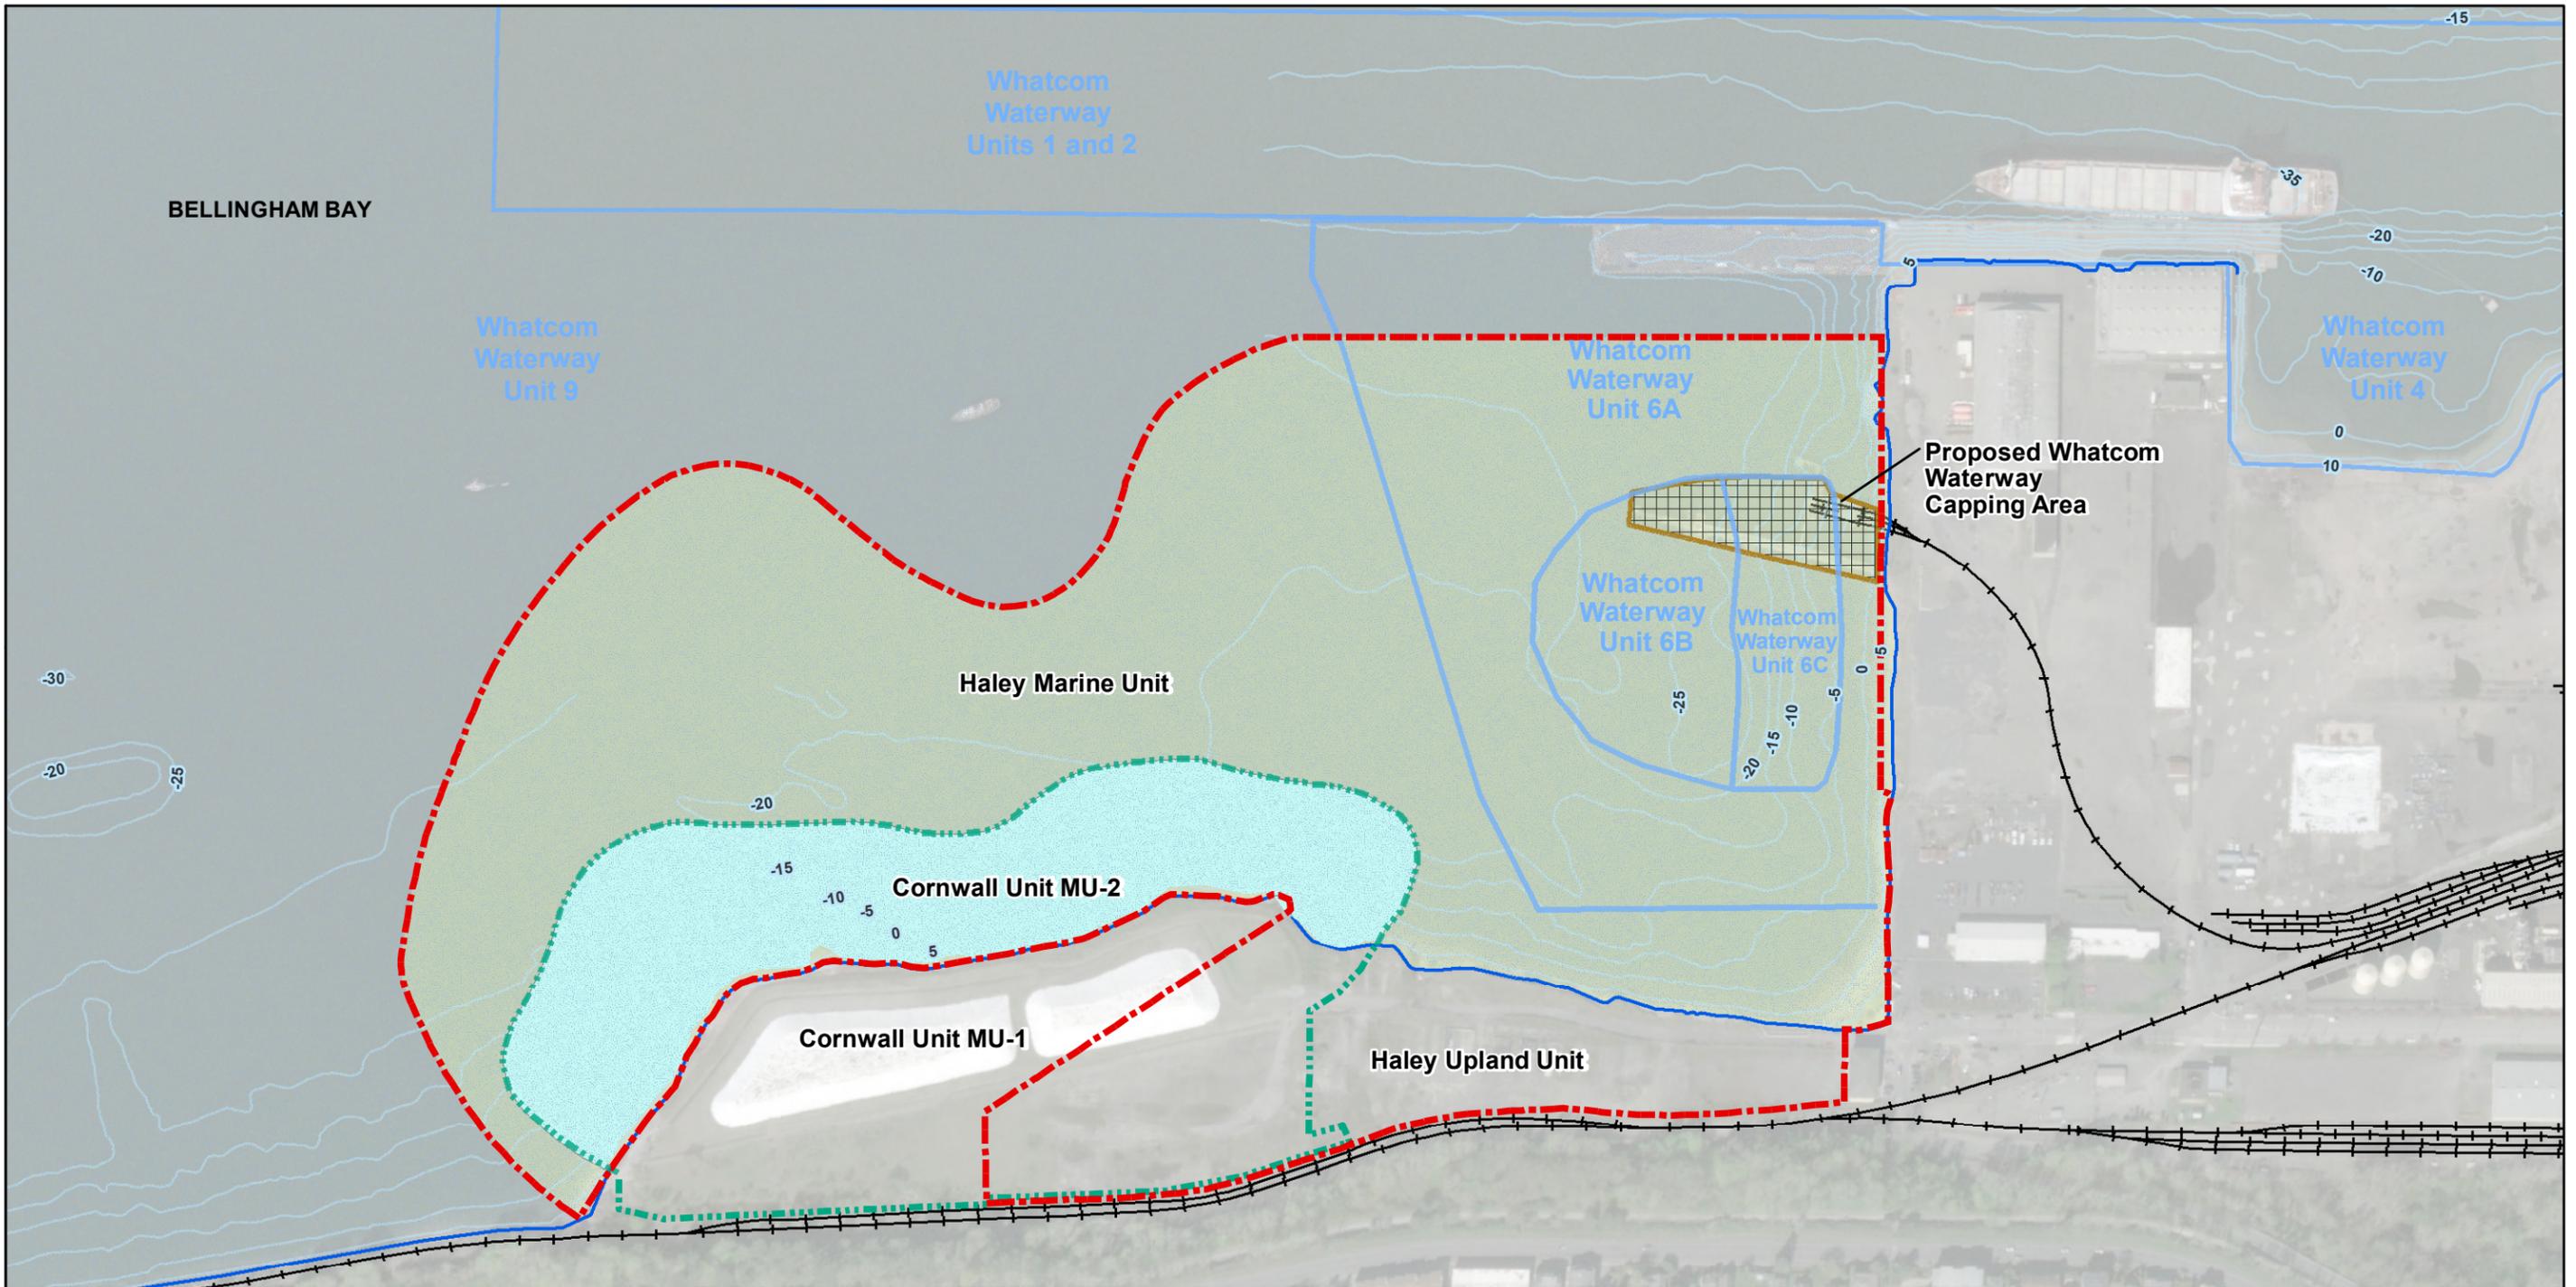
Haley, Cornwall and Whatcom Waterway Site Units	
R.G. Haley Site Bellingham, Washington	
GEOENGINEERS	Figure 4

- Legend**
- - - Haley Cleanup Area Boundary
 - - - Boundary of Cornwall Units MU-1 and MU-2
 - +— BNSF Railroad
 - Current Shoreline
 - Bathymetric Contour (5-ft interval)

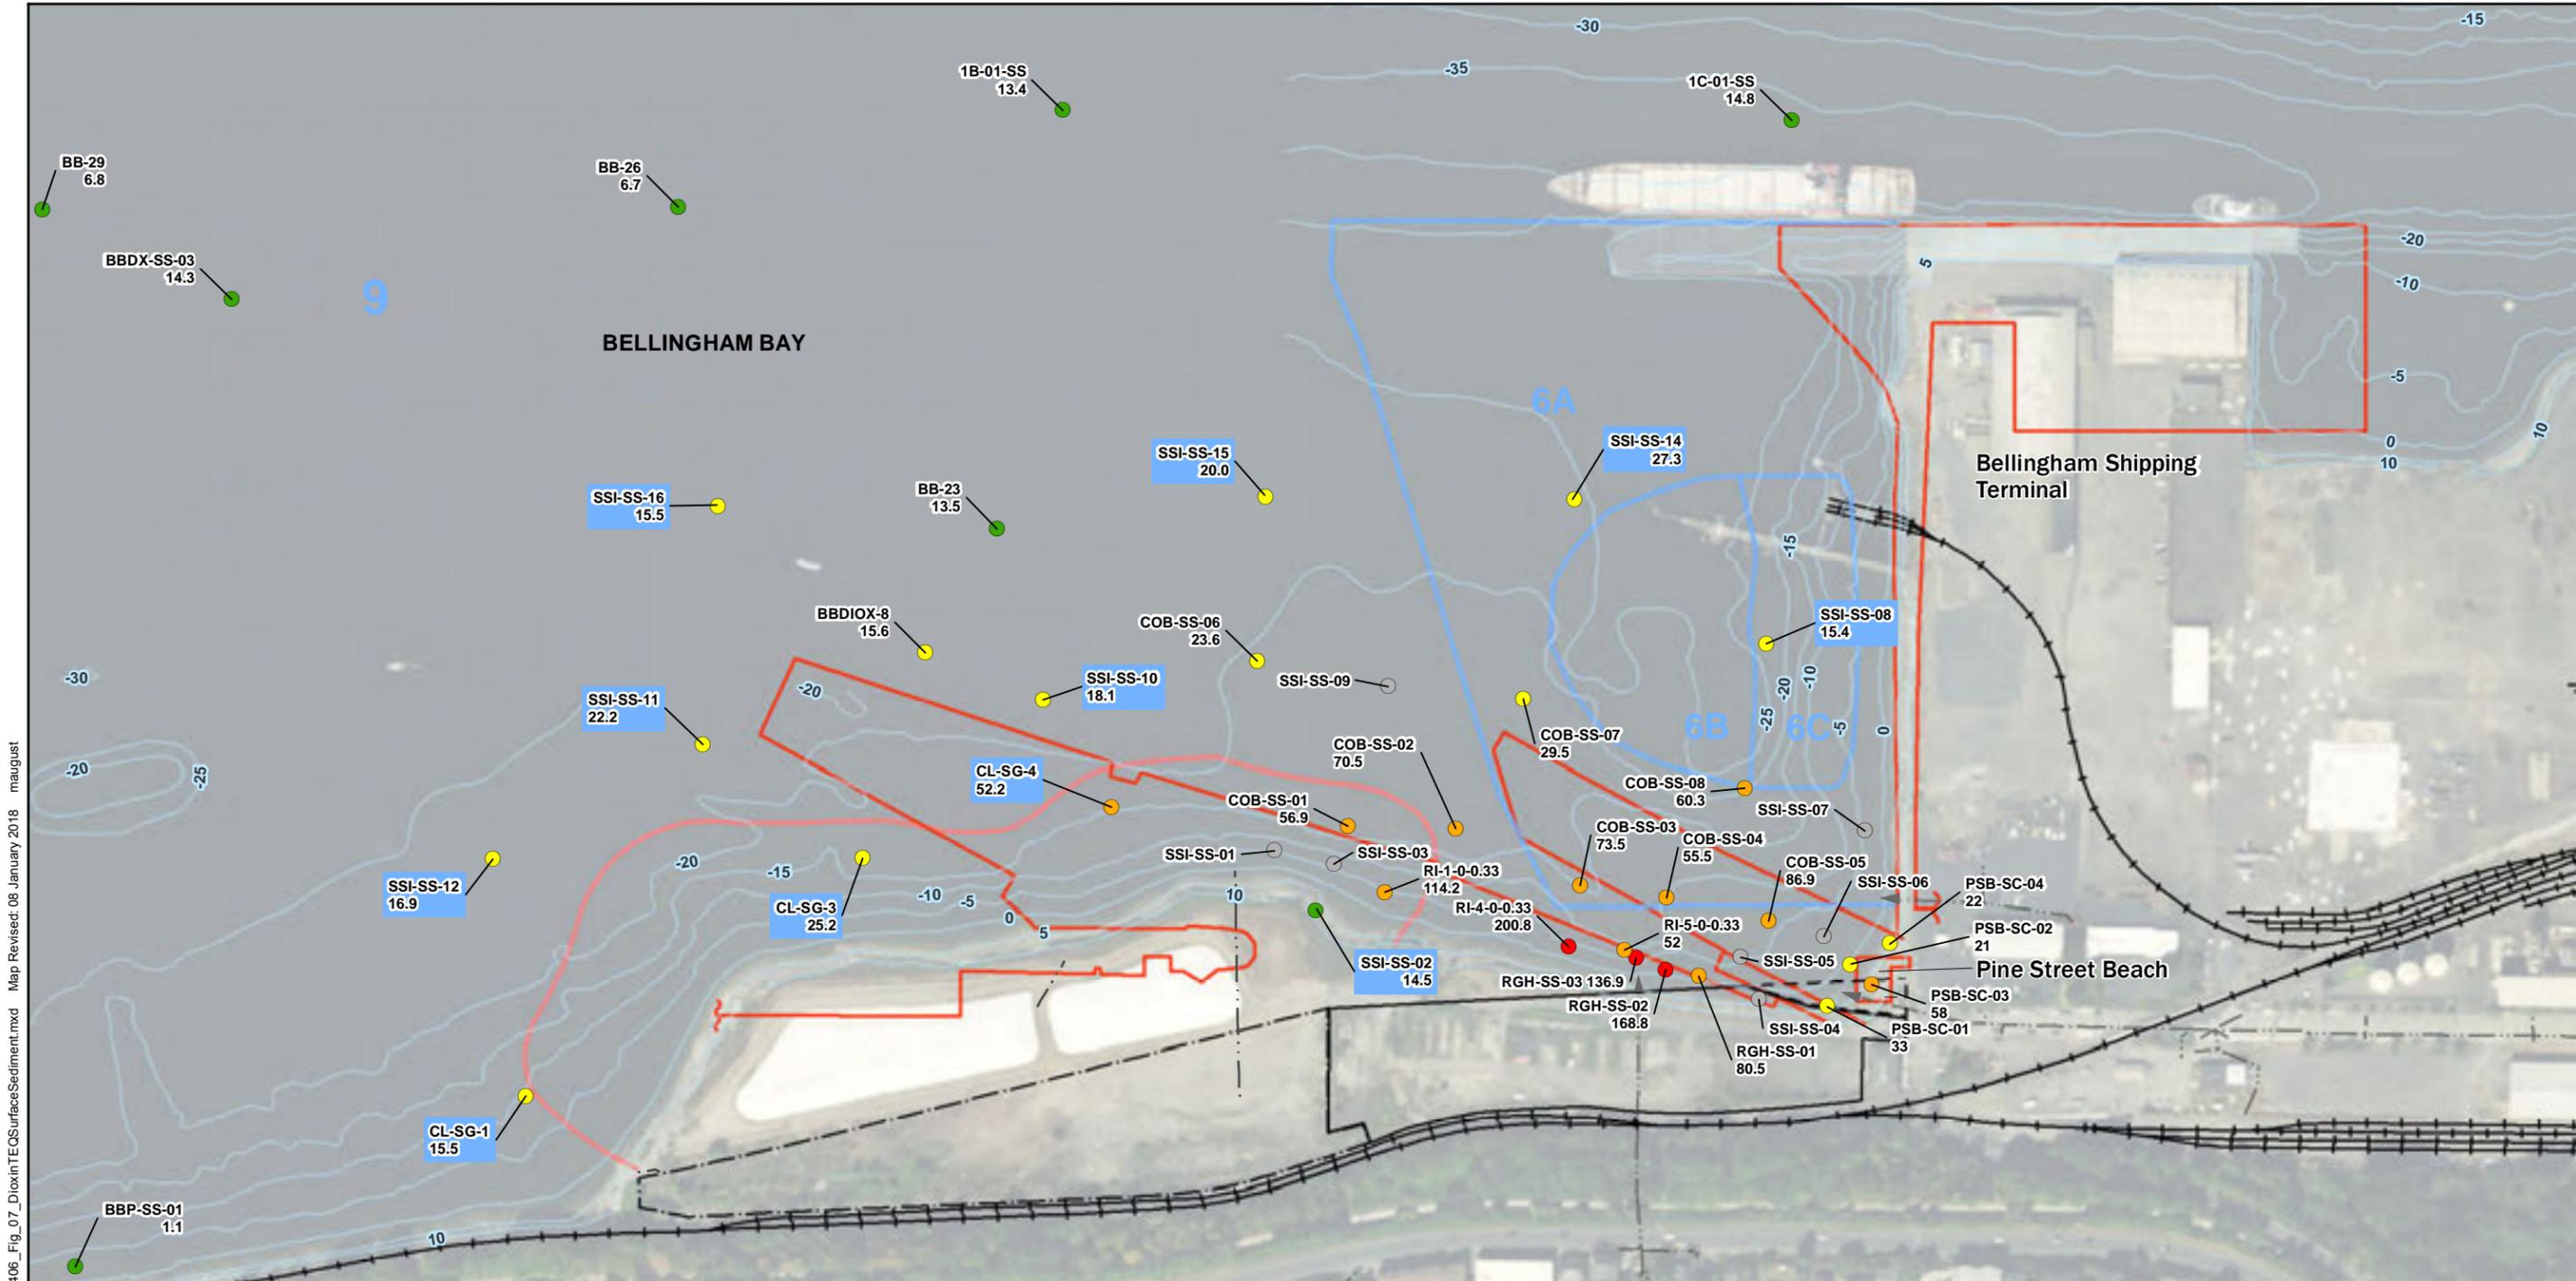
Dioxin TEQ Concentrations in Surface¹ Sediment	
R.G. Haley Site Bellingham, Washington	
	Figure 7

¹Surface = 0-0.39 ft below mudline (blm) except for sample labels noted by *, which are 0-2 ft blm.

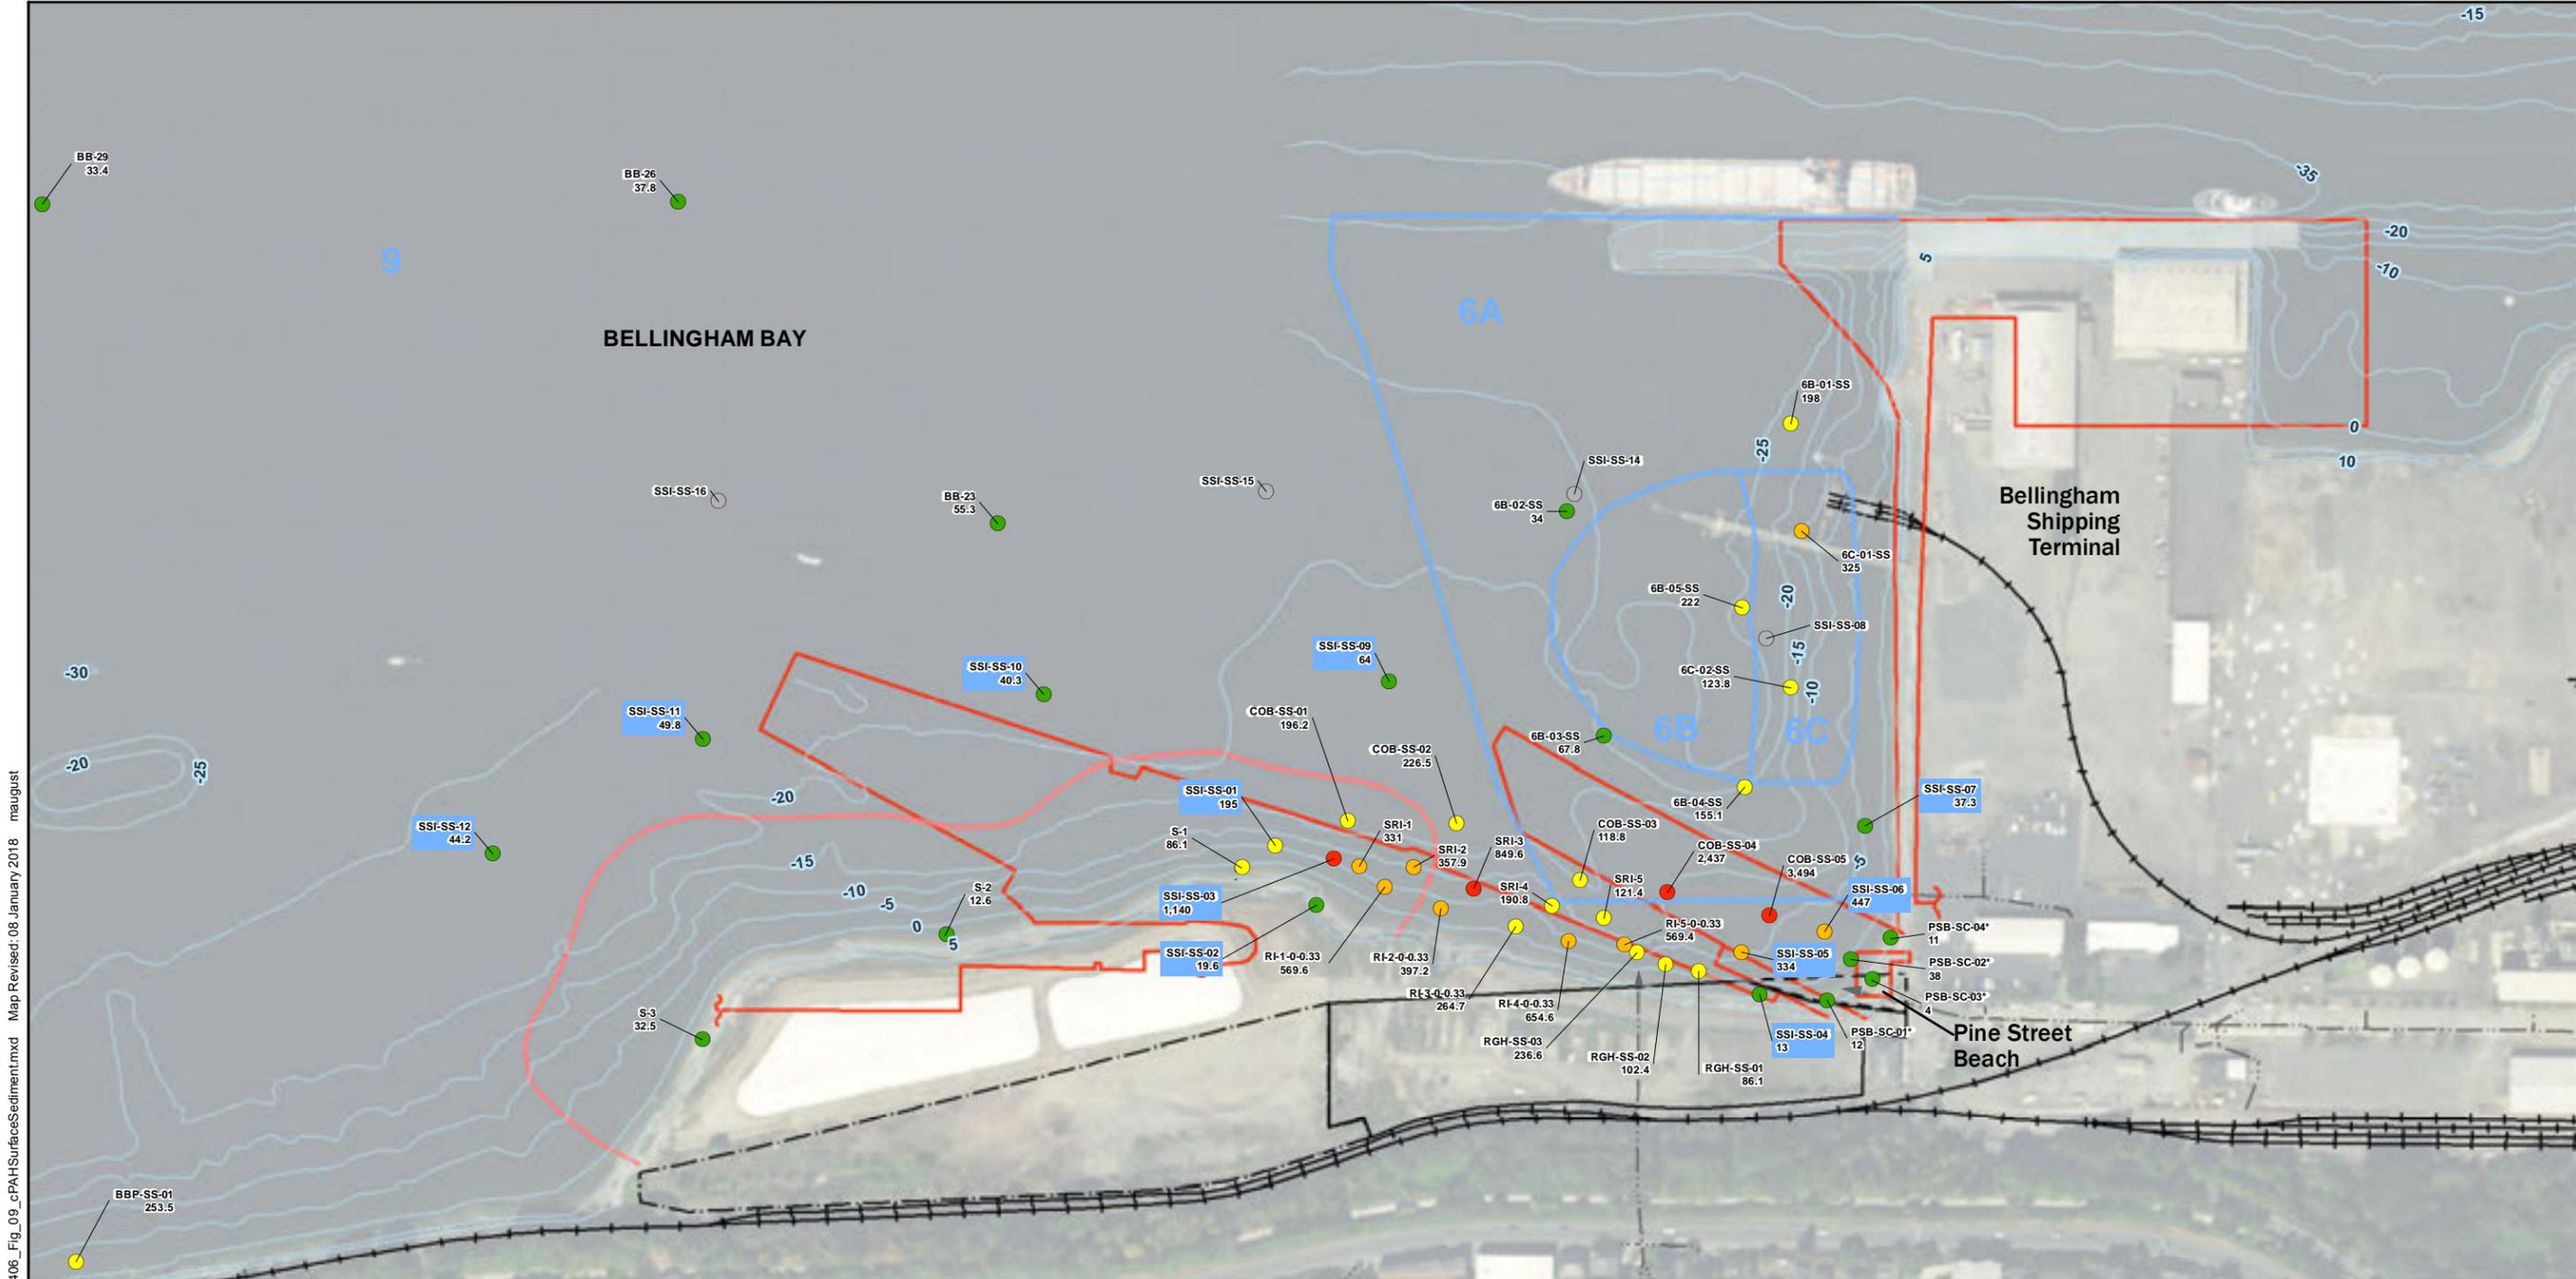
cPAH TEQ Concentrations in Surface¹ Sediment	
R.G. Haley Site Bellingham, Washington	
GEOENGINEERS	Figure 9

¹Surface = 0-0.39 ft below mudline (blm) except for sample labels noted by *, which are 0-2 ft blm.

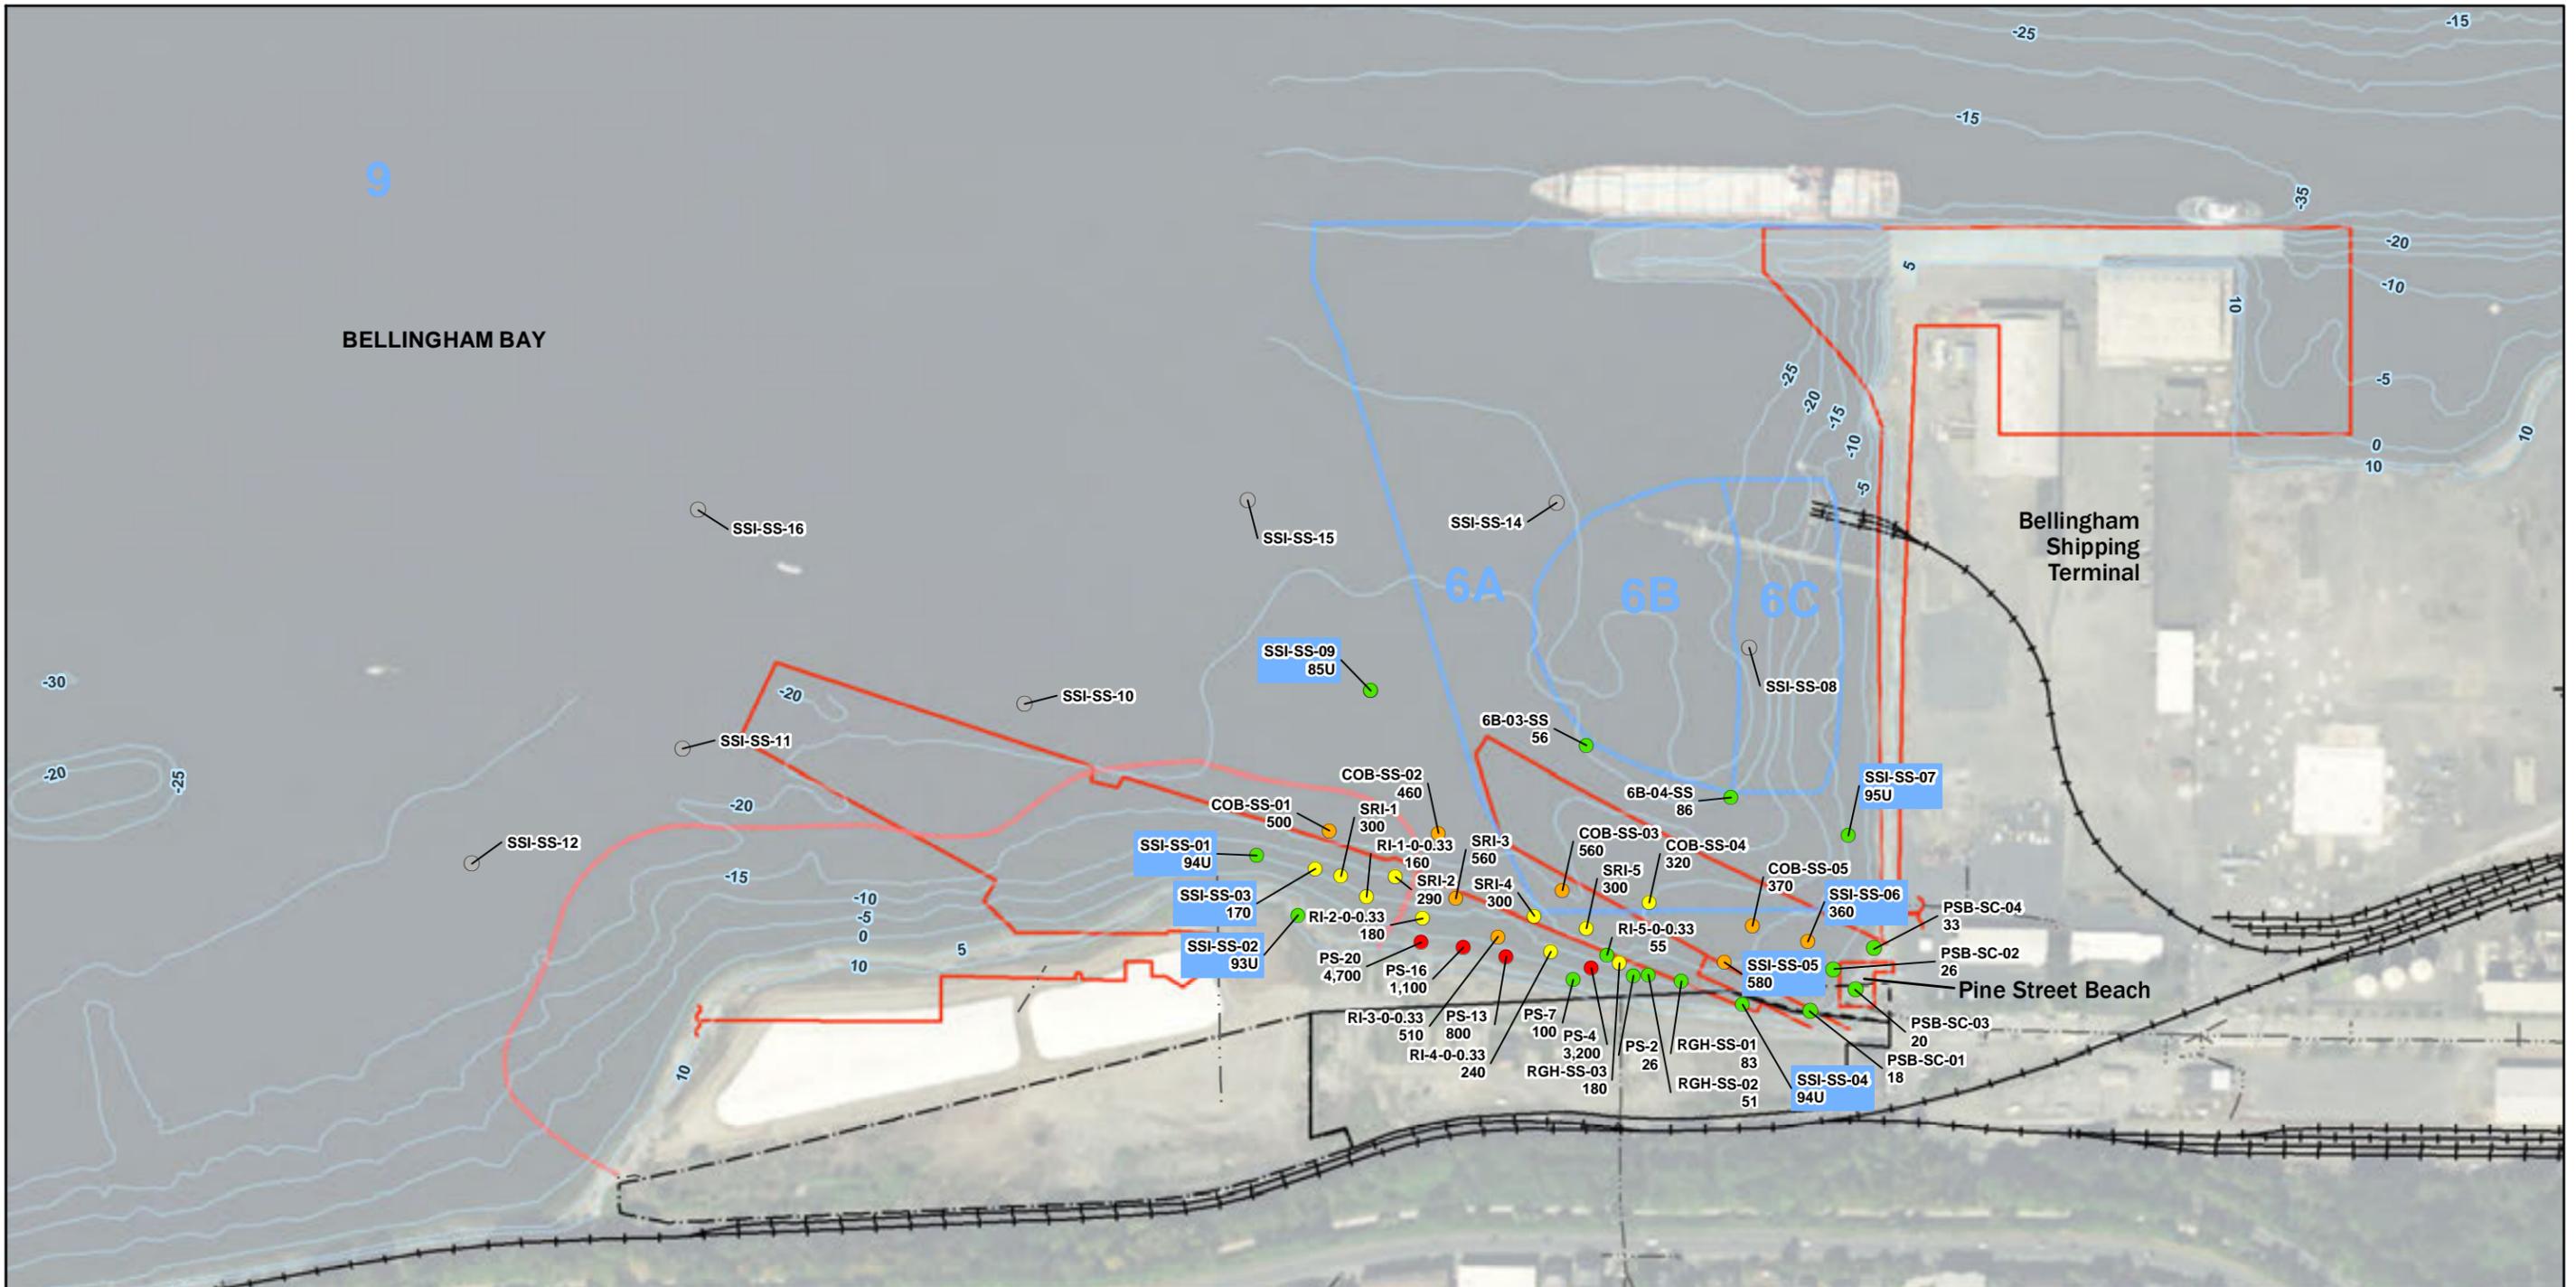
Pentachlorophenol Concentrations in Surface¹ Sediment	
R.G. Haley Site Bellingham, Washington	
GEOENGINEERS	Figure 11

Notes:
 1. Preliminary cleanup level = 100 µg/kg.
 2. The locations of all features shown are approximate.
 3. This drawing is for information purposes. It is intended to assist in showing features discussed in an attached document. GeoEngineers, Inc. cannot guarantee the accuracy and content of electronic files. The master file is stored by GeoEngineers, Inc. and will serve as the official record of this communication.
 4. U = chemical not detected at identified detection limit.

¹Surface = 0-0.39 ft below mudline (blm) except for sample labels noted by *, which are 0-2 ft blm.

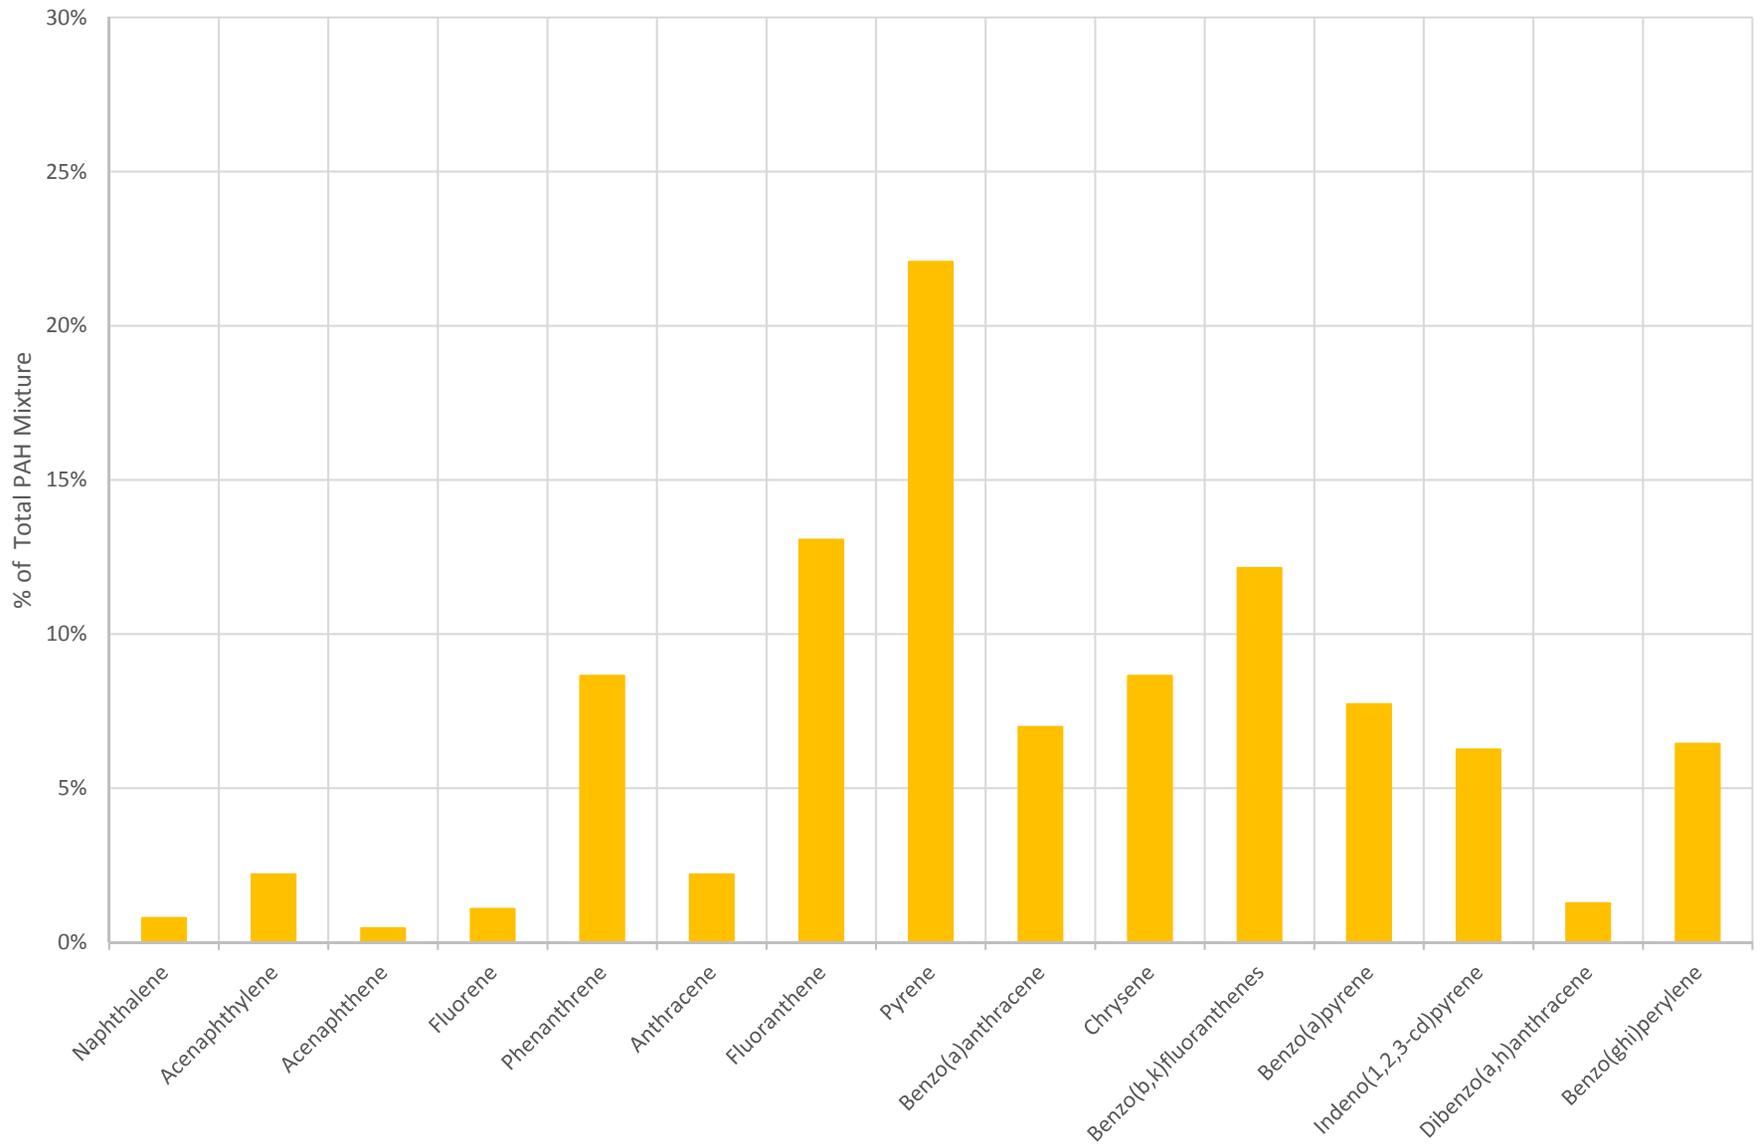
Figure G-1

PAH Profile--Sample RI-1_0-0.33

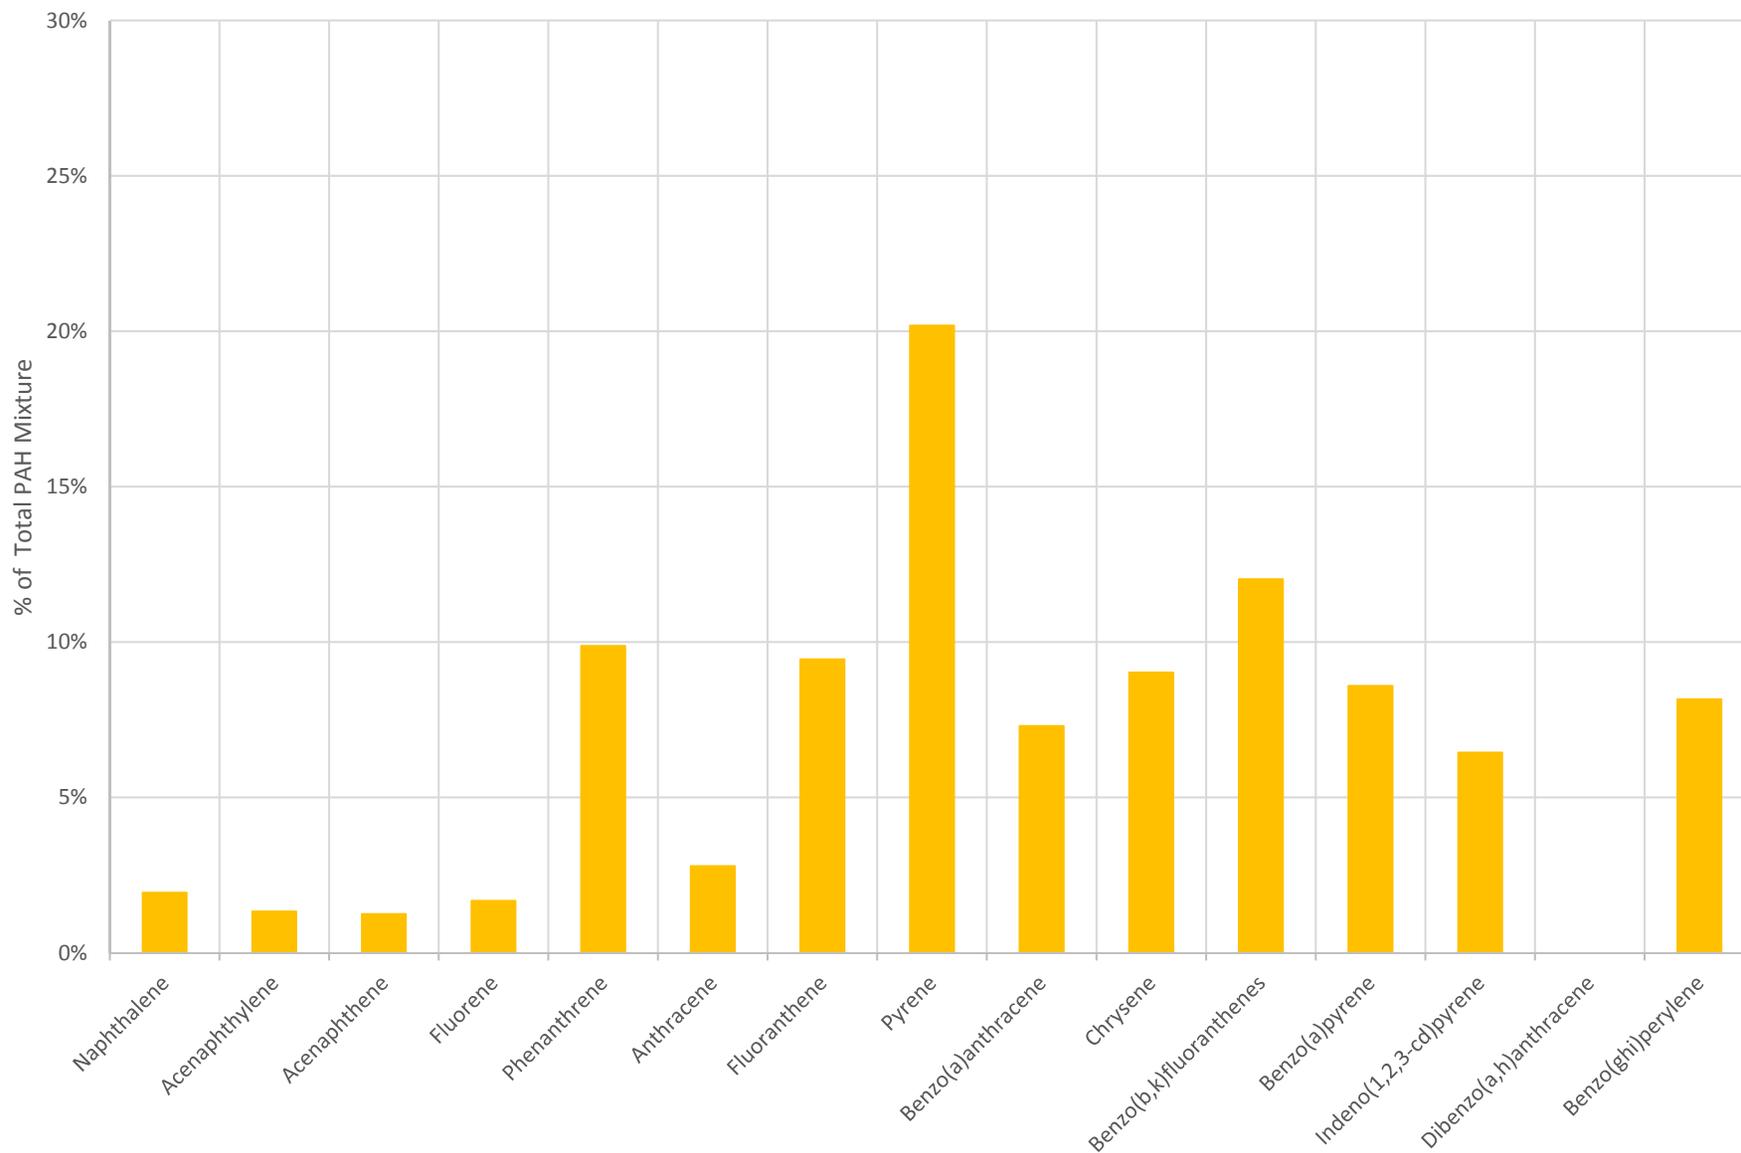
Figure G-3

PAH Profile--Sample RI-3_0-0.33

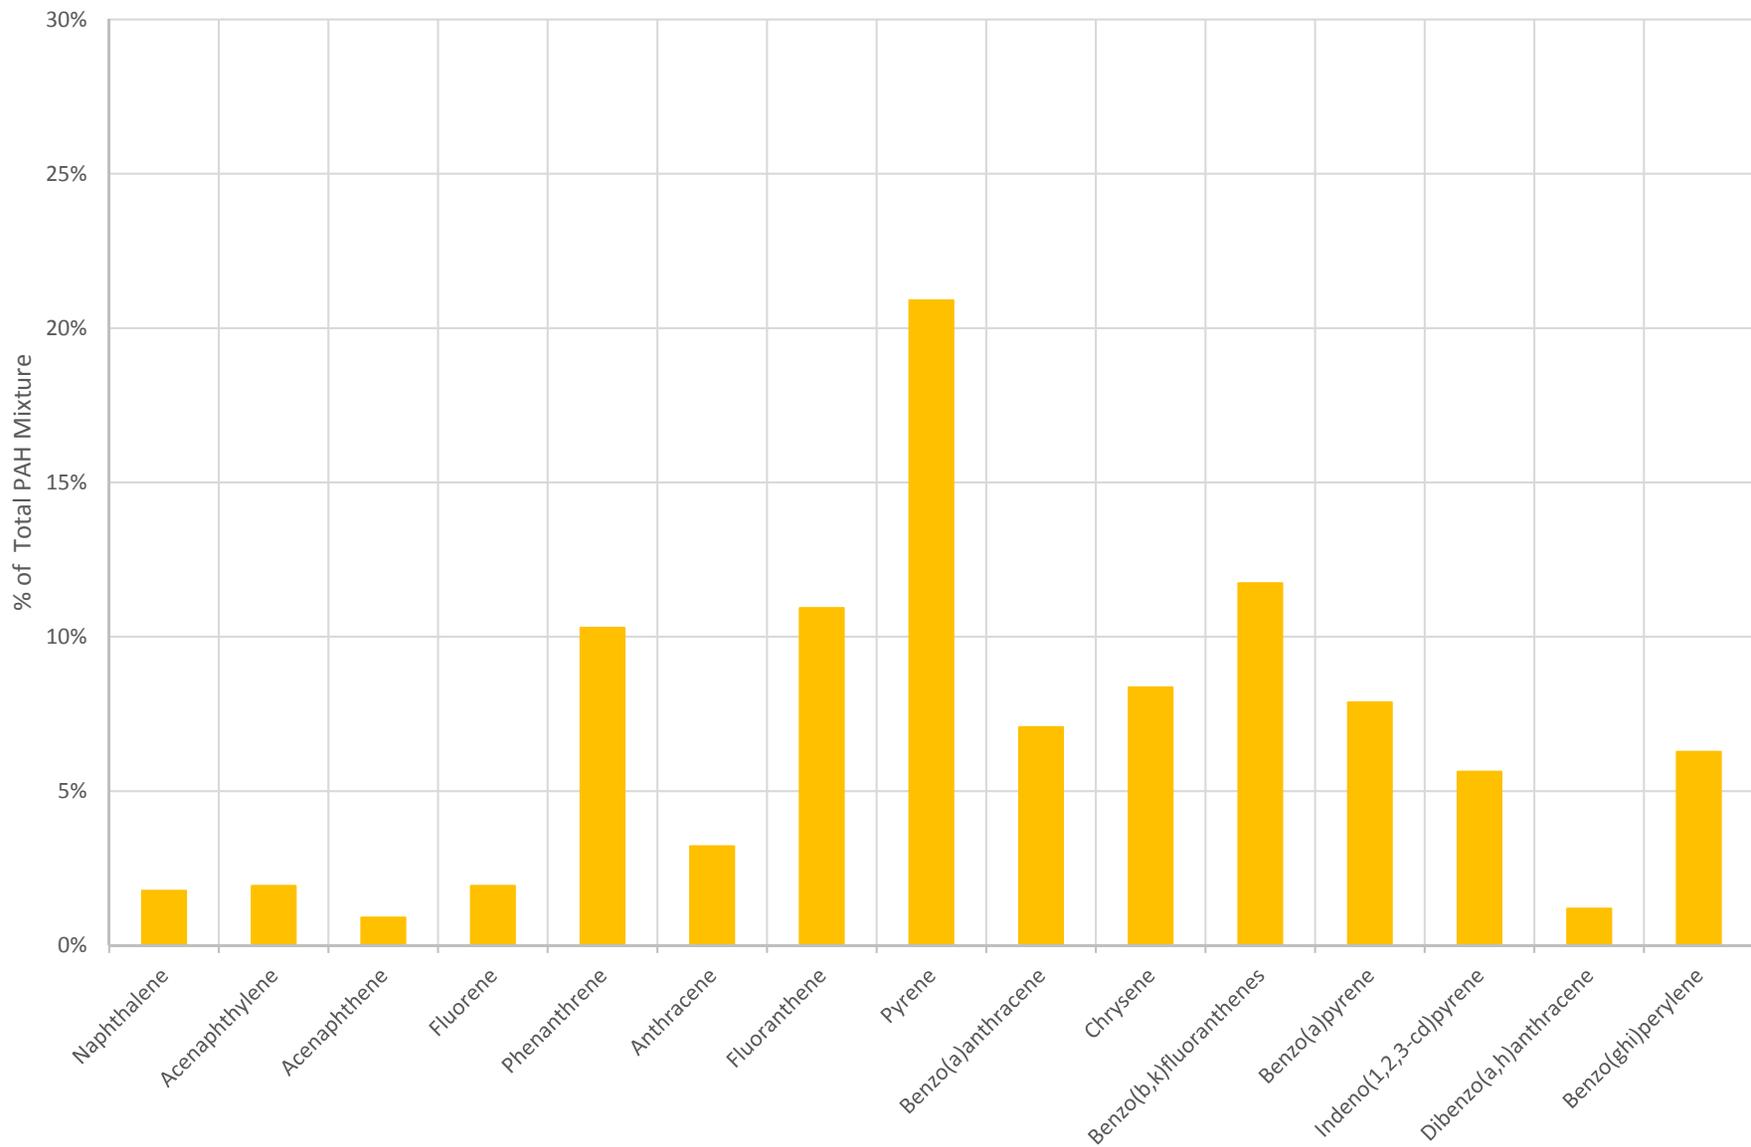
Figure G-4

PAH Profile--Sample RI-4_0-0.33

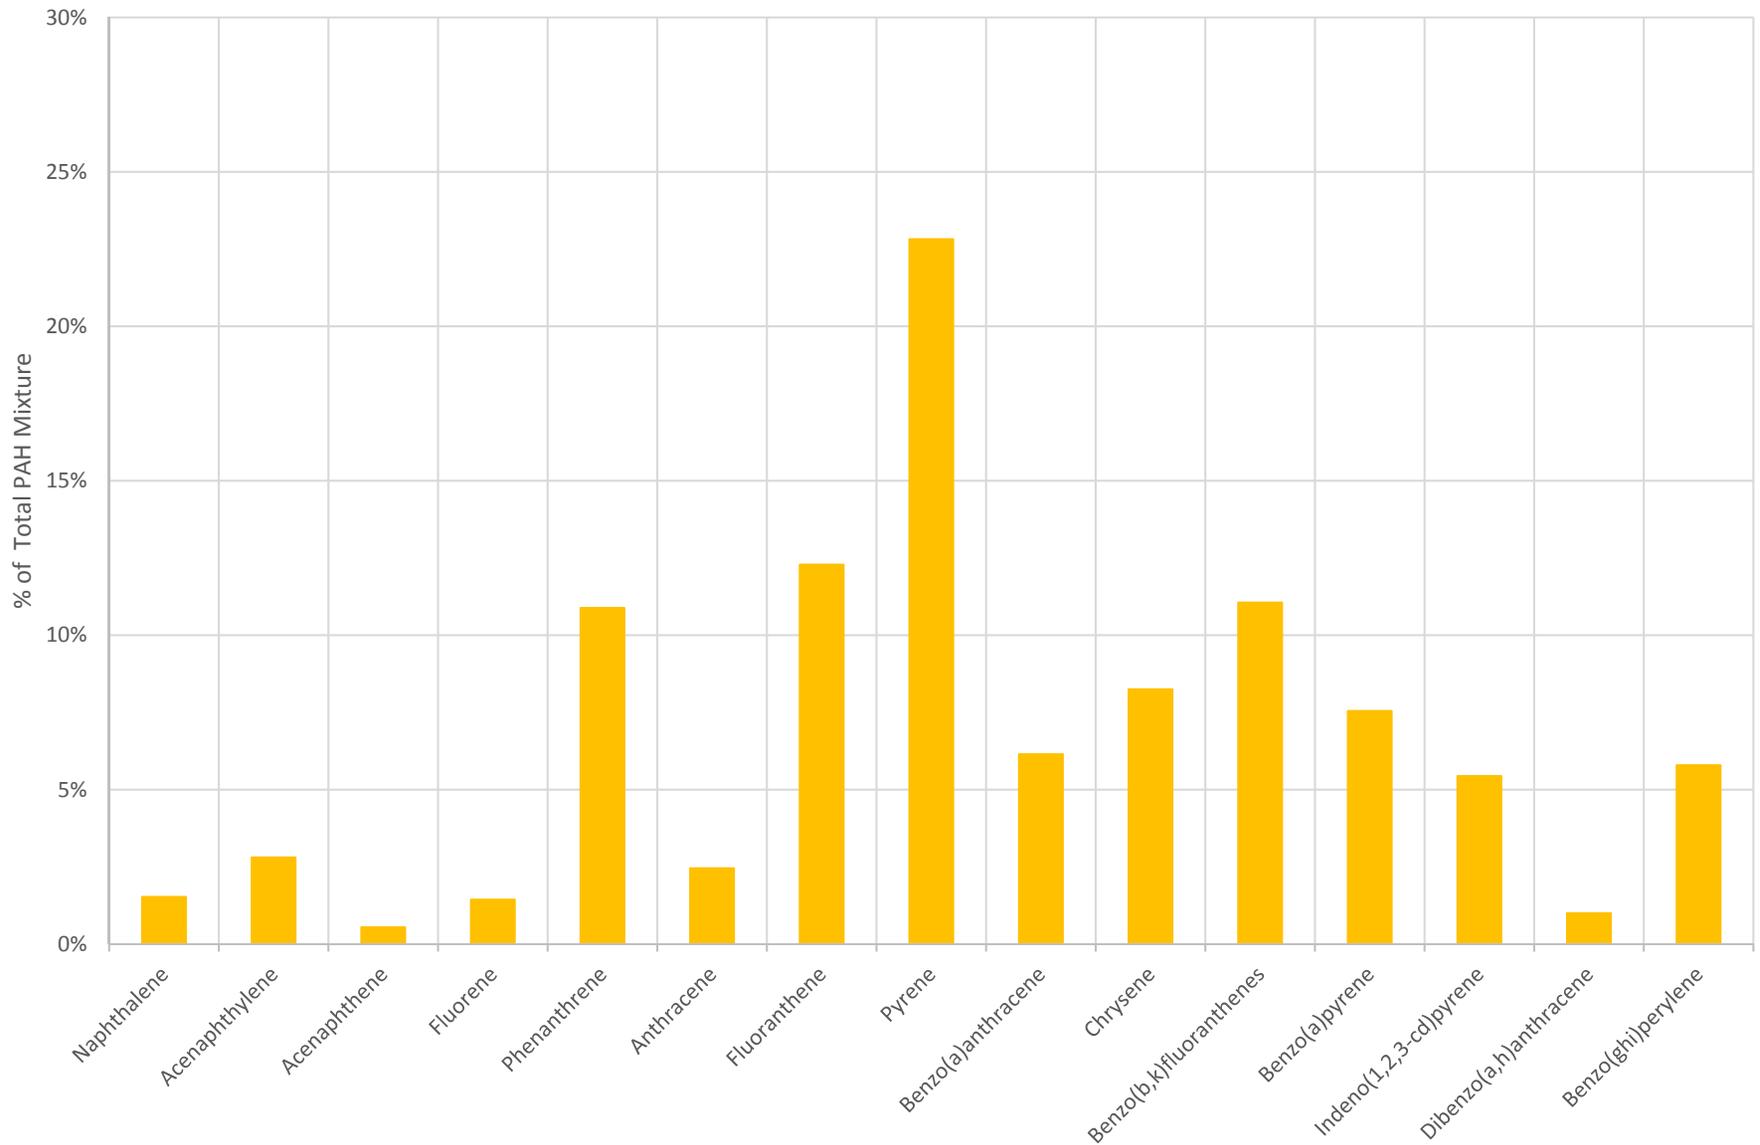
Figure G-5

PAH Profile--Sample RI-5_0.033
