DEPARTMENT OF
ECOLOGY
State of Washington

**CLEANUP ACTION PLAN
R.G. HALEY INTERNATIONAL CORPORATION SITE
BELLINGHAM, WASHINGTON**

April, 2018

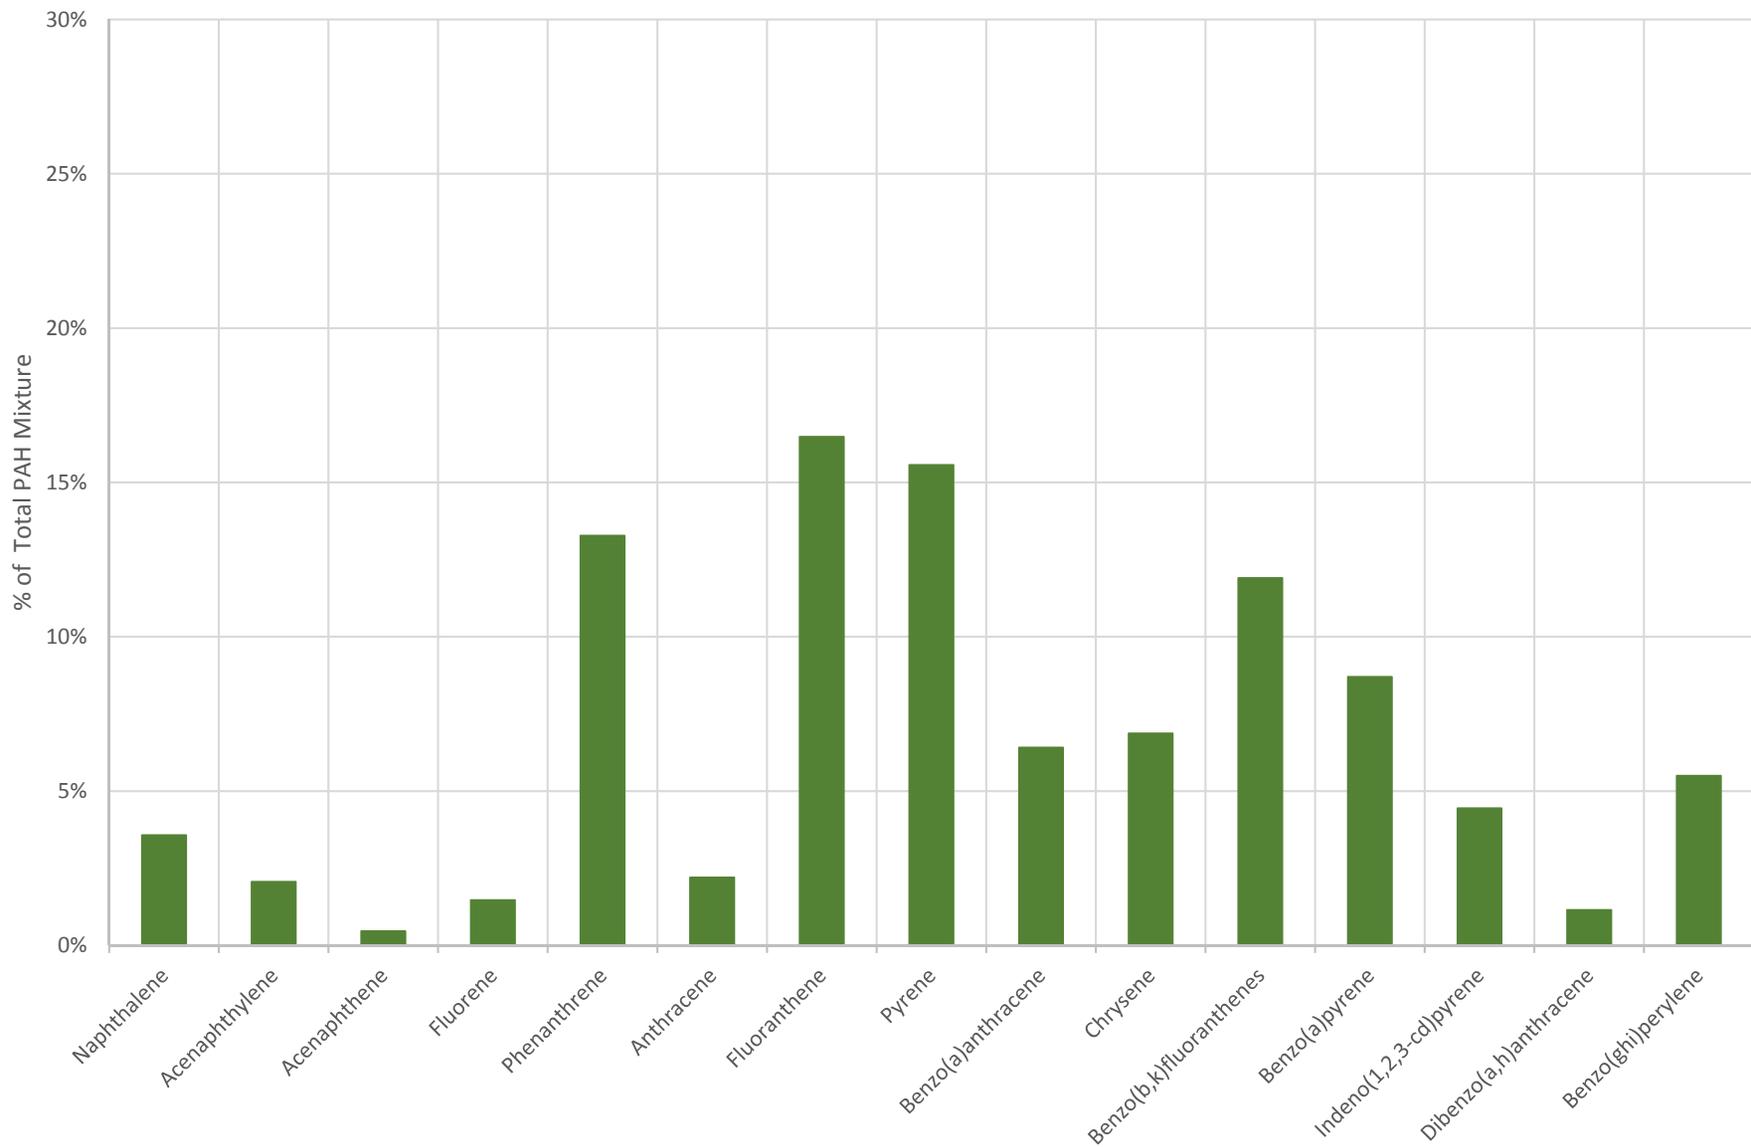
Figure G-9

PAH Profile--Sample COB-SS-04

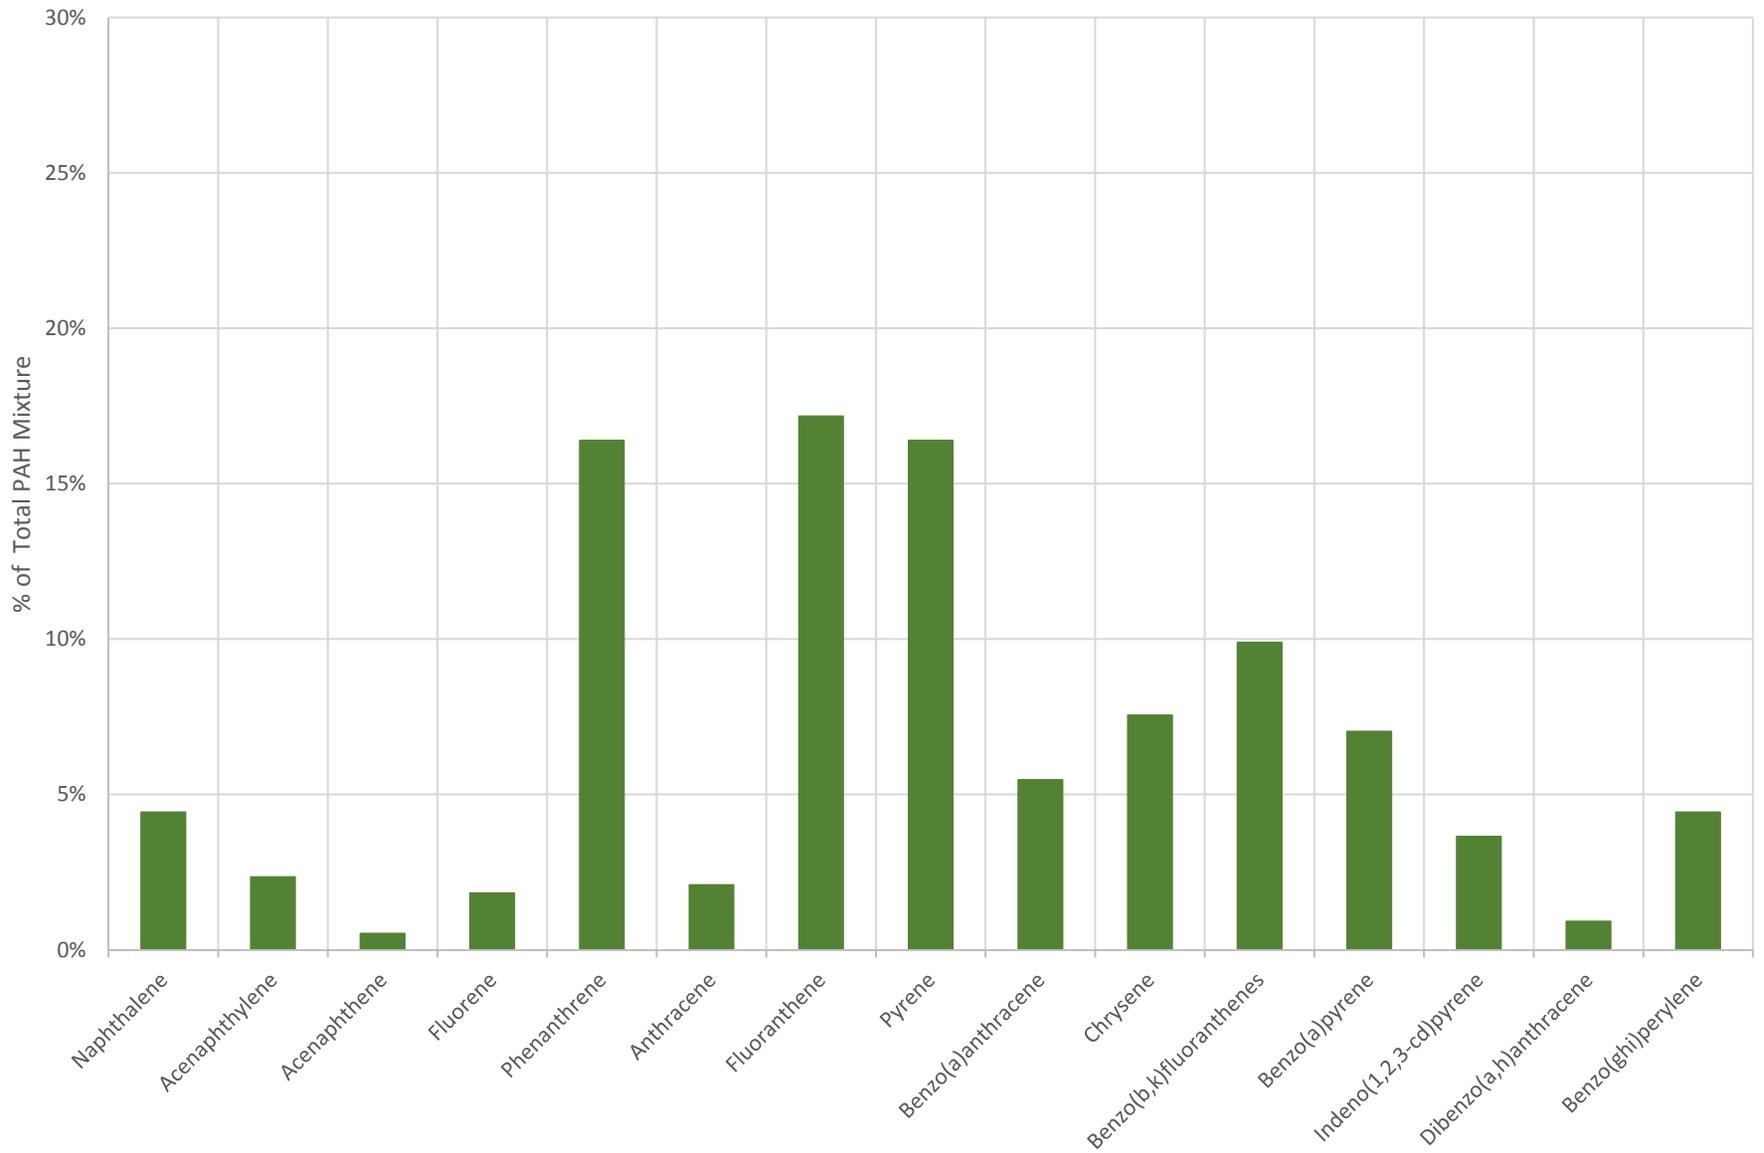
Figure G-10

PAH Profile--Sample COB-SS-05
