*Soil Remediation Report
Former Chevron Bulk Terminal
No. 100-1840
SE Sixth and SE Union Avenues
Camas, Washington*

*Prepared for
Chevron U.S.A. Products
Company*

*December 28, 1994
J-5407-01*

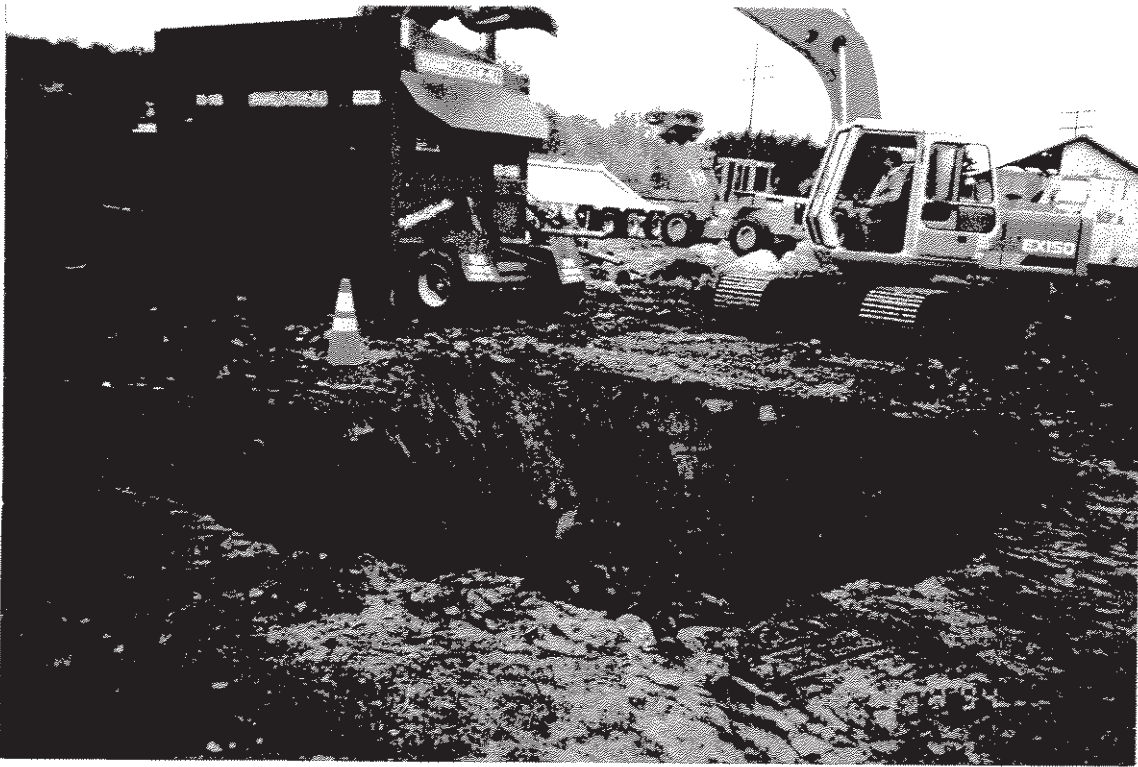
Photograph #1: Excavation of former loading rack area and screening. Loading in background. Photograph taken looking east.

Screening. Excavated soil was screened through a 3-inch shaker screen (Photographs #1 and #2), with material passing the screen being transported to

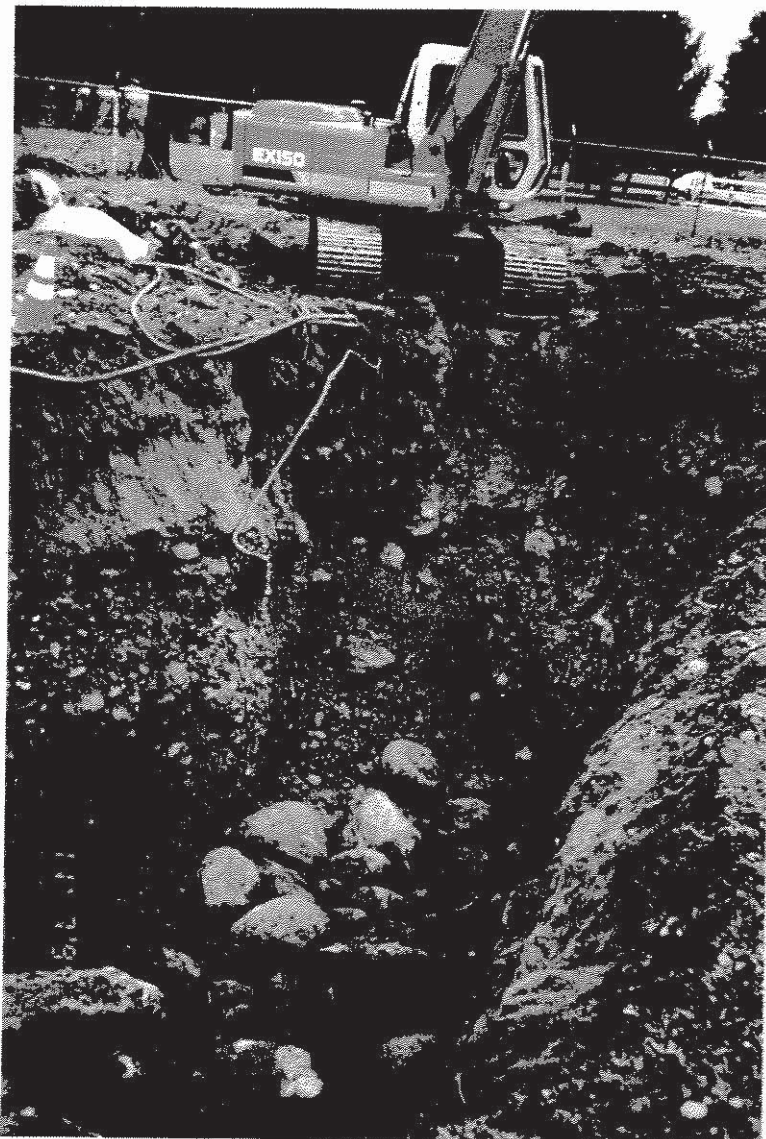
Photograph #3: Former ASTs excavation.
Note boulders at bottom.
Photograph taken looking
south (MW-1 marked by cone).

Soil Excavation, Screening, and Loading. Earthwork activities were accomplished by Terra Hydr, Inc., of Portland, Oregon, under subcontract to Hart Crowser. Soil was excavated using a trackhoe and transferred either directly or by a front loader to a 3-inch shaker screen (Photographs #1 and #2). When encountered, large boulders (those greater than 2 feet in diameter) were left in the bottoms of the excavations (Photograph #3).

Soil Conditions. Soils encountered in the excavations consisted of about 3 to 5 feet of light brown, gravelly SILT overlying light brown, very gravelly SILT with cobbles and boulders up to 5 feet in diameter (Photographs #3 and #5).

Soils with Field Evidence of Petroleum Hydrocarbons. Based on PID readings and field observations, soils with field evidence of petroleum hydrocarbons were present in the former AST, sand trap, and loading rack excavations (refer to Figure 3). These soils were excavated to the extent practicable as defined by initial subcell dimensions and the maximum depth attainable by the trackhoe. Soils with field evidence of petroleum hydrocarbons remain in the bottom of the former AST excavation and around and southeast of vapor monitoring well MW-1 (Photograph #3).

Backfilling. During excavation, large boulders greater than 2 feet in diameter were left on the bottoms of the excavations (Photograph #3). Imported sand was mixed with the boulders and compacted using a hoepack. Screened rocks were placed in the excavation with imported sand (Photographs #8 and #9), spread as an approximately one-foot lift, and compacted with a hoepack and/or vibratory, pad-foot compactor.

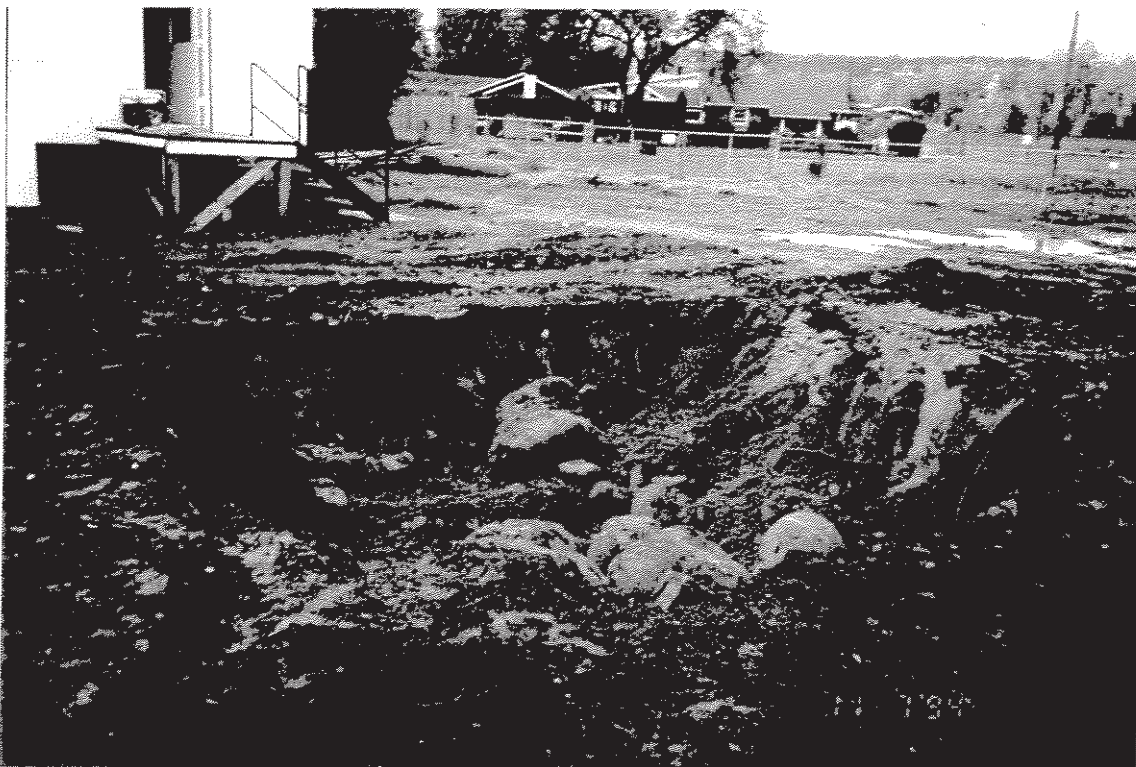
Photograph #5: Warehouse excavation nearest existing office building. Note silt in sidewalls. Boulders were encountered at bottom of excavation. Photograph taken looking west.

From November 7 through 9, 1994, we observed the excavation of about 700 cy of soil with petroleum hydrocarbons was excavated from six separate areas at the site (Figure 3; Photograph #5). In addition, another 130 cy of soil was excavated from the upper 2 feet in the former AST area (Photograph #6).

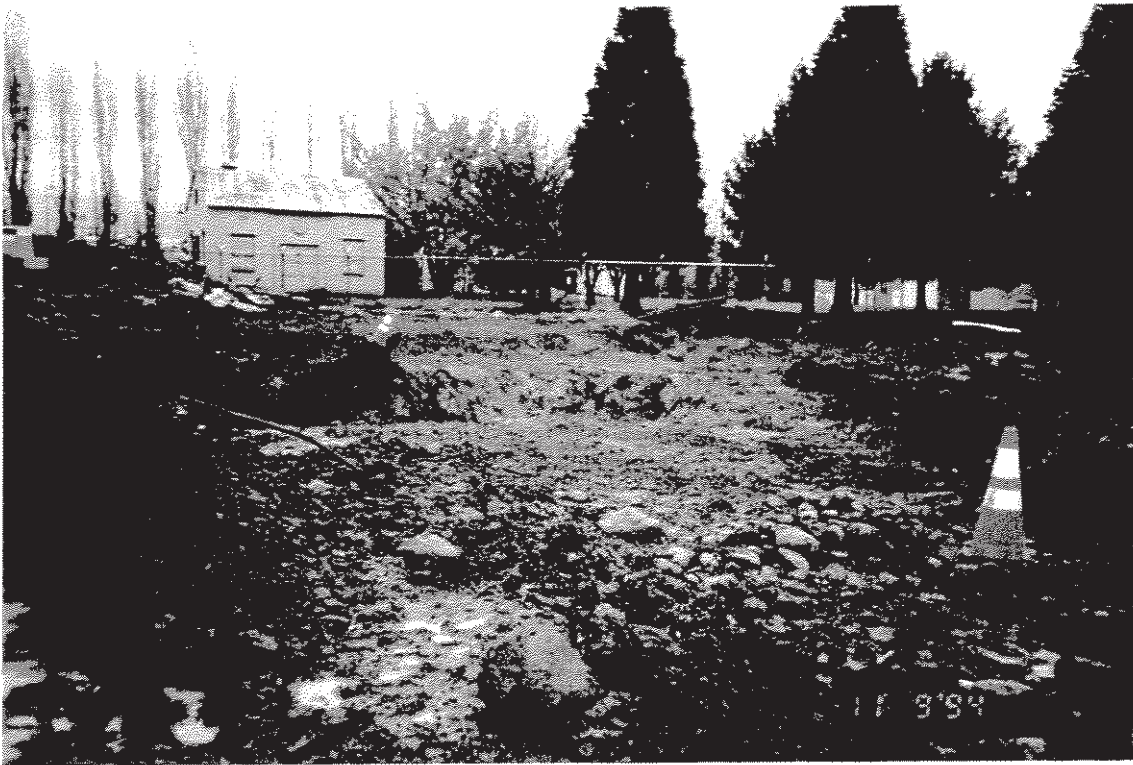
Photograph #6: Shallow excavation. Cones mark MW-5 (foreground) and MW-1 (background). Photograph taken looking southeast.

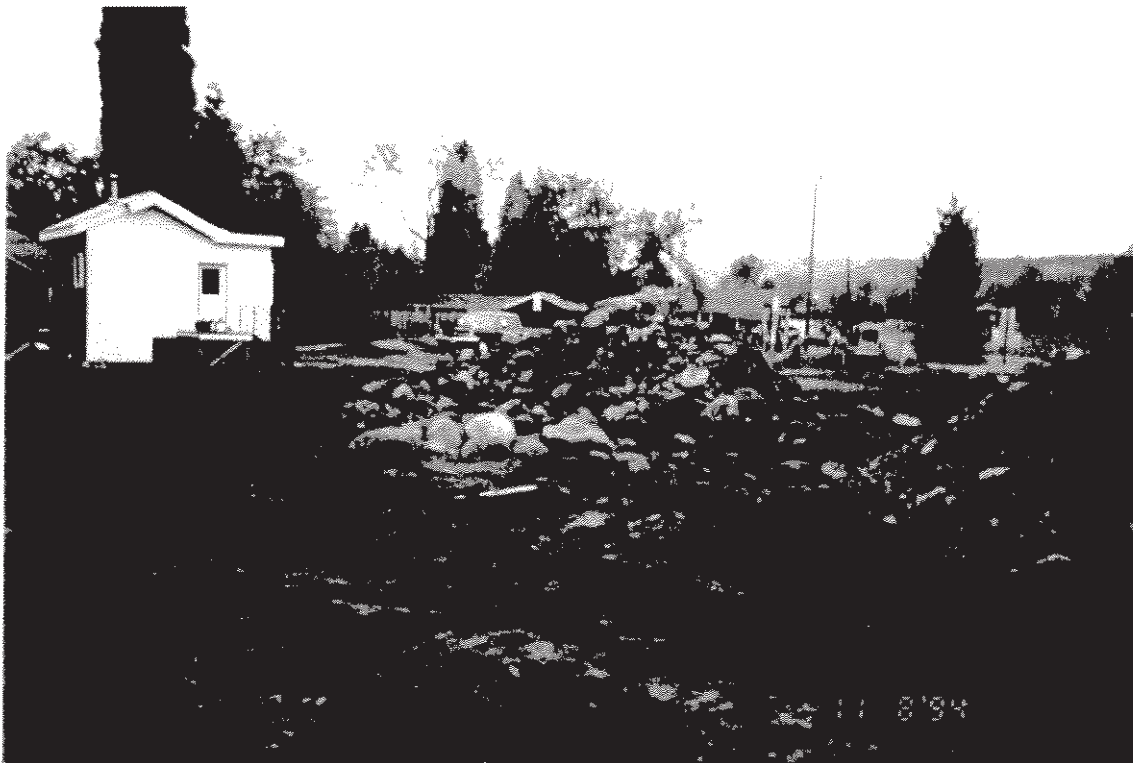
Photograph #7: Stockpile of screened rock (in center) after one day of screening. Compactor used for compacting backfill in background. Photograph taken looking west.

the Roosevelt Regional Landfill for disposal (see Section 3.6 below). About 200 cy of rocks greater than 3 inches in diameter were screened out and stockpiled for use as backfill material (Photograph #7).

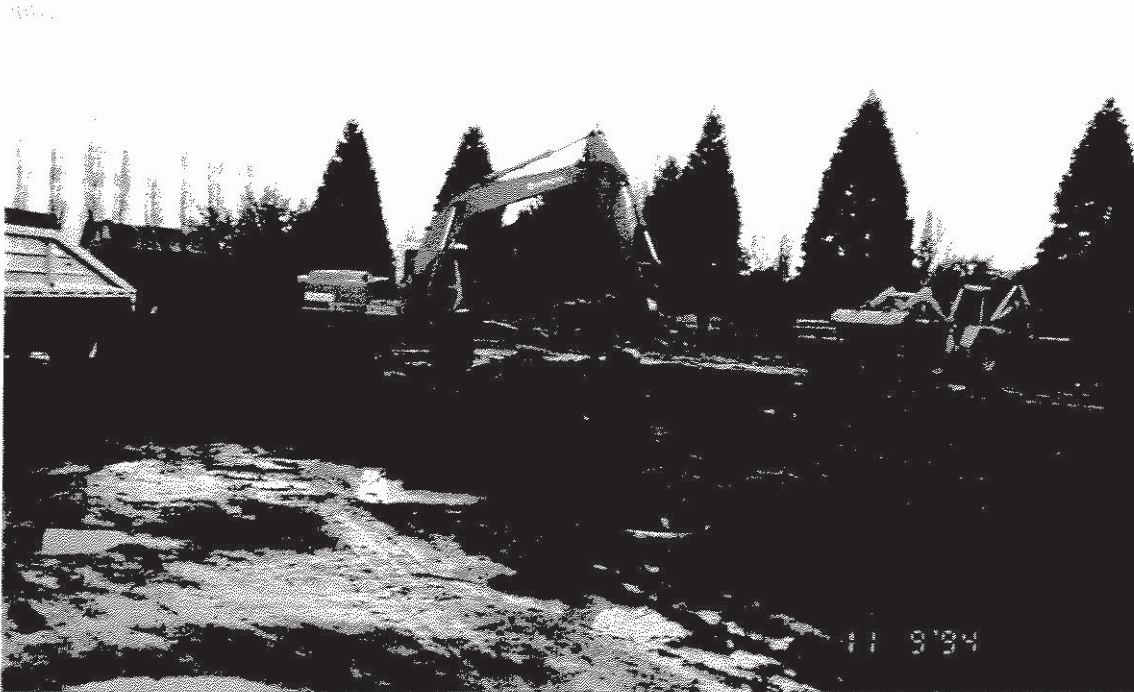
Photograph #8: Placing screened rocks into former AST's excavation. Imported sand to be mixed in with rocks is to left. Hoepack at right. Photograph taken looking east.

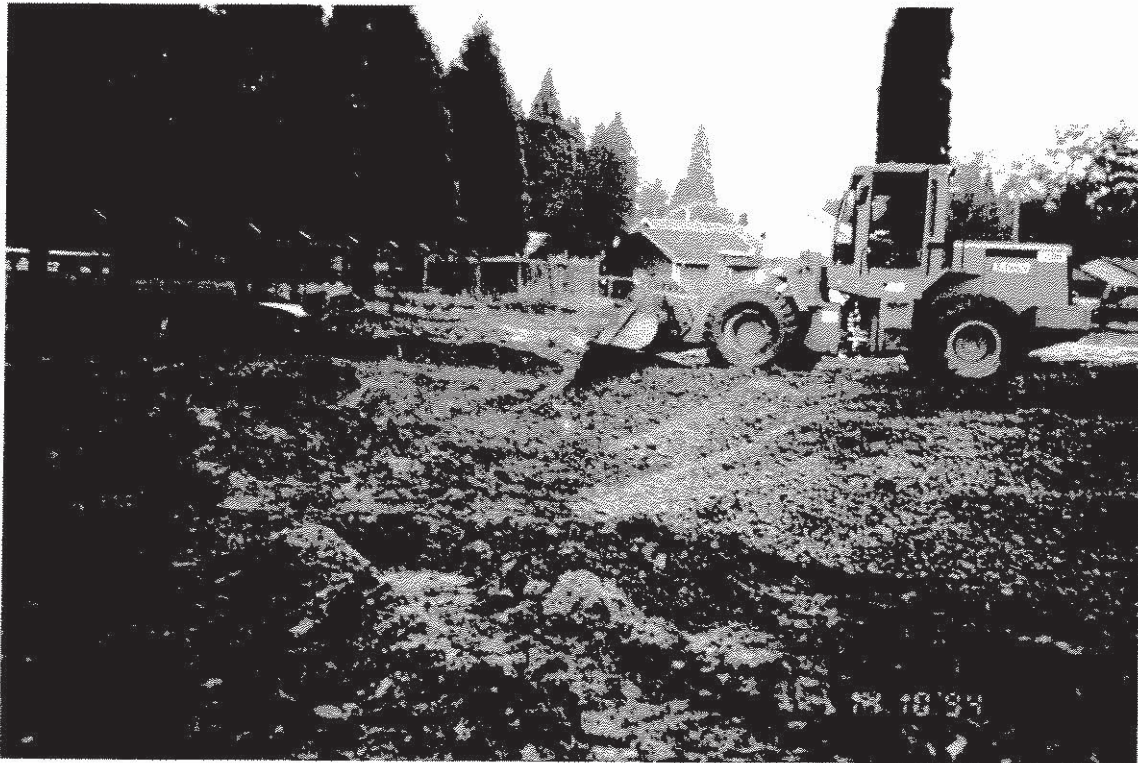
Photograph #10: Spreading pit run into shallow excavation. Photograph taken looking southwest.

After the screened rocks (with imported sand) had been returned to the excavations, backfill consisted of pit run. This coarse-grained material was used to facilitate compaction during heavy rains. As before, pit run was spread in approximately 1-foot lifts and then compacted (Photograph #10). Pit run was used to backfill all excavations to near grade. In preparation for paving of the site, about 6 to 12 inches of $5/8$ -inch-minus crushed rock was placed on all the excavated areas (Photograph #11).

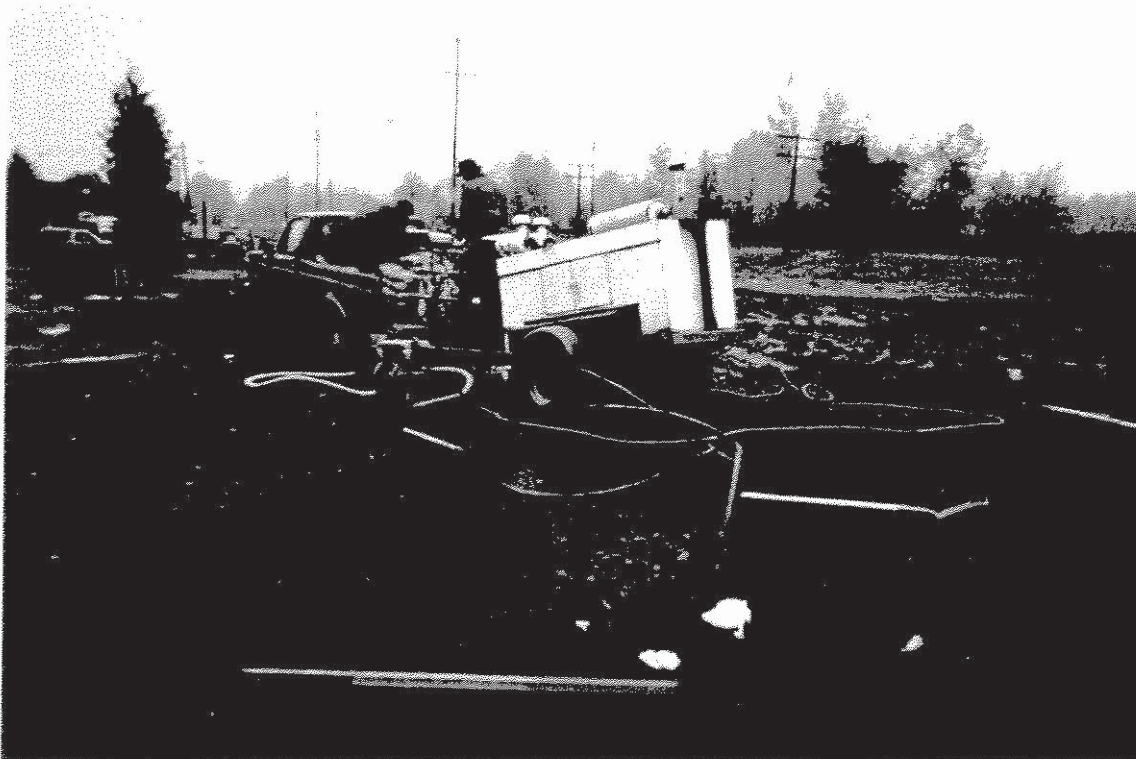
Photograph #11: Abandoning MW-1 by grouting. Note crushed rock for grade. Photograph taken looking northwest.

On November 21, 1994, Geo-Tech Explorations, Inc., of Tualatin, Oregon, abandoned vapor monitoring wells MW-1 through MW-4 in accordance with State of Washington regulations (Photograph #11). The wells were grouted with a bentonite/cement slurry, and the monuments were removed. Figure 5 shows the current layout of the site.
