Horn Rapids Landfill Remedial Investigation Phase I Push Probe Investigation

Prepared for City of Richland Public Works Department

February 2018

Prepared by **Parametrix**

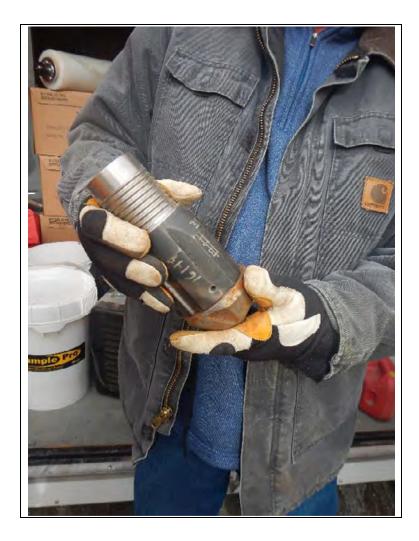
BFHD Benton-Franklin Health District

- Drive down to target depth.
- Knock out drive tip (drive tip remains in the hole) and pull back a few inches to ensure tip is free.
- Run in a standard stainless steel well screen on tubing and place on the bottom of hole.
- Pull back direct push tubing approximately 5 ft.
- Run sampling pump and collect groundwater sample.
- Remove screen and tubing.
- Decommission push hole by introducing grout as drive tubing is removed.

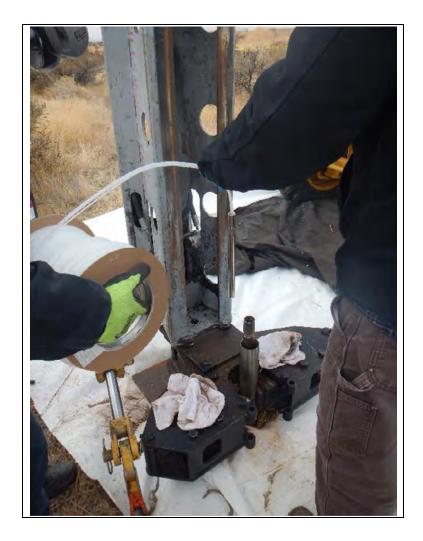
City City of Richland

Groundwater samples were collected at each probe location using a 0.75-inch diameter portable bladder pump. Stainless steel weights were attached to the bottom of the pump to facilitate introduction to the bottom of the hole. Although full development of the probe was not possible, the portable bladder pump was used to purge some water prior to sampling to reduce the amounts of fines. However, the low pumping rate of the small diameter pump (approximately 20 to 25 ml/min) only allowed a small quantity of water to be purged prior to sampling. The portable bladder pump was decontaminated between push probe locations using the procedures described in the QAPP.

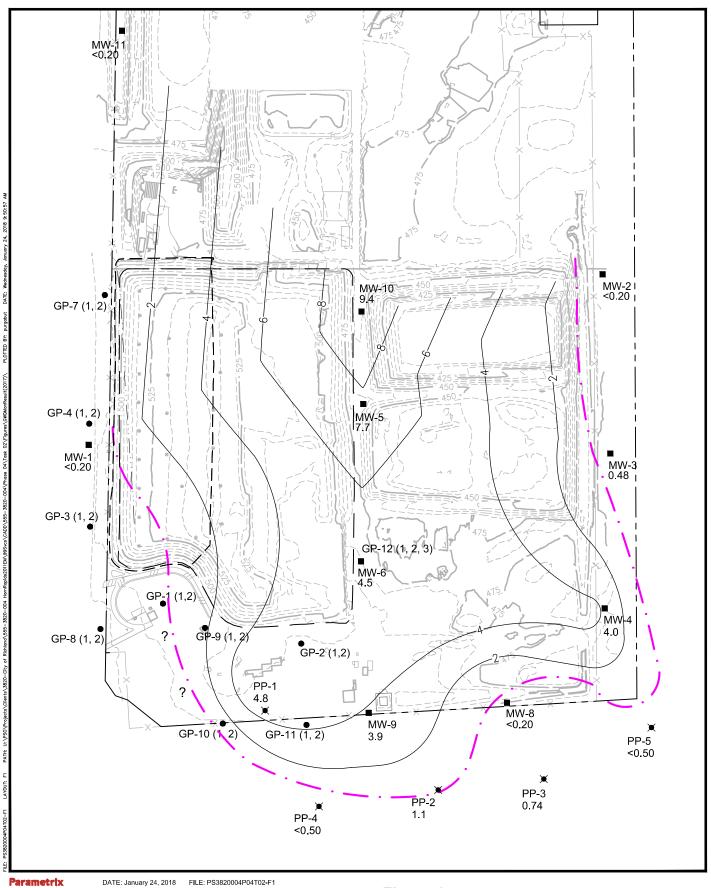
Figure 1 November 2017 Concentrations of 1,1-Dichloroethane (µg/L) in Groundwater Horn Rapids Landfill

VOC results are presented in Table D-1. Concentrations of 1,1-DCA, TCE, PCE, and VC were above the GWQS at PP-1, located in the southwestern portion of the City Facility. The concentrations observed at PP-1 were generally in the range of typical concentrations observed at MW-9 in routine and periodic groundwater monitoring performed at the Landfill over the past few years.

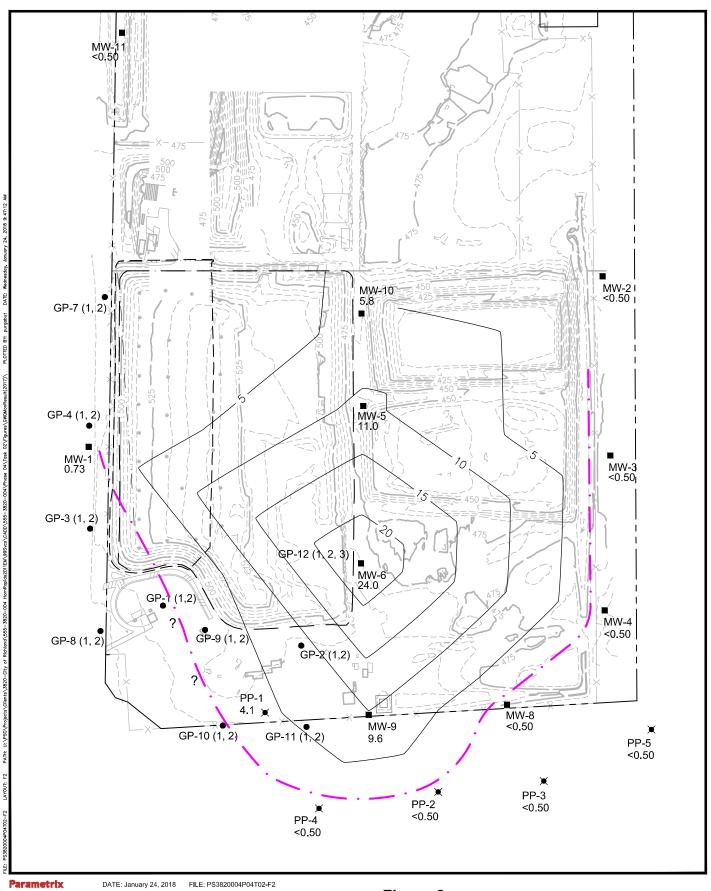
Figure 2 November 2017 Concentrations of Tetrachloroethene (µg/L) in Groundwater Horn Rapids Landfill

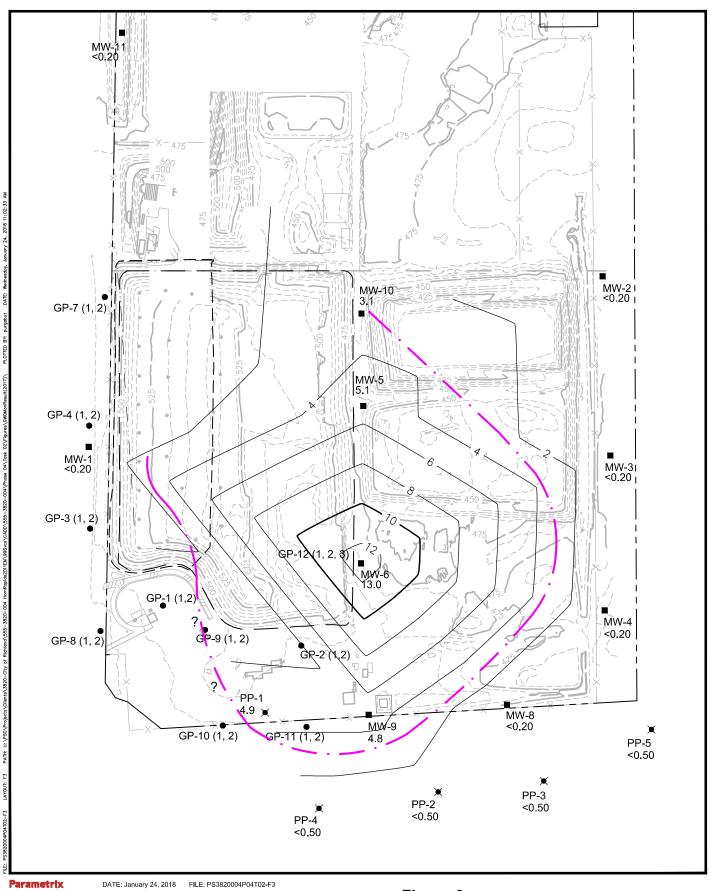
Figure 3 November 2017 Concentrations of Trichloroethene (µg/L) in Groundwater Horn Rapids Landfill

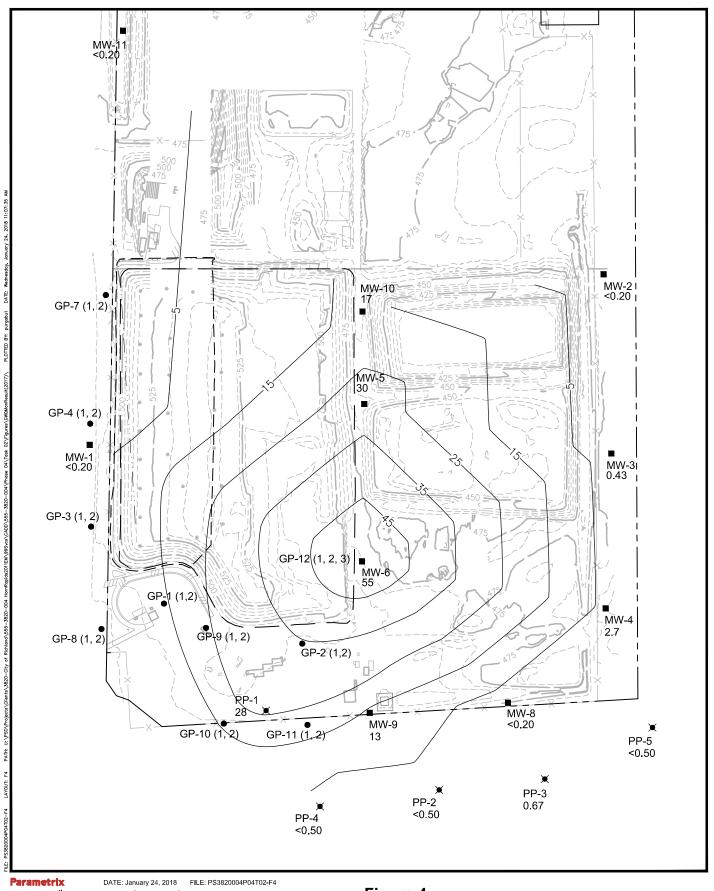
Figure 4 November 2017 Concentrations of cis-1, 2-Dichloroethene (µg/L) in Groundwater Horn Rapids Landfill

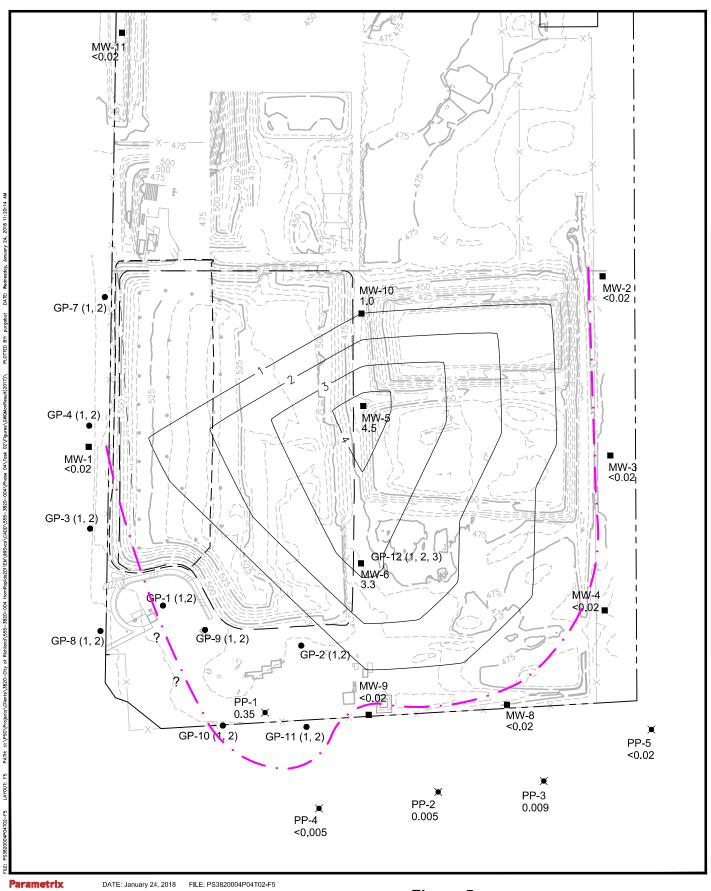
Figure 5 November 2017 Concentrations of Vinyl Chloride (µg/L) in Groundwater Horn Rapids Landfill

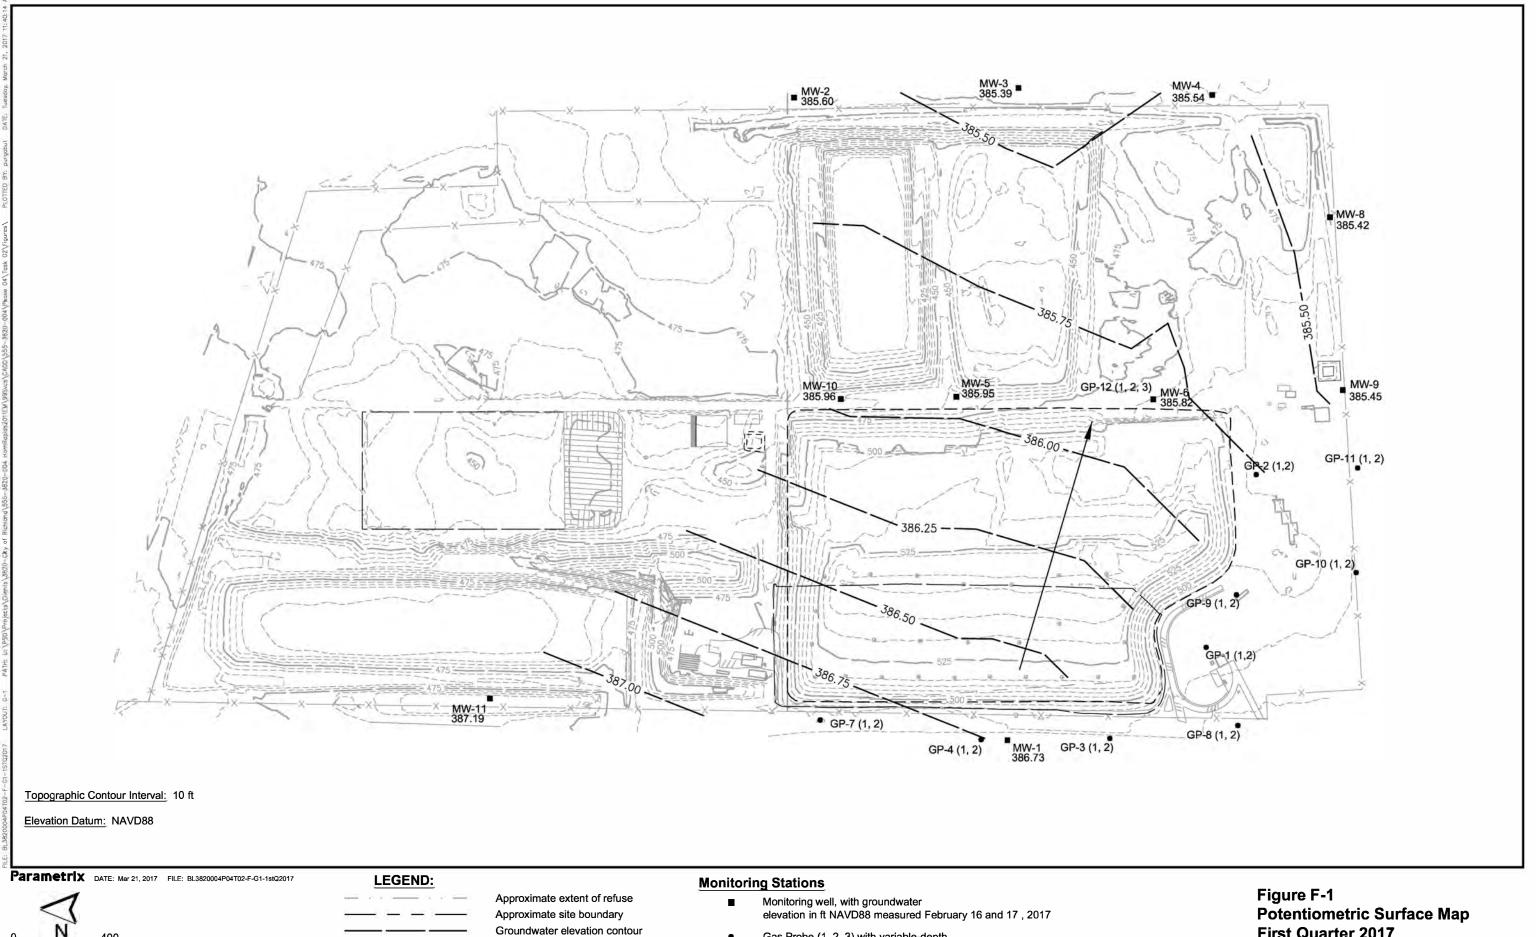
First Quarter 2017 Gas Probe (1, 2, 3) with variable-depth **Horn Rapids Landfill**

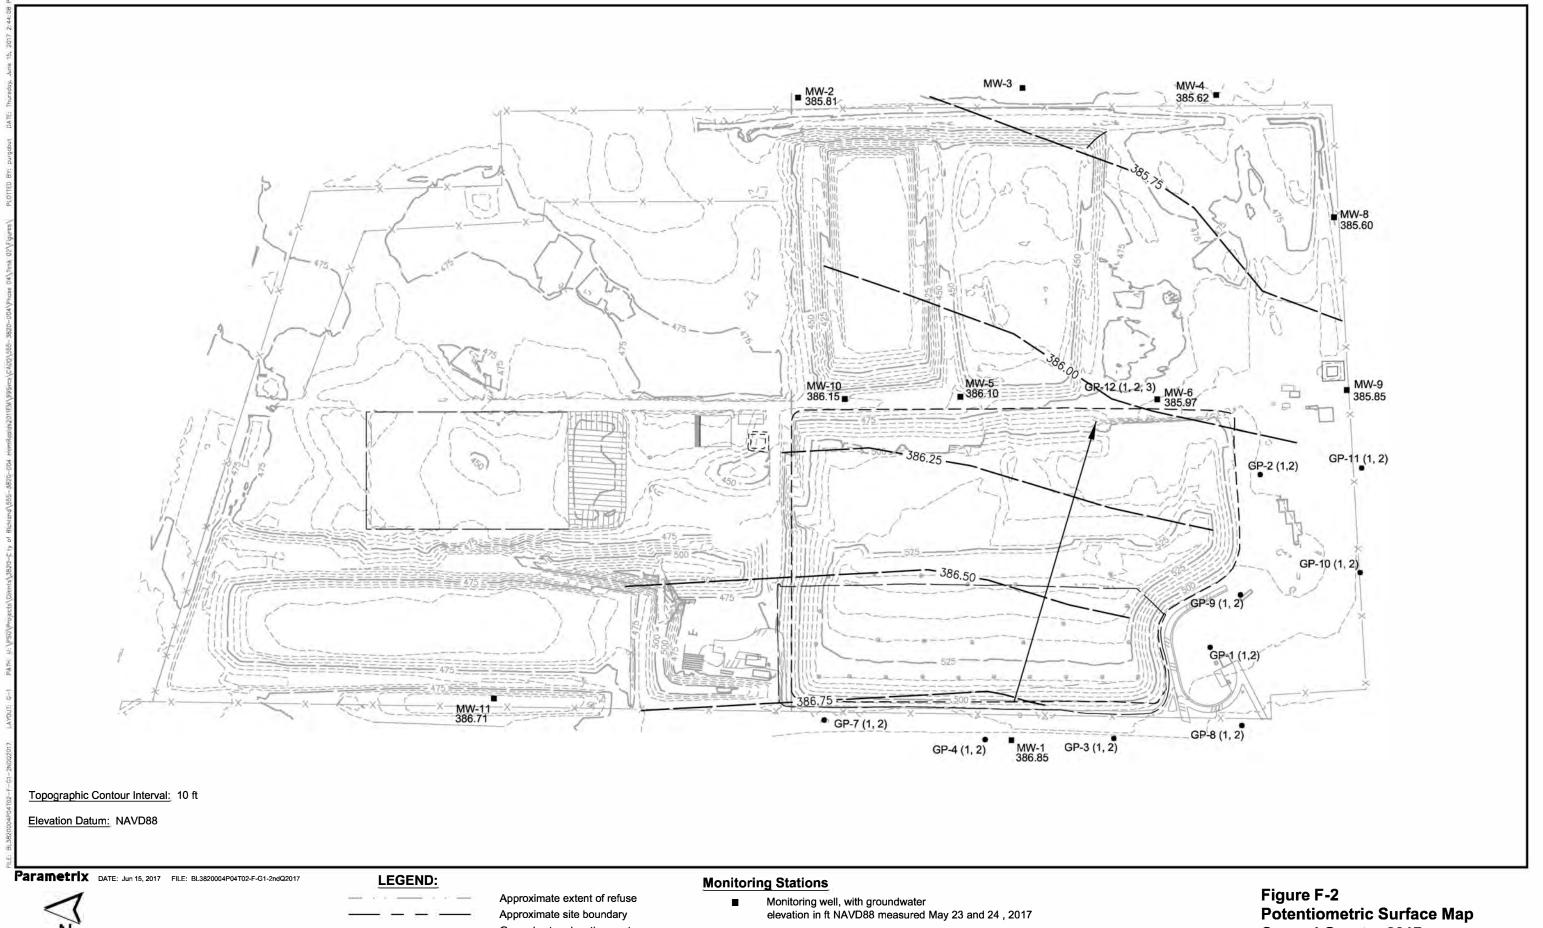
Second Quarter 2017 Horn Rapids Landfill

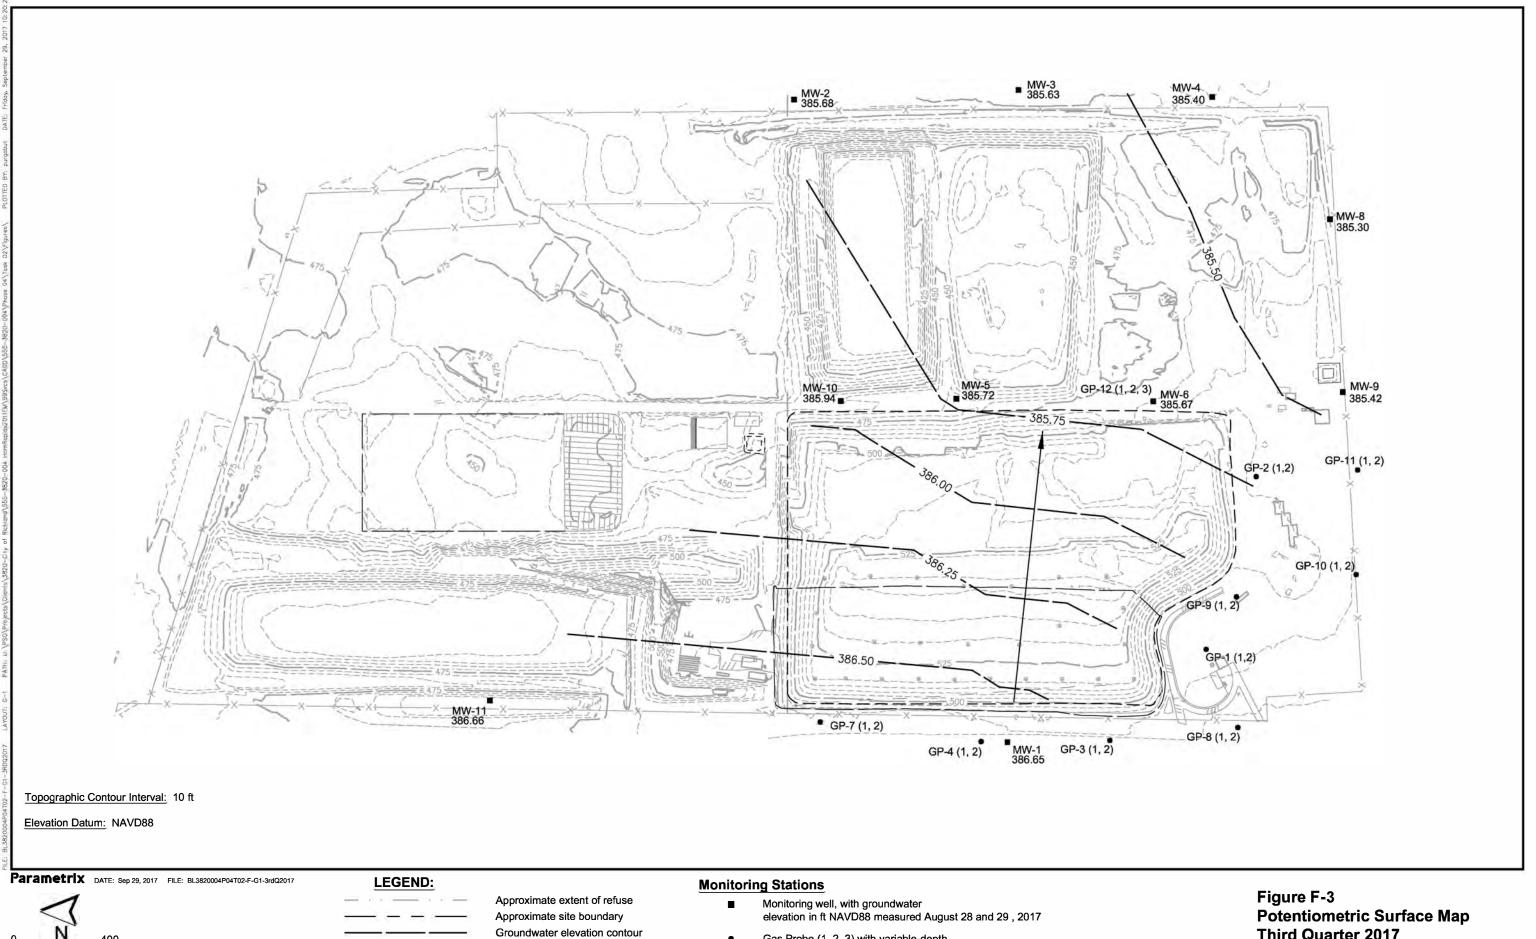
Third Quarter 2017 **Horn Rapids Landfill**
