**Re:** Resubmittal of Draft Final Remedial Investigation and Feasibility Study  
Warden City Water Supply Wells Nos. 4 and 5  
1900 Block W 1<sup>st</sup> Street, Warden, WA 98857  
Cleanup Site ID 1618; Facility/Site ID 2802409

**Re: March 2018 Draft Remedial Investigation and Feasibility Report  
Simplot Grower Solution, 1800 W. 1<sup>st</sup> Street, Warden, WA 98857**

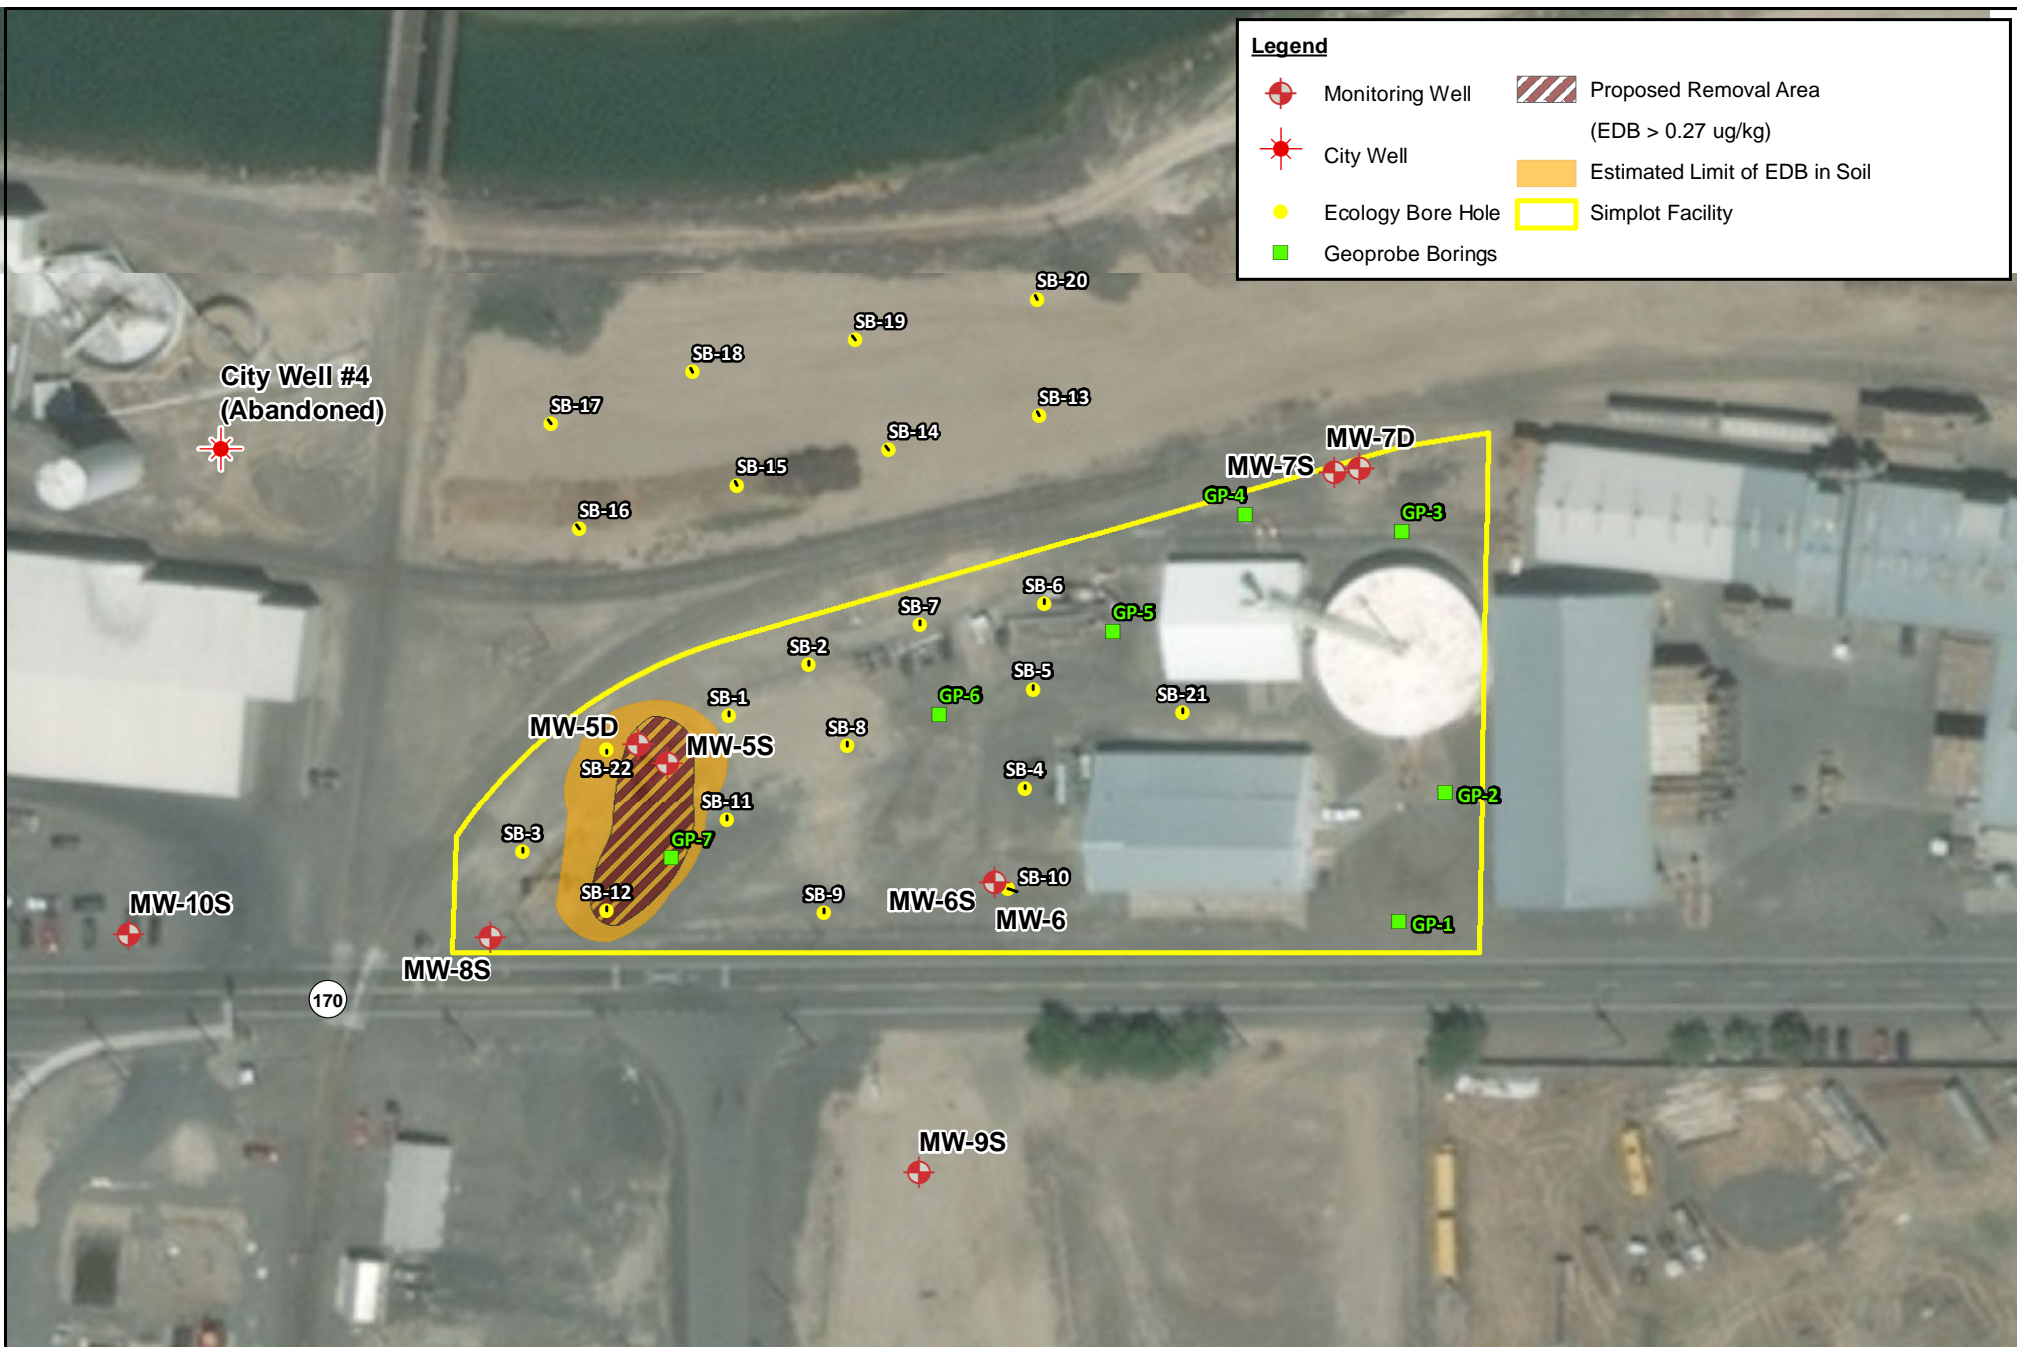
**Figure 17. Estimated Limit of EDB in Soil**  
**Simplot Grower Solutions,**  
**1800 W 1st St., Warden, WA 98857**
