# **INTERIM ACTION COMPLETION REPORT**

## **Eldridge Municipal Landfill Project**

*Prepared for*  
**City of Bellingham, Public Works**  
210 Lottie Street  
Bellingham, WA 98225

December 15, 2011

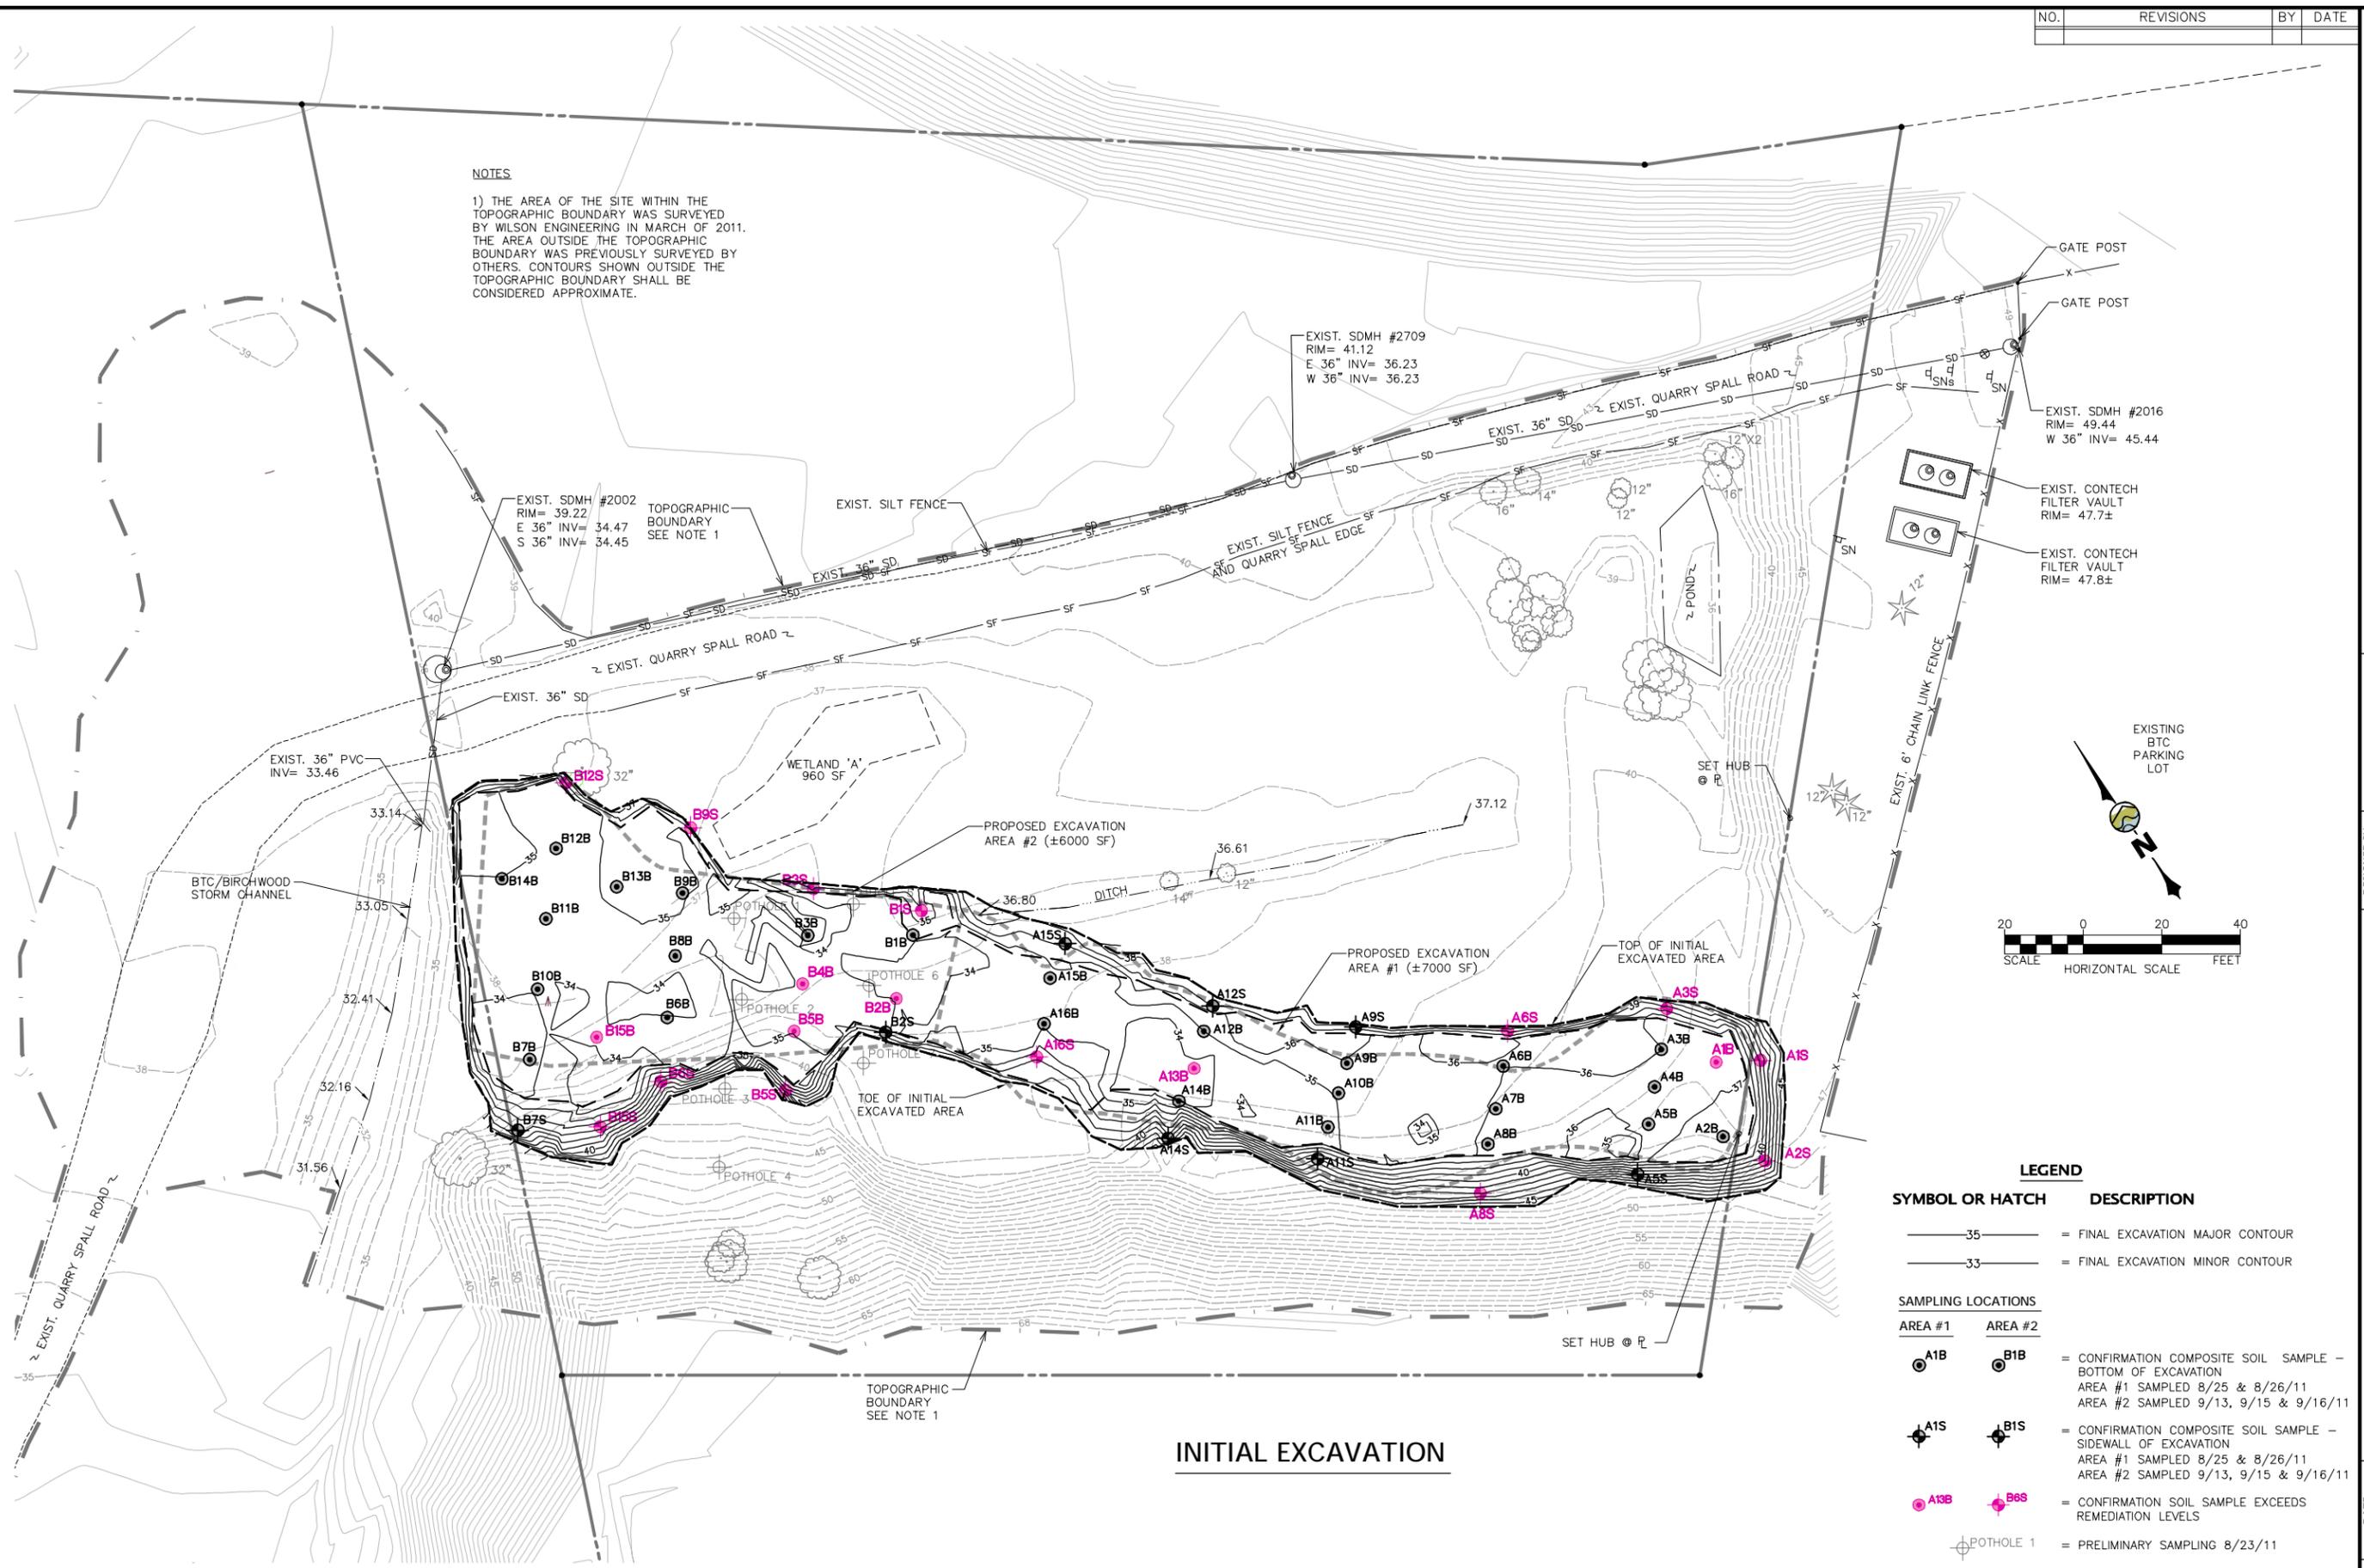
**INITIAL EXCAVATION**

On August 25 and 26, performance monitoring samples were collected from 27 locations (bottom and sidewall) within the initial excavation of Area 1 (Figure 2). All samples were

In consultation with Ecology, 7 sidewall and two bottom sample locations were above the RL for one or more metals requiring additional removal of soils at these locations (Table 3 and Figure 2). For three of the sidewall samples (A1S, A2S, A8S), additional removal was not possible either due to steep, unstable slopes or encroachment onto BTC property.

On August 31, approximately 5-10 ft of additional sidewall was excavated from stations A3S, A6S, and A16S. An additional 1 ft of soil was excavated from the bottom of stations A1B and A13B. The additional soil was excavated midway (delineated by tape measure) between the failing sample location and adjacent clean sample locations as described in the Monitoring Plan.

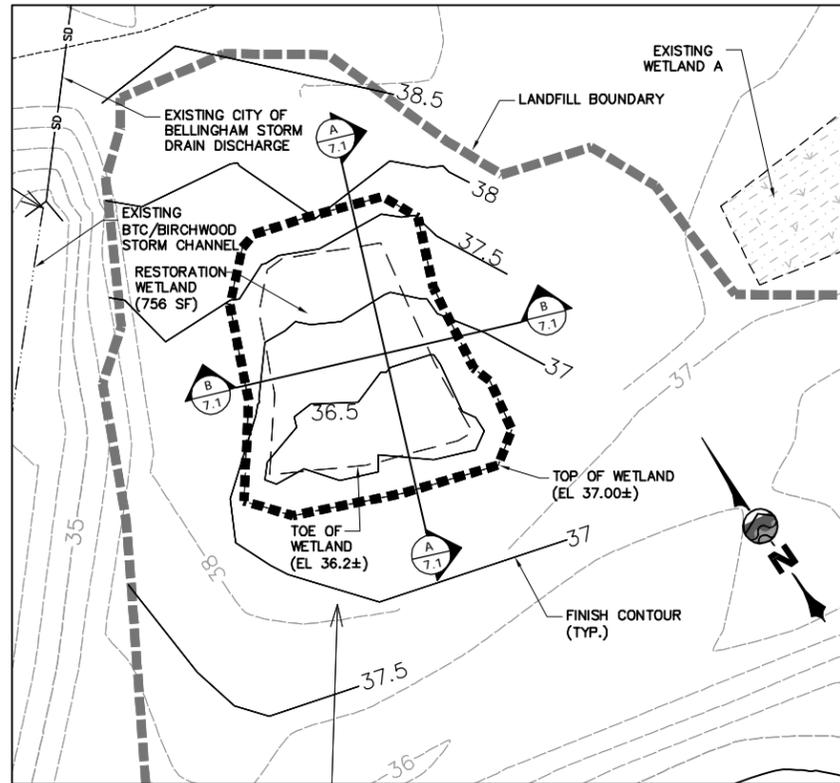
**RESTORATION WETLAND PLAN**

From October 3-6, an approximate 750 ft<sup>2</sup> wetland was created in accordance with the Wetland Restoration Plan (Herrenkohl Consulting and Wilson Engineering 2011) (Figures 4 and 5). The wetland creation site was prepared by excavating an area previously backfilled, followed by placement of a 6-inch low permeability layer, and then covered with 9-inches of topsoil. Approximately 33 tons of low permeability soil, provided by Ferndale Ready Mix, was compacted using the excavator bucket. Shelterbelt Inc. installed the wetland plants and placed a 3- to 6-inch mulch layer over the entire creation area.

- Subsurface and Liner Criteria:** The wetland should be excavated approximately 15 inches below the finished grade and a 6-inch layer of low permeability soil containing silts and clays should be placed as a relatively restrictive layer. The layer should have a minimum 30% silt and clay content to reduce infiltration and prevent drainage of the wetland. A 9-inch layer of silt loam or loamy silt should be installed on top of the clay liner as a base for plant growth. This soil should be a hydric soil.

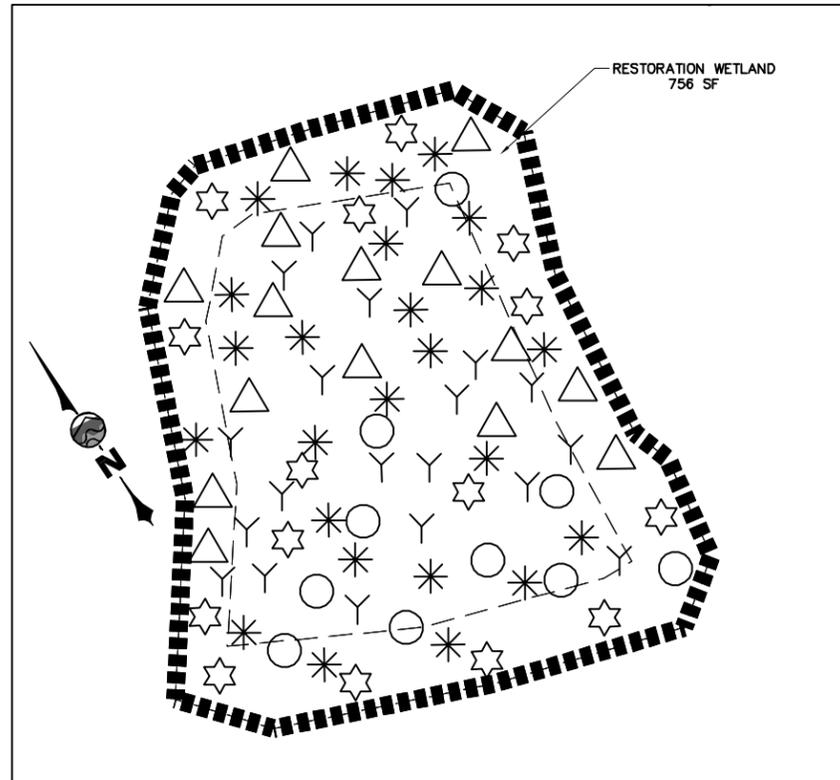
**RESTORATION WETLAND SCHEMATIC PLANTING PLAN**

Shelterbelt installed a total of 40 shrubs and 45 herbaceous plants (refer to Figure 5). Plants were installed according to the approved restoration plan, with the exception of the Pacific dogwood (*Cornuss Nuttallii*), which was replaced with cascara (*Frangula purshiana*) due to plant availability at the local nurseries. Blue tube plant protectors were installed around each plant to protect the plants from excessive grazing.

- Planting Locations:** Using the planting plan as a reference, plants should be located in areas best suited to promote growth and produce a natural and attractive habitat area. Plants should be laid out in clusters and islands that mimic natural plant distribution. Specific attention should be paid to hydrologic, soil, and shade conditions that can contribute to the success of the plantings. The planting plan locations may vary based on actual site conditions, but the total number of plants installed and the area enhanced should not be below the suggested numbers.

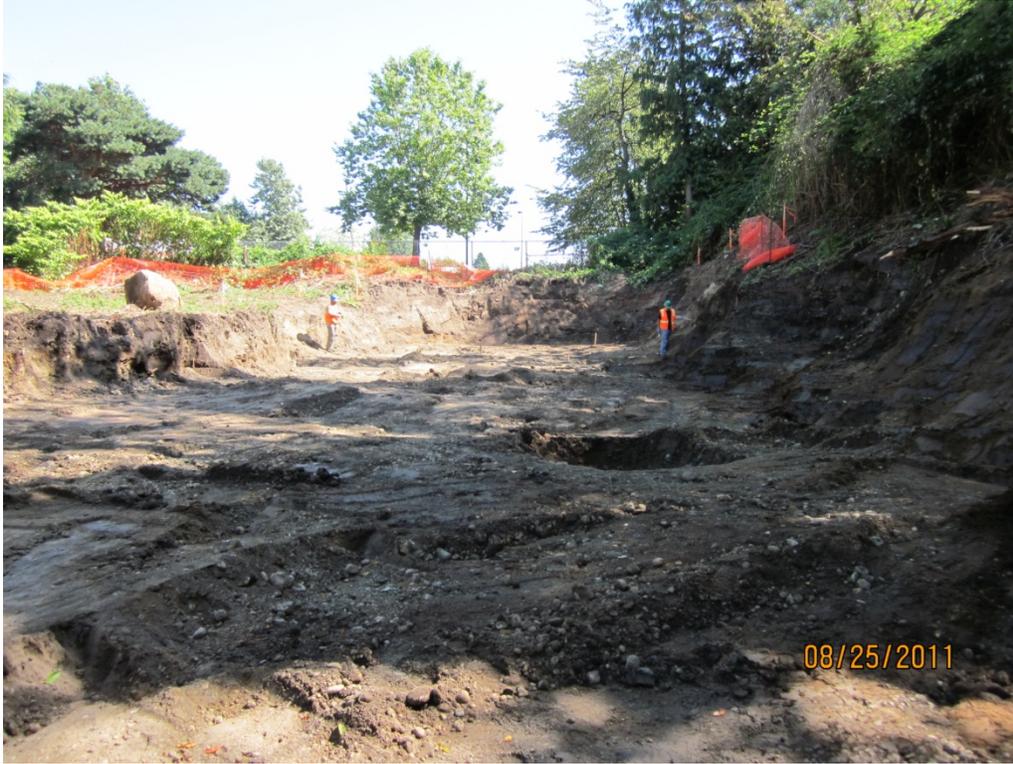
Photo 5. Confirmation sampling in Area 1.

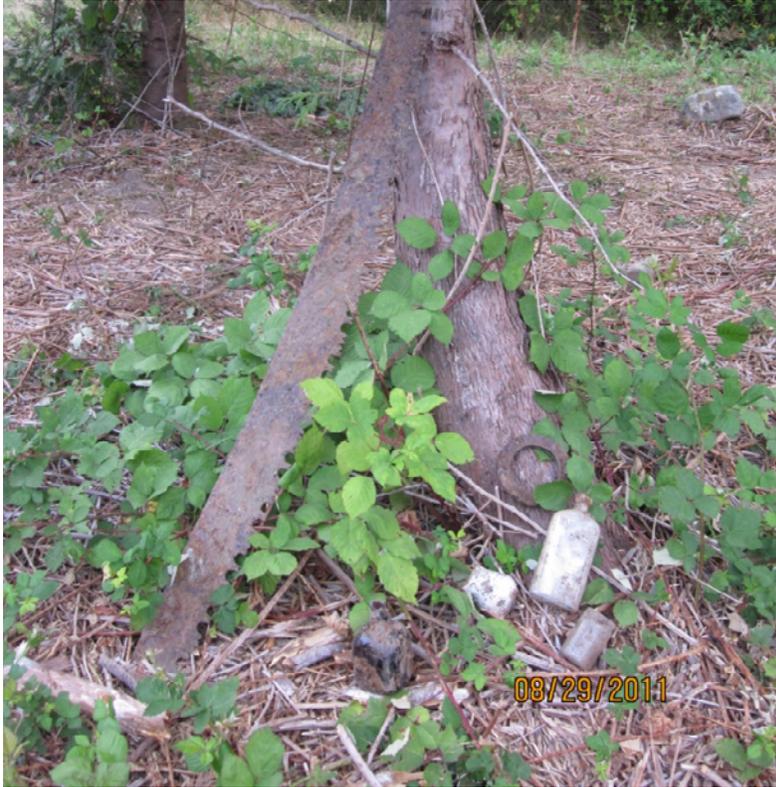
Photo 7. Landfill debris including long-saw blade, bottles, metal/rubber gasket, and misc. metal.

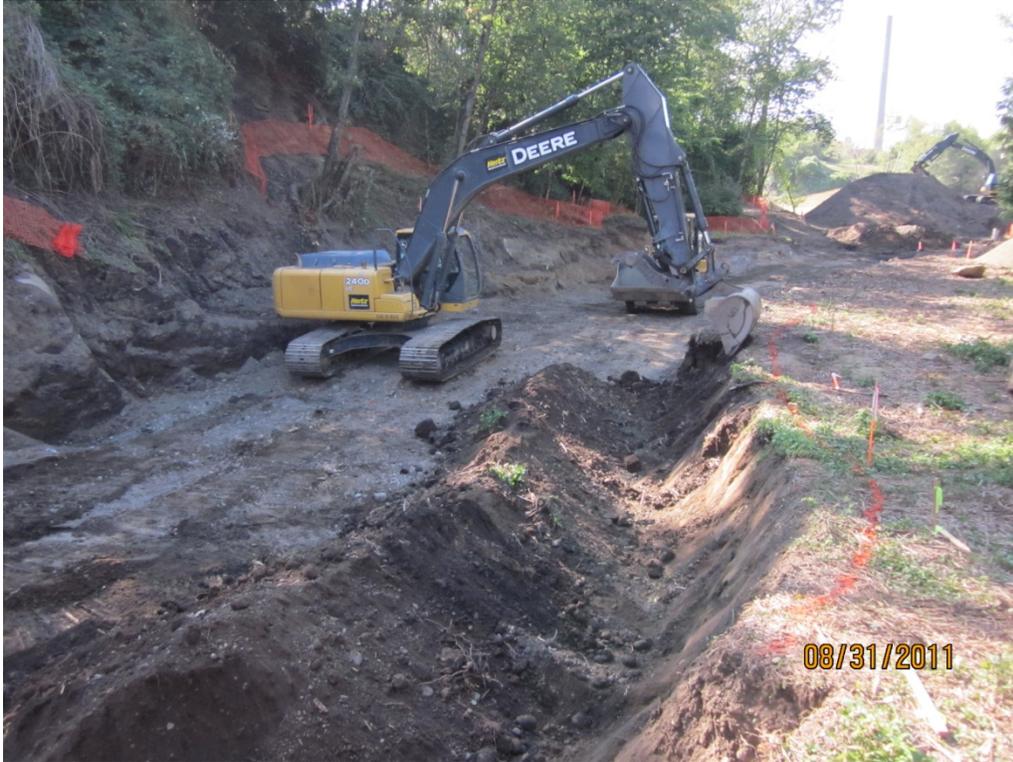
Photo 11. Additional sidewall excavation in Area 1 (delineated by orange paint).

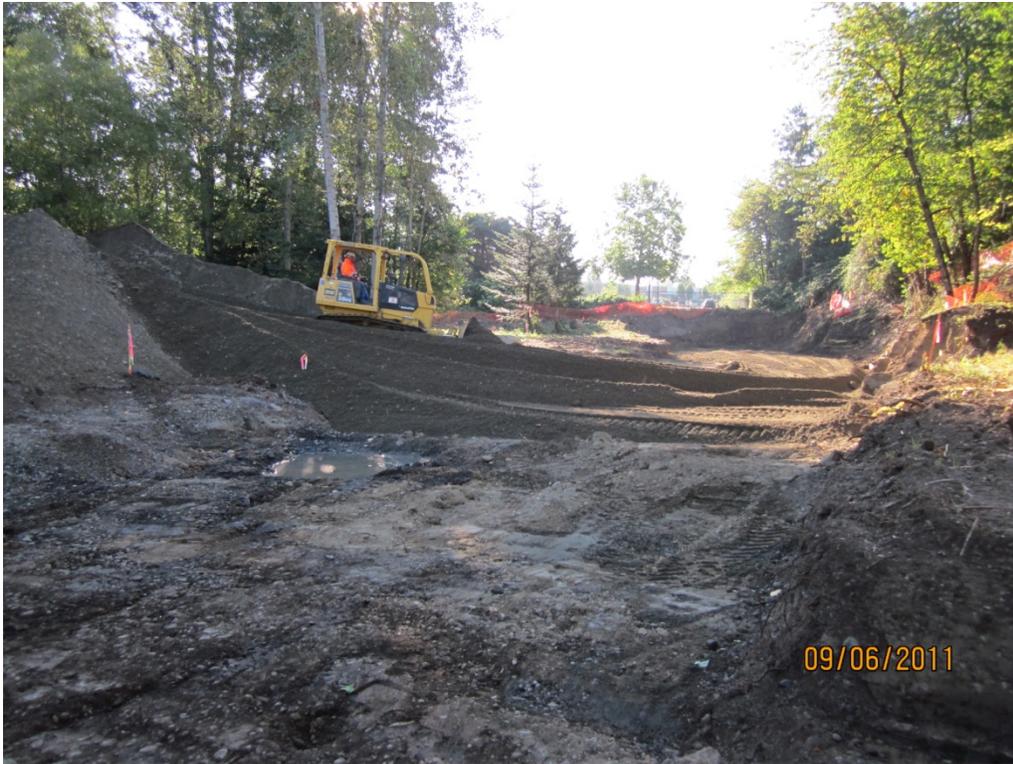
Photo 13. Filling excavation Area 1 with clean sand and gravel.

After confirmation sampling was completed, the excavation was backfilled with about 4,310 tons of clean sand with gravel. The fill material originated from the Polaris borrow pit (pit run south wall) operated by Ferndale Ready Mix and located in Whatcom County. Fill was initially stockpiled onsite and then spread over the Site in 1-2 ft lifts with a bulldozer and compacted using a roller as required by the project specifications.

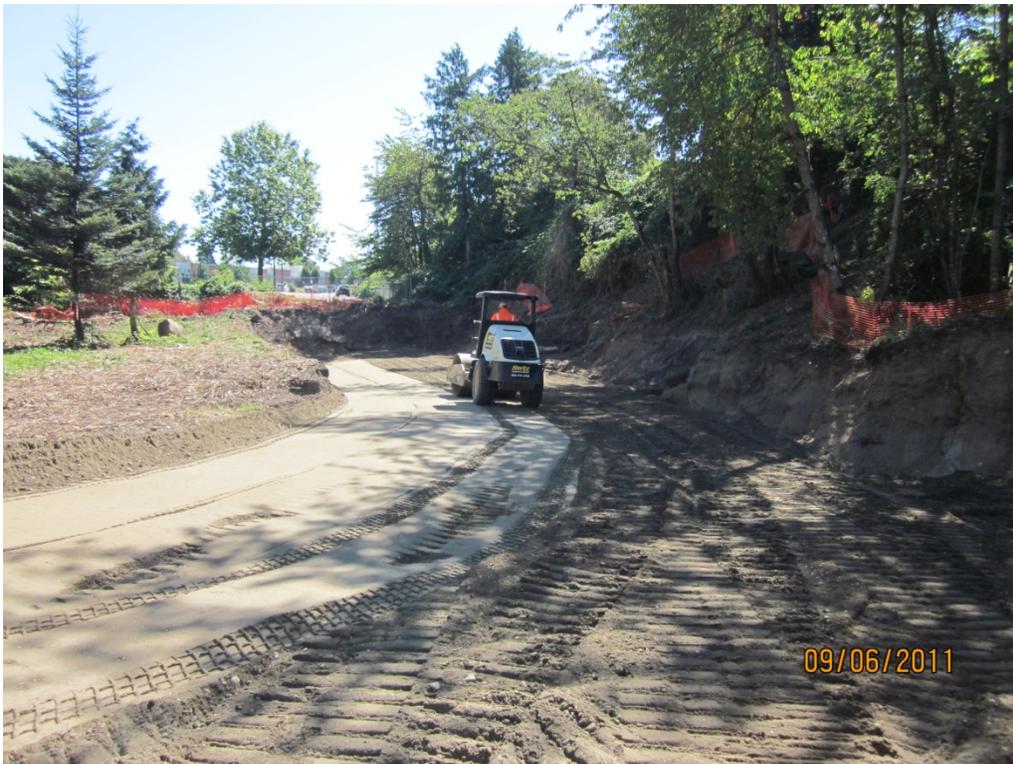
Photo 14. Compacting/rolling fill in Area 1.

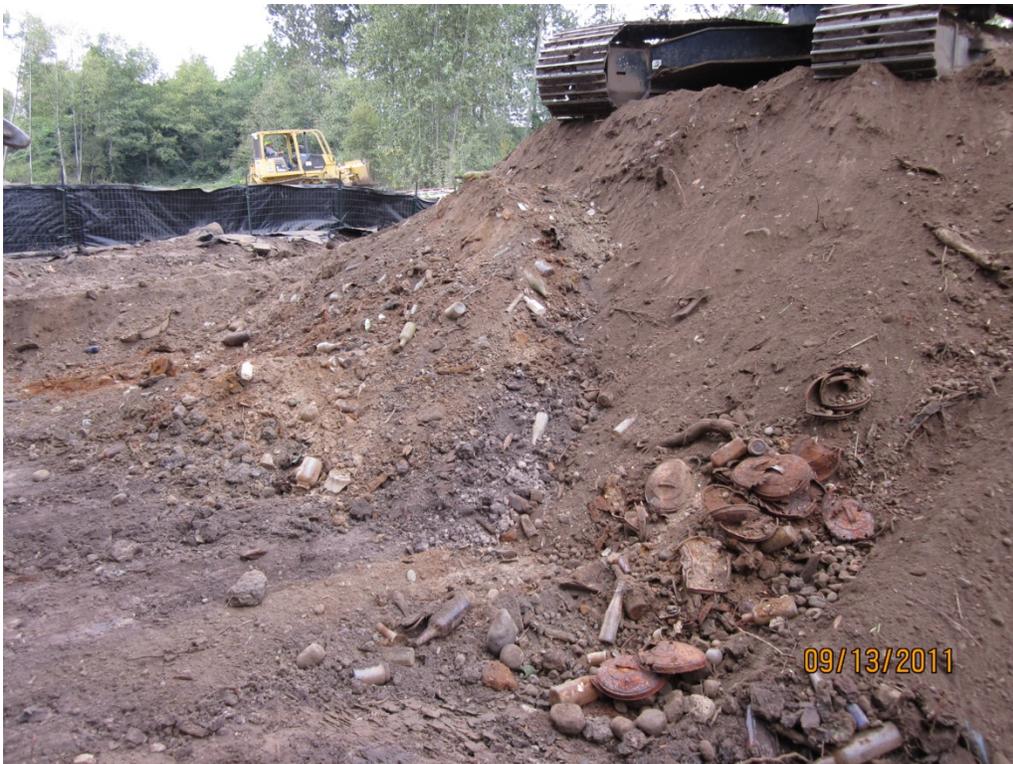
Photo 16. Landfill debris field in Area 2.

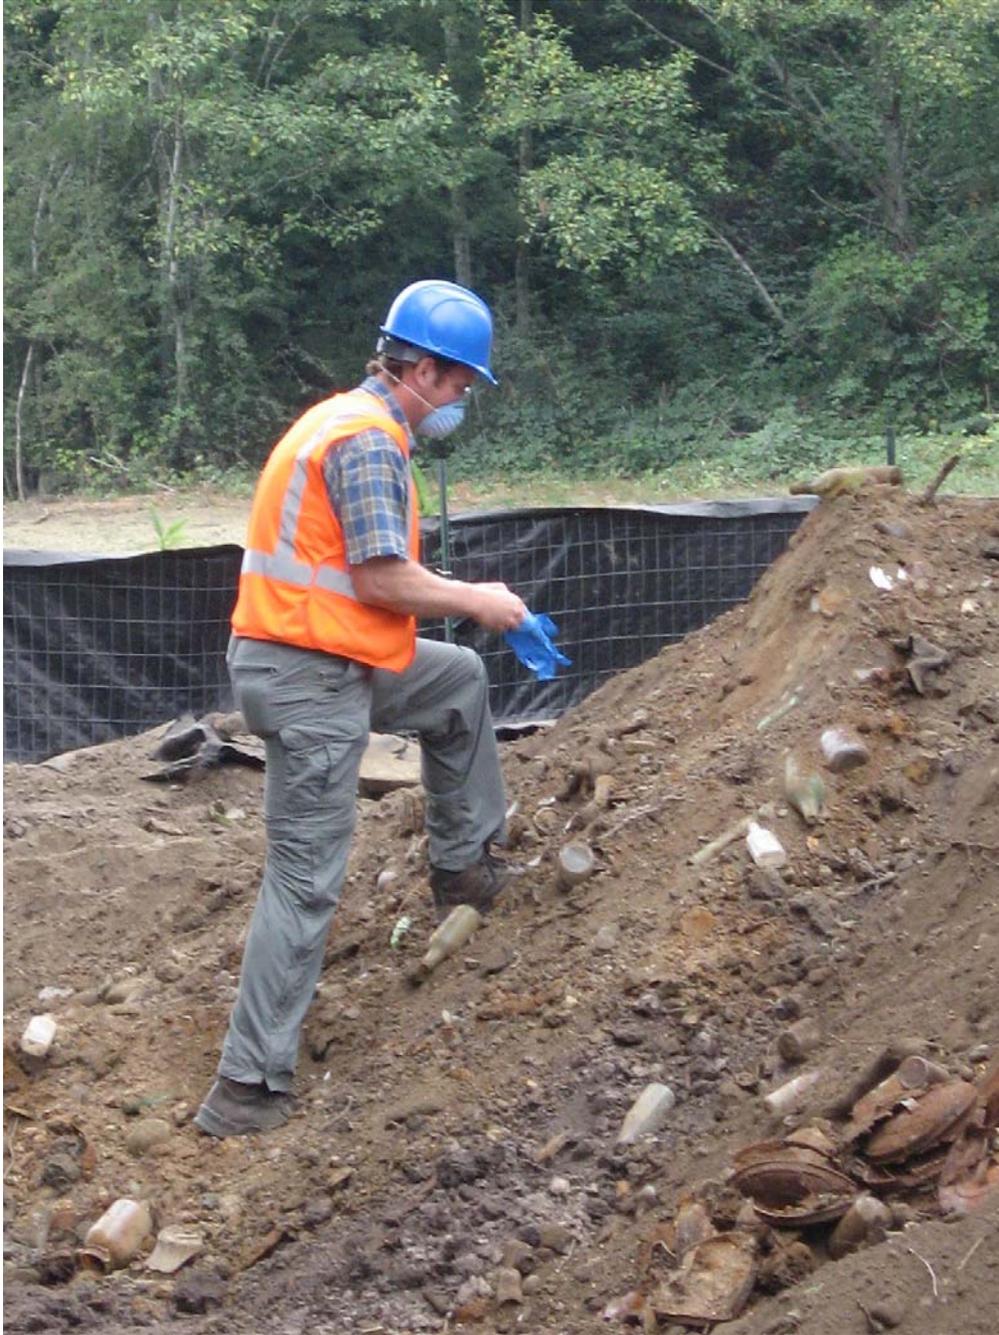
Photo 17. Sampling and field observations in Area 2 Landfill debris field.

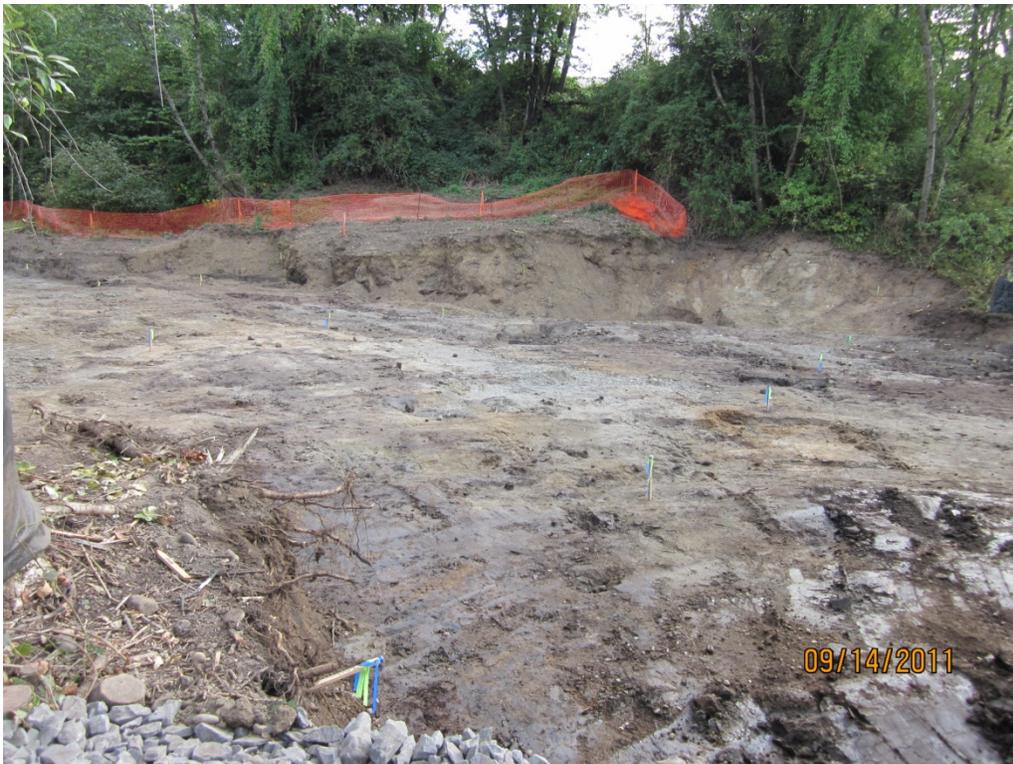
Photo 19. Confirmation sample locations in Area 2.

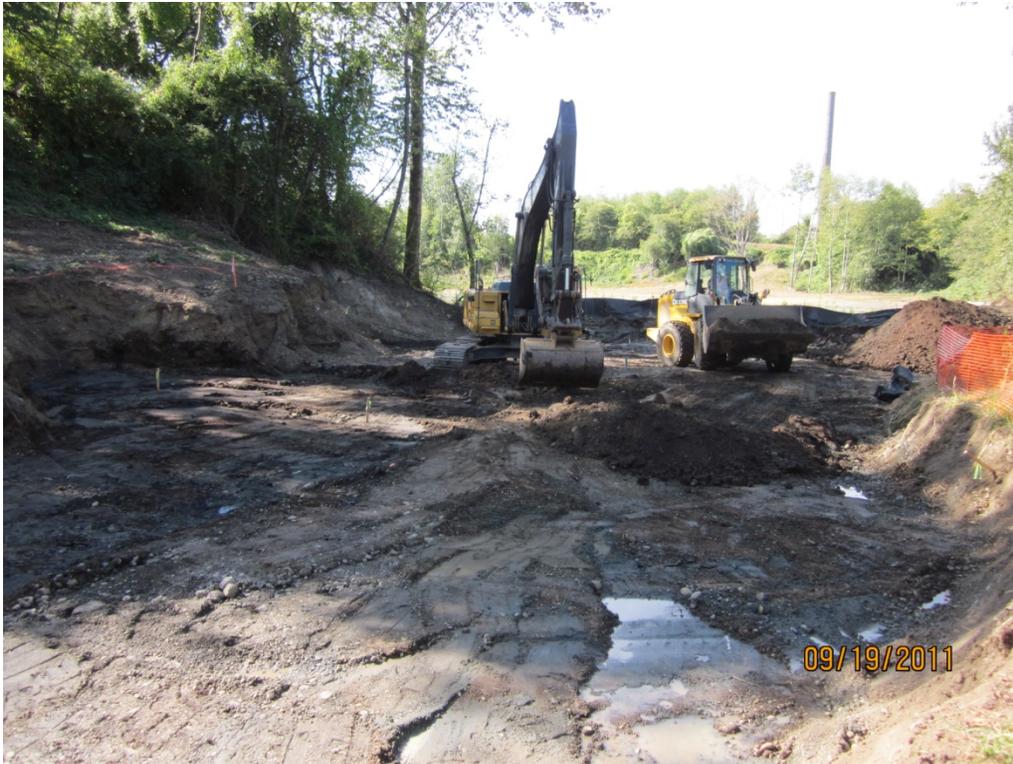
Photo 20. Additional removal required in Area 2.

On September 19-20, approximately 5 ft to 10 ft of additional sidewall was excavated from stations B1S, B2S, B5S, B6S, and B15S. An additional 0.5 ft to 1 ft of soil was excavated from bottom stations B2B, B4B, B5B, and B15B. The additional soil was excavated midway (delineated by tape measure) between the failing sample location and adjacent clean sample locations.

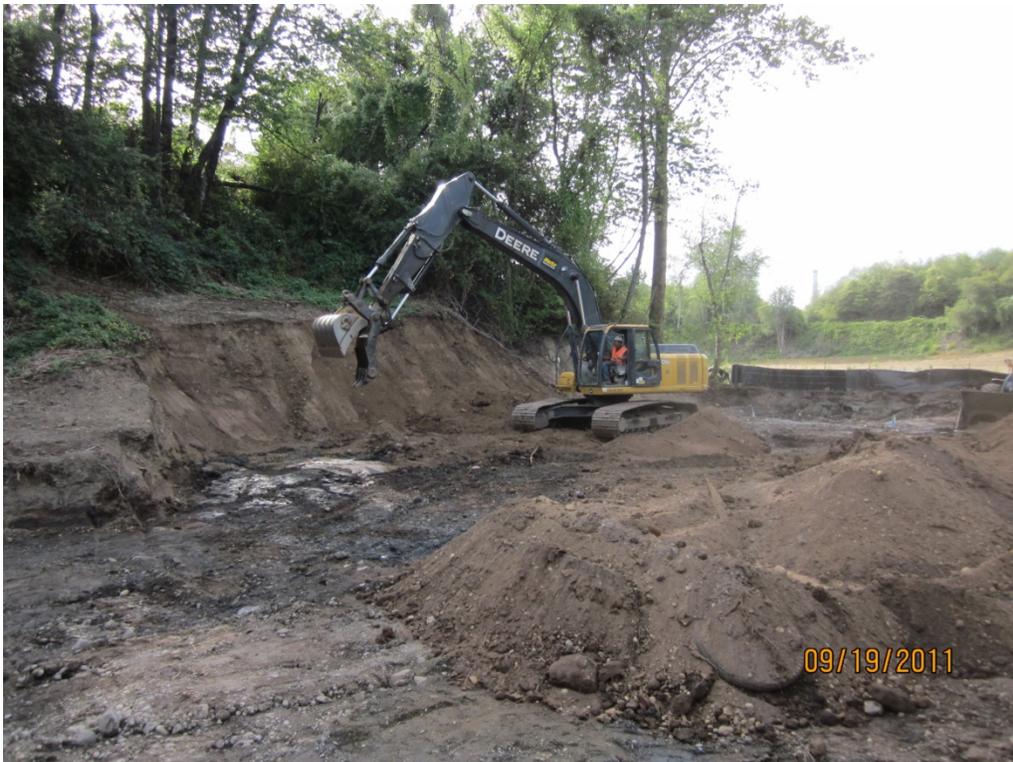
Photo 21. Additional removal of sidewall in Area 2.

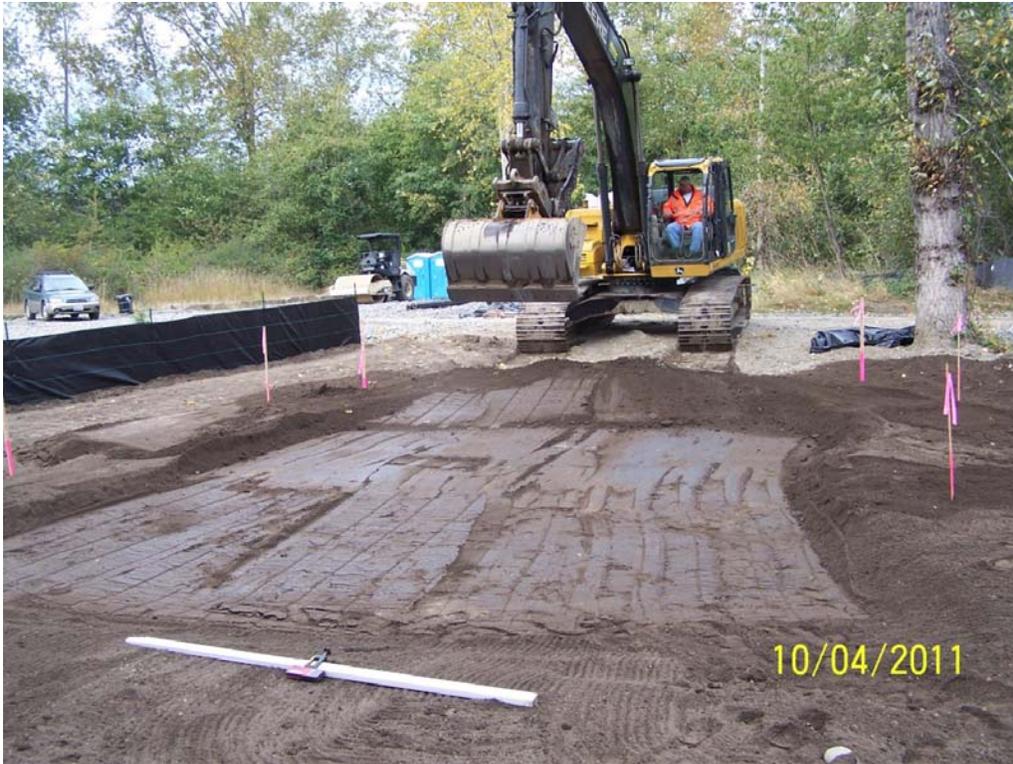
Photo 22. Grading and compacting low-permeable soil for wetland creation.

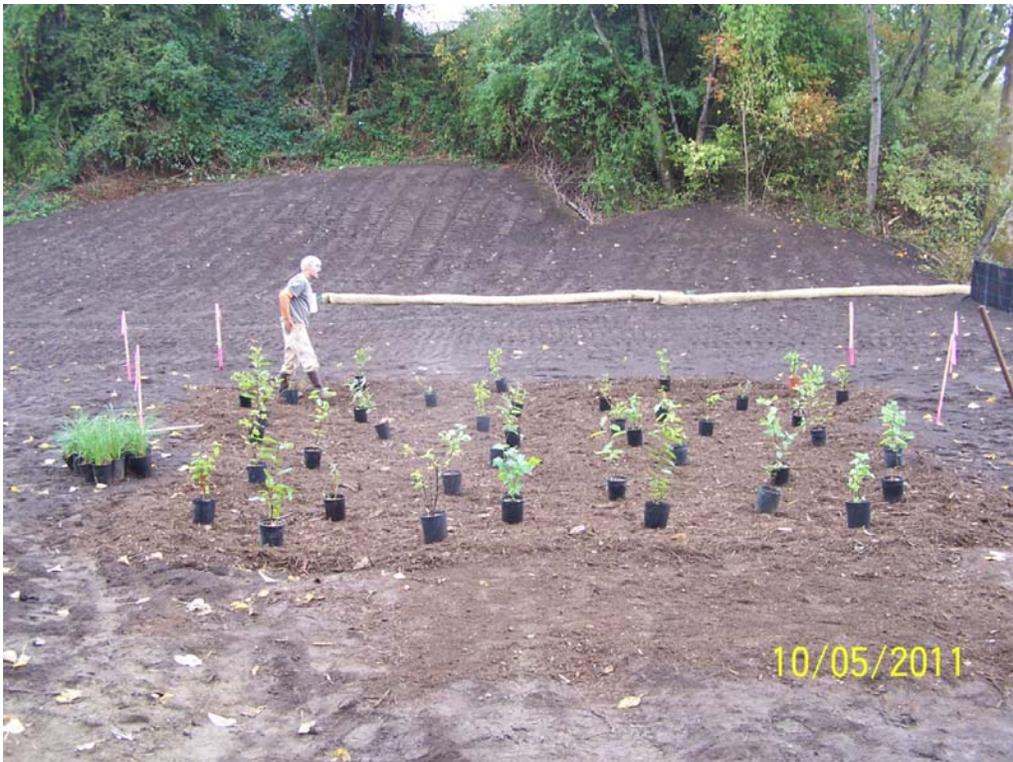
Photo 23. Shelterbelt Inc. arranging wetland plants and mulch for wetland creation.

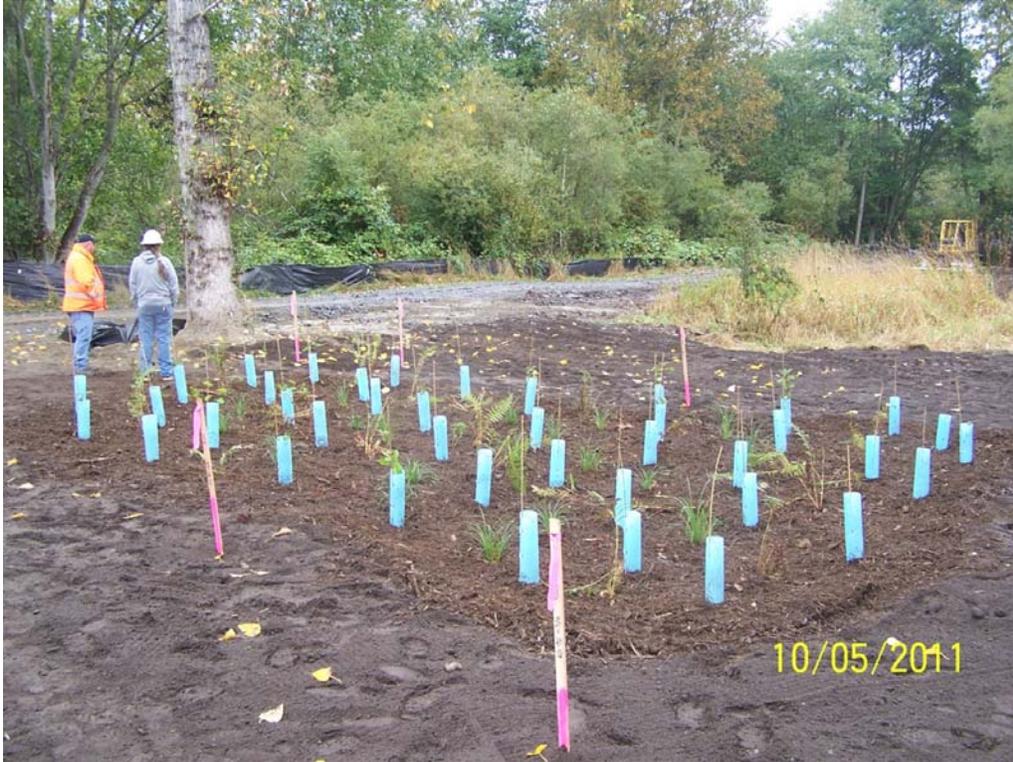
Photo 24. Wetland planting completed.

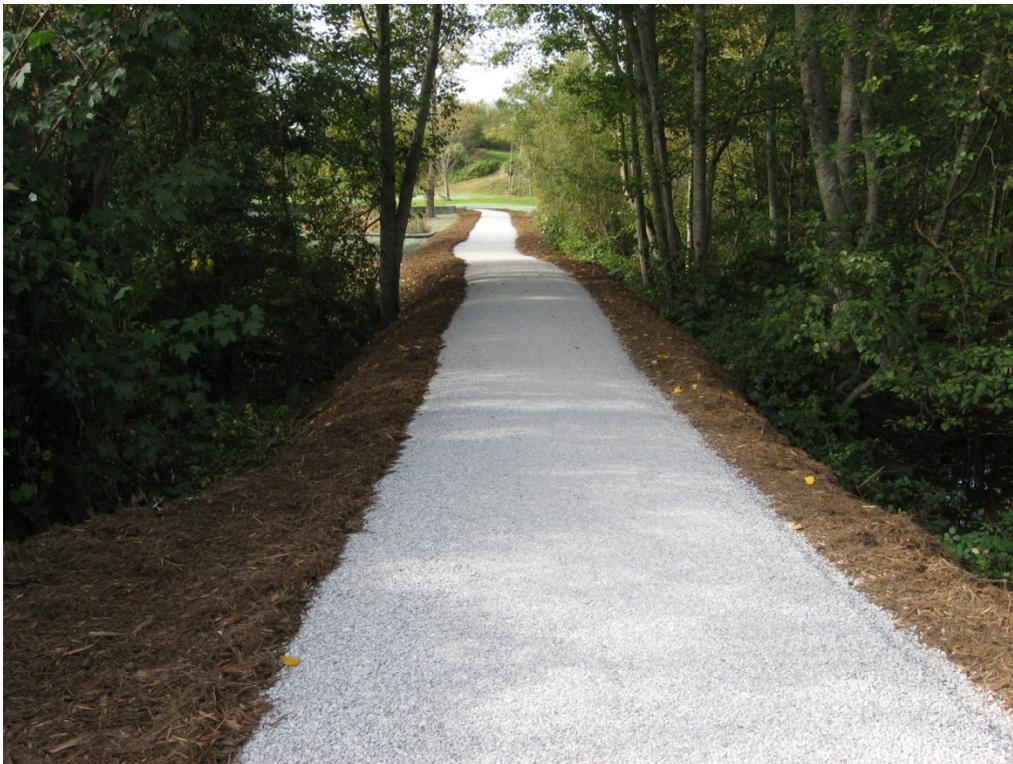
Photo 25. Finished trail entering Little Squalicum Park from Bellingham Technical College.

The quarry-spall access road was left in-place for possible future access to the Eldridge Site. However, a walking trail was constructed over the quarry spalls for public use. A woven geotextile was applied ovetop the quarry spalls before adding a 6-inch layer of crushed surfacing base course and a final 3-inch layer of crushed limestone. Coarse mulch was placed along the edges of the trail to cover any remaining quarry spalls.
