THIRD FIVE-YEAR REVIEW REPORT

Bainbridge Island Landfill

Prepared for: City of Bainbridge Island

Project No. 120097-003 • May 1, 2018

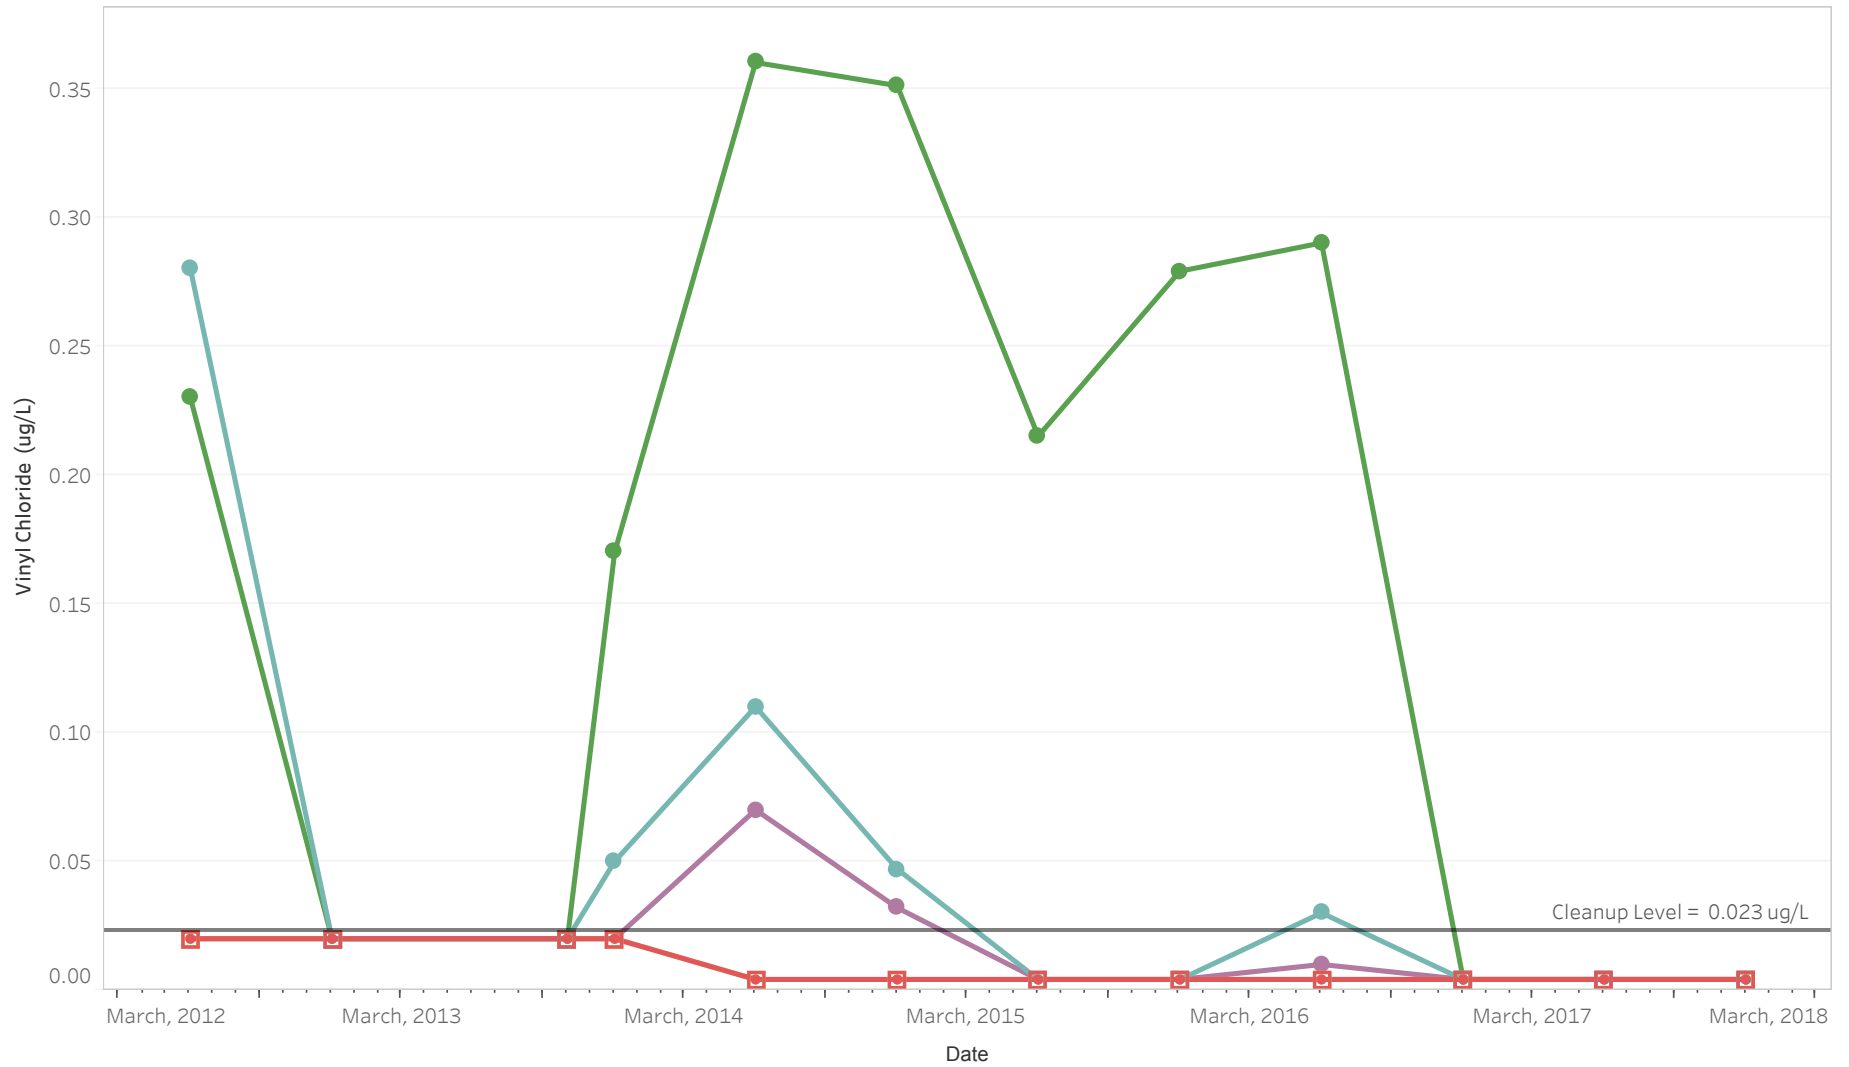
Figure 3-1: Vinyl Chloride Concentrations in Groundwater 2012-2017

Vinyl chloride concentrations in groundwater at MW-13 and BOW-37 continued decreasing during the reporting period, compared with previously observed concentrations (CH2M 2006; CH2M 2011). When vinyl chloride was detected at MW-14 during the reporting period, concentrations were similar to those observed from mid-2009

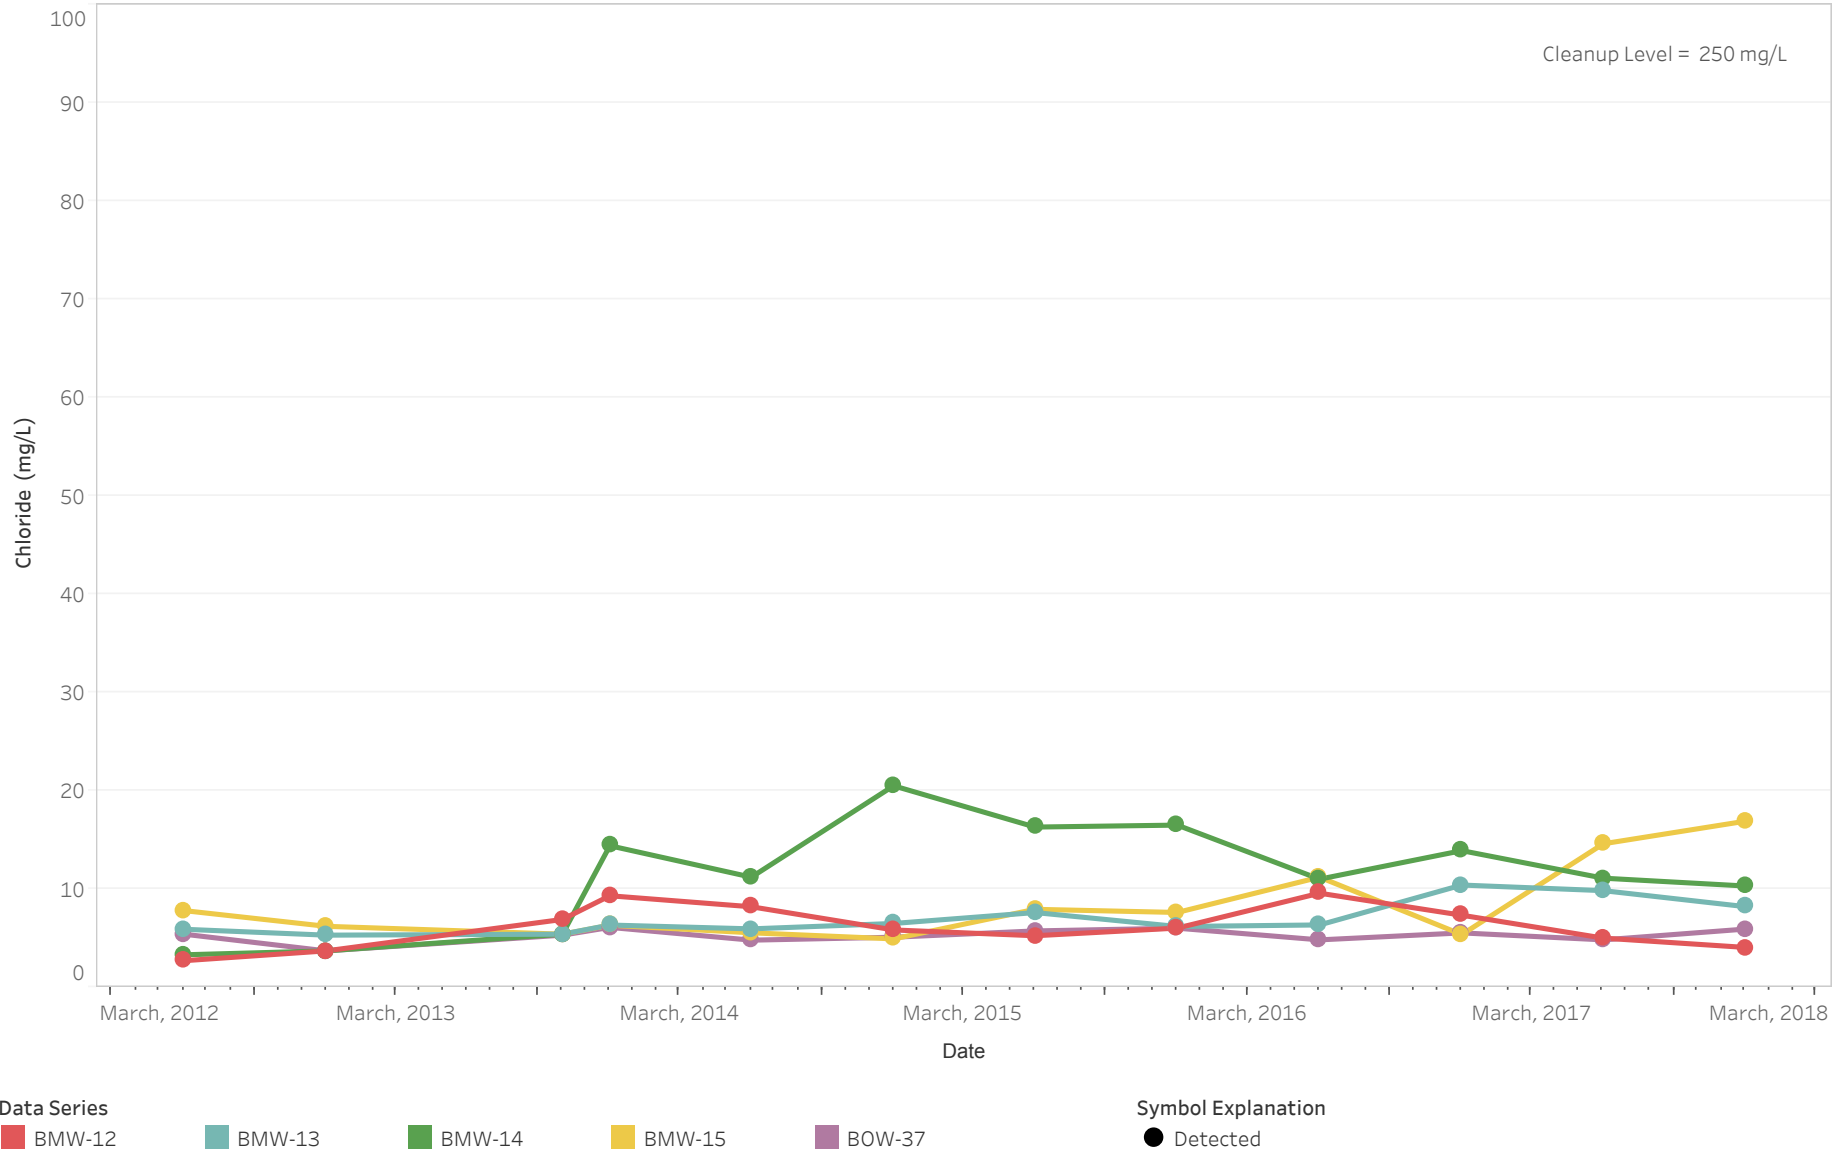
Figure 3-2: Chloride Concentrations in Groundwater 2012-2017

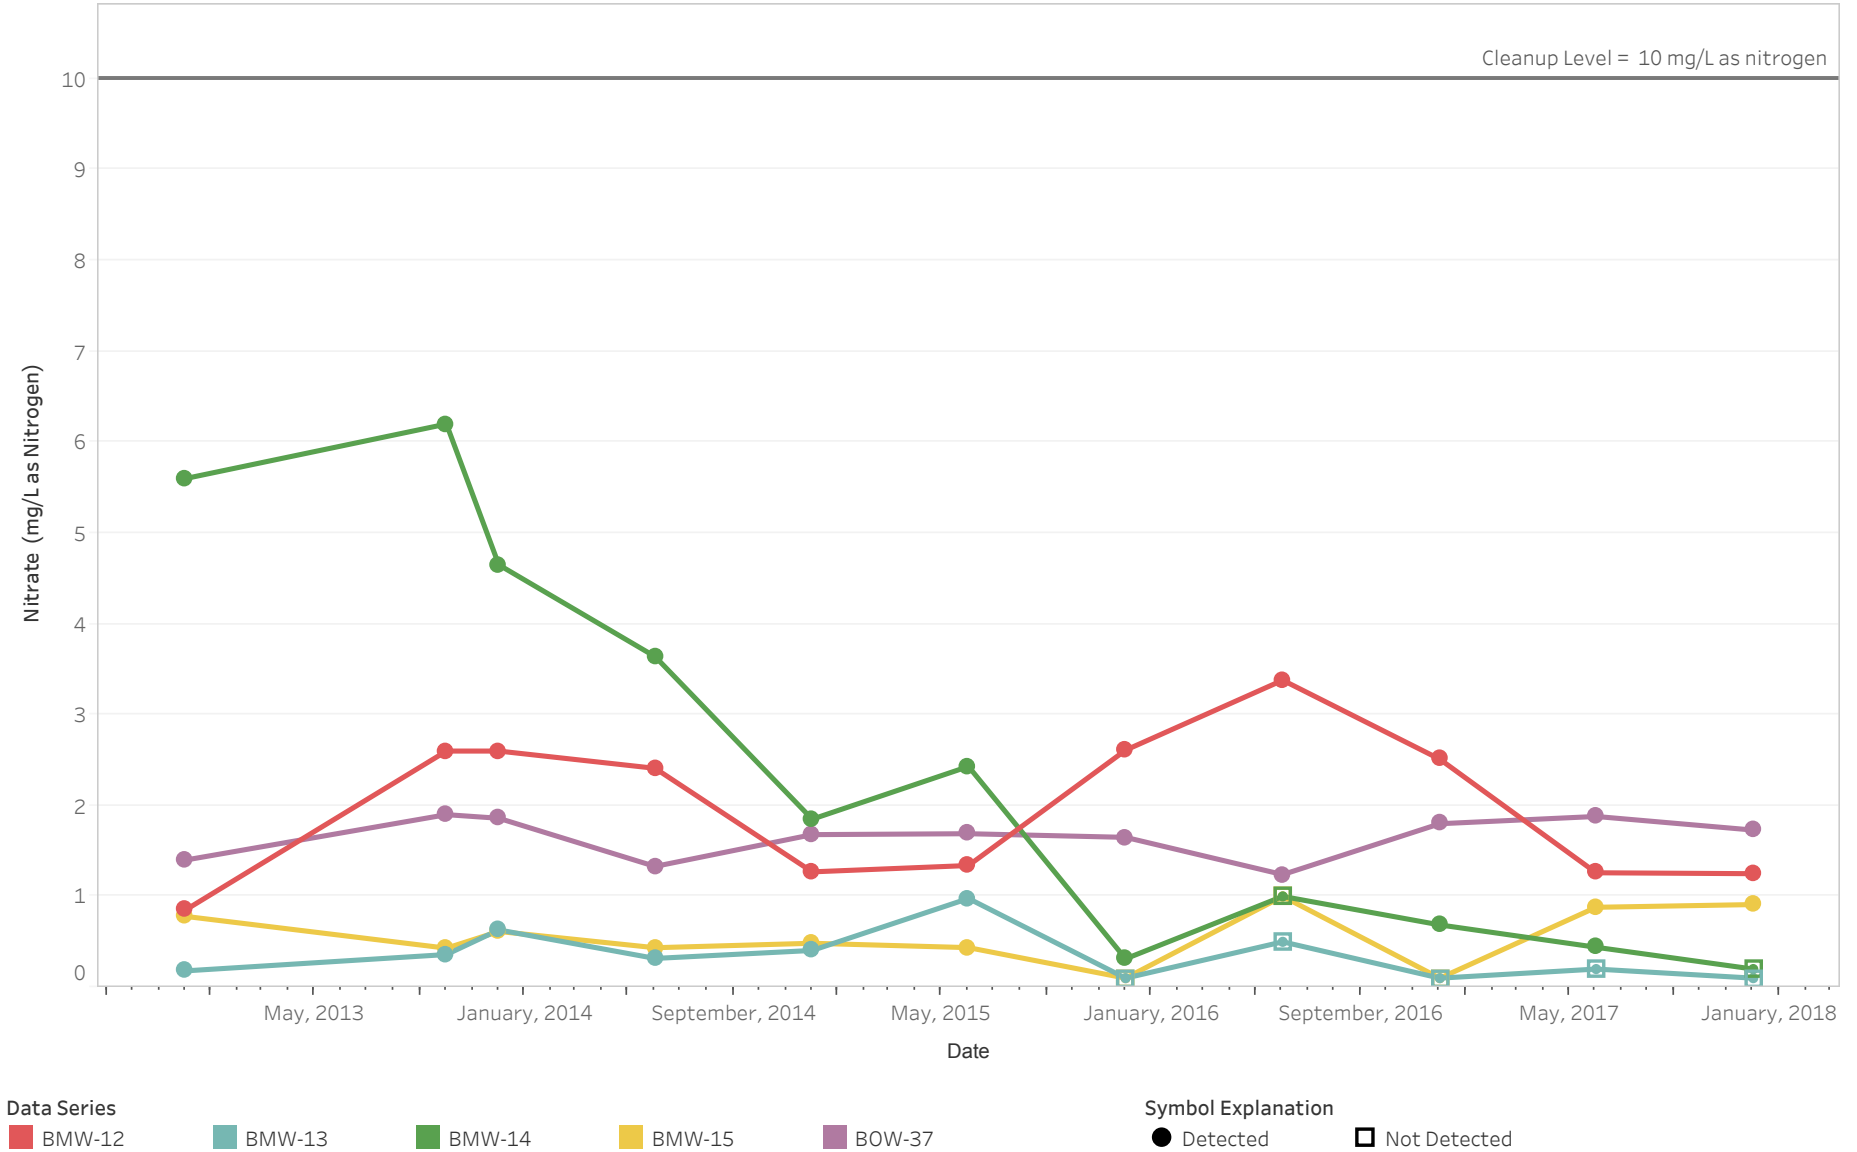
Figure 3-3: Nitrate Concentrations in Groundwater 2012-2017

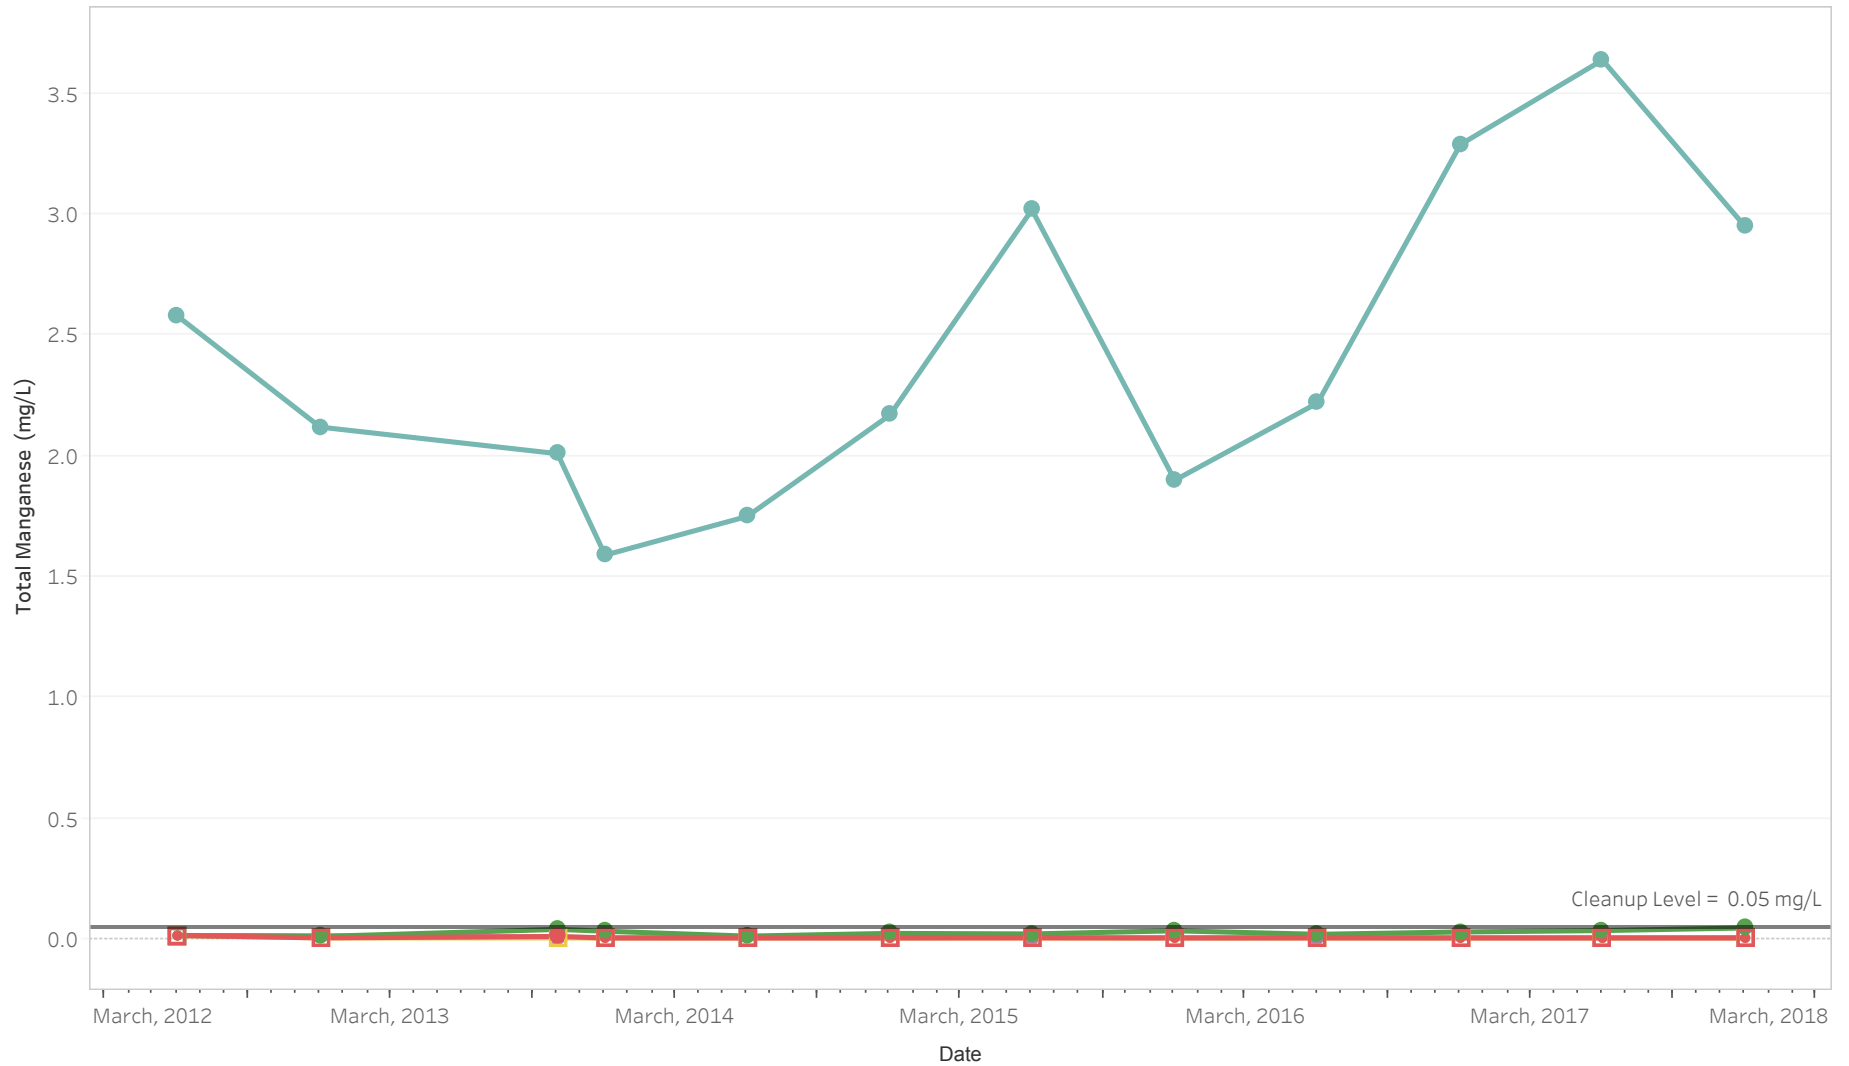
Figure 3-4: Total Manganese in Groundwater 2012-2017

Manganese concentrations were stable or increasing, based on groundwater sampling results. Figure 3-4 and 3-5 present time-series plots of total and dissolved manganese concentrations from 2012 through 2017, for all groundwater compliance wells. Manganese is a naturally occurring element and can be mobilized under reducing (anoxic) conditions.

Increasing concentrations of manganese (total and dissolved fractions) have been observed. Control of geochemical processes resulting in elevated manganese in groundwater may be warranted in the future. While increasing manganese trends above CUL have been detected at well MW-13, manganese concentrations have been non-detect or below the CUL in the off-property and downgradient Stetson Acres well (Table 3-5). The project is currently at the mid-point of the 30-year restoration time frame.

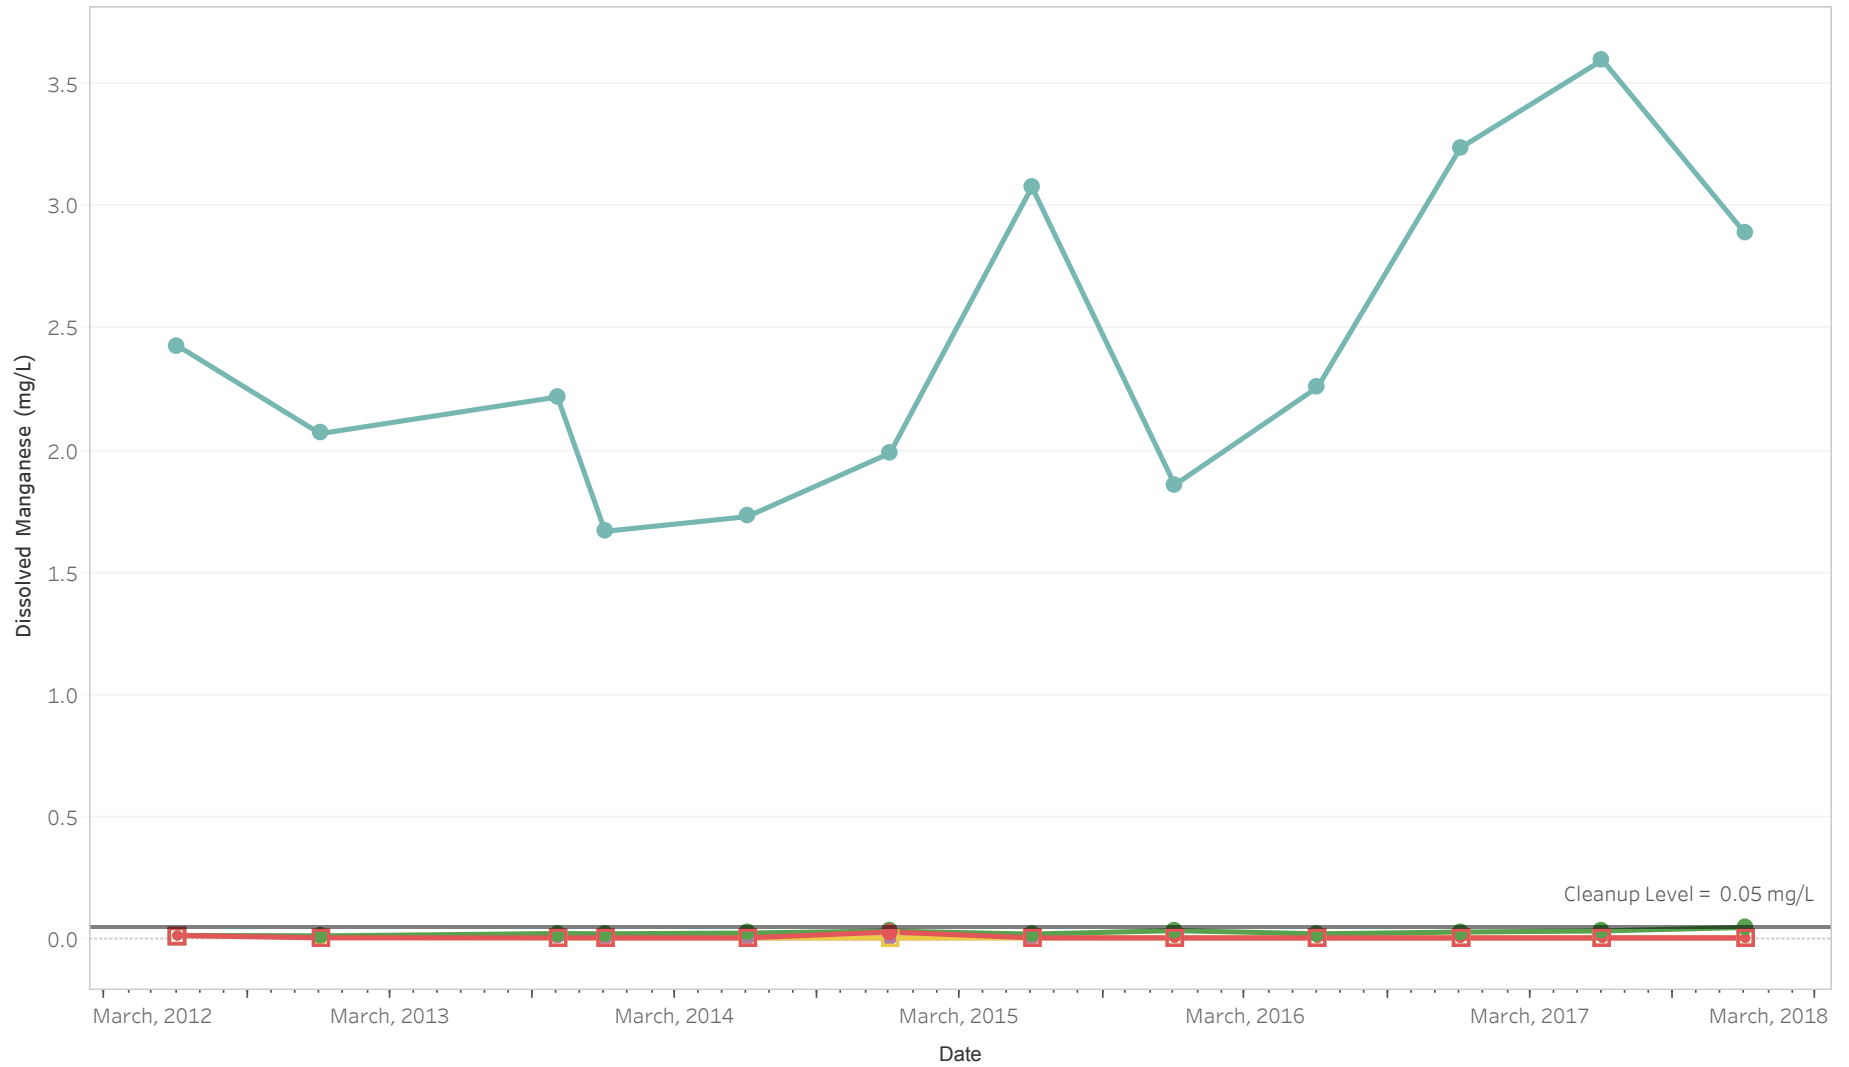
Figure 3-5: Dissolved Manganese in Groundwater 2012-2017

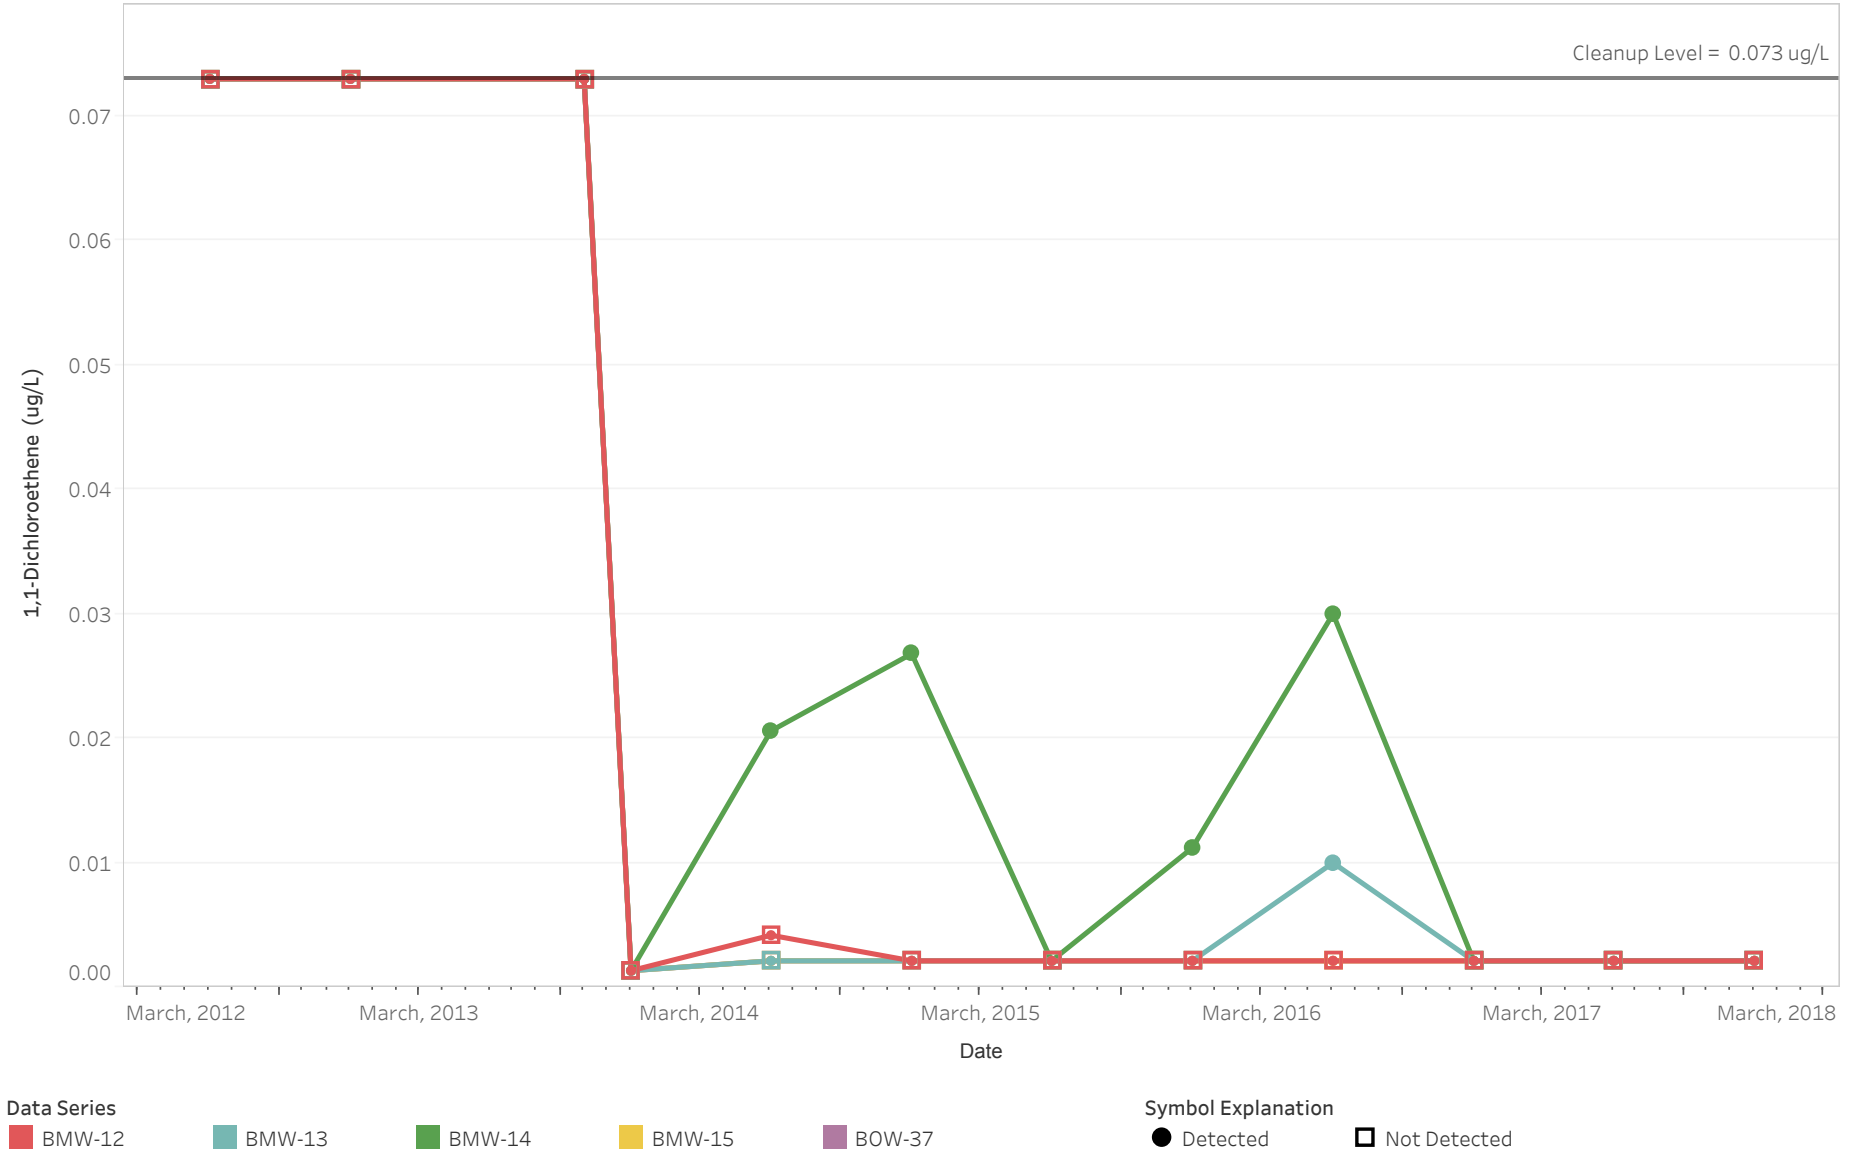
Figure 3-6: 1,1-Dichloroethene Concentrations in Groundwater 2012-2017

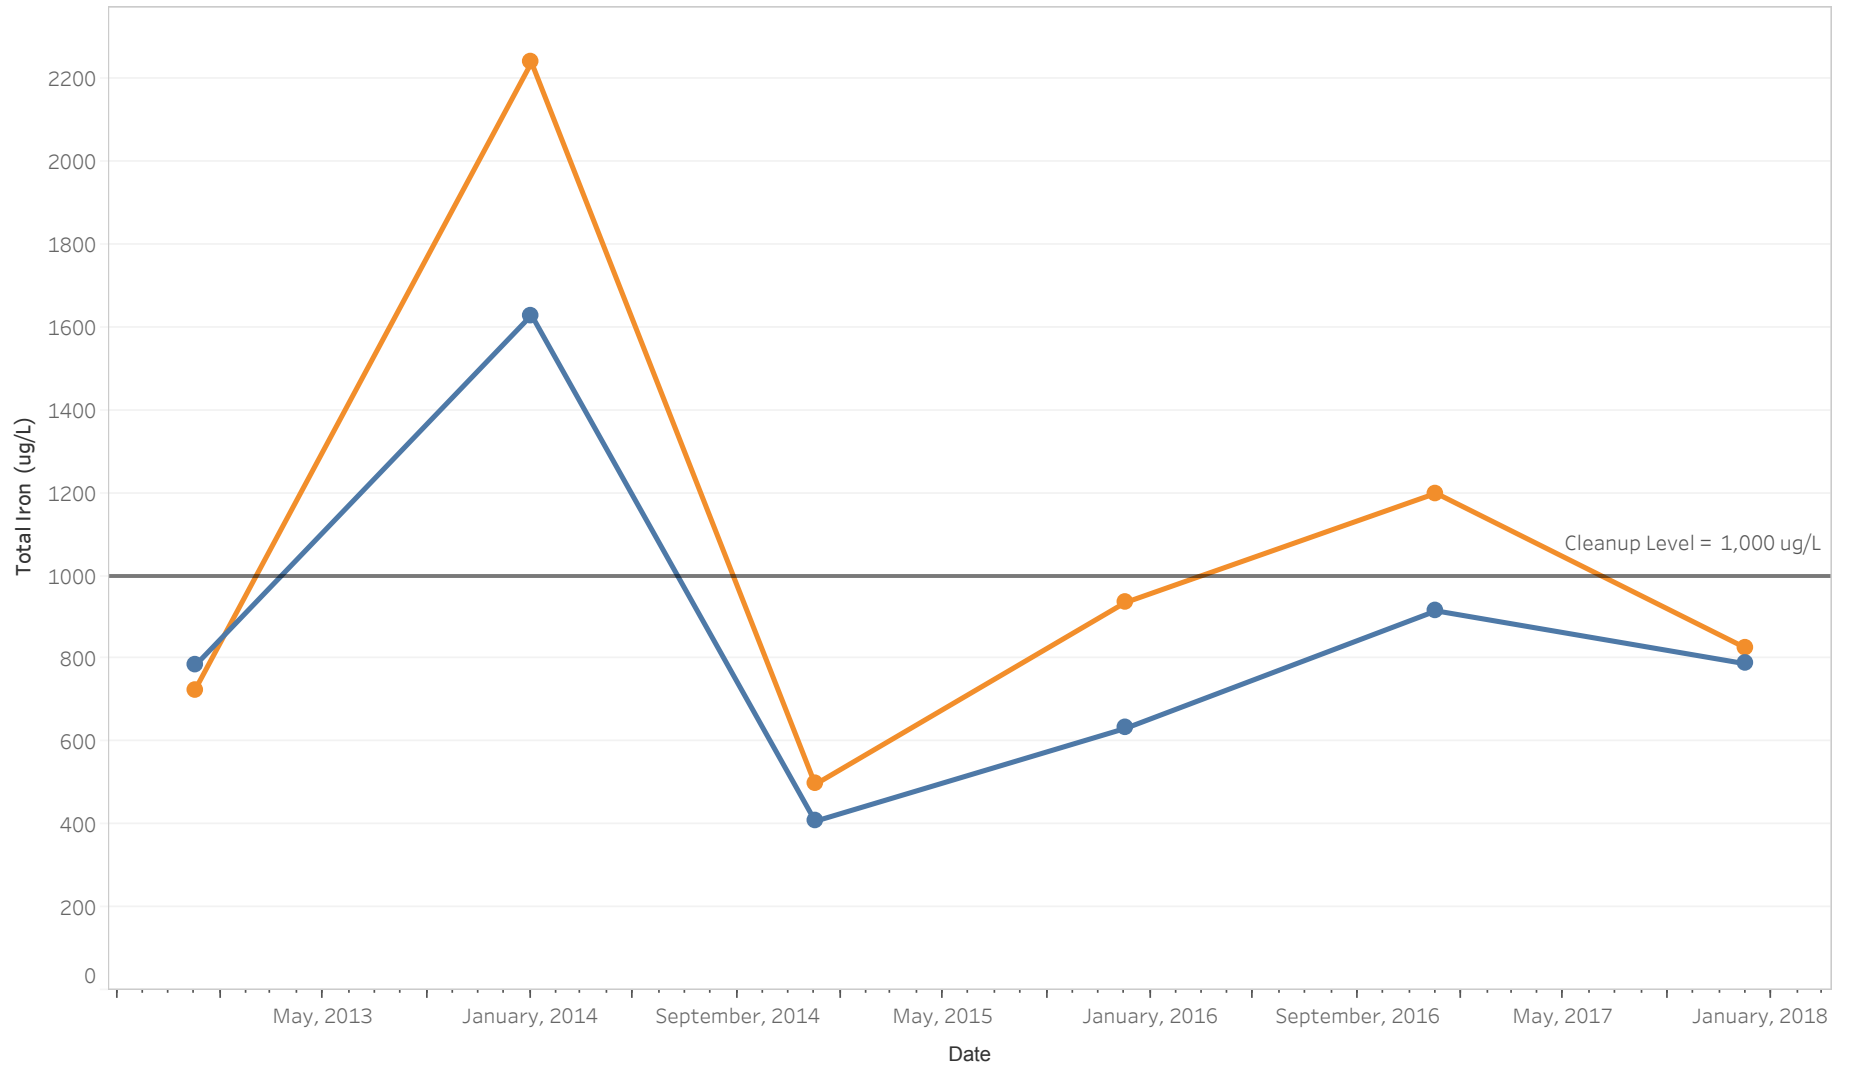
Figure 3-7: Total Iron Concentrations in Surface Water 2012-2017

Total iron concentrations in surface water appeared relatively stable, based on sampling results during the reporting period. Figure 3-7 presents a time-series plot of total iron concentrations from 2012 through 2017 at surface water compliance locations. Recent concentrations at SWD are much improved compared to concentrations of greater than 10 mg/L observed in 2004 and 2005.

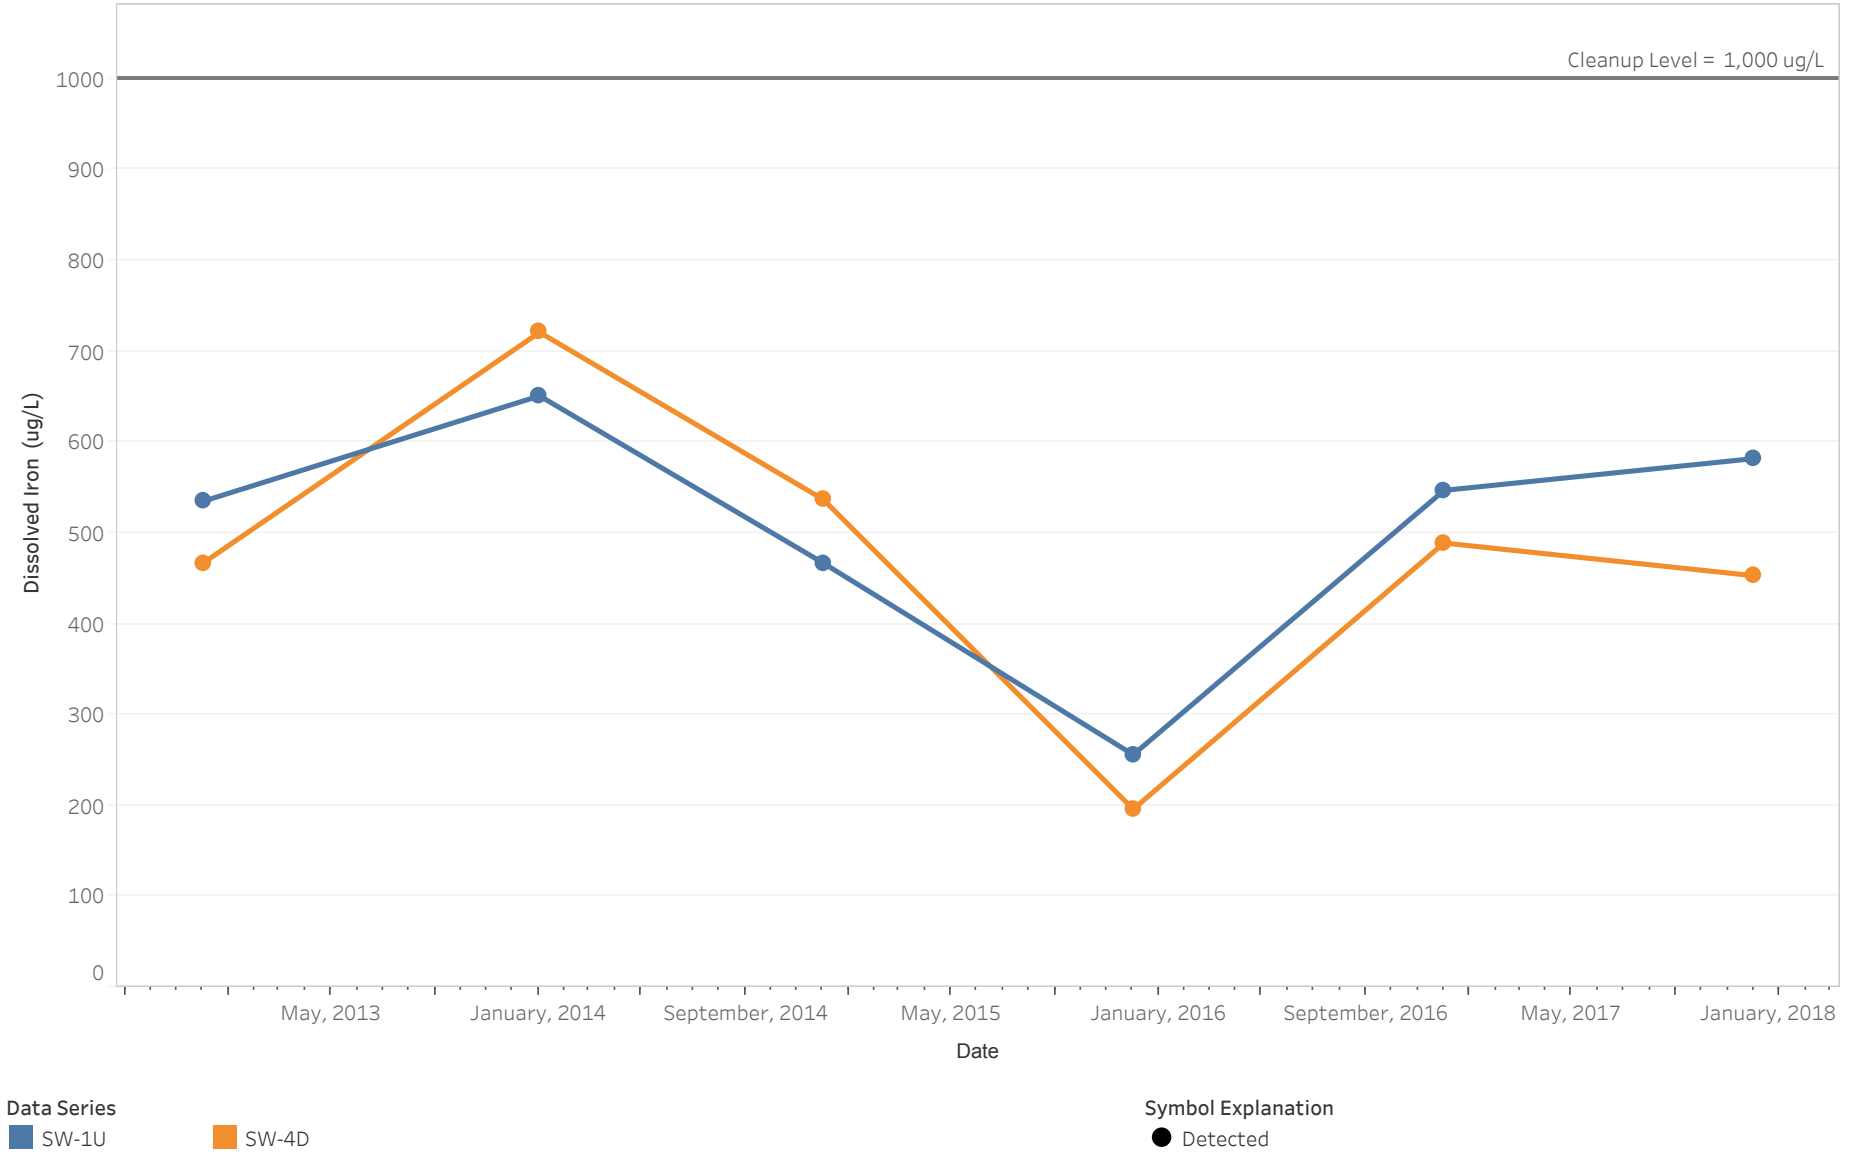
Figure 3-8: Dissolved Iron Concentrations in Surface Water 2012-2017

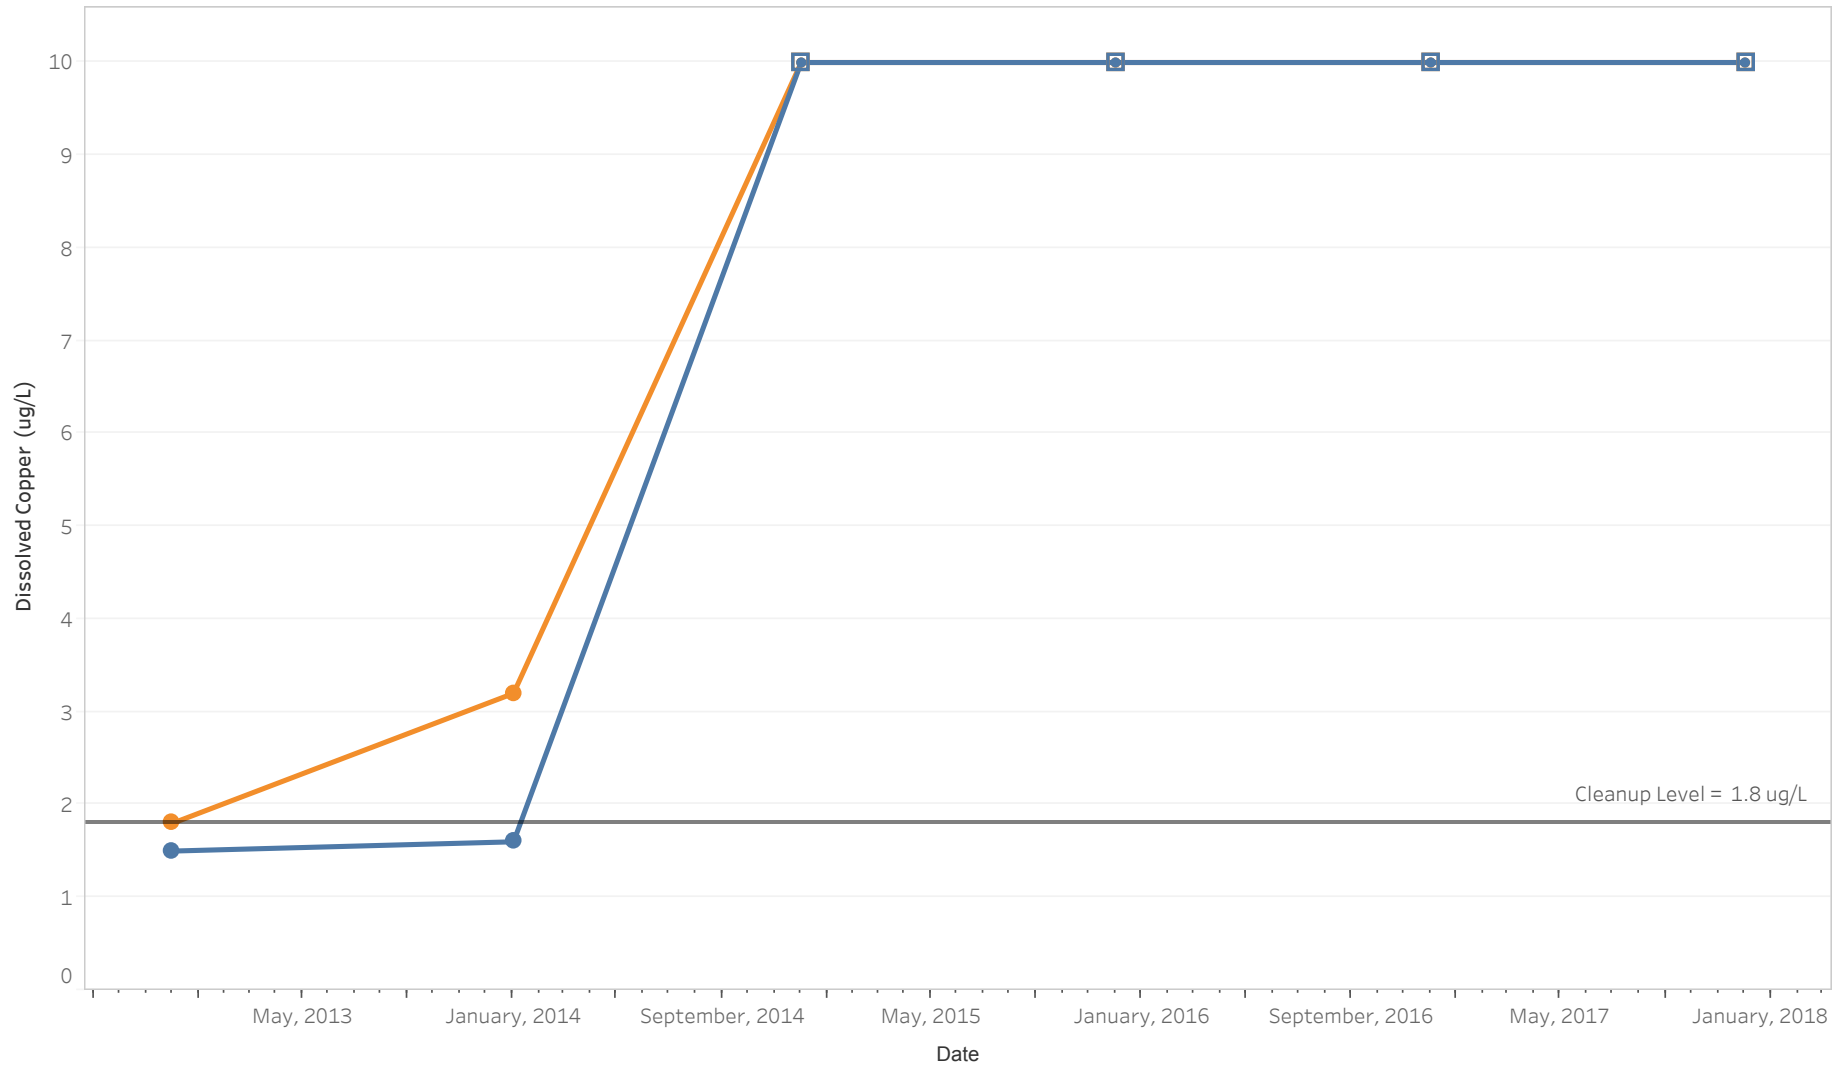
Figure 3-9: Dissolved Copper Concentrations in Surface Water 2012-2017

the CUL of 1,000 µg/L but were below the CUL for the other four events. During the first two sampling events, dissolved copper concentrations were near or above the CUL of 2.2 µg/L, and dissolved lead concentrations were above the CUL of 0.3 µg/L. During all monitoring events, dissolved iron and dissolved zinc were reported at concentrations below the respective CULs. By comparison with background surface water conditions, dissolved oxygen increased, alkalinity remained relatively stable, and bacterial counts increased.
