Remedial Investigation/Feasibility Study
Port of Seattle North Terminal 115

May 9, 2013

File No. 0303-112-00

GeoEngineers, Inc.
Plaza 600 Building
600 Stewart Street, Suite 1700
Seattle, Washington 98101
206.728.2674

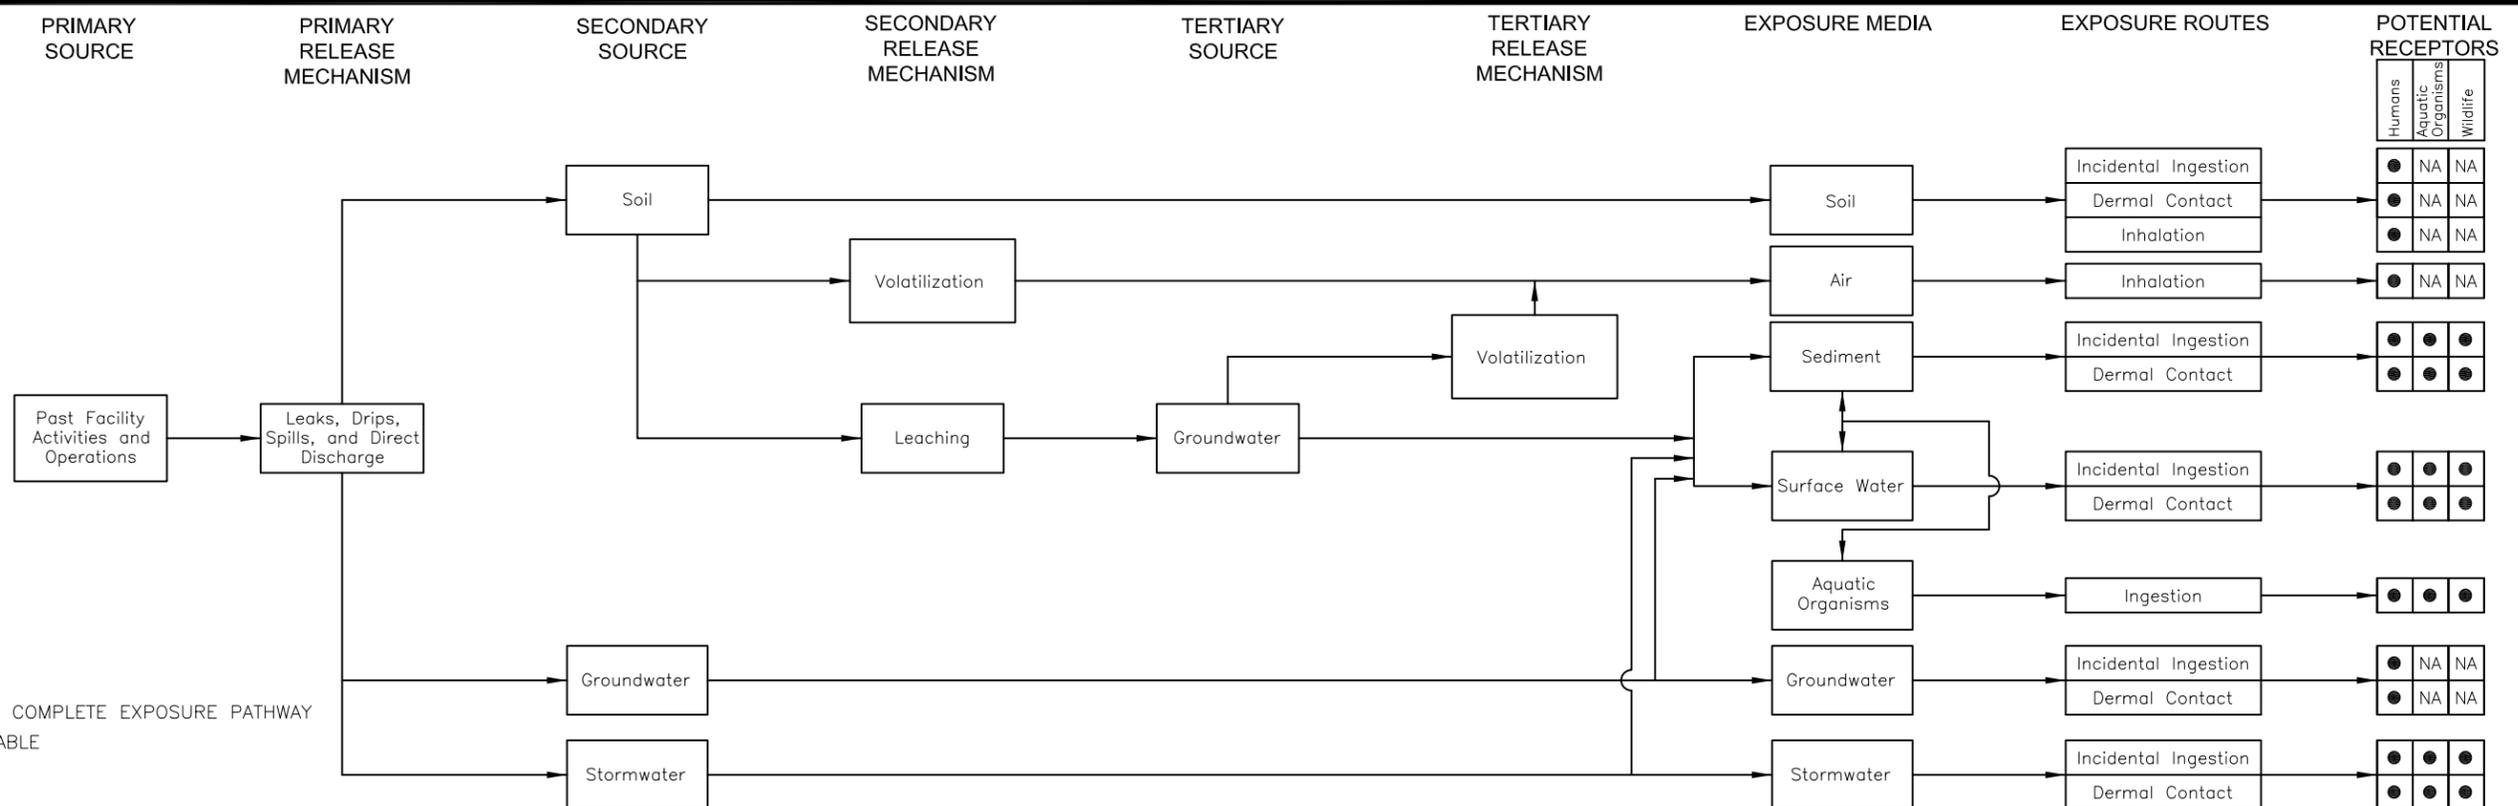
EXPLANATION:
 ● POTENTIALLY COMPLETE EXPOSURE PATHWAY
 NA NOT APPLICABLE

A preliminary conceptual site model (CSM) was developed based on the physical conditions at the Site, potential sources of contamination to Site media, the findings from previous investigations, and evaluation of the potential contaminant transport and exposure pathways. The CSM is a tool prepared to assist in identifying data gaps, develop an investigation approach to fill the data gaps, and for evaluating and identifying remedial actions for the Site. The preliminary CSM is presented in Figure 5 and is discussed below.

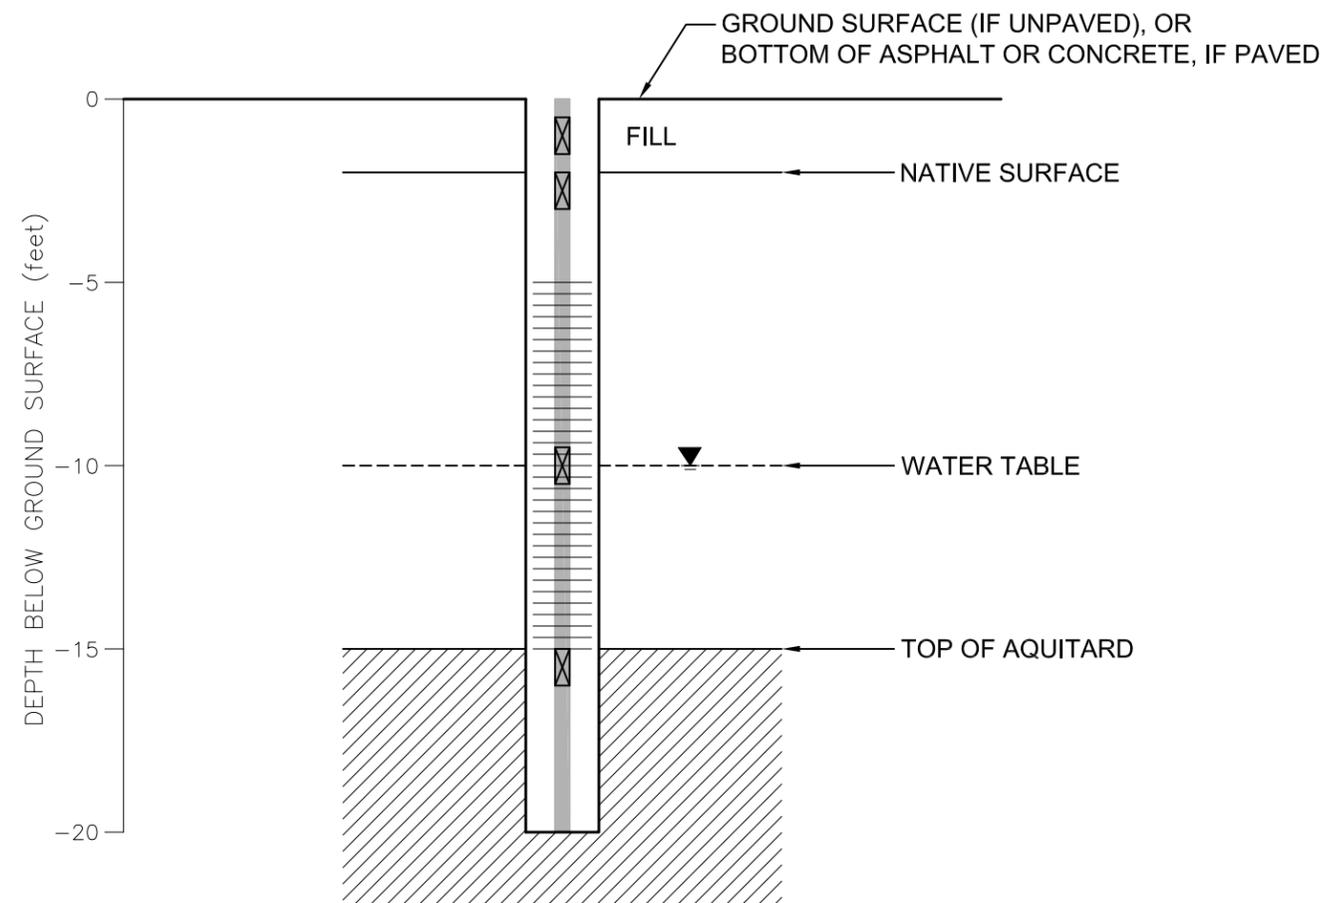
"WESTERN" WELL INSTALLATION

- DEFAULT SAMPLE INTERVAL TO BE COLLECTED: UP TO 1-FOOT LONG SOIL SAMPLE INTERVAL (SHORTER IF THINNER LAYERS OBSERVED)
- SUPPLEMENTAL DISCRETE SAMPLES THAT MAY BE COLLECTED BASED ON FIELD SCREENING OR OBSERVED LITHOLOGY
- APPROXIMATE 10' WELL SCREEN SCREENED ACROSS THE WATER TABLE OBSERVED AT TIME OF DRILLING

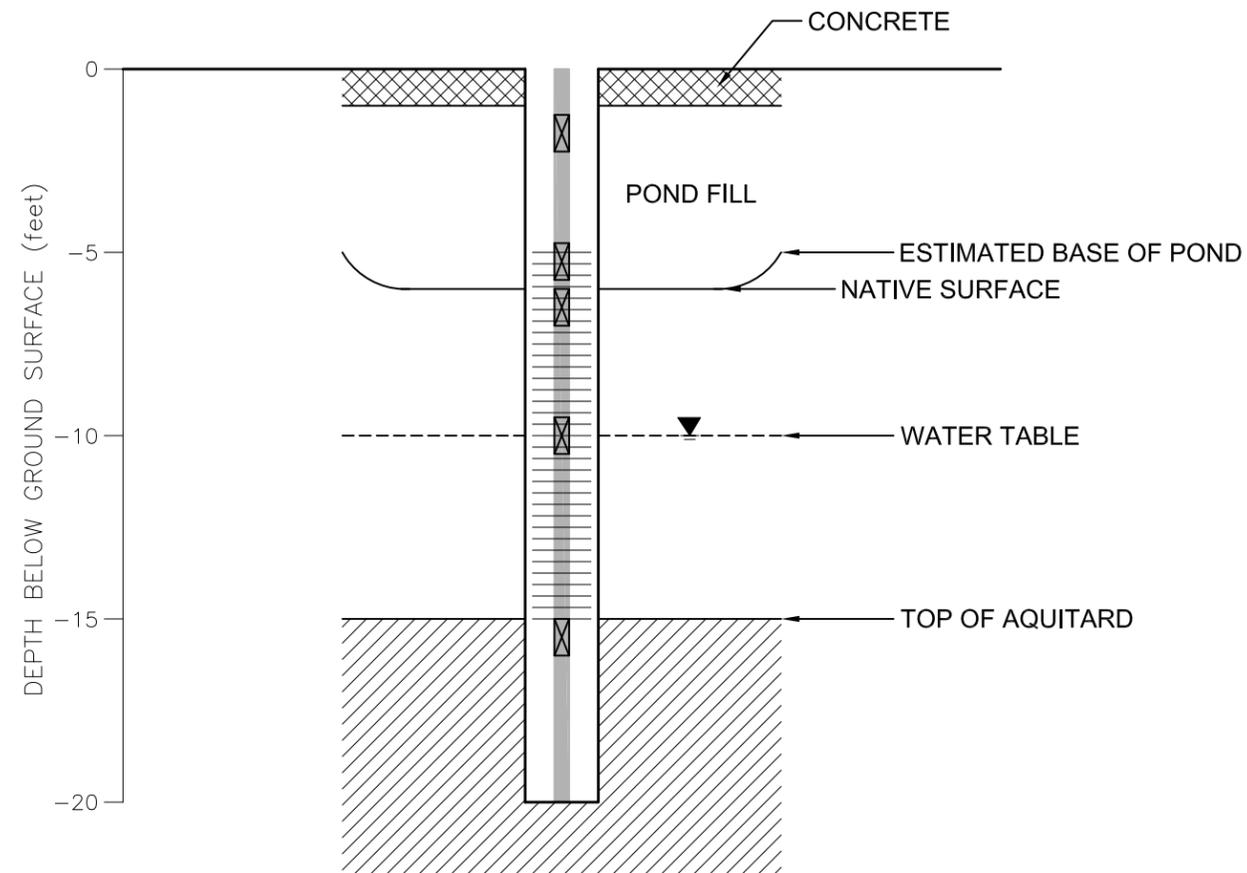
"POND" WELL INSTALLATION

- DEFAULT SAMPLE INTERVAL TO BE COLLECTED: UP TO 1-FOOT LONG SOIL SAMPLE INTERVAL (SHORTER IF THINNER LAYERS OBSERVED)
- SUPPLEMENTAL DISCRETE SAMPLES THAT MAY BE COLLECTED BASED ON FIELD SCREENING OR OBSERVED LITHOLOGY
- APPROXIMATE 10' WELL SCREEN SCREENED ACROSS THE WATER TABLE OBSERVED AT TIME OF DRILLING

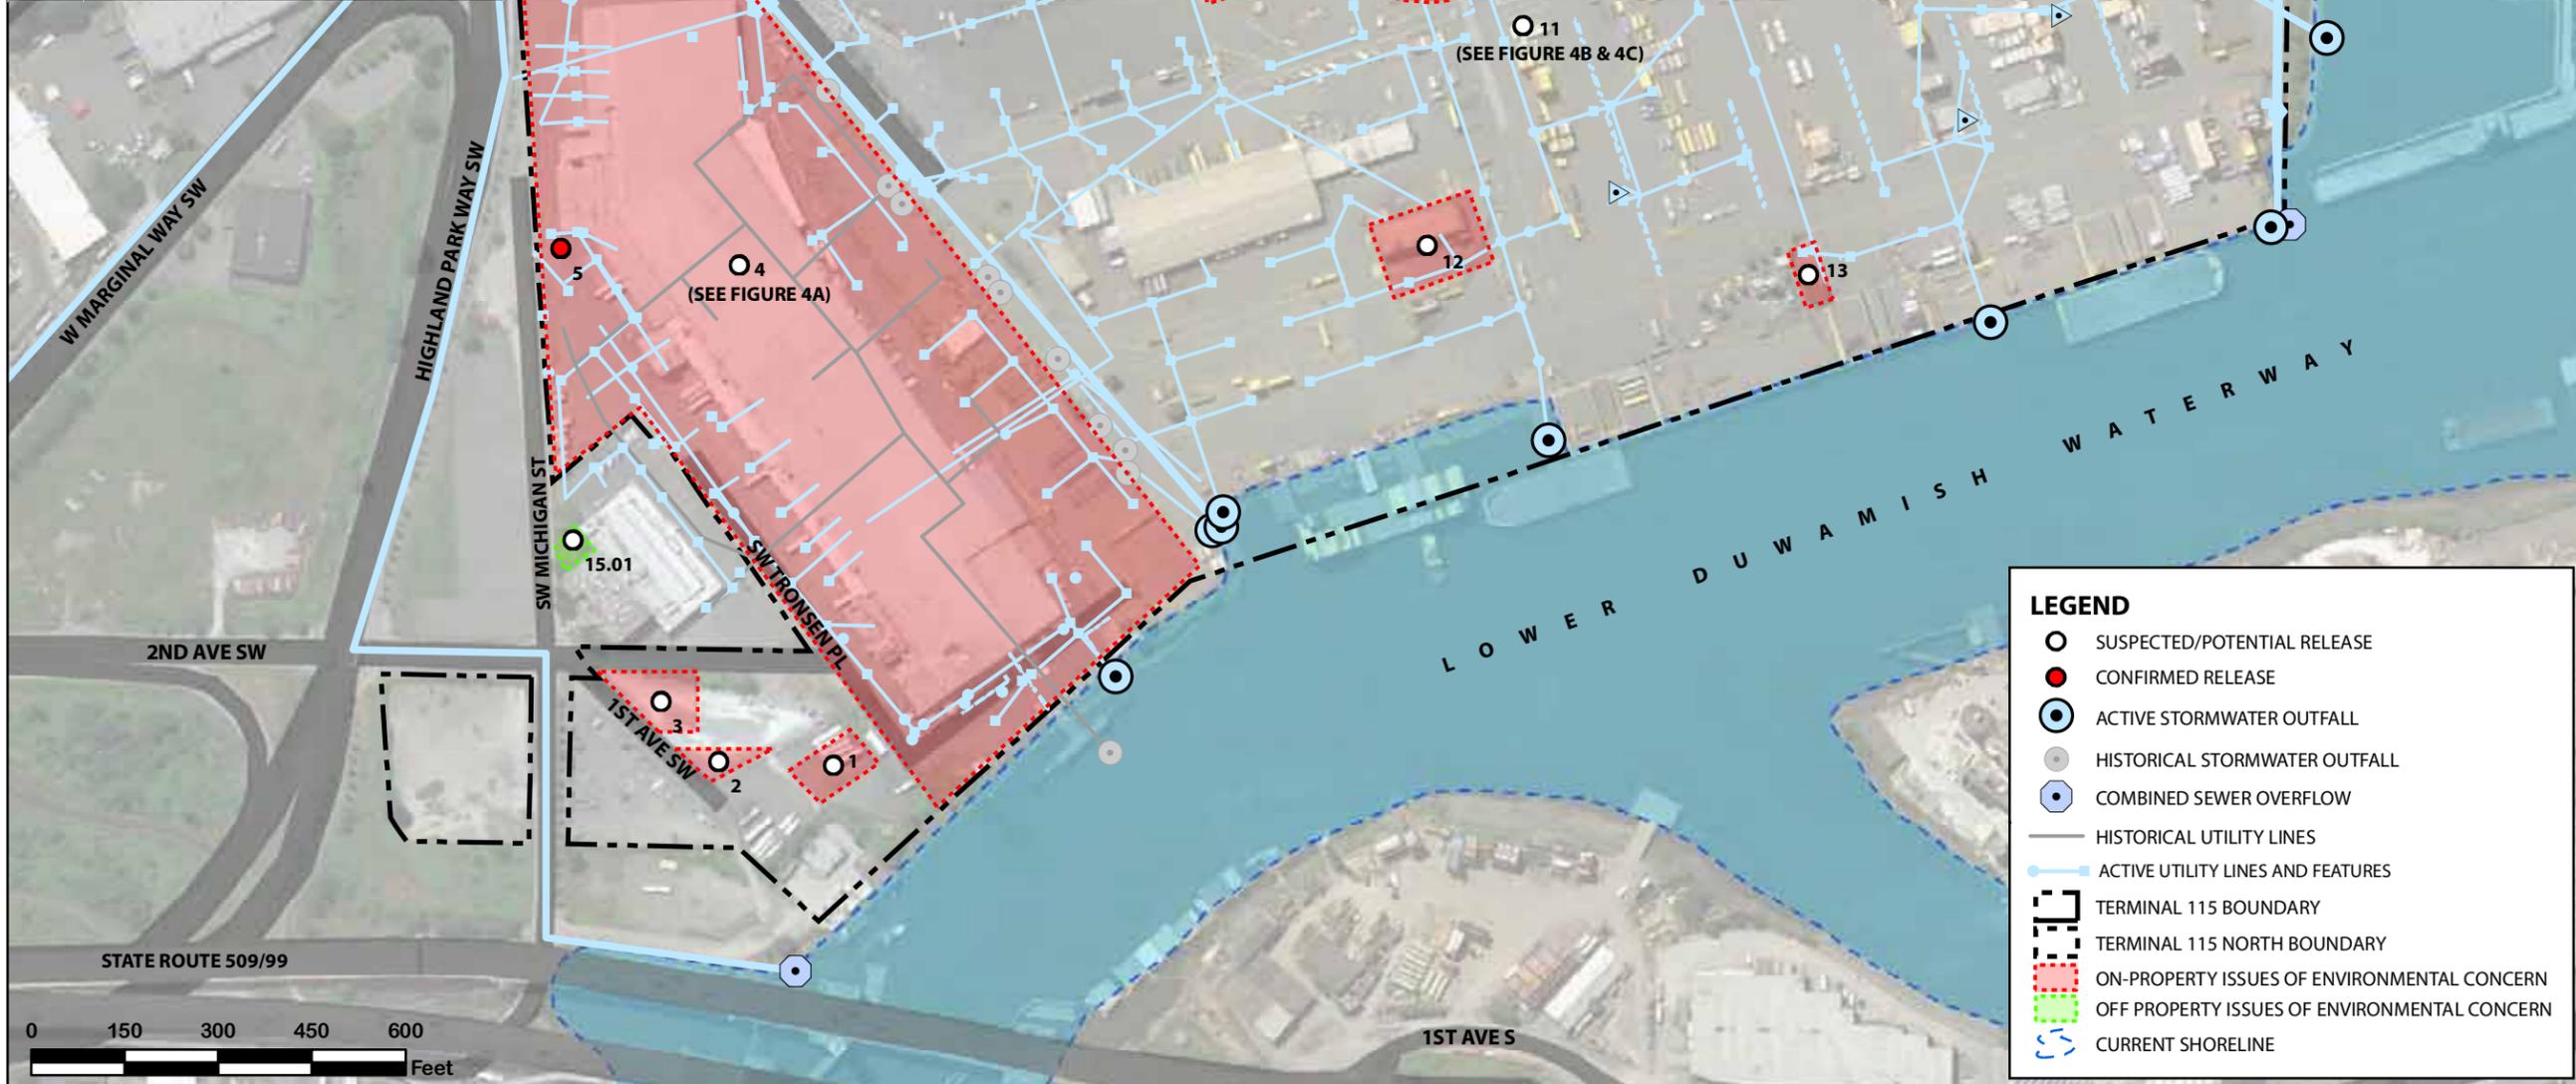
FIGURE 4
ISSUES OF ENVIRONMENTAL CONCERN
MASTER FIGURE

IEC Identification	
IEC #	Name
1	Standard Oil
2	"Refinery Building"
3	Richfield Oil Gas Station
4	Boeing Plant #1
5	Seafreeze/Boeing USTs
6	Auto Salvage Yard/Sav-Mor Service Station
7	Materials Reclamation Smelter
8	Southwest Tank Yard/Cardlock Facility
9	Klinker Gravel/Ready Mix
10	Buildings C1 & C2/Carwash
11	Landfill Activities
12	Building M2/Maintenance Building
13	Building A5/Marine Office Building
14	Tin Reclamation - T115N
15	Off-Property IECs
15.01	Boeing Building 1-01 USTs
15.02	Tire Shop
15.03	Foundry
15.04	Reichhold Chemical
15.05	Glacier NW/Kaiser

(Tank No. 15, Figures 4A and 5) located adjacent to the building to the east. The current status of Tank No. 15 is unknown. No other references to the tank were observed in the materials reviewed. The structure was demolished by 1974.

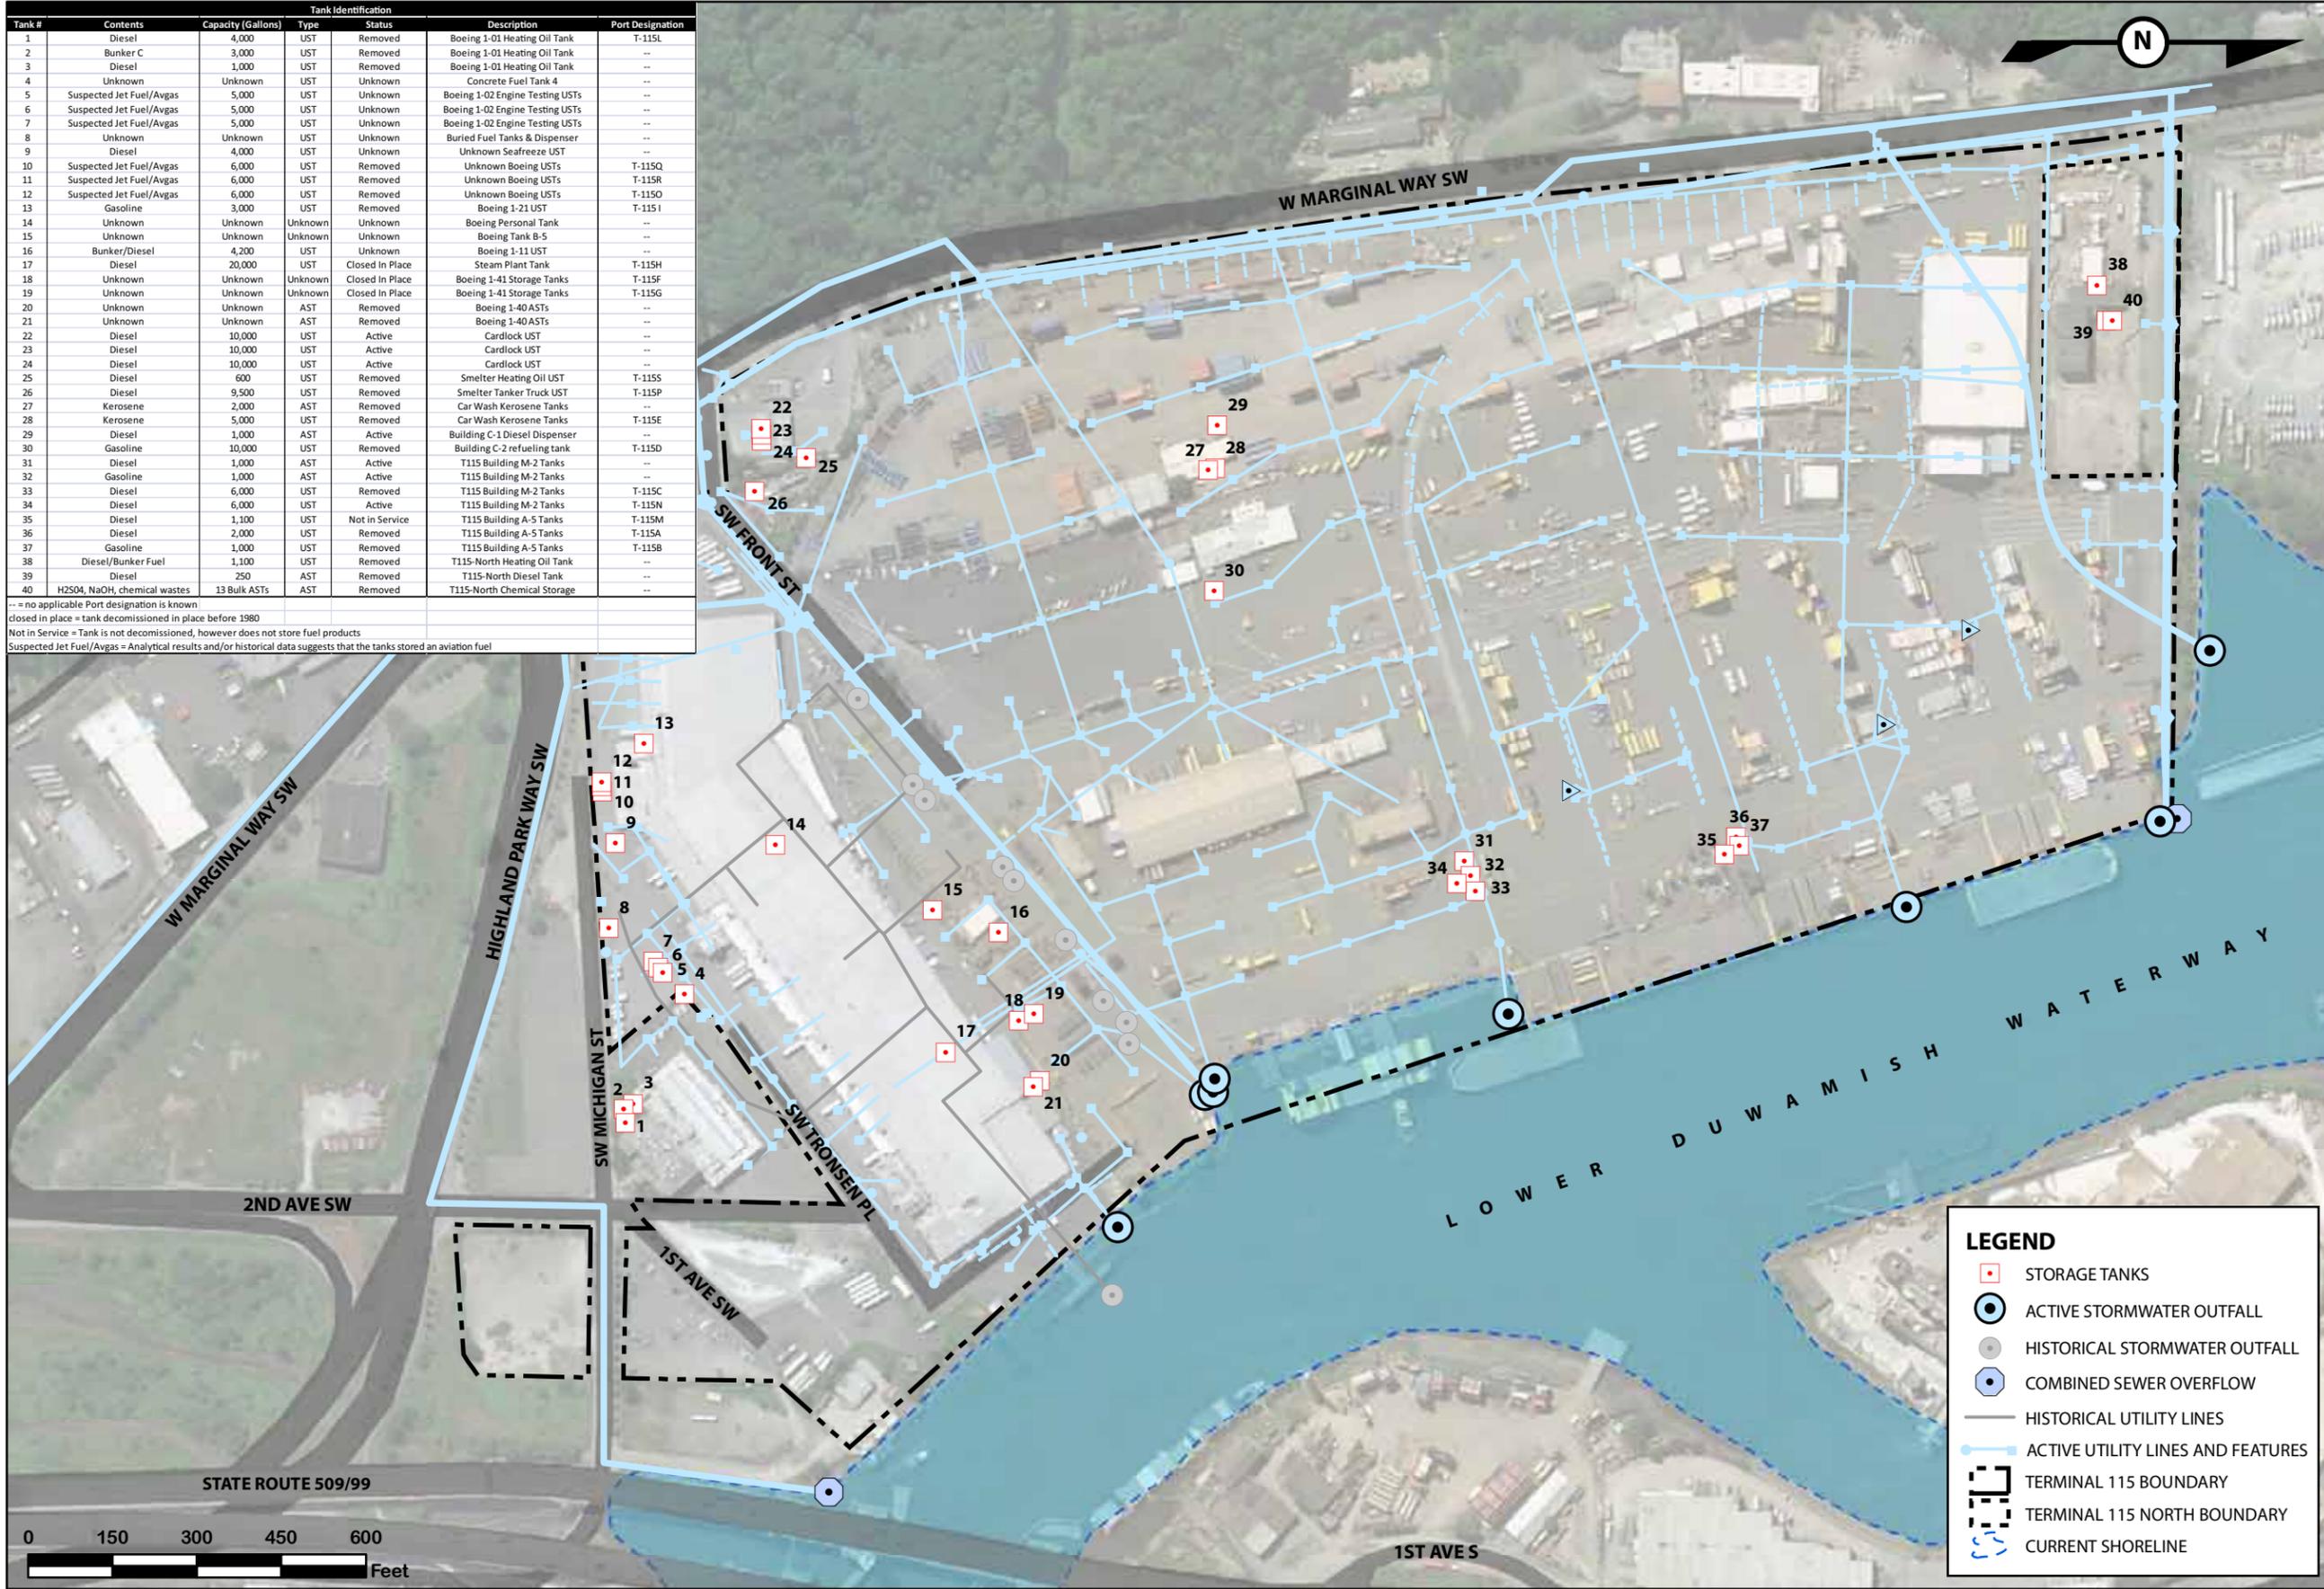
FIGURE 5
 STORAGE TANK LOCATIONS MAP

-- = no applicable Port designation is known
 closed in place = tank decommissioned in place before 1980
 Not in Service = Tank is not decommissioned, however does not store fuel products
 Suspected Jet Fuel/Avgas = Analytical results and/or historical data suggests that the tanks stored an aviation fuel

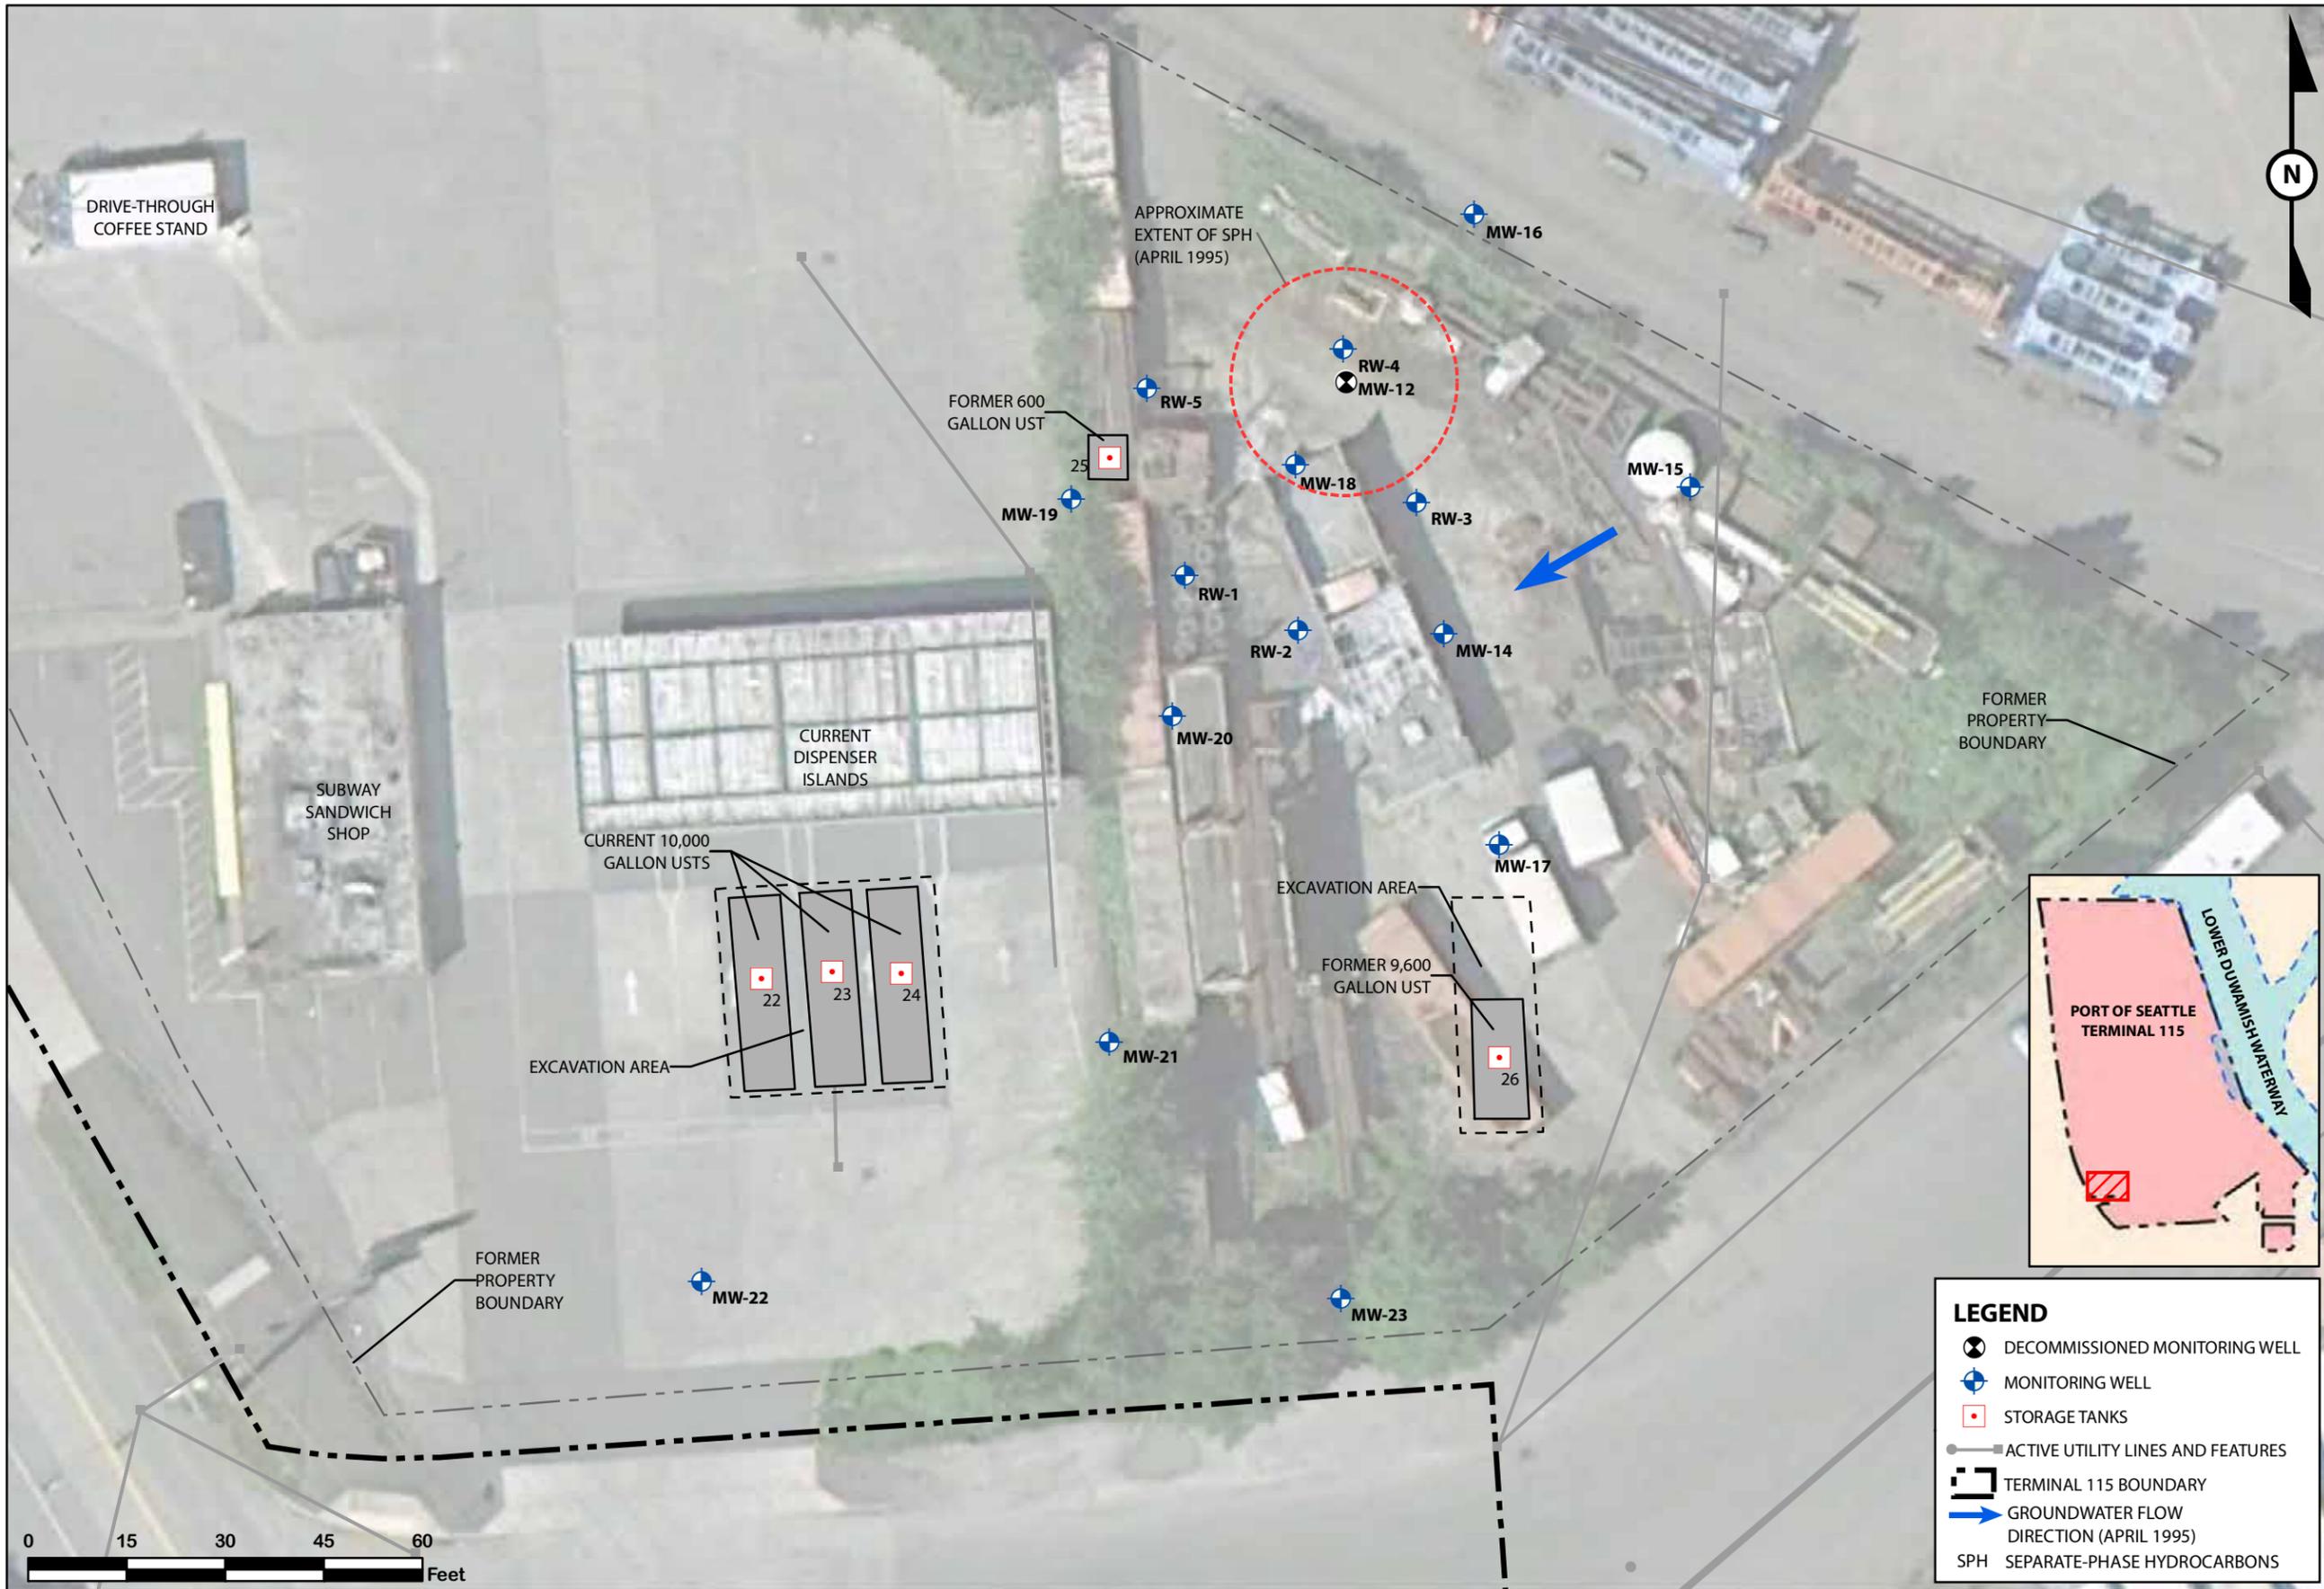
FIGURE 6B
 INVESTIGATION AREAS MAP
 CARDLOCK FACILITY
 SHULTZ DISTRIBUTING

- MONITORING WELL
- STORAGE TANKS
- ACTIVE UTILITY LINES AND FEATURES
- TERMINAL 115 BOUNDARY

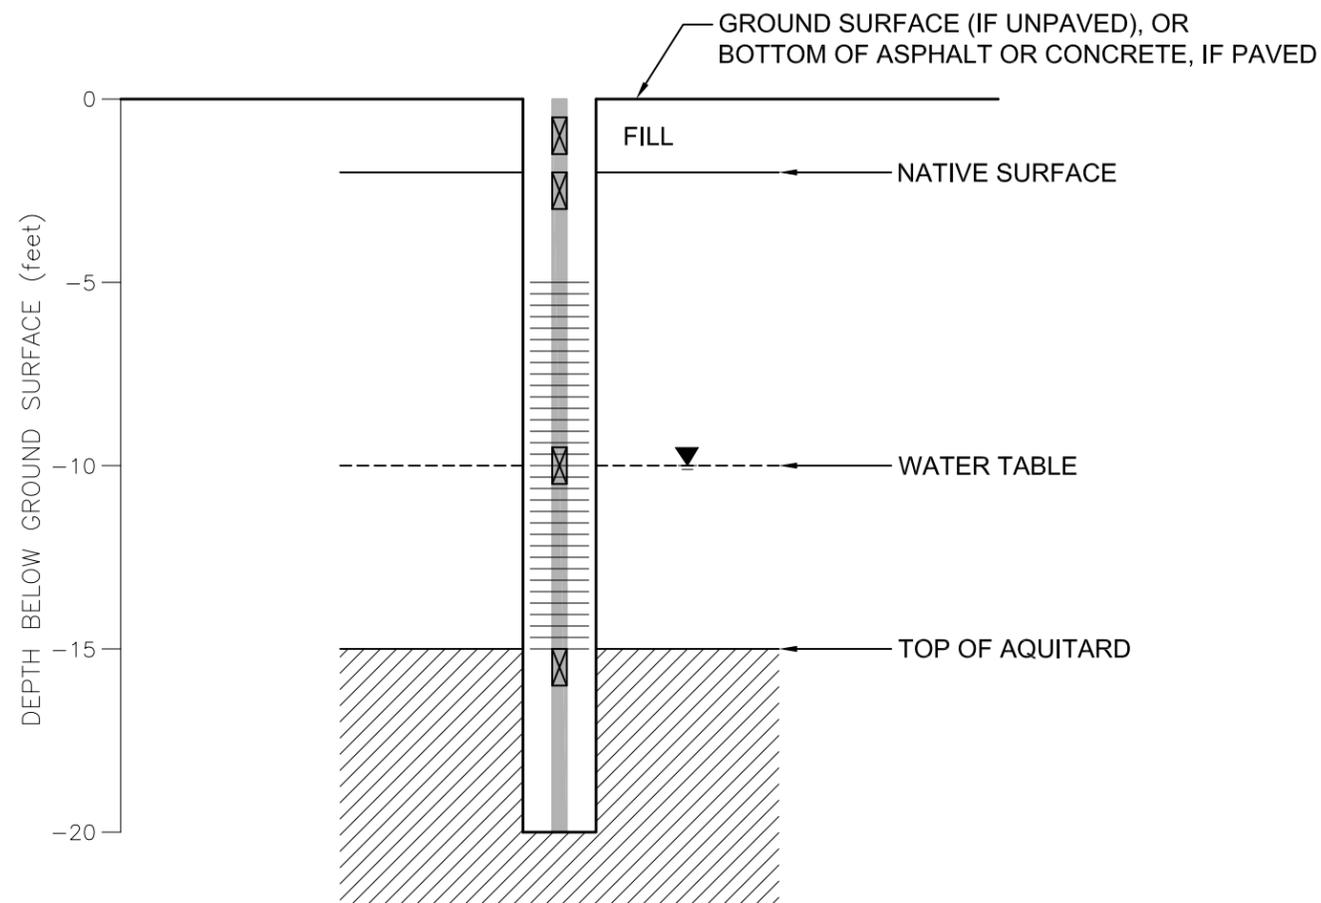
"WESTERN" WELL INSTALLATION

- DEFAULT SAMPLE INTERVAL TO BE COLLECTED: UP TO 1-FOOT LONG SOIL SAMPLE INTERVAL (SHORTER IF THINNER LAYERS OBSERVED)
- SUPPLEMENTAL DISCRETE SAMPLES THAT MAY BE COLLECTED BASED ON FIELD SCREENING OR OBSERVED LITHOLOGY
- APPROXIMATE 10' WELL SCREEN SCREENED ACROSS THE WATER TABLE OBSERVED AT TIME OF DRILLING

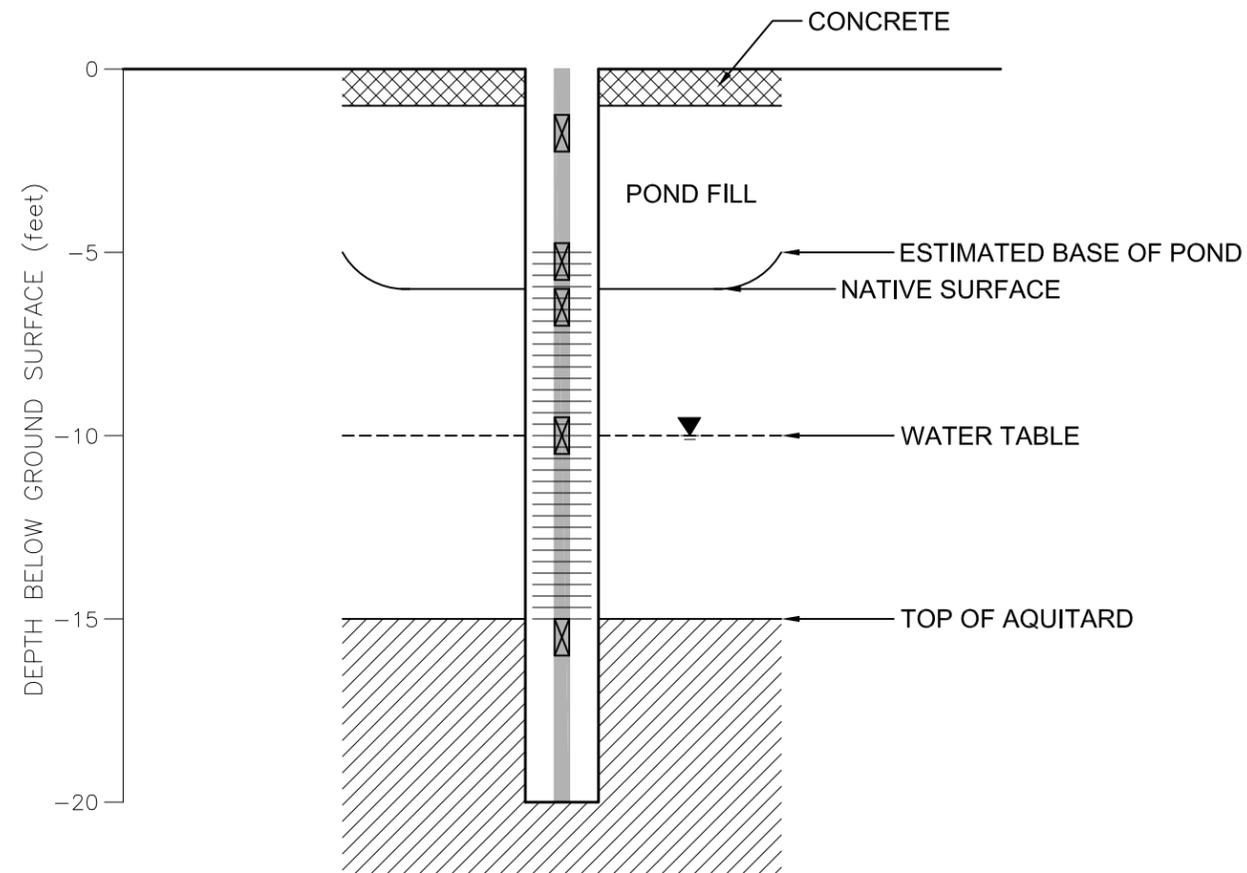
"POND" WELL INSTALLATION

- DEFAULT SAMPLE INTERVAL TO BE COLLECTED: UP TO 1-FOOT LONG SOIL SAMPLE INTERVAL (SHORTER IF THINNER LAYERS OBSERVED)
- SUPPLEMENTAL DISCRETE SAMPLES THAT MAY BE COLLECTED BASED ON FIELD SCREENING OR OBSERVED LITHOLOGY
- APPROXIMATE 10' WELL SCREEN SCREENED ACROSS THE WATER TABLE OBSERVED AT TIME OF DRILLING

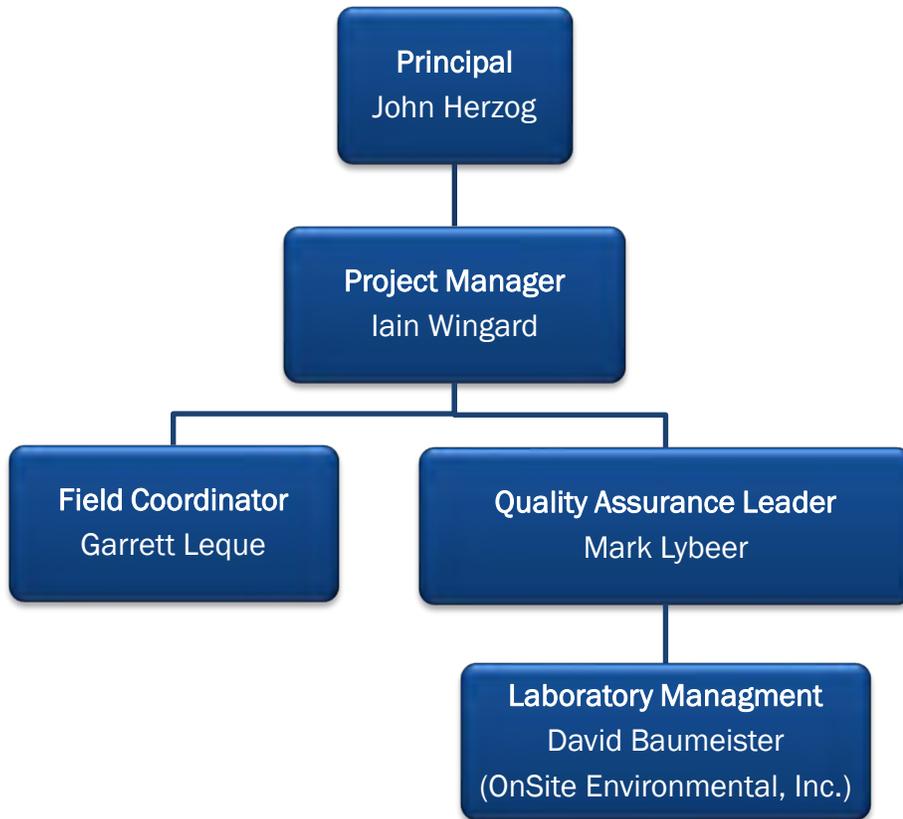
Figure 2-1. Project Organization Chart

Descriptions of the responsibilities, lines of authority and communication for the key positions providing quality assurance and quality control are shown in Figure 2-1. The project organization

facilitates the efficient production of project work, allows for an independent quality review, and permits resolution of any QA issues.
