Emerald Tool Contamination Site Memo

June 5, 2018

FROM: Mary Dzieweczynski, Owner Corvid General Contractors, LLC

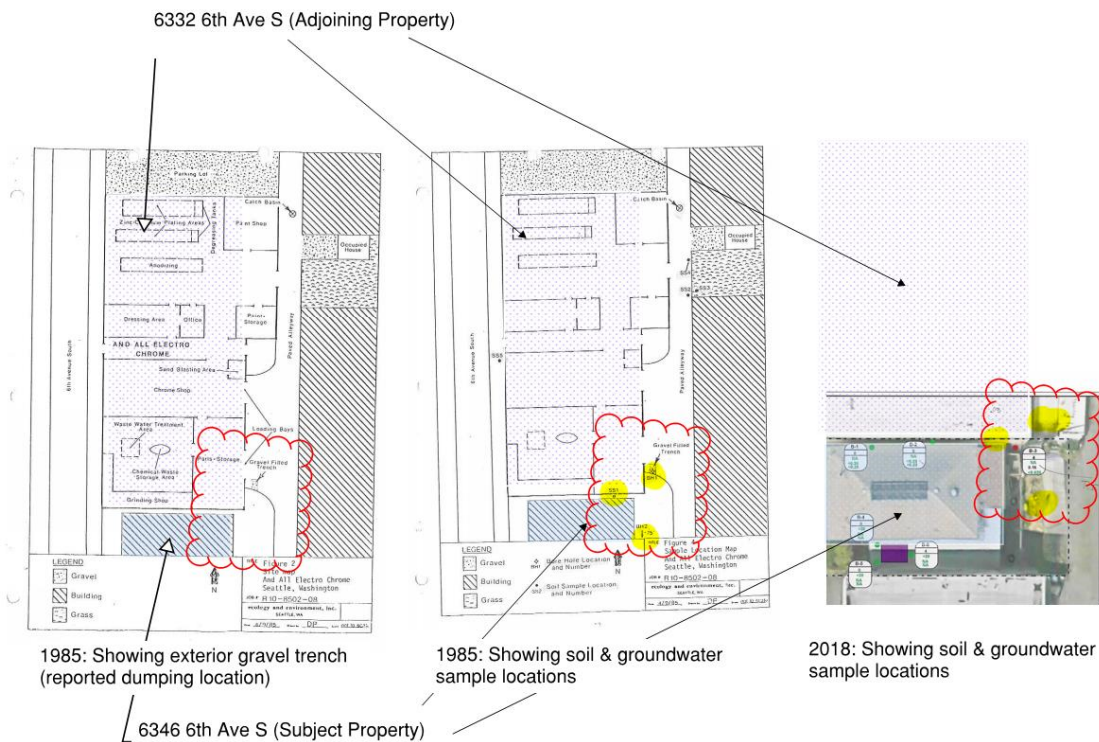
Emerald Tool (former And-All Electrochrome) "Adjoining Property" & 6346 6th Ave S "Subject Property: building functions & sampling locations

On 02/28/1985 (inspection) and 05/23/1985 (sampling) of the adjoining property was completed by Ecology & Environment as an EPA subcontractor. See below for a location comparison between reported dumping locations & contaminants reported in the 1985 assessment (By Ecology @ Adjoining Property), and contaminants reported in 2018 (By AeroTech for Subject Property). In 1985, soil sample (SS1), bore hole sample (BH1) and bore hole sample (BH2) all tested positive for contaminants. They are highlighted in yellow below. The map from the 2018 Phase 2 assessment is to the right showing the contaminated soil sample (B3) location relative to the 1985 findings.

FACT: The gravel-filled trench location in the SE corner of Adjoining Property was a documented dumping location by And-All Electrochrome at the Adjoining Property (See EPA Site Inspection Report 02/28/85). Soil in that area tested for contamination in 1985 & 2018 (See respective reports).

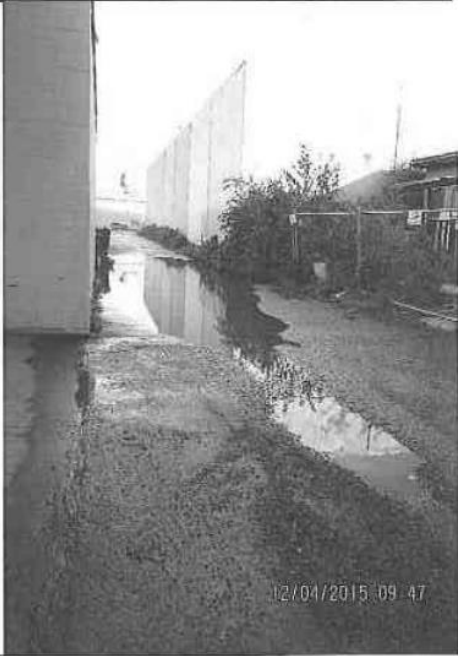
FACT: Regular flooding in the alley occurred/occurs during heavy rains at the same location as reported dumping. (See Ecology Inspection Report 12/04/15).

Area & Description	Photographs
<p>#3</p> <p>Alleyway to the east of the shop</p> <p>Stormwater ponding on the driving surface.</p>
