INITIAL INVESTIGATION FIELD REPORT

<u>Site Name (Name over door):</u> Corvid Construction	<u>Site Address (including City, State and Zip):</u> 6346 6th Ave S Seattle, WA 98108	<u>Phone</u> <u>Email</u>
<u>Site Contact, Title, Business:</u> Mary Dzieweczynski, owner Corvid General Contractors, LLC	<u>Site Contact Address (including City, State and Zip):</u> 6346 6th Ave S Seattle, WA 98108	<u>Phone</u> (206) 456-6215 <u>Email</u> mary@corvidseattle.com
<u>Site Owner, Title, Business:</u> 6346 6th Ave S, LLC	<u>Site Owner Address (including City, State and Zip):</u> 1100 NW 52nd St Seattle, WA 98107	<u>Phone</u> <u>Email</u>
<u>Site Owner Contact, Title, Business:</u>	<u>Site Owner Contact Address (including City, State and Zip):</u>	<u>Phone</u> <u>Email</u>
<u>Previous Site Owner(s):</u>	<u>Additional Info (for any Site Information Item):</u> Adjacent Site: Emerald Tool FSID: 2084 CSID: 1305	
<u>Alternate Site Name(s):</u>

Mary Dzieweczynski submitted Phase I and II Environmental Site Assessment reports for a property where she is the current tenant and potential purchaser.

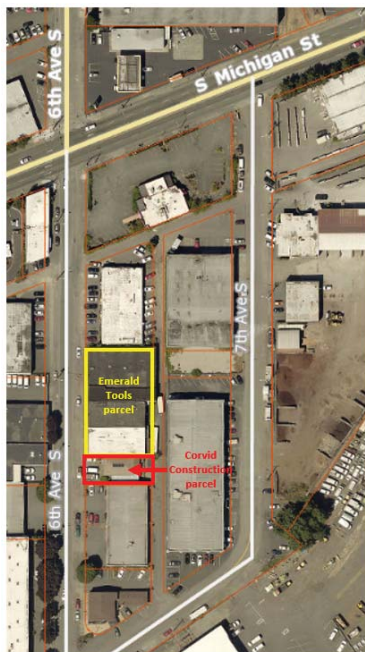
The UST was removed in 2000 and reportedly had never leaked. Since no samples were collected at the time of removal to confirm a clean tank closure, soil samples were collected from 3 borings (B-4, -5, -6; see figures below) in the former UST location. Groundwater was encountered in borings B-4 and B-5 at approximately 5.5 feet below ground surface (bgs), and samples were collected. Soil and groundwater were analyzed for diesel and oil range petroleum hydrocarbons. None of the samples contained petroleum hydrocarbons above laboratory reporting limits.

General Site location.

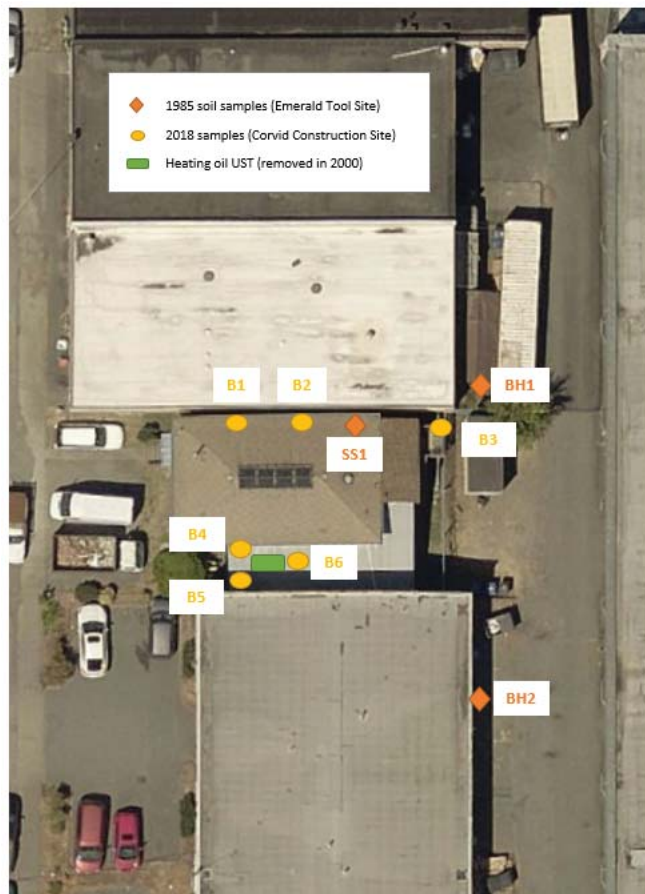
Soil samples were collected from 3 locations (B-1, -2, -3) in the northern portion of the property to investigate potential contamination from the adjacent Emerald Tool property. Groundwater was encountered at approximately 5.5 feet bgs in boring 2 and a sample was collected. Samples were analyzed for chlorinated VOCs. Soil collected from boring B-3 contained TCE above the MTCA Method A cleanup level. Groundwater from boring B-2 contained vinyl chloride above the Method A cleanup level. There are no documented uses of chlorinated VOCs on the Corvid property.

Soil samples were collected near the border of the Corvid and Emerald Tool properties in 1985. TCE and PCE were used for metal degreasing prior to plating, and were detected in samples BH-1 and SS-1 above Method A cleanup levels. BH-1 was collected in a gravel trench area near a chemical storage tank. It was acknowledged that any leaking chemical storage tanks or direct discharge into the trench would lead to contamination of groundwater. Based on other Ecology sites within 750 feet of the Site (Mastermark Equinox, Shell 121430), groundwater in the area flows to the southwest. Metals were also detected in SS-1, which is on the Corvid Construction property, above Method A cleanup levels.

While the extent of contaminated soil and groundwater was not fully delineated for the Emerald Tools property in 1985, based on the location of the contaminated samples, it appears to include the locations of the contaminated 2018 samples.

Locations of samples collected in 1985 and 2018. Contamination with chlorinated VOCs above Method A cleanup levels occurred in soil at BH1, SS1, and B3 and in groundwater at B2.

Two issues are addressed in the reports. One is a former heating oil UST. Samples do not indicate any contamination in the area of the UST. The second issue is contamination with chlorinated VOCs on the northern portion of the property. Based on locations and historic sampling events on the property to the north, it appears the source of the contamination is the adjacent property (Emerald Tool). Recommendation: update to Emerald Tool site file.
