February 13, 2017

**Additional Site Assessment Report**

**Site No. 0700**

100 East Wine Country Road  
Grandview, Washington

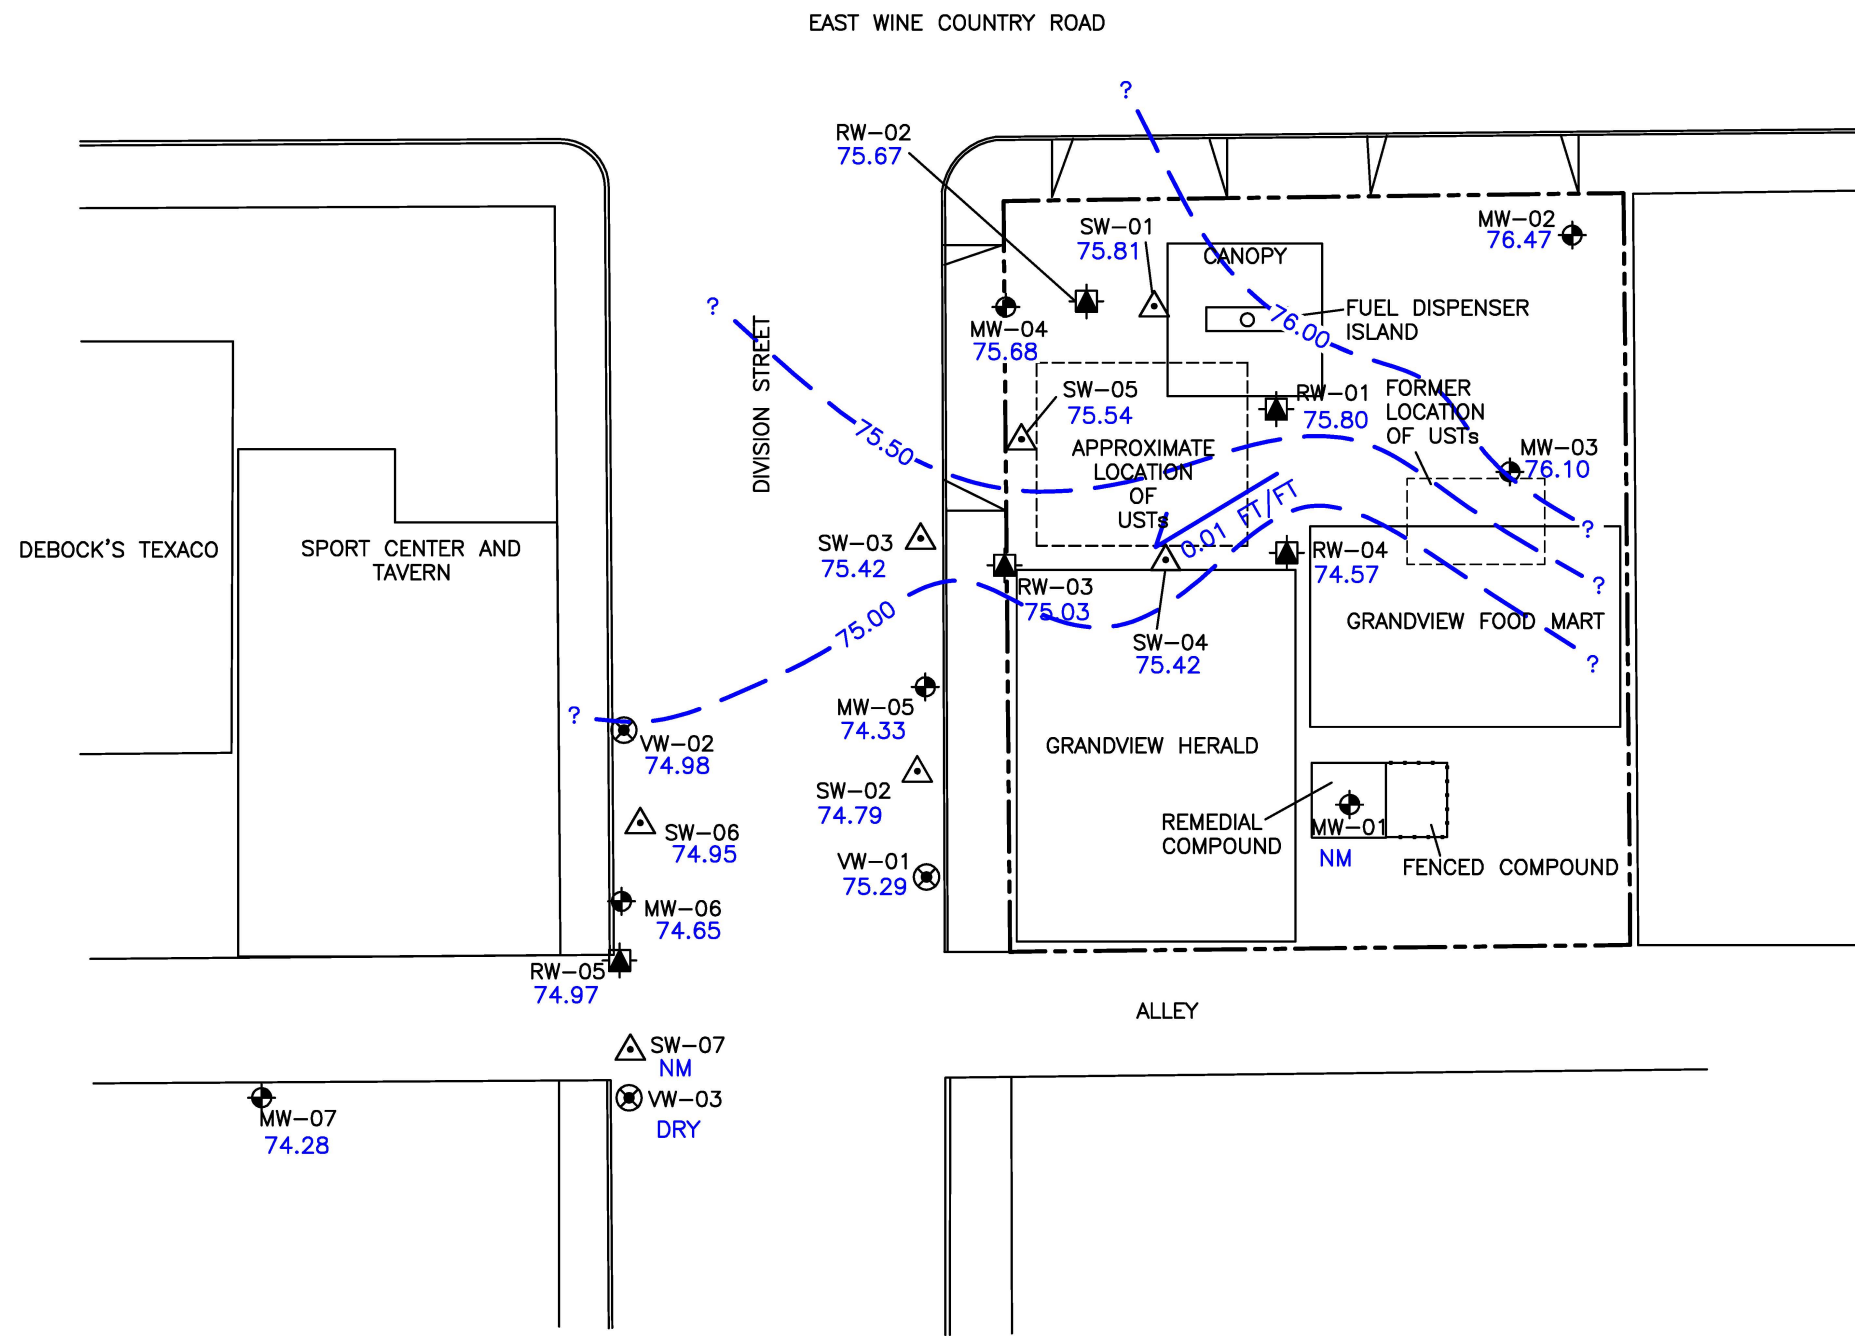
Historically, hydrogeological conditions on the subject site have been relatively consistent, with a groundwater gradient of approximately 0.01 feet per foot flowing towards the southwest (**Table 5**). The aforementioned data suggests that the TPH-Gx detection in soil sample CB-10-17 (210 mg/kg) may be related to the release at the DeBocks Texaco property. Soil boring GP-5 is located up gradient (north-northeast) of confirmation boring CB-10 and contains hydrocarbon contaminants at 15 feet bgs. The location of CB-10, the location of GP-5 (former UST complex), the soil and groundwater analytical results from GP-5, and the consistent southwest flow of groundwater suggest that the contamination in CB-10 may be related to contamination originating from the DeBocks Texaco property.

- RW-02 RECOVERY WELL
- VW-03 VAPOR WELL
- SW-04 SPARGE WELL
- MW-01 MONITORING WELL
- PROPERTY BOUNDARY
- UST UNDERGROUND STORAGE TANKS
- 75.70 GROUNDWATER ELEVATION BASED ON A RELATIVE SITE DATUM OF 100.00 FEET
- NM NOT MEASURED
- \* NOT USED IN CONTOURING
- DRY WELL DRY, NOT USED IN CONTOURING
- APPROXIMATE GROUNDWATER CONTOUR
- APPROXIMATE DIRECTION OF SHALLOW GROUNDWATER FLOW AND GRADIENT IN FEET PER FOOT; CALCULATED USING WELLS MW-02, VW-02, AND MW-07

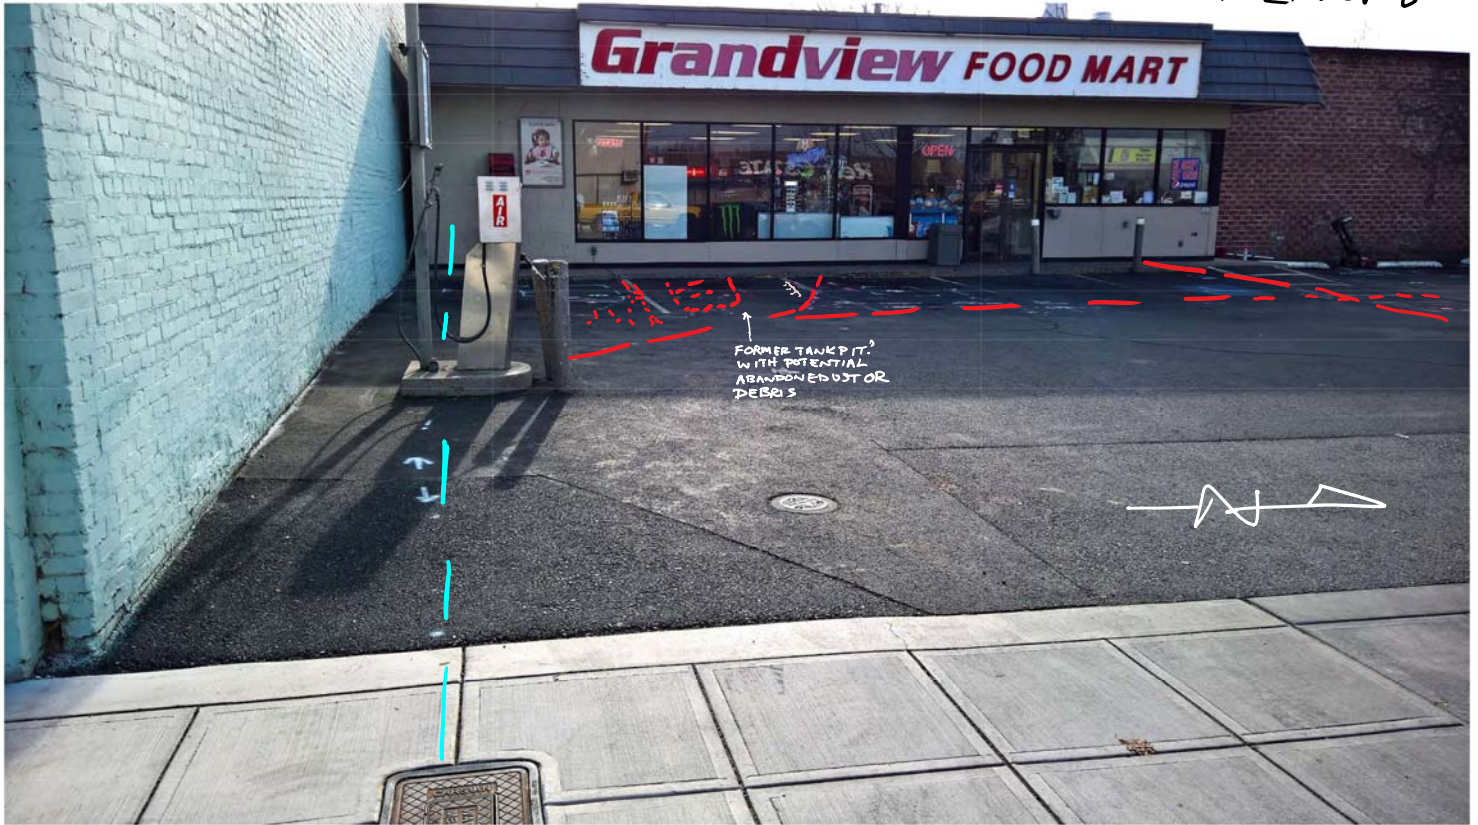
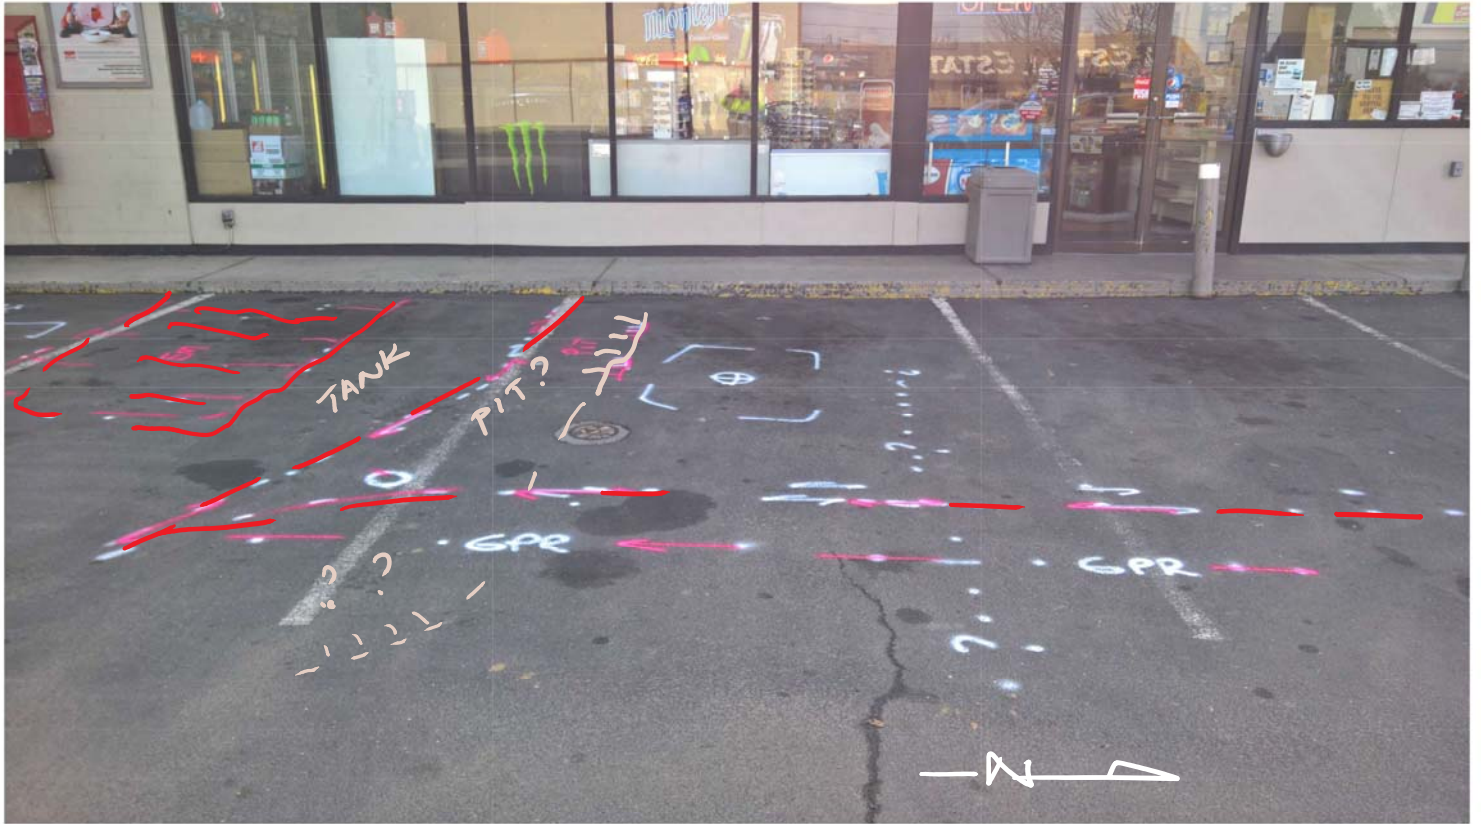
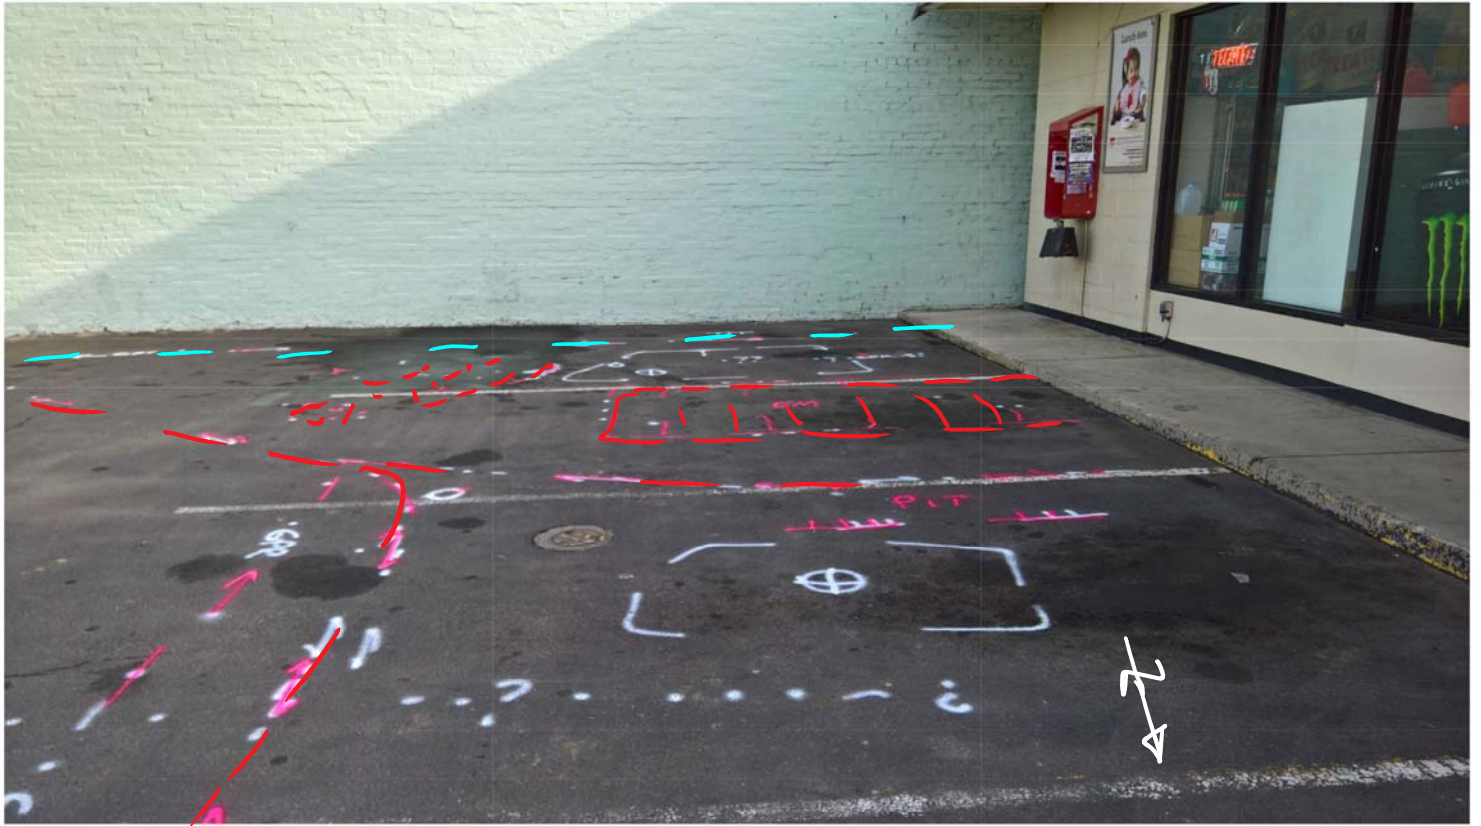
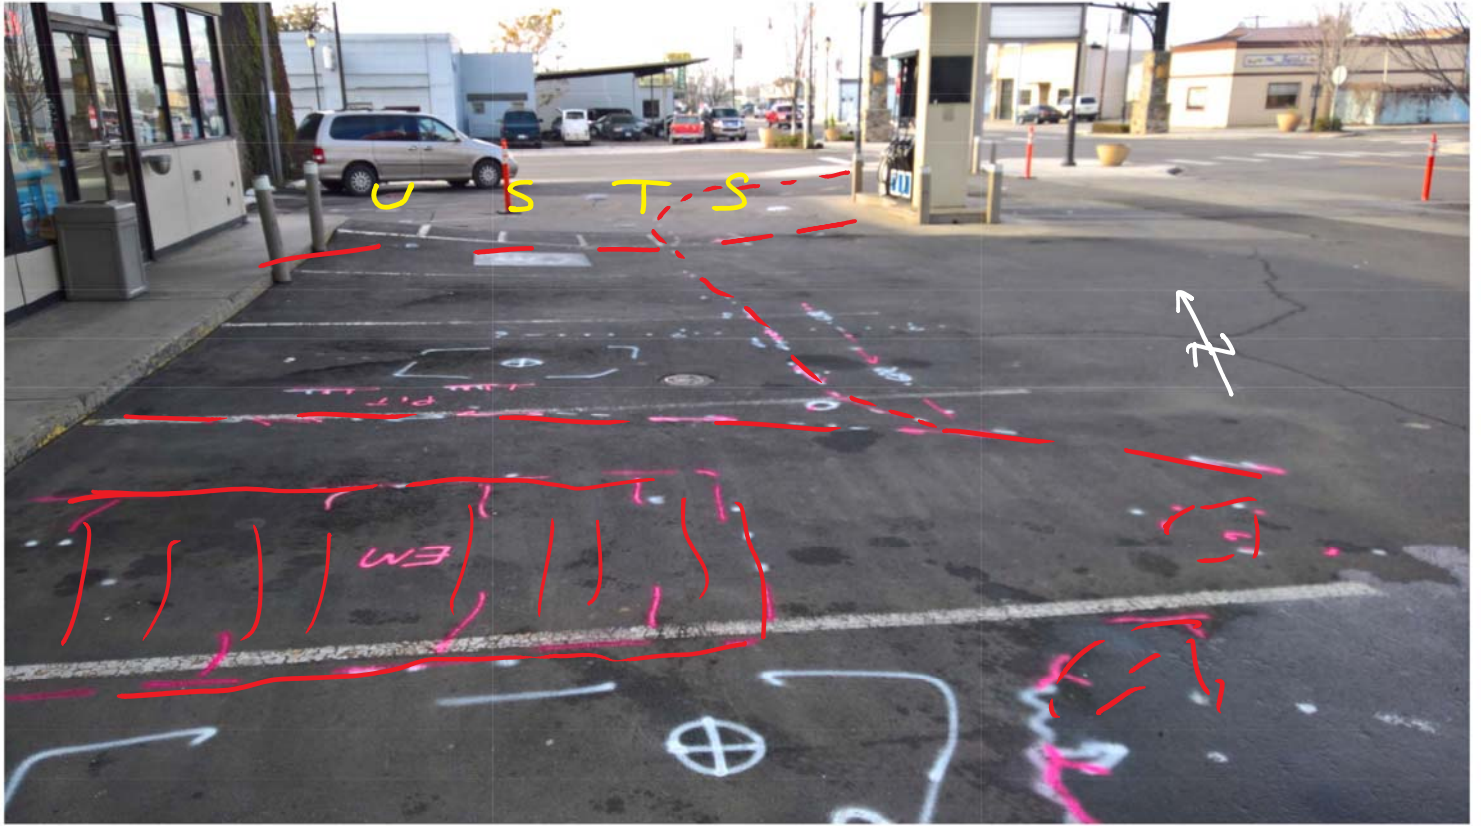
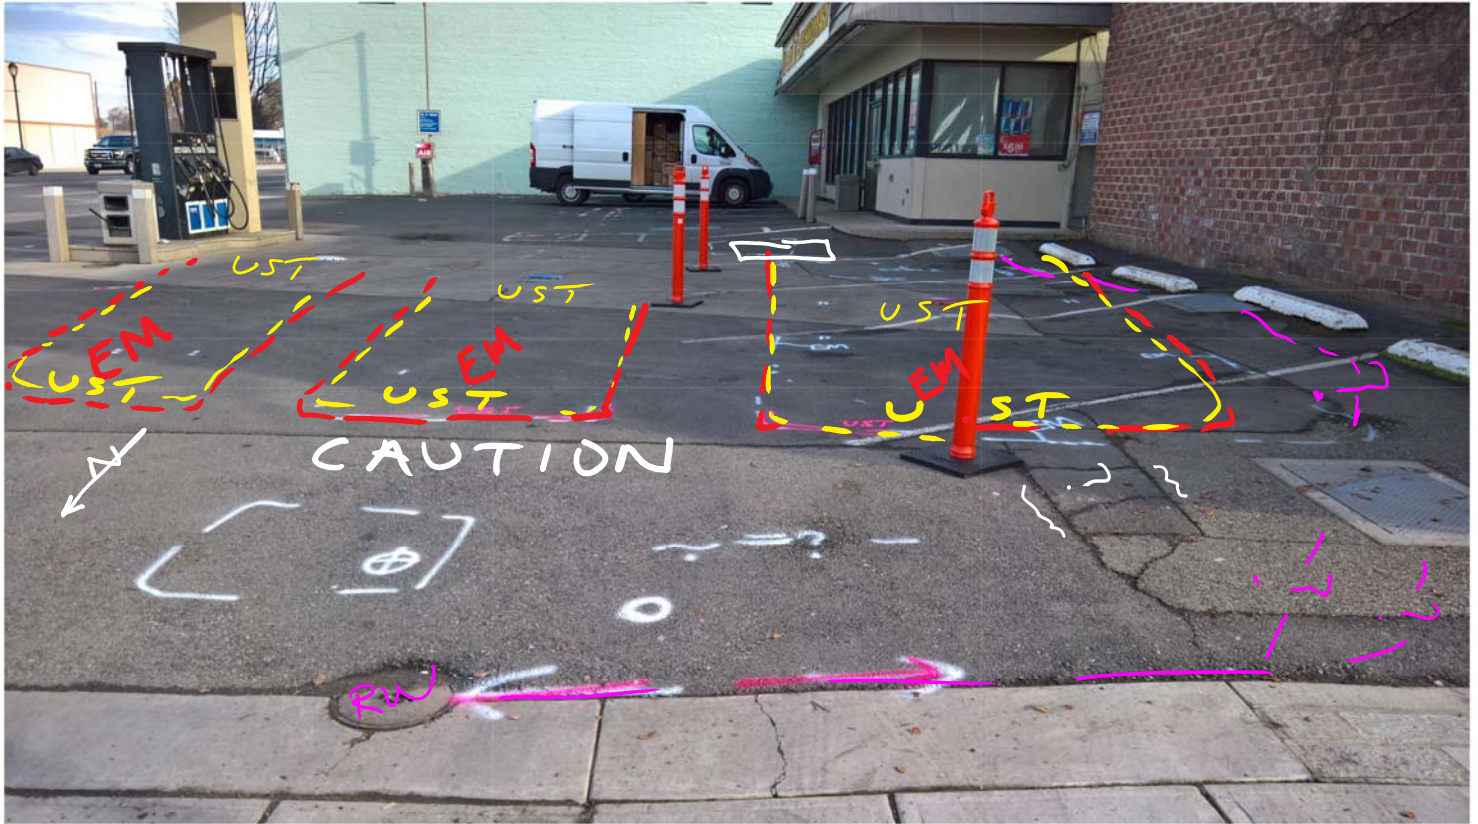
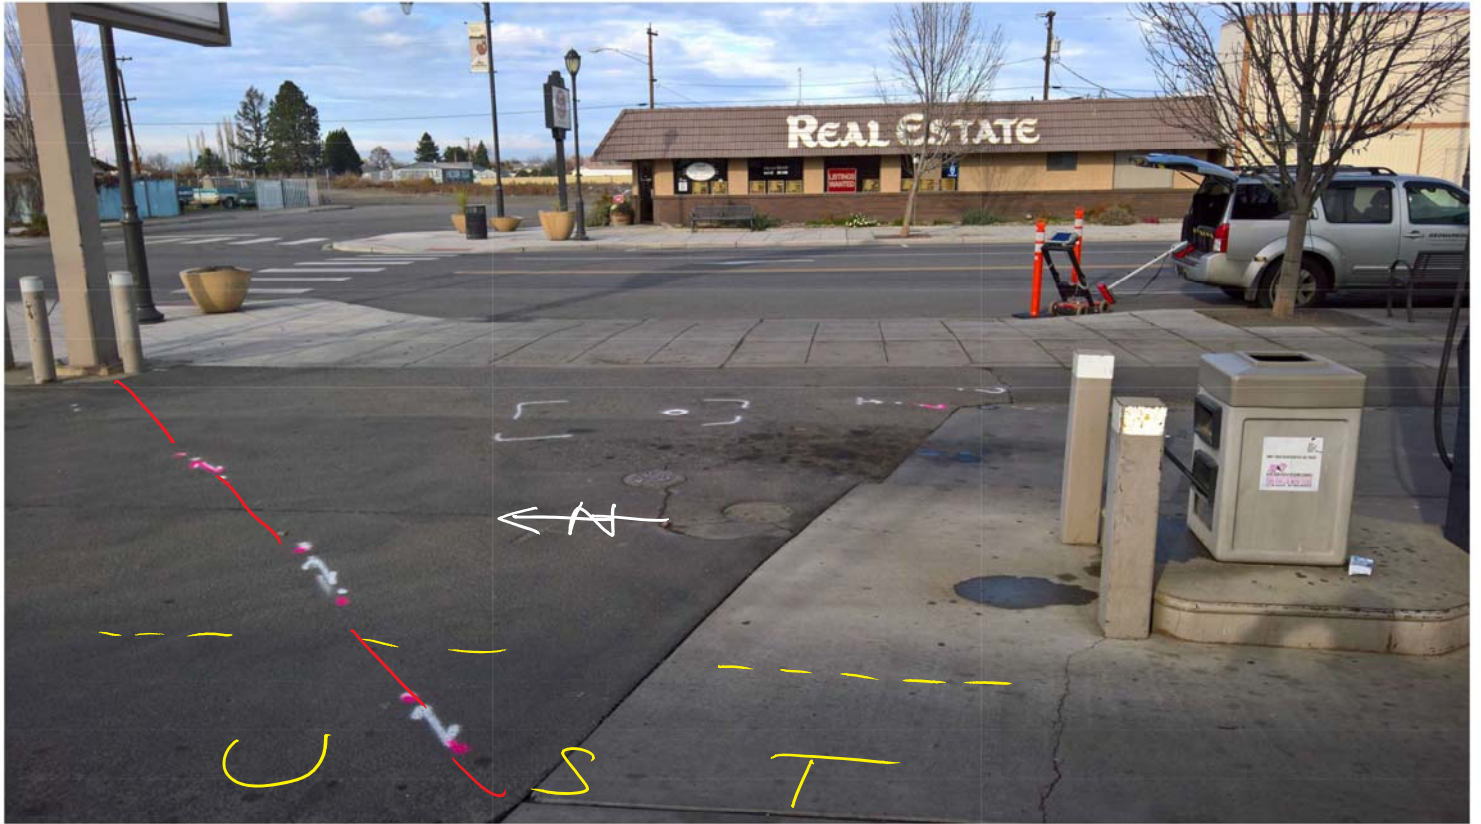
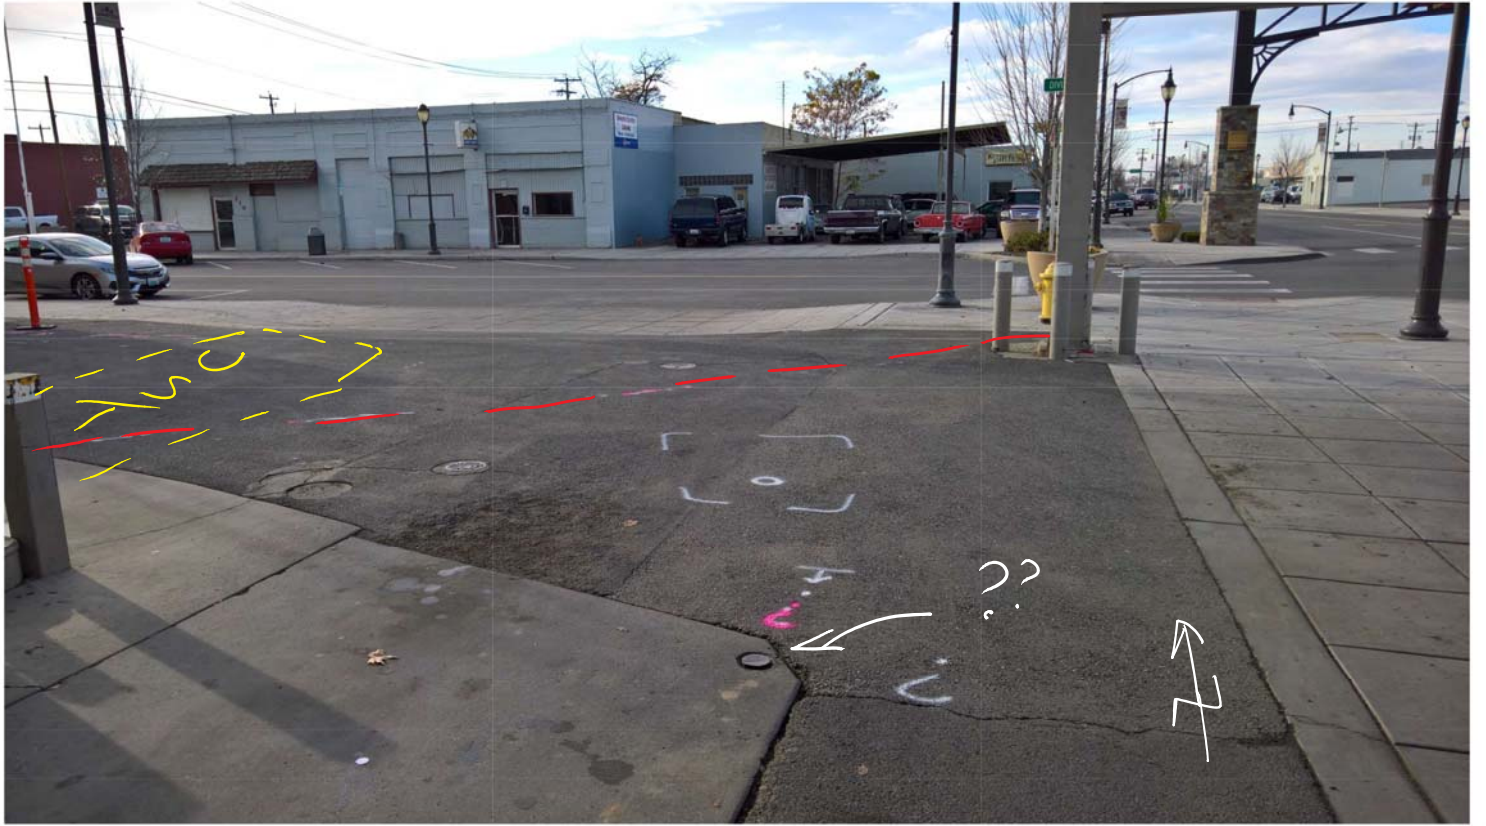
UTILITY CLEARANCES 100 WINE COUNTRY RD.  
AND GEOMARKOUT 21NOV16

**LOCATE ENERGY ISOLATION INCLUDING NG AND WATER AT THIS SITE AND SAWCUT, JACKHAMMER, AIRKNIFE DIG CAREFULLY IN EACH LOCATION. CAREFULL WHEN DIGGING OR DRILLING NEAR OR INTO ANOMALIES IN THE EVENT VAPORS ARE PRESENT. \*\*\*\*\*HANDIG NEARNATURAL GAS LINES\*\*\*\*\***
