SUBJECT Operations and Maintenance Memo – Second Quarter 2016
Former Exxon Fueling Facilities
Grant County International Airport
7810 Andrews Street Northeast
Moses Lake, Washington

At the request of ExxonMobil Environmental Services Company (EMES), on behalf of Exxon Mobil Corporation, Cardno has operated and maintained a NAPL recovery system at the Former Exxon Fueling Facilities, located at Grant County International Airport, in Moses Lake, Washington.

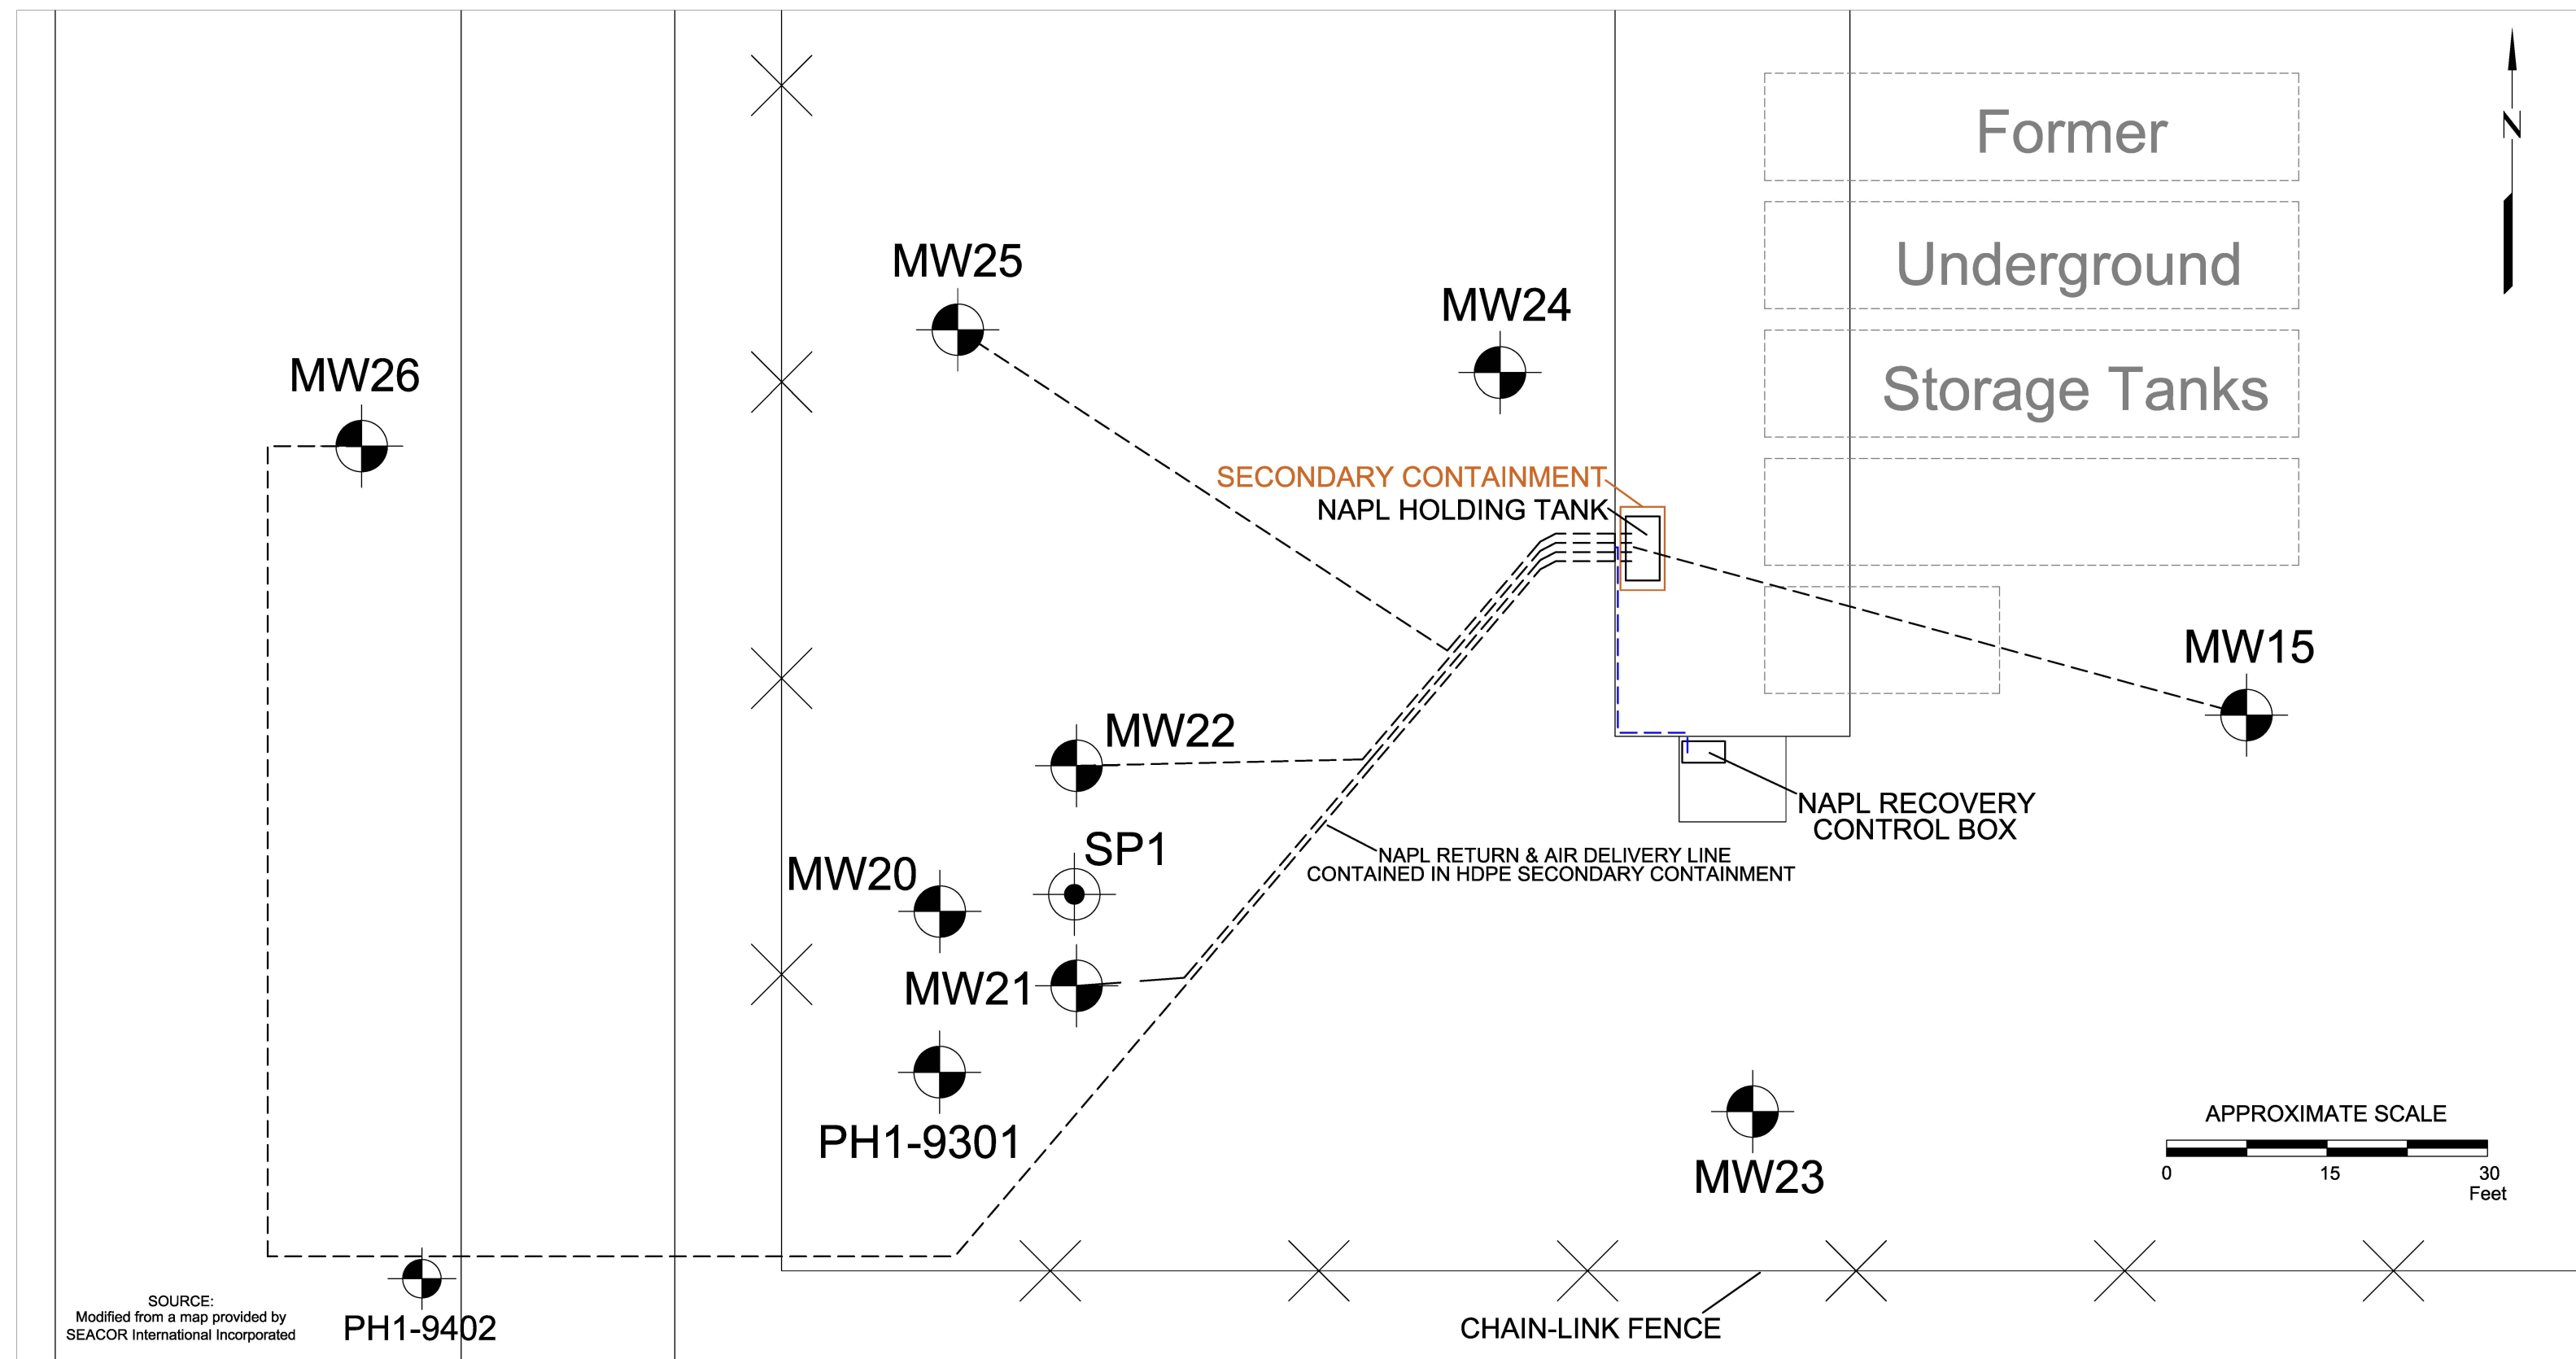
3

**REMEDIATION SYSTEM
TRENCHING MAP (PUMPHOUSE #1)**
GRANT COUNTY AIRPORT
FORMER FUELING FACILITIES
7810 Andrews Street Northeast
Moses Lake, Washington

- PH1-9402
- Groundwater Monitoring Well
- Steam Injection Well
- Remediation System Air Supply
- Remediation System Air Supply and NAPL Return Piping
