PHASE I & II ENVIRONMENTAL SITE ASSESSMENT

POTENTIAL REDEVELOPMENT PROPERTY
104-124 12TH AVENUE & 1209 E. FIR STREET
SEATTLE, WASHINGTON 98122

September 1, 2017
Project No. WES-1591

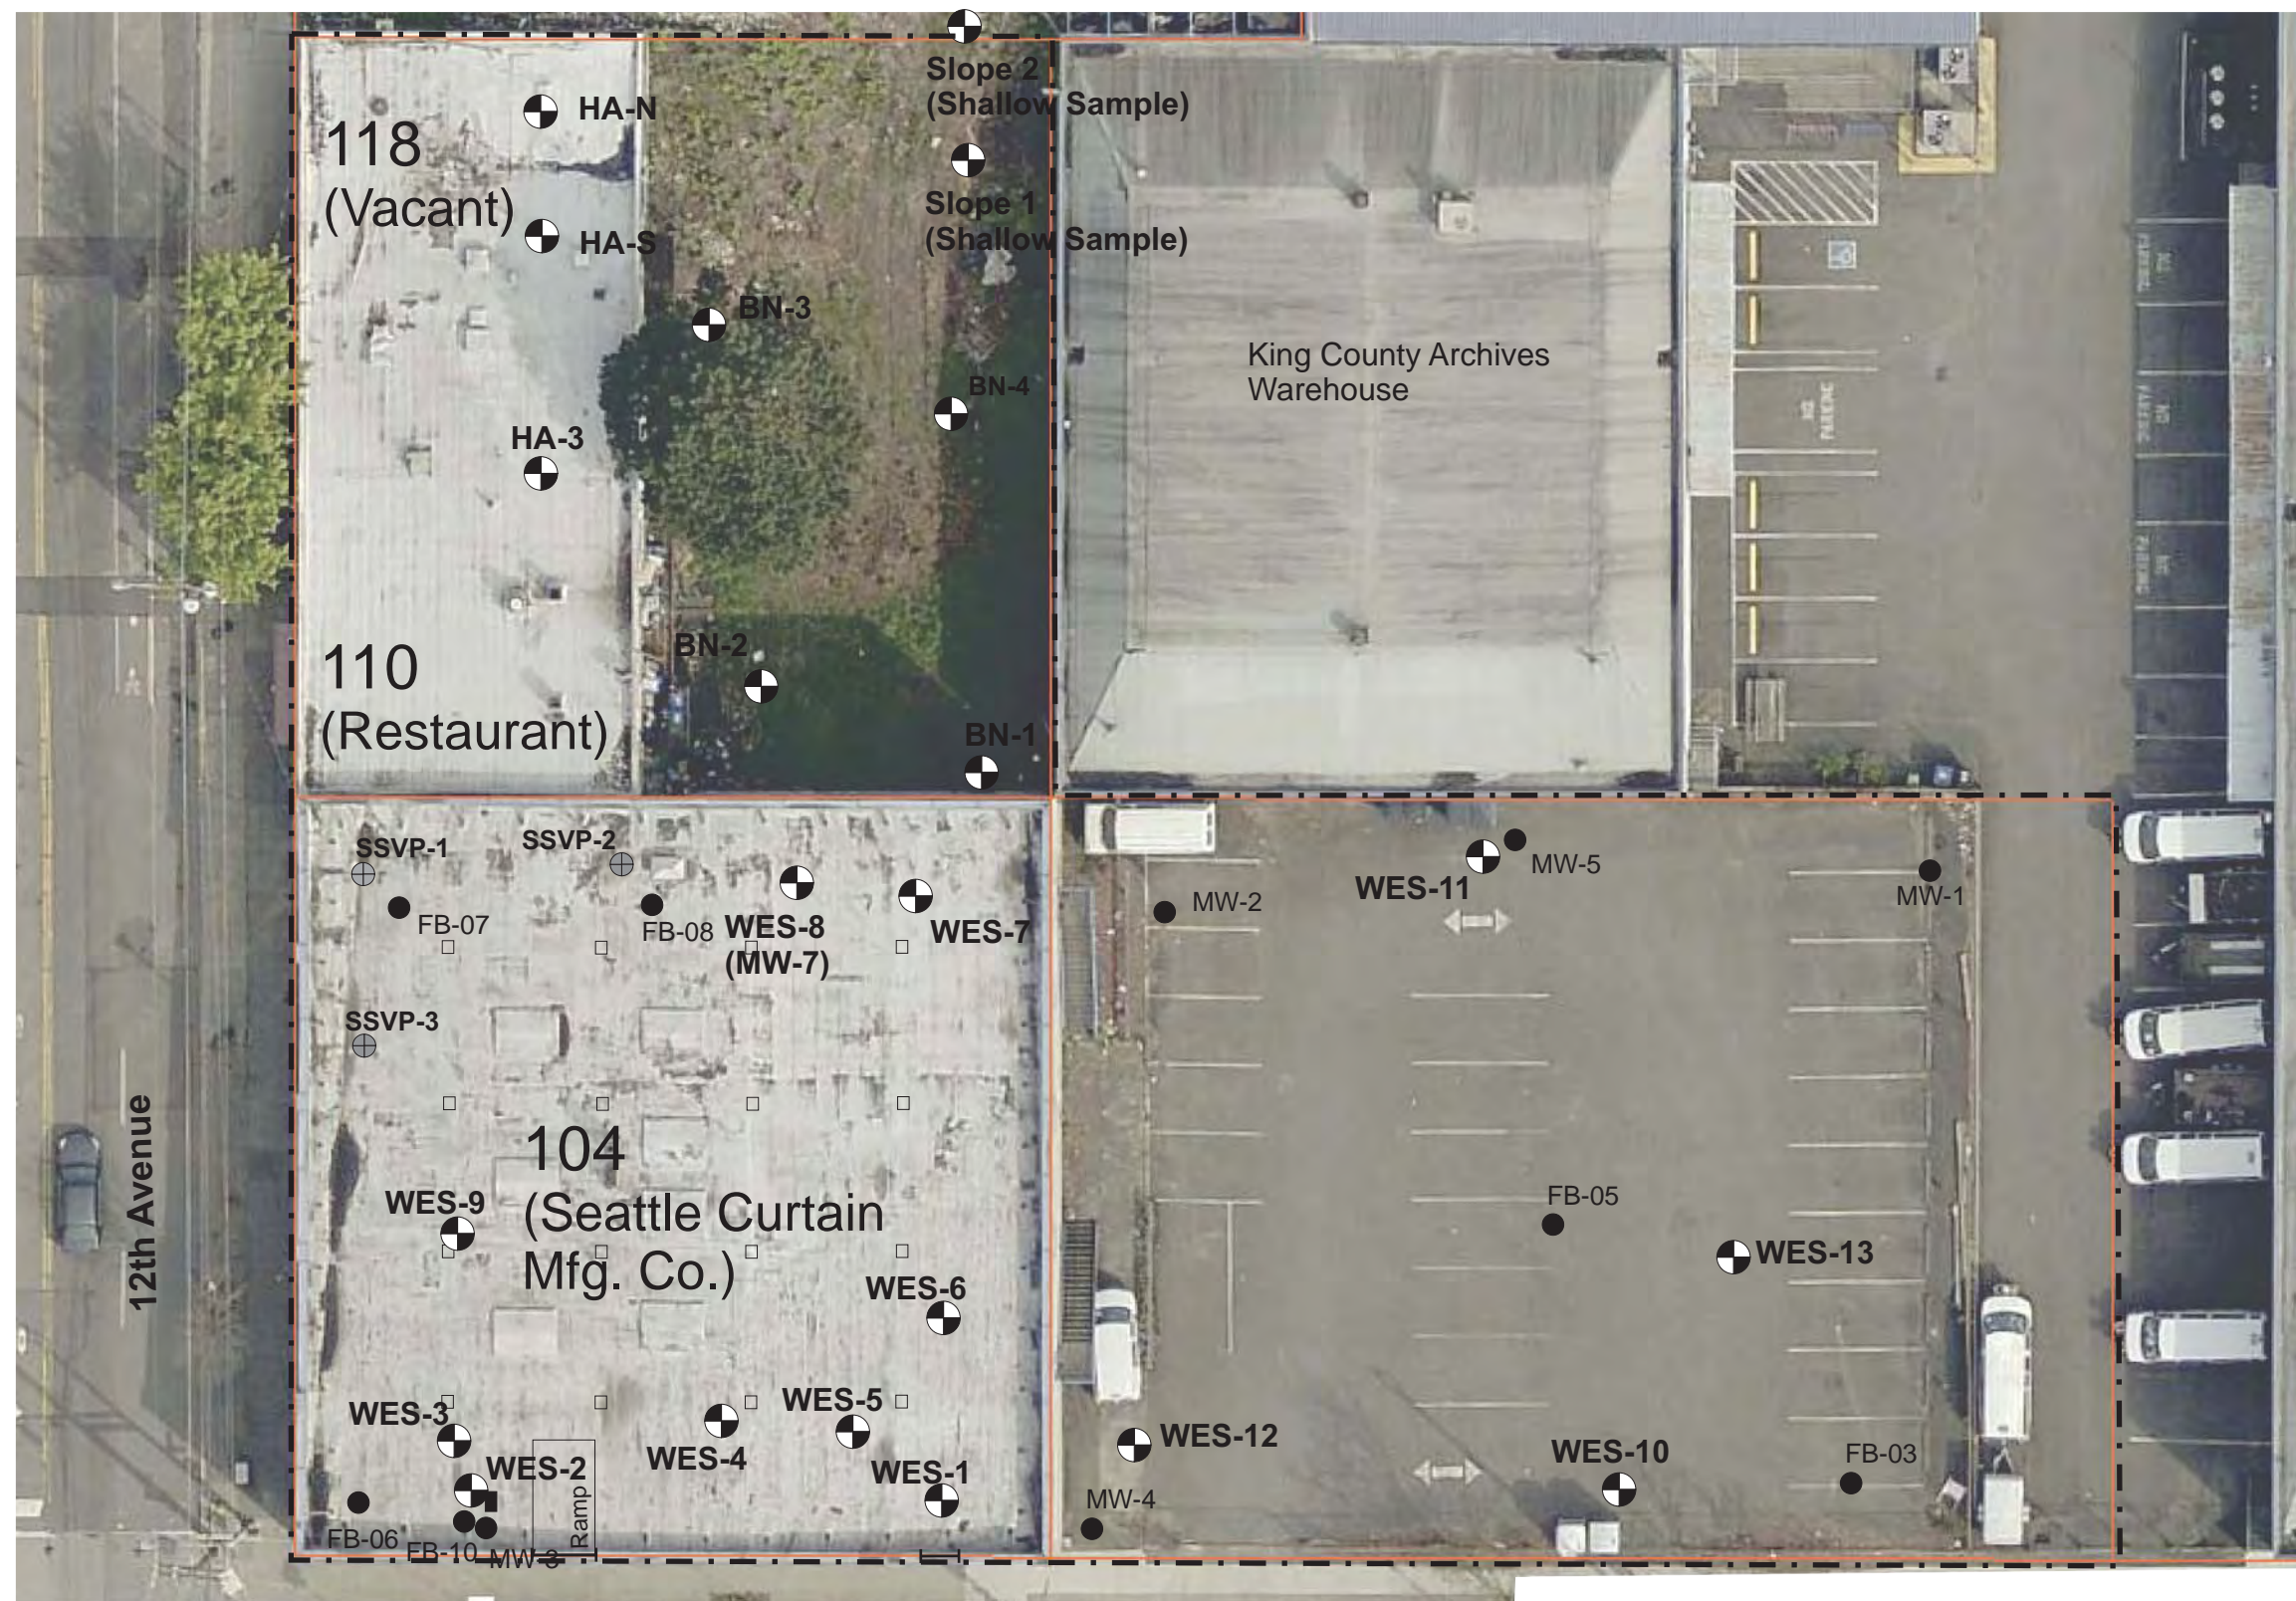
Project No.	WES - 1591
Date	Aug 15, 2017
File ID.	1591F3

- Approximate Location of Current Soil Boring or Monitoring Well
- ⊕ Approximate Location of Current Sub-Slab Soil Vapor Probe
- Approximate Location of Previously Drilled Soil Boring or Monitoring Well (Farallon, 2016)

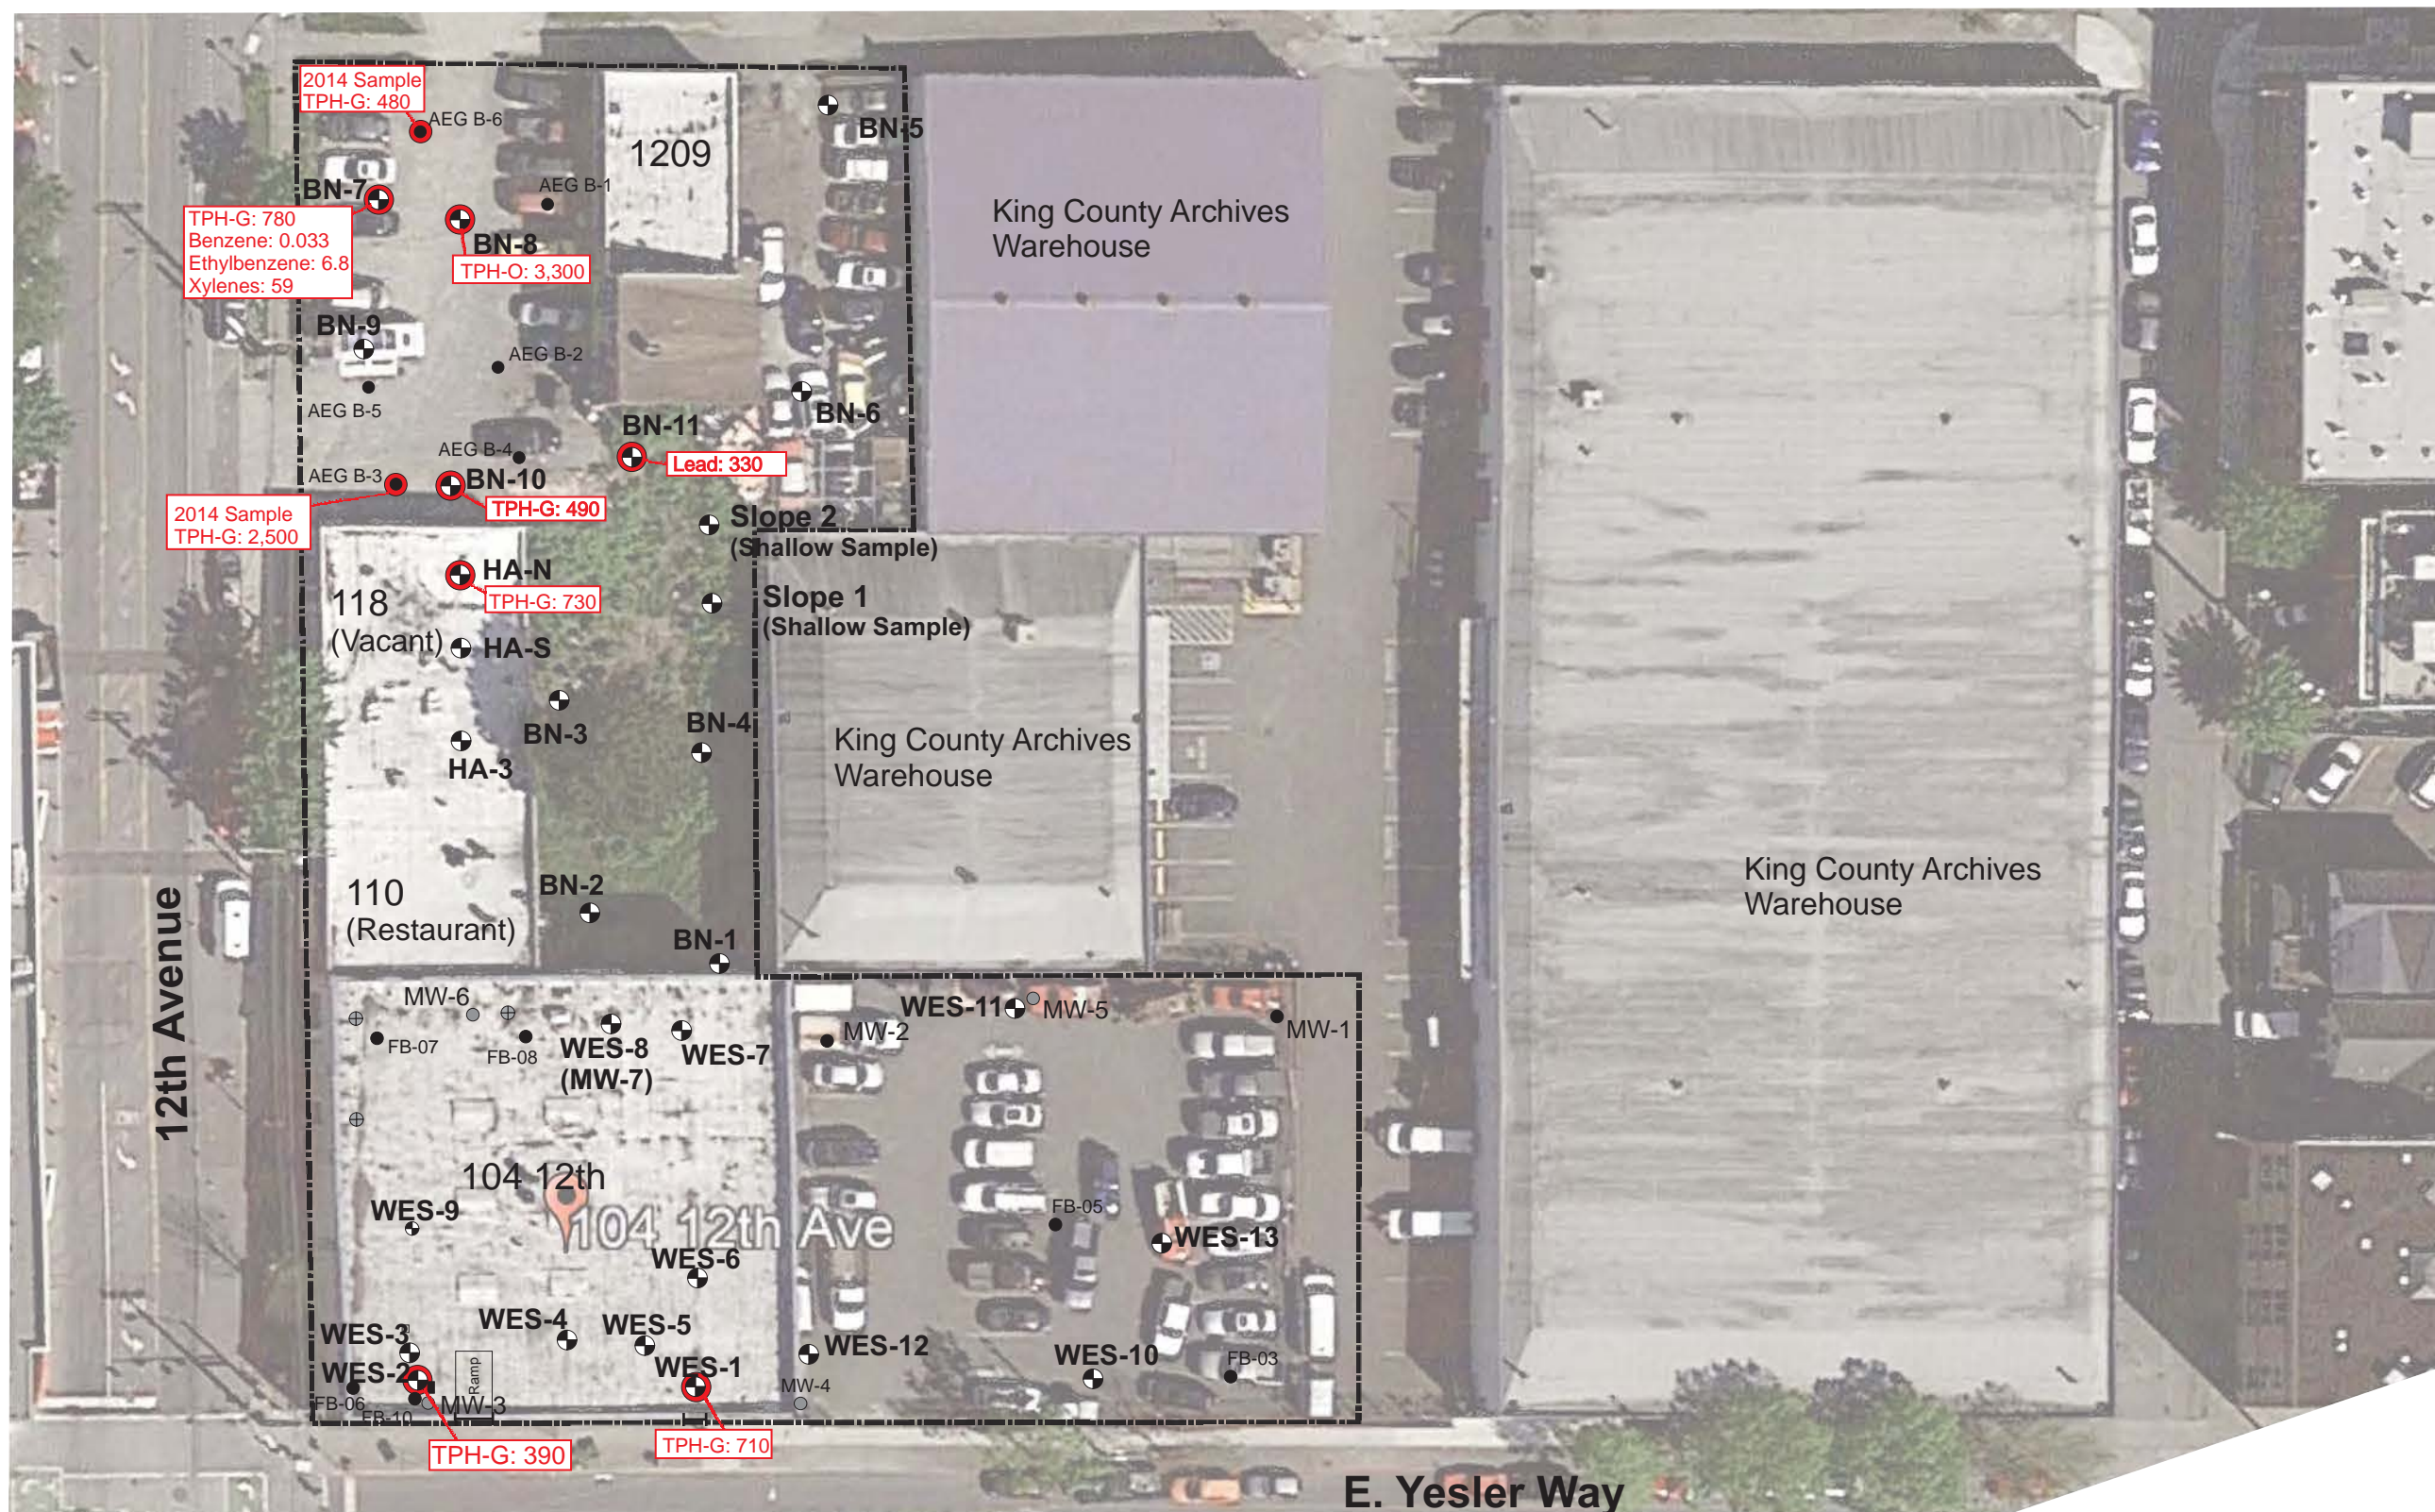
Project No.	WES - 1591A
Date	July 17, 2017
File ID.	1591AF3B

- Approximate Location of Current Soil Boring or Monitoring Well
- Approximate Location of Previously Drilled Soil Boring or Monitoring Well (2014-16)
- ⊕ Investigation location where soil sample was not obtained or data not available

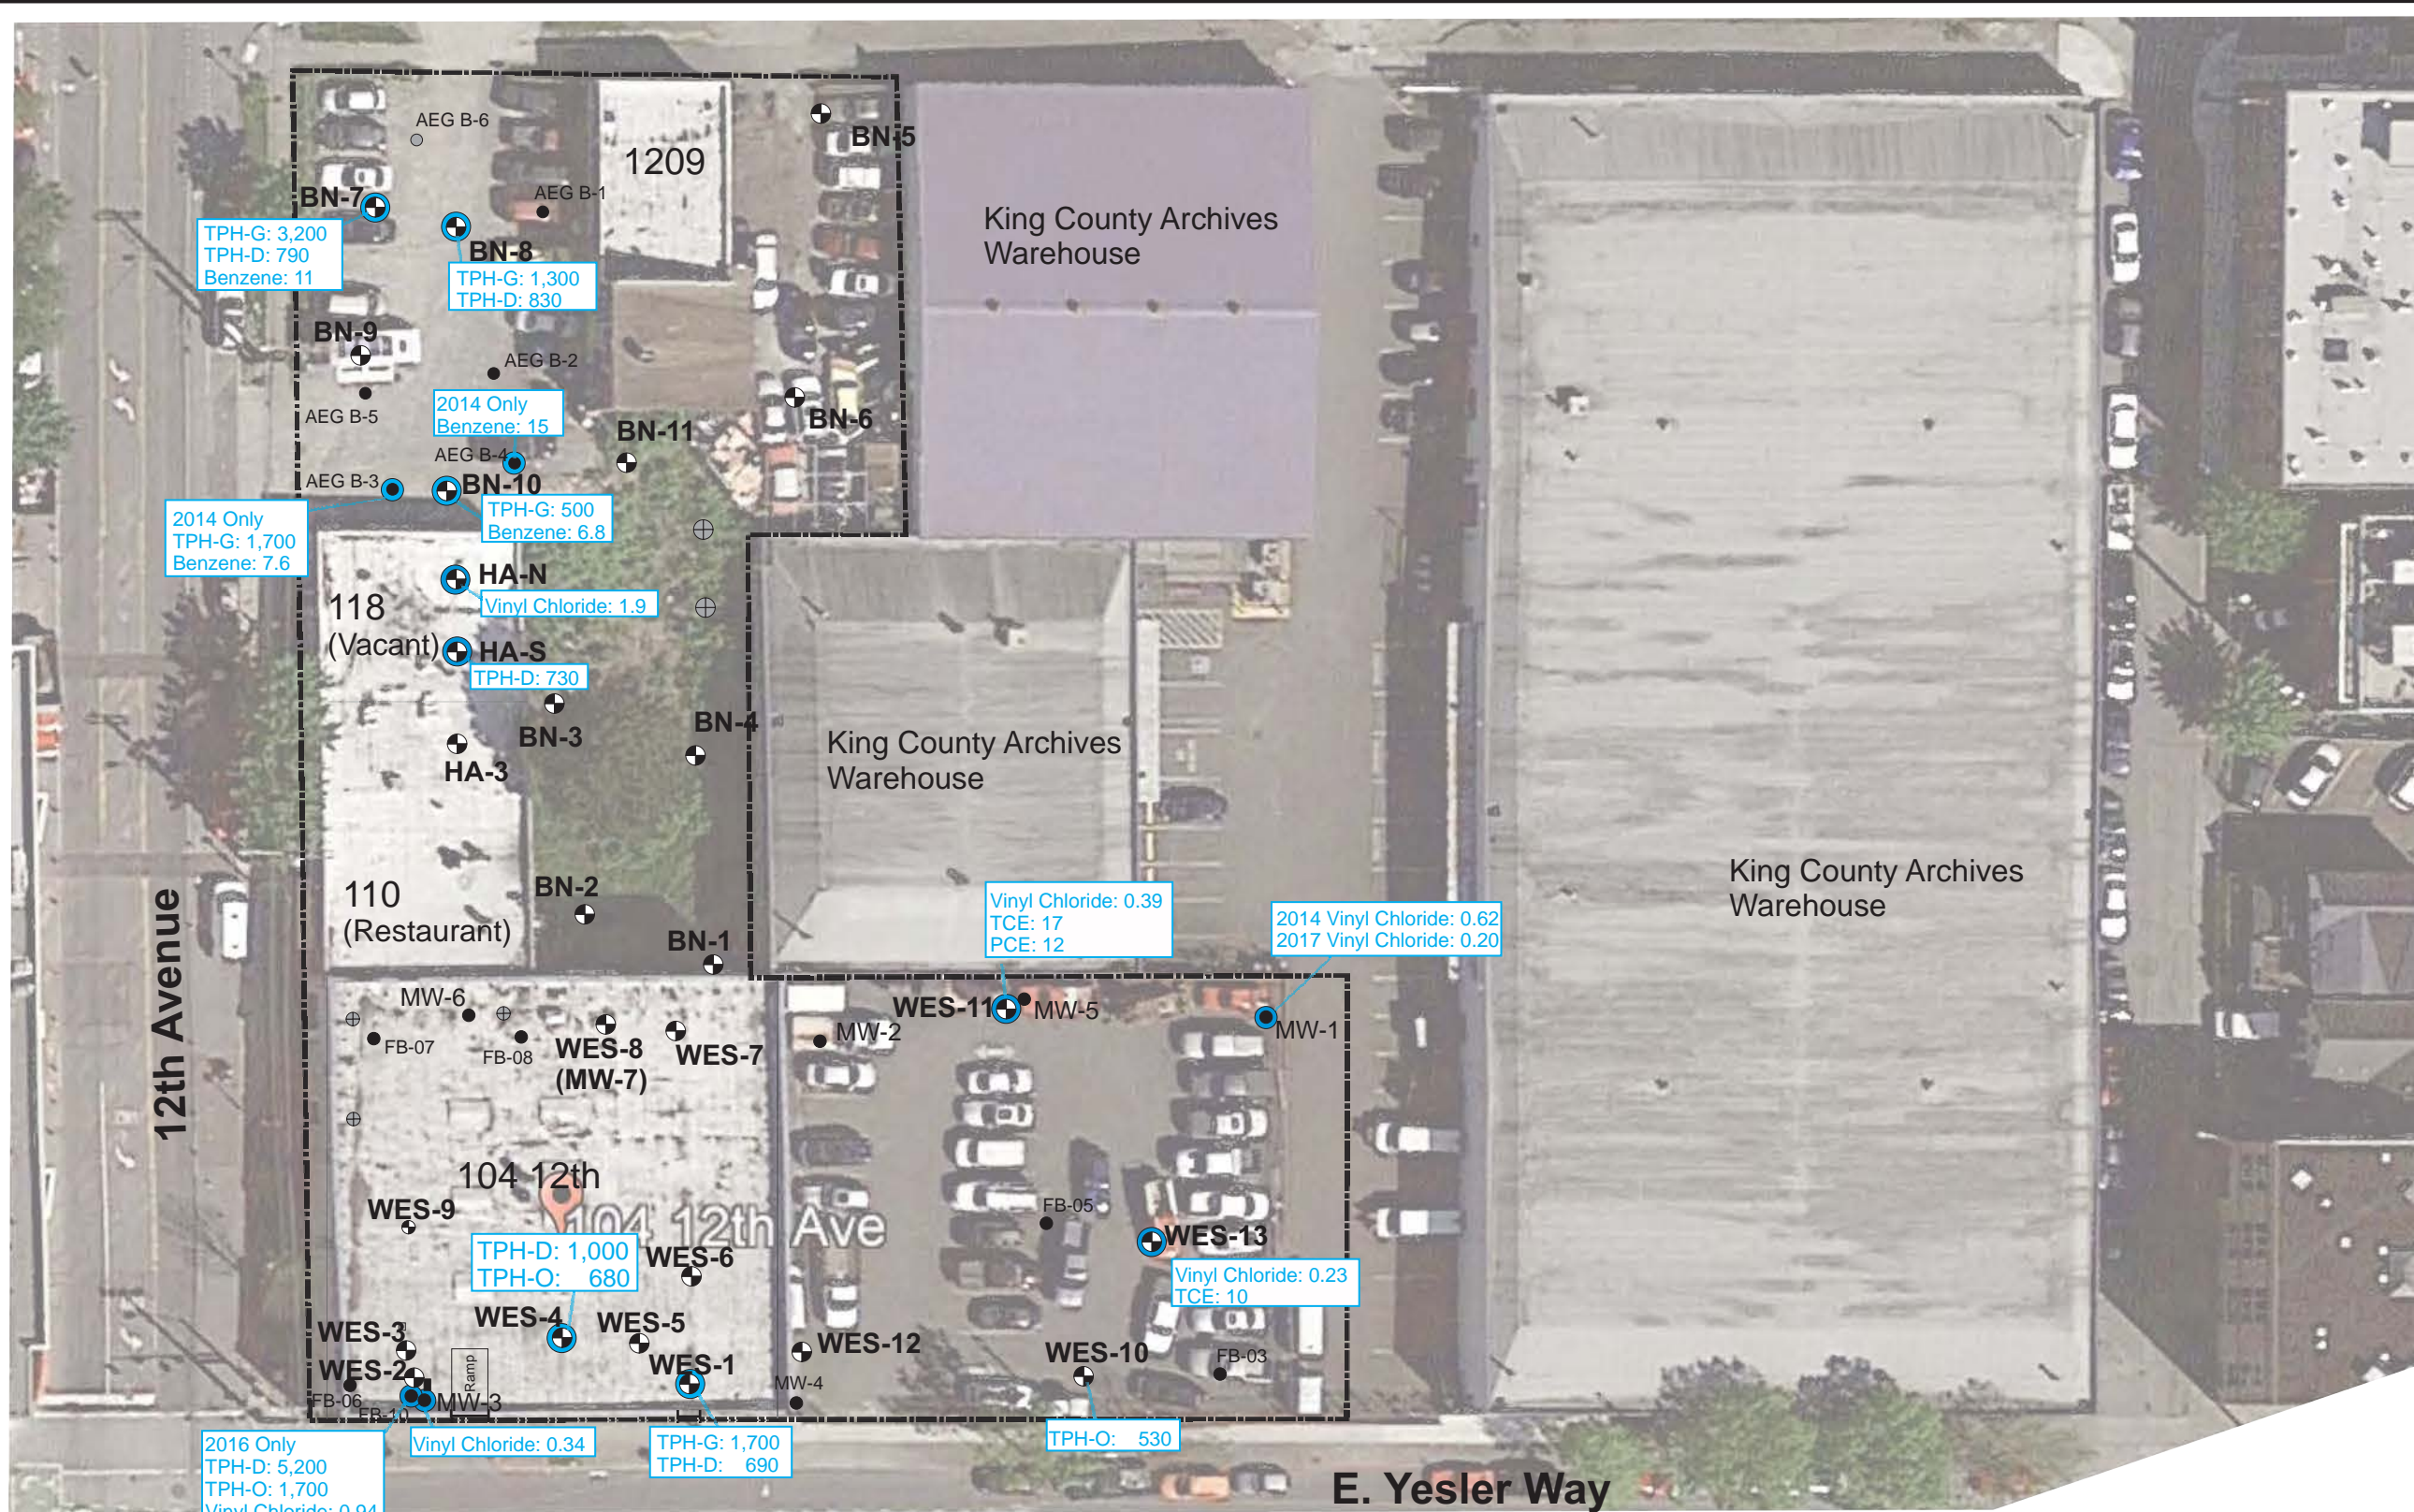
Project No.	WES - 1591
Date	Aug 15, 2017
File ID.	1591F4

- Approximate Location of Current Soil Boring or Monitoring Well
- Approximate Location of Previously Drilled Soil Boring or Monitoring Well (2014-16)
- ⊕ Investigation location where groundwater sample was not obtained

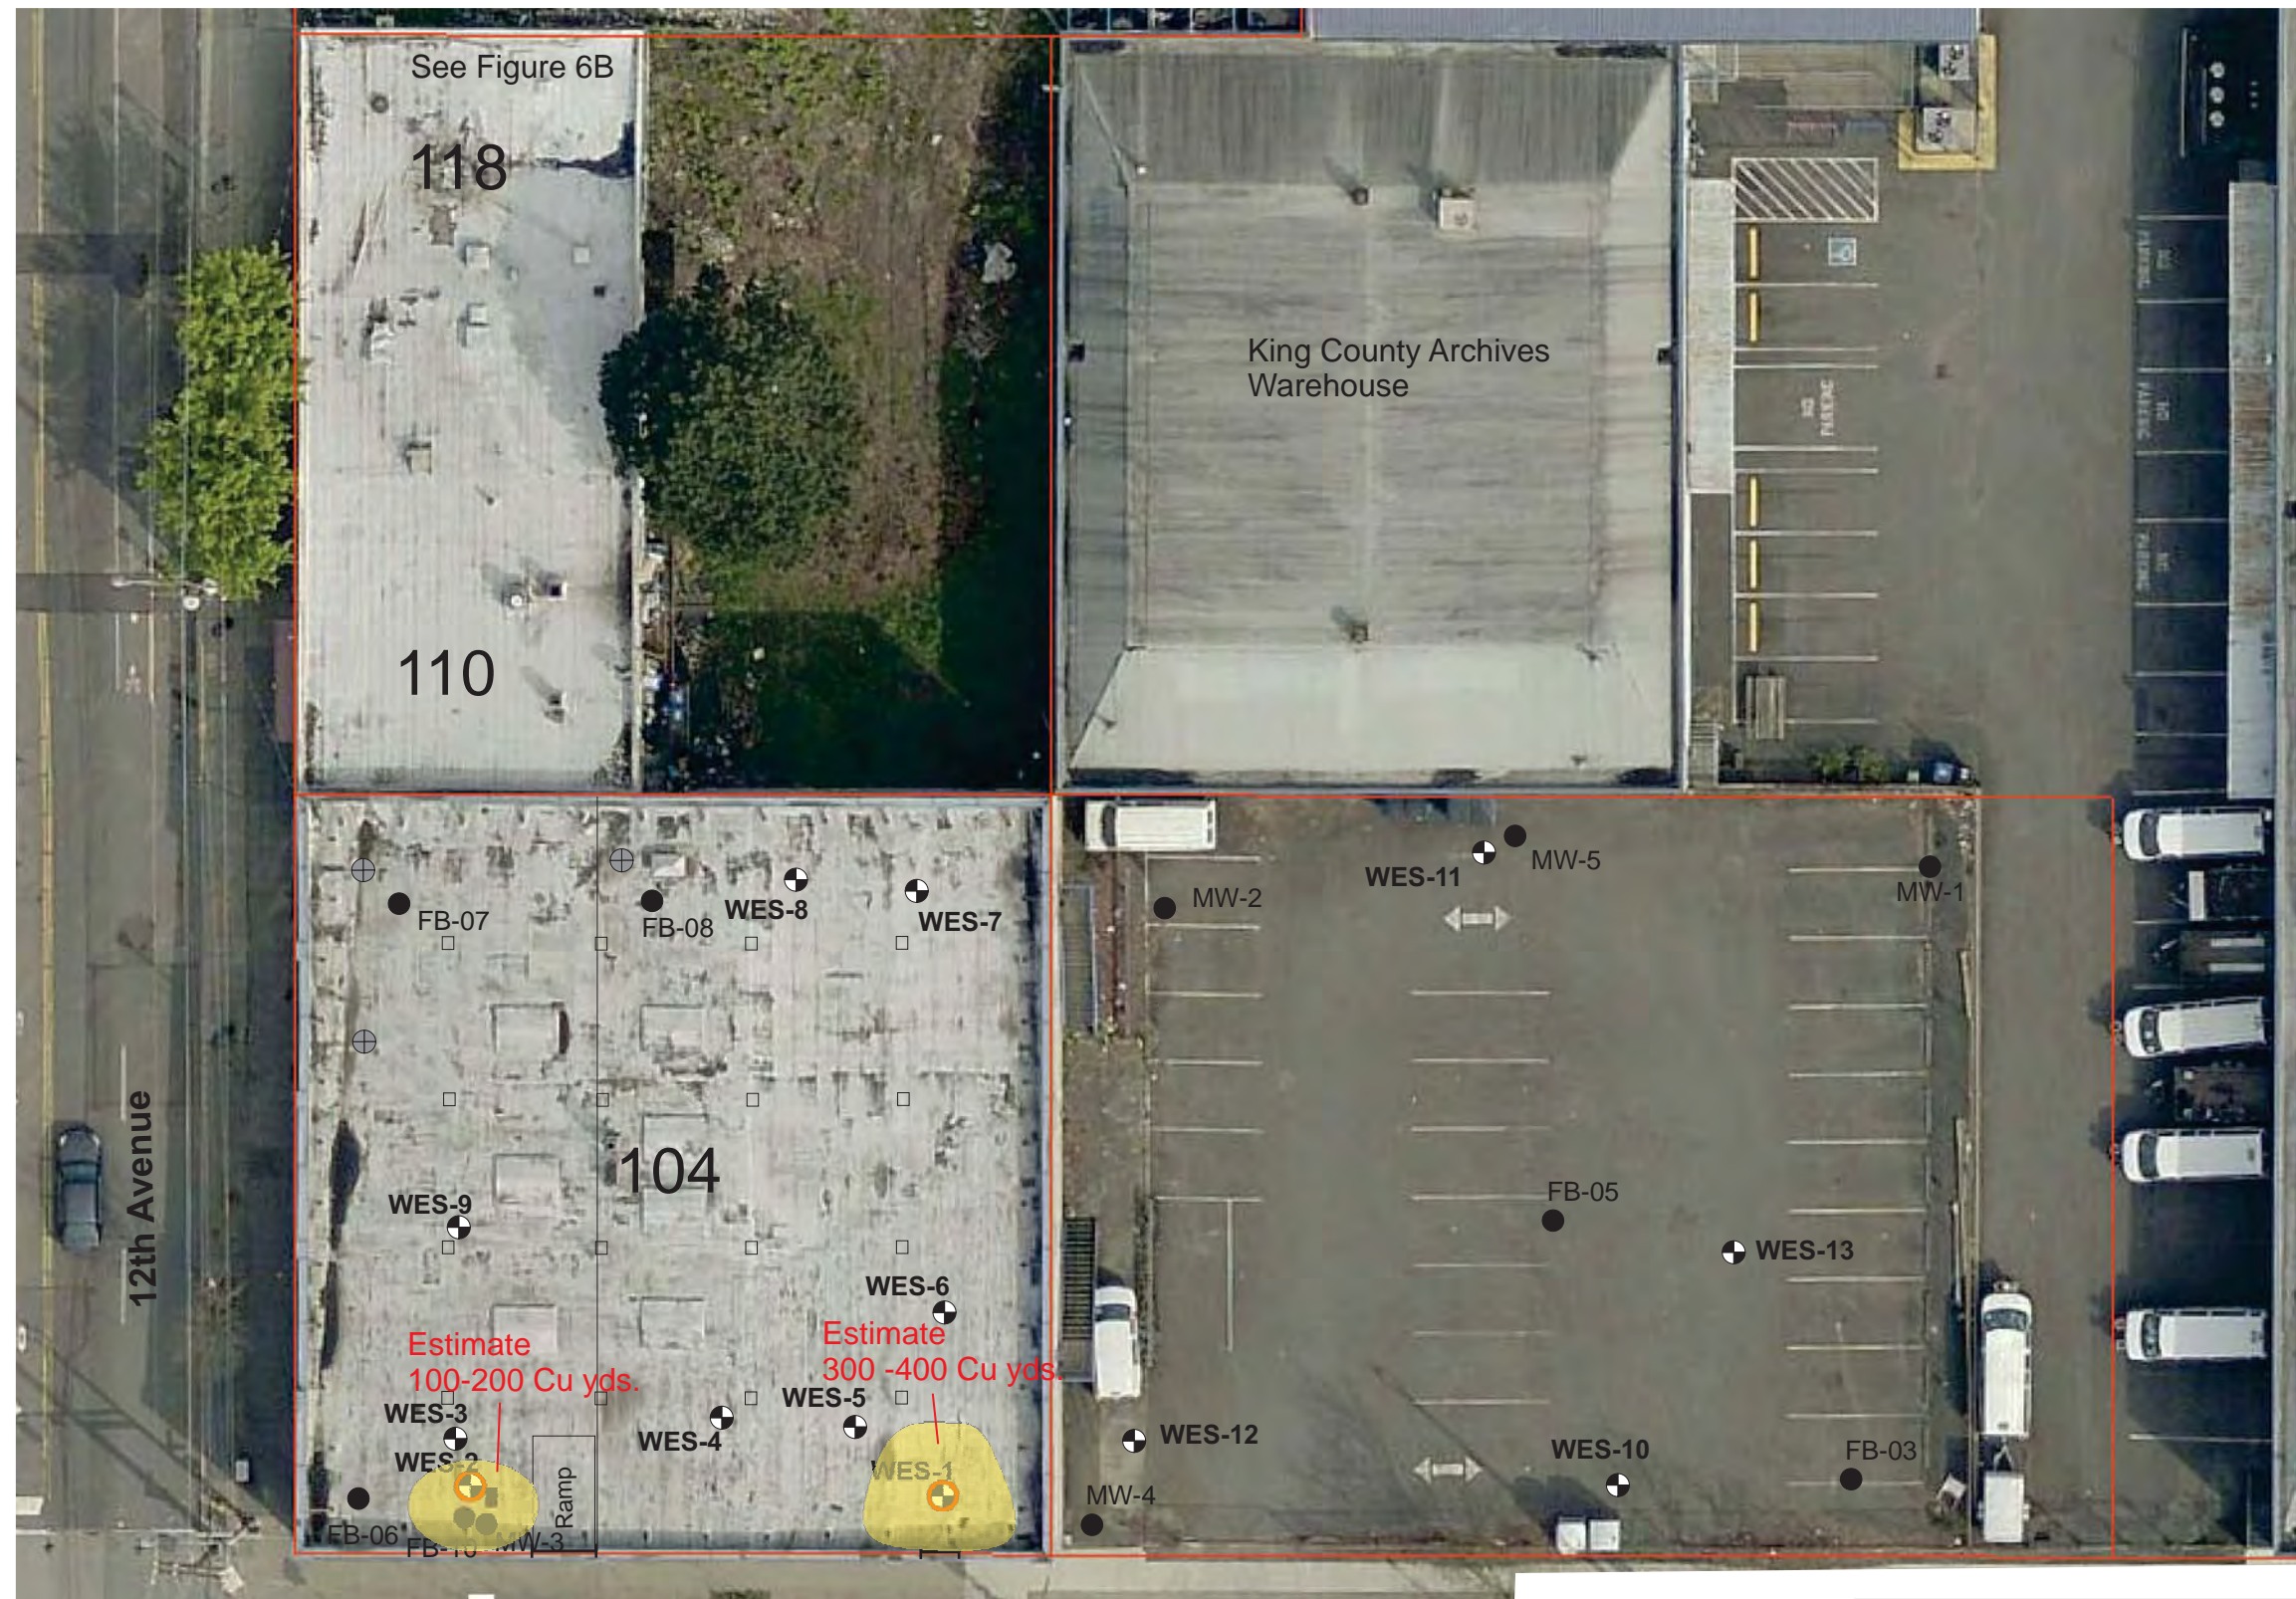
Figure 6A - South Parcel Estimated Soil Cleanup Areas	
Proposed Redevelopment Property 104 12th Avenue Seattle, WA	
Project No.	WES - 1591
Date	July 17, 2017
File ID.	1591F6A
WHITMAN Environmental Sciences

- Approximate Location of Current Soil Boring or Monitoring Well
- Approximate Location of Previously Drilled Soil Boring or Monitoring Well (2016)
- ⊕ Location with Soil Concentrations of Petroleum Above MTCA Method A Cleanup Level
- Likely Areas of Soil Cleanup

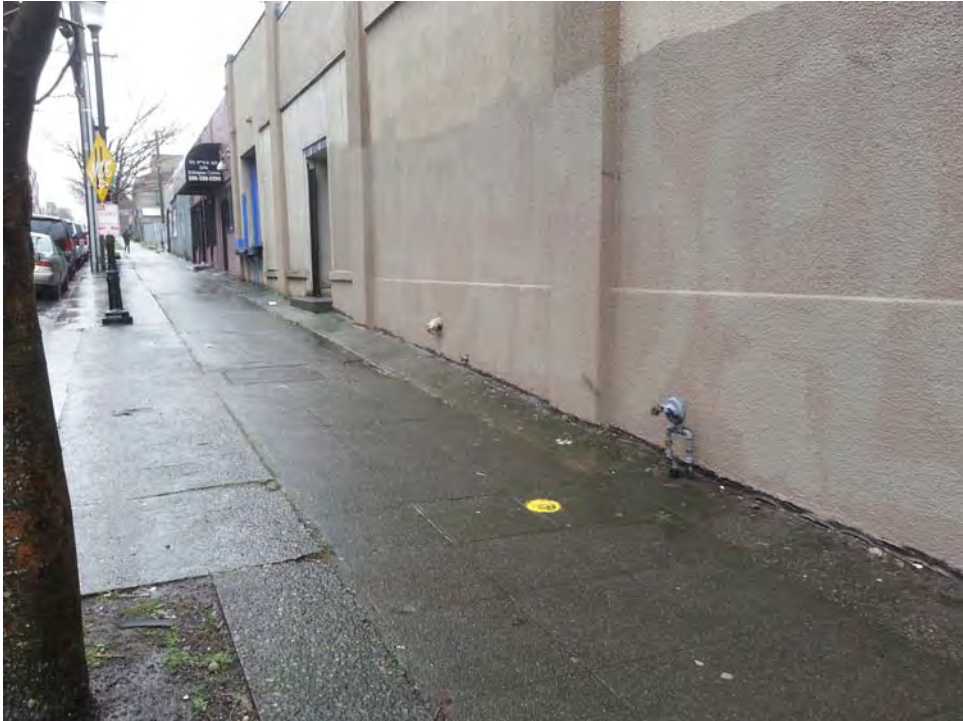
1.) View of the west side of the 104 12th Avenue building, with 110 12th building in the background. Awning covers the entry to restaurant at 110 12th.

The building addressed 104 12th Avenue is a two-story reinforced concrete building of about 10,000 square feet in area, built in 1926. The building has been used by the Seattle Curtain Manufacturing Co. since at least 1966. The building is outdated but remains in fair condition. The main entrance and truck dock is near the northwestern corner of the building along 12th Avenue. An entrance and truck ramp on the south side of the building, along Yesler, accesses the basement. The building has large work areas where cloth panels can be sewn, offices and storage areas. The basement is no longer used for manufacturing and consists of somewhat cluttered storage for materials and old equipment. The building is heated by a central gas-fired boiler enclosed in an isolated room in the basement. There are no reported or observed underground storage tanks associated with the building.

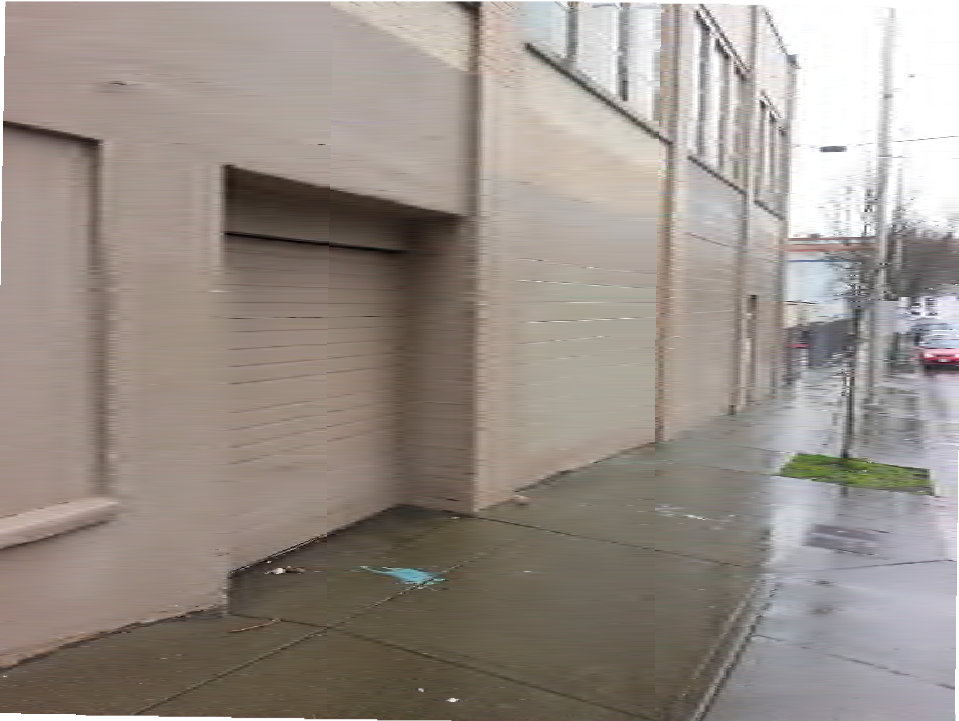
2.) View of the south side of thq 104 12th Avenue building, along Yesler Way.

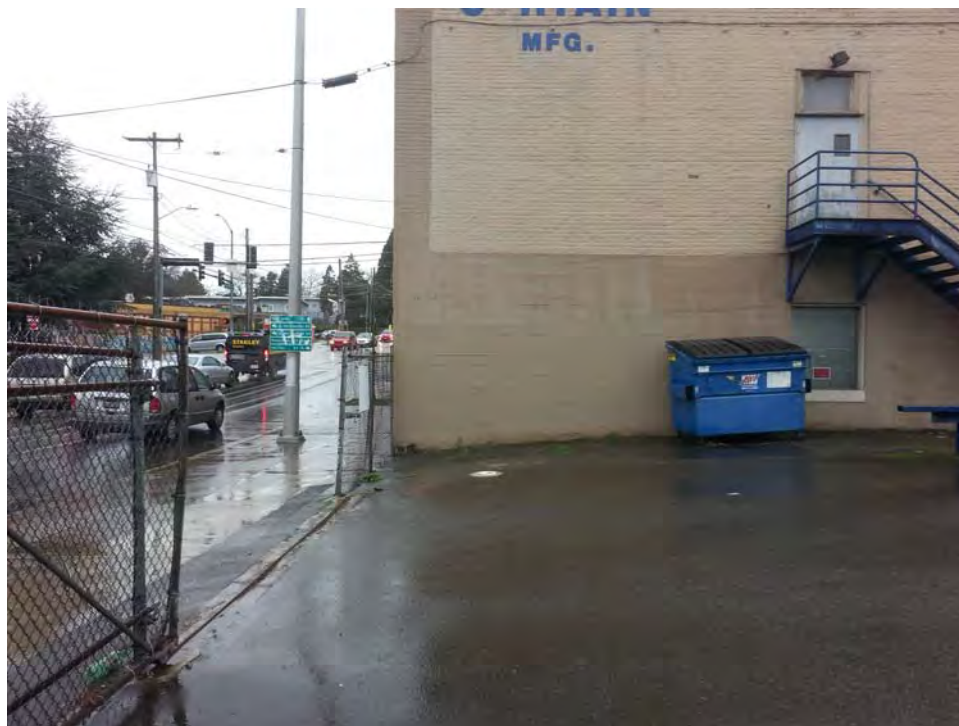
- 4.) View of the 104 12th Avenue building from the parking lot. Typical waste management dumpster and monitoring well visible on the pavement near the corner of the building.

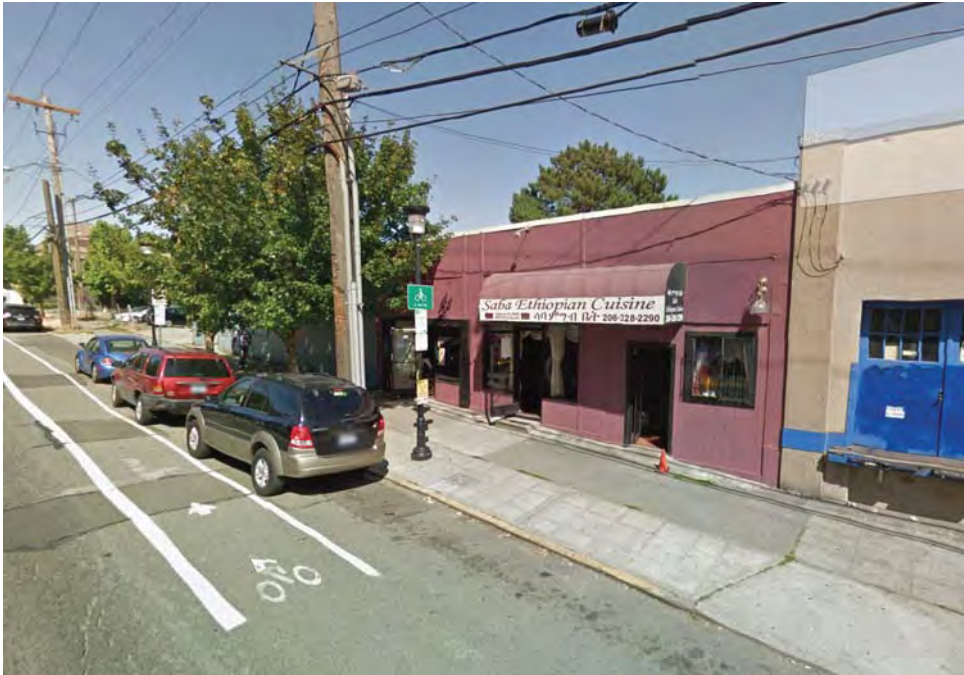
5.) View of the restaurant at 110 12th Avenue.

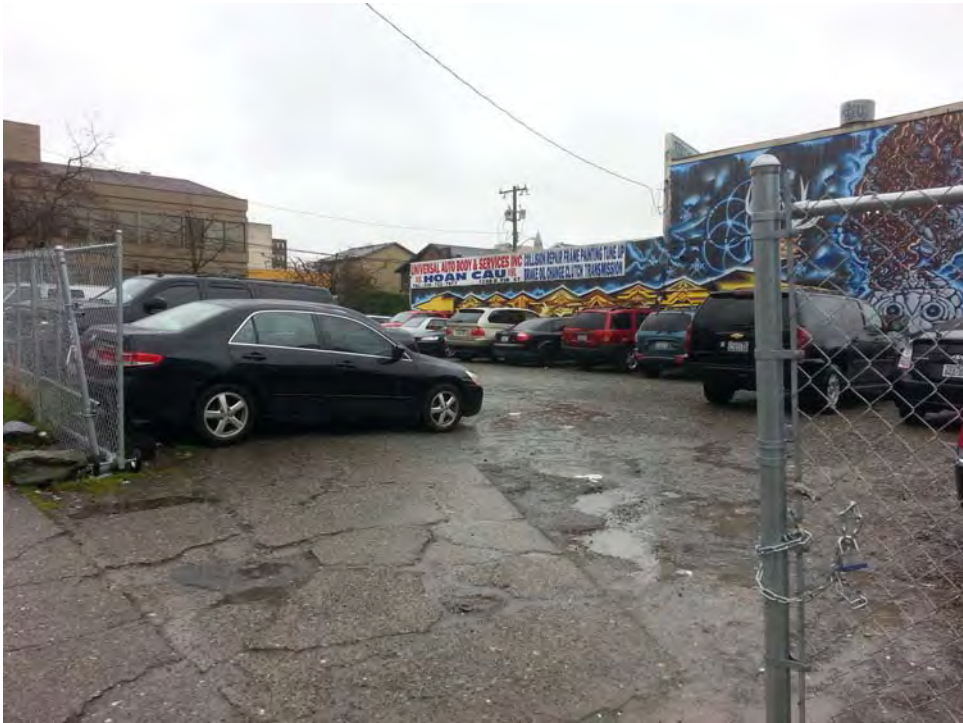
7.) View of the north parking lot at 124 12th Avenue, a former gas station.

From 1976 to a 1987-88 edition, Polk directories show the service station at 130 12th Avenue as Frank's Twelfth Avenue Station, or Frank's Auto Repair. An aerial photograph from 1985 shows the service station lot filled with cars and debris in a disorderly manner. The service garage at 1209 E. Fir had a few cars near it, but appeared to be more organized. In a 1989 aerial photograph, the service station was removed and the lot appeared mostly empty. Assessor's records indicate the building was then demolished in July of that year. There is no information about tank removal as part of the demolition, but a 2014 ground penetrating radar (GPR) survey by Associated Environmental Group, Inc. found no evidence of underground tanks. The GPR survey identified a formerly excavated area near the center of the parking lot. This location may have been the former underground storage tank basin.

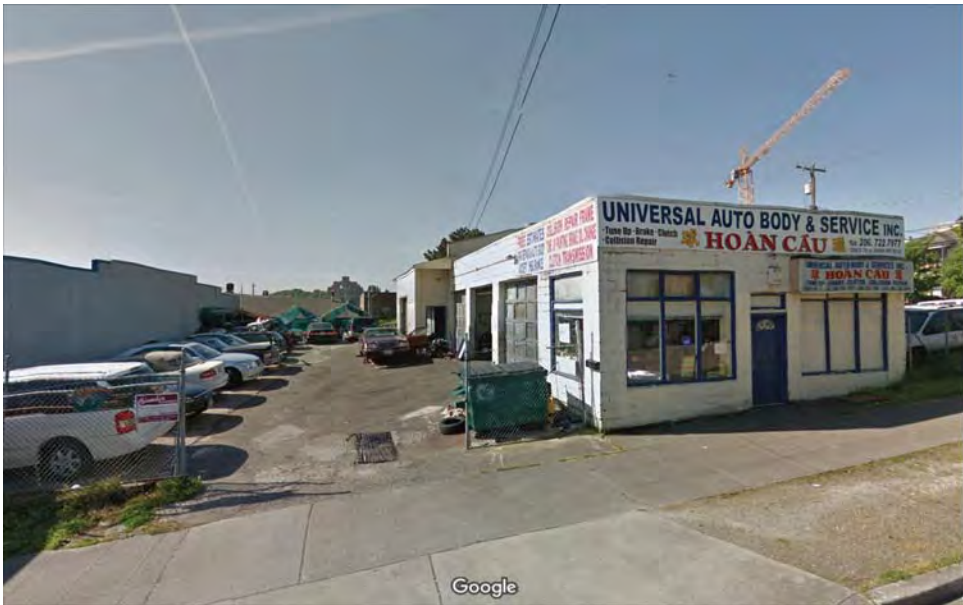
8.) View of the auto repair shop at 1209 E. Fir Street and parking lot to the east of the building.

The building addressed 1209 E. Fir Street is located on the northern-most parcel of this property. The parcel itself is addressed 124 12th Avenue in current King County Assessor's records. It is an older auto repair garage of masonry block construction built in about 1949. There is a small office area and two garage bays used for auto repair. A storage room addition was built on the south end of the structure in about 1988. That addition is now used as a paint booth for auto body repairs. The building has no reported or observed below-ground hydraulic lifts or underground storage tanks. There is limited amount of paved parking on the east side of the building with a storm drain catch basin fitted with a crude oil/water separator.

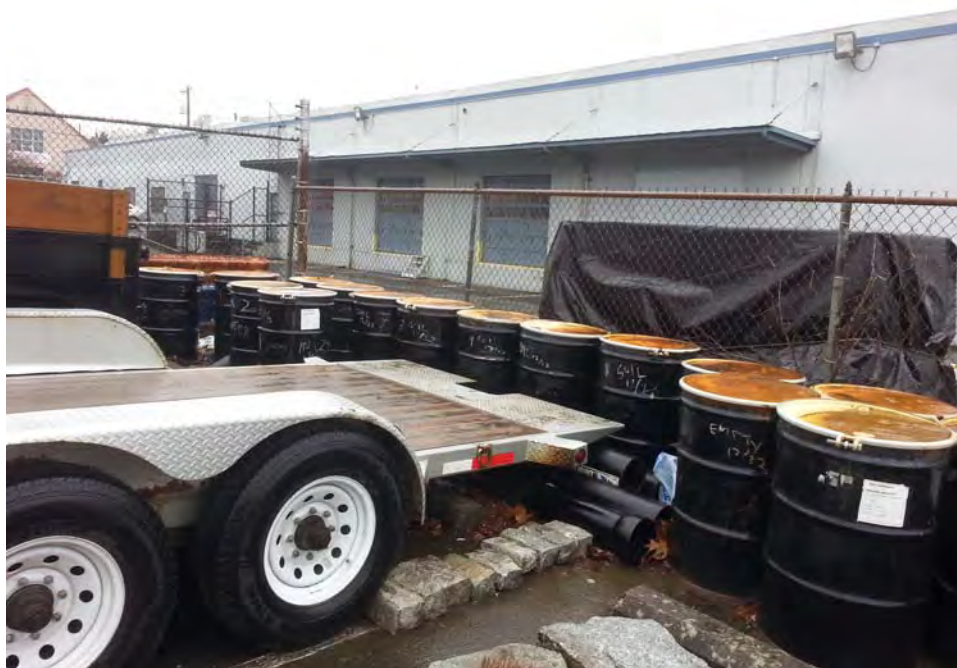
- 9.) View of investigation derived waste drums in the southern parking lot. Typically containing soil cuttings, purge water and decontamination wash water. Generated during 2016 site investigation by Farallon Consulting.

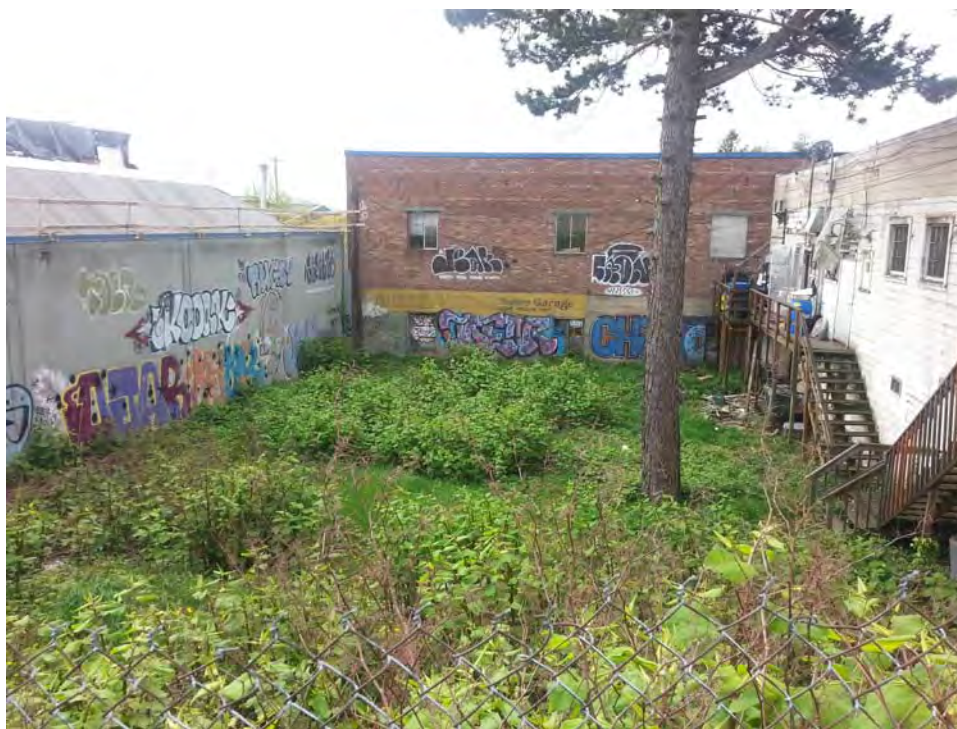
- 10.) View of the open area behind the 110 12th Avenue building, facing south.

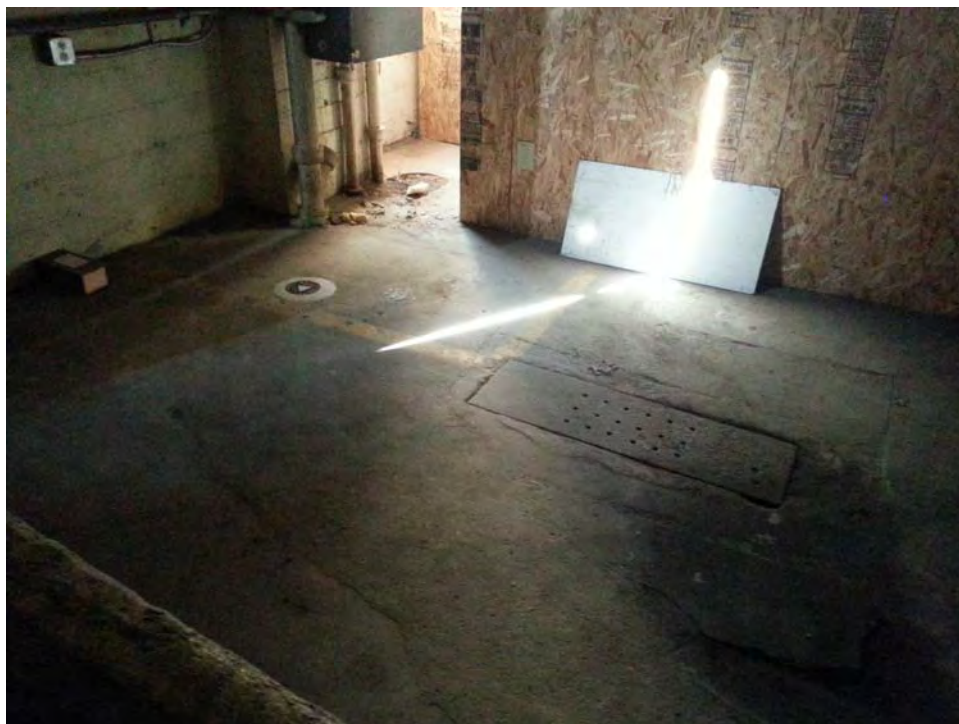
12.) View of the oil/water separator in the southwestern corner of the 104 12th Avenue building. Adjacent monitoring well installed in 2016 site investigation.

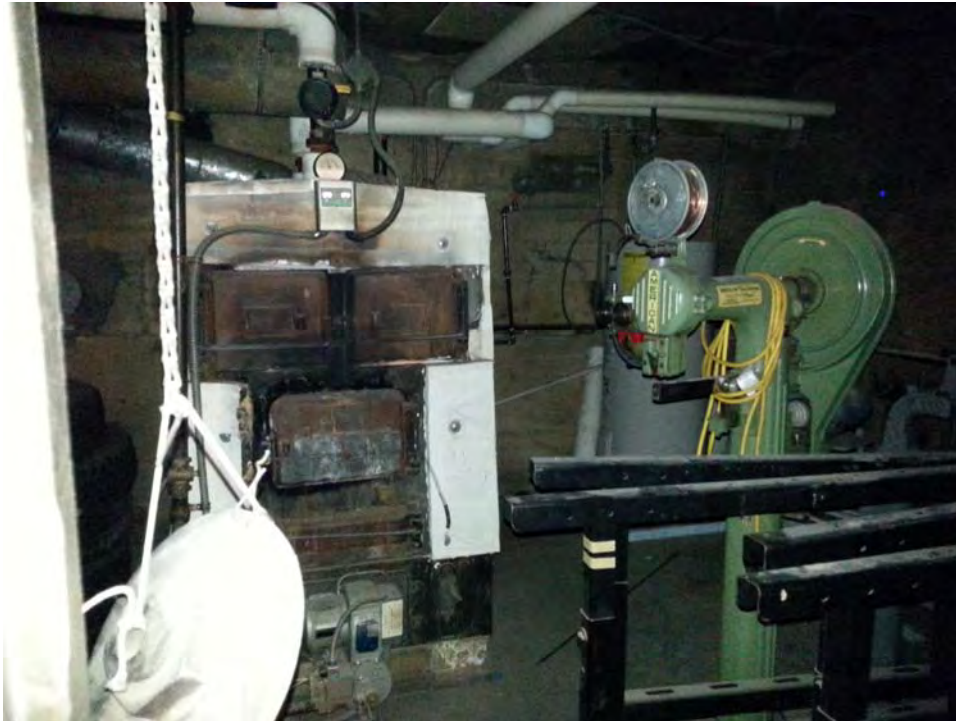
13.) View of the furnace in the basement of the 104 12th Avenue building.
