PHASE I & II ENVIRONMENTAL SITE ASSESSMENT

POTENTIAL REDEVELOPMENT PROPERTY
104-124 12TH AVENUE & 1209 E. FIR STREET
SEATTLE, WASHINGTON 98122

September 1, 2017
Project No. WES-1591

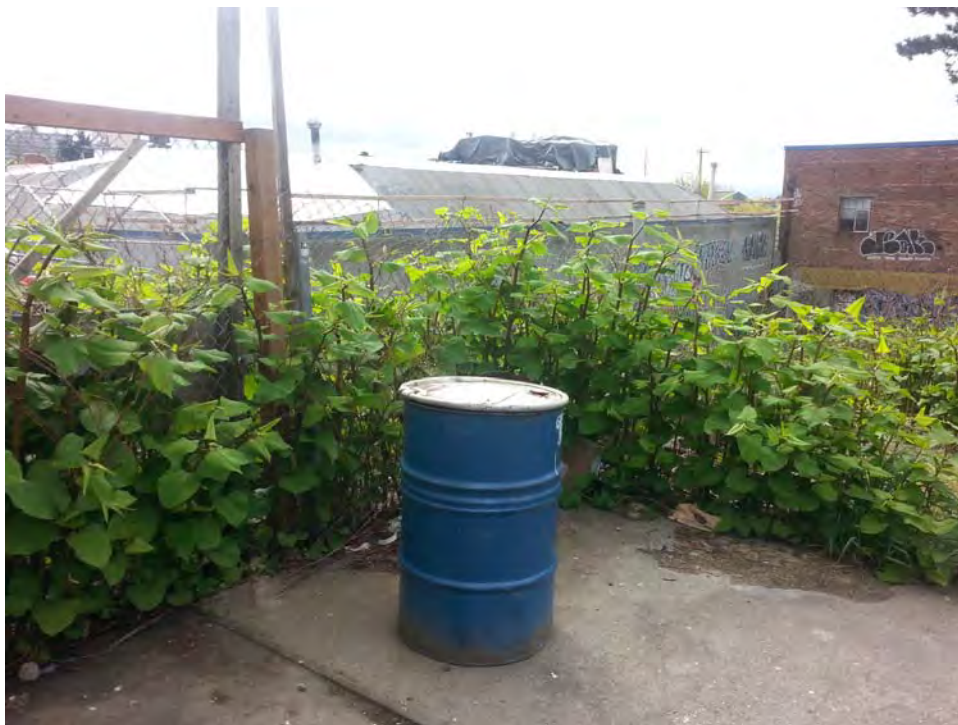
14.) View of restaurant grease drums stored in the corner of the northern parking lot.
