**Subsurface Investigation
&
Soil Remediation Report**

**Everett Cleaners
Mr. Chong Lee
1130 North Broadway
Everett, Washington**

December 30, 1999

**Assessment and Remediation Consulting Services (ARCS)
475 SE Sycamore Lane
Issaquah, Washington 98027
(425) 837-0220**

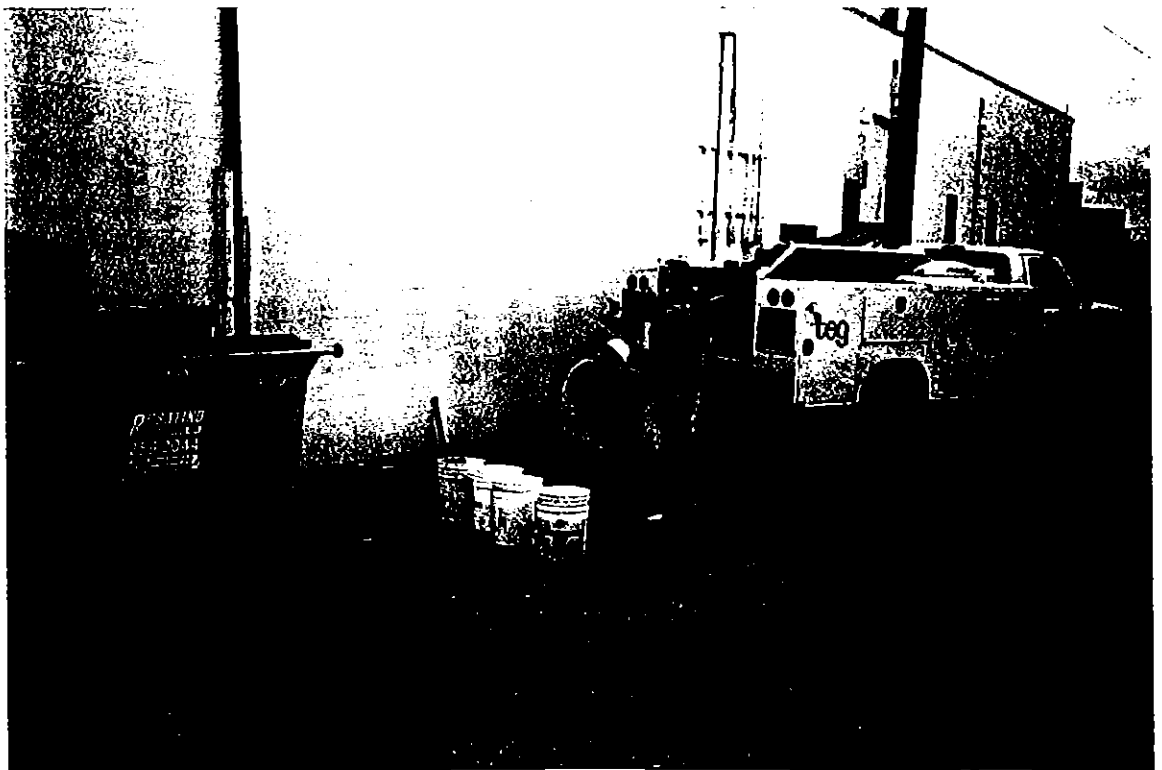
Photograph 1: View of Strataprobe setting up at soil boring location B2, on the west side of the building, looking southeast..
