UST DECOMMISSIONING REPORT

July 26, 2007

**4221 228th Avenue Southeast
Issaquah, Washington**

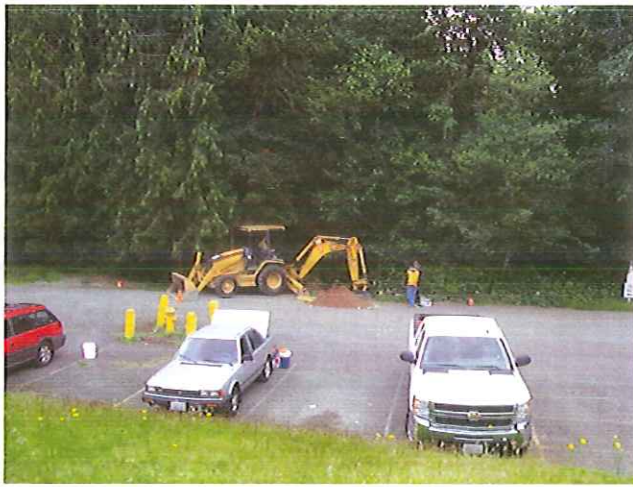
- The emergency generator UST was orientated in a north-south direction parallel to the access road on the east side of the campus (Photograph 1, Site Photographs). The fuel oil tank had a capacity of approximately 500 gallons.
- The UST was triple-rinsed and inerted with carbon dioxide gas prior to tank removal (Appendix C).
- The UST was removed from its cavity on June 21, 2007 (Photograph 2, Site Photographs).

Photograph 1. Overview of excavation area, looking east (June 21, 2007).

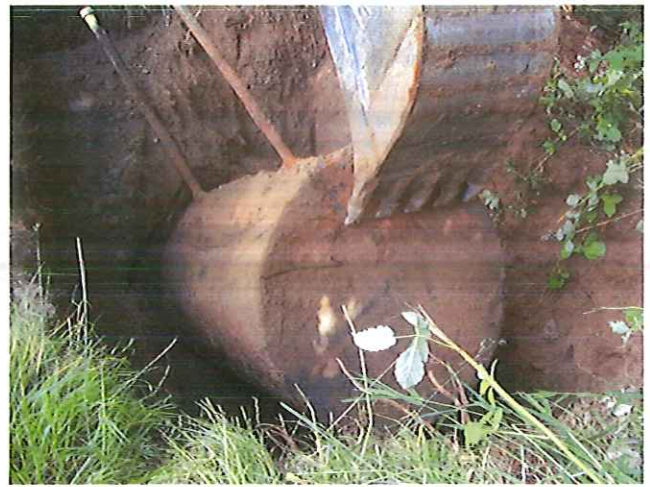
Photograph 2. Removal of UST, facing north (June 21, 2007).

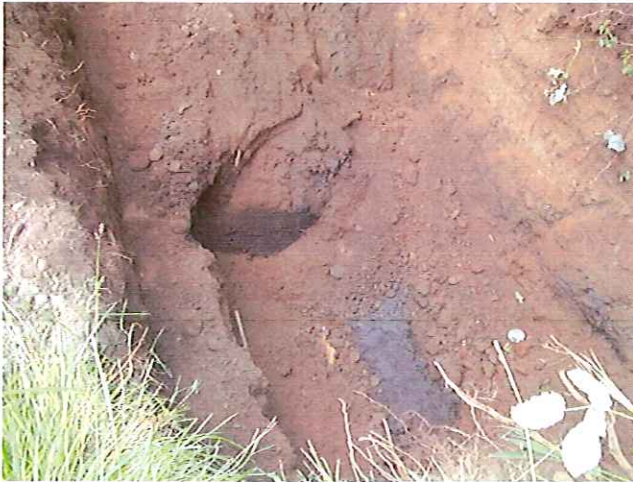
- Soils with a strong petroleum odor and with visual petroleum stains were observed directly below and to the sides of the UST (Photographs 3 and 6, Site Photographs).

Photograph 3. Gray petroleum staining evident in soil directly below and surrounding UST (June 21, 2007).

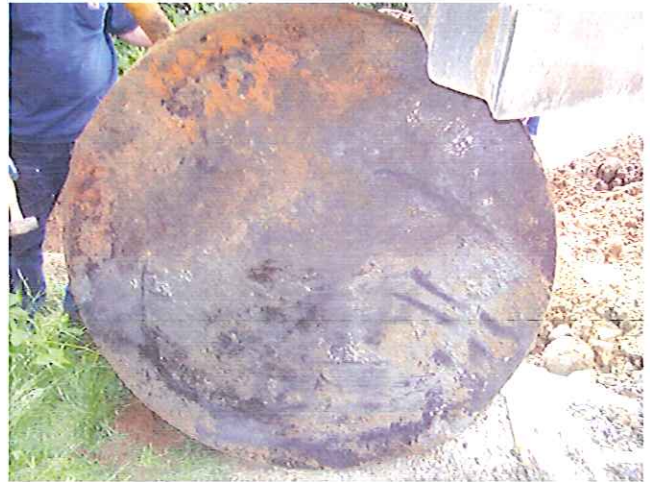
Photograph 4. North side of UST (June 21, 2007).

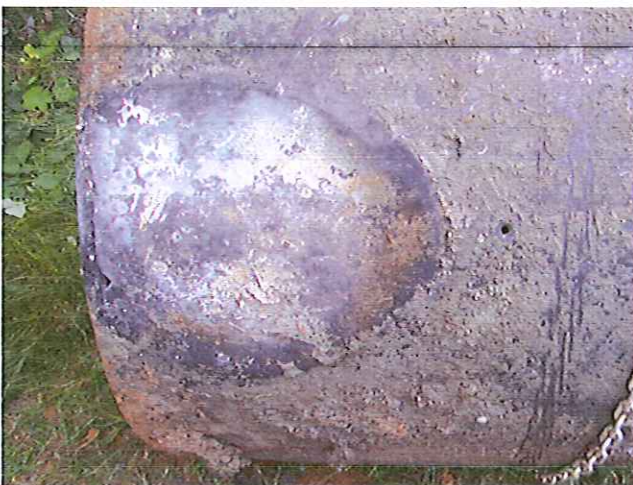
- UST had three observable pinholes, ranging from 1/8-inch to 1/4-inch in size (Photograph 5, Site Photographs). Petroleum leaks to the soil were evident around the pinholes and where the product line attached to the UST.

Photograph 5. Holes visible on bottom and west end of UST (June 21, 2007).

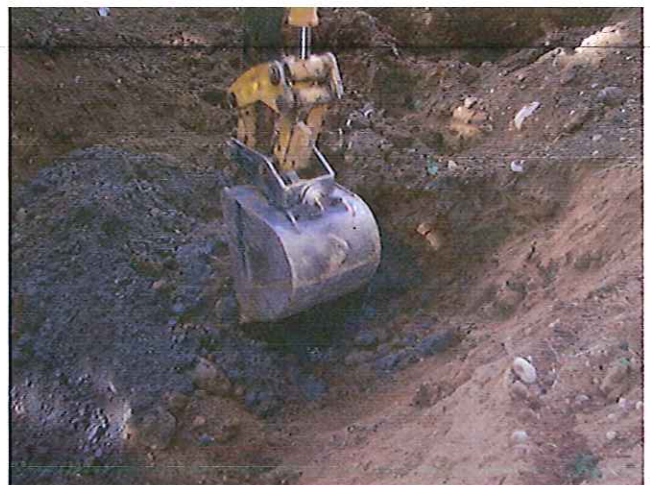
Photograph 6. Removing gray petroleum stained soil from excavation floor (June 25, 2007).

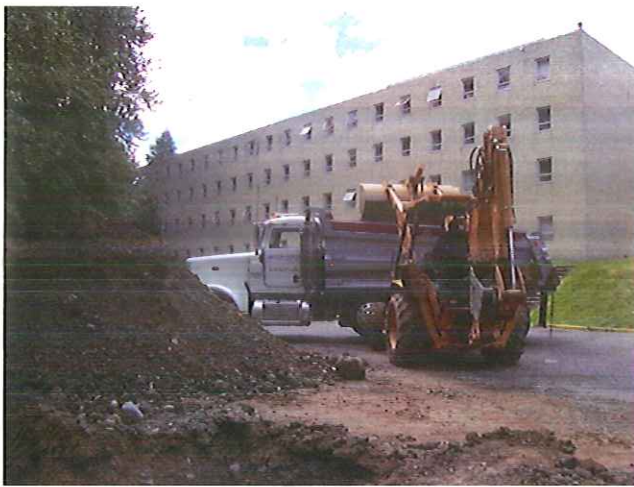
Photograph 7. Petroleum contaminated soil directly loaded onto truck for offsite disposal (June 25, 2007).

- Soil was excavated to a maximum depth of 13.5 feet bgs (Photograph 9, Site Photographs).
- The apparent PCS was loaded directly into trucks for off-site disposal (Photograph 7, Site Photographs). Clean backfill was brought onsite to replace the PCS for backfilling.

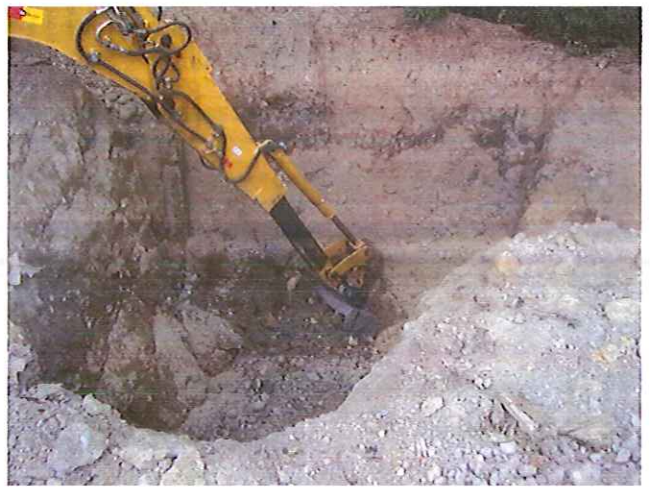
Performance soil samples P-1 and P-2 had concentrations of 1,900 mg/kg DRPH and 400 mg/kg DRPH, respectively. Performance sample EX01F02-10.0 had a DRPH concentration of 3,500 mg/kg, greater than the cleanup level of 2,000 mg/kg. The soil areas represented by these samples were overexcavated. Confirmation soil samples EX01S01-06.0, EX01F01-10.0, SP-02, and SP-03 had concentrations of 140 mg/kg; 1,400 mg/kg; 120 mg/kg; and 91 mg/kg respectively, all below cleanup levels. Sample SP-02 had an ORPH concentration of 760 mg/kg.

Photograph 8. Over-excavation soil sample EX01F02-10.0 location (June 27, 2007).

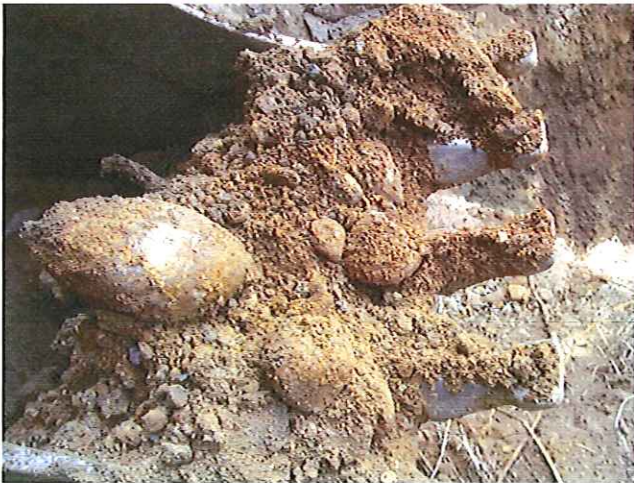
Photograph 9. View of soil conditions at maximum excavation depth of 13.5 feet (June 27, 2007).

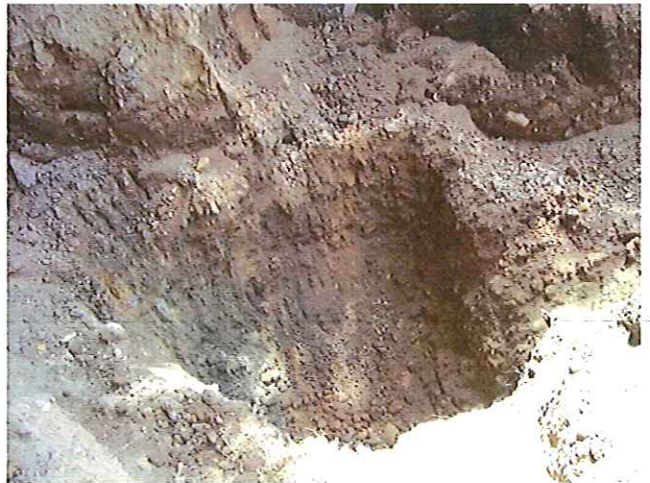
Photograph 10. Looking west at excavation area upon completion of soil removal (June 27th, 2007).

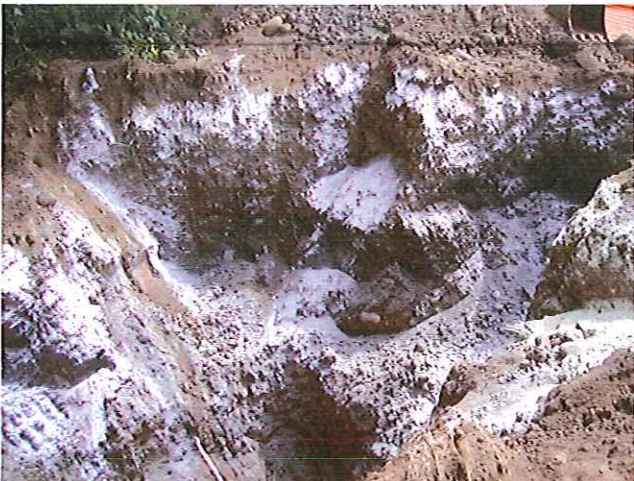
Photograph 11. White Oxygen Release Compound applied to excavation before backfilling (June 27, 2007).

- Oxygen Release Compound (ORC) was applied to the sidewalls and floor of the excavation upon conclusion of PCS removal and before backfilling (Photograph 11, Site Photographs).

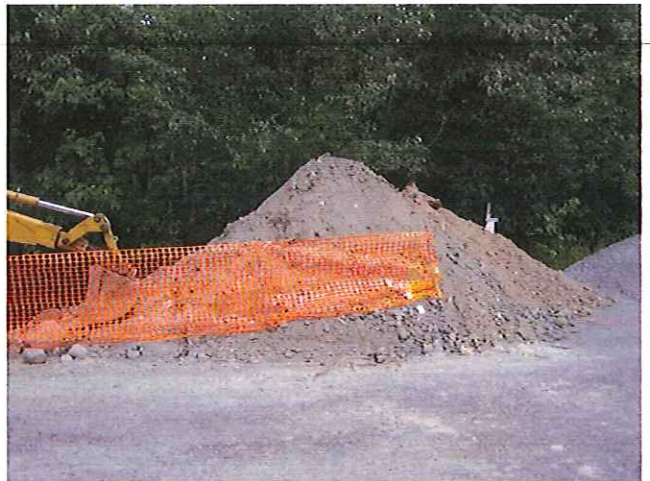
Photograph 12. Looking east at stockpiled soil (June 27, 2007).

- Soil suspected to be clean was removed from the excavation and stockpiled. Once characterization sampling was complete the soil was backfilled into the excavation (Photograph 12, Site Photographs).
