CONSTRUCTION REPORT

Enhanced Natural Recovery/Activated Carbon Pilot Study

Lower Duwamish Waterway

Approved by EPA June 2018

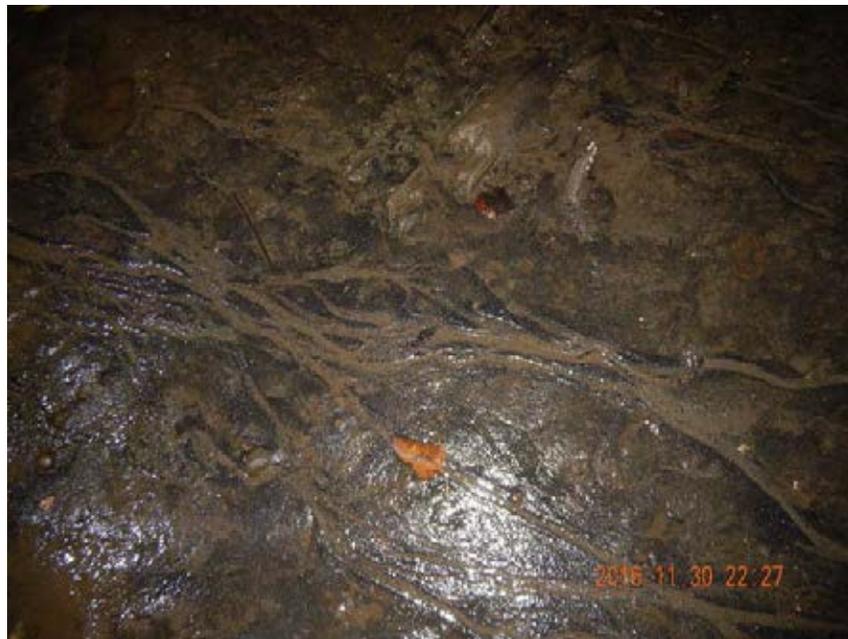
Photo 26 Thin veneer of fine-grained AC observed downstream of the intertidal plot.

During visual inspection of the subplot, it was noted that a thin veneer of fine AC material was present over parts of the subplot as well as upstream and downstream of the subplot. It was also noted that when submerged ENR+AC material was disturbed, fine-grained AC particles were suspended in the water column and even floated to the surface. These particles remained suspended in the water column for some period of time (Attachment 2, Photo 27).

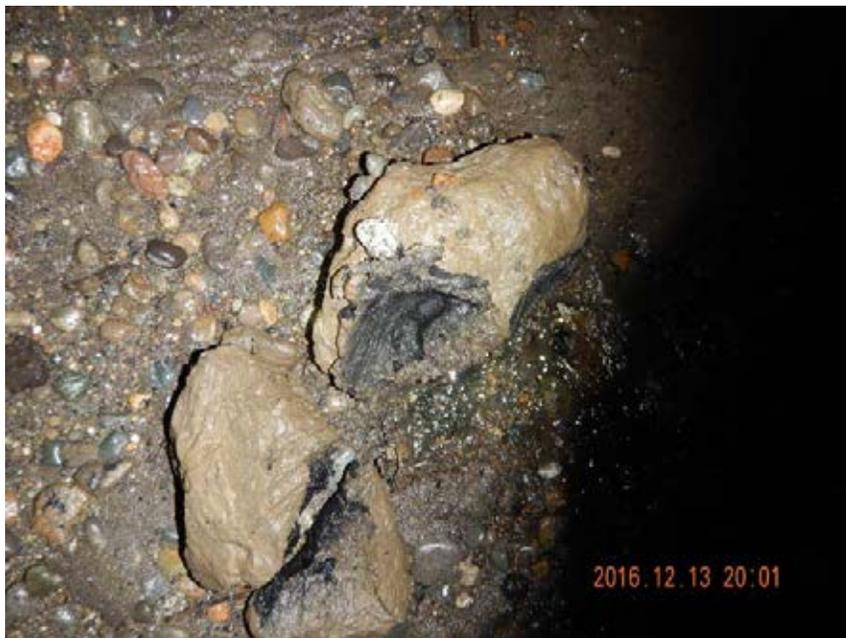
Photo 28 AC ball found in the Intertidal plot.

Construction management representatives also noted the observance of objects that appeared to look like rounded rock on and near the subplot. Upon further investigation, these rock-shaped objects appeared to be collections of fine-grained AC with soft-grained sediment adhering to the outer perimeter. These rock-shaped objects ranged in size from 1- to 2-inches (2.5- to 5.1-cm) in diameter up to 8- to 10-inches (20.3- to 25.4-cm) in diameter. The larger objects were generally found downgradient from the shoreline, and smaller objects were congregated in depressions in the riverbed (Attachment 2, Photo 28).

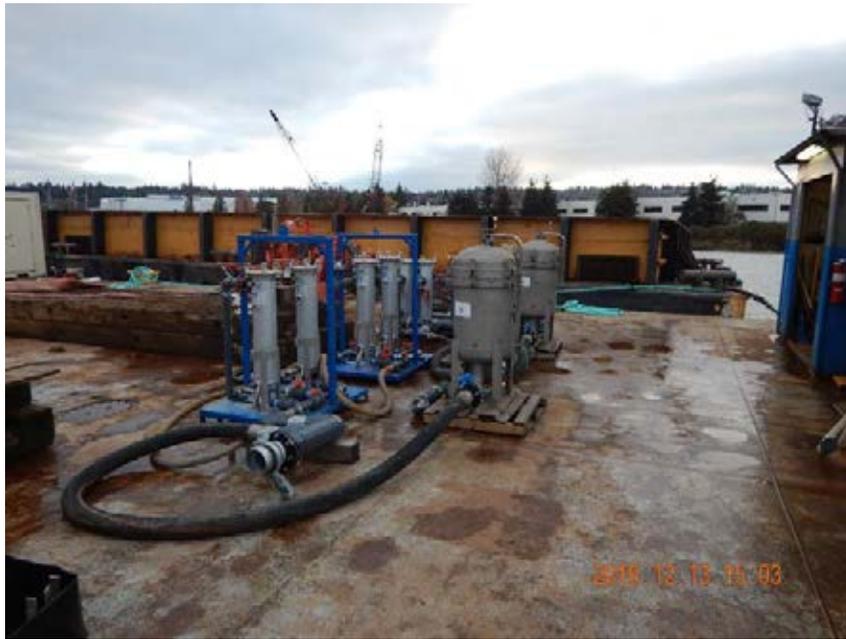
Photo 29 Water treatment plant for all water that is pumped out of the barges.

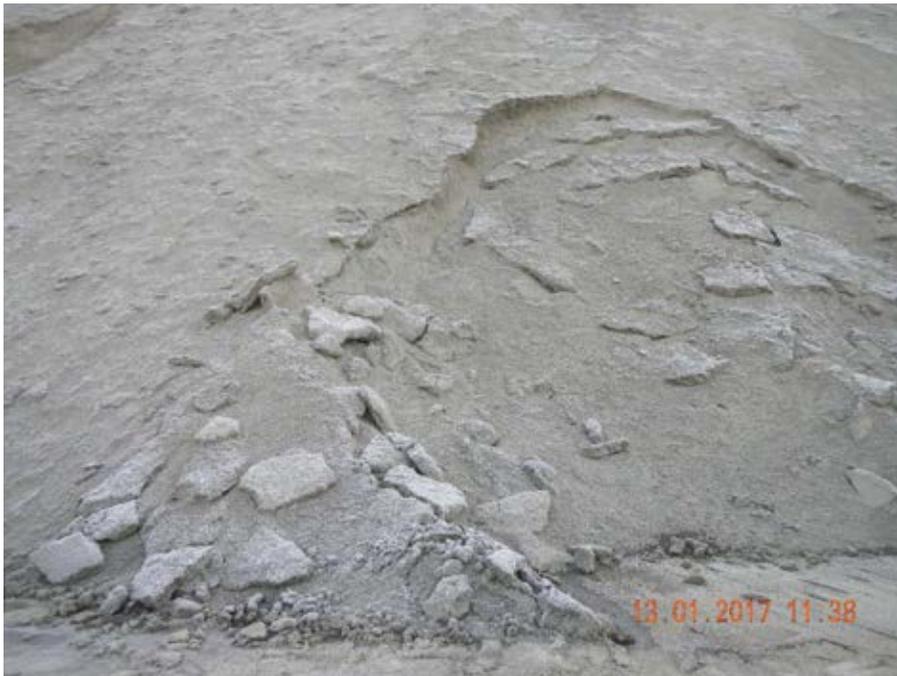
2017-01-13 11.38.46 Clumps of frozen sand at the stockpile caused loading of the KP-3 barge to be interrupted several times. The clumps would get caught in the bars of the grizzly; effectively blinding off the hopper below until removed.

Due to subfreezing temperatures during loading, the loading of sand ENR material during barge load six was extended by several hours. This delay was caused by sand that had become frozen into slab-shaped pieces of sufficient size to cut off the flow of this ENR material onto the conveyor as it was fed from the stockpile. As a result, loading was interrupted while the frozen material was cleared, increasing the loading time from approximately 1 hour to about 3 hours.

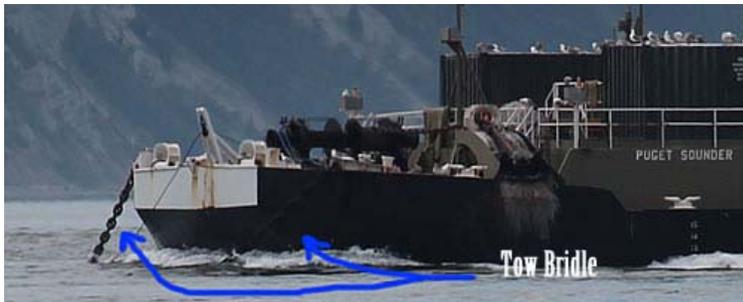
During solid-phase microextraction (SPME) deployment and attempted retrieval at the subtidal plot, divers reported that the waterway bottom appeared very disturbed, with furrows and ridges on the order of 1- to 1.5-feet oriented parallel to the river flow. They appeared to be mechanically created as typical sand waves are oriented perpendicular to the flow. Additional investigation by the field

crew led to the hypothesis that when large, ocean going barges enter the Duwamish Waterway, they lower and drag their bow mounted tow bridles as they are pushed by tugs up the waterway.

Marine traffic is believed to have affected the ENR and ENR+AC material after placement in the subtidal plot. Several barges were observed passing over or near the plot with tow bridles hanging from the bow into the water. Several barges moored upstream of the plot were moved between shifts, and they may have had bridles hanging from their bows (Attachment 2, Photos 32, 33, and 34) into the waterway as they moved up or down the waterway.

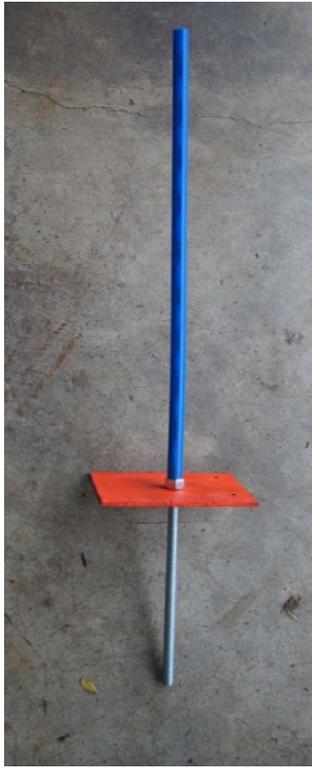
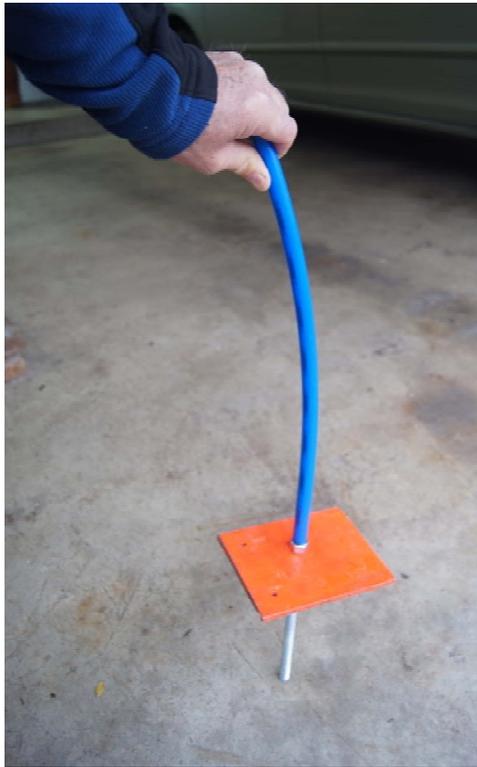
The stakes will all be made to a fixed length of 18 inches above the steel plate. Divers will then be able to measure from top of stake down to the top of the ENR material to determine placed thickness of ENR material (18 inches minus the measurement from top of stake equals the placed thickness of ENR material). In addition, at several locations adjacent to a stake location, divers will attempt to measure the thickness of the placed material using a probe to detect the textural change in the material as a probe is inserted into the substrate. If the diver can detect a change in the

substrate texture, a measurement of the depth to the textural change will be made. The probing will also be conducted at locations where a stake was deployed but was missing when material thickness is being assessed.

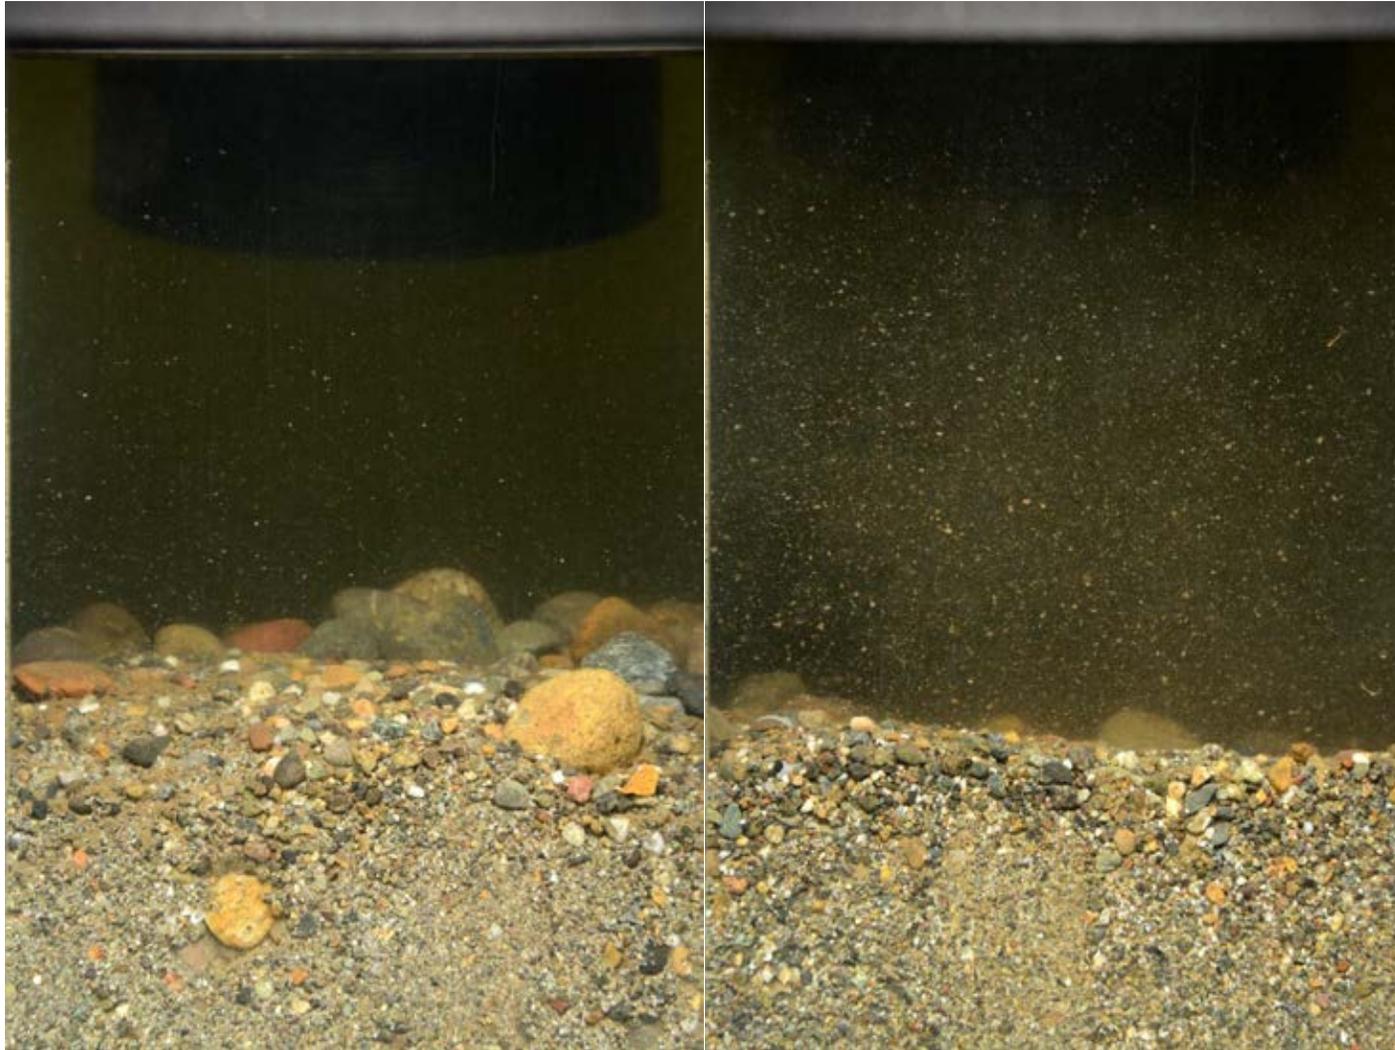
Figure 3-1. Representative SPI images from Stations LDW-Y0-IN-ENR-2-B-SPI-R1 (left) and LDW-Y0-IN-ENR-4-B-SPI-R1 (right) showing ENR sands and gravels typical of the intertidal ENR subplot. SPI images are 14.42 cm in width.

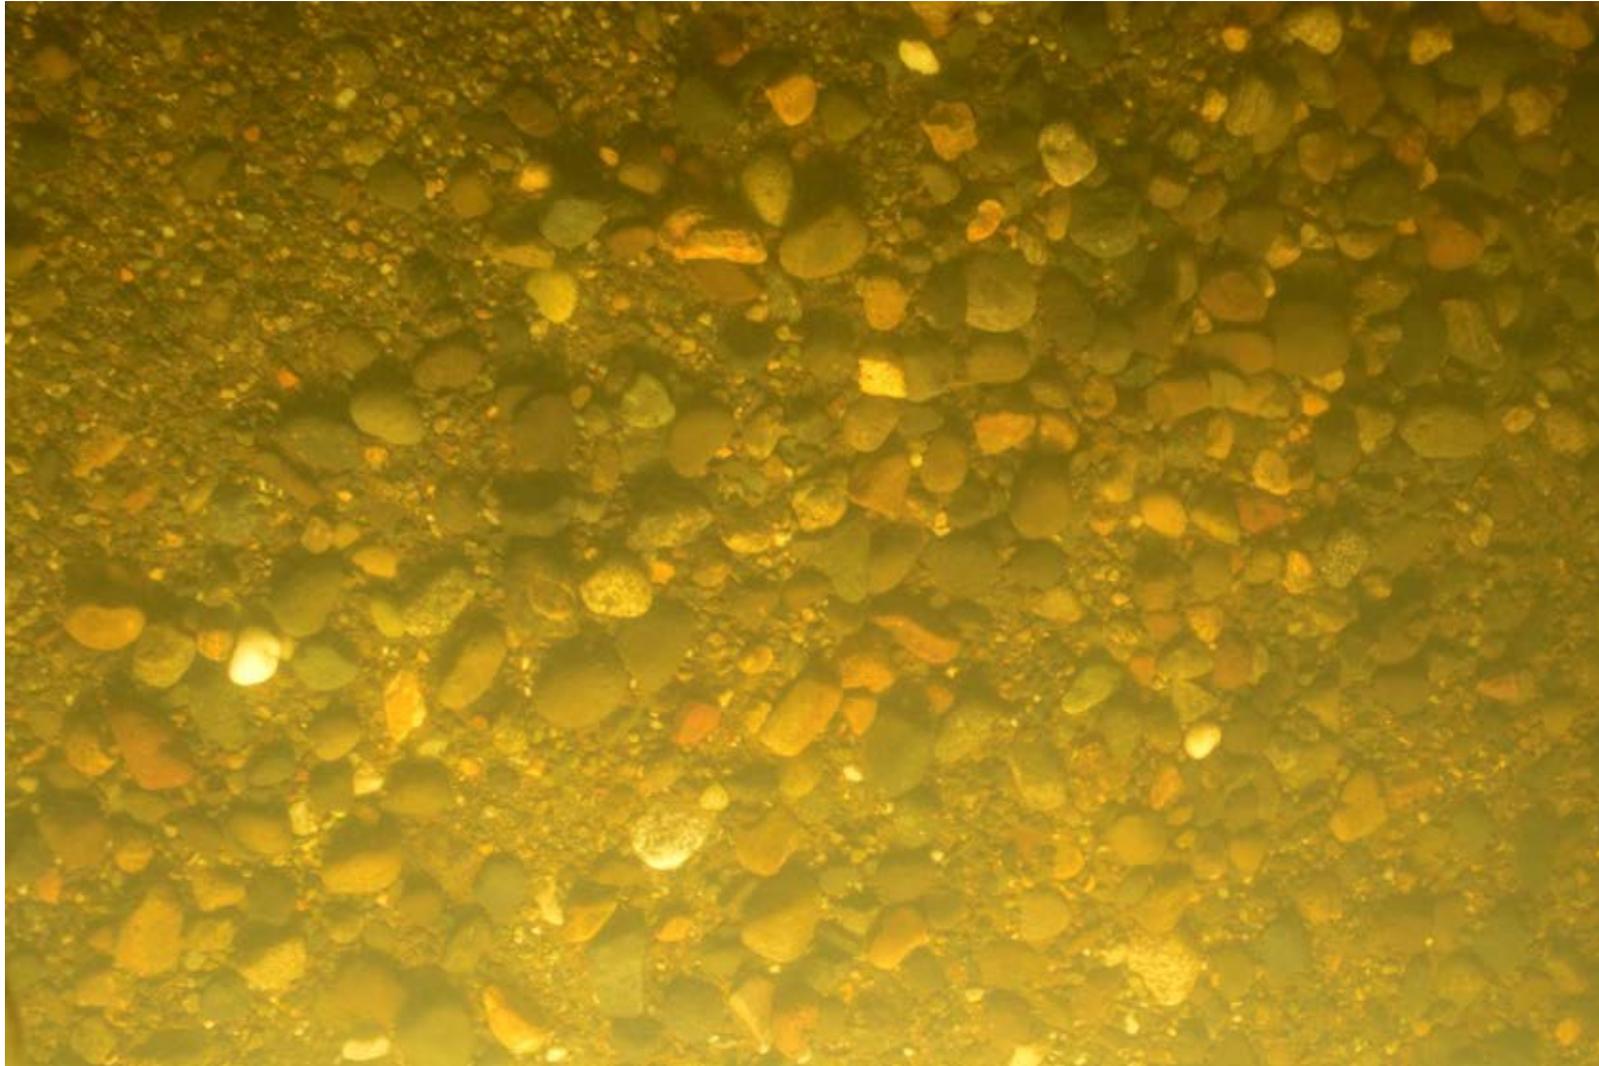
Figure 3-2. Representative PV image from Station LDW-Y0-IN-ENR-3-A-PV-R1 showing ENR sands and gravels typical of the intertidal ENR subplot at 100% cover.

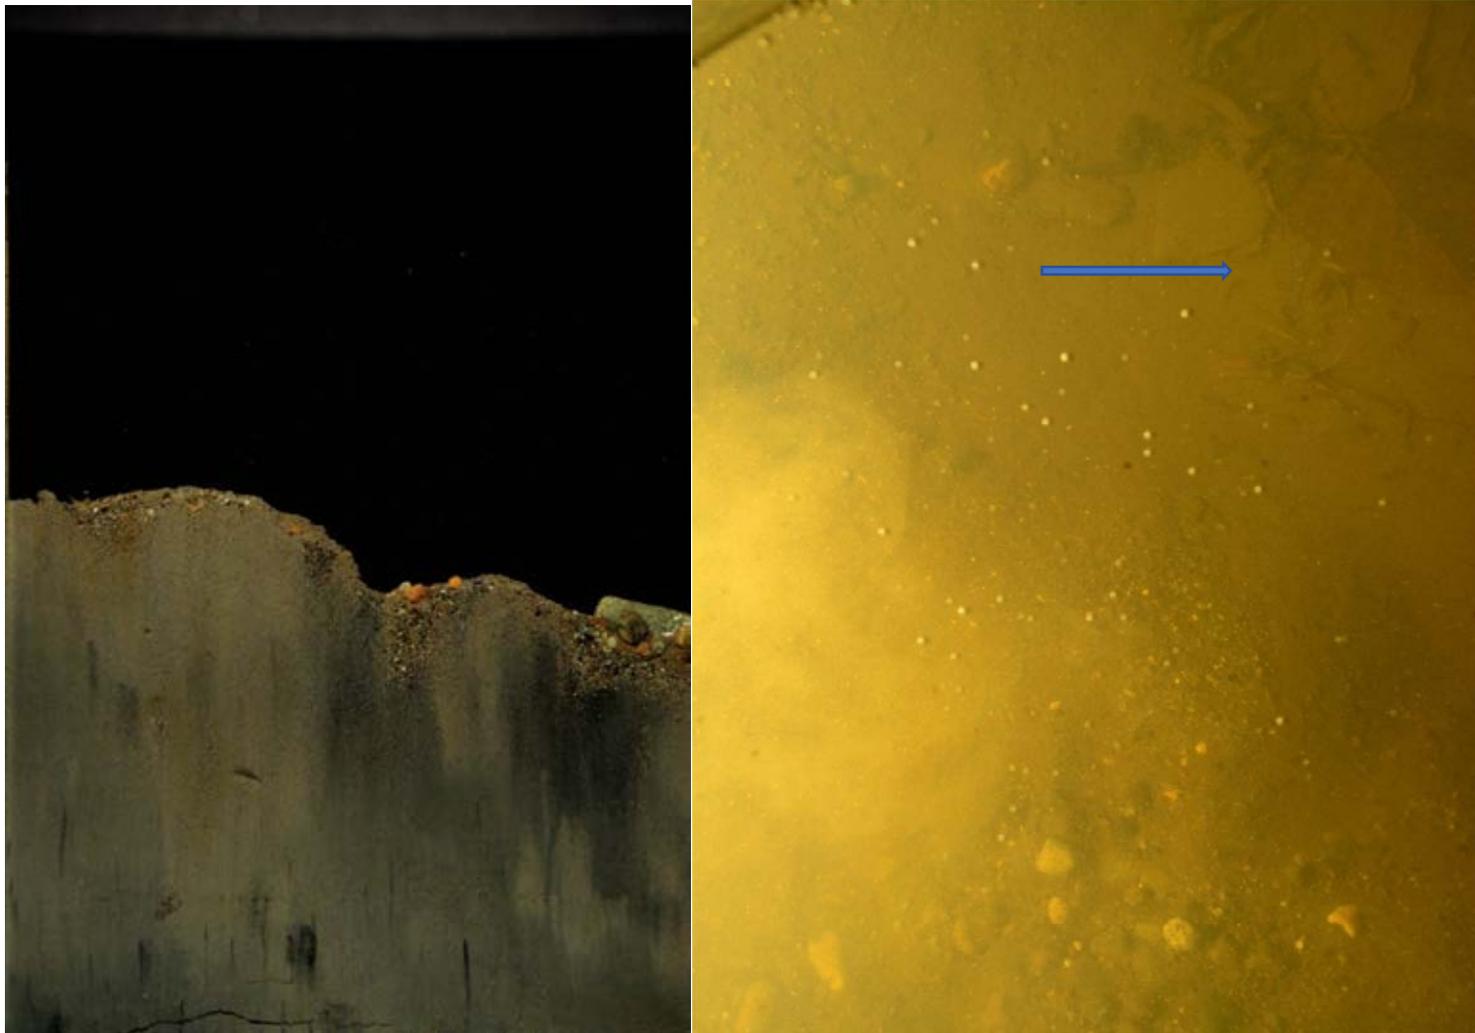
Figure 3-3. Representative SPI and PV images from Stations LDW-Y0-IN-ENR-1-A-SPI-R2/LDW-Y0-IN-ENR-1-A-PV-R2 showing a thin veneer of ENR material in the SPI image and incomplete cover of sand and gravels in the PV image. There is a noticeable change in elevation in the PV area that is not covered by gravel. Approximate location of the SPI image is denoted by the arrow. SPI images are 14.42 cm in width.

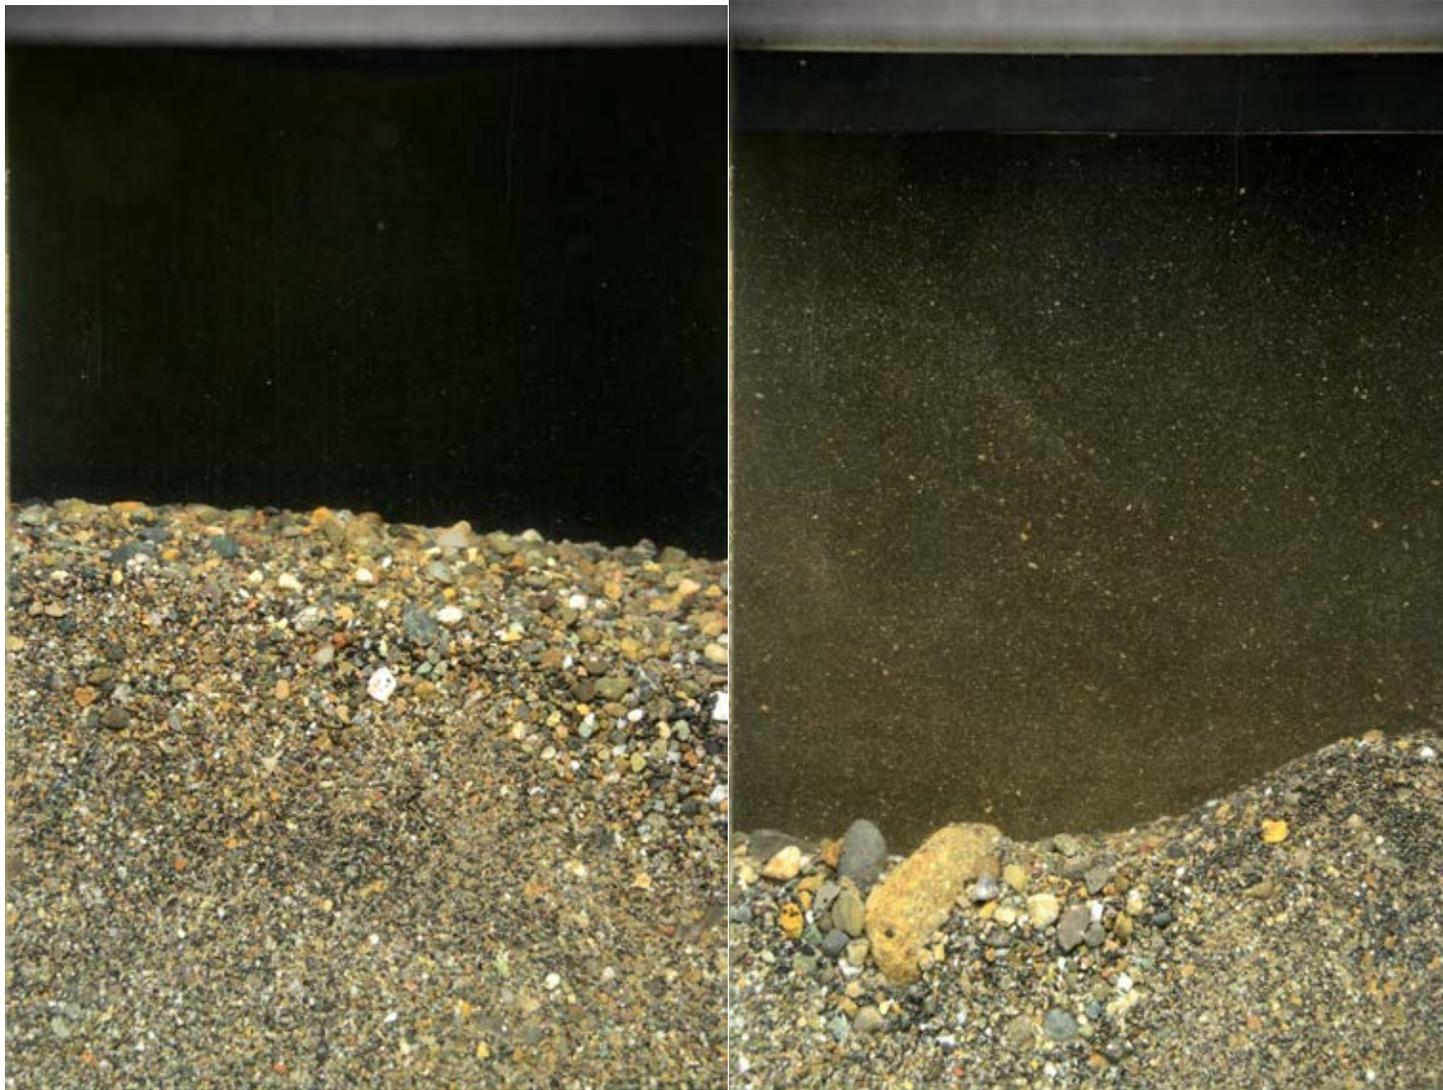
Figure 3-4. Representative images from Stations LDW-Y0-IN-ENR+AC-1-B-SPI-R3 and LDW-Y0-IN-ENR+AC-5-B-SPI-R3 that show ENR+AC sediments from the intertidal plot. SPI images are 14.42 cm in width.

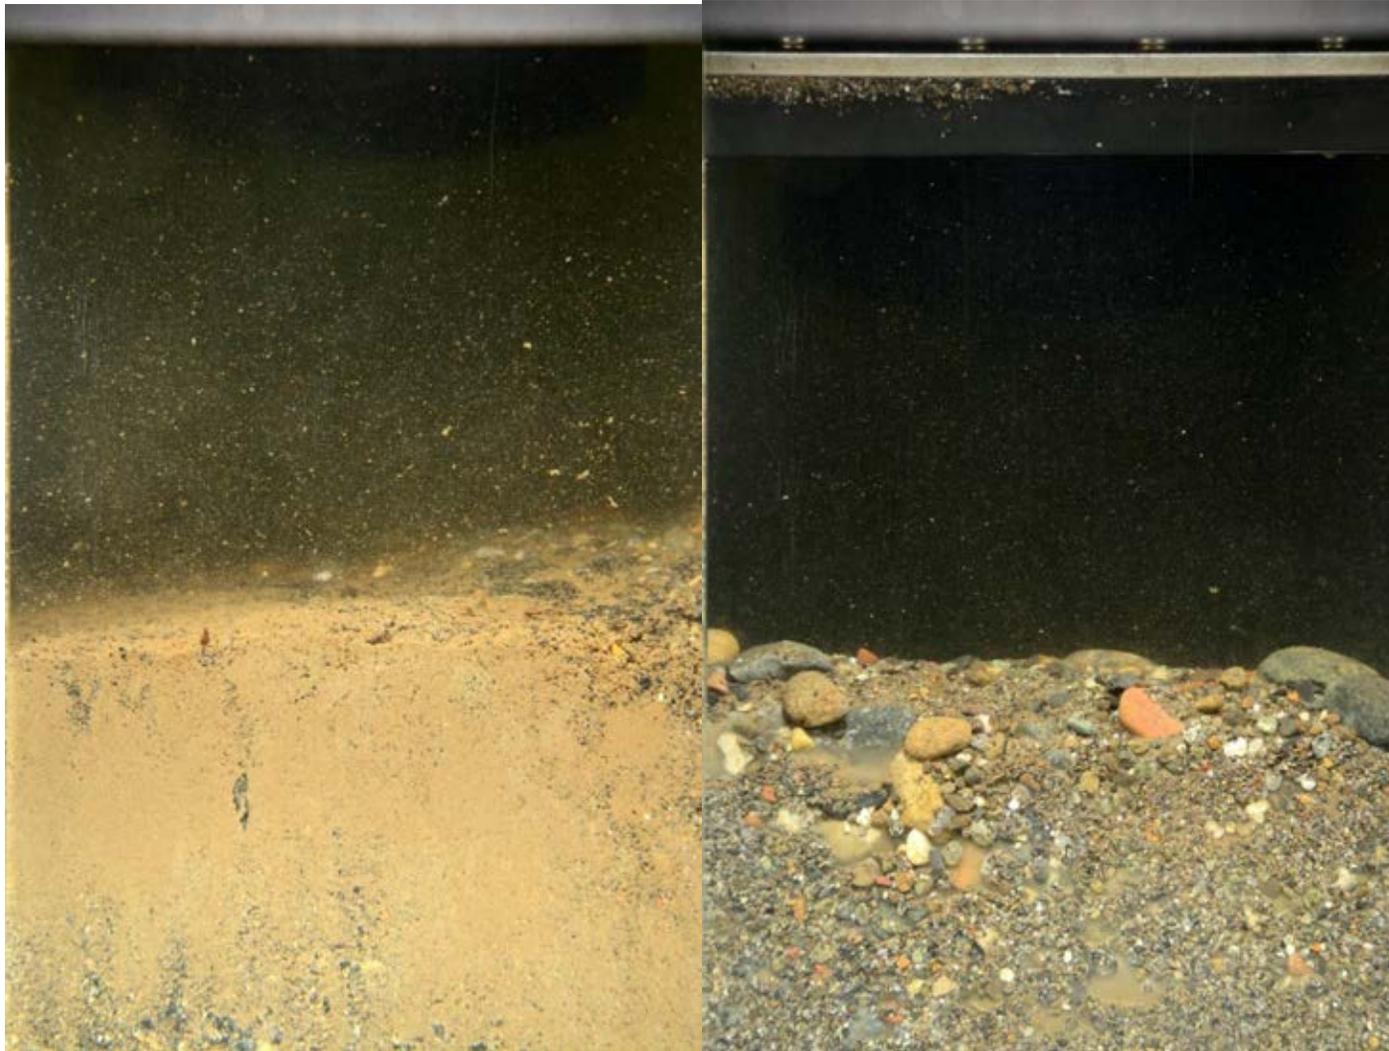
Figure 3-5. Representative SPI images from LDW-Y0-IN-ENR+AC-6-A-SPI-R1 and LDW-Y0-IN-ENR+AC-3-B-SPI-R3 showing the variability in recent deposition observed. At LDW-Y0-IN-ENR+AC-6-A-SPI-R1, there is abundant recent deposition that has been smeared down. At LDW-Y0-IN-ENR+AC-3-B-SPI-R3 there is only a trace amount of post-placement recent deposition. SPI images are 14.42 cm in width.

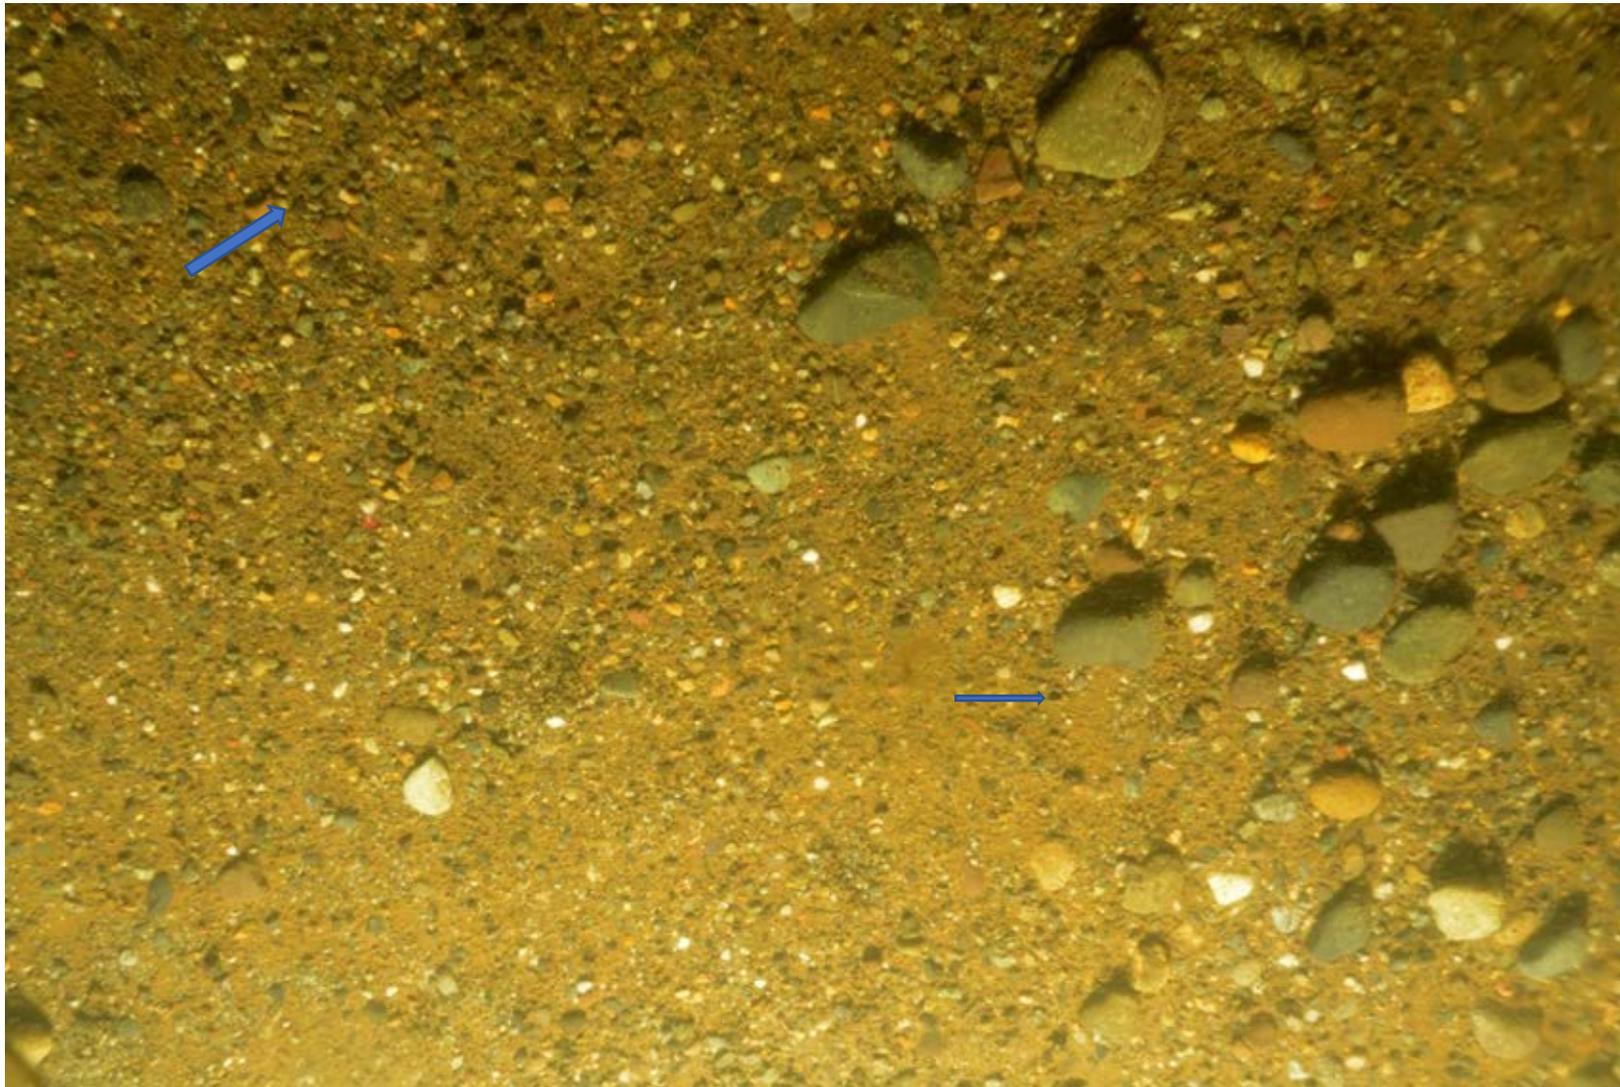
Figure 3-6. Representative PV image from Station LDW-Y0-IN-ENR+AC-2-A-PV-R2 showing sand and gravels from the intertidal ENR+AC subplot. Scattered small sand-sized black particles can be seen at the sediment surface. At this station and replicate, the sediment surface is mostly free of recently deposited post-placement sediment. Scaling lasers (red dots) are 26 cm apart.

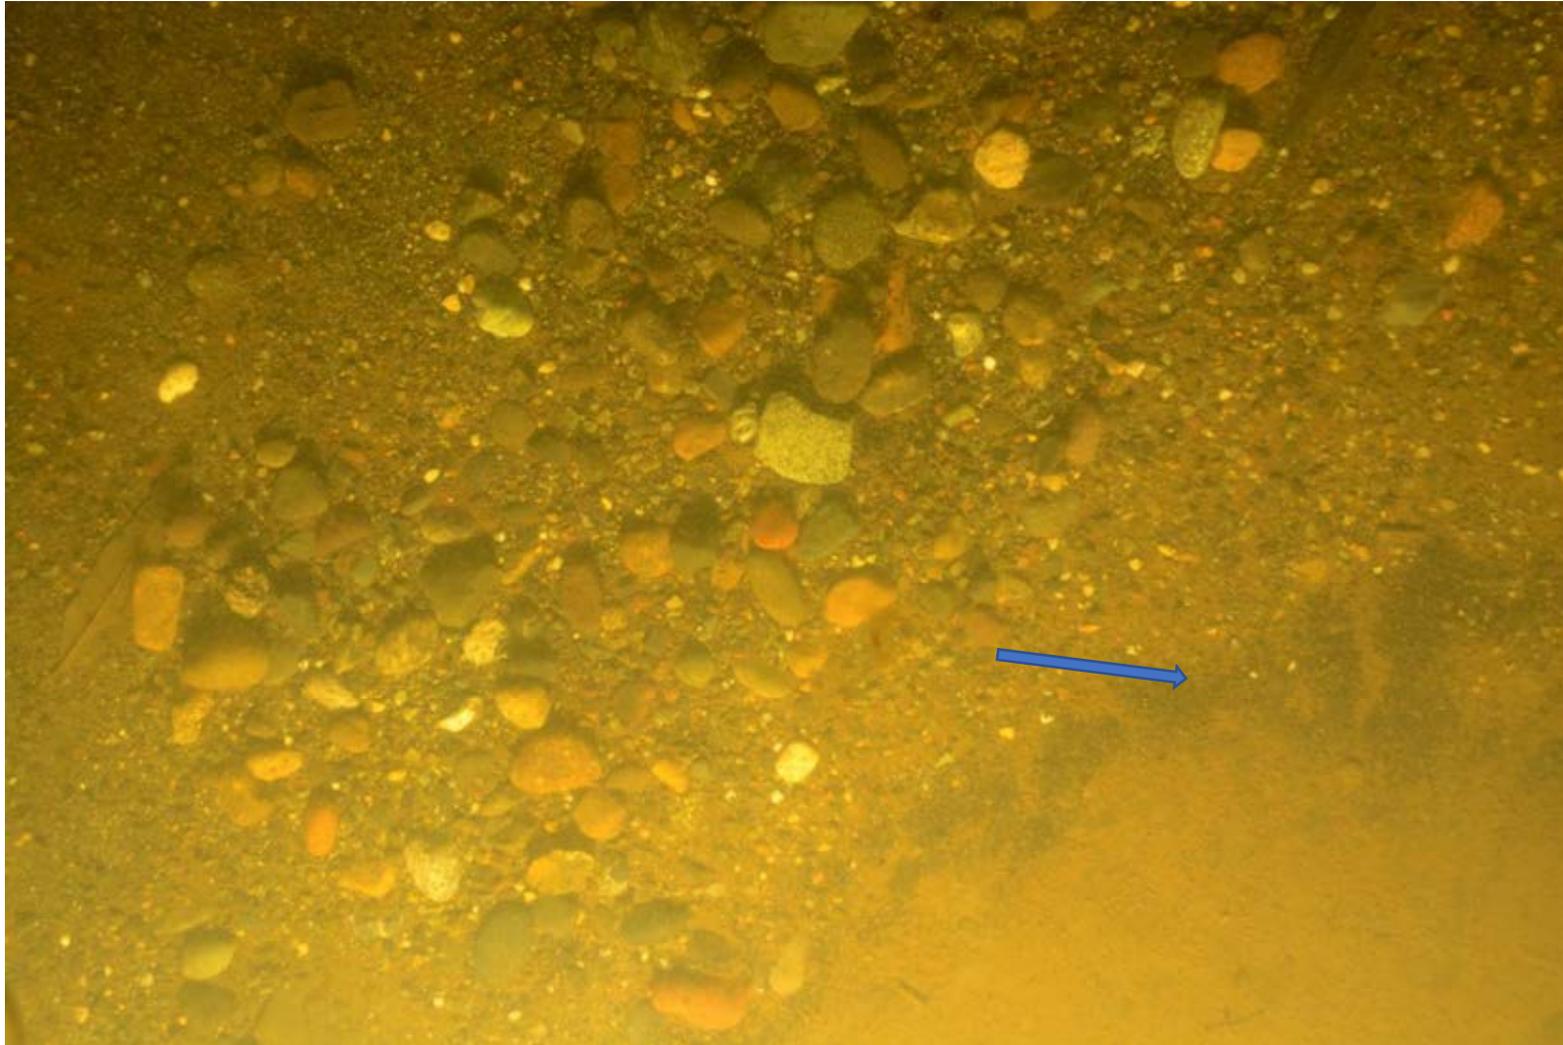
Figure 3-7. Representative PV image from Station LDW-Y0-IN-ENR+AC-6-A-PV-R1 showing ENR+AC sands and gravels from the ENR+AC subplot. Small sand-sized black particles can be seen at the sediment surface and in a band at the lower right. At this station and replicate, there are patches of recently deposited fine-grained sediment that obscure the ENR+AC material (lower right). Scaling lasers (red dots) are 26 cm apart.

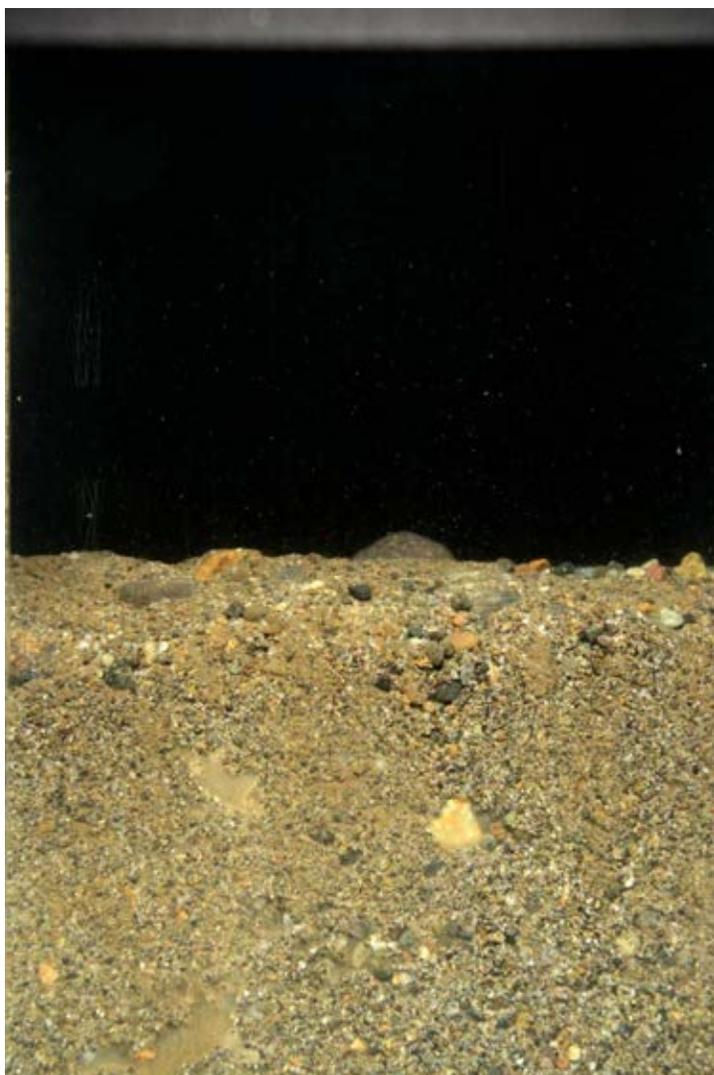
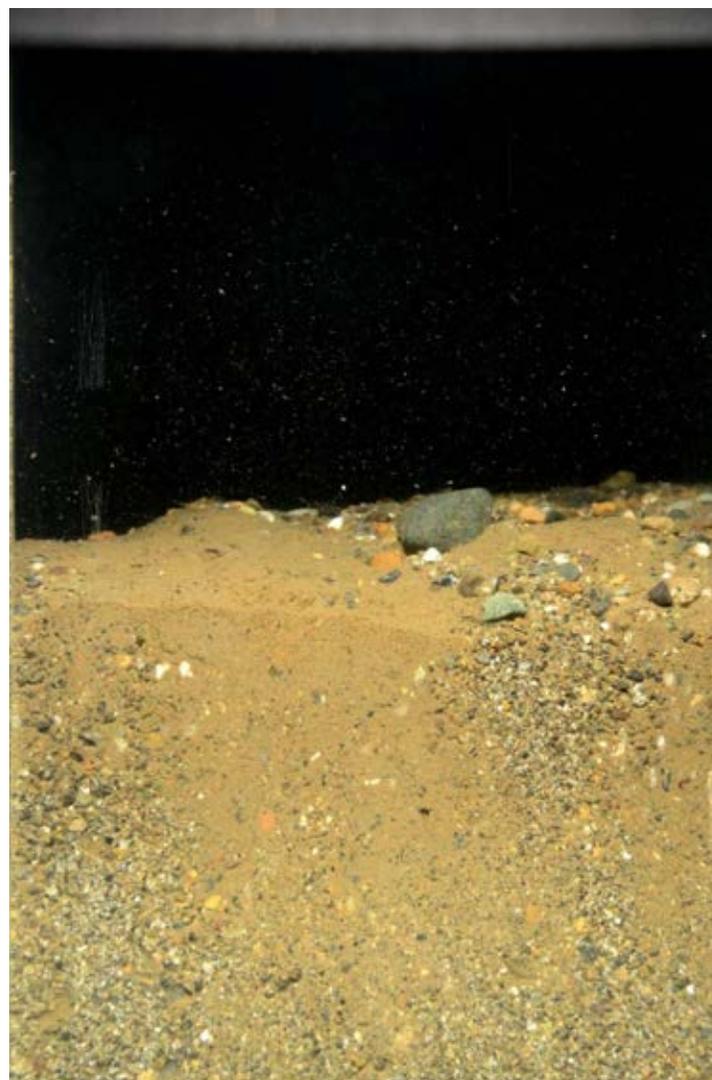
Figure 3-8. Representative SPI images from Stations LDW-Y0-SC-ENR-1-A-SPI-R3 (left) and LDW-Y0-SC-ENR-3-A-SPI-R1 (right) showing typical ENR sediments from the scour ENR subplot. In both images material thickness extends beyond the prism penetration. The image on the right shows a thin band of recently deposited sediment overlying the ENR material. SPI images are 14.42 cm in width.

Triplicate SPI images were taken at 12 locations (n=36) within the scour ENR subplot 10 days after construction completion (Attachment 5). The ENR+AC material was observed at all stations and all replicates in thicknesses that exceeded the prism penetration depth. Prism penetration depths ranged from 2.4 inches (6.2 cm) to 6.5 inches (16.4 cm) and the average prism penetration depth was 3.9 inches (9.9 cm).

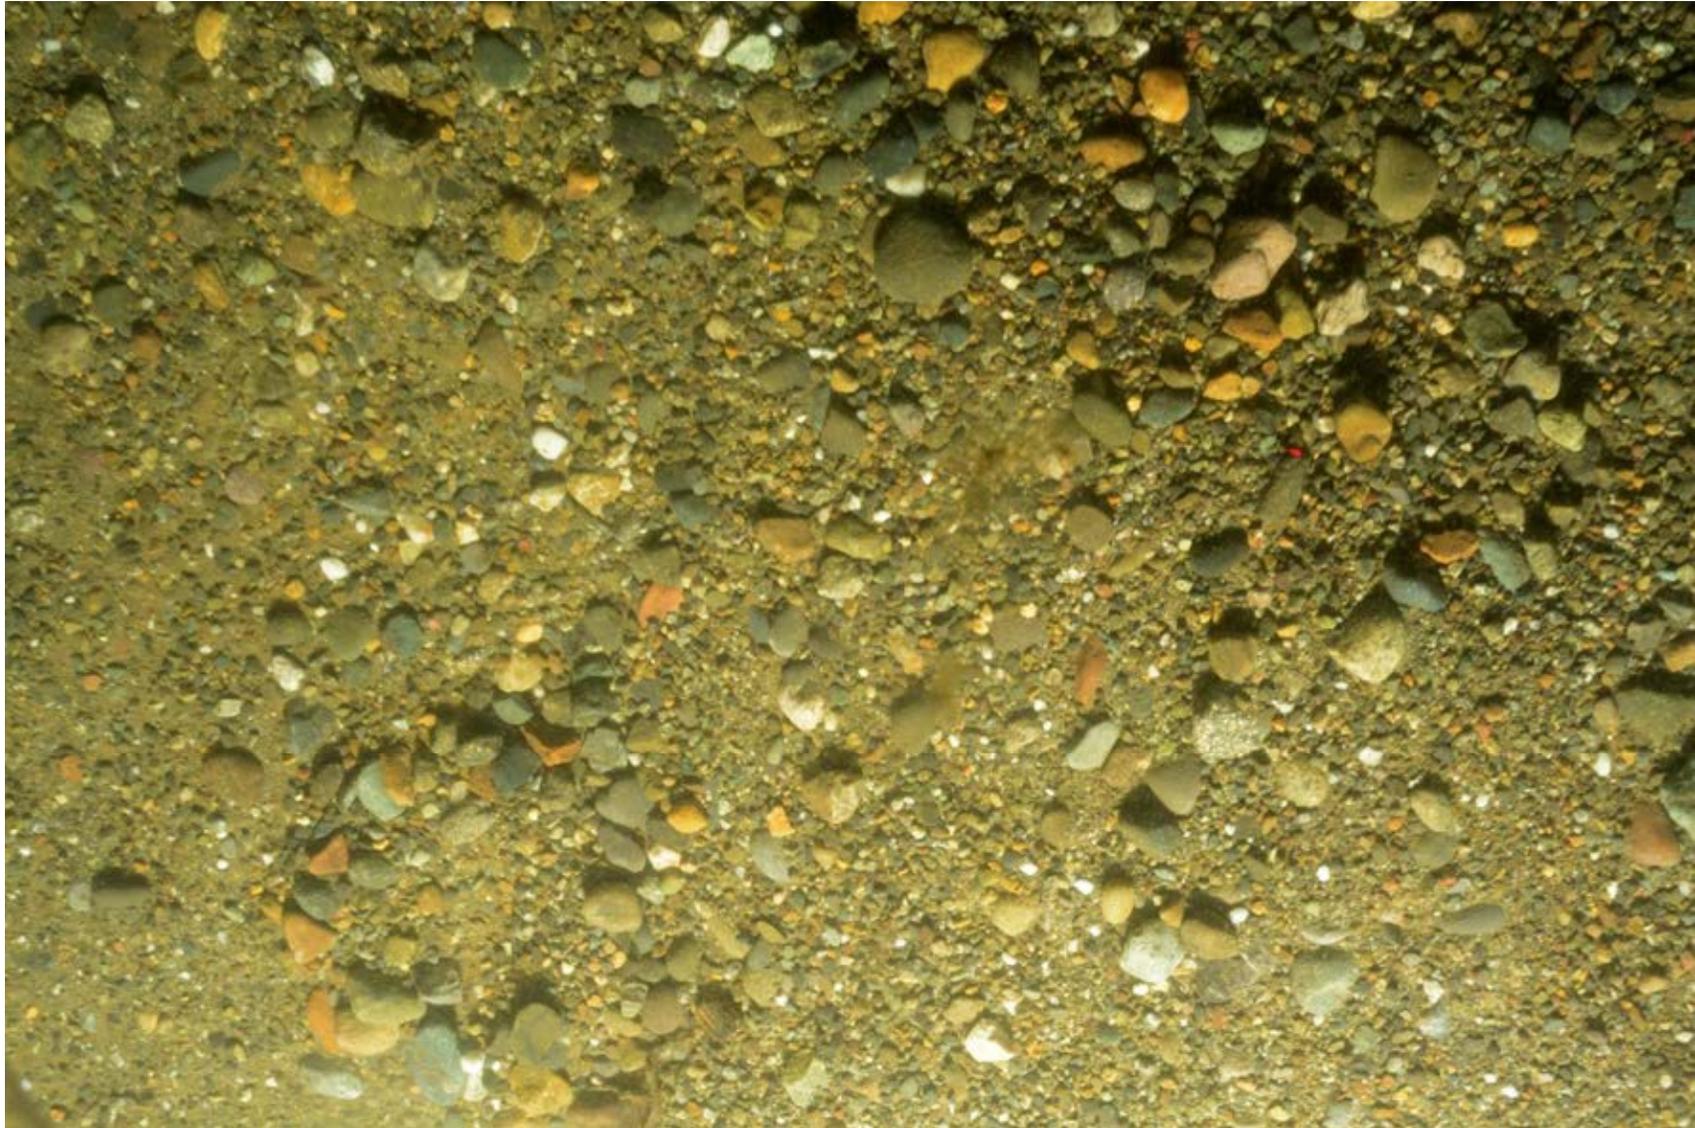
Figure 3-9. PV image from Station LDW-Y0-SC-ENR-2-B-PV-R1 showing typical ENR sediments from the scour ENR subplot. ENR materials are lithic sands and gravels. The sediment surface is mostly free of fine-grained sediment. Scaling lasers (red dots) are 26 cm apart.

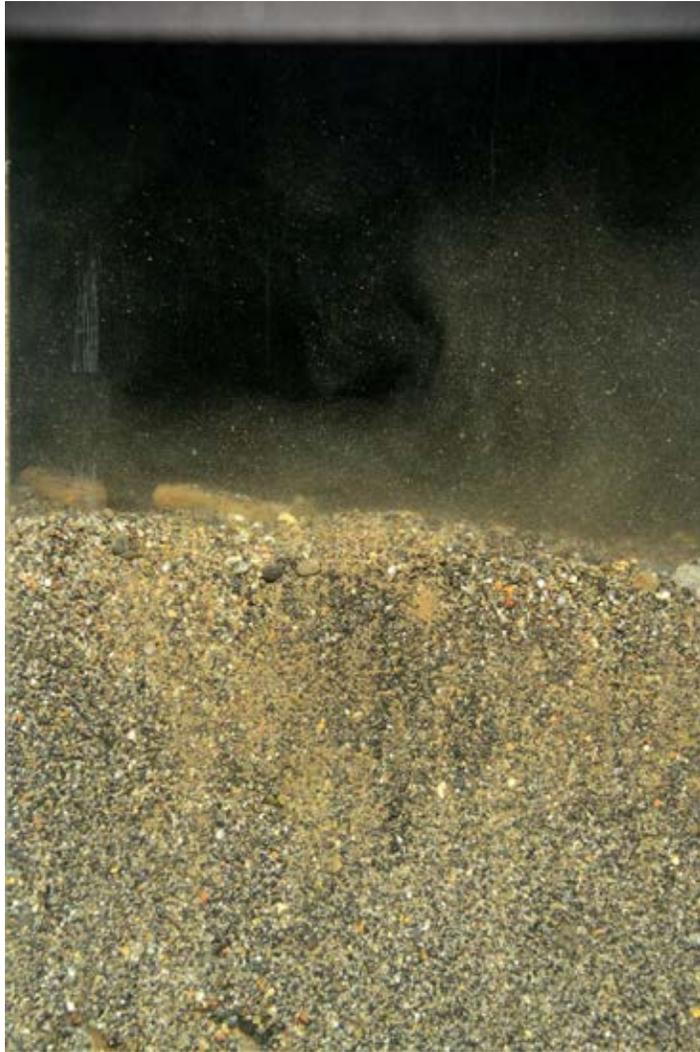
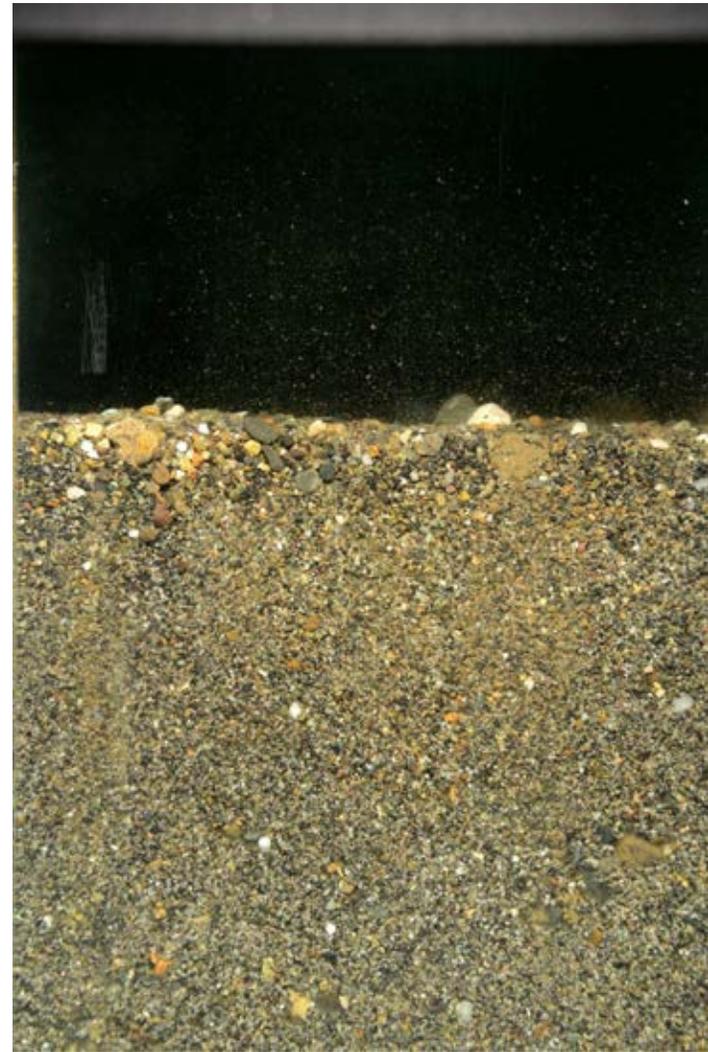
Figure 3-10. Representative SPI images from Stations LDW-Y0-SC-ENR+AC-2-A-SPI-R3 (left) and LDW-Y0-SC-ENR+AC-3-B-SPI-R1 (right) showing typical ENR+AC material from the scour subplot. In both images, ENR+AC material extends beyond the depth of camera prism penetration. Small, fine sand-sized, black, low reflectance particles are interspersed throughout the sediment column and its extent into the sediment column persists beyond the depth of prism penetration. SPI images are 14.42 cm in width.

Triplicate SPI images were taken at 12 locations (n=36) within the scour ENR+AC subplot 19 days after construction (Attachment 5). The ENR+AC material was observed at all stations and all replicates. The ENR+AC was present at thicknesses that exceeded the prism penetration depth at all locations and all replicates except for a single replicate; at this location the thickness of the ENR+AC material was 3 inches (7.5 cm) over fine-grained native sediments. The other two replicate images at the location had thicknesses of ENR+AC material greater than the prism penetration depth. Prism penetration depths ranged from 2.6 inches (6.5 cm) to 7.5 inches (19.1 cm) and the average prism penetration depth was 3.9 inches (9.9 cm). It should be noted SPI locations were not collocated with the stake locations; therefore, there may be differences between SPI observations and stake measurements.

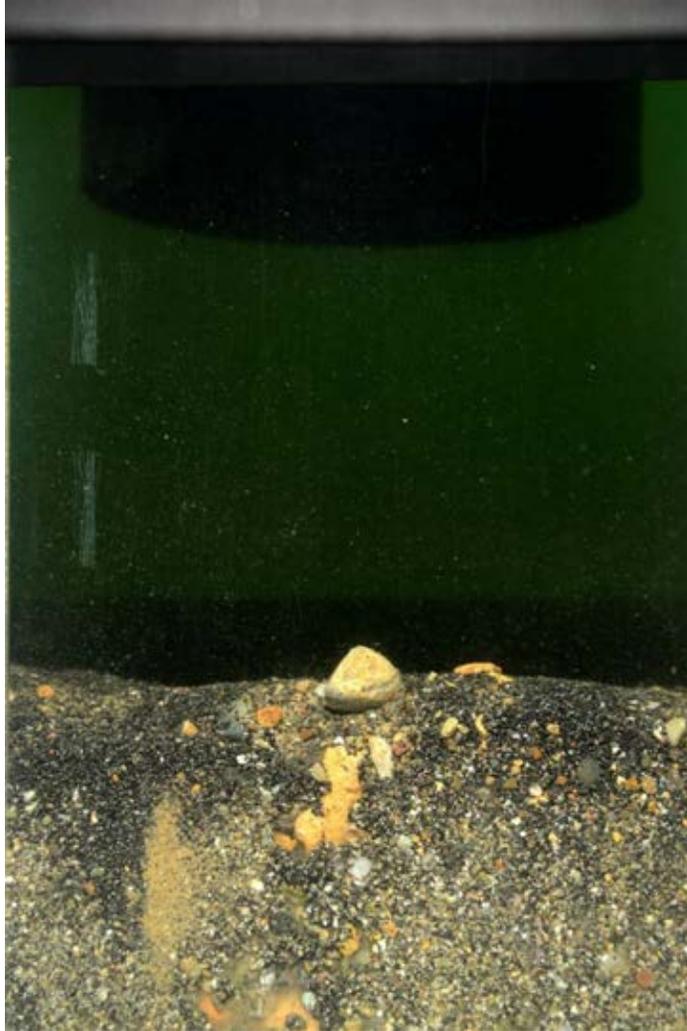
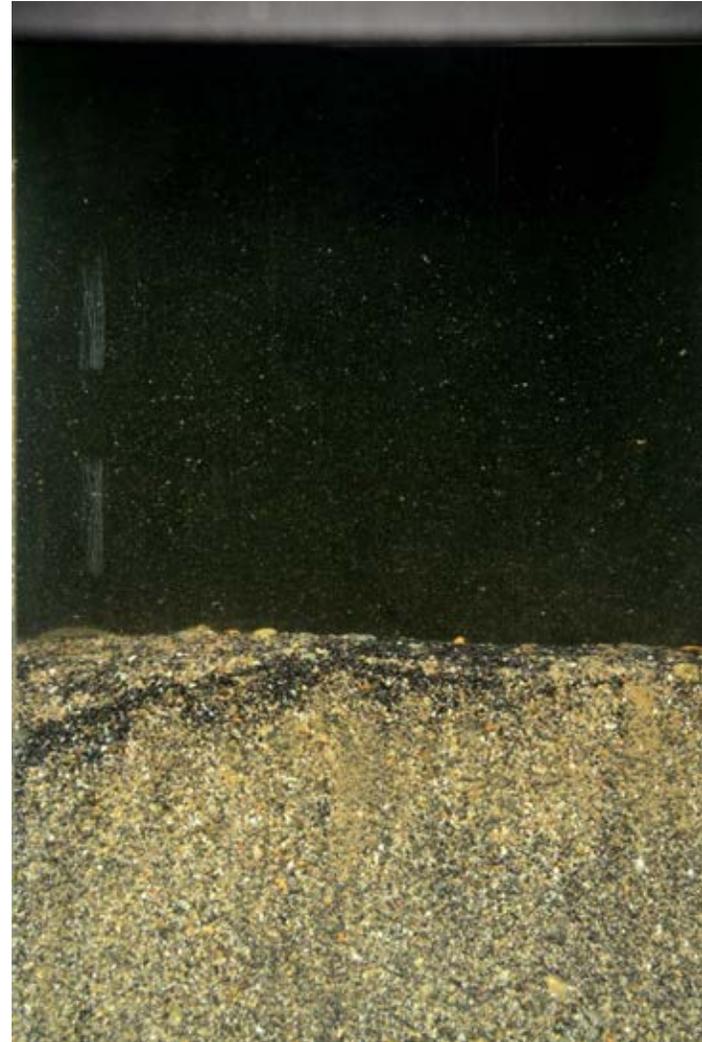
Figure 3-11. Representative SPI images from Stations LDW-Y0-SC-ENR+AC-5-B-SPI-R1 (left) and LDW-Y0-SC-ENR+AC-3-A-SPI-R3 (right) showing ENR+AC material from the scour subplot. ENR+AC extends into the sediment column beyond the depth of prism penetration although in both images there is a thin band of black particles at the sediment-water interface. At both stations, there is little to no recently deposited sediment. SPI images are 14.42 cm in width.
