CONSTRUCTION REPORT

Enhanced Natural Recovery/Activated Carbon Pilot Study

Lower Duwamish Waterway

Approved by EPA June 2018

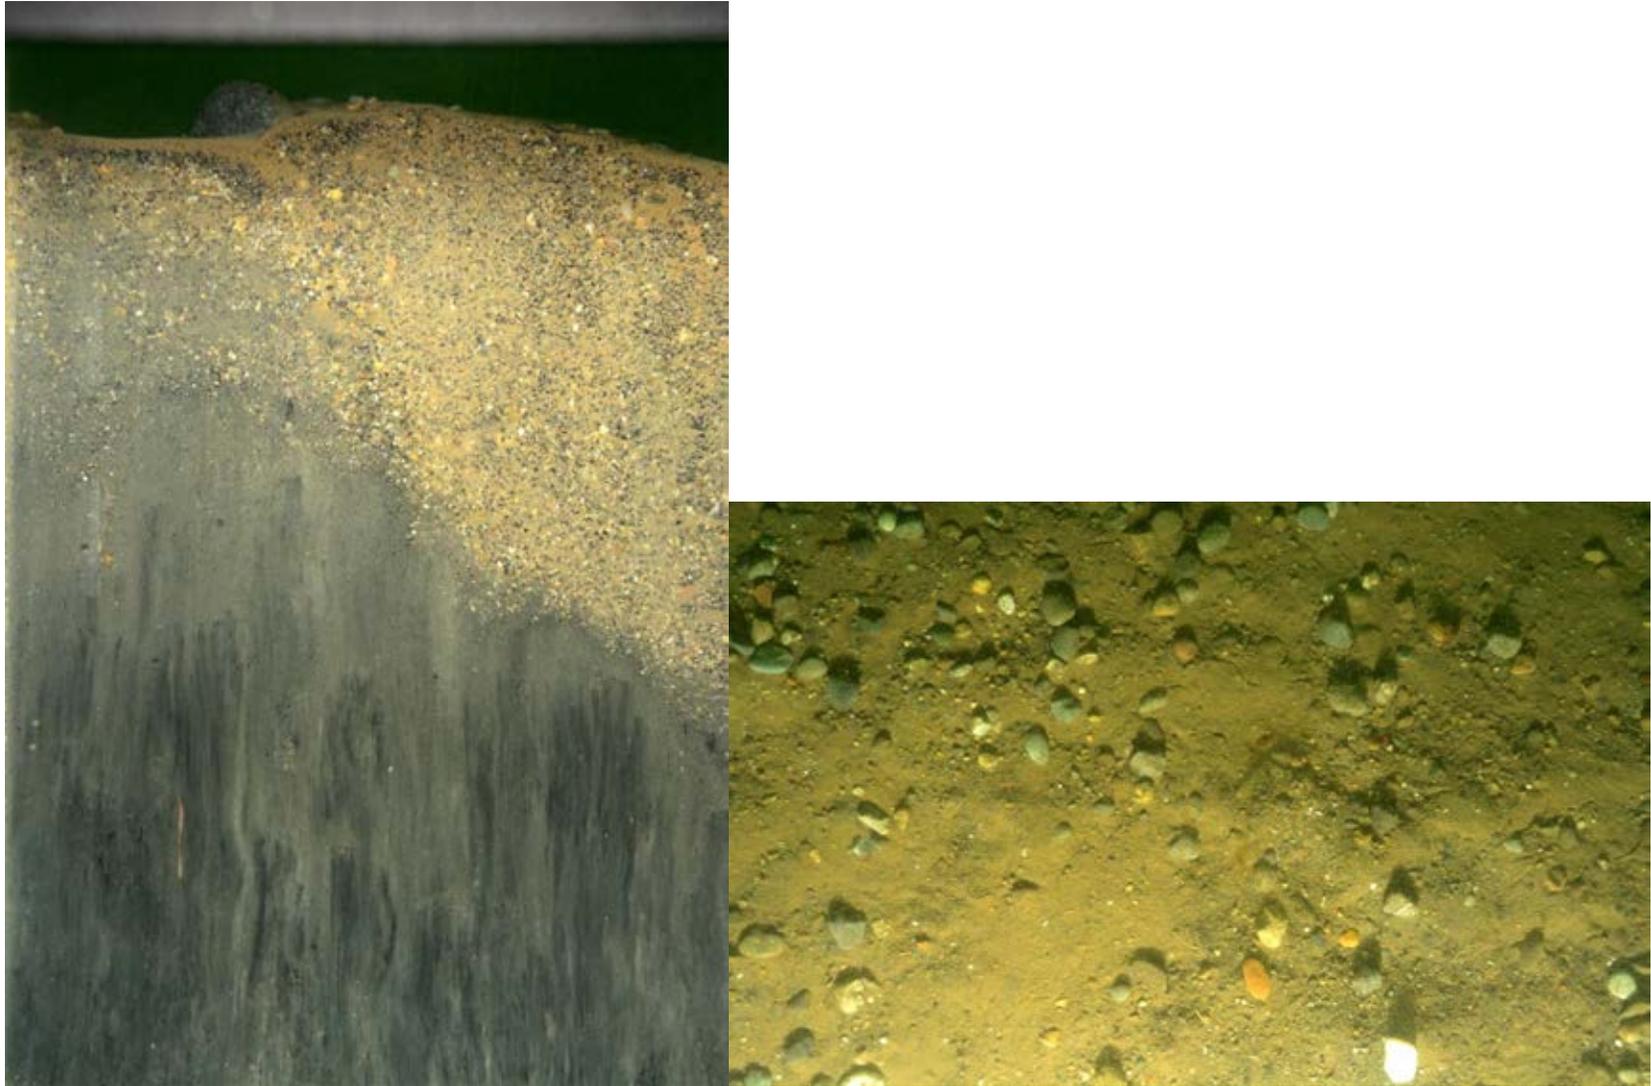
Figure 3-12. SPI and PV images from Station LDW-Y0-SC-ENR+AC-5-A-SPI-R2. The SPI image shows a layer of ENR+AC material over native sediment. The PV image shows 100% cover of ENR+AC material and a patch of recently deposited sediment in the lower center of the frame. This is the only location in the scour subplot where the thickness of ENR or ENR+AC was less than camera prism penetration.

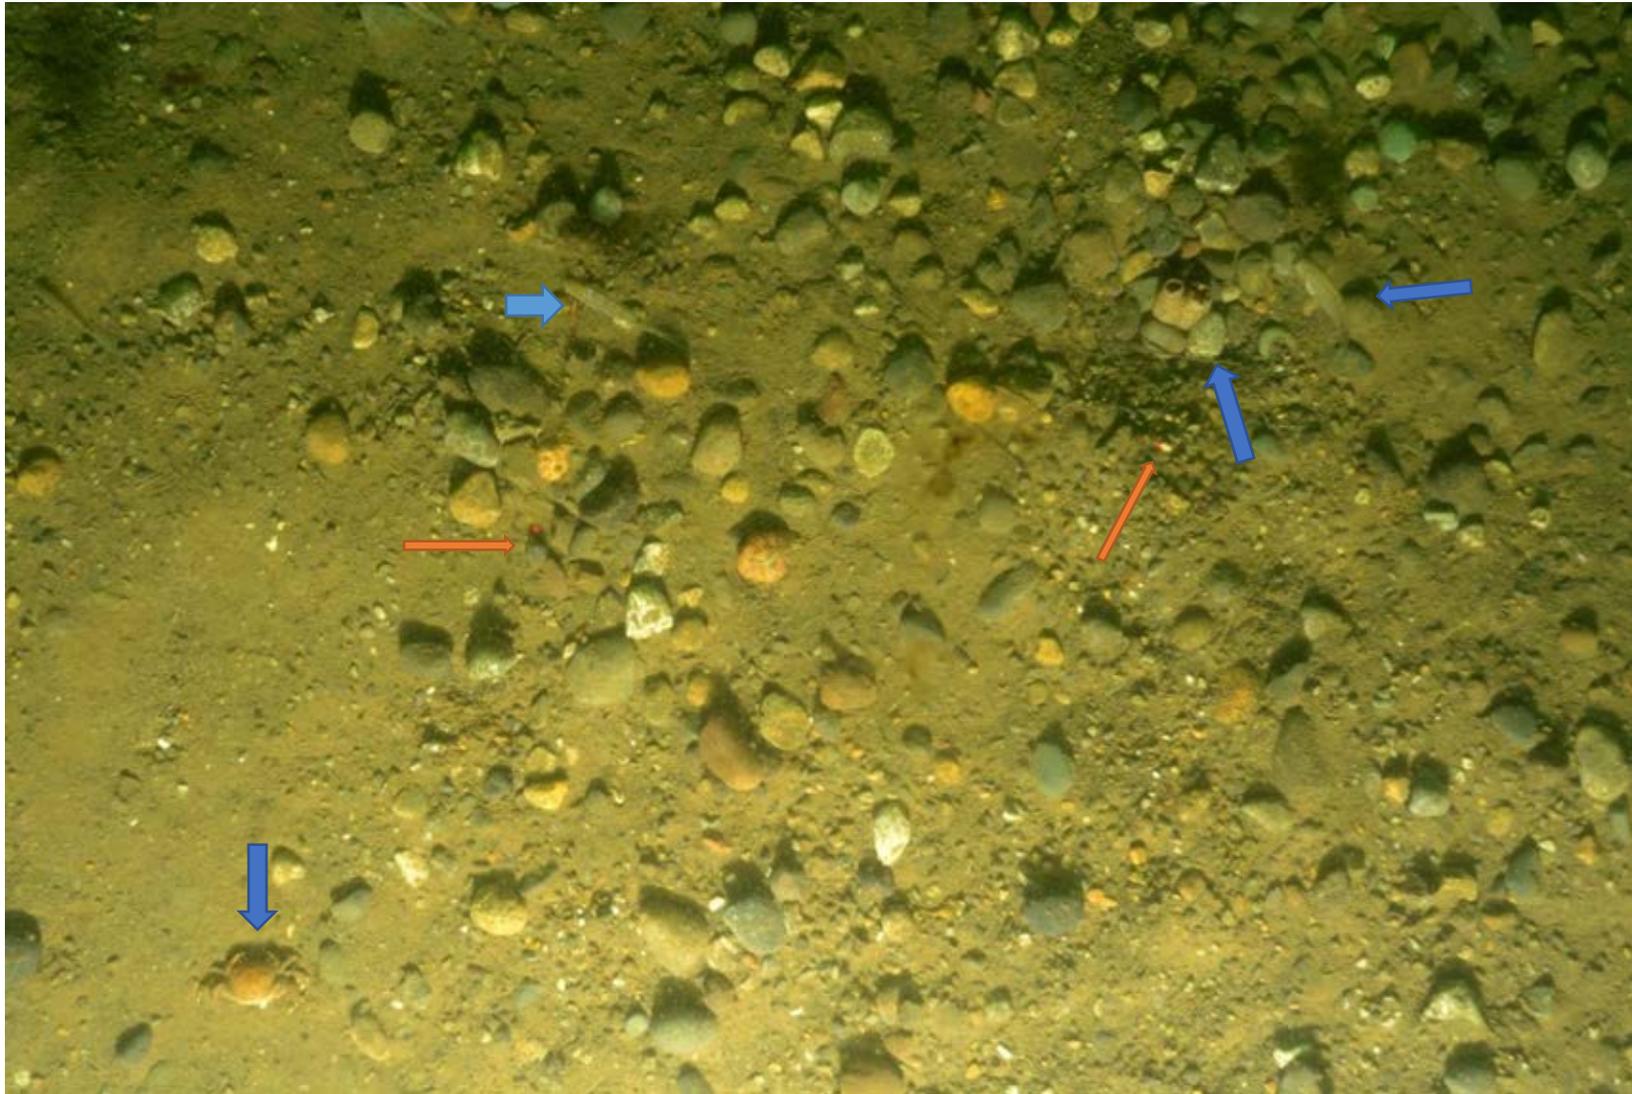
Figure 3-13. PV image from Station LDW-Y0-SC-ENR+AC-5-A-PV-R1 showing ENR+AC material (sands and gravels) and some patchy recent deposition of fine-grained sediment. Two fish, a crab, and a bivalve siphon can be seen in the image (arrows). Scaling lasers (red dots) are 26 cm apart.

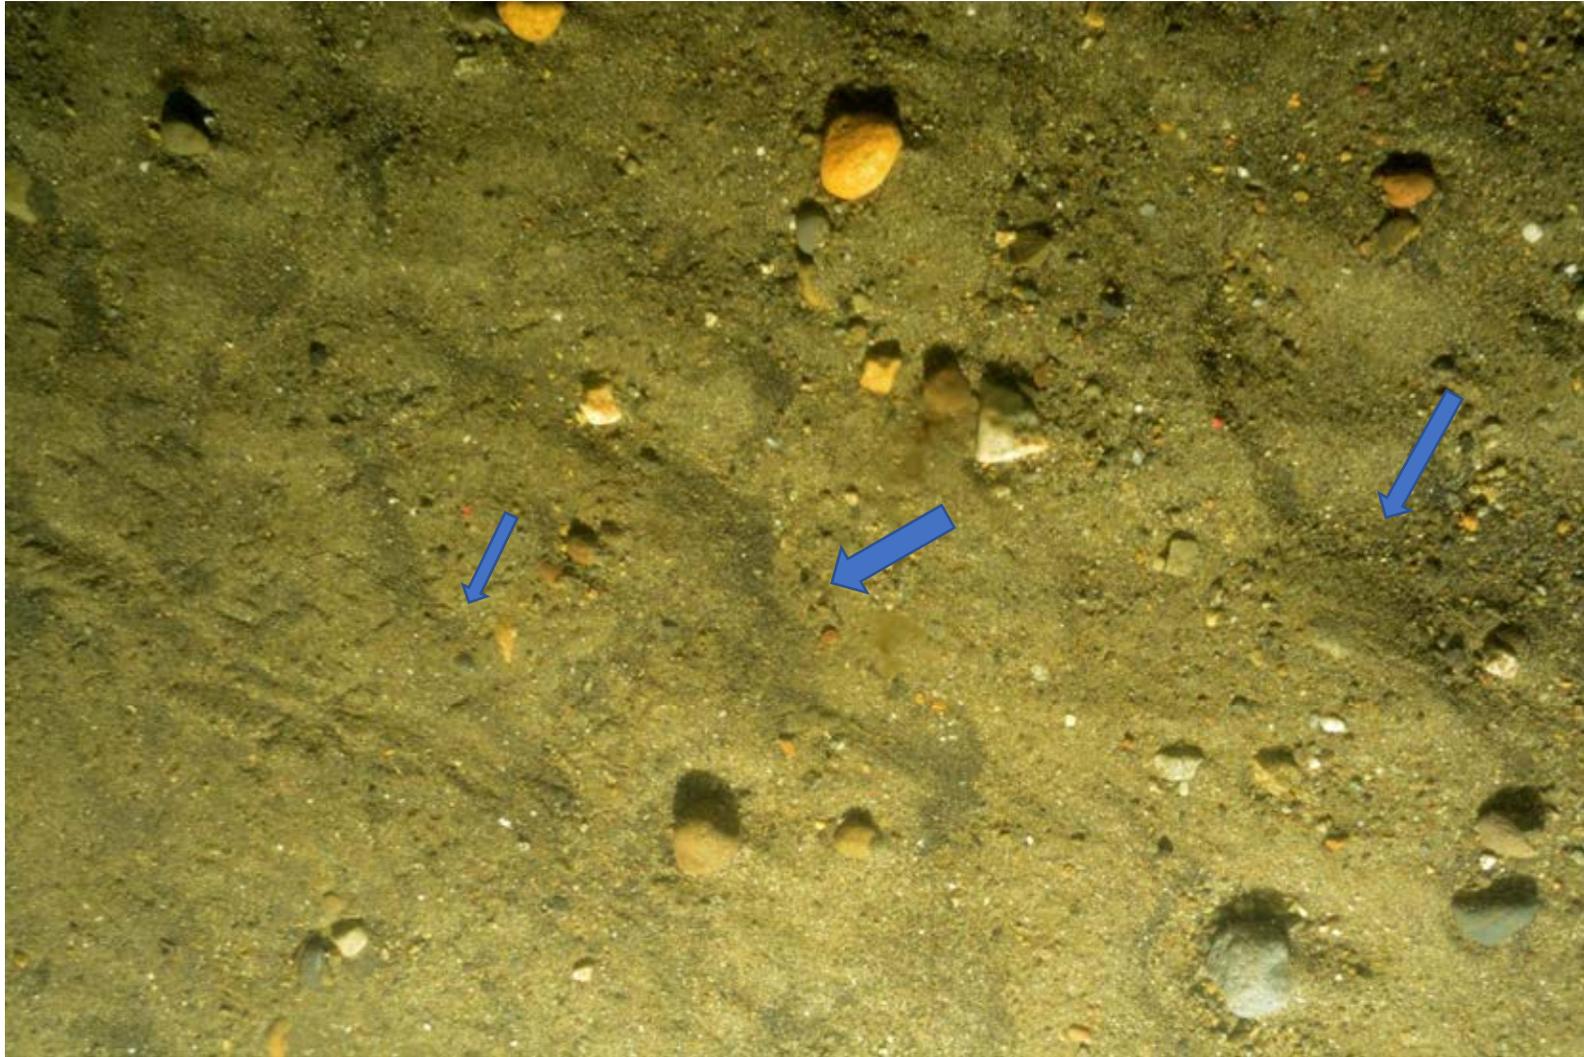
Figure 3-14. PV image from Station LDW-Y0-SC-ENR+AC-2-A-PV-R1 showing ENR+AC material. The sediment surface is faintly rippled and small accumulations of black particles can be seen on the lee side of the ripples. Scaling lasers (red dots) are 26 cm apart.

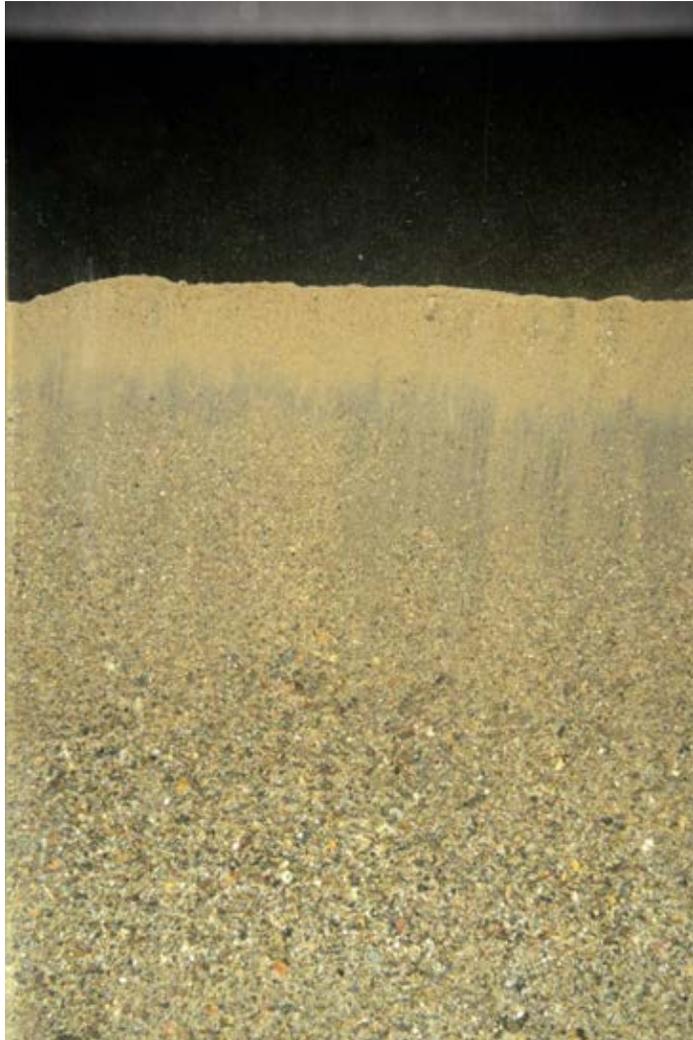
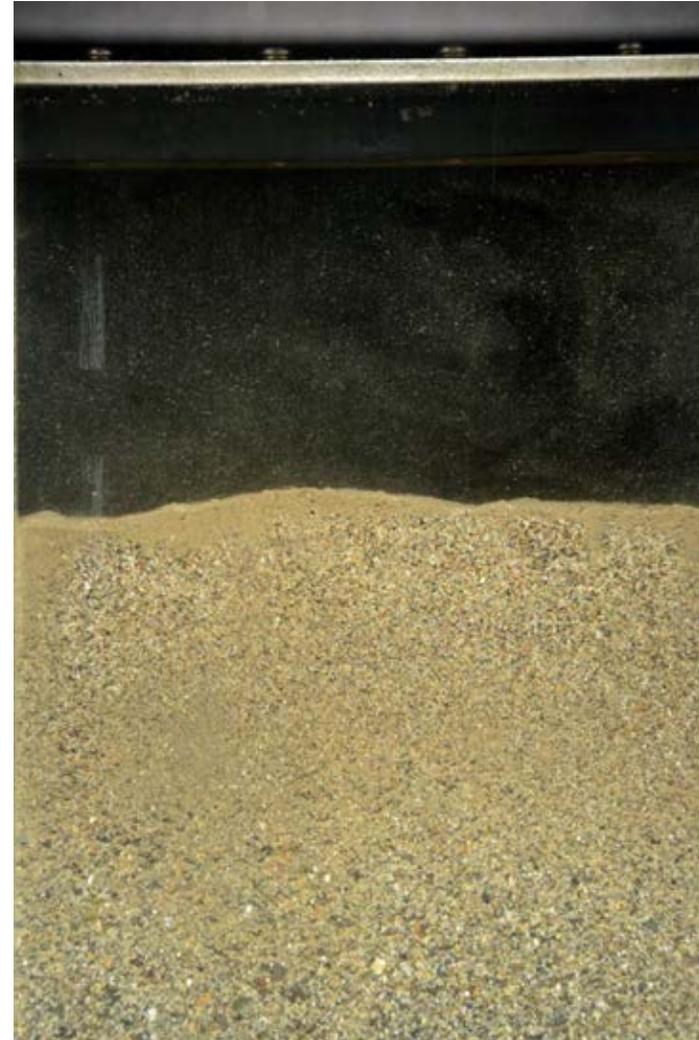
Figure 3-15. Representative SPI images from Stations LDW-Y0-SU-ENR-1-B-SPI-R1 (left) and LDW-Y0-SU-ENR-3-B-SPI-R3 (right) showing ENR material typical of the subtidal plot. In both images, the thickness of ENR material extends beyond the penetration of the prism into the sediment column. A distinct layer of fine-grained sediment has been deposited on the sediment in the elapsed period between the cessation of placement and start of the SPI/PV survey of the subtidal plot. SPI images are 14.42 cm in width.

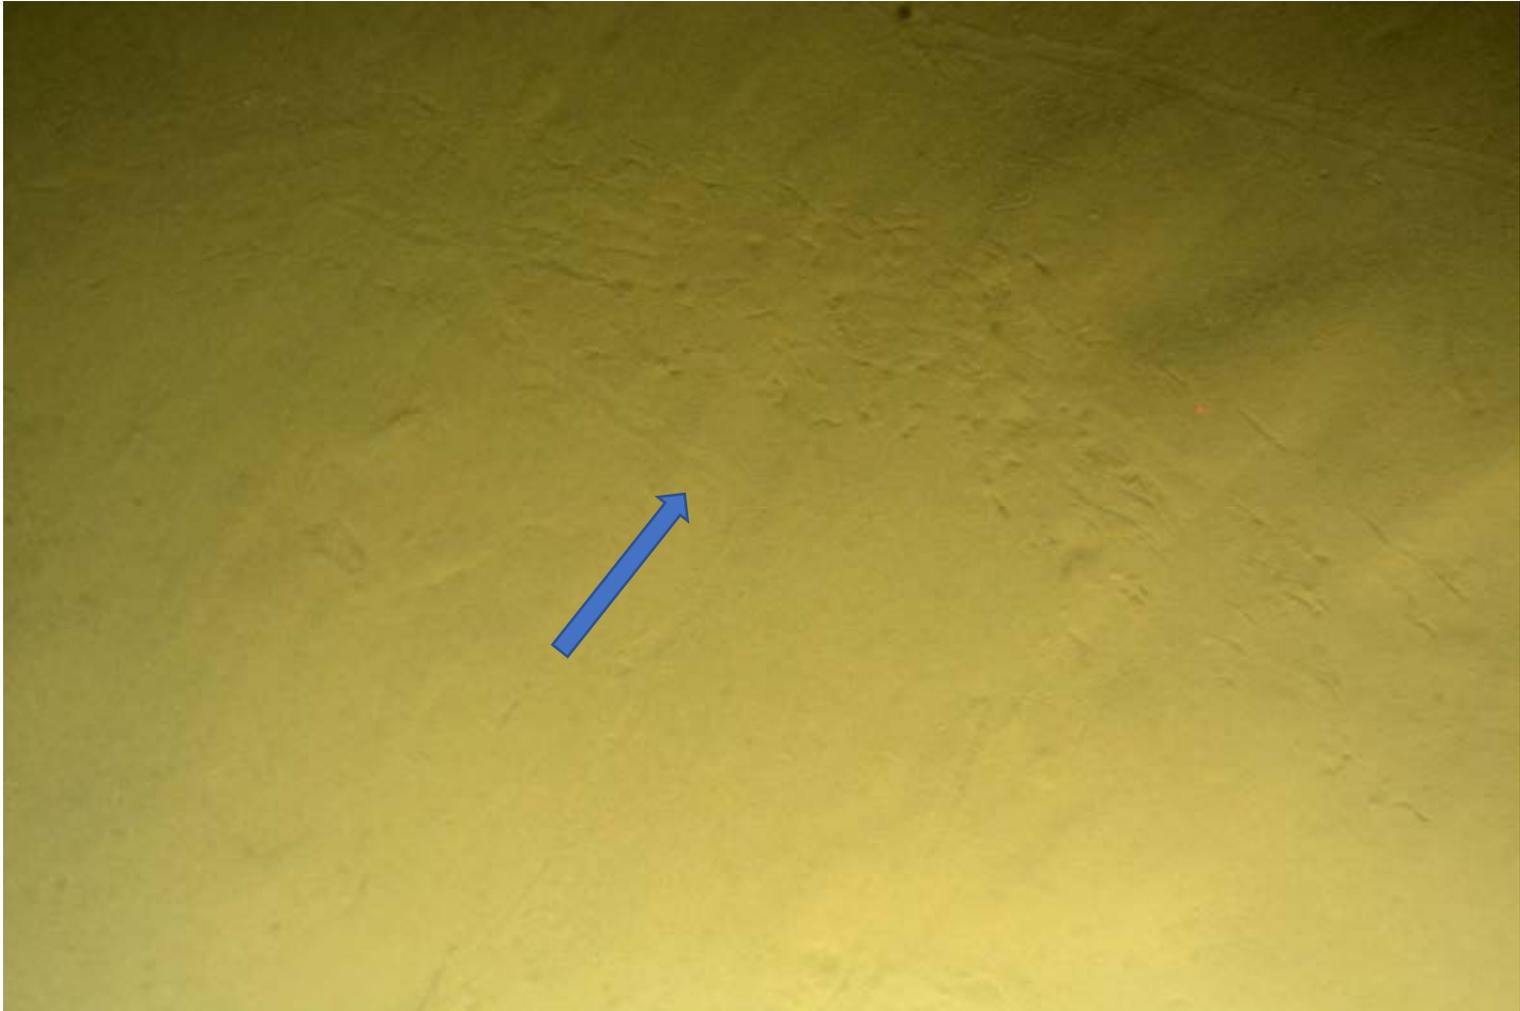
Figure 3-16. PV image from Station LDW-Y0-SU-ENR-1-B-PV-R1 showing typical surface sediments encountered at the subtidal ENR subplot. Surface sediments seen in the PV image are fine-grained silts and clays with some epifaunal tracks (arrow). ENR sands and gravels are not visible through the veneer of the recently deposited sediment. The SPI image from this replicate is shown in Figure 3-14. Scaling lasers (red dots) are 26 cm apart.

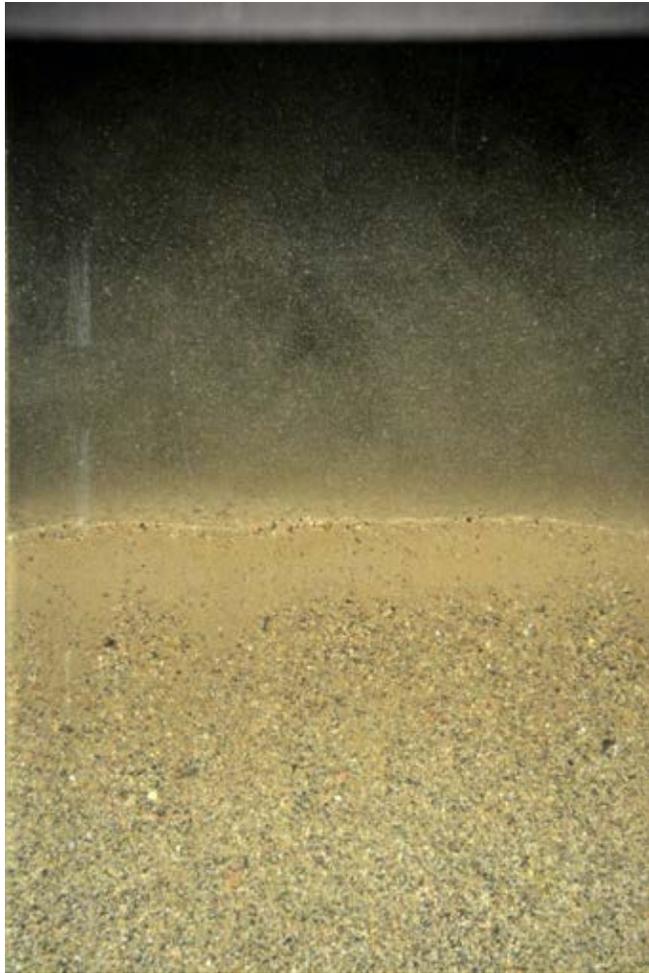
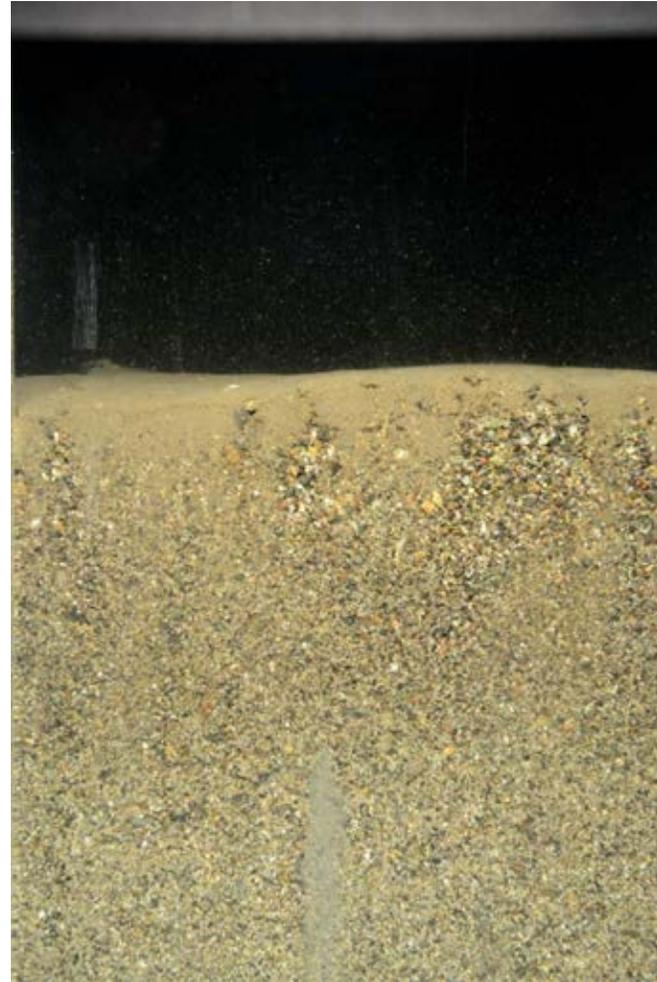
Figure 3-17. Representative SPI images from Stations LDW-Y0-SU-ENR+AC-4-A-SPI-R1 (left) and LDW-Y0-SU-ENR+AC-6-A-SPI-R1 showing ENR+AC materials from the subtidal ENR+AC subplot. ENR+AC material extends into the sediment column beyond the depth of prism penetration. There is a thin band (~1 cm) of recently deposited sediment at the top of the sediment column. SPI images are 14.42 cm in width.

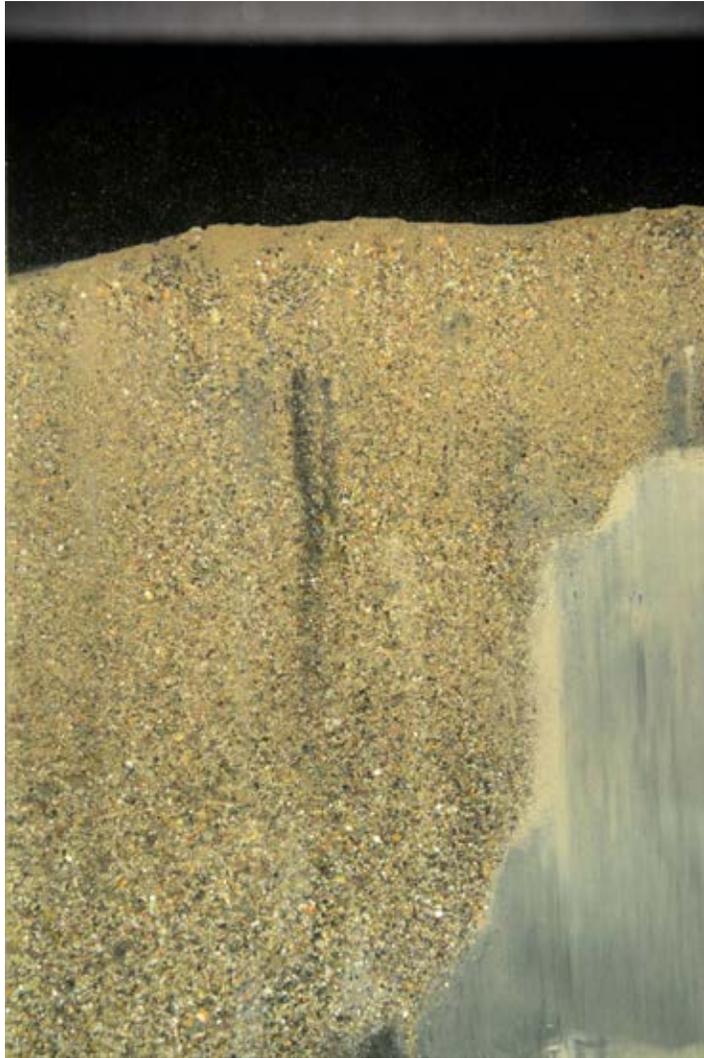
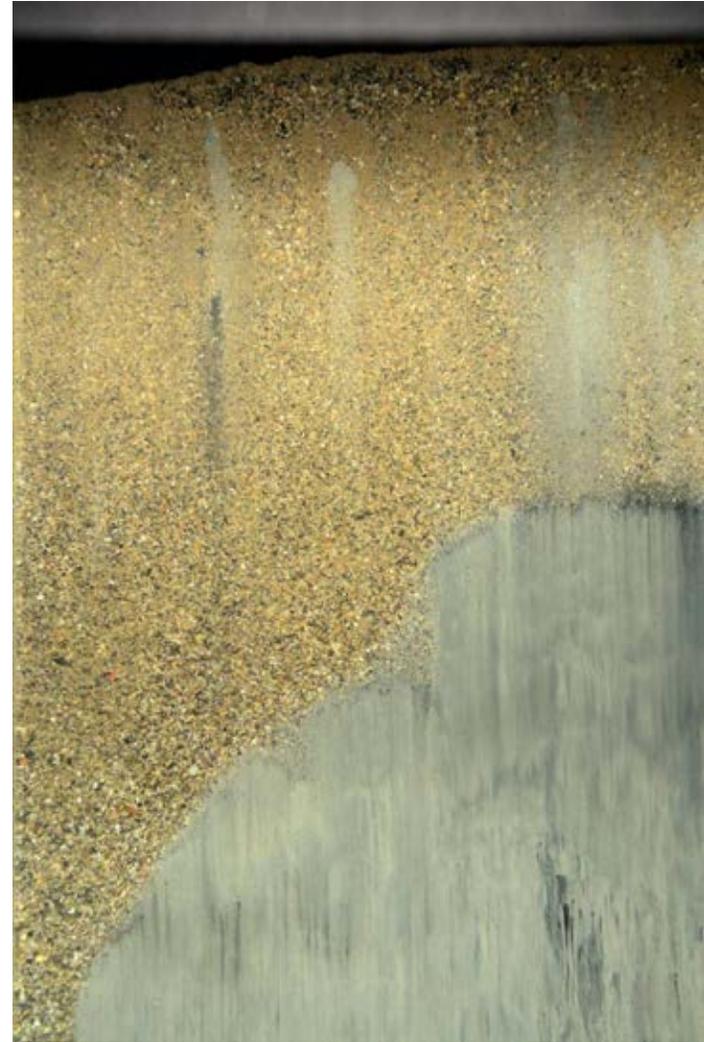
Figure 3-18. Representative SPI images from Stations LDW-Y0-SU-ENR+AC-4-B-SPI-R1 (left) and LDW-Y0-SU-ENR+AC-4-B-SPI-R1 (right) from the subtidal ENR+AC subplot. ENR+AC material overlies gray, reduced native sediments providing 100% cover. These are the only two replicates from this subplot (from the same station) where the ENR+AC thickness is less than prism penetration. SPI images are 14.42 cm in width.

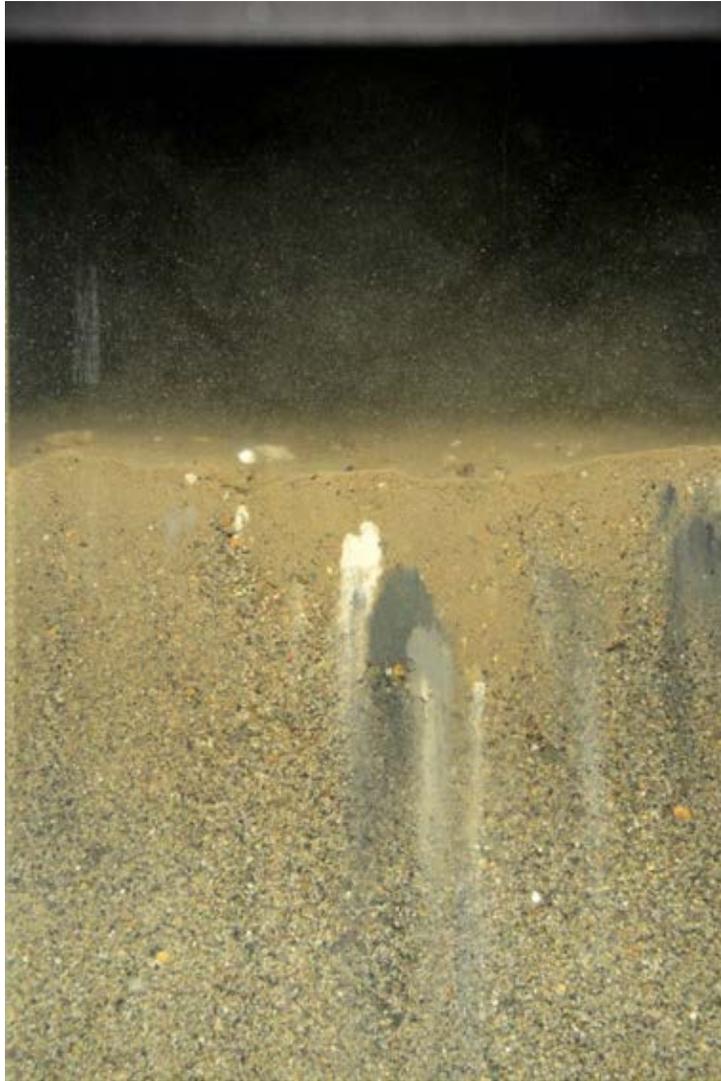
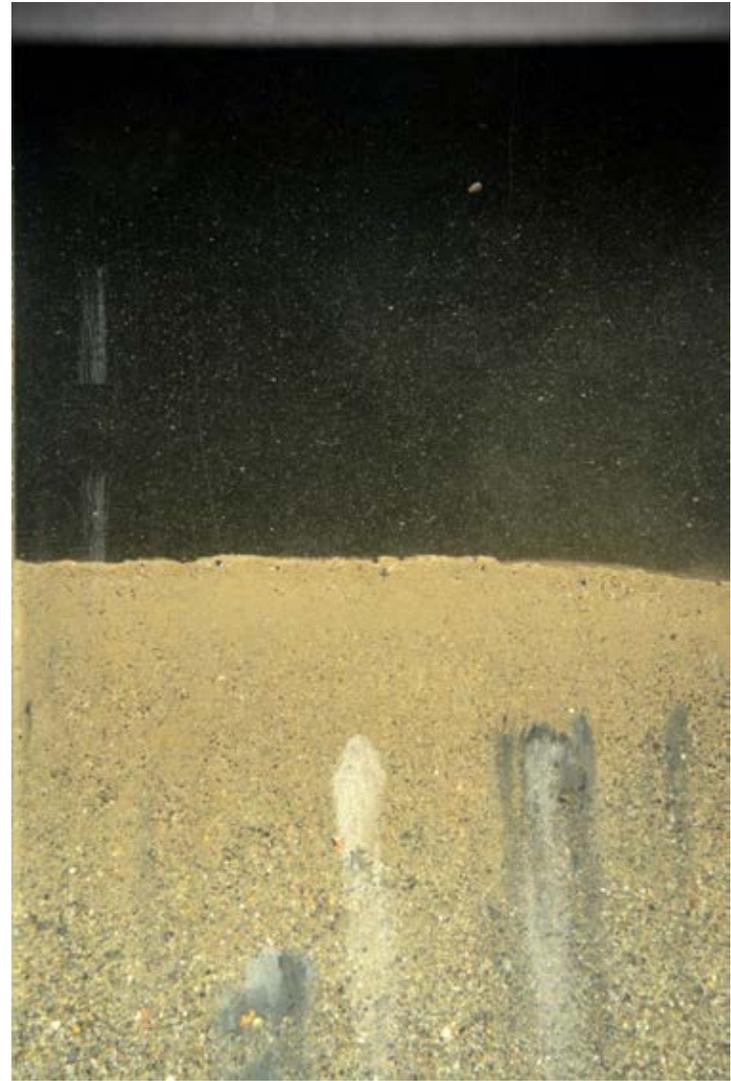
Figure 3-19. SPI images from Stations LDW-Y0-SU-ENR+AC-6-A-SPI-R2 (left) and LDW-Y0-SU-ENR+AC-6-B-SPI-R2 (right) showing ENR+AC material from the subtidal plot, which is overlain by a thin, 1- to 2-cm deposit of recently deposited sediment that contains distinct balls of allochthonous clay. SPI images are 14.42 cm in width.

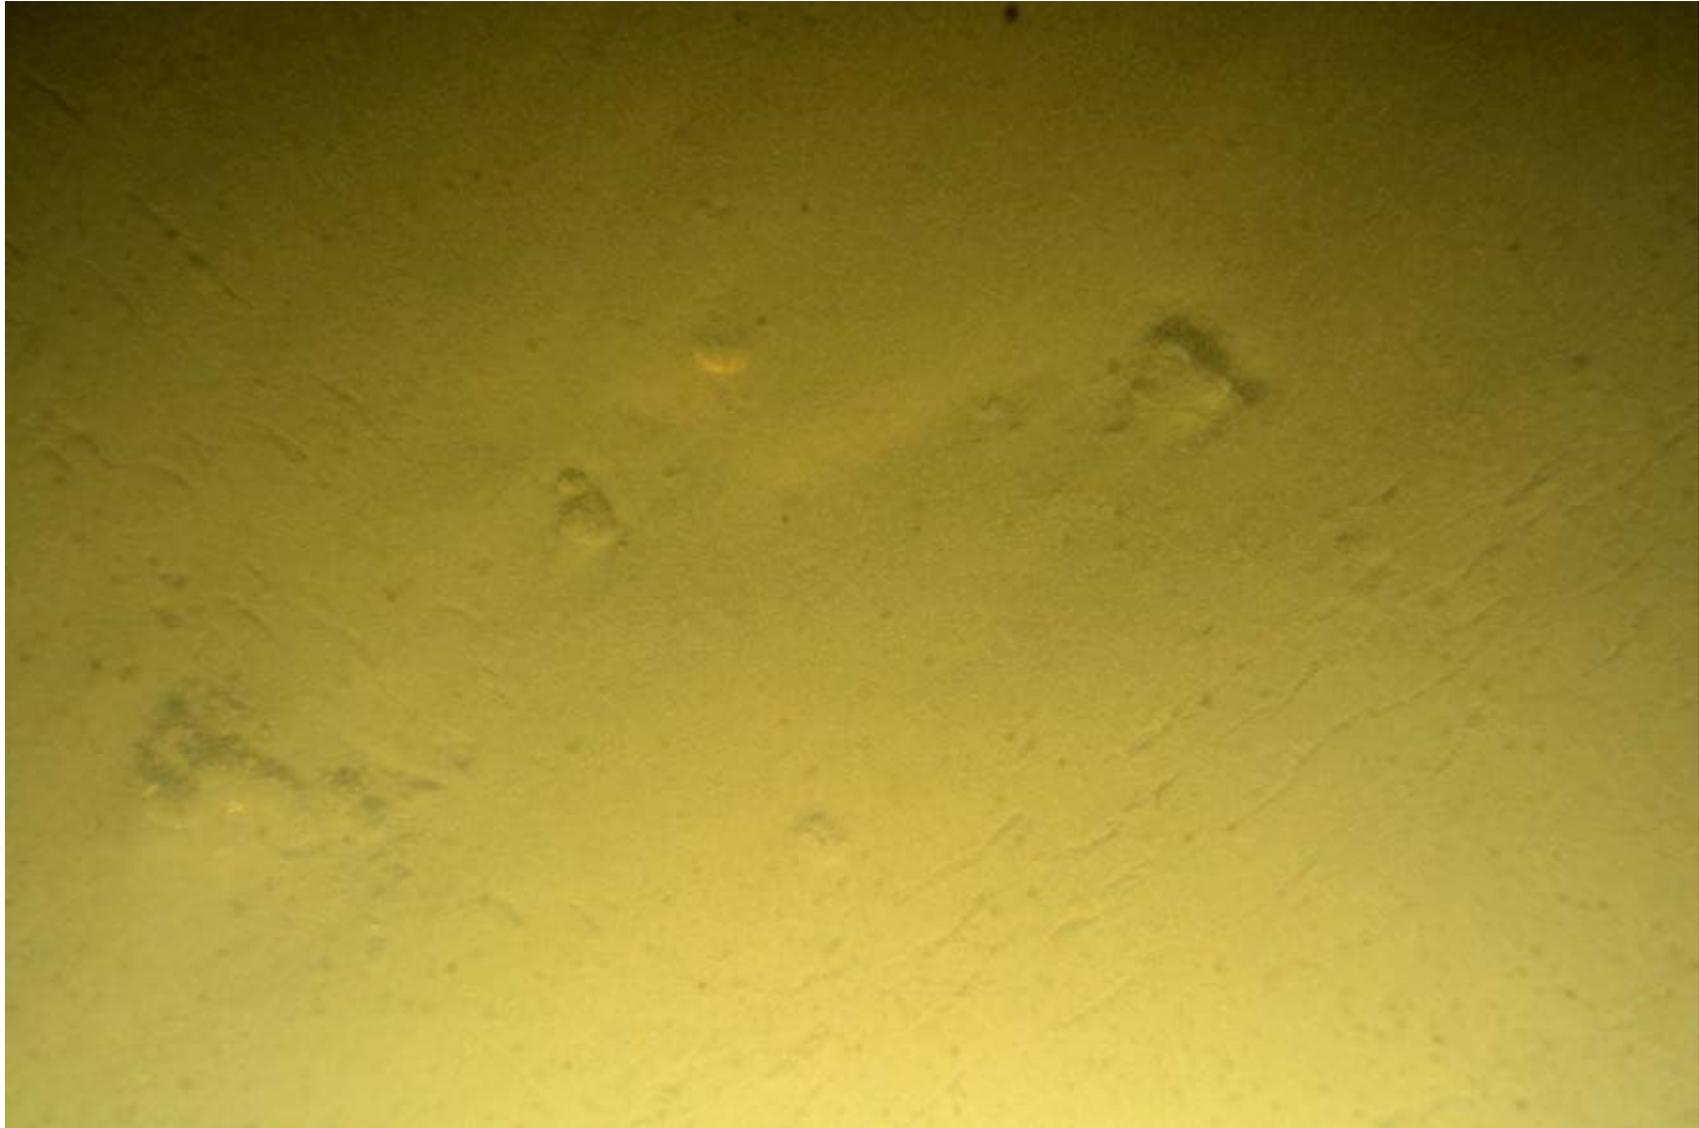
Figure 3-20. PV image from Station LDW-Y0-SU-ENR+AC-3-A-PV-R1 showing soft, fine-grained recently deposited sediment and mud clast deposited over and obscuring ENR+AC material. ENR+AC material is only visible in the SPI images from this station.
