**Heating Oil Tank Cleanup Report  
State of Washington Department of Ecology**

**712 W 35th Street**

**Vancouver, WA 98660**

## SITE NARRATIVE FOR 712 W 35TH STREET

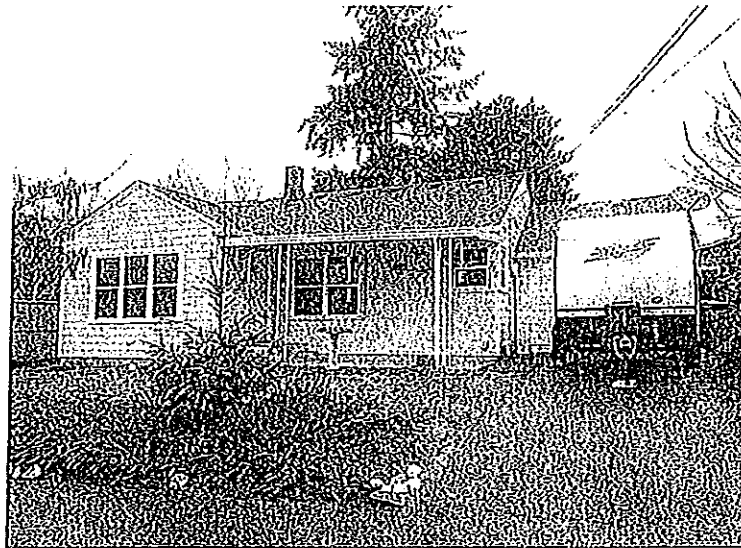
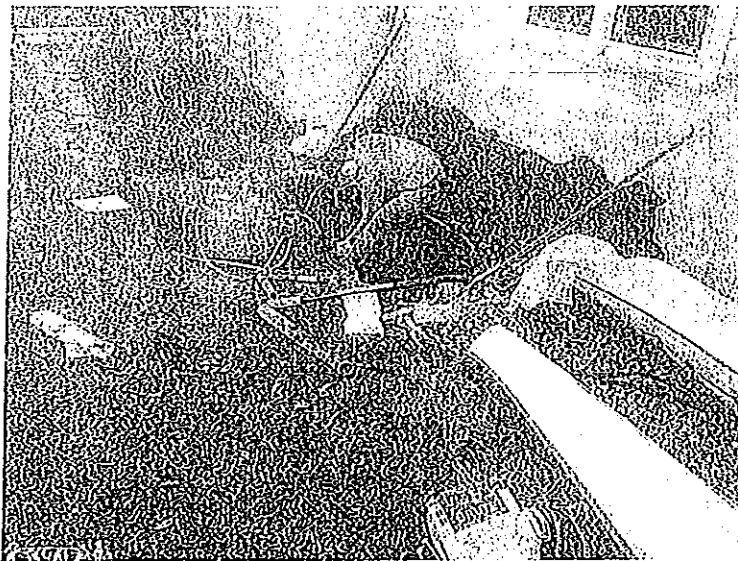
The property located at 712 W 35<sup>th</sup> Street in Vancouver, Washington had an underground storage tank located adjacent to the north side of the house.

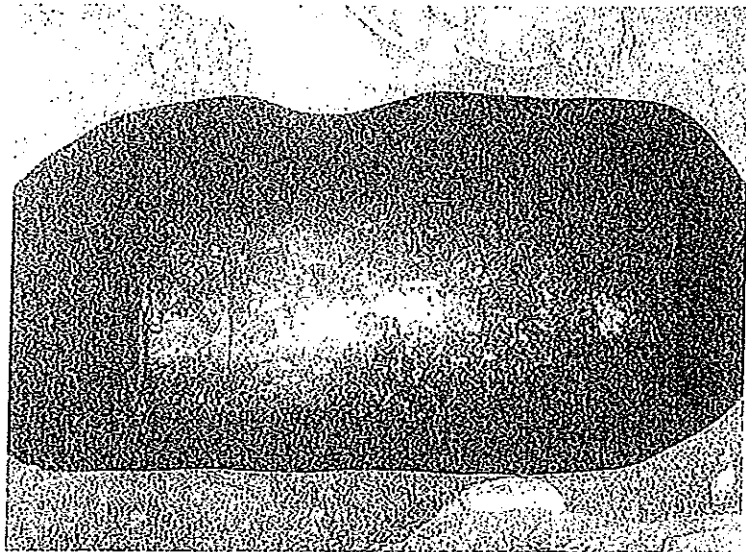
The top of the tank was exposed and cut open. The tank contents were removed and the tank was thoroughly pressure-washed.

The top of the tank was exposed and a portion was cut open. Approximately 5 gallons of sludge and a trace of product were removed from the tank and the interior was thoroughly pressure-washed. The tank contents were transported to SSES equipment yard for temporary storage. The sludge and liquids were transported, in bulk, by Oil Re-Refining Company (ORRCO) for proper disposal. A copy of the disposal receipt is attached. There were holes observed in the tank sides.

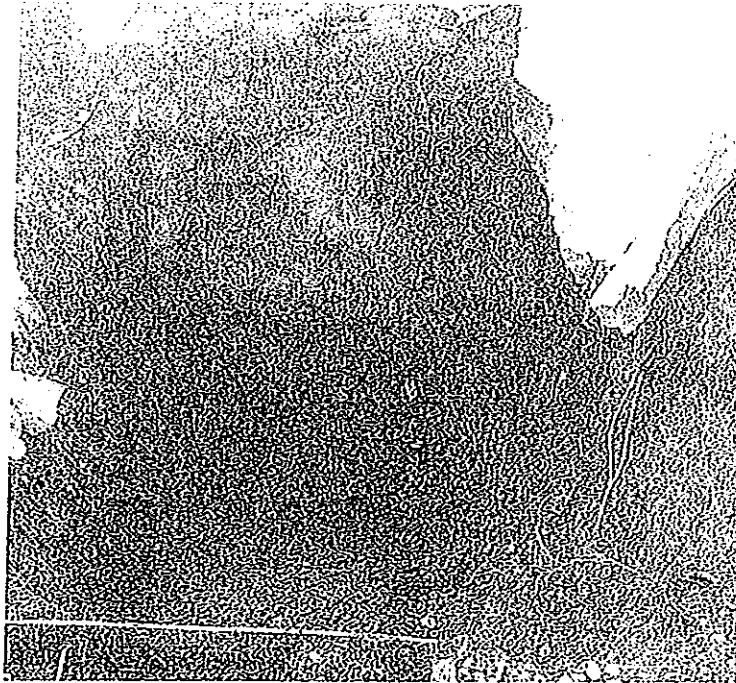
Approximately 2.67 tons of petroleum-contaminated soil was removed from beneath the tank bottom and taken to the Hillsboro Landfill for proper disposal.

Digging began at a depth of 4.5 feet on both pit ends. Digging ceased at 8 feet on the east pit bottom. Approximately 2.67 tons of diesel-contaminated soil was removed from the excavation pit and transported by drop box to Waste Management Hillsboro Landfill for proper disposal. A copy of the disposal receipt is attached. Five discrete soil samples were collected from the excavation pit. One from the pit center at a depth of 6 feet and four samples around the east pit bottom and walls, that appeared most contaminated, at depths of 6-8 feet bgs. These samples were collected using the excavator-grab method. The samples were submitted to F&BI for NWTPH-Dx analysis. The laboratory report showed contamination remained on the east pit bottom. All soil sampling lab results are presented in Table 1.

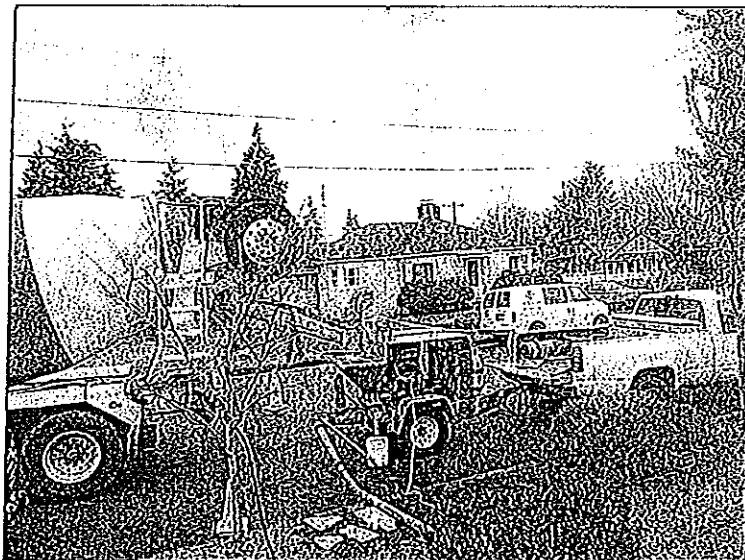
The excavation area was backfilled with concrete slurry.

The final dimensions of the excavation pit were approximately 5 feet in width by 7 feet in length and 6-8 feet in depth. Due to the location of the excavation and the house, the City of Vancouver's Fire Marshal's Office required that the excavation pit be backfilled with structural fill in lieu of standard gravel backfill. On March 29, 2017 the excavation pit was backfilled with concrete slurry from Sonny's Concrete Pumping. The site was restored to surface grade with soil and topped with grass seed.

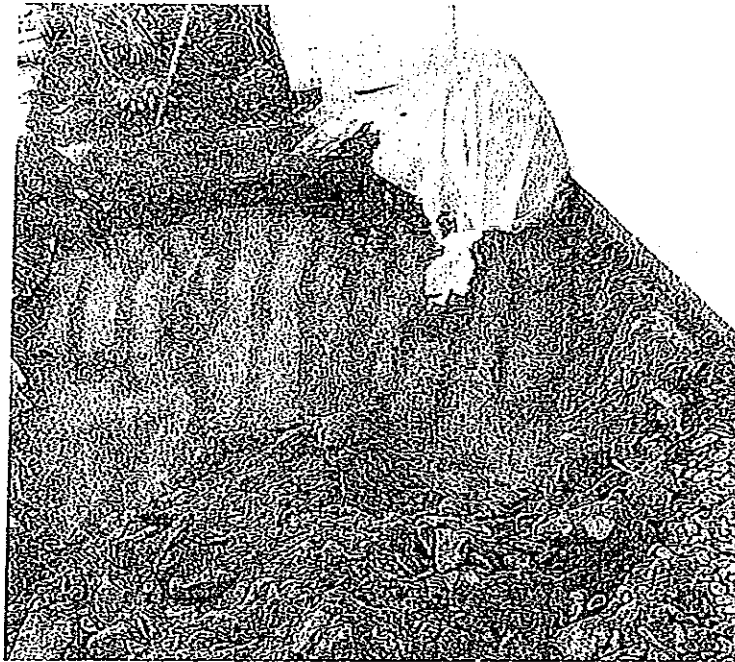
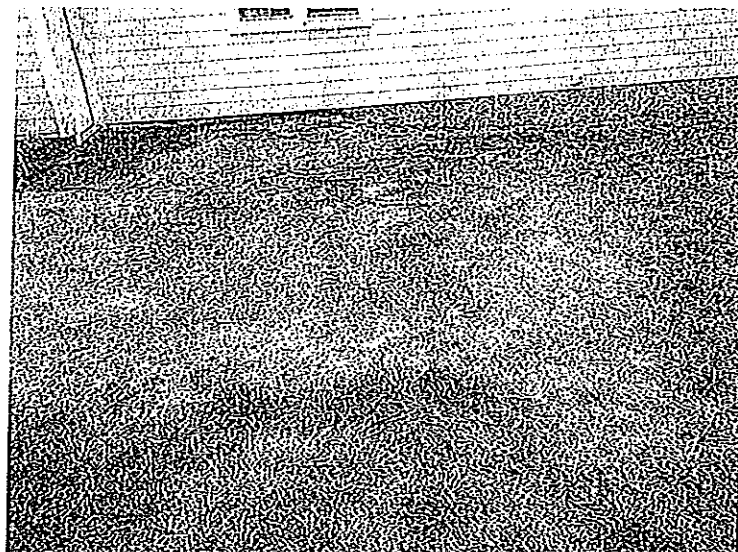
The tank area was restored to surface grade with soil.
