# **MU1 and MU2 Engineering Design Report Cornwall Avenue Landfill Site Bellingham, Washington**

April 30, 2018

Port of Bellingham  
Bellingham, Washington

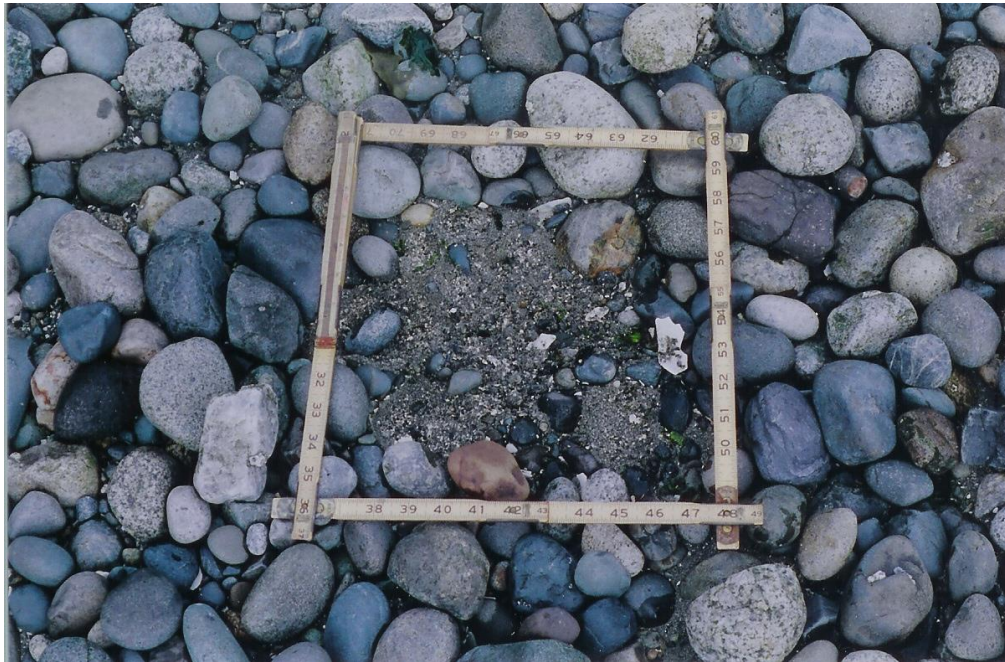
**Figure 8. Representative type of material that may be used for construction of south gravel cobble beach**

Puget Sound area, gravel cobble beach material with a diameter of  $D_{50} = 2.5''$  is recommended. Figure 8 shows a photograph with representative type of material that may be used for construction of the south gravel cobble beach.

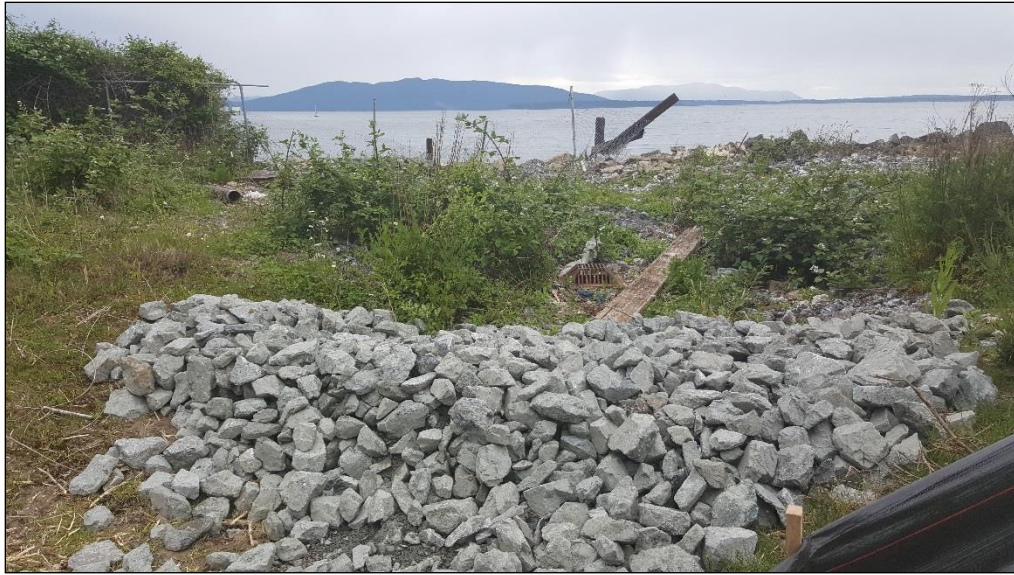
8. Quarry spall check dam installed instead of silt fence.

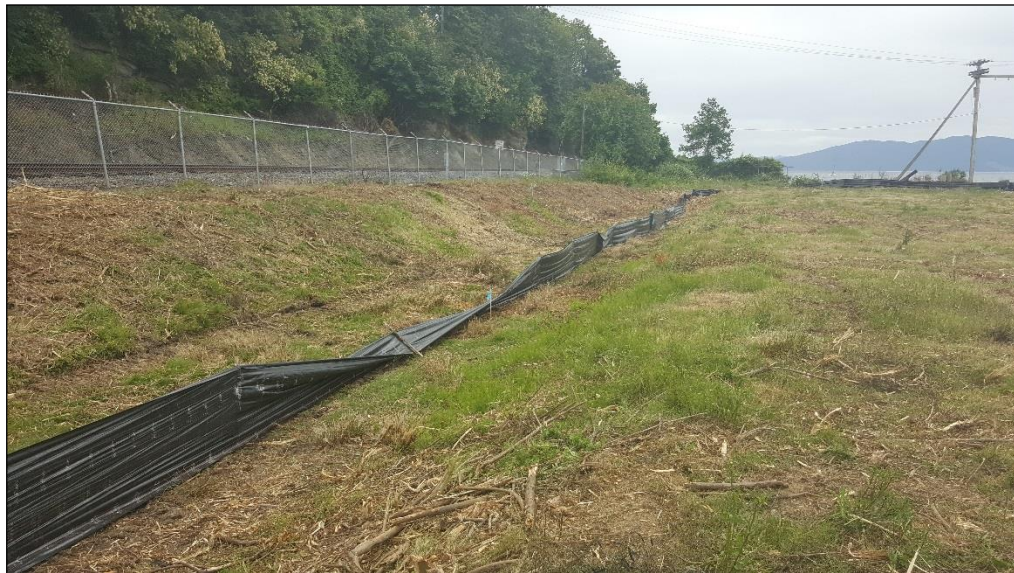
9. Silt fence installed around perimeter of stockpile areas.

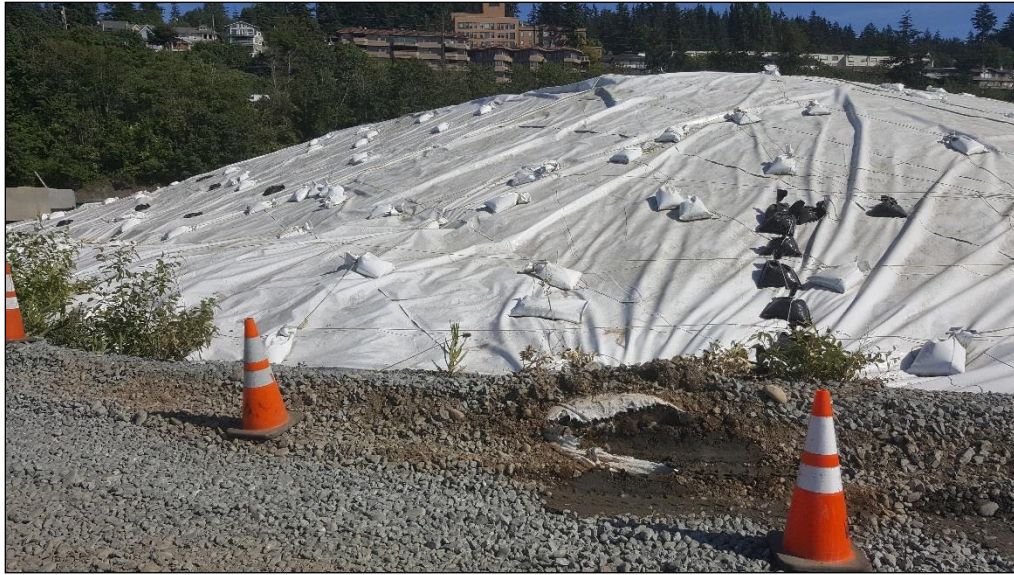
12. Area where cap material was damaged by truck traffic.

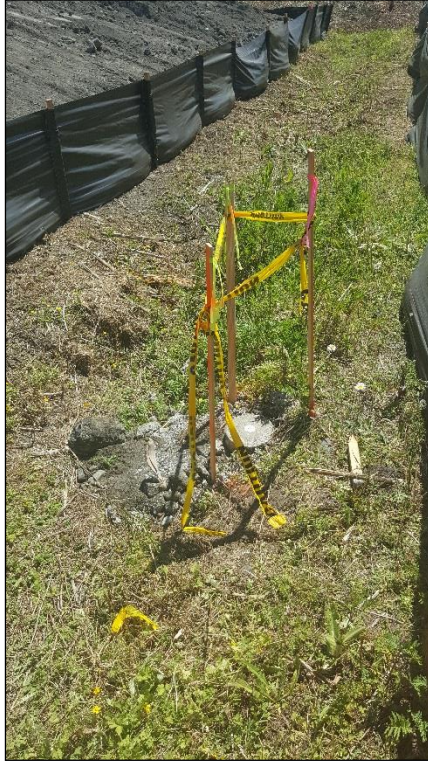
14. Destroyed settlement survey monument SSM-5 has been replaced.

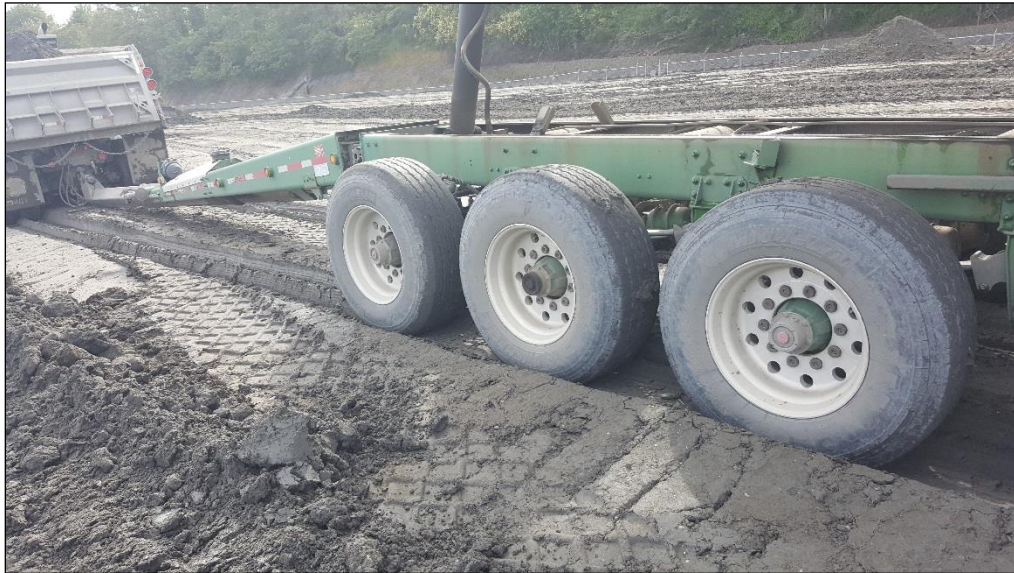
18. Trucks getting stuck in compacted fill material.

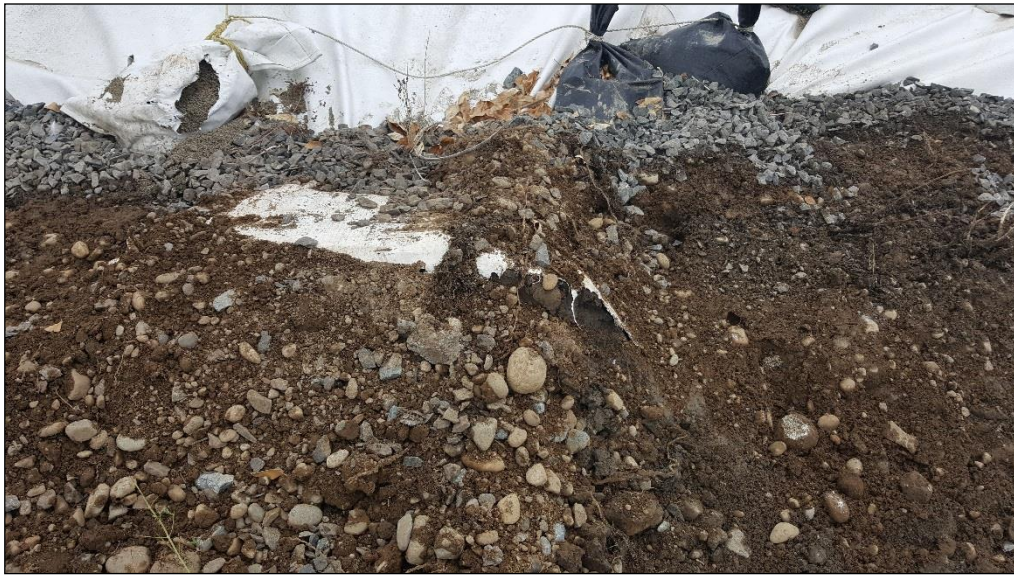
26. Repairs made to damaged stockpile cover.

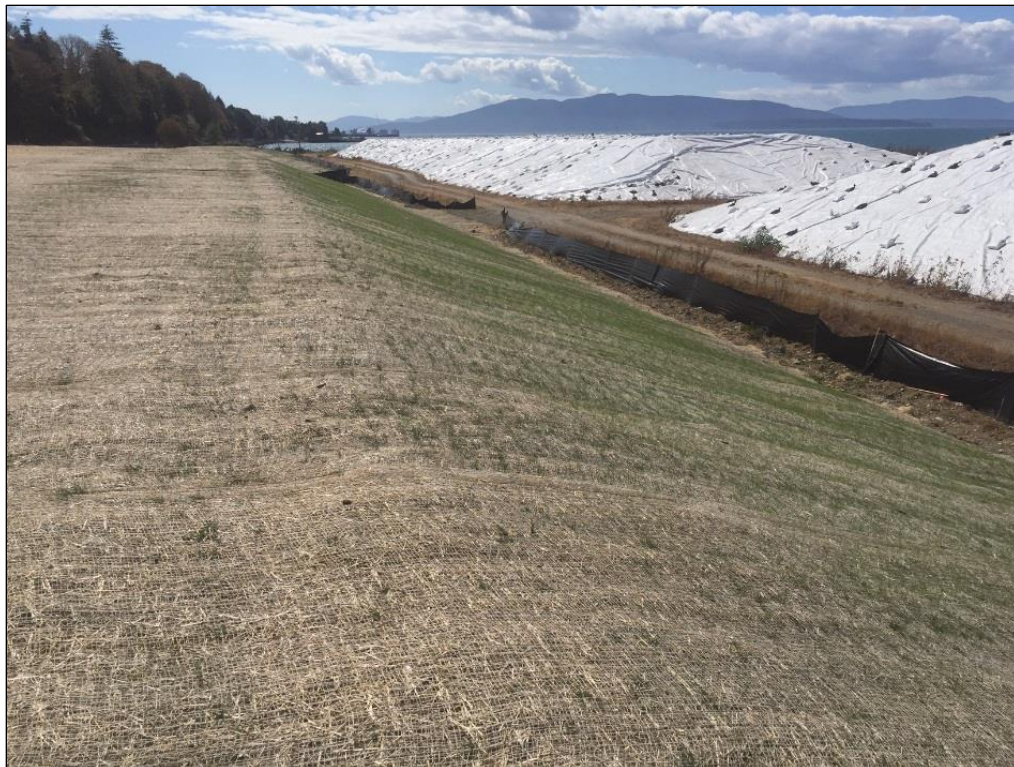
4. Top of pile showing western slope, silt fence visible, grass visible. Loose soil along upstream side of silt fence needs to be graded out and stabilized with grass or some other means.
