UNDERGROUND STORAGE TANK REMOVAL REPORT

Firestone Tire and Auto Center # 31K7 1012 164th S.E. Mill Creek, Washington

UST REMOVAL REPORT

December 10, 1991

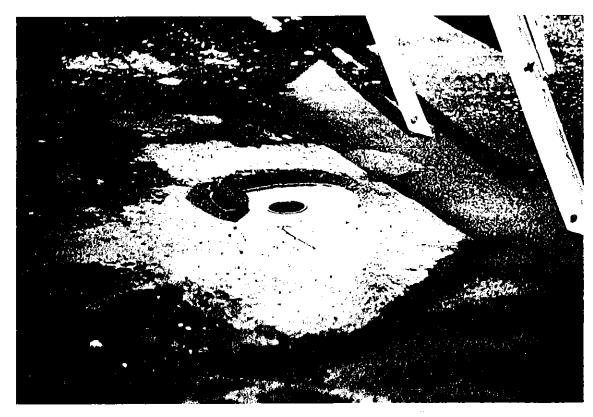
Waste Oil Underground Storag Tank (UST) Fill Receptacle

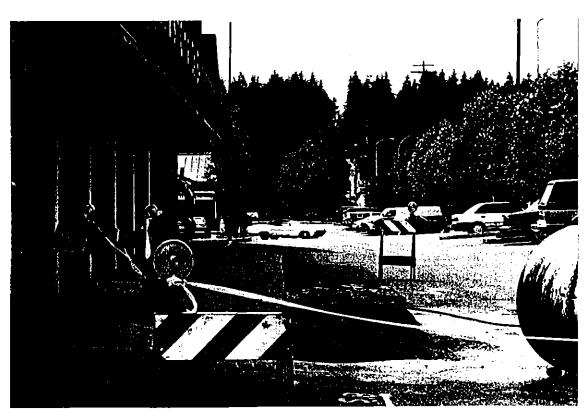
Tank Excavation at Edge of Concrete Slab in Front of Service Bay

On August 6, 1991, Jesus Cuellar of RMI, along with Mike Osborne and a crew from A.G.A. Systems, mobilized to the site. The asphalt surface cover from over the tank location was removed and hauled off to a disposal facility. The tank was partially located beneath an adjacent concrete slab, but only asphalt was removed with the intent that the tank could be removed without breaking up the concrete slab. Excavation of the tank was begun, with generated excavated soils stockpiled adjacent to the tank excavation.
