- Laboratory Analytical Reports and Chains of Custody

Please find enclosed the analytical data report for the *Modutech Marine (C80309-1)* Project.

PHASE I ENVIRONMENTAL SITE ASSESSMENT

The Riley Group, Inc. (RGI) conducted a Phase I Environmental Site Assessment (ESA) of the Modutech Marine, Inc. property located at 2218 Marine View Drive, Tacoma, Pierce County, Washington (hereafter referred to as the Site), Figure 1. The Site currently is occupied by an industrial boat manufacturing and repair facility. Site photographs are included in Appendix A.

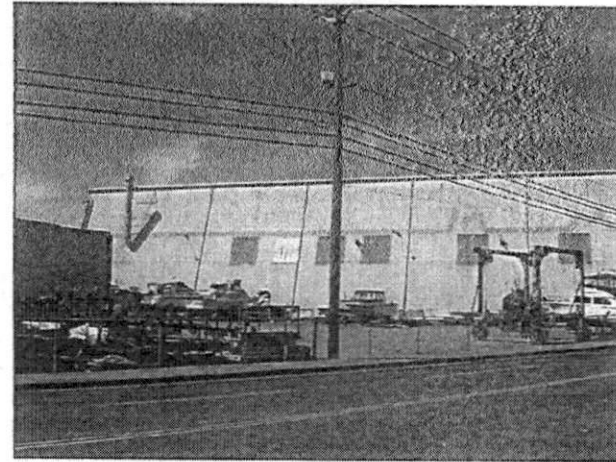
Photograph 2: View of Site, facing west.

The manufacturing building is a single-story, approximately 20,700-square-foot industrial warehouse structure with two mezzanine levels. The building is a wood-framed structure of slab-on-grade construction with a flat roof and corrugated metal siding (Photographs 1 and 2).

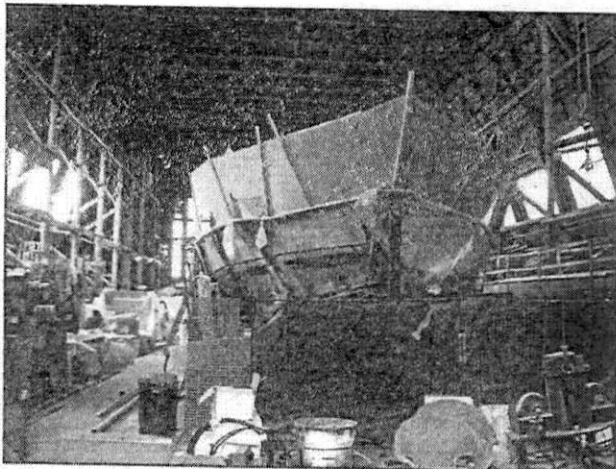
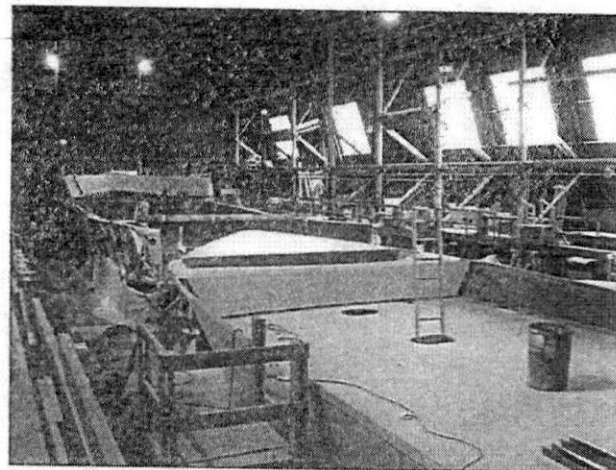
- Fiberglass boat hulls are produced in the manufacturing building (Photographs 5 and 6). The forms are made of wood or other suitable materials. Resin (Photograph 9) is applied to the forms with sheets of fiberglass cloth in layers. The resin is hardened with methyl ethyl ketone peroxide (MEKP). Drums of resin and MEKP and sheets of fiberglass cloth were noted throughout the building. Minor resin drips were noted on some of the collection/rinse buckets and on drip-collection panels. Staining on the concrete floors appeared to be de minimus.

Photograph 5: View of manufacturing building interior, facing southwest.

Photograph 6: View of manufacturing building interior, facing northeast.

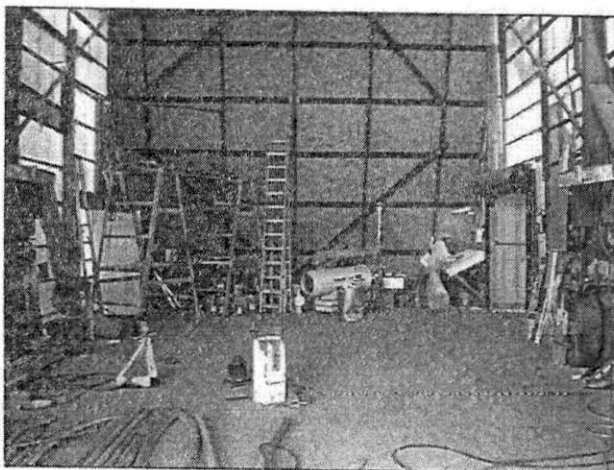
- The work shop contained various pneumatic tools and equipment, apparently for assembling the mechanical aspects of the boats (Photograph 7). No assembly work was being performed in the work shop at the time of the inspection.
- No evidence of improper storage or release of hazardous substances or petroleum products were observed inside the work shop building.

Photograph 7: View of workshop interior.

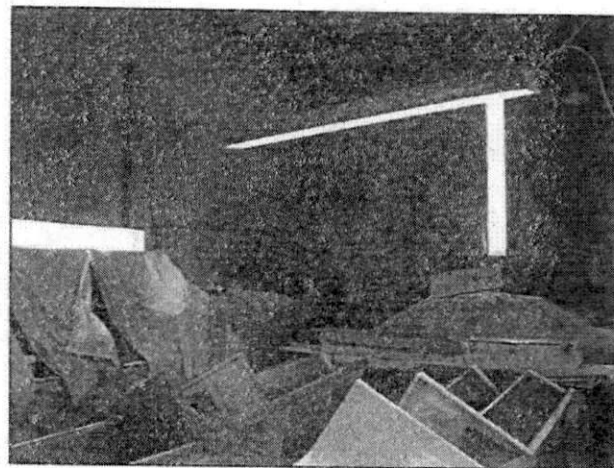
- The spray shop contained various fiberglass forms and panels that were either being finished or spray painted (Photograph 8).
- Tarps appeared to line the entire building.
- No evidence of improper storage or release of hazardous substances or petroleum products were observed inside the work shop building.

Photograph 8: View of spray shop interior.

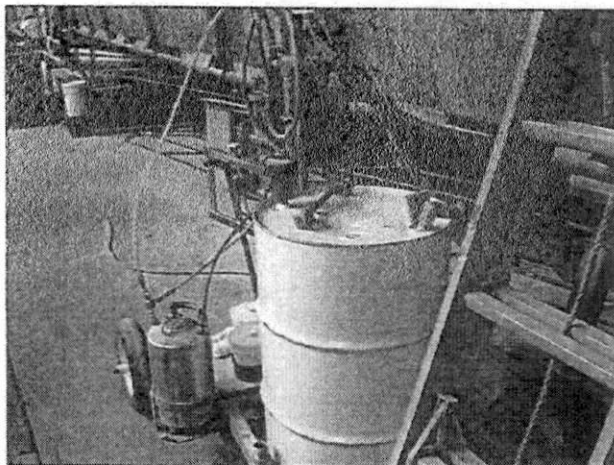
Photograph 9: Resin applicator.

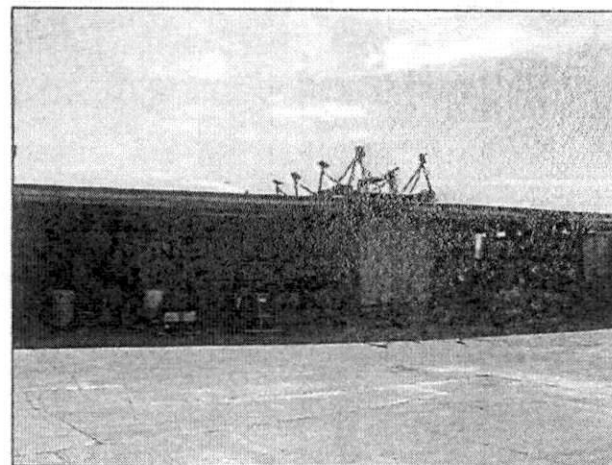
- A steel intermodal container, located south of the waste storage area, serves as a hazardous chemical storage locker (Photographs 10 and 12). Containers up to 5 gallons in size, containing paints, thinners and coatings that are currently in use, were stored in the locker. Some minor staining was noted within the locker. However, no staining or signs of release was noted outside of the locker.

Photograph 10: View of covered storage area, facing south.

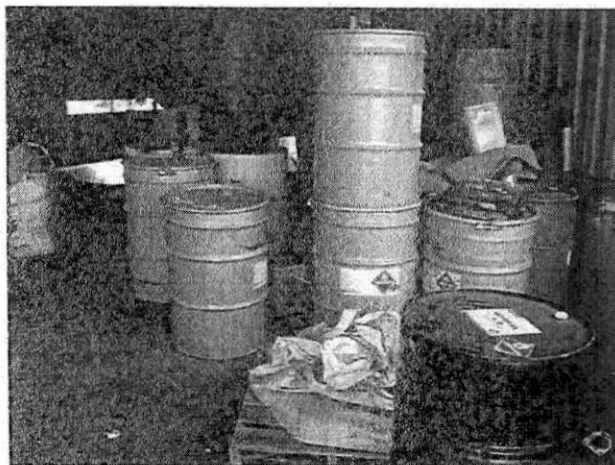
- No drinking water or groundwater monitoring wells were noted at the Site. Drinking water is provided to the Site by the local utility.
- 55-gallon drums of resin and biodiesel (Photograph 11) were stored in the covered shelter on the southeastern corner of the Site (Figure 2). Significant staining was not noted on the concrete beneath the drums.

Photograph 11: Resin and biodiesel storage drums.

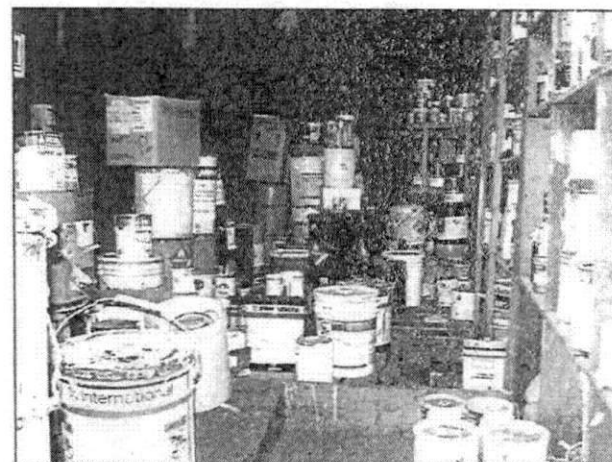
Photograph 12: View of hazardous materials storage locker.

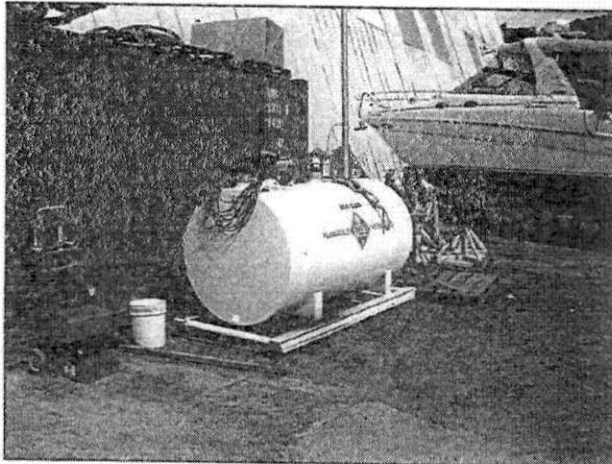
The Site utilizes a 500-gallon diesel AST (Photograph 17) for fueling boats and equipment. The AST is portable and used where needed. No staining was noted on or around the AST.

Photograph 17: View of diesel AST, facing northwest.

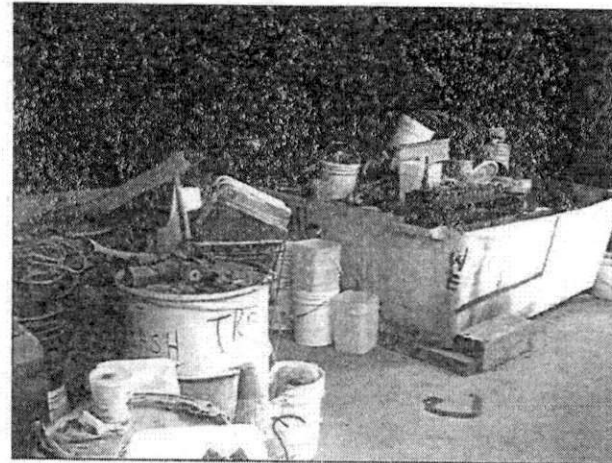
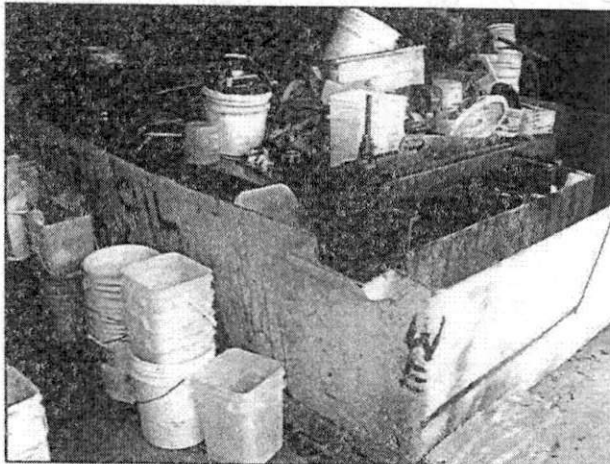
Minor staining in the covered concrete area appeared to be de minimus. Waste oil is reportedly picked up by Arcom approximately every one to two months.

Photograph 18: View of covered waste oil storage area.

Photograph 19: Close-up view of waste oil storage area. Note secondary containment.

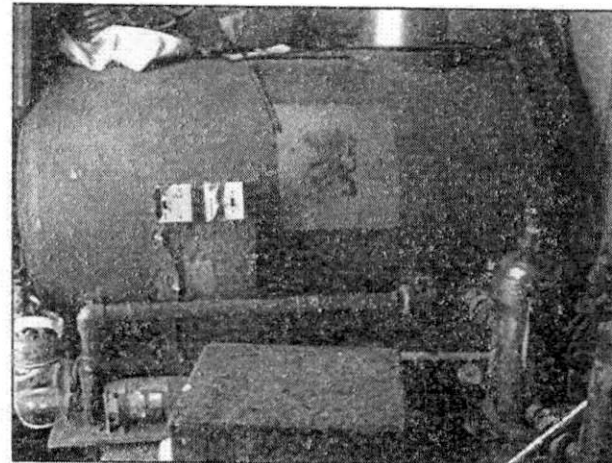
- Stormwater infiltrates into the unpaved Site surfaces, into stormwater catchbasins located along the shoreline embankment and into catchbasins located in the paved areas of the Site. The catchbasins in the concrete-paved areas are reportedly connected to a closed-loop system for wash water retention. The wash water drains to and is contained within an AST (Photograph 20) in a pump house located on the southeast corner of the Site (Figure 2), where it is reportedly recycled for later use. Dirty water is hauled away as needed for off-Site disposal.

Photograph 20: Wash water recycle station.

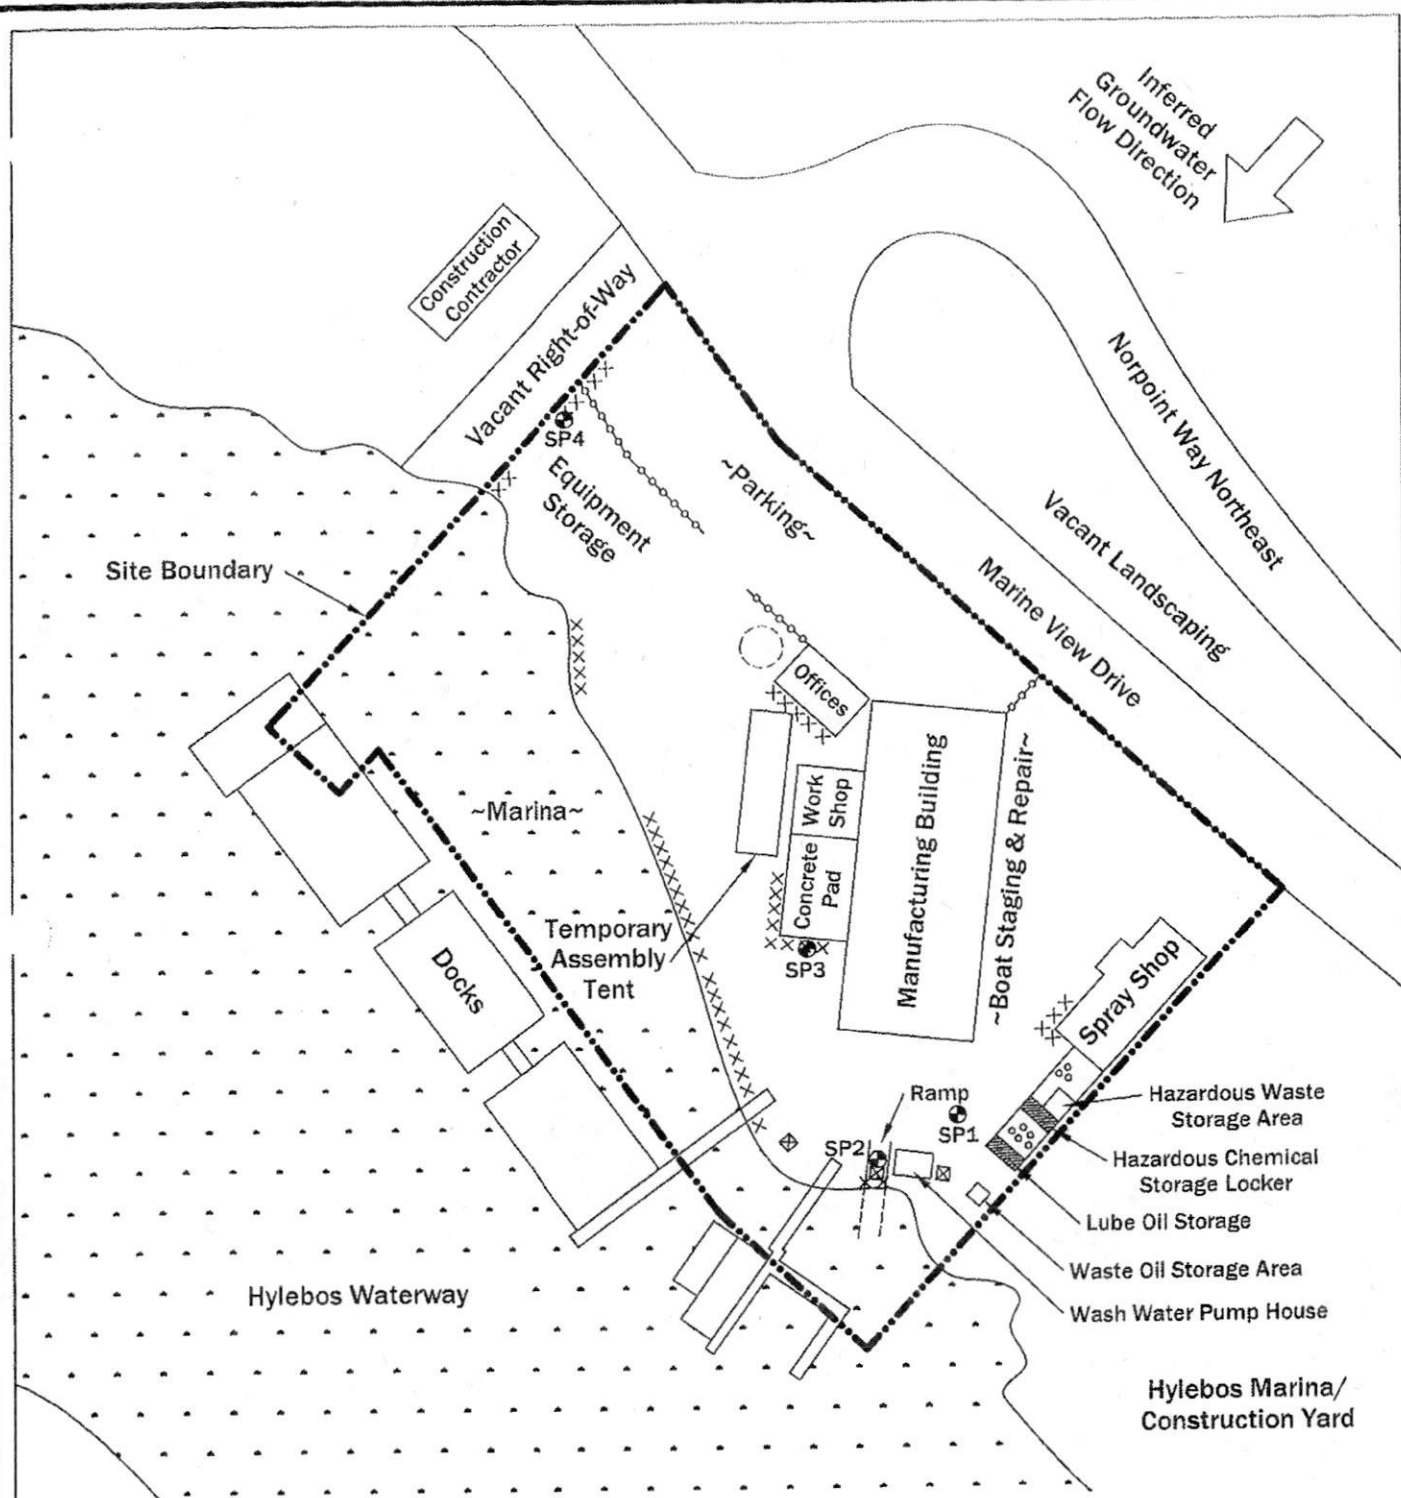
- = Boring Location by RGI on 10/21/09.
- ☒ = Wash Water Catch Basin
- xxx = Approximate Location of Former Suspect Fill Areas
- = Approximate Location of Former Septic Tank
- = Drum
