SUBSURFACE INVESTIGATION REPORT

EAST WATERFRONT PROPERTY

East Waterfront Property 2750 West Commodore Way Seattle, Washington

December 2, 2015

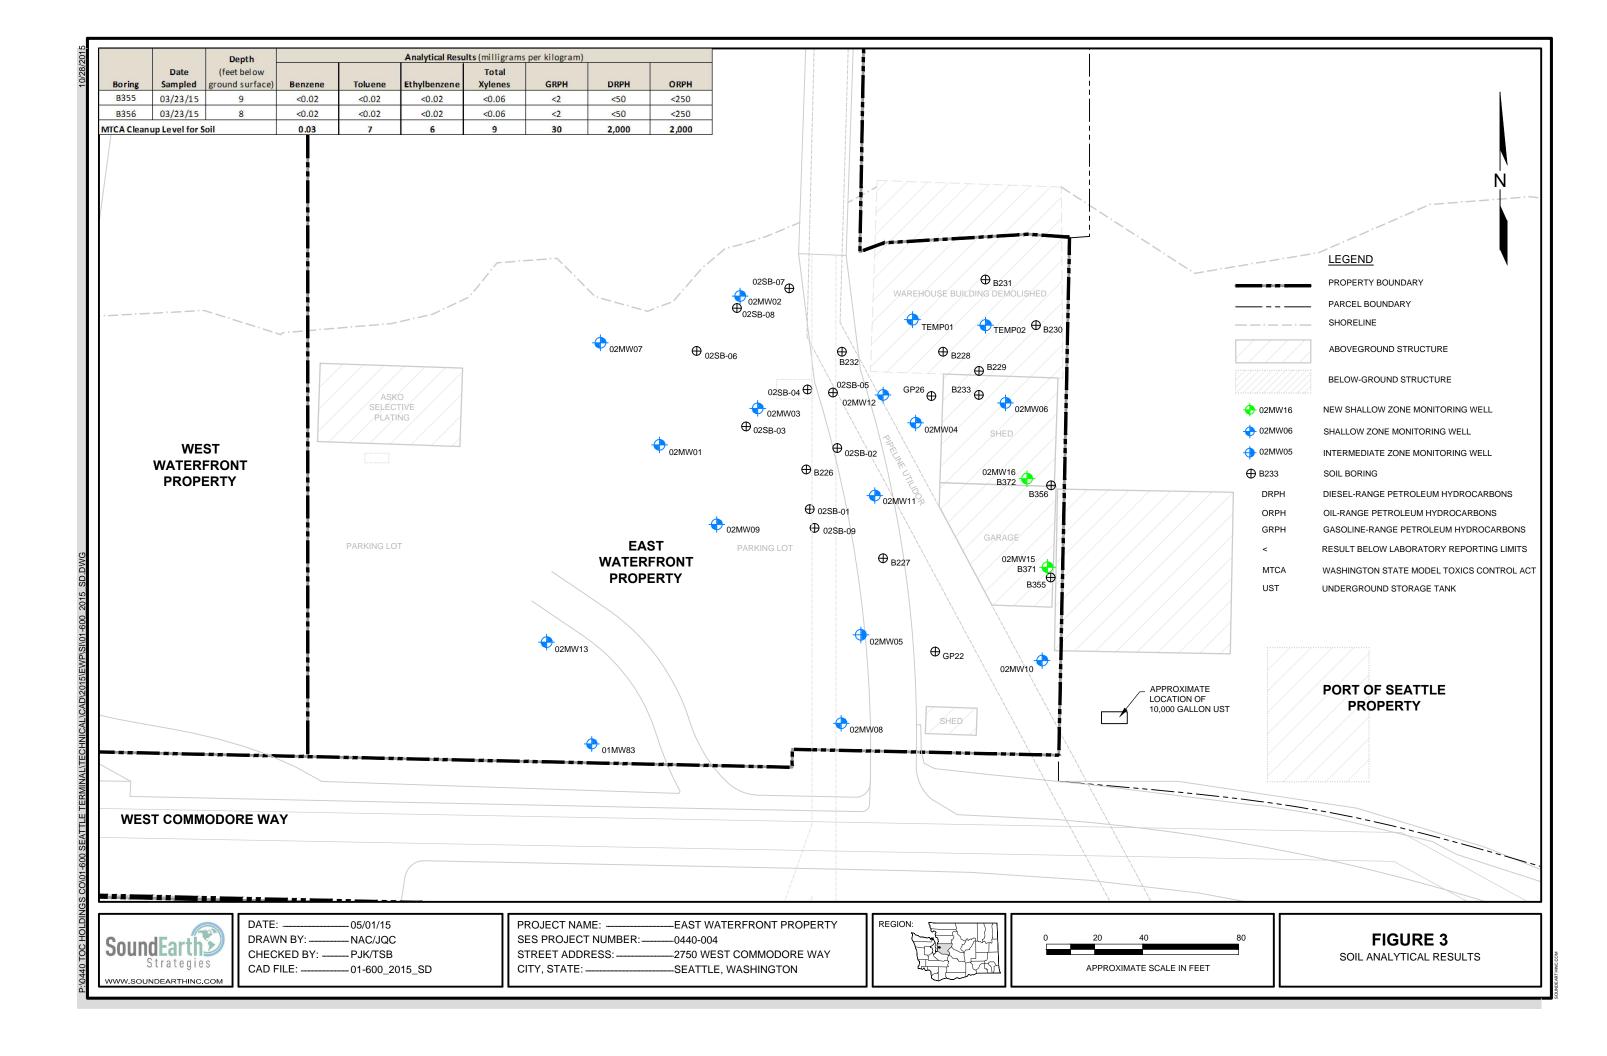
On March 23, 2015, borings B355 and B356 were advanced inside of the garage and shed structures, adjacent to the eastern property line of the East Waterfront Property (Figure 2). The borings were sampled continuously until probe refusal was encountered to the maximum depths explored ranging from approximately 8 to 9 feet below ground surface (bgs). The borings were sampled using a 5-footlong probe rod driven with a 140-pound-per-square-inch hydraulic hammer. The sampler was lined with disposable acetate sleeves that were removed and opened to reveal the soil for each driven sampling interval. Sample recovery percentages were logged for each sample interval.

On April 23, 2015, borings B371 and B372 were advanced to approximately 15 feet bgs with a limited-access, hollow-stem auger drill rig. The borings were located in the vicinity of borings B355 and B356. The borings were completed as monitoring wells 02MW15 and 02MW16 (Figure 2). The monitoring wells were screened from 5 to 15 feet below the top of the casing. The monitoring wells were constructed of 2-inch-diameter blank PVC casing, flush-threaded to 0.010-inch slotted well screen. The bottom of each well was fitted with a threaded PVC bottom cap, and a locking compression-fit well cap was placed in the top of the well casing. The annulus of each monitoring well was filled with #2/12 silica sand to approximately 1 foot above the top of the screened interval. A bentonite seal having a minimum thickness of 2 feet was installed above the sand pack. The wells were completed at the surface with a flush-mounted, traffic-rated well box set in concrete.

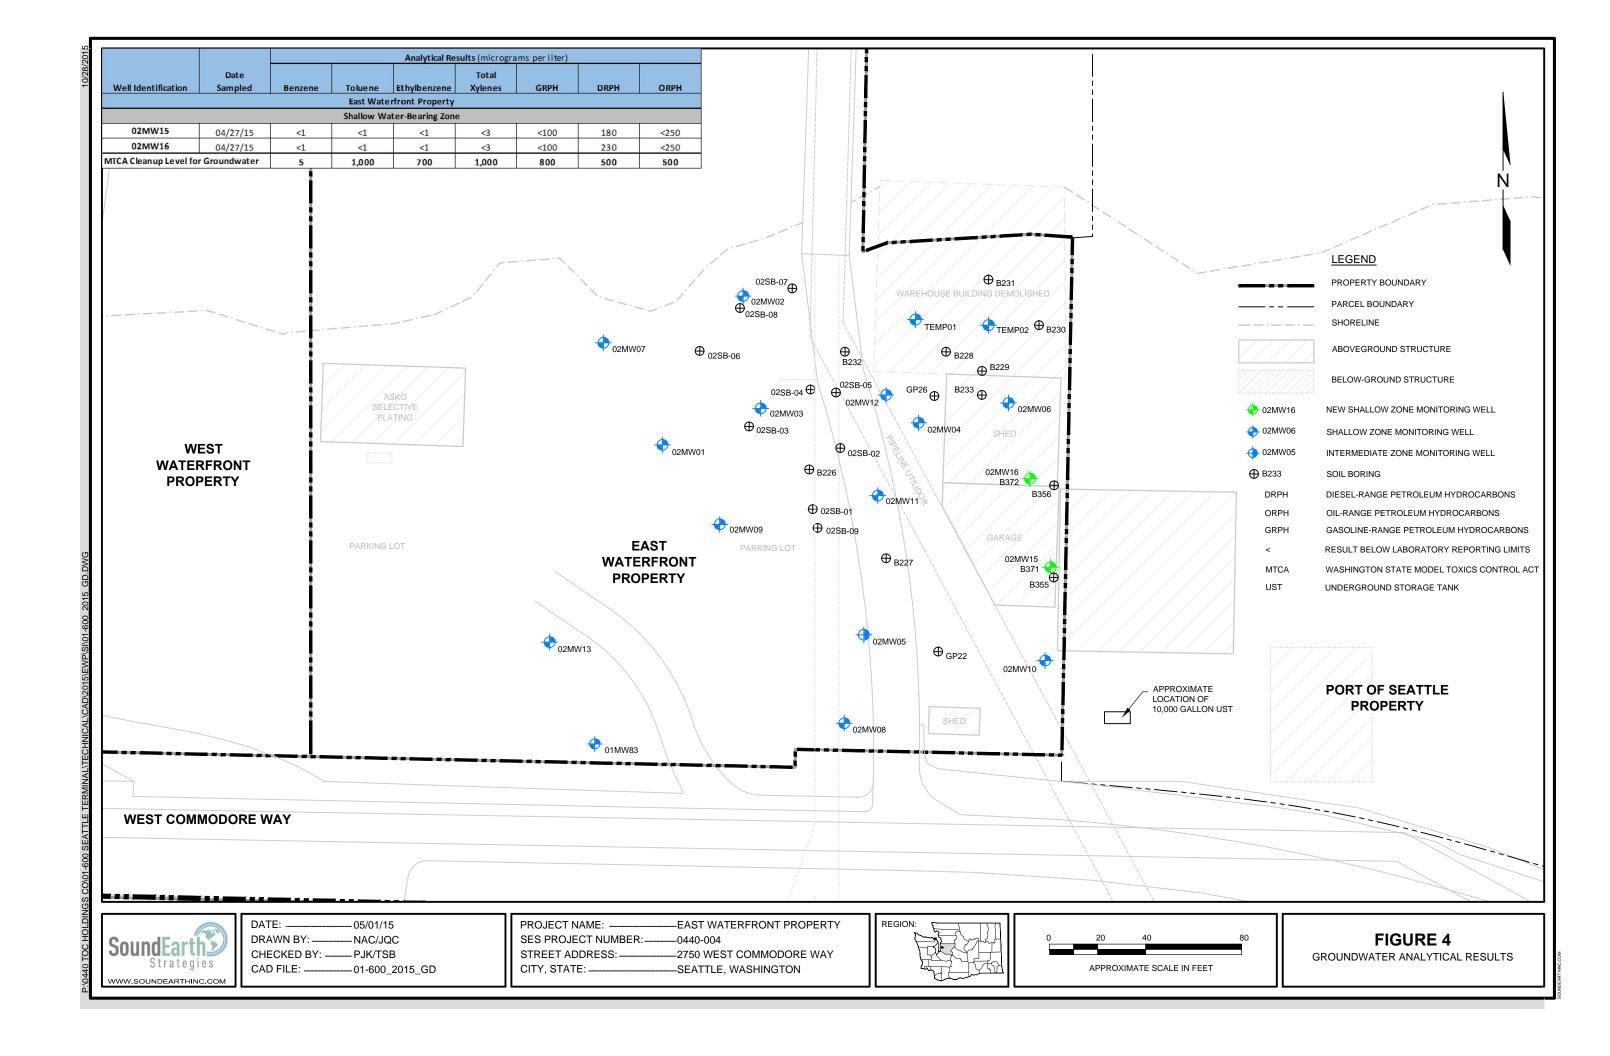
This section summarizes the soil profile observed during soil sampling activities and the results of soil and groundwater samples analyzed for this subsurface investigation. Soil analytical results are presented on Figure 3 and in Table 1. Groundwater analytical results are presented on Figure 4 and in Table 2. Laboratory reports for the samples analyzed as part of the subsurface investigation are included as Appendix B.

One soil sample from each boring advanced on March 23, 2015, was selected for laboratory analysis for DRPH, ORPH, GRPH, and BTEX. Concentrations of DRPH, ORPH, GRPH, and BTEX were not detected in the two soil samples (B355-09 and B356-08). The analytical results for the two soil samples were also less than the laboratory reporting limit and the MTCA Method A cleanup level for the analyzed compounds.

- The soil conditions observed at borings B355 and B356 were below the applicable MTCA cleanup levels for DRPH, ORPH, GRPH, and BTEX, indicating that soil in the vicinity of the borings does not require cleanup. In addition, the soil conditions located near the eastern property line between wells 02MW06 and 02MW10 do not appear to have been impacted significantly by historical operations at the East Waterfront Property.

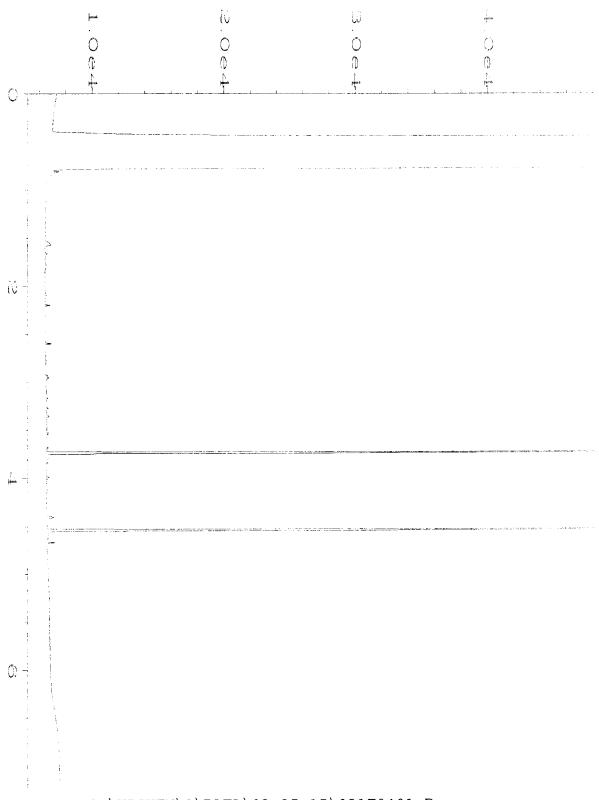
Data File Name : C:\HPCHEM\1\DATA\03-25-15\021F0401.D Page Number Operator : sp Vial Number : GC1 Instrument Injection Number: 1 : 503416-03 Sample Name Sequence Line Run Time Bar Code: Instrument Method: DX.MTH 12:55 PM Acquired on : 25 Mar 15 Analysis Method : DX.MTH Report Created on: 25 Mar 15 04:03 PM

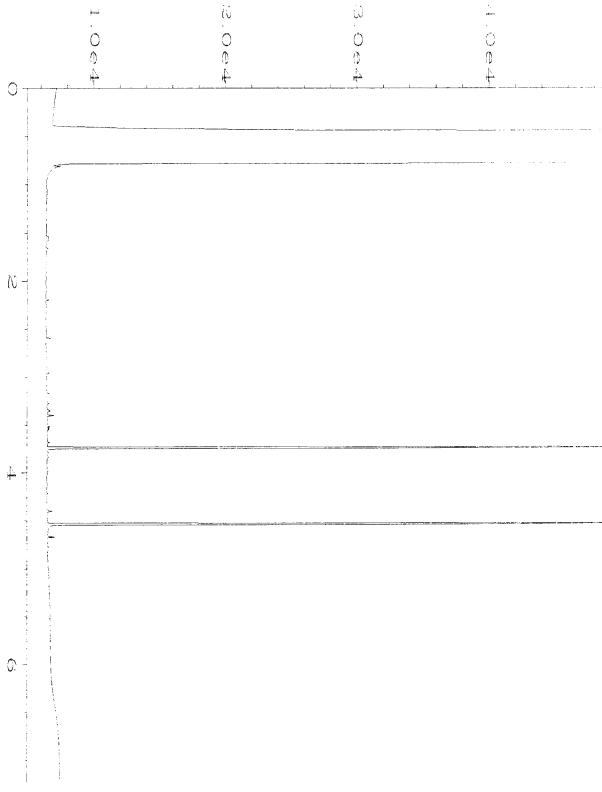
```
: C:\HPCHEM\1\DATA\03-25-15\022F0401.D
Data File Name
                                               Page Number
Operator
                                                                : 1
                : sp
                : GC1
                                               Vial Number
                                                                : 22
Instrument
                : 503416-06
                                               Injection Number: 1
Sample Name
Run Time Bar Code:
                                               Sequence Line : 4
                                               Instrument Method: DX.MTH
                : 25 Mar 15 01:06 PM
Acquired on
Report Created on: 25 Mar 15 04:03 PM
                                               Analysis Method : DX.MTH
```

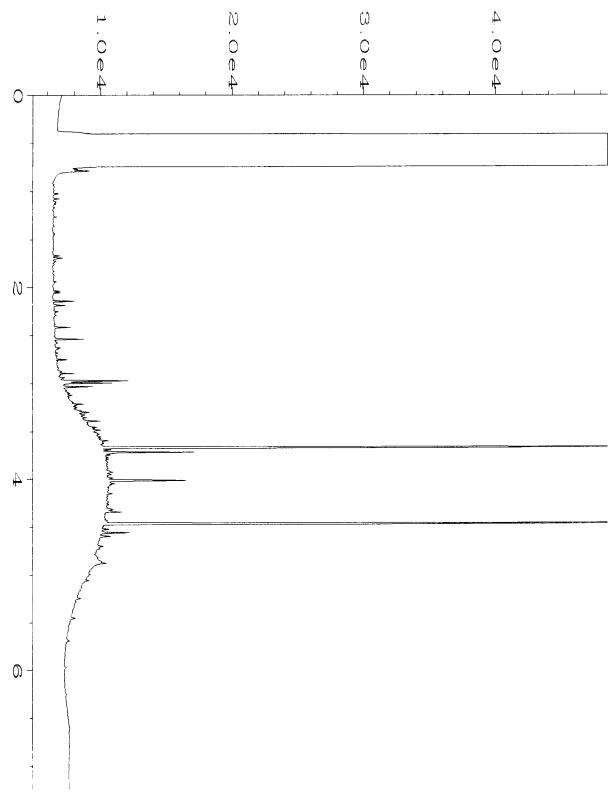
```
: C:\HPCHEM\1\DATA\04-28-15\020F0701.D
Data File Name
Operator
                                               Page Number
                : mwdl
                                              Vial Number
Instrument
                : GC1
                                               Injection Number: 1
Sample Name
                : 504487-01
Run Time Bar Code:
                                               Sequence Line : 7
Acquired on : 28 Apr 15 03:02 PM
                                               Instrument Method: DX.MTH
                                              Analysis Method : DX.MTH
Report Created on: 29 Apr 15 09:13 AM
```

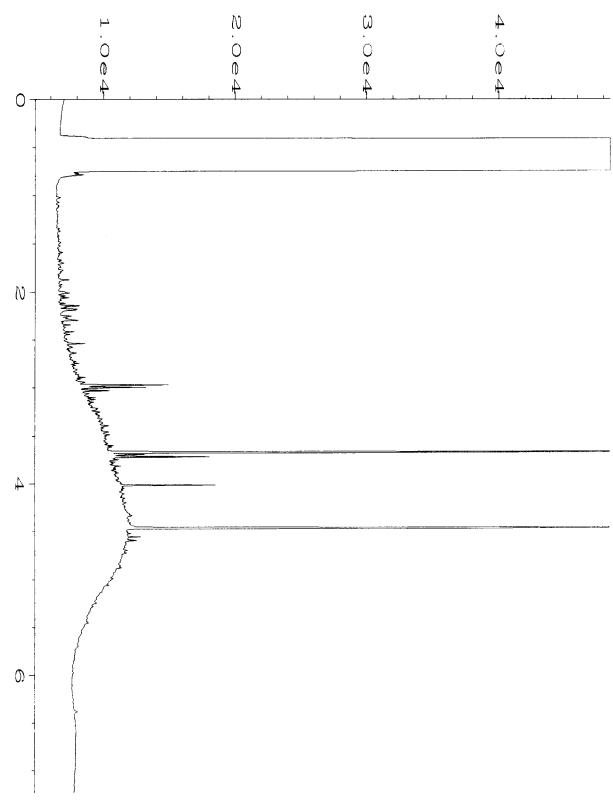
```
: C:\HPCHEM\1\DATA\04-28-15\021F0701.D
Data File Name
                                               Page Number
Operator
                : mwdl
Instrument
                : GC1
                                               Vial Number
                                                               : 21
                                               Injection Number: 1
Sample Name
                : 504487-02
Run Time Bar Code:
                                               Sequence Line : 7
                                               Instrument Method: DX.MTH
Acquired on : 28 Apr 15 03:13 PM
                                               Analysis Method : DX.MTH
Report Created on: 29 Apr 15
                            09:14 AM
```
