CLEANUP ACTION CLOSURE REPORT

**6050 EAST MARGINAL WAY SOUTH
SEATTLE, WASHINGTON**

**Submitted by:
Farallon Consulting, L.L.C.
975 5th Avenue Northwest
Issaquah, Washington 98027
Farallon PN: 1071-010**

**Prepared For:
Prologis, Inc.**

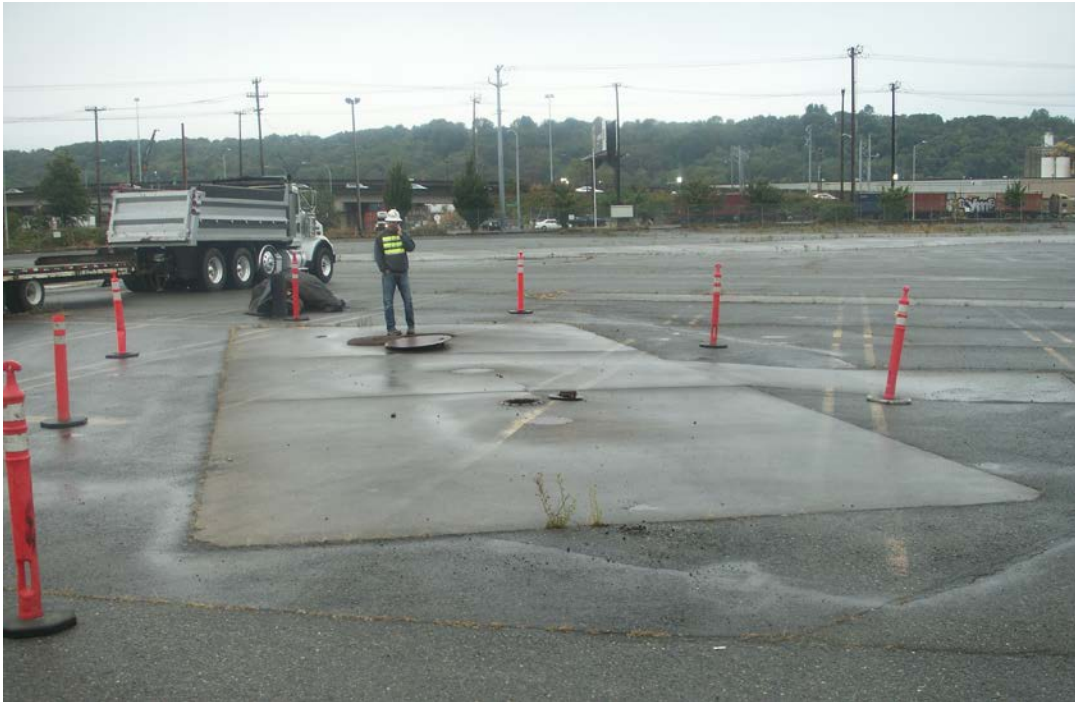
Photograph 1: Concrete pad overlying the underground storage tank (UST) prior to start of excavation, looking west.

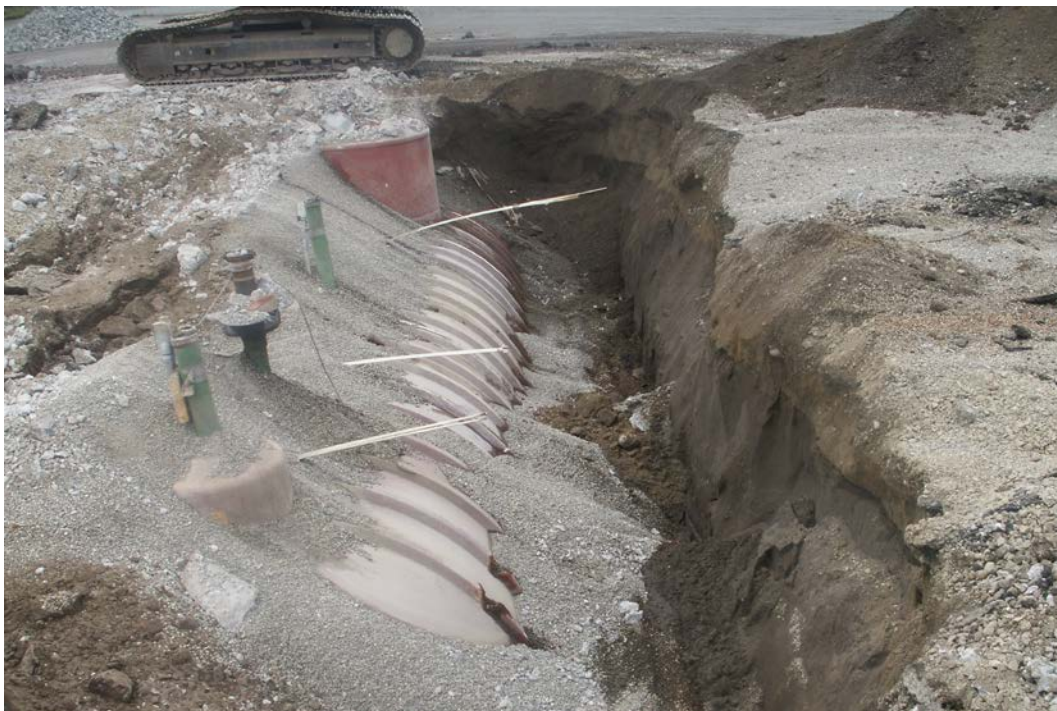
Photograph 2: Partial excavation of northern side of UST hold, looking west.

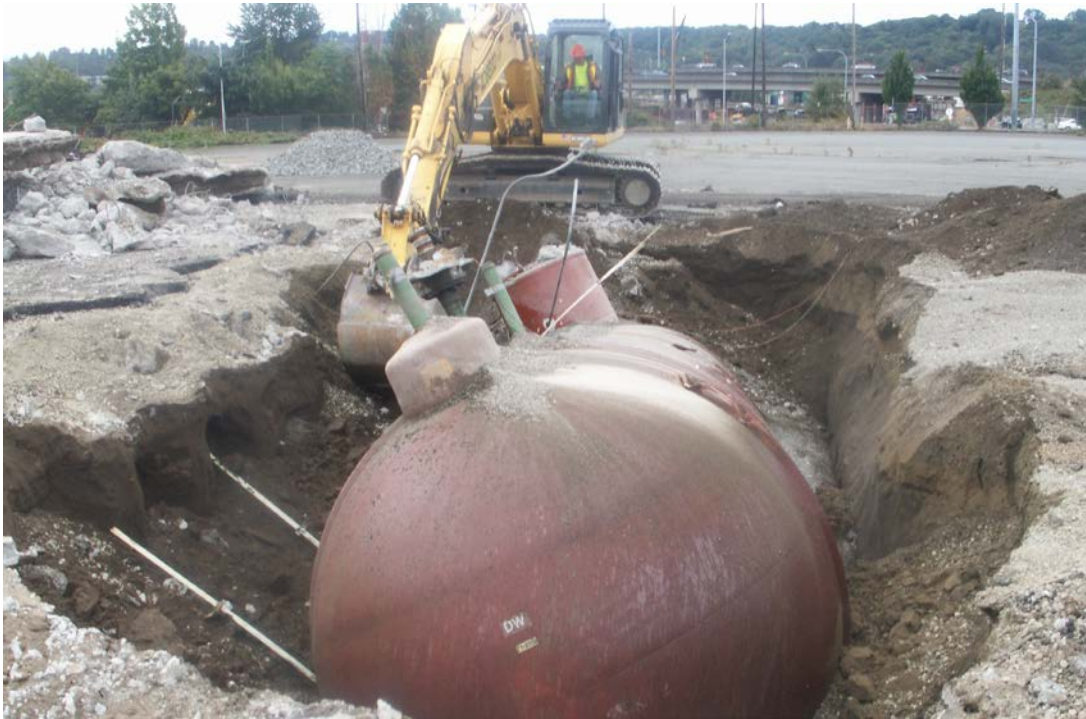
Groundwater in the UST excavation stabilized at a level of 6.5 feet bgs. No petroleum-like sheen was observed on groundwater. Groundwater samples were not collected during the decommissioning of the UST because previous groundwater investigations identified the nature and extent of petroleum hydrocarbons in groundwater on the Site, as discussed above.

Photograph 3: Uncovered UST floating on groundwater following removal of hold-down straps, looking west.

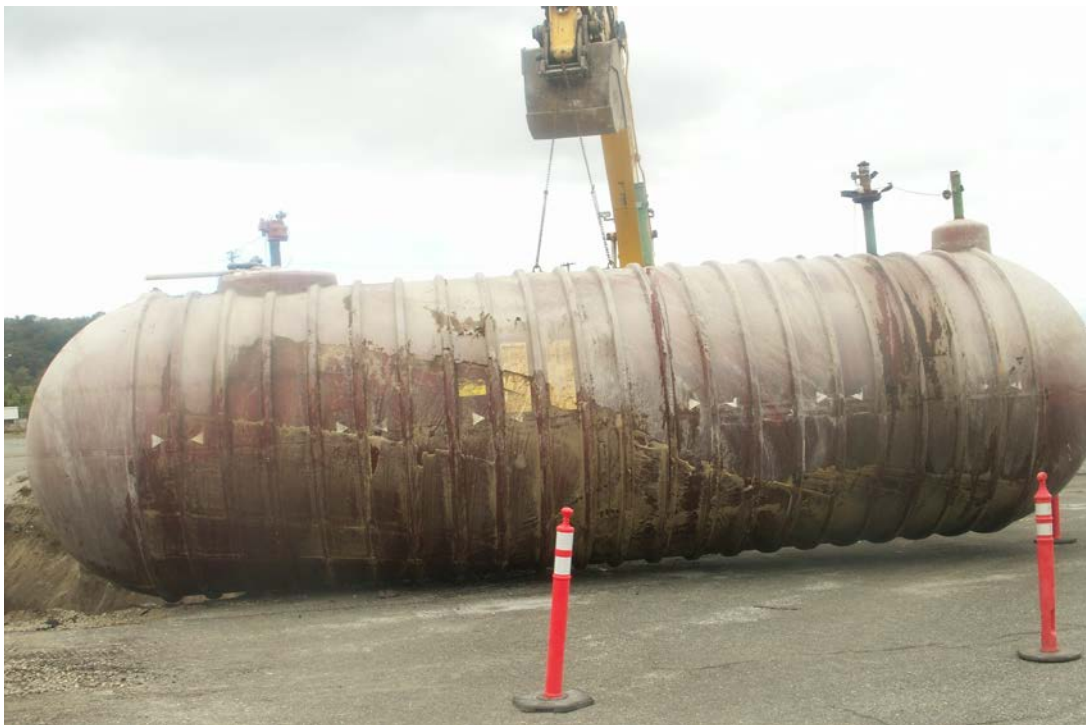
Photograph 4: Southern side of removed UST.

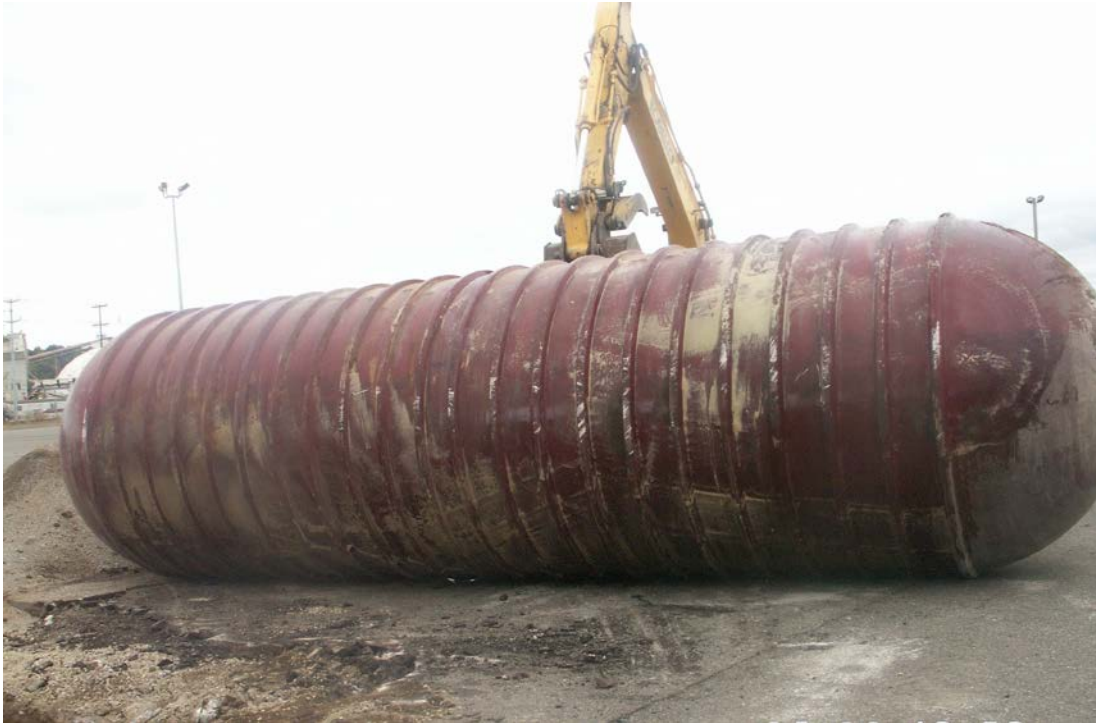
Photograph 5: Bottom of removed UST.

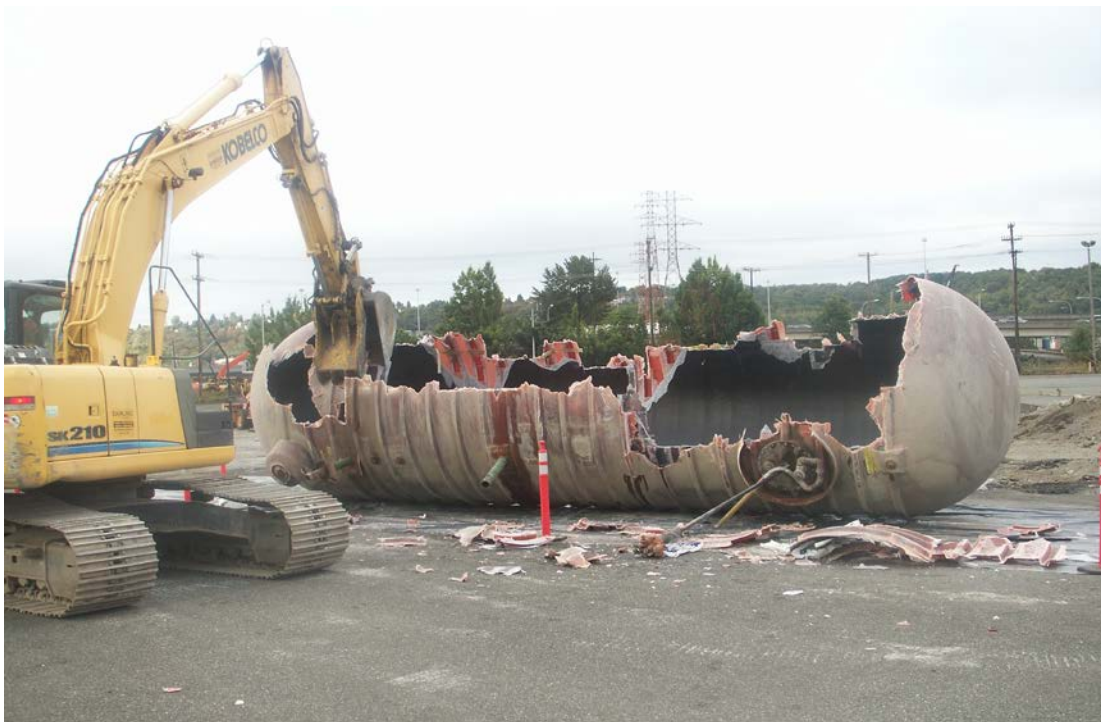
Photograph 6: Track hoe breaking up the UST for disposal.

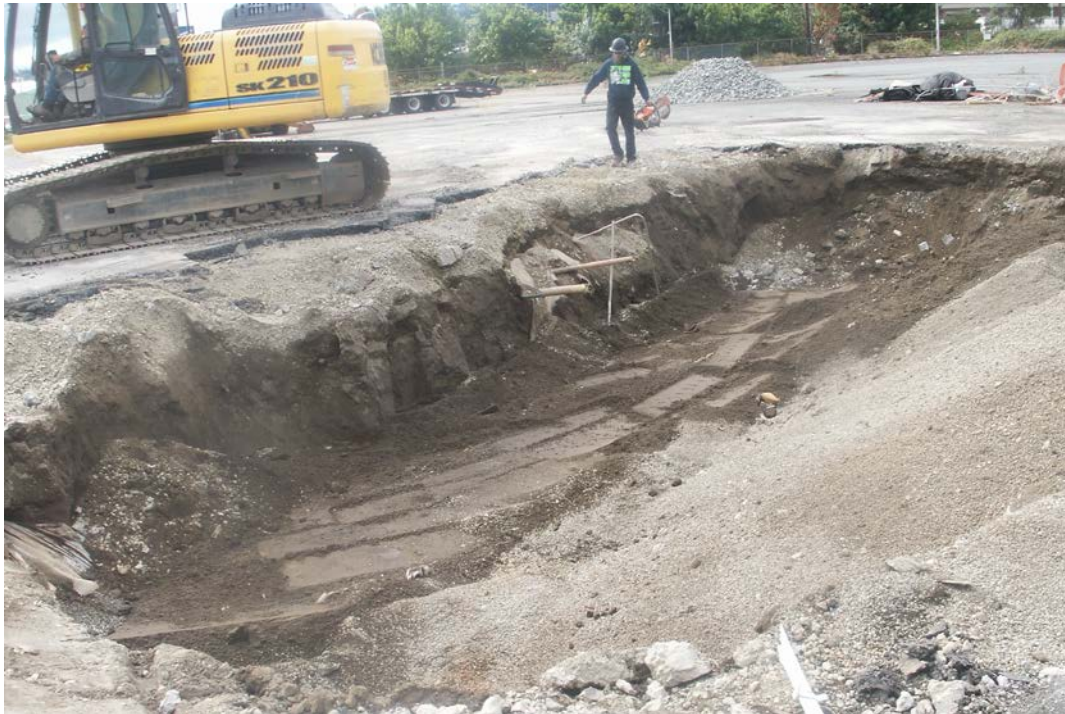
Photograph 7: Partially backfilled UST excavation, looking southwest.

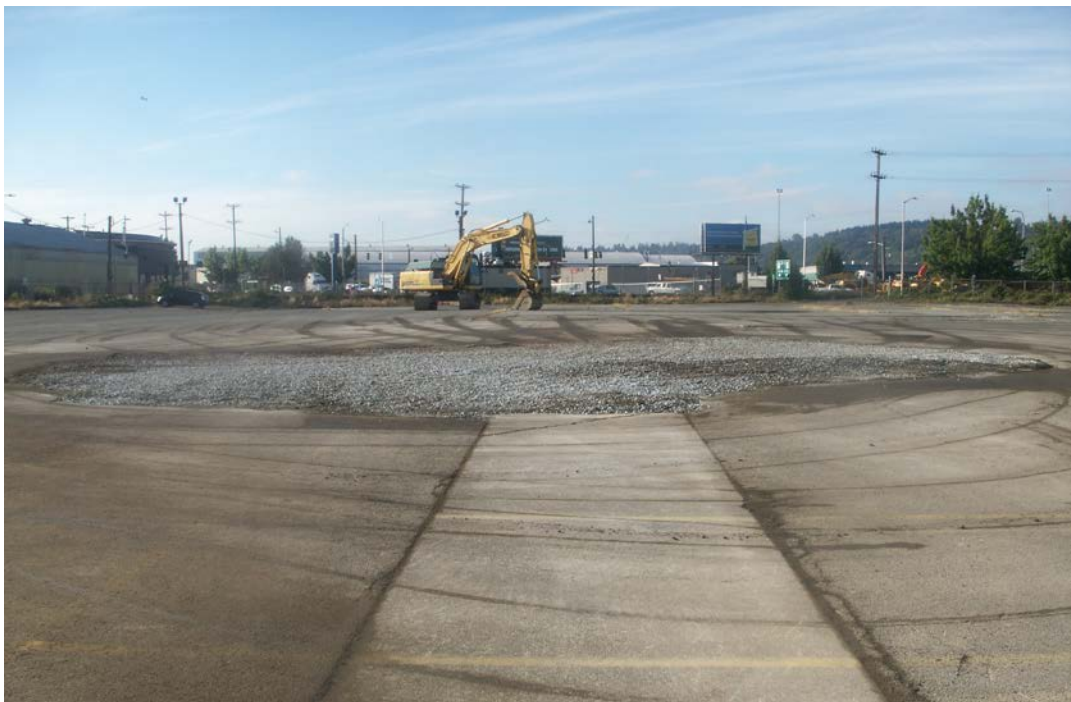
Photograph 8: Completed surface of backfilled and compacted UST excavation, looking south.
