RGI PROJECT No. 2016-023A

**REMEDIAL INVESTIGATION/ FEASIBILITY STUDY (RI/FS) AND
REMEDIAL ACTION REPORT**

**SEA MAR COMMUNITY HEALTH CENTER
9635 DES MOINES MEMORIAL DRIVE SOUTH
SEATTLE, WASHINGTON 98108**

MARCH 13, 2017

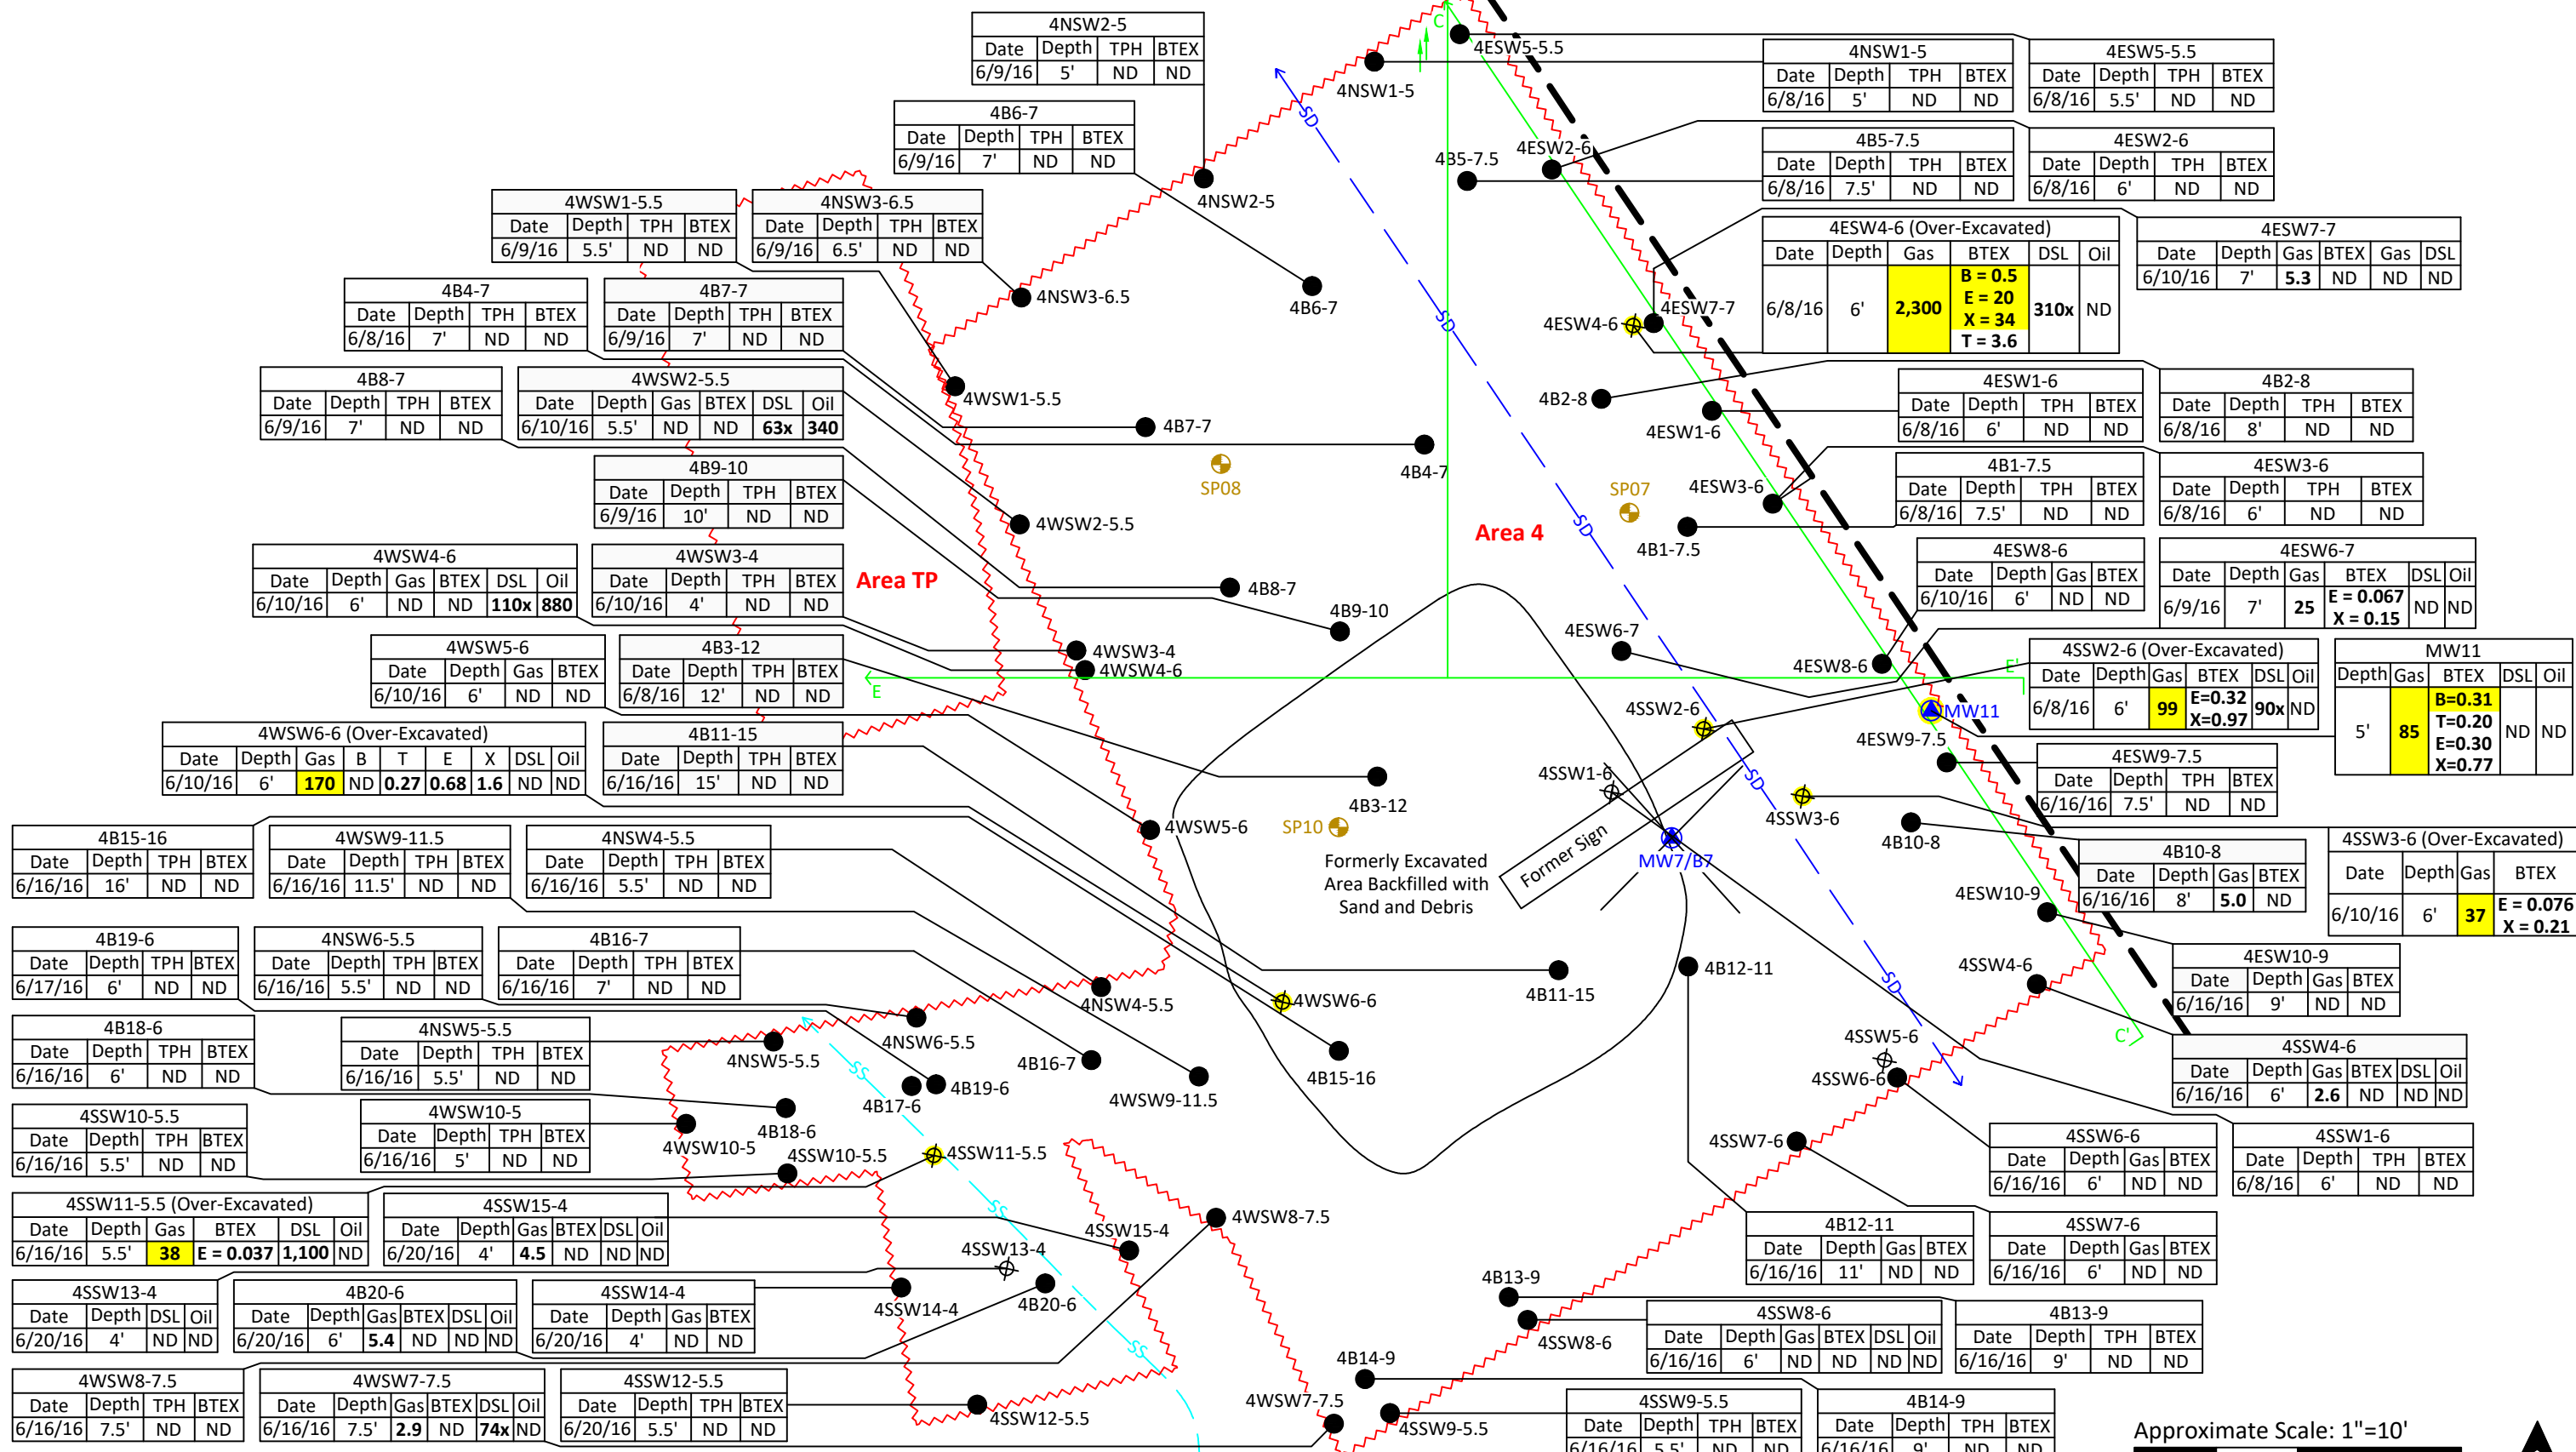
Figure 9

- = Monitoring well by RGI
- = Overexcavated (interim sample), June 2016
- = Sample location by RGI, June 2016
- SD = Storm sewer (3 feet in diameter)
- SS = Sanitary sewer
- = Area 4 remedial excavation limits

= Soil Analytical Laboratory Result in mg/kg;
 Gas = Gasoline Total Petroleum Hydrocarbons
 DSL/Oil = Diesel/Oil Total Petroleum Hydrocarbons with silica gel cleanup
 TPH* = Gas, Diesel, and Oil Total Petroleum Hydrocarbons
 BTEX = Benzene, Toluene, Ethylbenzene, Xylenes
 ND = Not Detected Above Laboratory Detection Limits
 ---- = Not Analyzed
Bold and yellow highlighted results exceed MTCA Cleanup Level.
