# **Pugnetti Park: Soils and Groundwater Investigation, Former Underground Storage Tanks**

**Prepared by Joyce Mercuri  
Department of Ecology  
Toxics Cleanup Program  
Southwest Region  
October 31, 2006**

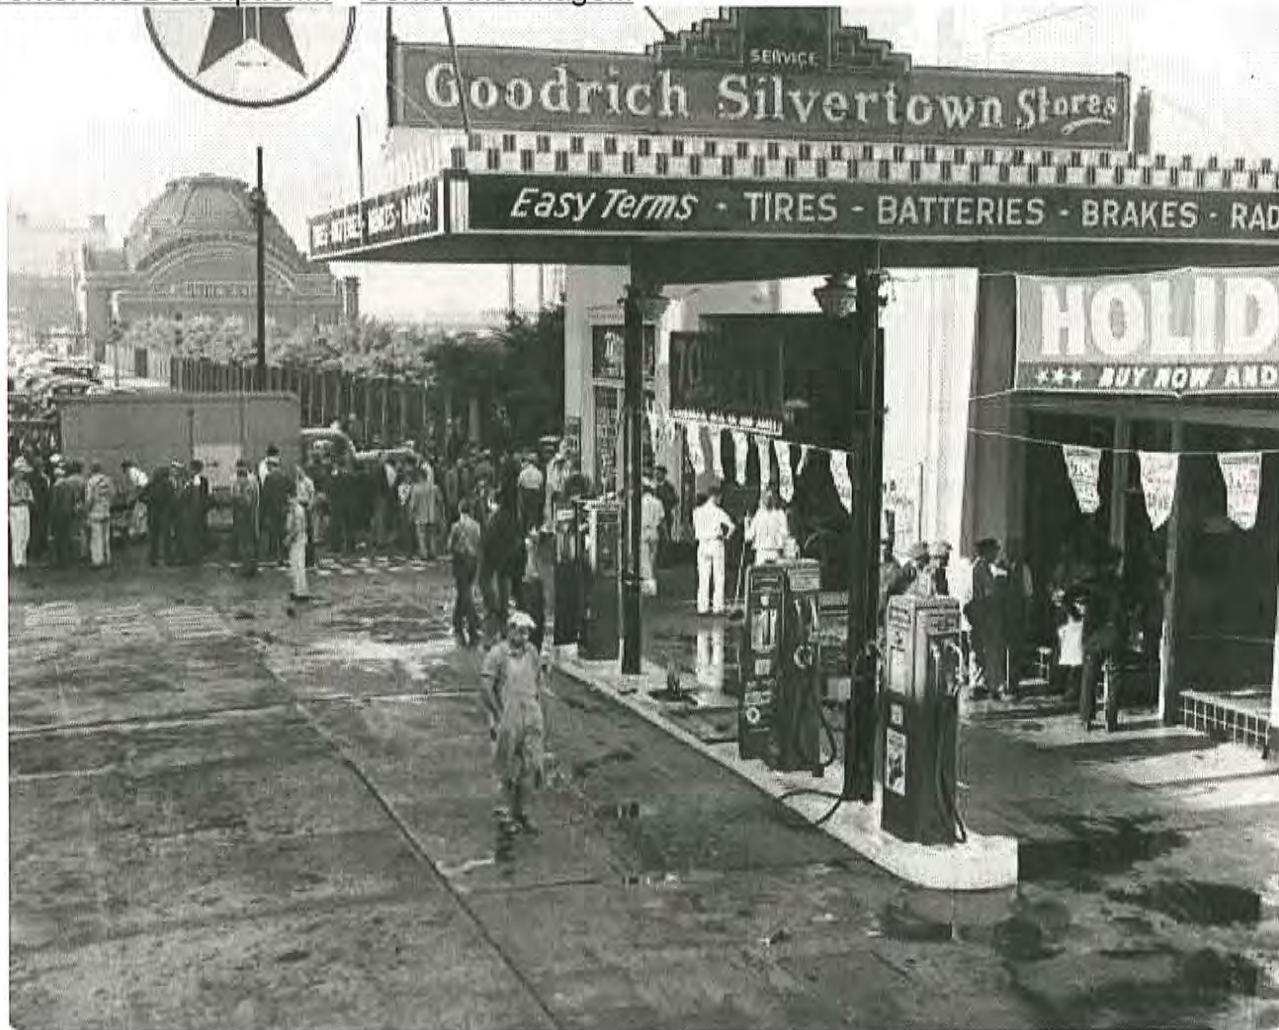
7 of 15 - [Center the Image...](#) | [Order a copy of this image](#) | [Recognize the contents?](#)**Collection:** Richards Studio Collection **Series:** D8809-8 (Unique: 7595)**Date:** 08-29-1939**Description:** Bystanders observe traffic accident damage at the Goodrich Silvertown Stores, tire, battery and automobile service station on August 29, 1939. At about 3:30p.m. on that date, a 6 ton mach truck carrying about 3 tons of groceries lost its drive shaft and brakes on the descent down steep Pacific Ave. at about 32nd Street. The truck gained momentum, flying down Pacific against the lights at about

60 mph with driver Greg Marion swerving to avoid cars and blowing his horn. Near Silvertown, the truck hit a fire hydrant, hurling it 50 yards and demolishing a shed in the center of the gas pump stand, uprooted a gas pump, sent its rear wheels through a plate glass window and came to rest a few yards later. Miraculously, only 2 people were hurt and none seriously. (T. Times 8/30/1939, pg. 1)

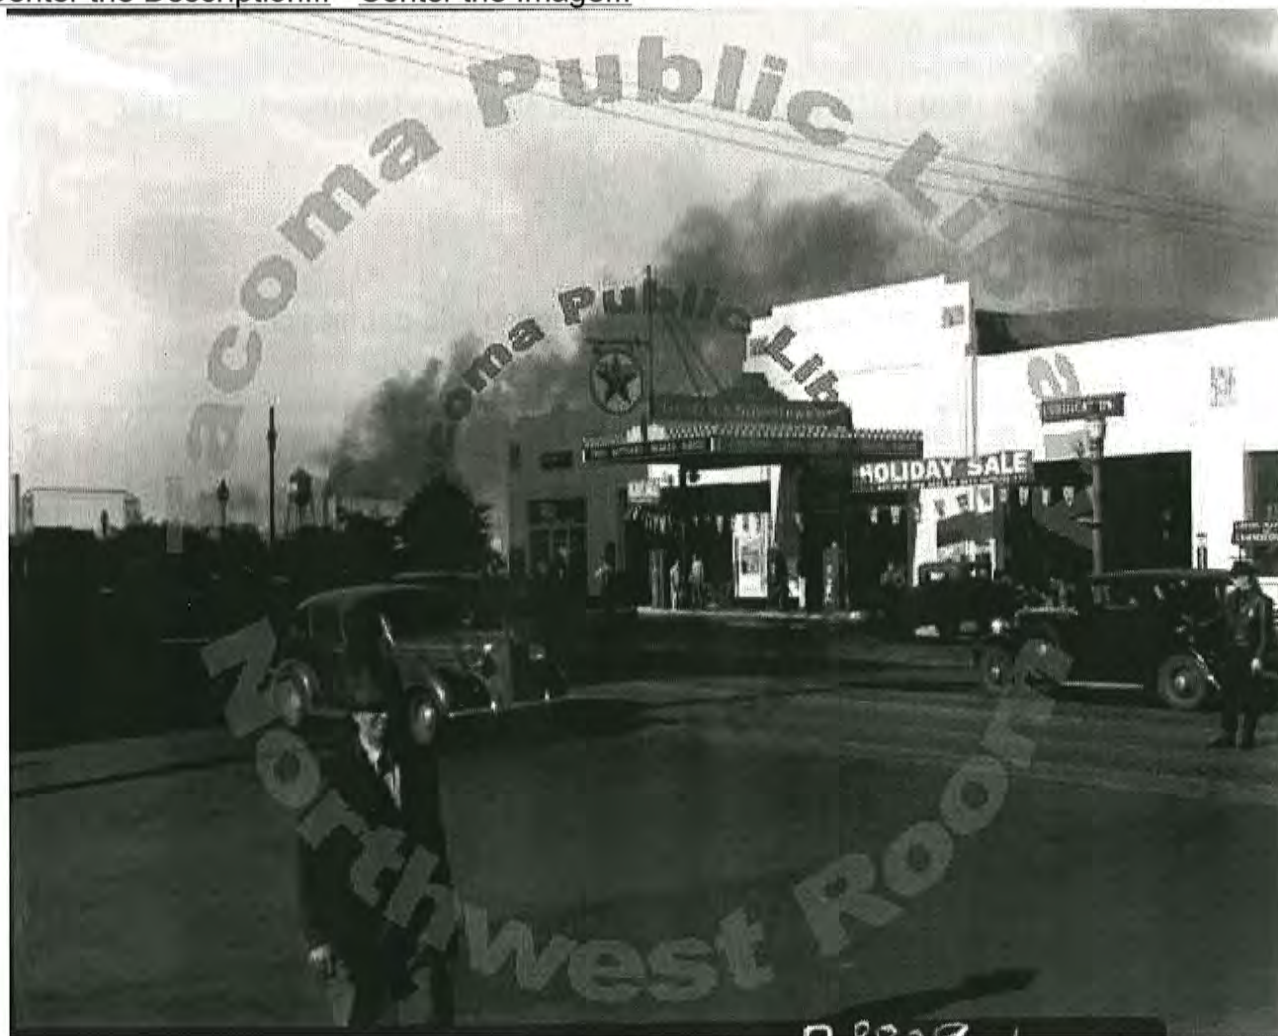
6 of 15 - [Center the Image...](#) | [Order a copy of this image](#) | [Recognize the contents?](#)**Collection:** Richards Studio Collection **Series:** D8809-1 **(Unique: 7590)****Date:** 08-29-1939**Description:** Aftermath of truck accident on August 29, 1939 at the Goodrich Silvertown Stores, tire, battery and automobile service station. View from across street, showing station with "Holiday Sale" banner on front. Traffic officer supervises traffic for truck accident nearby. At approximately 3:30p.m., a six ton mach truck, driven by Greg Marion of Seattle, lost the use of his brakes on steep Pacific Ave. at

about 32nd Street. The truck gained momentum down the steep slope, but driver Marion was able to steer the truck around surrounding vehicles. At around 21st and Pacific, his luck ran out. The truck grazed a Tacoma Grocery Co. truck, hit a fire hydrant hurling it 50 yards across the street, sent its back wheels through the Silvertown's plate glass office windows, uprooted a gas pump and, its momentum broken, came to rest in the street. Miraculously, only two people were injured and those only slightly. Driver Marion was unhurt. (T. Times 8/30/1939, pg. 1)

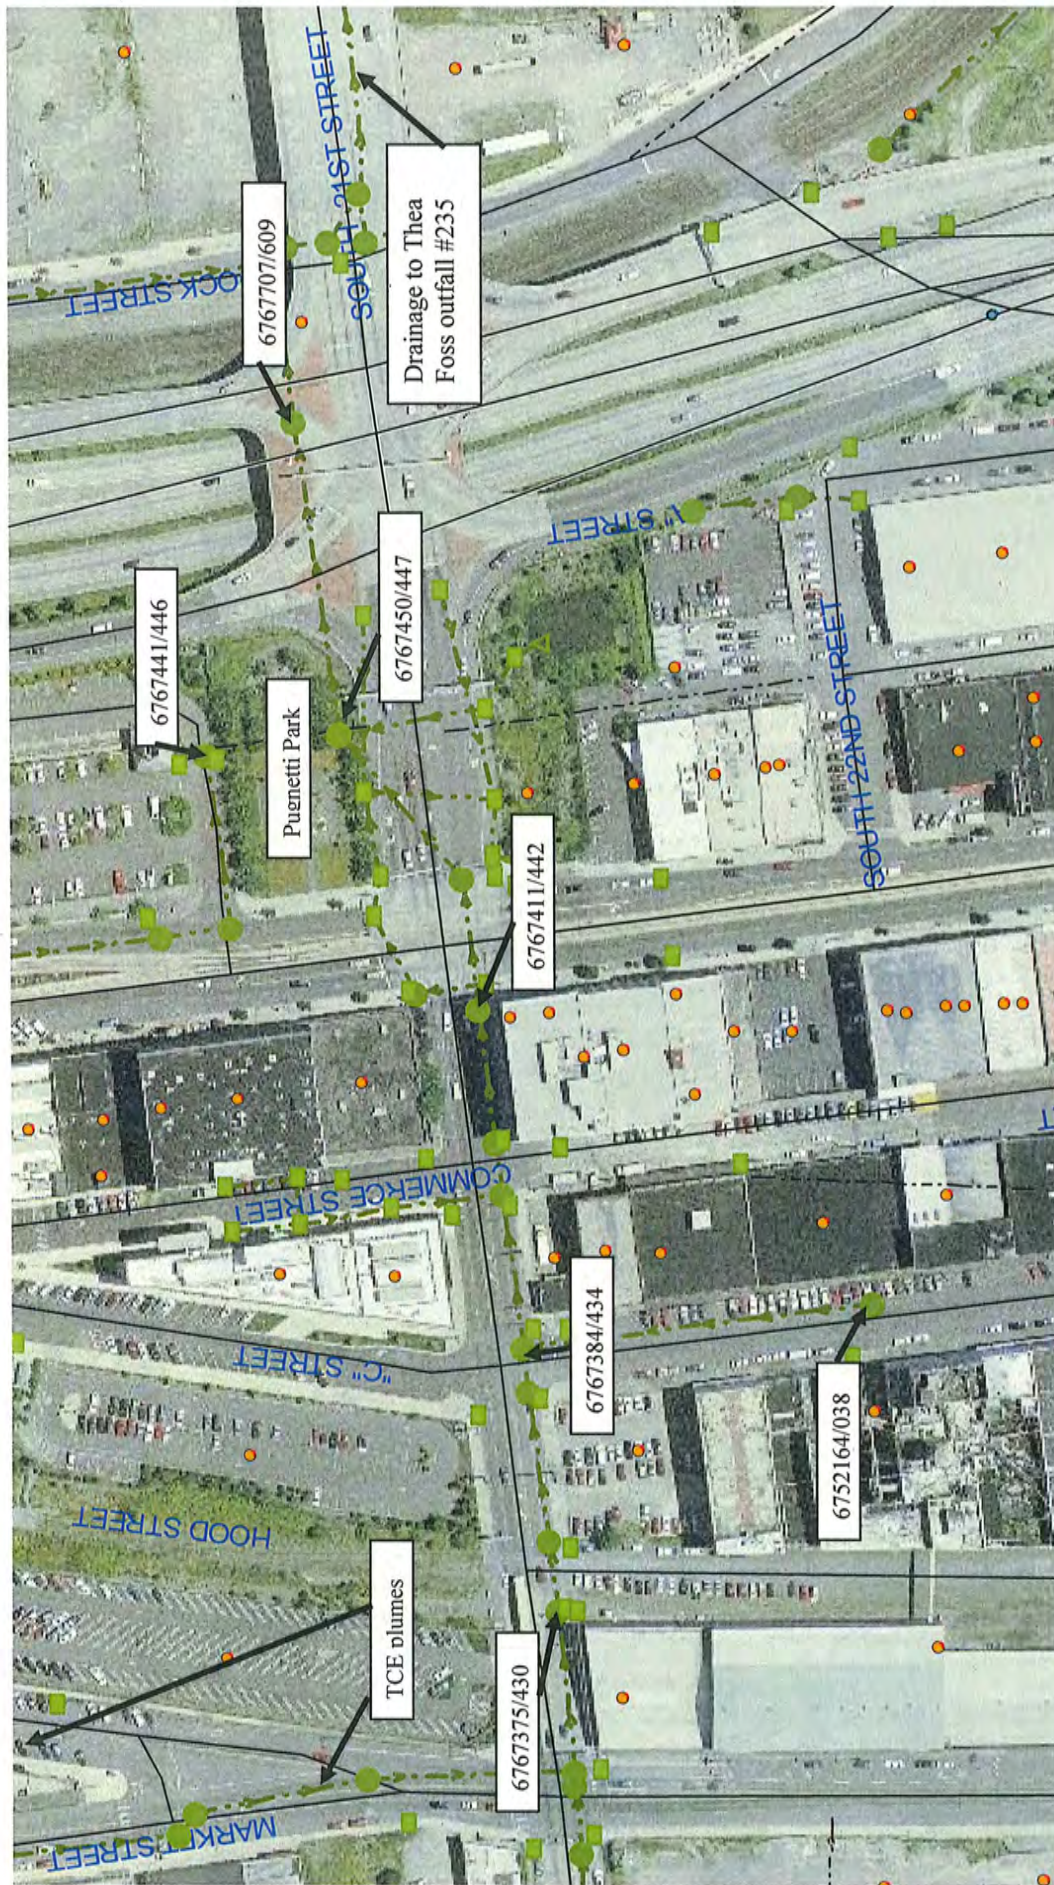
PUGNETTI PARK UPSTREAM AND DOWNSTREAM DRAIN SURVEY 6/2/03

In June of 2003, Ecology and the City of Tacoma source control team investigated storm drain dry weather flows in a number of manholes in the vicinity of Pugnetti Park. Dry weather flows were sampled to determine if there was evidence of gasoline infiltrating into other storm drains in the area, either from an upgradient source or from the Pugnetti Site. The dry weather flows in the upgradient manholes did not contain evidence of petroleum. The dry weather flow at manhole 446 did contain ethylbenzene and xylene.

Manhole 446 is located directly downgradient of the former tank locations. Water from downstream manhole 609, close to outfall 235 into the Thea Foss Waterway, did not contain gasoline but did contain some benzene. Manhole 609 is the next downstream manhole from Pugnetti Park, about ¼ mile to the east. Results of this drain investigation are found in **Appendix D**).

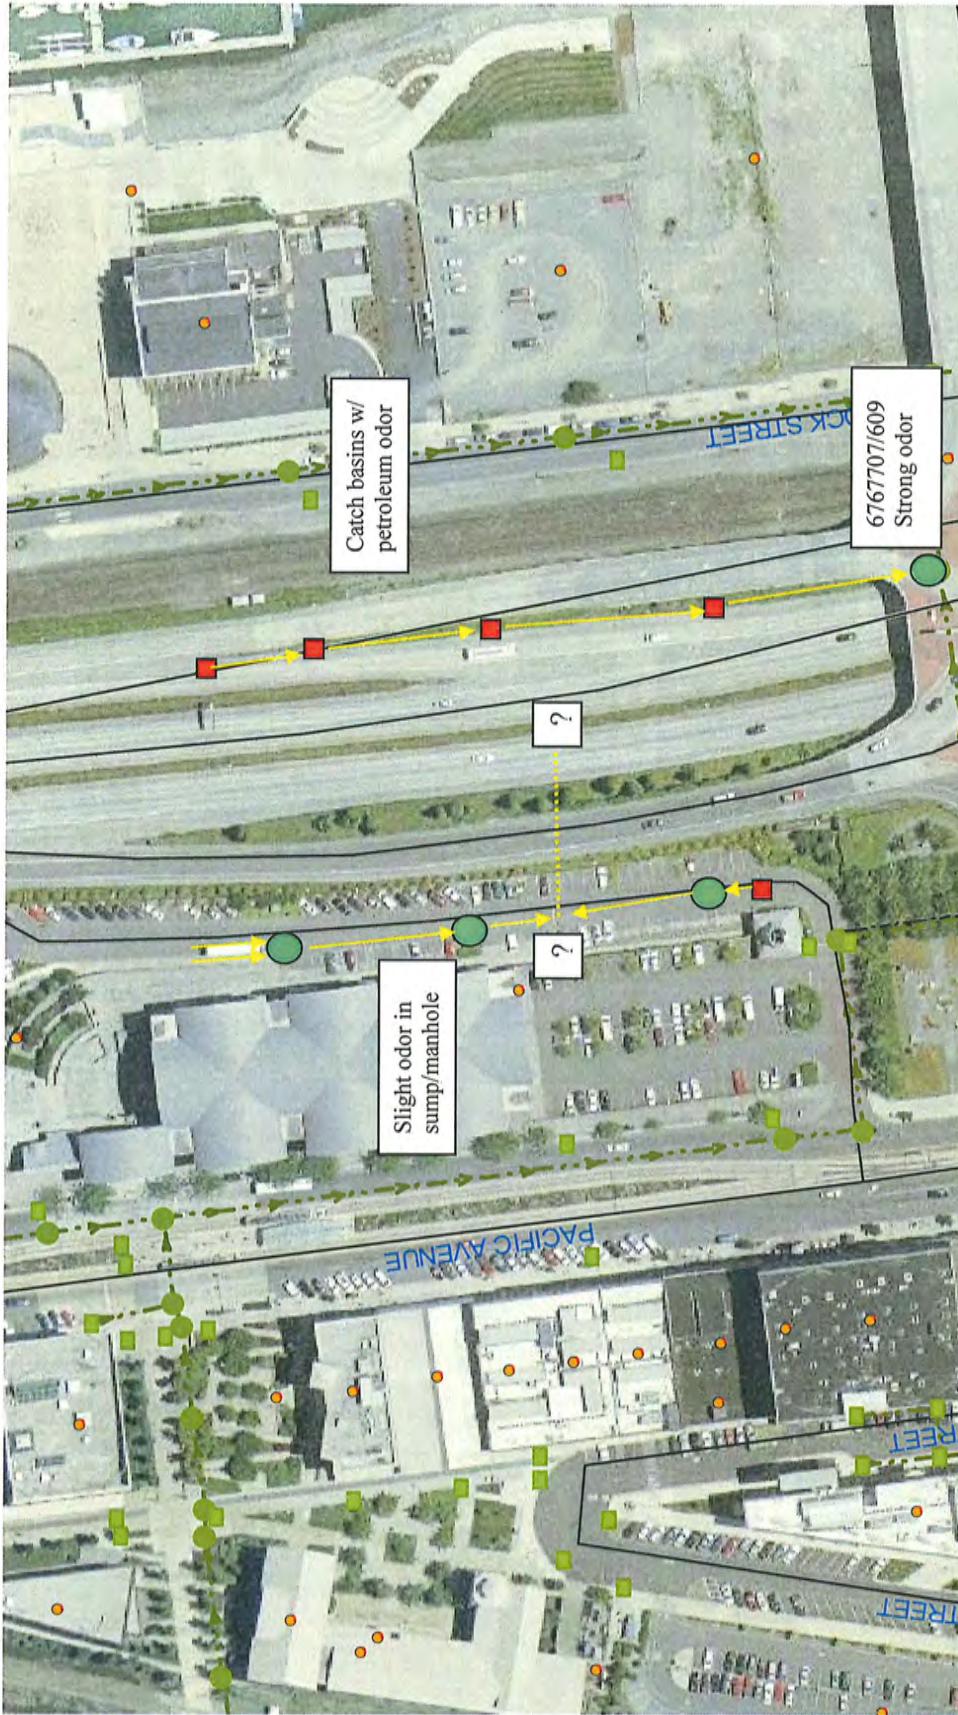
DRAINAGE AND ODORS – WASHINGTON STATE HISTORY MUSEUM AND DOWNSTREAM DRAINAGE

On several occasions an odor has been noted emanating from manholes and catch basins around Pugnetti Park and behind the Washington State History Museum. The same odor was smelled in catch basins along I-705, just east of the history museum, and in manhole #609, located underneath the 21<sup>st</sup> street bridge. This is not a gasoline/benzene odor, but instead has been characterized as creosote-like, or heavily weathered diesel or oil.

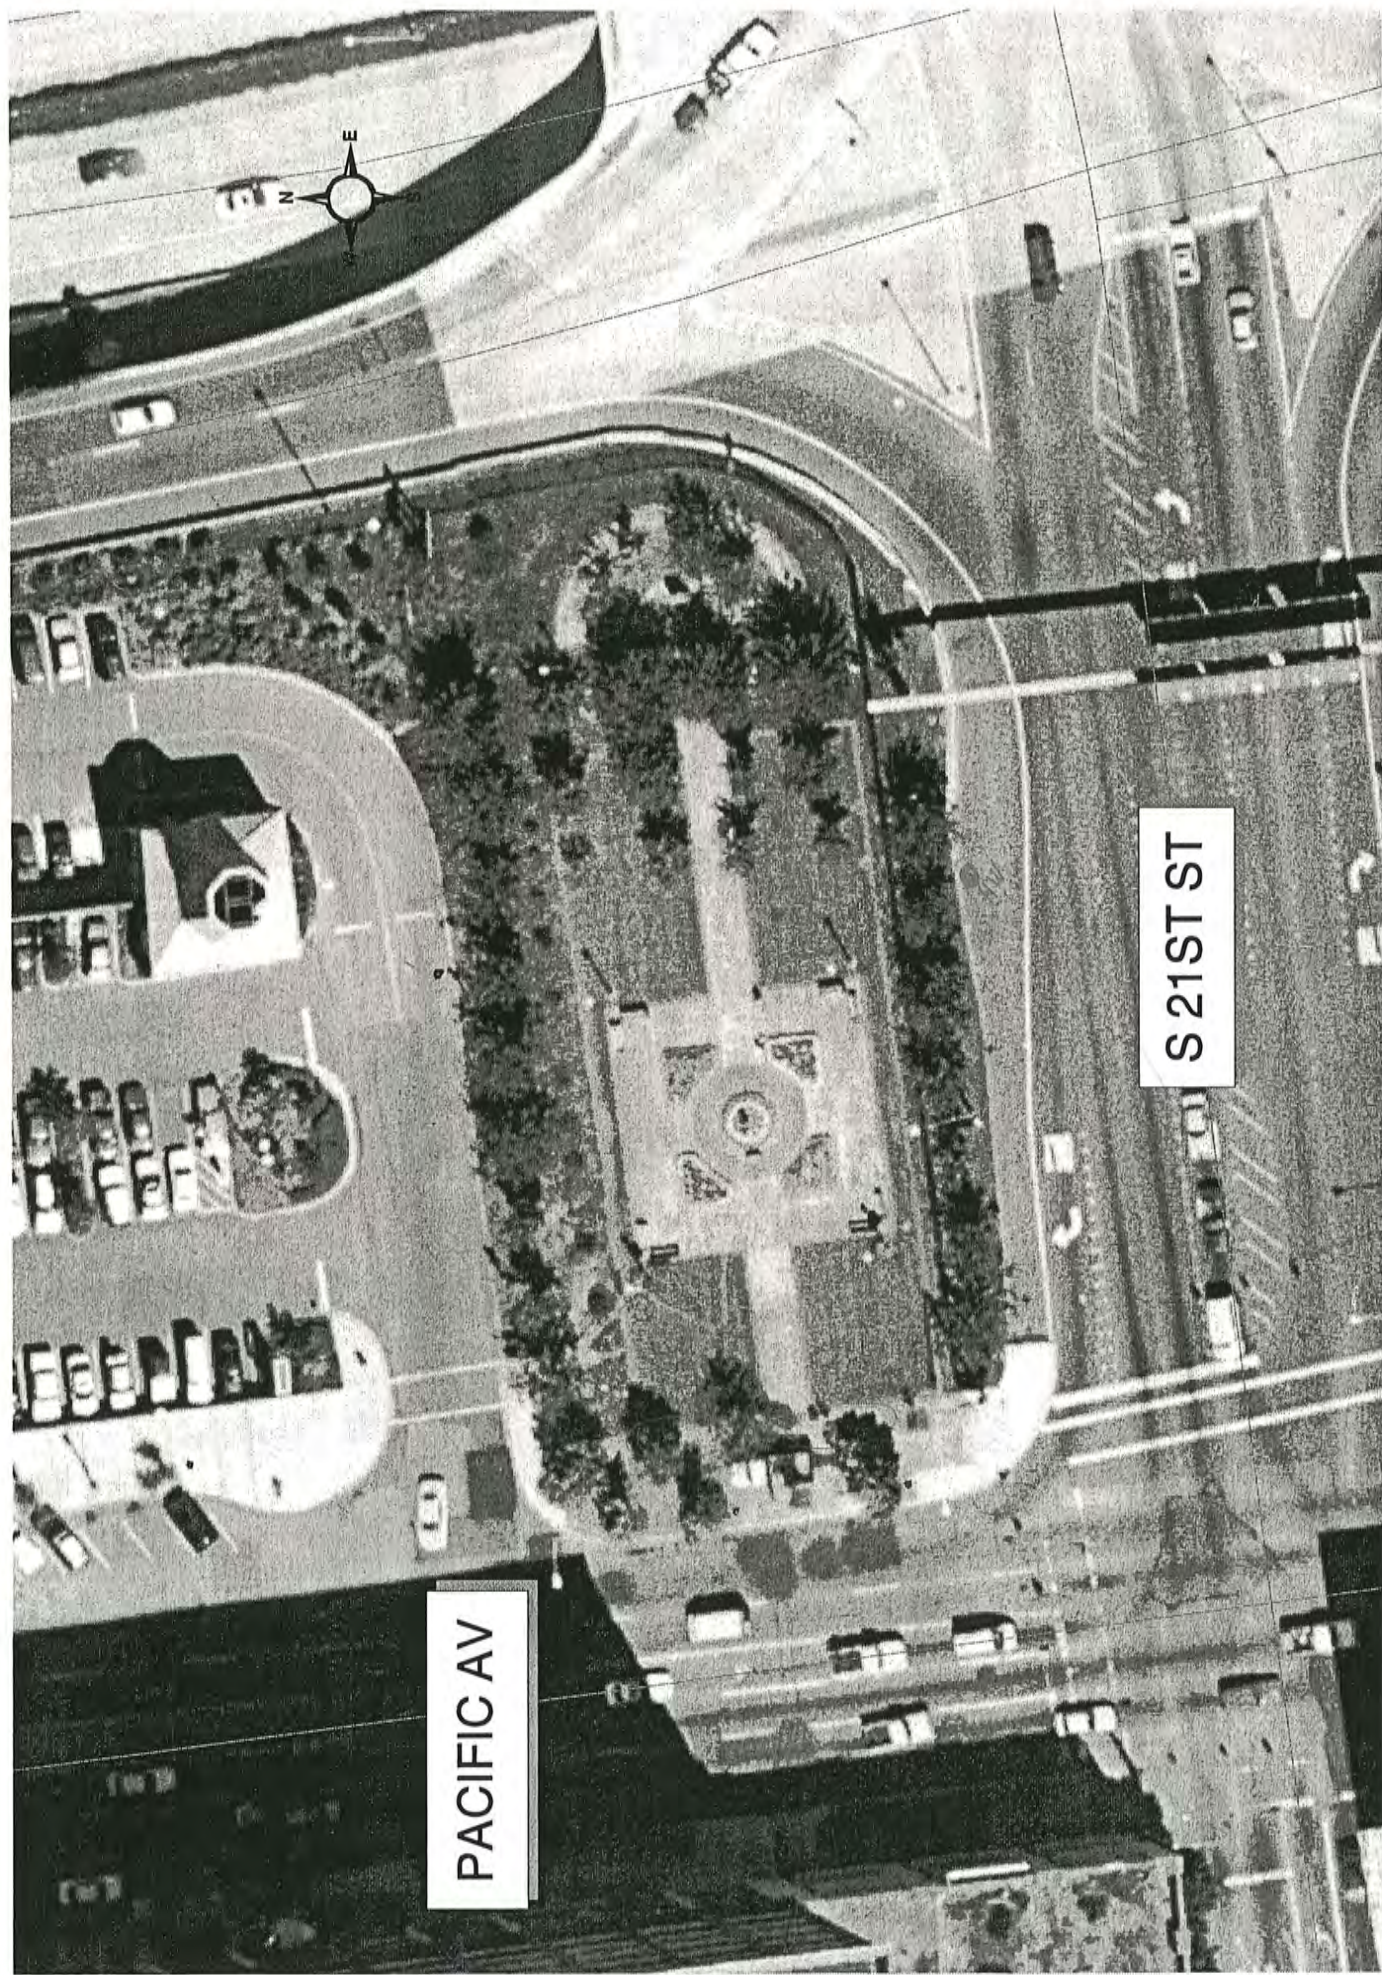
Figure 1

The petroleum contaminant concerns were isolated to the southern end of the Historical Museum property and Pugnetti Park (Figure 1.). Samples had been taken of stormwater infiltrate at a location on the east side of the museum and on the south side of Pugnetti Park (see Figure 2., park is outlined in red). Water samples were taken within catch basins where cracks or holes in the storm water system allowed groundwater to “infiltrate” into the system. Both samples indicated elevated levels of petroleum contaminants (Attachment A). Stormwater samples taken from the system away from areas affected by the “infiltration” did not contain petroleum contamination. Petroleum contamination sources to the stormwater system around the park and museum were therefore isolated to the “infiltrates”.
