2016 and 2017 Riverfront Park Soil Management Report

Riverfront Park
Spokane, Washington

for
City of Spokane

July 13, 2018

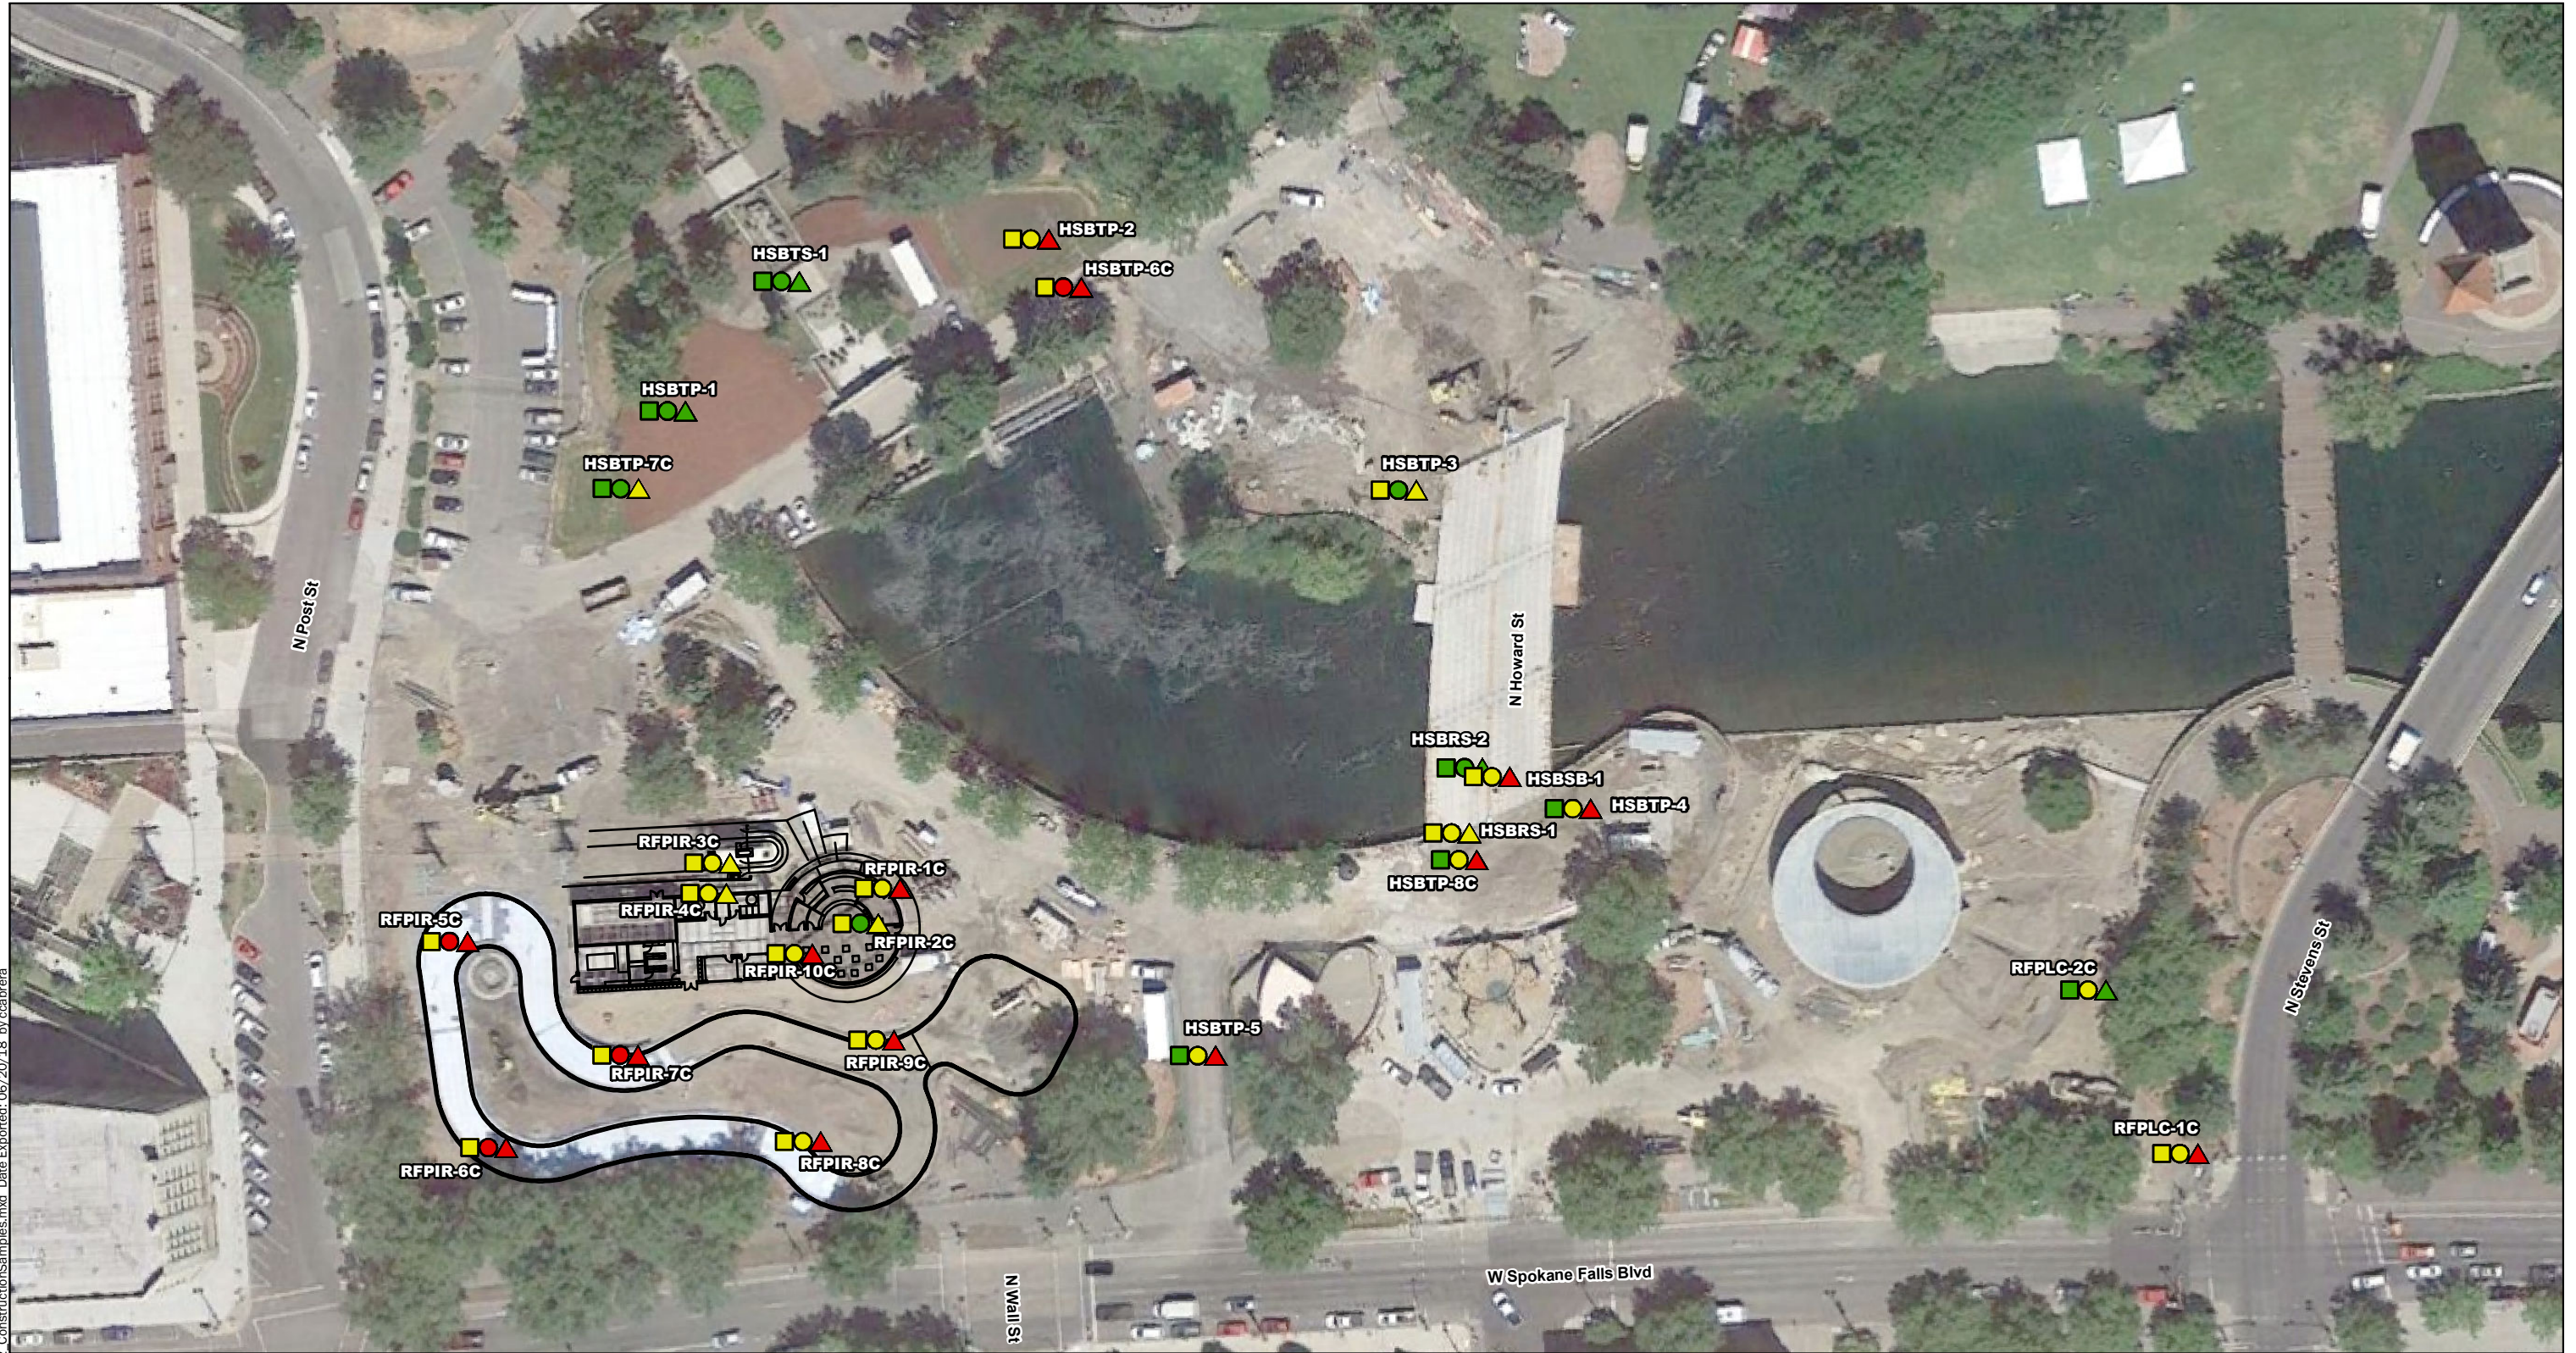
Construction Sample Locations	
Riverfront Park Spokane, Washington	
	Figure 2

- Contaminated – Concentration greater than MTCA Method A Cleanup Level for one or more COC analyzed
- Impacted – Concentration less than MTCA Method A Cleanup Levels and greater than laboratory reporting limits or twice the available background metals concentration for each COC analyzed
- Clean – Concentration less than laboratory reporting limits or less than twice the available background metals concentrations for each COC analyzed

■ TPH
 ● Metals
 ▲ PAHs

During construction, multiple soil samples were collected to profile soil for disposal or characterize soil left in place. The following sections describe the soil sampling conducted for the HSBSC project. Analytical results of soil samples collected for the HSBSC project are summarized in Table 1 and sample locations are shown on Construction Sample Locations, Figure 2.

On August 22, 2016, five test pits (HSBTP-1 HSBTP-2, HSBTP-3, HSBTP-4 and HSBTP-5) were excavated to characterize soil for the HSBSC project (Figure 2). Two test pits were excavated to characterize soil designated for export to construct stormwater ponds along the new access road and two additional test pits were excavated to characterize soil at the HSBSC north and south abutments. The fifth test pit was excavated to characterize soil designated for export to construct a construction entrance to the site from Spokane Falls Boulevard. One soil sample from each test pit was collected from depths ranging from about 1 to 2½ feet below ground surface and submitted for laboratory chemical analysis. Analytical results generally indicated the soil was contaminated or impacted in accordance with the project SMP (GeoEngineers 2017). Results are summarized in Table 1. Soil characterized by these test pits was excavated and disposed at Graham Road.

Construction for the Ice Ribbon started in February 2017. Initial work included leveling the site and excavating for utilities and building footings. Along the alignment of the ice ribbon, the soil was excavated about 2 feet to accommodate the ice ribbon foundation and cooling system. Soil excavated from the site was stockpiled on the North Bank of the Spokane River (Figure 4). Stockpile construction and preparation is discussed in Section 2.1. Approximately 7,000 cubic yards (CY) of soil were hauled from the Ice Ribbon project and stockpiled at the North Bank. Waste profile samples were not collected for the soil removed for the Ice Ribbon project. The soil excavated from the site was generally characterized using the results of the Geotechnical Engineering Evaluation and Environmental Site assessment for the project (GeoEngineers 2016b). As earthwork was completed, characterization samples of soil left in place were collected. Characterization analytical results of samples collected for the Ice Ribbon project are summarized in Table 3 and sample locations are shown on Figure 2.

A total of 10 characterization samples were collected for the Ice Ribbon project as shown on Figure 2. Eighty percent of the characterization samples contained PAH concentrations greater than the MTCA Method A cleanup level. In addition, 30 percent of the samples contained lead concentrations greater than the MTCA Method A cleanup level. Soil with lead concentrations greater than the MTCA Method A cleanup level was generally located on the western portion of the site. Other COCs were less than their respective MTCA Method A cleanup levels.

Excavation for the building foundation was generally conducted into bedrock and as a result, a limited number of characterization soil samples were collected for the Loeff Carousel Project. Analytical results of soil samples collected for the project are summarized in Table 4 and sample locations are shown on Figure 2.

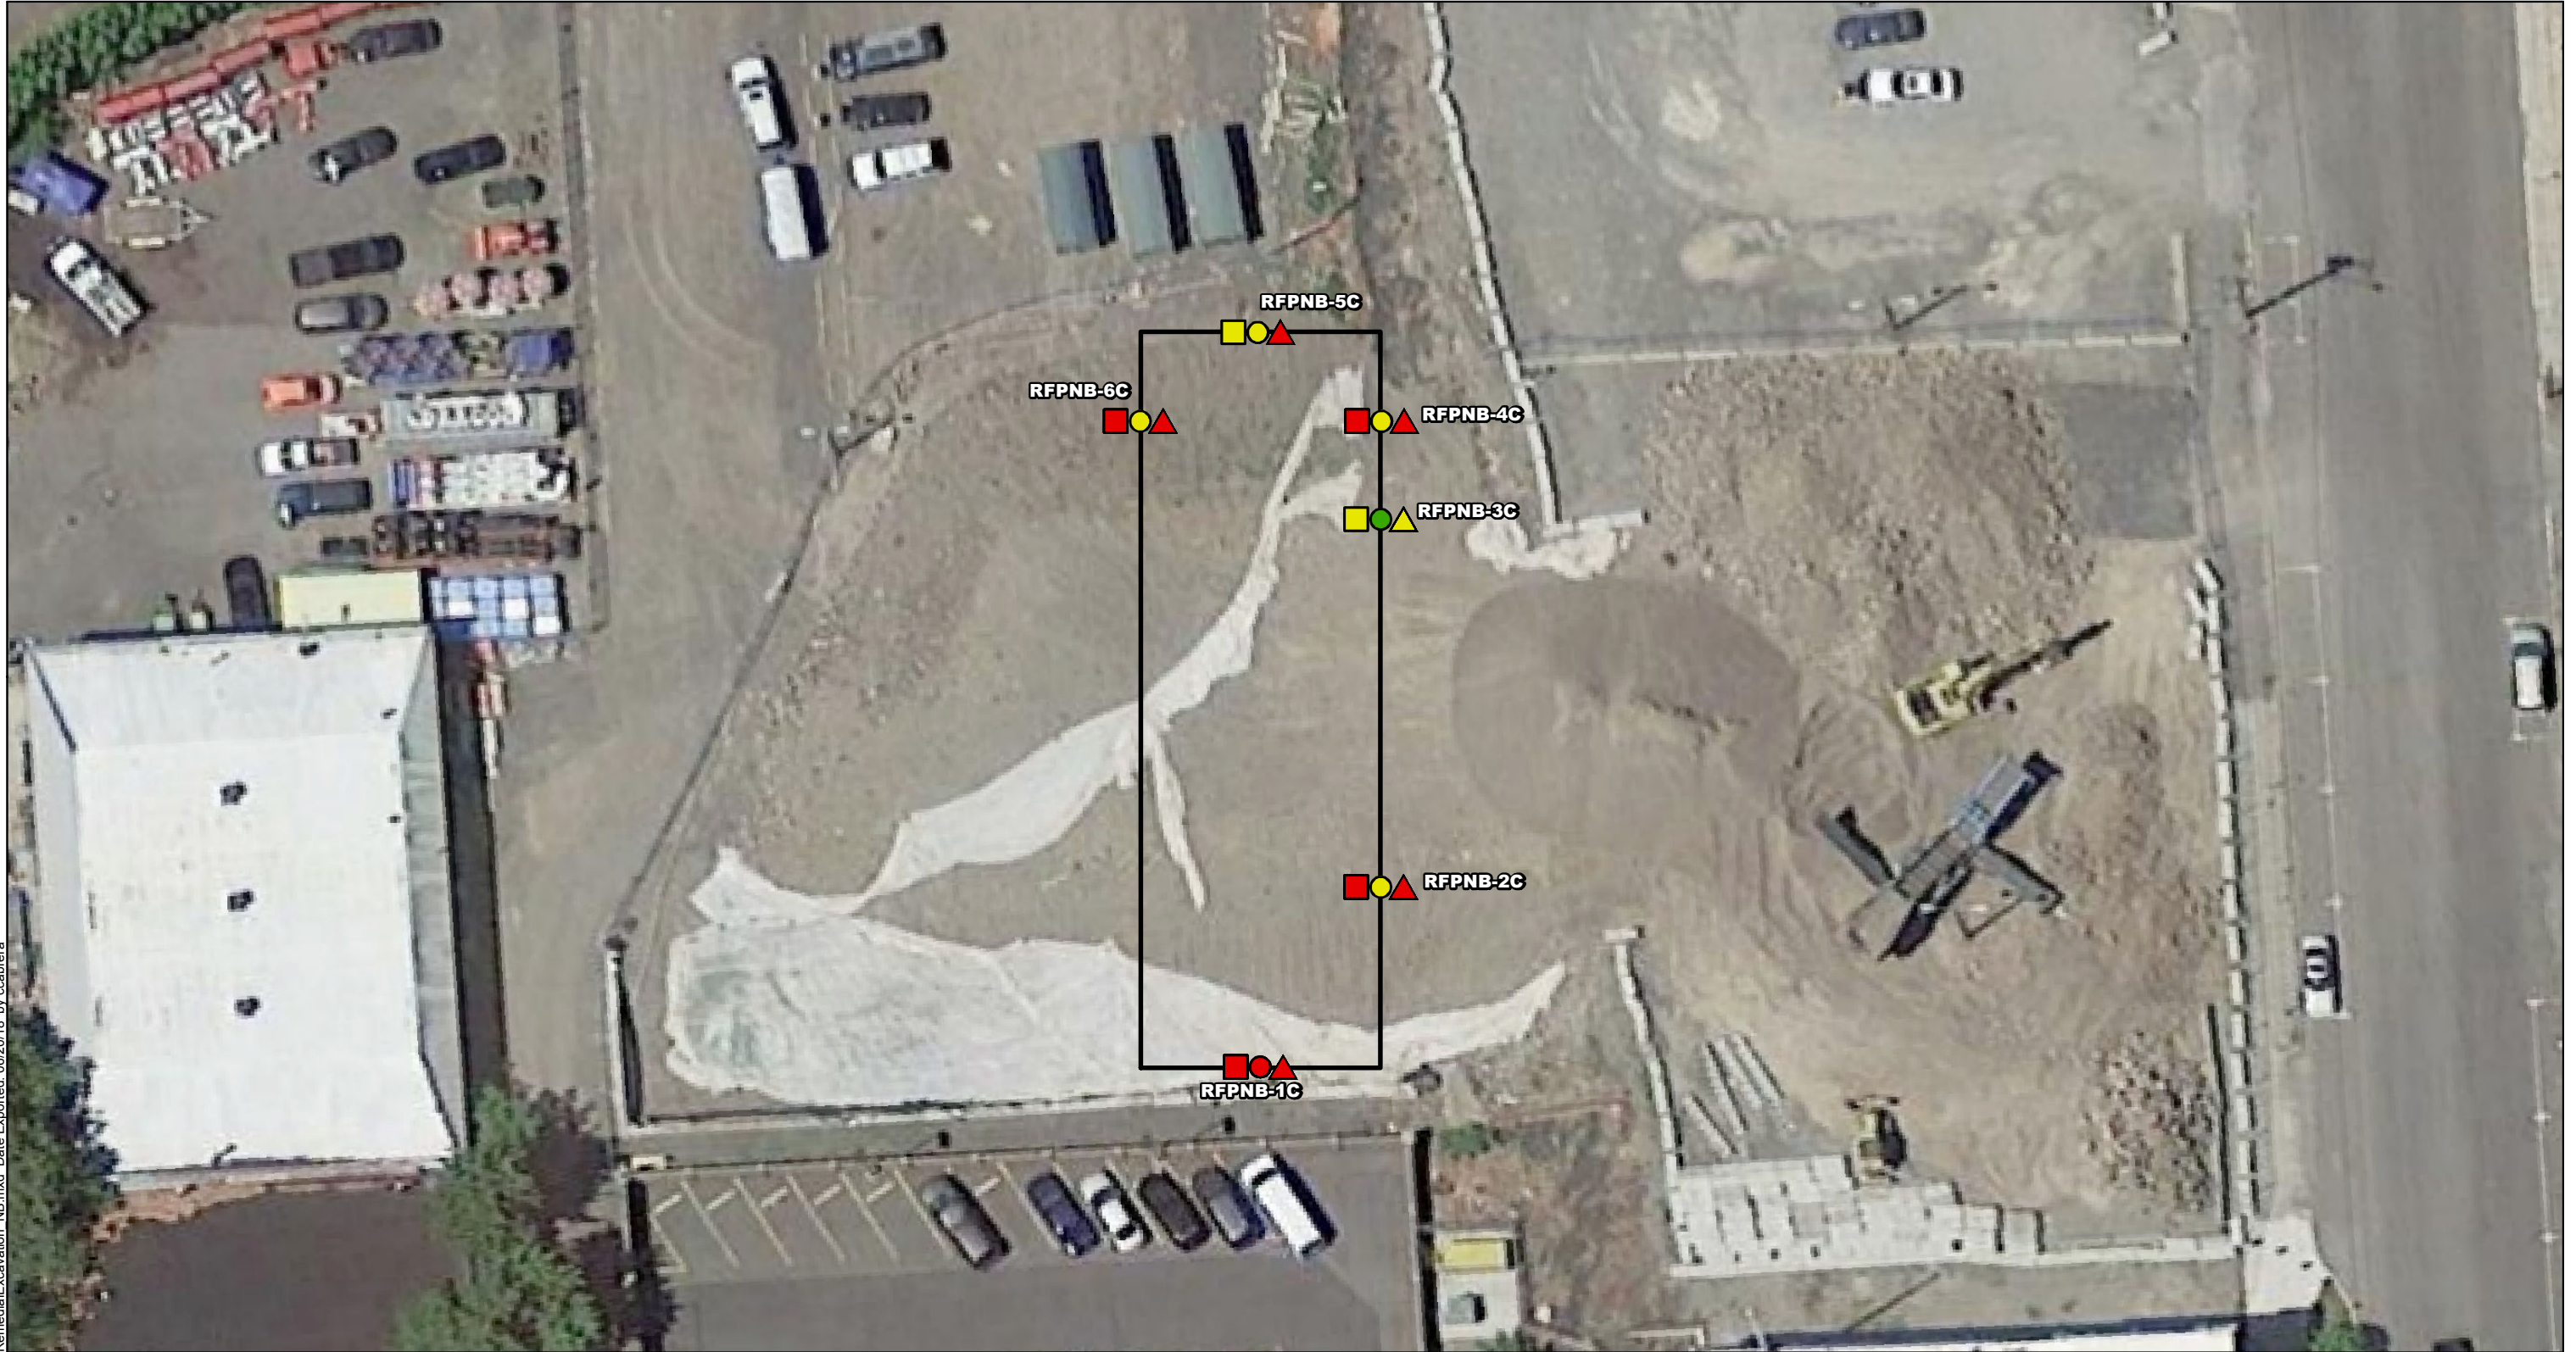
North Bank Remedial Excavation	
Riverfront Park Spokane, Washington	
	Figure 4

- Contaminated - Concentration greater than MTCA Method A Cleanup Level for one or more COC analyzed
- Impacted - Concentration less than MTCA Method A Cleanup Levels and greater than laboratory reporting limits or twice the available background metals concentration for each COC analyzed
- Clean - Concentration less than laboratory reporting limits or less than twice the available background metals concentrations for each COC analyzed

- TPH
- Metals
- PAHs
- Approximate Limits of Remedial Excavation

Parks anticipated the soil stockpile would remain in place, and therefore, initiated a removal action for the PCS between March 6 and March 9, 2017. PCS excavation was limited to the bedrock bluff to the north and a masonry wall to the east. PCS excavation to the south and west was terminated under direction from Parks, was anticipated that the stockpile footprint would not exceed the southern and western extents of the excavation at the time of termination. Parks planned to remove the remaining PCS in the future during construction of improvements in that area. Characterization results of samples collected from the excavation are provided in Table 2 and Locations are showing on North Bank Remedial Excavation, Figure 4.

Approximately 500 tons of contaminated soil was removed by T. LaRiviere and transported to Graham Road for disposal. The completed limits of excavation measured approximately 135 feet long by 48 feet wide by 3½ feet deep (Figure). Laboratory analysis results for characterization samples of soil left in place at the excavation extents (RFPNB-1C through RFPNB-6C) are shown on Table 2. The excavation was backfilled with soil from the ice ribbon construction project. As the stockpile was constructed, the footprint of the stockpile eventually exceeded the footprint of the excavation as shown on Figure 4.
